**Archaeological Building
Recording in the East
Wing of Alton Towers,
Alton, Staffordshire**

Birmingham University Field Archaeology Unit
Project No. 1039
February 2003

by
Malcolm Hislop

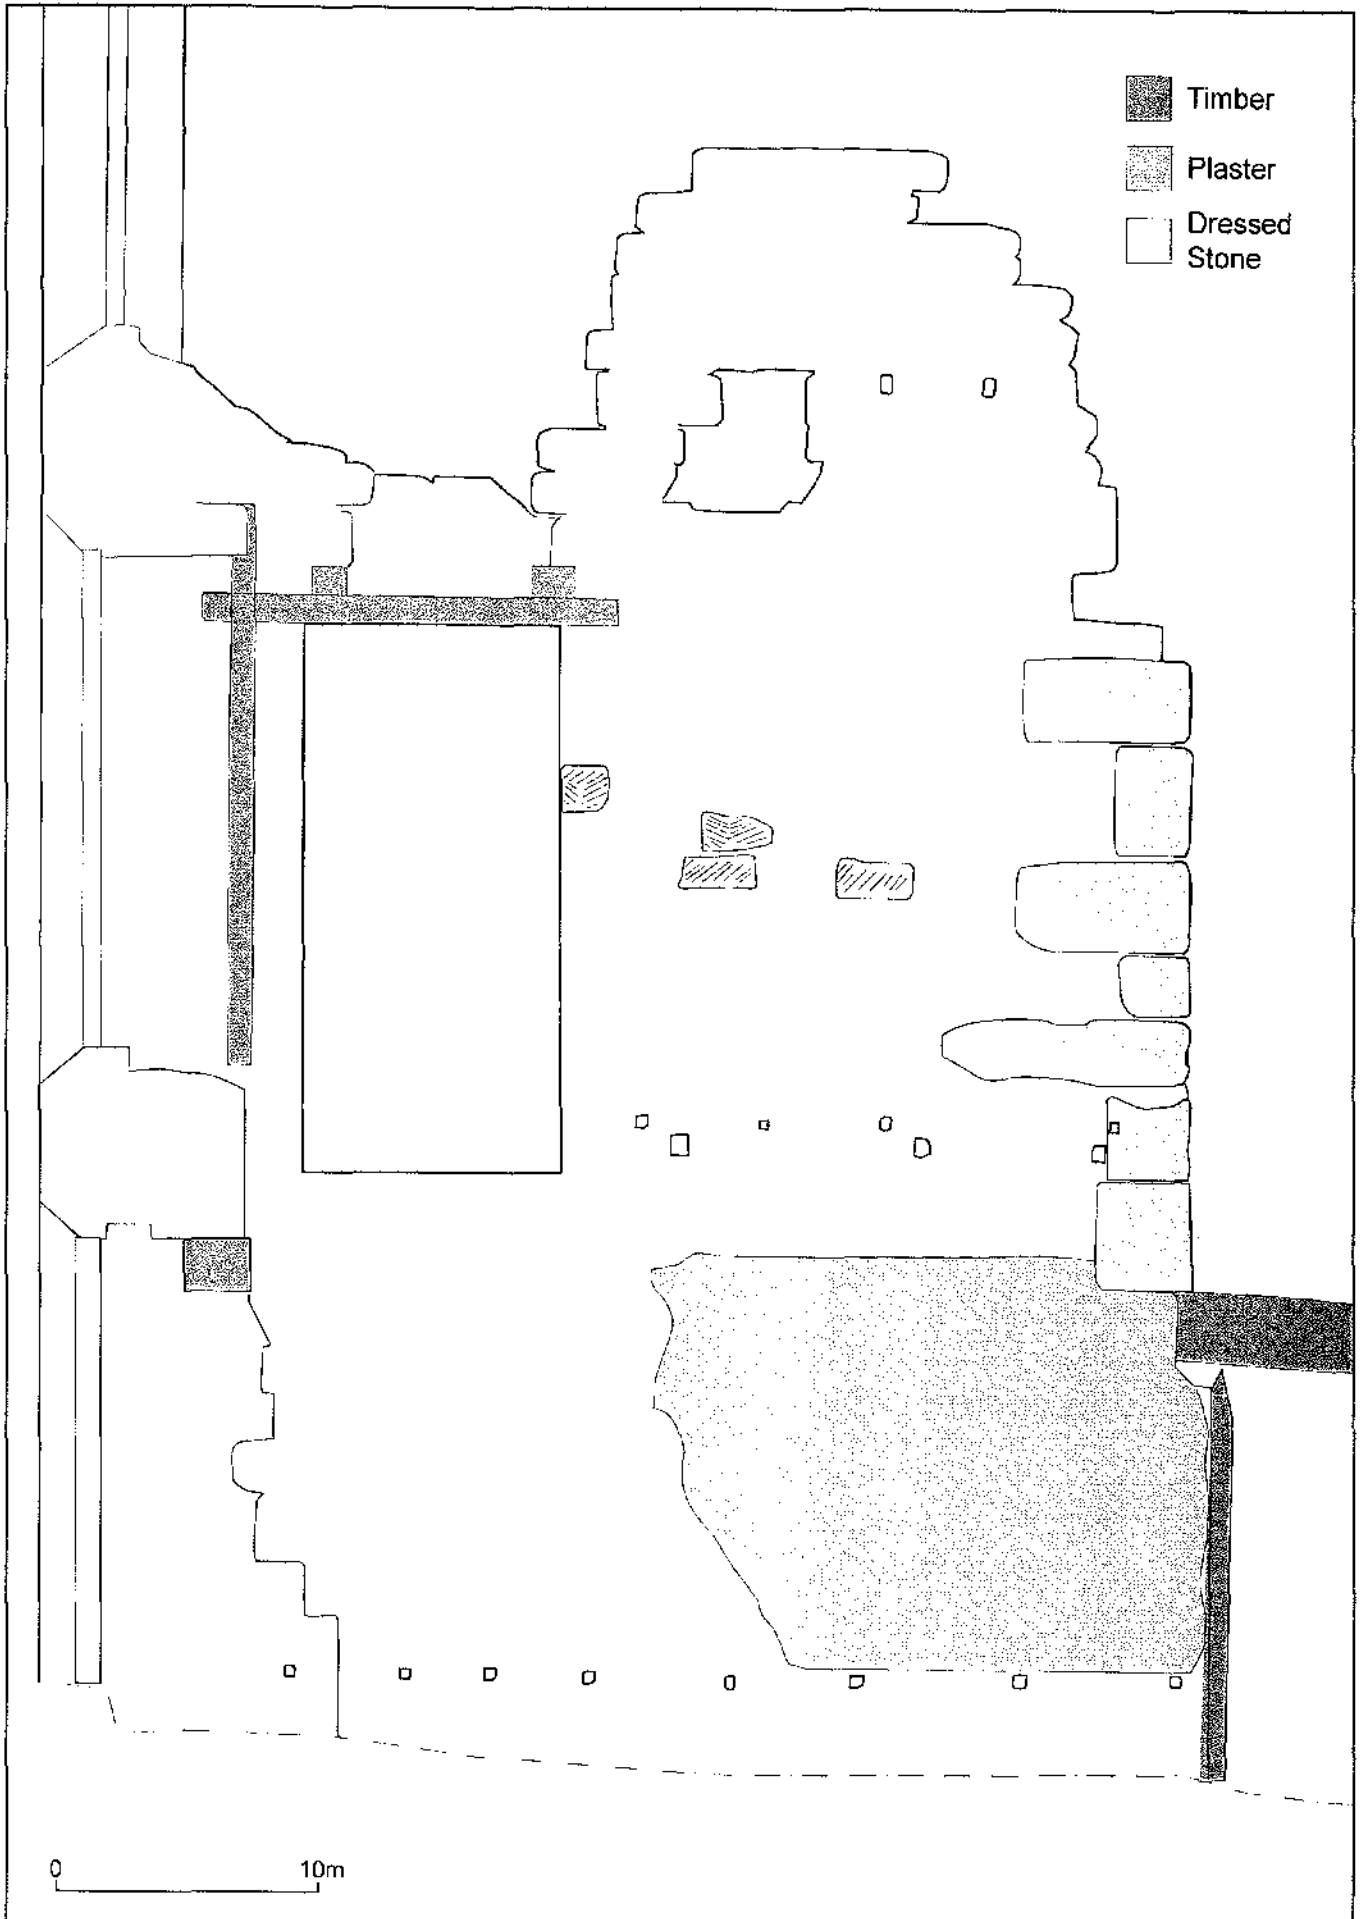
Fig.6 North Elevation

First Floor

Plaster had been applied directly to the wall, and still adhered to the western half, terminating 0.4m above the existing floor level. Almost immediately beneath this, extending across the entire length of the wall, was a row of eight holes for timber plugs, approximately 0.02m square, probably for fixing skirting boards to. Towards the eastern end was an irregular vertical joint in the masonry (Plate 2), beginning at the western corner of the timber lintel over the east window embrasure, and descending to floor level, suggesting, on the whole, that the cross-wall post-dated the east wall of the house. The construction of the embrasure itself was of very poor quality, giving the impression that the opening was secondary and had been broken through an older wall. An examination of the area behind the southern jamb of the window frame suggested that the stonework of the window frames had been cut back in the 19th century to accommodate the new surrounds. One of the stones behind the jamb was a fine-grained sandstone with fine diagonal striations (Plate 3); this stone contrasted markedly with the coarser-grained herringbone-patterned masonry that is more characteristic of Alton Towers. At the eastern extremity of the wall there was a doorway, the substantial timber lintel of which projected westwards from the surviving wall.

At second floor level the lower part of the wall appeared to butt against the east wall in a continuation of the vertical joint recorded below, though the upper part was obscured. Immediately west of the window was a doorway, 2.04m high by 0.98m wide, with a timber lintel. The jambs were formed of similar coursed rubble as the rest of the wall, including one reused piece of dressed stone with coarse herringbone pattern tooling, and a few 9" x 4" x 2¼" bricks, probably of 16th or 17th-century date.

To the west of the door, 0.06m above the level of the sill, was a row of three plug holes, approximately 0.06 x 0.08m, and, 0.08m above sill level, a row of five plug holes approximately 0.02m square. The western end of the wall was formed by a series of dressed blocks, which contrasted markedly with the rubble work. It is evident that they formed the eastern jamb of a primary doorway that splayed outwards towards the south (Fig. 7, inset). Within the wall at this level was a number of reused fragments of dressed stone, including two with coarse diagonal tooling and another piece with herringbone tooling.

Only a fragment of the wall survived above third floor level, up to a height of 1.1m. The only features were two plug holes approximately 0.2m above the floor, and an irregular shaped hole that seems to have been broken through after the building went out of use.

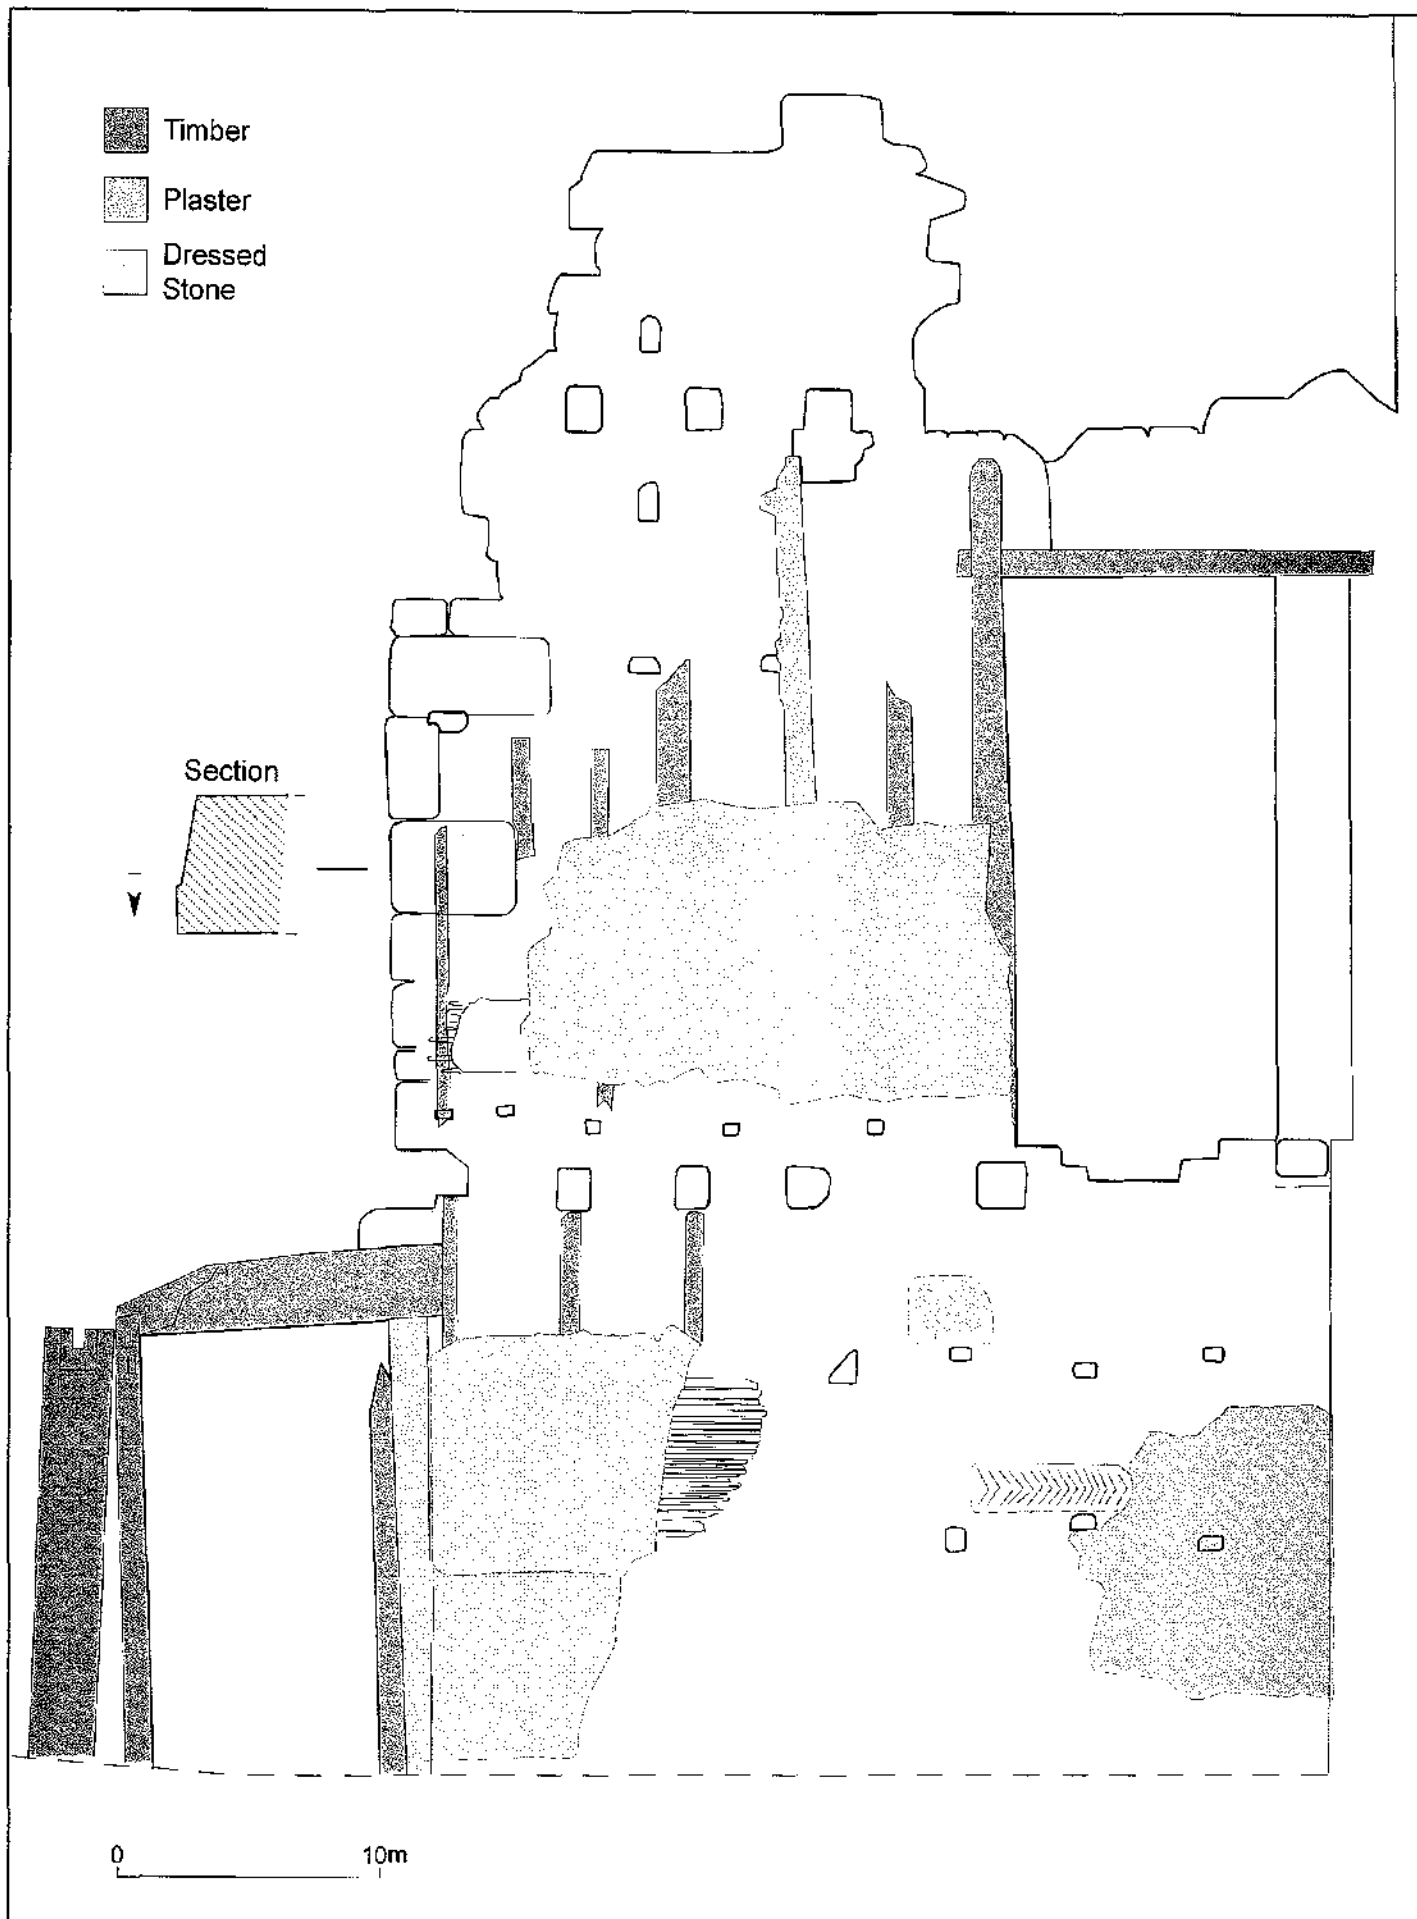
Fig.7 South Elevation

Two blocks of dressed masonry were recorded in this wall. One of these measured 0.60m x 0.19m and had herringbone pattern tooling (Plate 4), the other was 0.32m x 0.24m and had fine diagonal tooling (Plate 5). Patches of plaster survived at both ends of the wall. That at the east end was applied directly to the wall, whereas that at the west end comprised two skins applied to laths, which were themselves fixed to vertical batons attached to wooden plugs set into the walls. Two irregular rows of plug holes, about 0.08m x 0.06m, were visible at approximately 0.90m and 1.6m above floor level; one of the lower row of holes was cut through the plaster at the east end of the wall. The doorway at the west end of the wall retained the main elements of its timber frame and a chamfered, plaster-covered eastern jamb.

The relationship between the cross-wall and the east wall was unclear. At least one of the east wall stones was jointed into the cross-wall, but several of the cross-wall courses were jointed into the east wall.

At second floor level there was a row of floor joist sockets, and, in the east wall, a corresponding offset level with the sill of the eastern doorway. Ten centimetres above the joist sockets was a row of plug holes, probably for the skirting boards. A large patch of plaster on a lath and batten framework survived between the eastern and western doorways. A number of plug holes in the remaining areas of the wall indicated that this plasterwork extended across the whole surface.

At third floor level three floor joist sockets survived.

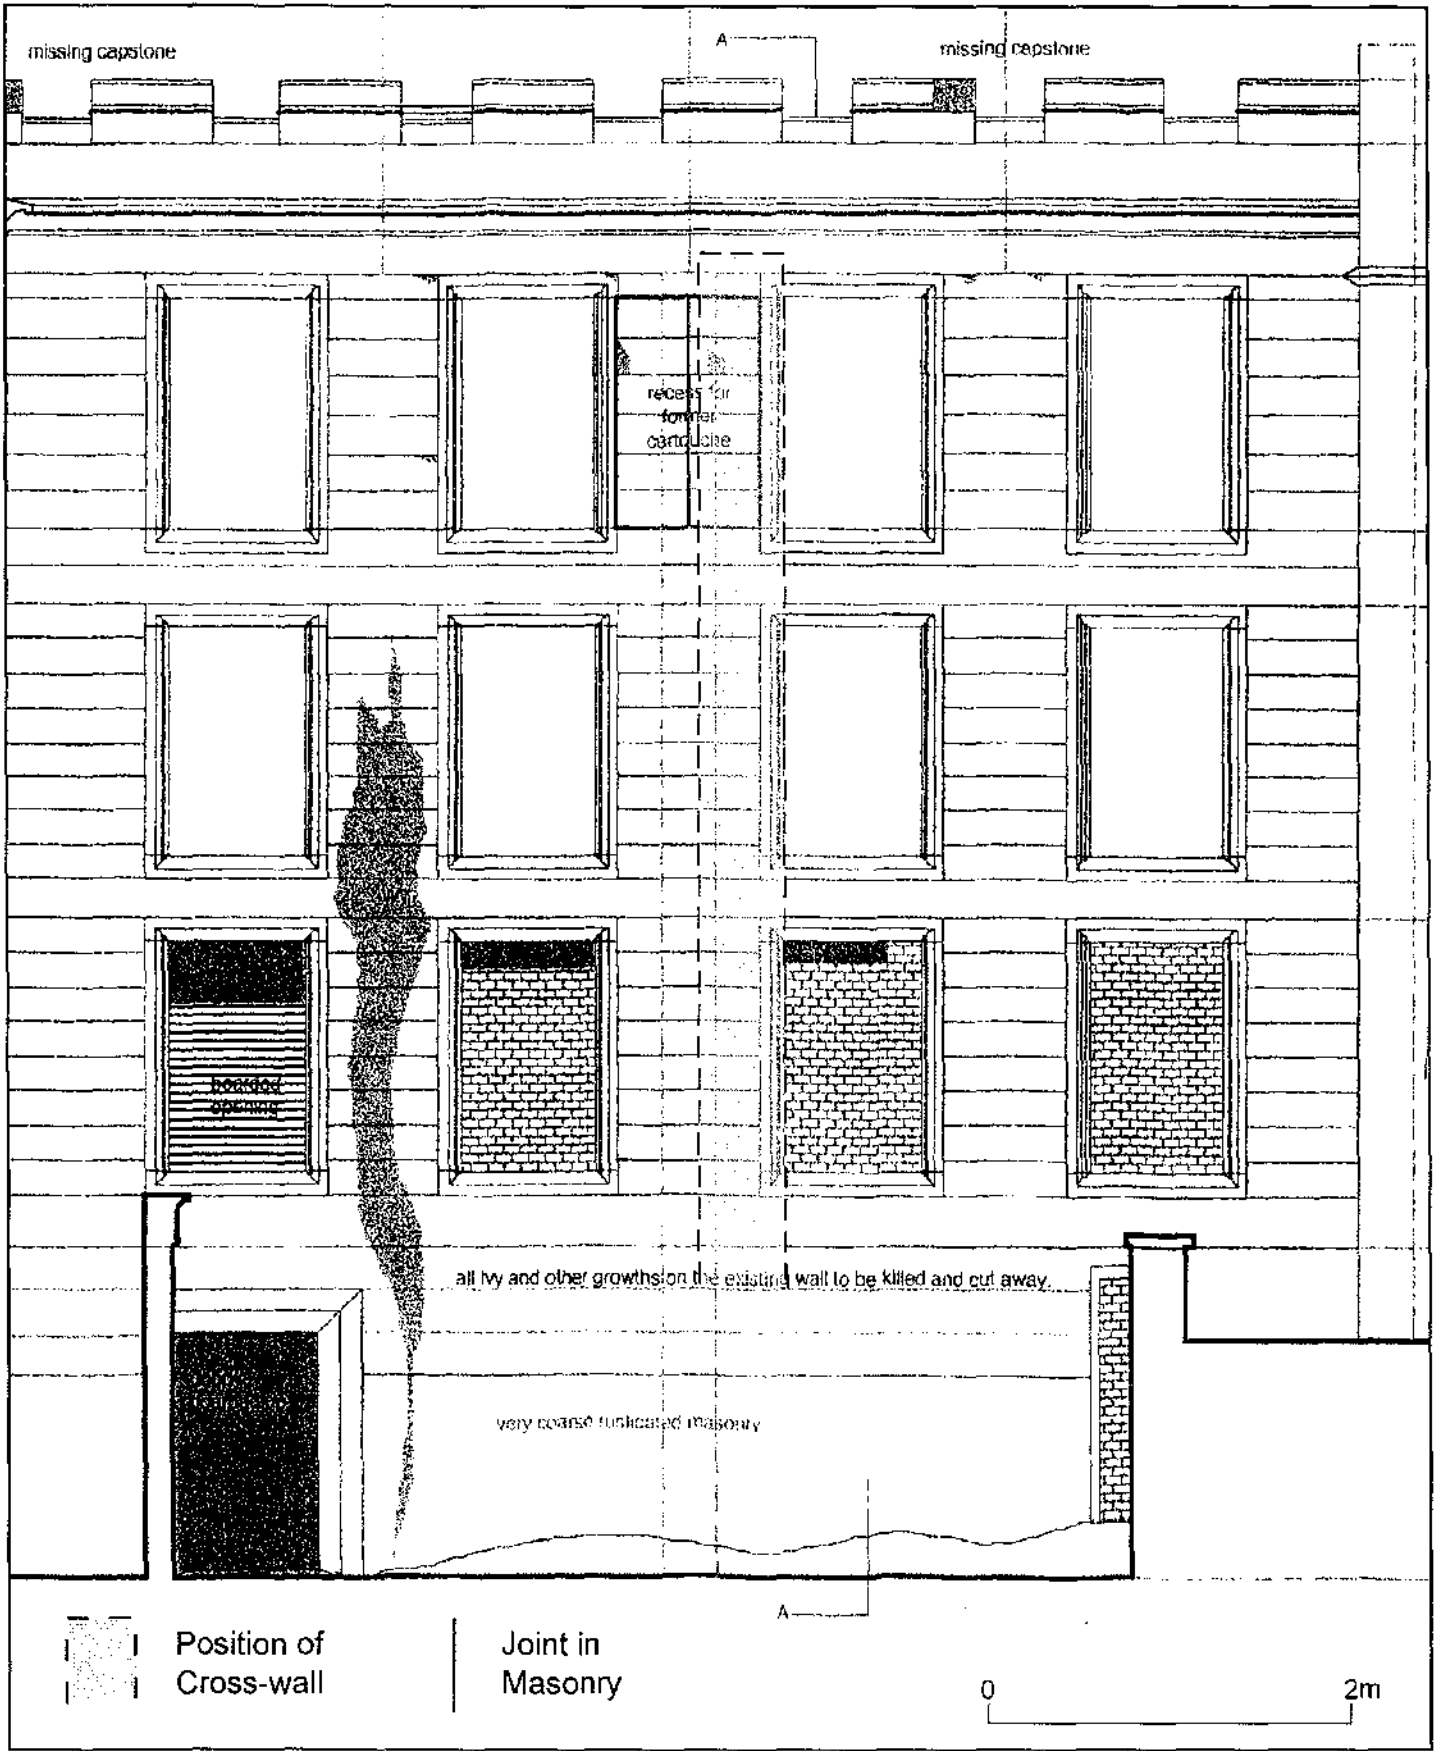
Fig.8 East Elevation

Crucial to the interpretation of the cross-wall was the relationship between it and the east wall. At the time of the survey, the east wall retained similar proportions to those shown in the drawing of c.1800, though there was now a blind basement storey that is not evident in the drawing, and which was probably a creation of the 19th century.

However, it was clear from an investigation of the external elevation during repair work, that not only had the window frames been replaced, but that the entire front had been refaced with 19th-century ashlar masonry. The masonry of both the chapel of 1833, at the south end of the old east front, and the eastern entrance tower of 1811-20, at the north end, butted against this 19th-century refacing which must therefore pre-date both (Plate 7).

The east wall of the wing, apart from the external 19th-century facing and the window frames, appeared to belong to the Alton Lodge phase, and is probably to be dated to the 17th or 18th centuries, though the uppermost storey, at least, consisted of two structural phases denoted by a vertical joint in the masonry. This joint coincided with what seems to have been a cross-wall immediately to the south of the existing cross-wall. It does not seem to have been thick enough for an external wall, and was presumably a component of the internal layout of Alton Lodge. This suggests, perhaps, that Alton Lodge was built in at least two planned stages, a phenomenon that has been recognised in some medieval buildings (Hislop 1996).

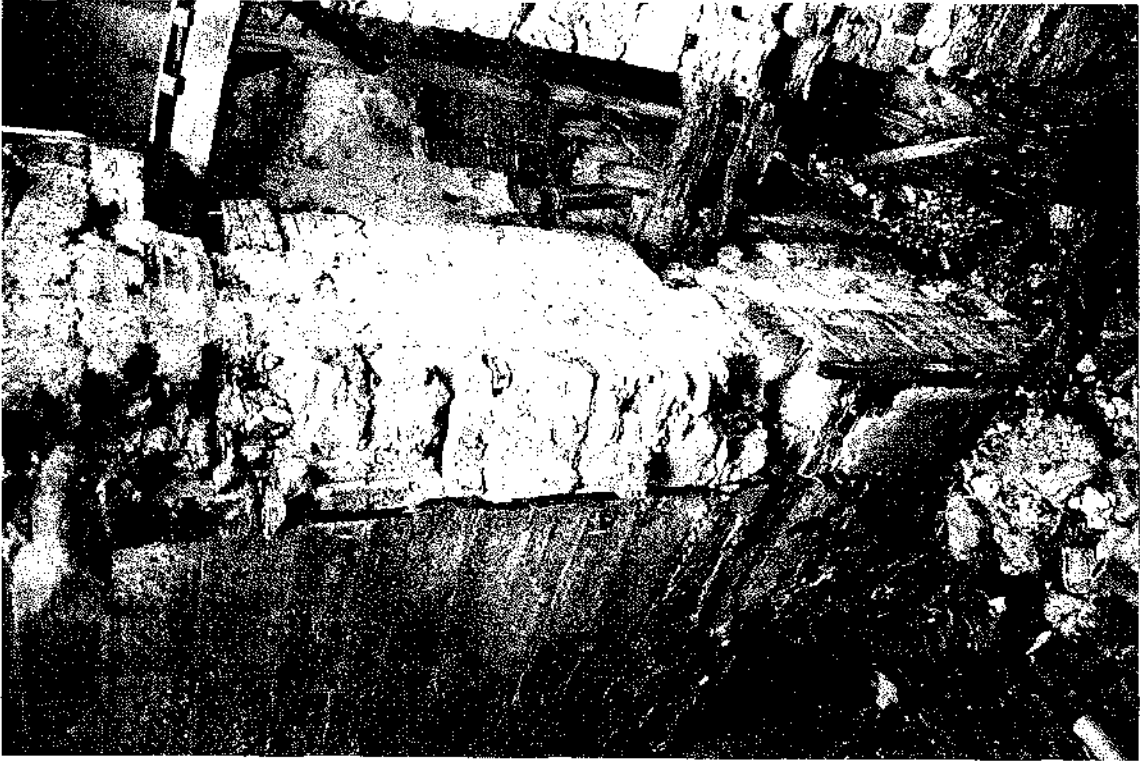
The cross-wall was situated between the two centre windows of the wing (Fig. 5). It was approximately 6m high, 4m wide and 0.52m thick. It was built of coursed sandstone rubble, incorporating some reused fragments of dressed stone and a number of dressed stone blocks, and laid with lime-based mortar. It rose from the 19th-century first floor level through two full stories and part of a further storey. Formerly, it extended right across the building, but most of the western half (Plate 1) had been demolished by the time of the survey, and the brief was confined to the eastern part.

Plate 1. North Elevation, West End of Cross-wall

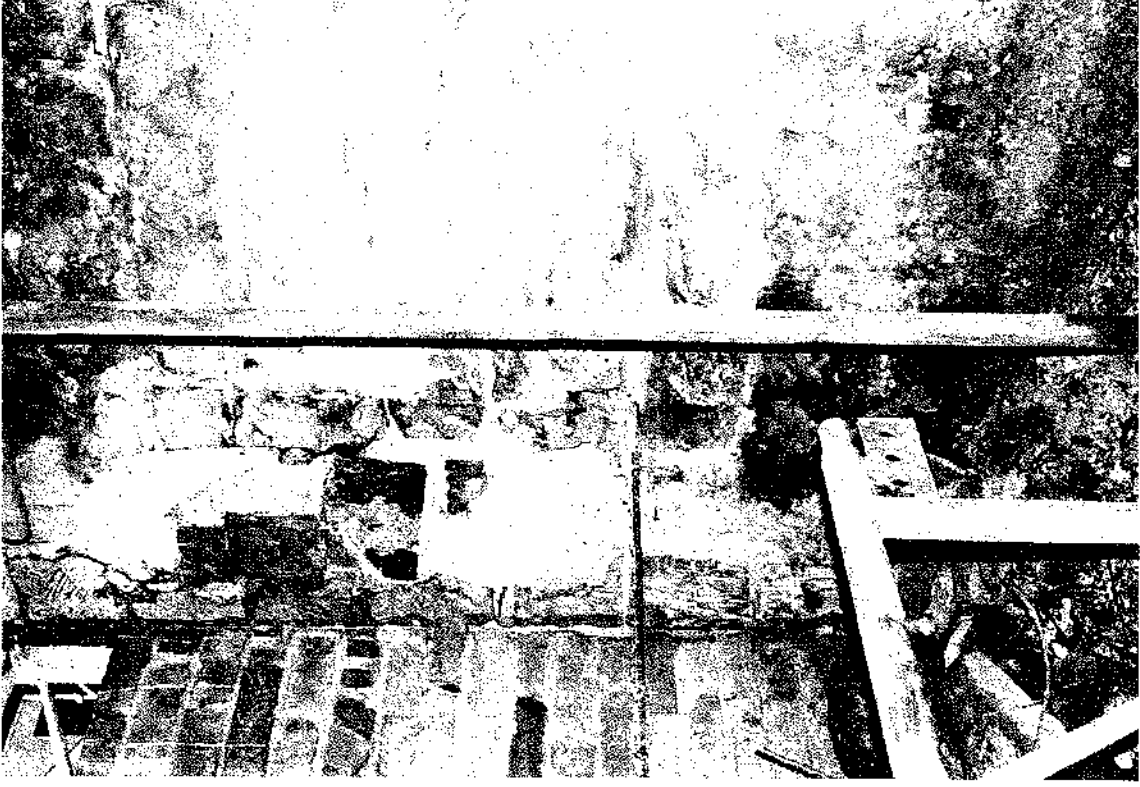
Plate 2. North Elevation, Vertical Joint at First Floor level

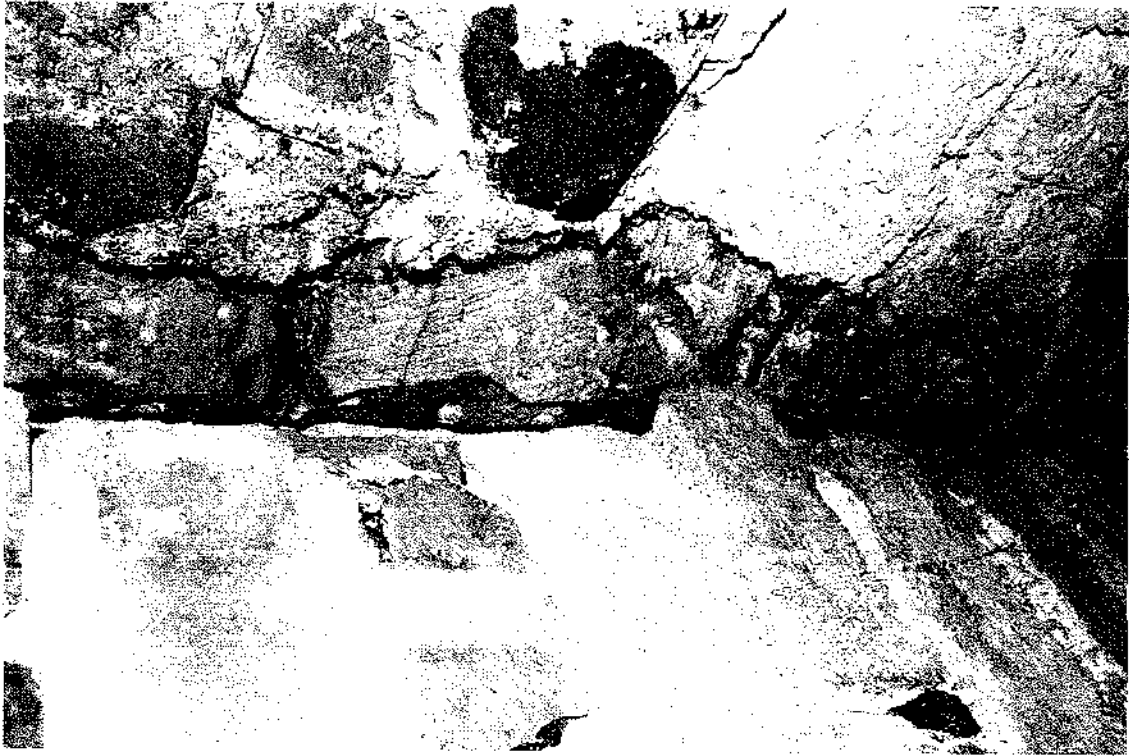
Two stones, one on the south side of the cross-wall and the other on the north side, in the jamb of the east window, were of a different character to most of the masonry, being a more finely grained sandstone. They also bore a different type of tooling mark, namely fine, diagonally-placed striations. This treatment evidently belongs to a quite different tradition of masoncraft, and would not be out of place in a medieval context. At least one of these stones, perhaps both, was re-used and may represent material from an earlier building than the 18th-century house.

Plate 3. North Elevation, South Jamb of East Window

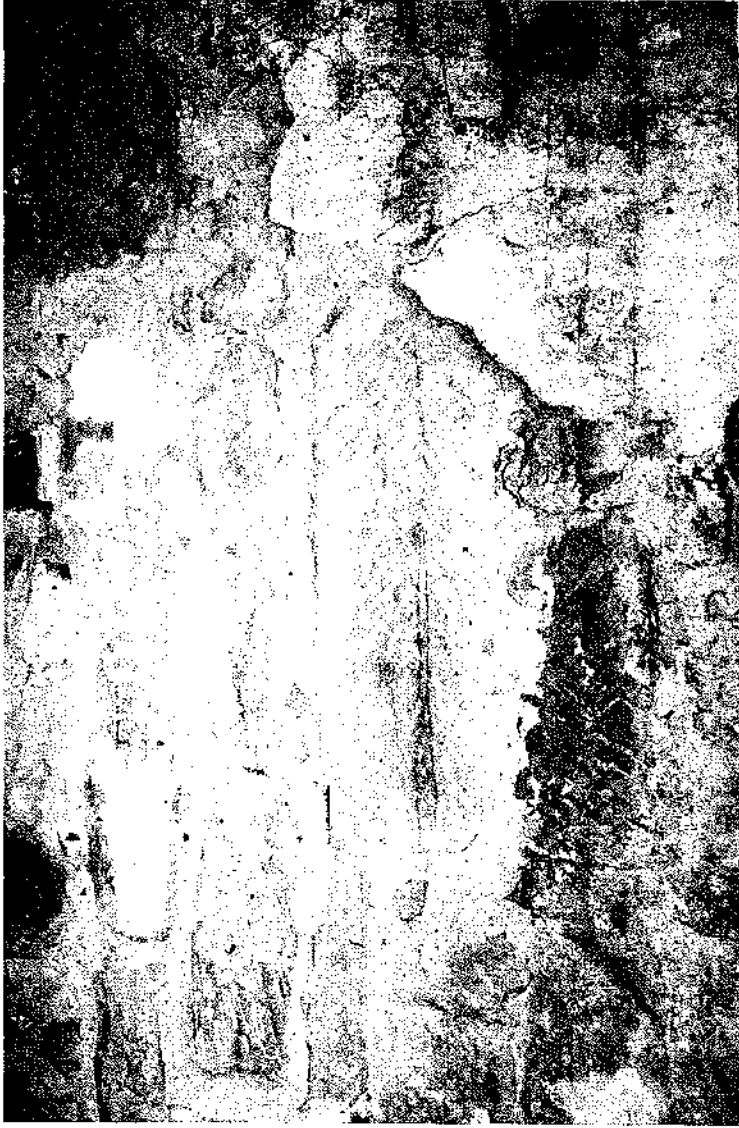
Plate 4. South Elevation, Reused Stone at First Floor Level

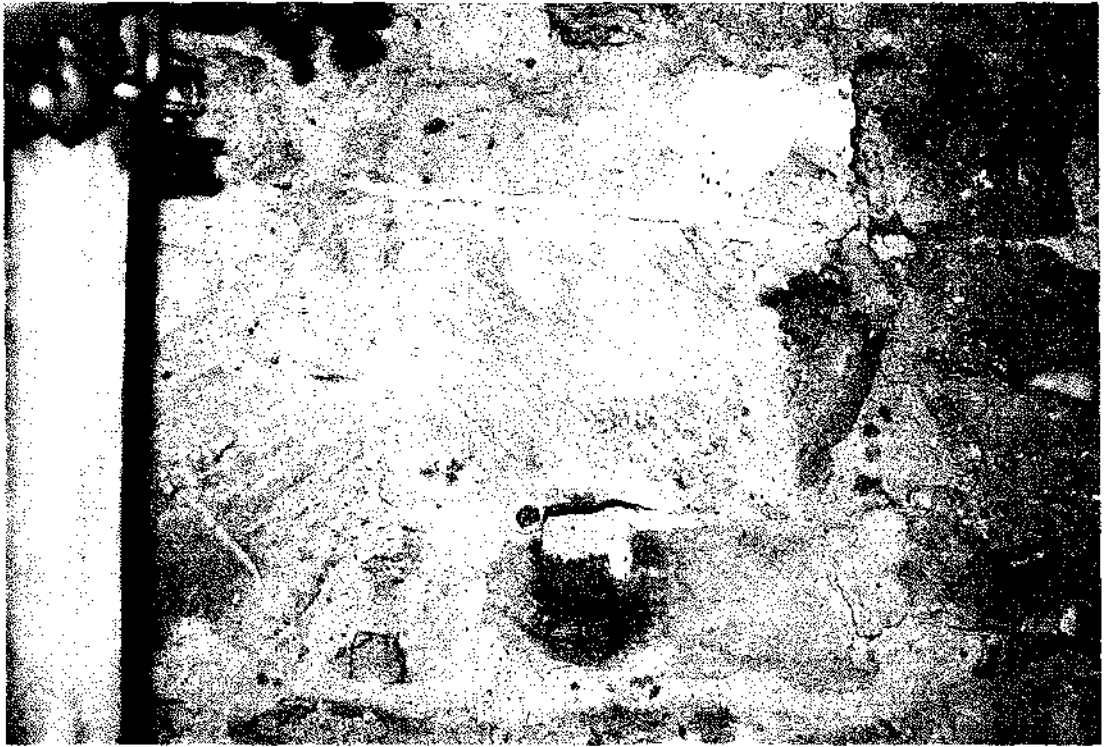
Plate 5. South Elevation, Reused Stone at First Floor Level

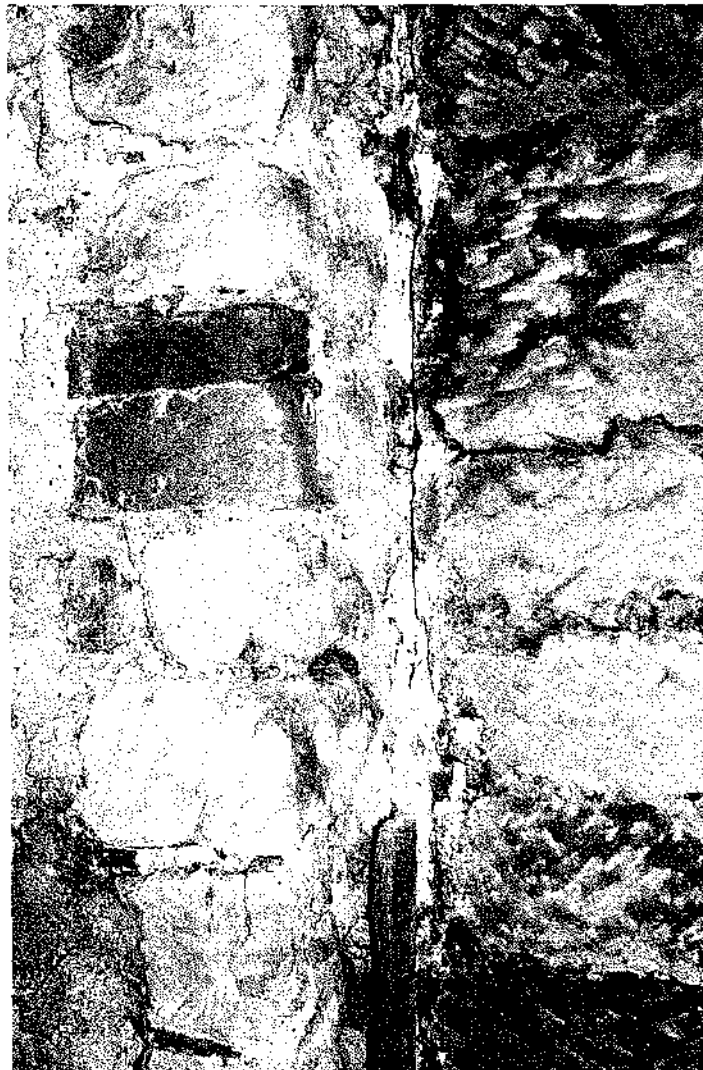
At this level the east wall appeared to butt against the cross-wall (Plate 6).

If this is the case, then it is probable that the southern part of Alton Lodge came first, and that the existing cross-wall within the northern part is later. The structural relationship between the cross-wall and the east wall is ambiguous. At first floor level the cross-wall seems to stratigraphically later than the east wall, but at second floor level the reverse seems to be true. The very presence of the structure points to a change in the original layout of the house, in which the earlier cross-wall became redundant.

Plate 6. South Elevation, Junction of Cross-wall and East Wall at Second Floor Level

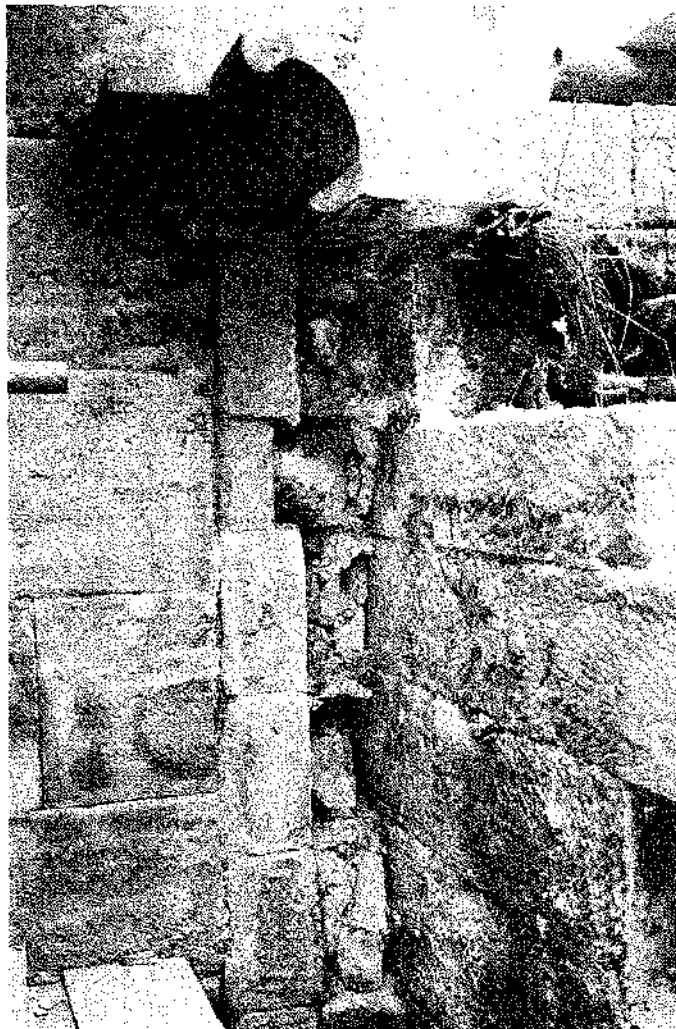
Plate 7. Junction of East wall (Right) and Chapel of 1833 (Left) After Removal of 19th-century Facing

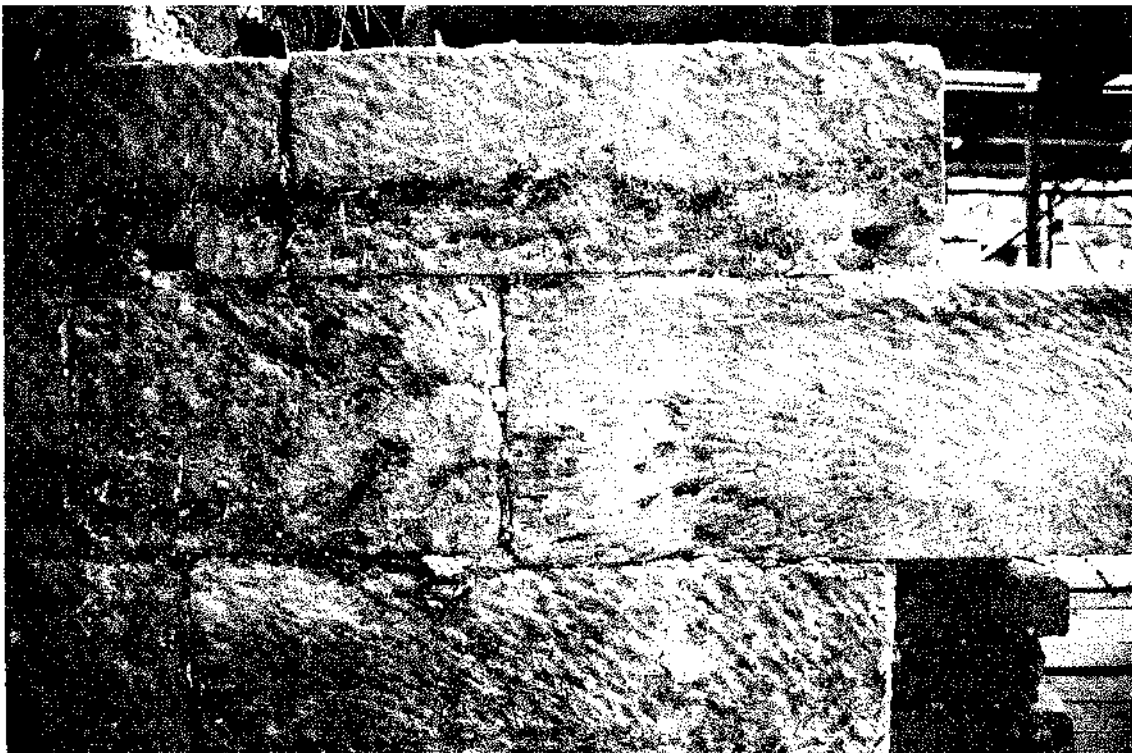
facing, was constructed of high quality ashlar masonry, with herringbone pattern tooling (Plate 8). Metal clamps had been used to tie in the two phases of stonework. In the centre of the elevation (Plate 9), at third floor level, there was a vertical joint in the masonry, the two halves of the face being keyed together with a single block. This joint did not coincide with the position of the cross-wall but with the north side of a short, internal wall stub situated immediately south of the cross-wall at third floor level (Plate 10). This stub appeared to correspond with traces of a cross-wall on the west side of the room (Plate 11).

Plate 8. East Elevation , Masonry Behind the 19th-century Facing

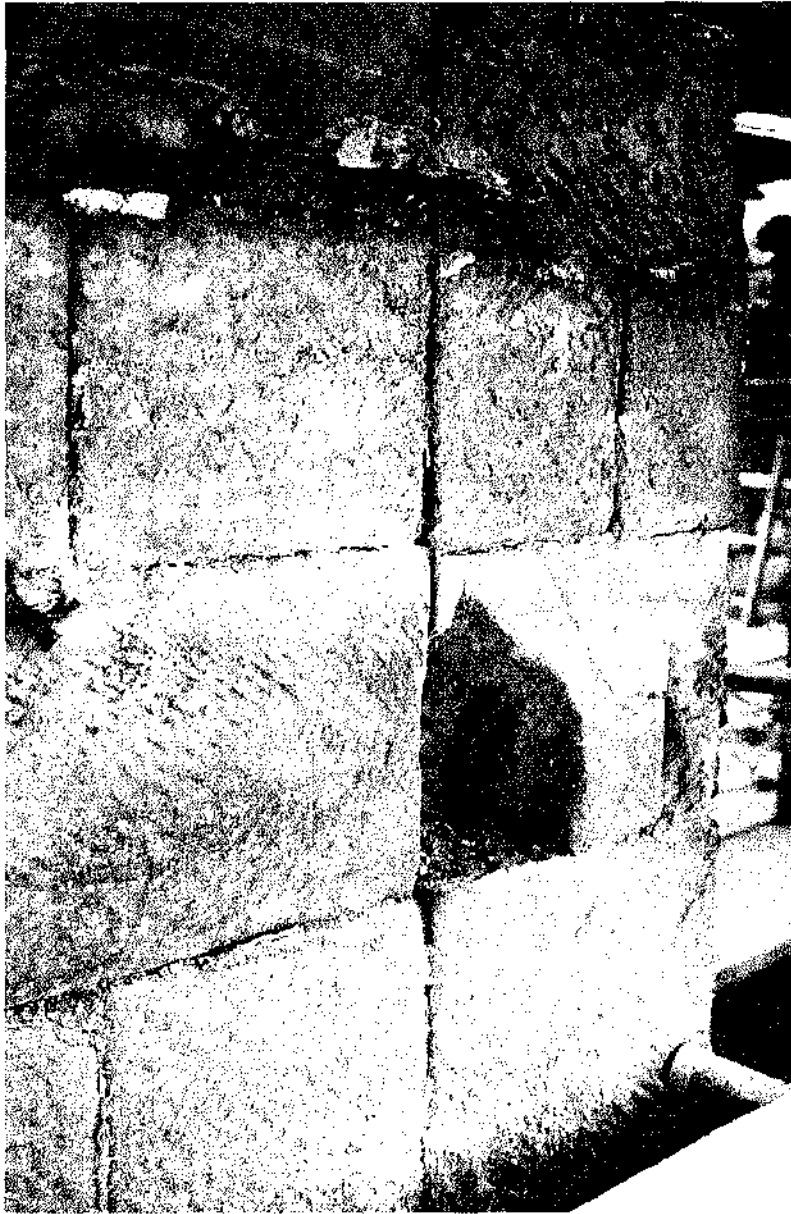
Plate 9. East Elevation, Vertical Joint in the Masonry Behind 19th-century Facing

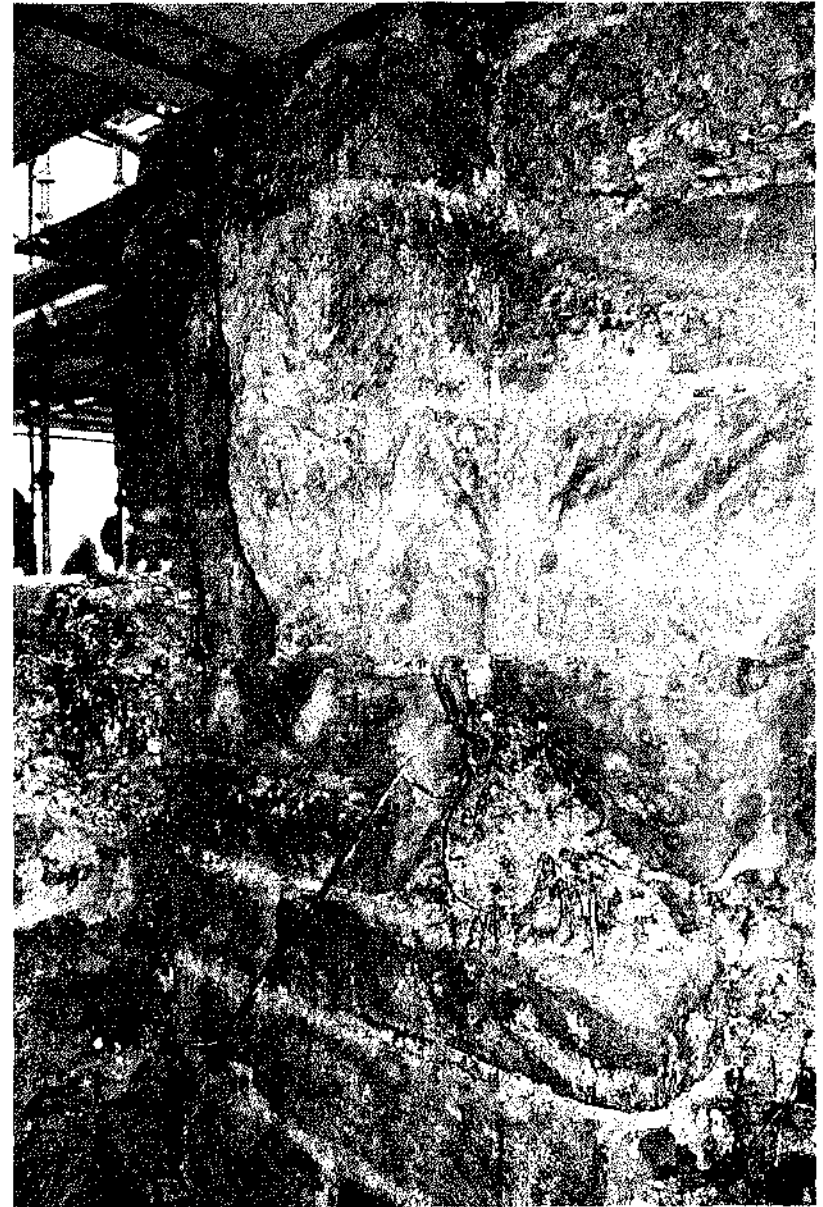
Plate 10. Wall Stub Projecting from East Wall at Third Floor Level

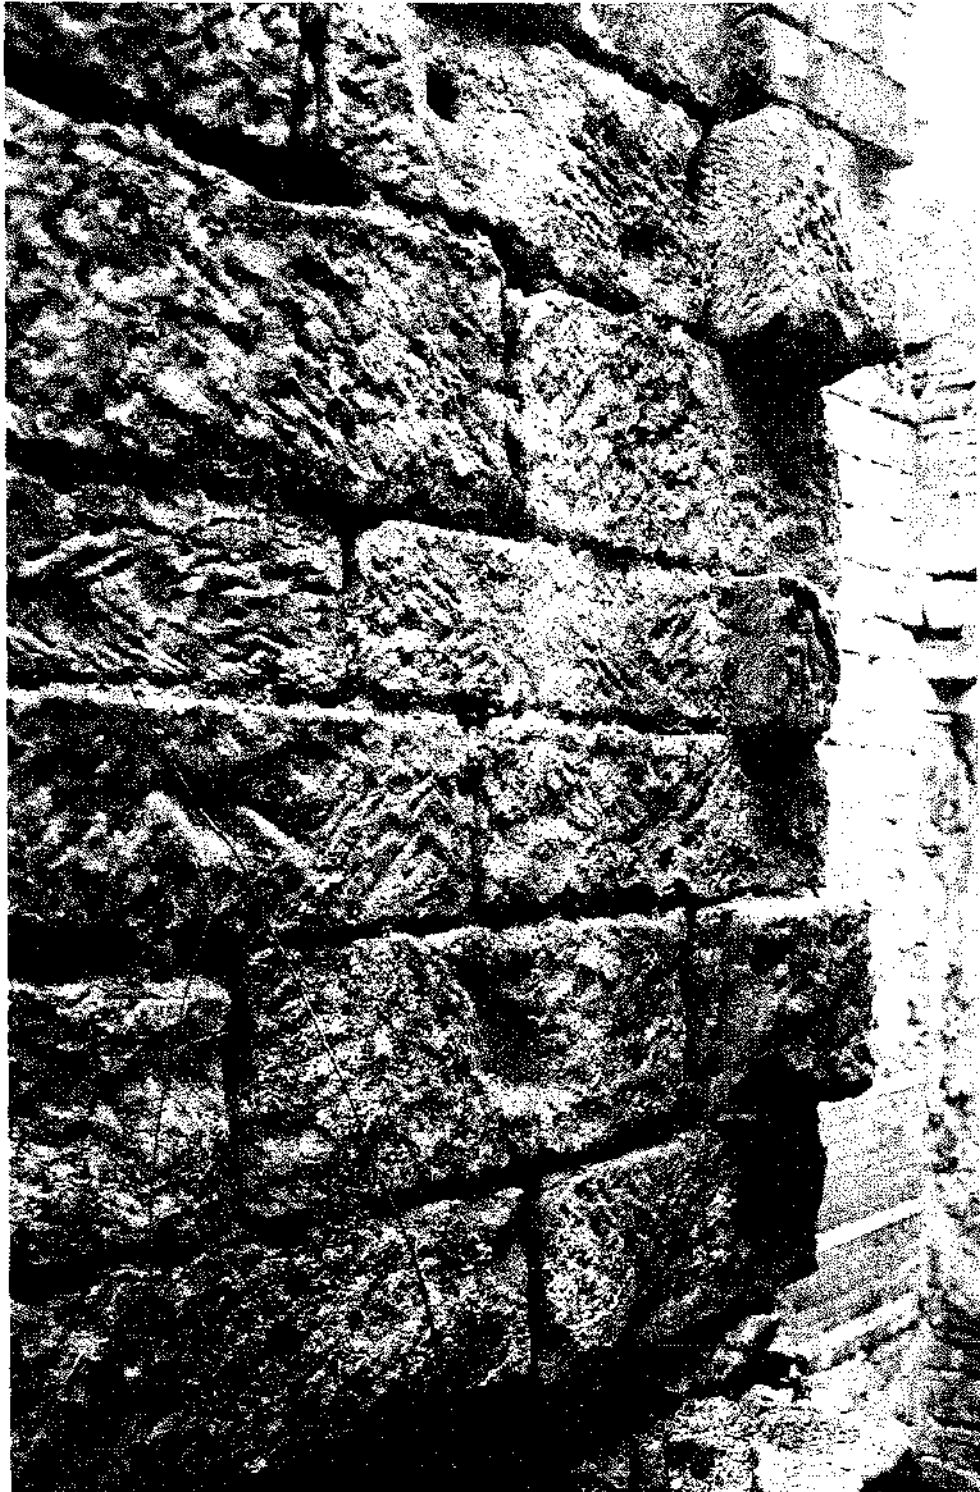
Plate 11. Keying for Former Cross-wall Opposite Wall Stub
