# A Building Record of Keys Farm, Lower Bentley, Worcestershire (WSM 3402)

by Malcolm Hislop

#### A Building Record of Keys Farm, Lower Bentley, Bromsgrove, Worcestershire (WSM 32402)

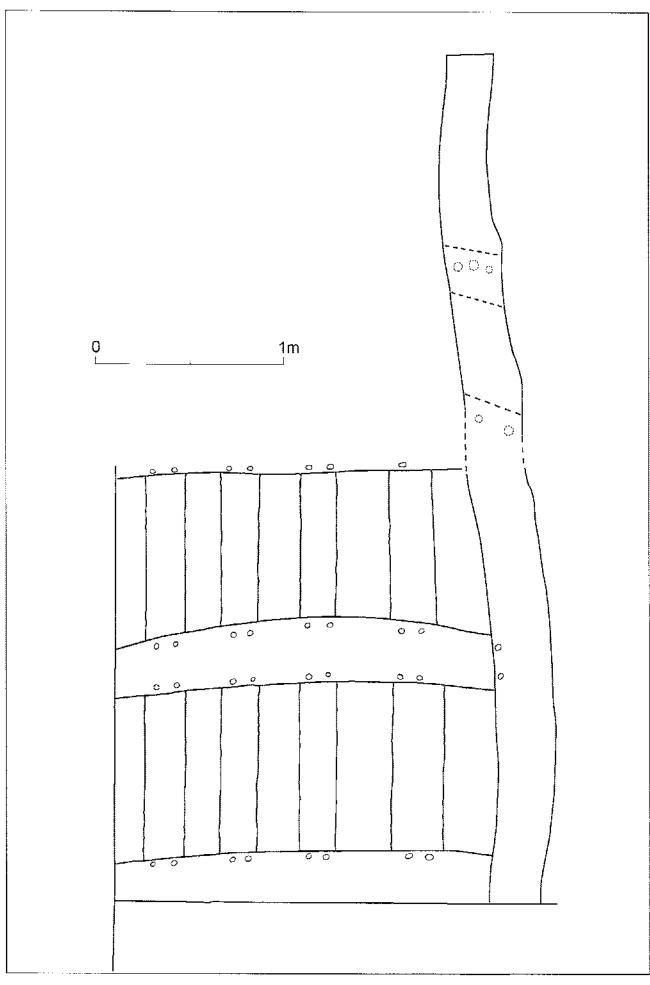
Fig.7: Reused Timbers in North Wall of Farmhouse from the North

In contrast to the well ordered main (south) front the north elevation had an irregular framing pattern. In part, this was because the east bay of the main range was closestudded whereas the rest of the wall consisted of square-panelled framing. An additional factor, however, was that the north wall of the main range incorporated a number of re-used timbers with pronounced curves (Fig. 7, Plate 3). A close examination of these timbers suggested that they could be identified as cambered tiebeams and collars, probably of medieval date. There are three former tie-beams in this elevation, two of them were used as wall posts, while the third formed the firstfloor level rail within the west bay. A former collar was used as the lowest rail within the west bay. None of these members appeared to have any redundant joints, all being utilised for studs or rails. At the east end of the range was the original (blocked) entrance, partially occupied by a later window (Plate 3). That the current doorway into the second bay from the west was an insertion was indicated by peg holes in the posts to either side of it, which suggested that there was formerly a rail in this position. In front of the ground storey was a full-length glazed porch or conservatory with lean-to plain tile roof. Above was one window (right of centre) and a gabled dormer to the right.

The most interesting aspect of the project was, perhaps, the reused timber. These pieces were unusually obvious and identifiable, and their unwieldy size lends support to the theory that they may have come from a previous house on the site rather than having been transported from elsewhere. The consistency with which those members identified as reused tie beams had halvings cut into one side only suggests that these joints were integral to the structural character of the building from whence they came. If the reused members were tie beams then the halved joints might denote that passing braces were used in the construction. However, the angles of approximately 70-80° to the horizontal are unusually steep, and this explanation can only be tentative. A more detailed survey of all the reused timbers within the house might throw further light on the character of the building that they came from.

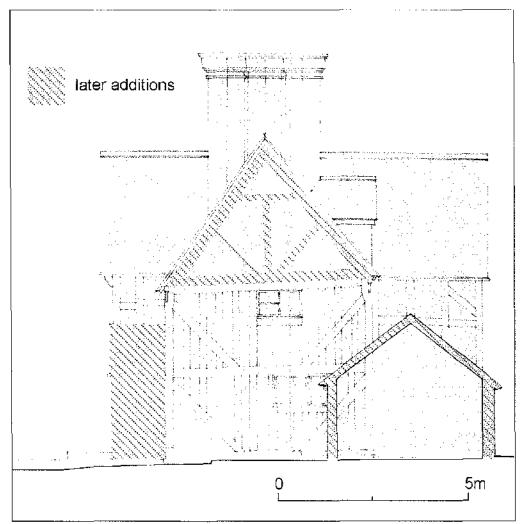
Fig.8: East Elevation

The east end clevation of the main house had two tiers of closely spaced studs and long straight tension braces. The gable had been rebuilt with a king strut roof with raking braces at the same angles as the tension braces below; it was inscribed 'LP / AD 1975'. There were late 20<sup>th</sup>-century windows to the ground and first floor. Under this elevation was a trap door entrance to a small cellar under the east bay of the main range.

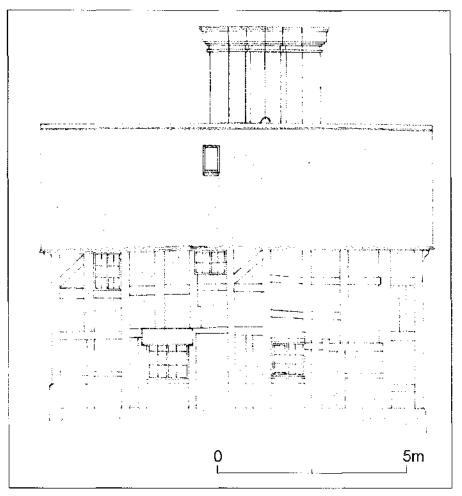
Fig.9: West Elevation

The framing pattern of the west wall of the wing was inconsistent, being made up of two elements divided by the main wall post at the bay division. Both bays were composed mainly of square panels with straight braces, but the two elements did not match.

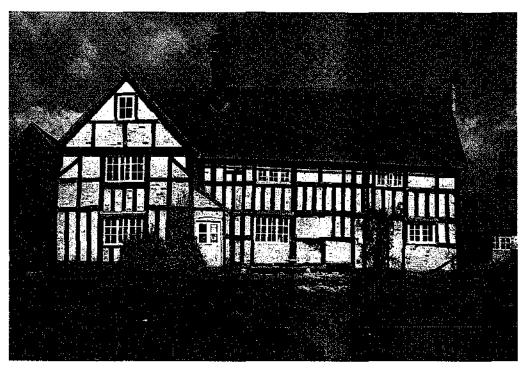
Plate 1

The main house had two stories and gable-lit attics, and the principal range had four framed bays, the left-hand (west) bay longer than the other three. The roof line of the main range was at a slightly higher level than the apex of the gabled wing to the left (west), and a cluster of tall lozenge-sectioned chimney stacks towered over it. Four tiers of closely spaced studs (some of the studs had been removed but the peg holes survived to indicate their former existence) occupied the main range, whereas the cross-wing had a single tier of closely spaced studs to the ground storey and two tiers of small square panels to the first floor with straight braces. Moulded console brackets flanking the first-floor window of the wing, together with plain end brackets, sat beneath the jetty bresummer that supported the oversailing gable, which had been rebuilt in brick. The fcnestration pattern of the wing remained much as it was originally, though the windows had been replaced. That of the main range had been altered , though an original blocked first-floor window survived to the left. Most of the south clevation windows were 19<sup>th</sup>-century small-pane casements. A later lean-to porch occupied the angle between main range and cross-wing.

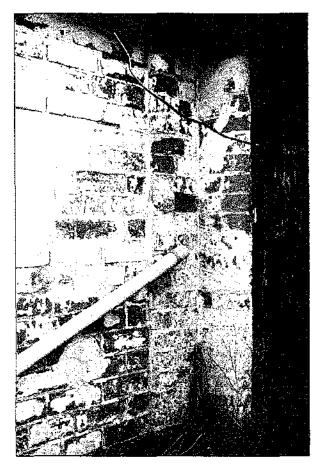
Plate 2

To the right (cast) was a single-storey range of outbuildings with gabled wing breaking forward at the right-hand (east) end. These were largely of brick and stone but there is some evidence to suggest that they were at least partially timber-framed originally. The wall plate of the left-hand range was supported at the east end by a brick pier with bullnose bricks at the corners. There was a vertical joint between this pier and the brickwork to the west (Plate 2), suggesting that the range was formerly open fronted.

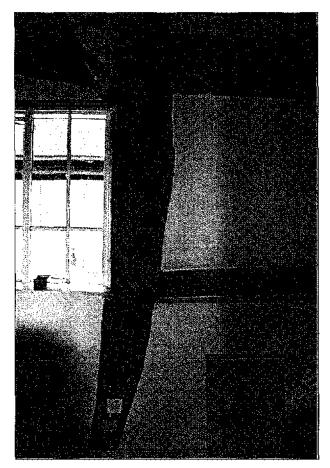
Plate 5

G2 was the hall or house, the main living room where cooking may have been carried out. Timber framing was exposed on all walls except the south, and the main crossbeam and joists were all chamfered and stopped. In the centre of the east wall an alcove had been formed which contained a rail just below ceiling level, perhaps a former door lintel (Plate 4). In the north wall both the main wall post and the rail to the east of it, just below ceiling level were obvious reused pieces. Both had obliquely placed halvings cut out of them within which were peg holes (Plate 5).

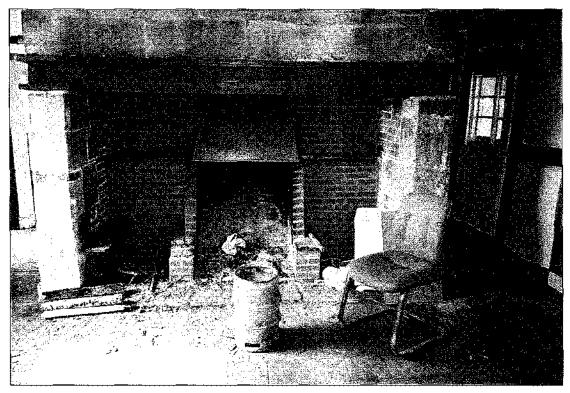
Plate 6

At the west end of the room was a large open fireplace with sandstone ashlar stack and plain timber mantel beam, possibly a replacement (Plate 6). The stone had been cleaned mechanically in recent years, a process that had left score marks. Inside the fireplace the side walls were of  $9-9\frac{1}{2}$ " x 2" bricks, probably  $16^{th}$  or  $17^{th}$  century in date.

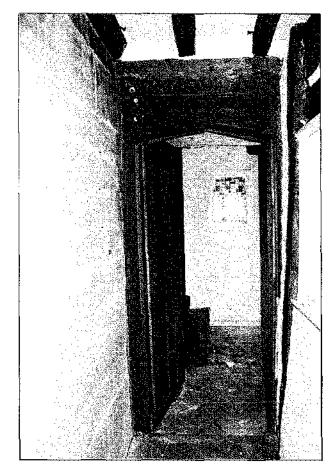
Plate 7

To the north of the fireplace was a former entrance lobby, originally entered from the blocked doorway in the north wall. At the west end of the lobby was the original doorway to the cross-wing with cambered head and chamfered surround (Plate 7). To the south of the stack was another entrance lobby, though all traces of the original external doorway were destroyed when the porch was added.

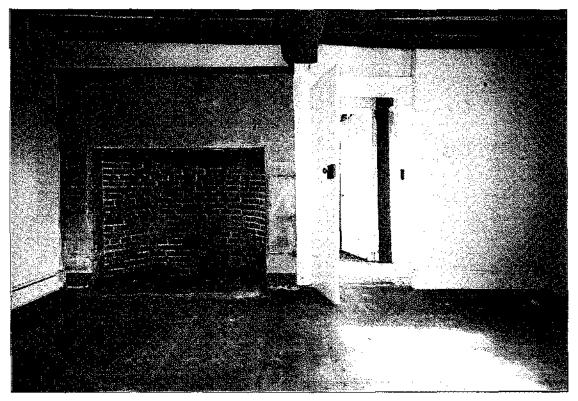
Plate 8

On the west side of the south lobby was a  $19^{\text{th}}$ -century four-panelled door with butterfly hinges. The door opens to the parlour (G3) within the south bay of the crosswing. G3 had a stone fireplace in the cast wall (Plate 8), the lintel of which bore a

number of faint inscriptions, including at least one date (1604, Fig. 11). A cross-beam and its associated joists were all chamfered and stopped.

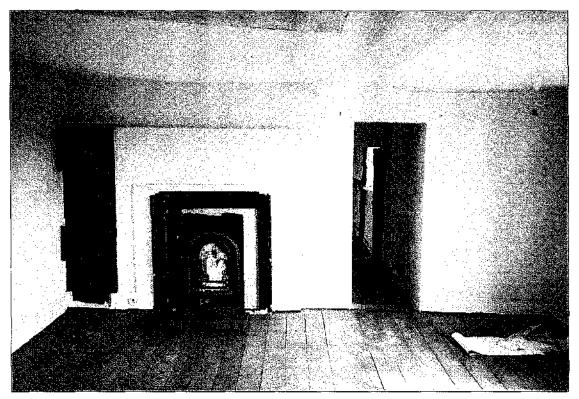
Plate 12

The southern room of the wing (F3) has a  $19^{th}$ -century cast iron fireplace in the east wall with an ovolo-moulded wooden mantelpiece (Plate 12). On the left (north) side of the fireplace is series of four small  $17^{th}$ -century guilloche-decorated cupboards, one on top of the other. In the north wall is a  $17^{th}$ -century six-panelled door, the panels with moulded surrounds towards the room, and plain fielded panels towards the staircase landing.

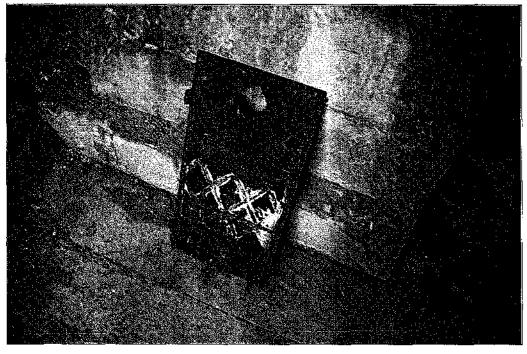
Plate 13

The two rooms above F3 and F4 were lit by windows and were probably sleeping chambers, but the attic over the main range was not lit and was probably only for storage. Standing against the chimney stack at this level, at the time of the survey, was the pane of a casement window. It had lead cames and was probably a fragment of one of the original windows (Plate 13).

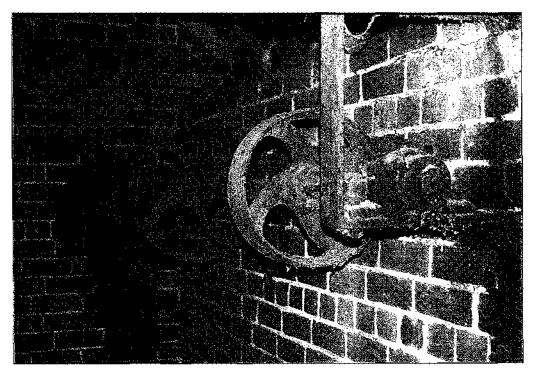
Plate 16

On the exterior of the north wall at first-floor level is the drive wheel for a line shaft, probably powered by a portable engine. Inside the building the shaft supports three more drive wheels and may have powered a winnowing machine situated at first floor level (Plate 16).

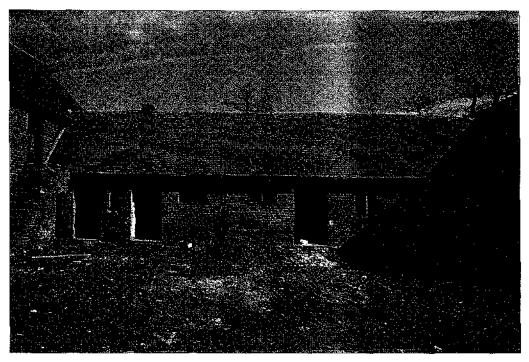
Plate 17

The eastern half of the North Range was originally divided internally into three components. To the right (east) is a loose box with segmental-headed door and window containing its original frame. To the left (west) is a room with segmental-headed door and small cambered-arch window. Inside is a chimney breast that formerly served a small fireplace, now gone. Against the north wall are the remains of a two-bay brick structure, bonded with the side walls and probably original. Above it is a series of sawn off timbers, suggesting that there was a low loft above it. In the east wall, mostly south of the brick structure is a tall blocked window opening with bullnose brick jambs and a timber lintel, and on the south side of the chimney a small window with chamfered jambs.

The central section of the range was originally open fronted with a wall plate rollmoulded on the outer edge, and was probably a shelter shed for cattle. At a later date the front of the shed was built up in 9"  $\times$  4½"  $\times$  3" bricks laid in Flemish stretcher bond, and provided with a pair of doors and windows, suggesting that it was converted into a pair of loose boxes. Inside, brick foundations of two former walls are visible showing that the space was divided both longitudinally and laterally. This probably dates from the conversion of the building. At the time of the survey the building was divided into two by a breeze block wall, above which was a roof truss with pegged members.

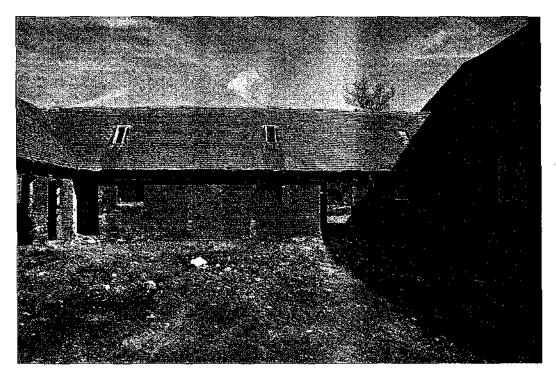
Plate 18

The north range was occupied by a cowhouse with original segmental-arched doorway (now blocked) to the left of centre. At each end of the range is an inserted doorway, and there are three inserted metal framed windows of mid-20<sup>th</sup>-century date. The interior has been gutted but it appears that the feed passage was on the south side, and entered from the central range through an original segmental-arched doorway. A doorway at the opposite (west) end is a later insertion.

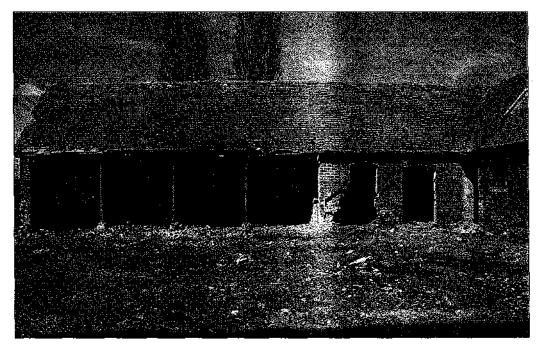
Plate 19

The left hand (south) end of the west range was occupied by a four-bay open-fronted shed with roll-moulded wall plate like the shelter shed in the east yard. The bay divisions are formed by a series of cast-iron columns with moulded capitals. On the grounds that this unit faces the yard, it is probably a shelter shed for cattle rather than a cartshed.
