**Rectory Farm, Dodderhill  
Common, Hanbury,  
Worcestershire**

**An Historic Building Record  
2004**

**Project No. 1163**  
March 2004

By  
Malcolm Hislop

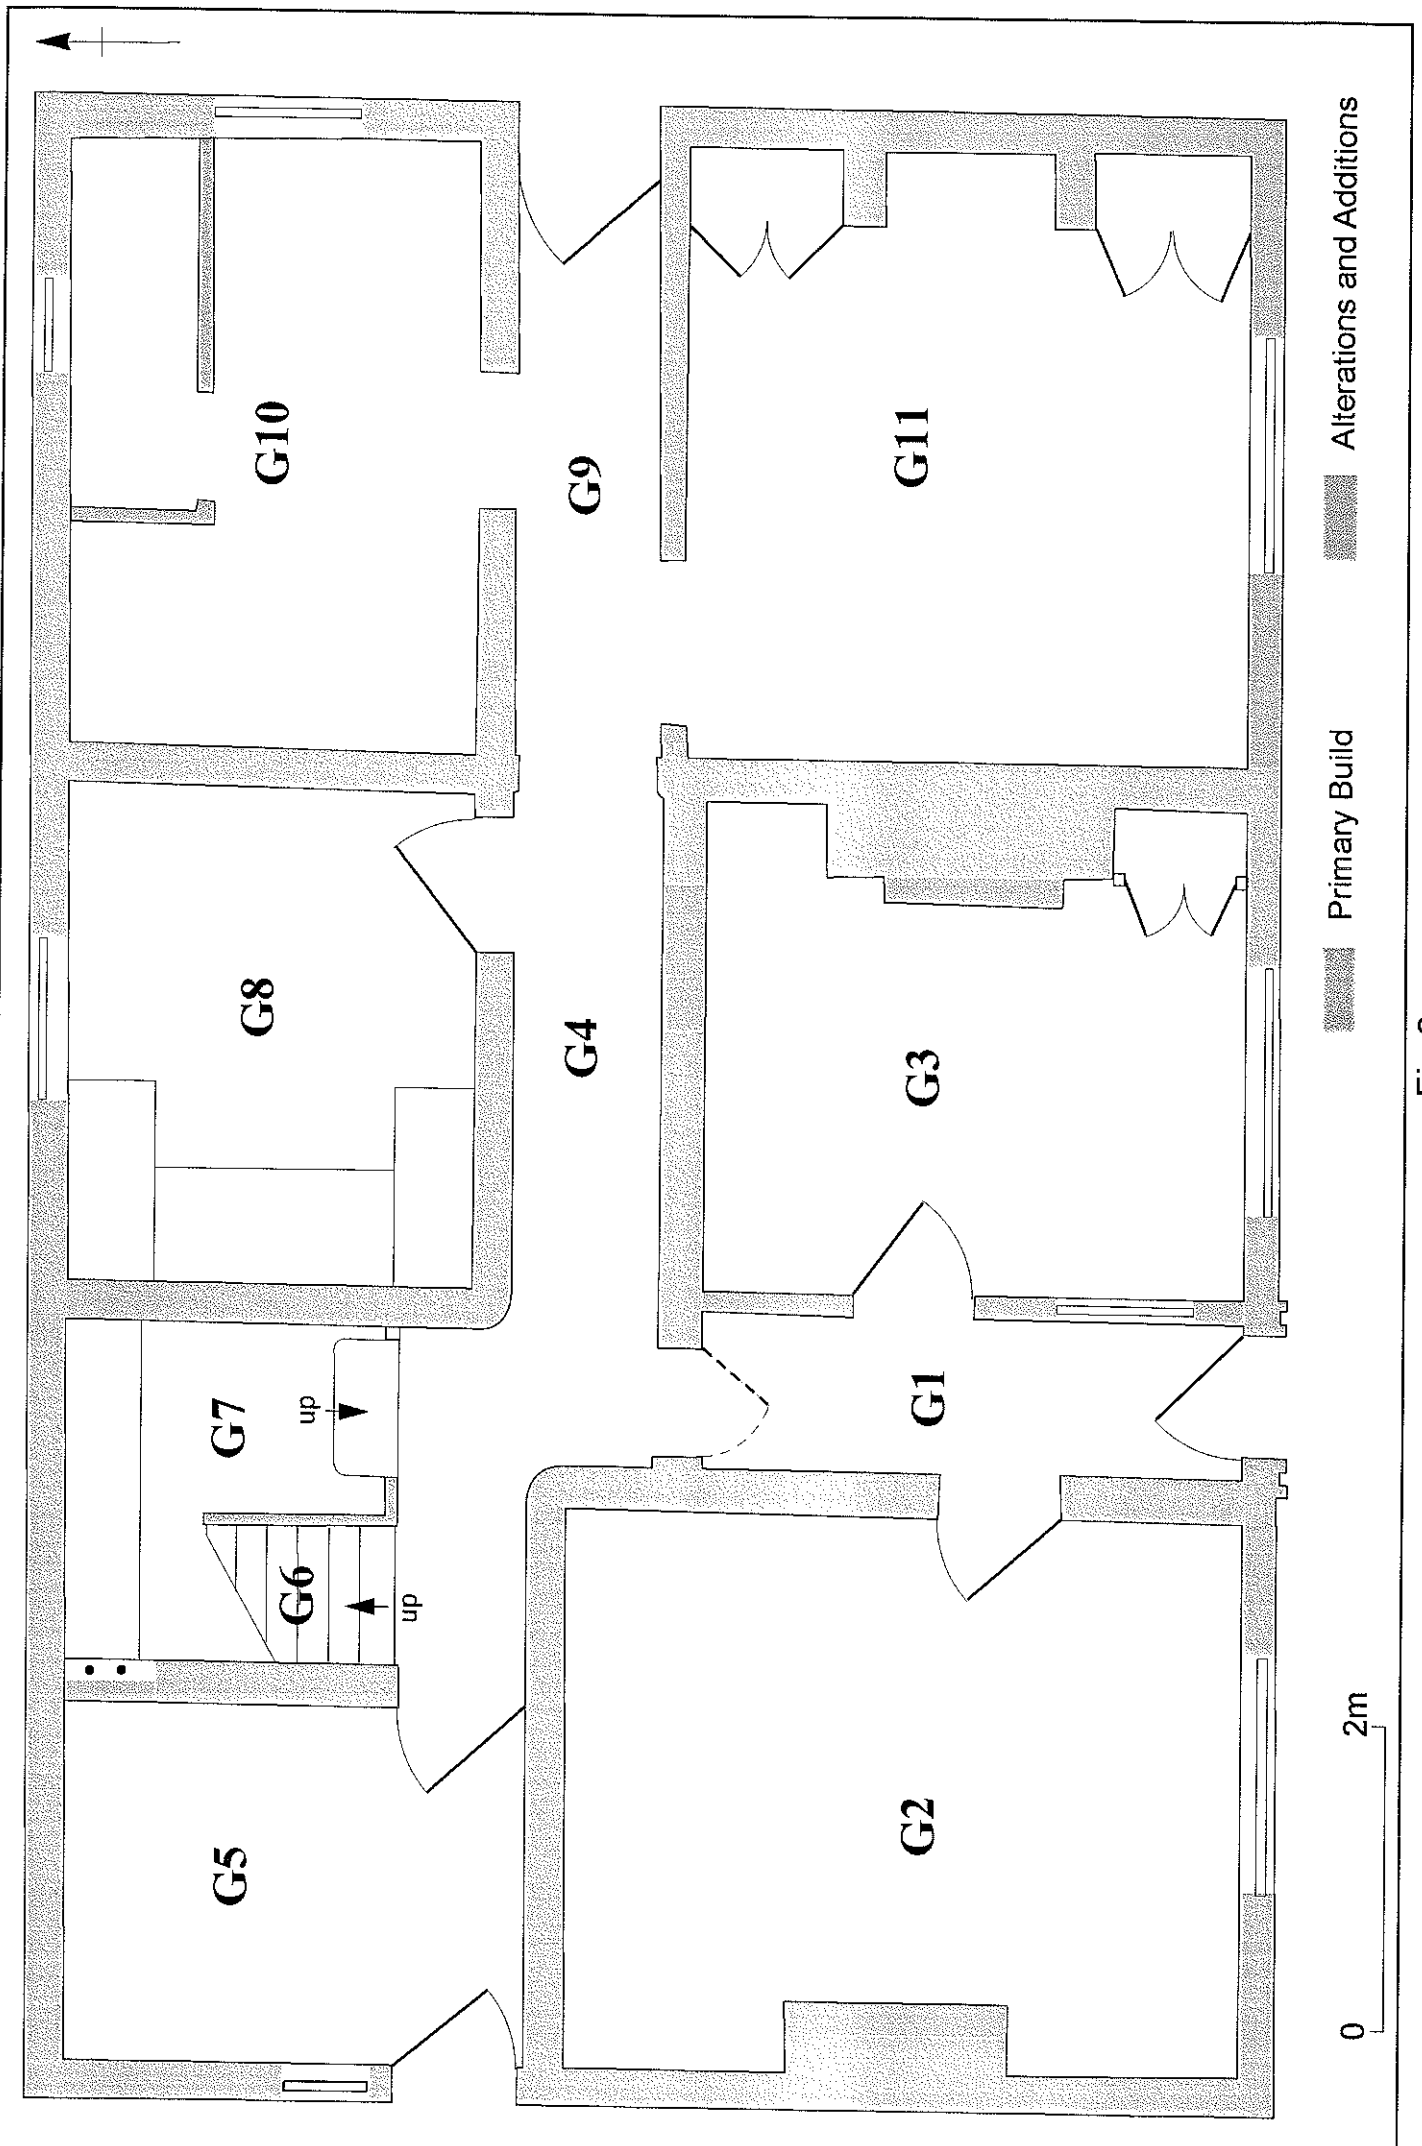
Fig.8

Two-storey farmhouse of c.1820-30 with a late 19<sup>th</sup>/early 20<sup>th</sup>-century east wing, and later alterations (Plate 1). Original build of white brick (9" x 4 " x 2<sup>3</sup>/<sub>4</sub>" ), some with parallel skintling marks, laid in Flemish bond (Plate 2), hipped Welsh slate roof and brick chimney stacks; red brick extension wing with slate roof. Originally L-shaped in plan, the main house aligned east-west facing south, away from the access lane, with low east-projecting annexe set back from the front of the house.

Access from the front door was to a north-south aligned entrance passage (G1) which gave access to two reception rooms (G2 & G3) at the front (south) of the house, and to a kinked east-west aligned passage (G4), which serviced the rear rooms. These included, from west to east, a tack room (G5), stairs (G6), a pantry under the stairs (G7) and a dairy (G8). There would have been an external doorway at the east end of the passage, giving access to a yard, and thence the annexe. The extension contains a kitchen and an eastward extension to passage G4 (G9).

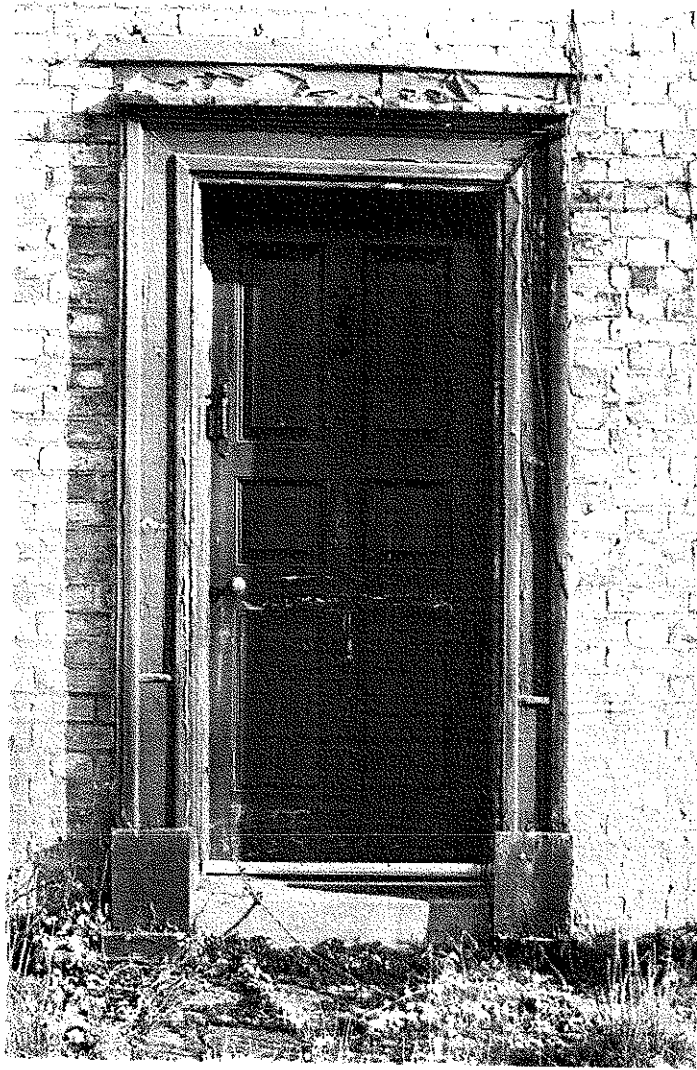
Plate 3

*South Elevation* – Original three-bay house to the left (west) and single-bay gabled extension wing to the right (east). The main house has a central 19<sup>th</sup>-century six-panelled door with raised and fielded panels (Fig. 9, Plate 3). The windows have been replaced with mid-20<sup>th</sup> century metal-framed casements with concrete sills, the original openings having been opened out to accommodate them. However, the segmental-arched heads at ground level, and the wooden lintels at first floor level, have survived. The central first floor window is blind. There is a clear staggered building break between the main house and the wing. Segmental-arched windows with chamfered red brick sills. 20<sup>th</sup>-century metal framed casement to ground floor and wooden casement to narrower first floor window. Dentilled gable cornice with short returns at eaves level to suggest a pediment.

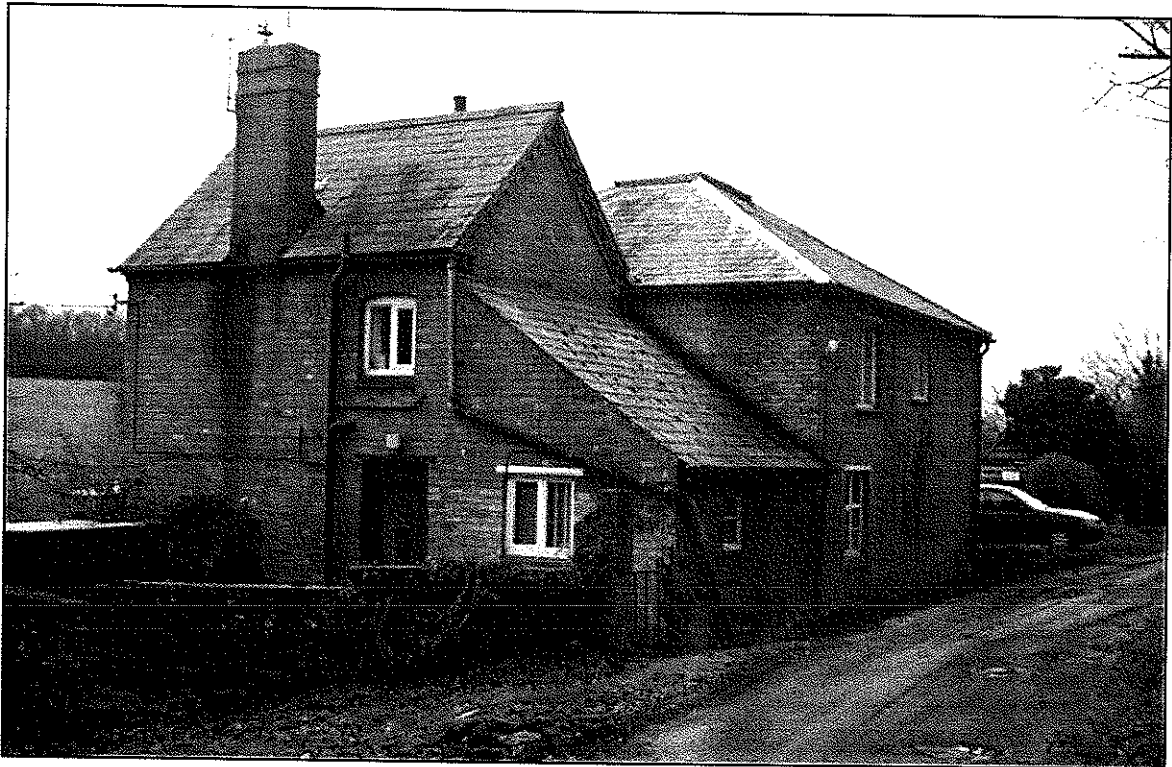
Plate 4

*East Elevation* (Plate 4)–The two phases of brickwork are also visible on this side. At the right hand (north) end is the white brick of the single-storey former annexe, and to the left (south) the red brick of the later wing (Plate 5). Half-glazed door to right of centre, the right hand (north) jamb formed by the southeast corner of the former annexe. The door itself is later 20<sup>th</sup>-century in date, but the opening with its narrow overlight appears to be original. Segmental arched window at first floor level above the door.

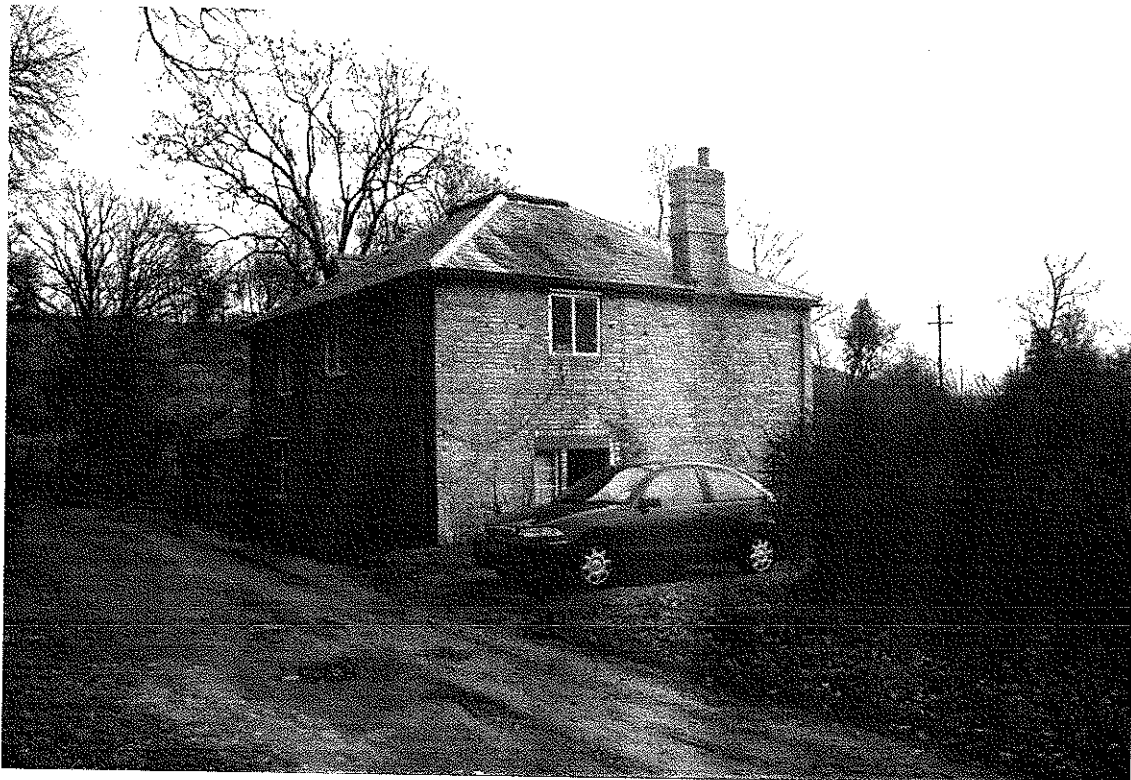
Plate 6

*West Elevation* (Plate 6) – 20<sup>th</sup>-century door to left (north) with concrete lintel. Immediately left of it a metal-framed casement with concrete tile sill. Although these features are insertions it is possible that there was an earlier doorway in this position; the outline of a gabled doorcase or porch is visible on the brickwork above it. At first floor level is an early 19<sup>th</sup>-century casement with leaded lights, the only original window to survive (Plate 7).

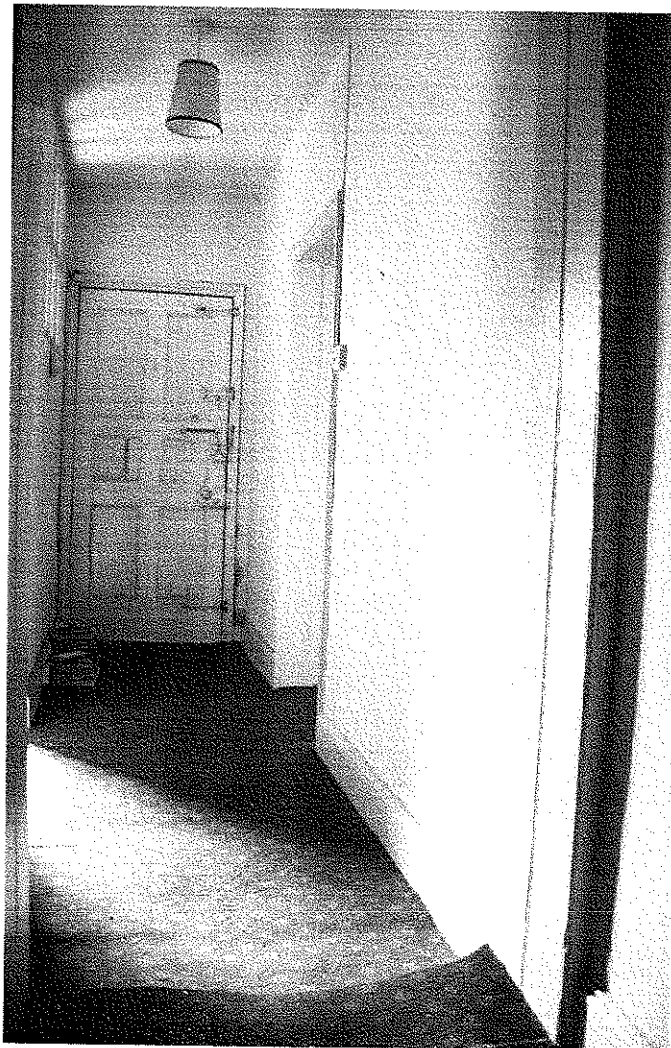
Plate 8

*G1 (Entrance Passage)* (Plate 8) - Skirting board on each side, but of different patterns (Fig. 9). Six-pane window on east side with ovolo-moulded glazing bars containing old glass. Doorway on each side leading into G2 and G3.

G3 is also worthy of note owing to the probability that the partition between the current entrance passage (G1) and G3 is an insertion. The reasons for suggesting this are that it is much thinner than the wall between G1 and G2, that the skirting boards on the two sides of the passage do not match and are therefore unlikely to be contemporary, and that the door within the wall is not an original feature. G1 and G3, then, may have formed a single room originally directly accessible from the front door.

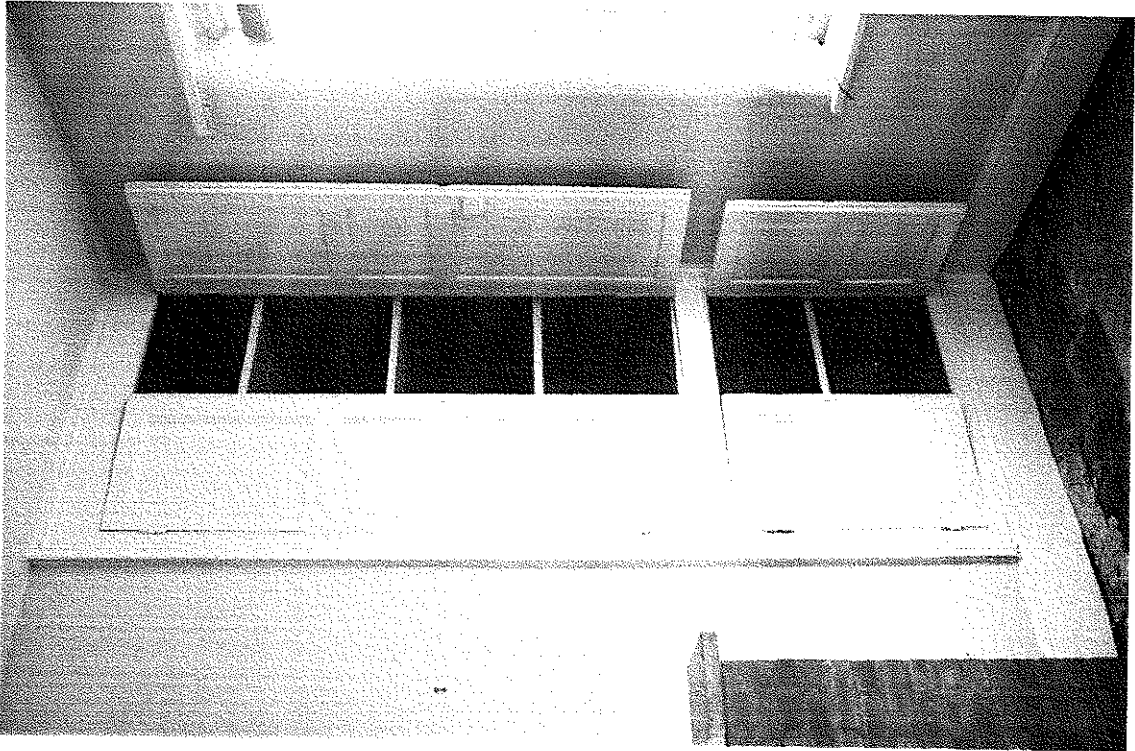
Plate 9

*G3 (Dining Room)* - Access from the east side of the entrance passage through a plain four-panelled door with brass knob but no architrave. 19<sup>th</sup>-century skirting boards (Fig. 9) with breaks in the one against the north wall, possibly indicating the position of a former doorway. Chimney breast against the east wall with late 20<sup>th</sup>-century brick fireplace. Alcove to north of chimney breast containing, at the top of the wall a wire for a bell pull, extending through the north wall. On the south side of the chimney breast an early 19<sup>th</sup>-century two-tier built-in cupboard with panelled doors, the panel mouldings matching those on the architrave of the door to G2 (Fig. 9, Plate 9).

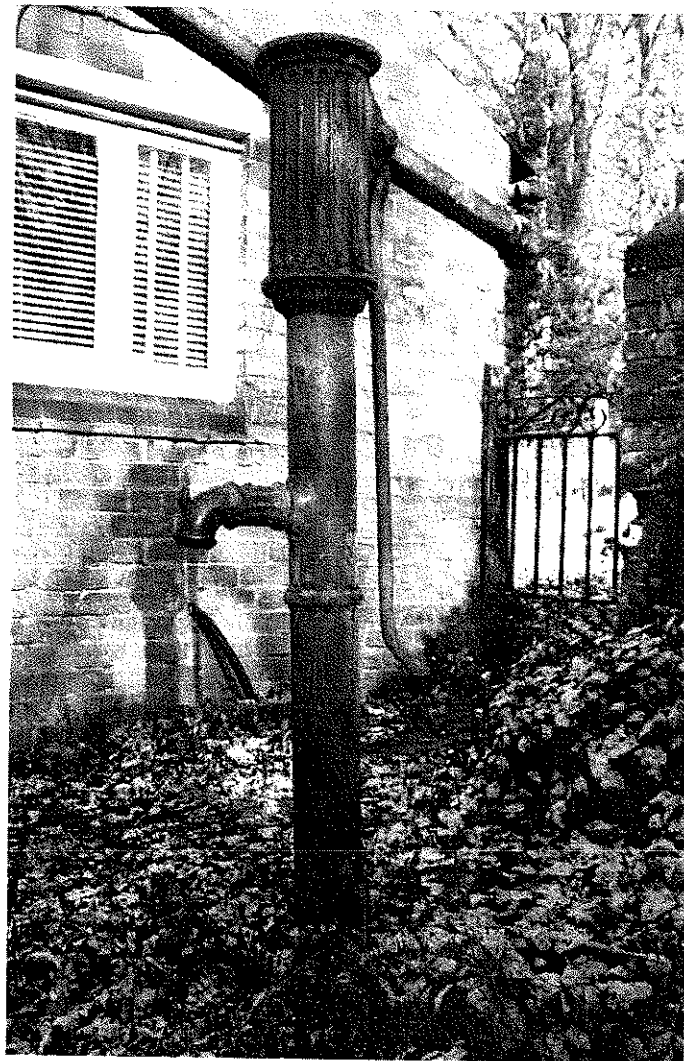
Plate 11

Immediately to the east of the farmhouse is a 19<sup>th</sup>-century cast iron pump (Plate 11).

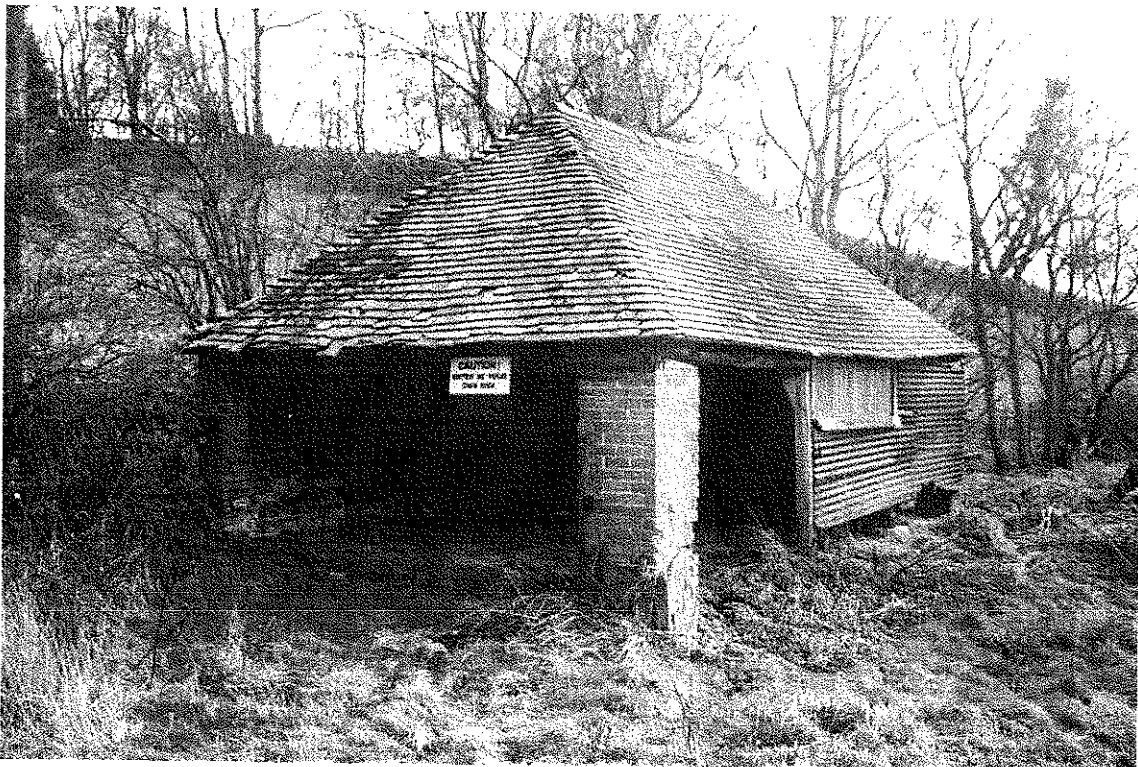
Plate 12

Worcestershire cowhouse (Plate 12). Early 19<sup>th</sup> century. Red brick (9" x 4¼" x 2¾"), some with parallel skintling marks, laid in Flemish stretcher bond, with some timberwork and hipped plain tile roof. Aligned north-south facing west. Brick walls to south and east, three-bay open front articulated by timber posts on stone stylobates (Plate 13), and open north end. Tie beams supported on jowelled heads of posts to west and brick piers to each. King-post roof, jointed and pegged, supporting a plank ridge.

In contrast to the farmhouse, the cowhouse is very much in the vernacular tradition. It is a Worcestershire cowhouse, that is to say a local, open fronted, type of structure, to a great extent unaltered. The timber posts on stone stylobates are typical of this type of building, and represent a distinct regional type of construction.<sup>1</sup> The jointing and pegging of the roof trusses points to a date of before c.1830 (Peters 1988).
