The Malthouse, Harvington
Hall, Kidderminster,
Worcestershire

Evaluation, Historic Building
Recording and Interpretation,
2004

P.N. 1249
January 2005

By Leonie Driver and Malcolm Hislop

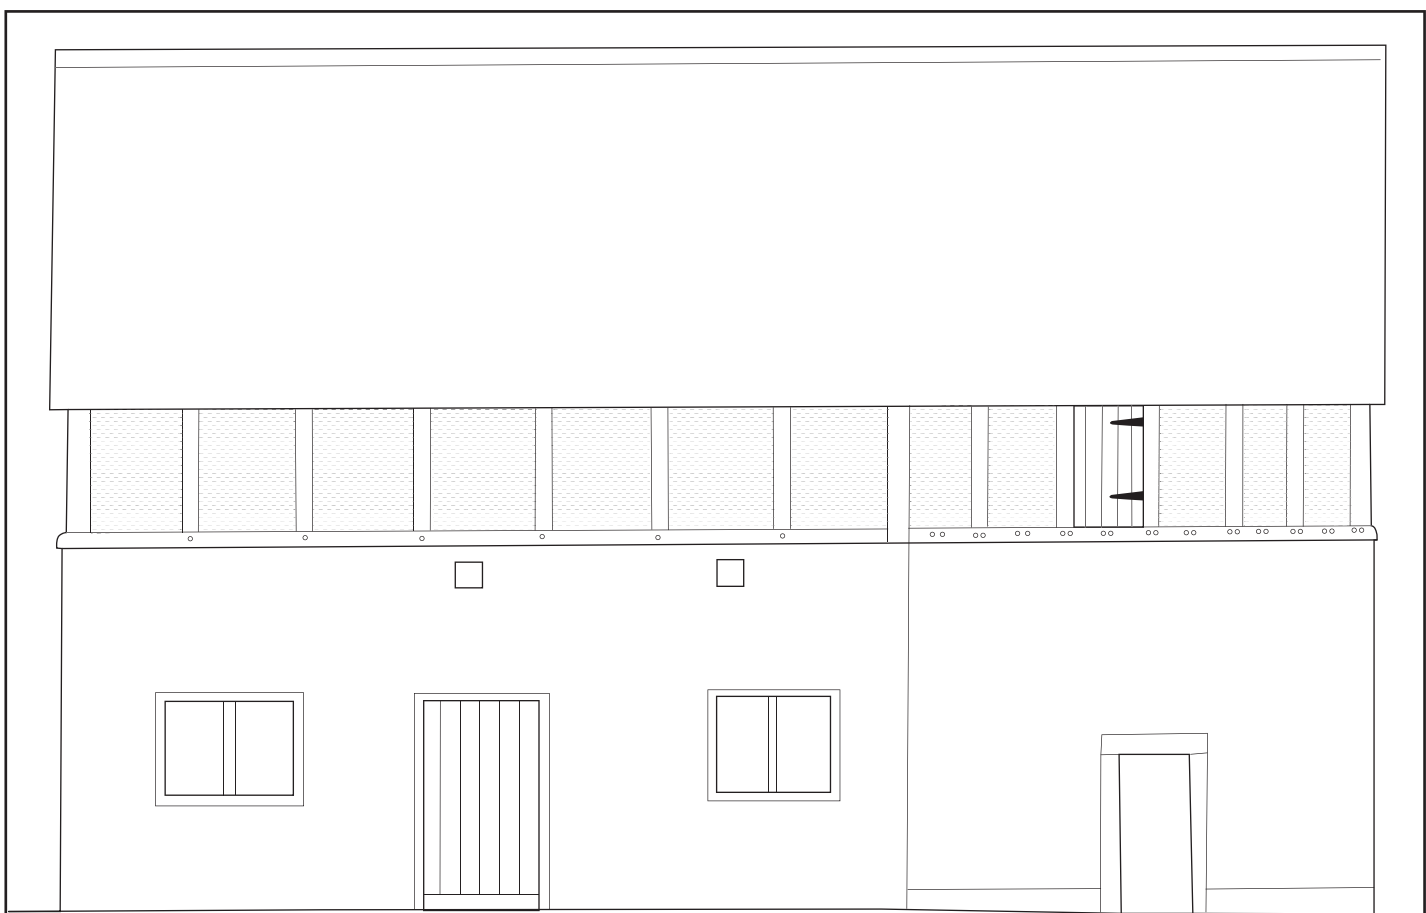
Fig.3 Northeast Facing Elevation

Central boarded door flanked by a pair of two-light wooden mullioned windows with leaded panes. Neither door, nor windows were provided with a stone lintel, and the stonework is supported on timber. This gives the stonework above, which in each case consists of three stone blocks, a structurally precarious appearance (Plate 5), though in the case of the right-hand (northwestern) window the ends of the blocks are gently angled to produce a joggled joint (Plate 6). The timber framing above comprises a single tier of square panelling infilled with horizontally laid bricks (Plate 7). At the northwestern end of the elevation the main post stands directly on the top of the sandstone rather than a sill beam (Plate 8). At the southeastern end the corner post is supported on a sill beam, though this appears to be a replacement, so the original arrangement might have been different (Plate 9).

In contrast to the Southeast Block the Northwest Block has a plain projecting stone plinth, which is carried around the three sides of this part of the malthouse. Central old boarded door with leaf-head strap hinges, probably 17th century (Plate 14). It could not be ascertained whether this doorway was original or whether it had been inserted. The vertical jamb stones in the upper half of the frame look awkward, contrasting markedly with the horizontal jamb stones in the lower half of the frame. In common with the doorway to the Southeast Block, there was no stone lintel, only the wooden lintel of the doorframe. It is possible that this doorway represents an opened out window, the upper jambs of which survive, though not the head or sill. The timber framing above consists of a single tier of rectangular panels, though redundant peg holes in the sill beam show that the present configuration is a modification to the original pattern of closely-spaced studs. The panels are infilled with brick laid in stretcher bond, except for the centre panel, which contains a hatch.

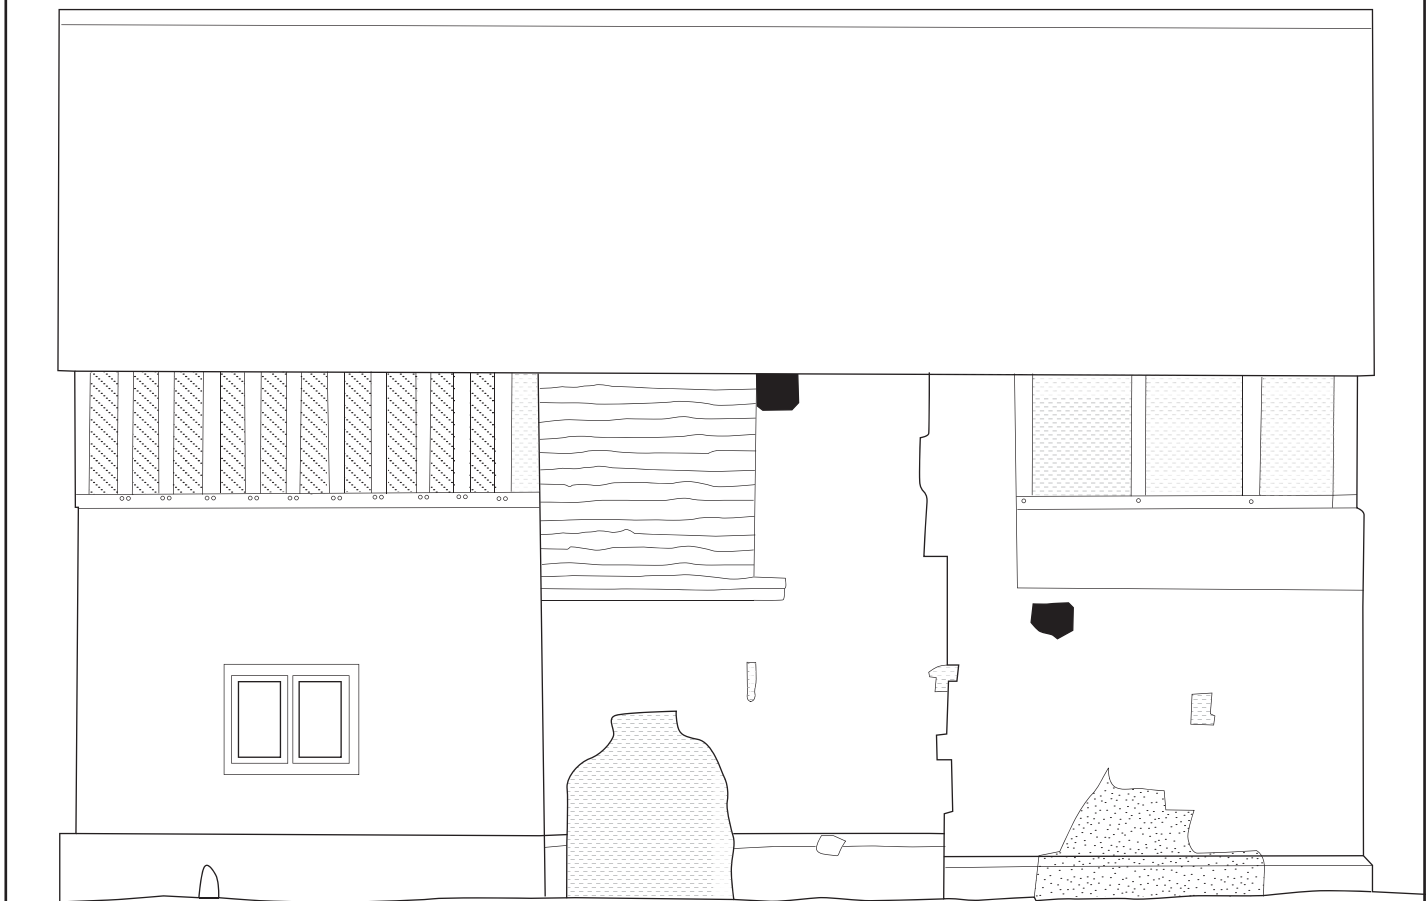
Fig.4 Southwest Facing Elevation

The rear elevation towards the moat is one of the most archaeologically challenging. The wall sits on a chamfered plinth. This is broken towards the northwest end of the elevation by a blocked doorway (Plate 10) and by a roughly central, but irregular vertical building break, the plinth being at a slightly lower level to the right (southeast) of the break (Plate 11). The left-hand (northwest) jamb of the blocked opening appears to be regularly cut and chamfered, but the right-hand (southeast) side is roughly hewn, and evidently a modification to the original fabric. The opening has an irregular shouldered head that appears to be the result of accidental modification rather than a deliberate construction.

Approximately mid-way between the two breaks in the plinth there is a blocked small, roughly square aperture in the plinth, the purpose of which is unknown but which could represent a secondary feature, perhaps to accommodate a timber, and possibly associated with the lean-to that formerly stood in this position. Other blockings or repairs within this elevation may represent the positions of former timbers.

Above the blocked doorway, at first floor level, is a section of weatherboarded timber framing of closely spaced studs. This is framed on the right-hand (southeast) side by a well-cut stone jamb, though the stonework in this area has a modified appearance, but this is the result of a large crack to the right (southeast). This area of framing does not correspond in height to the square-panelled framing at the southeast end of the elevation, which only occupies the upper half of the second storey. It may be significant that there is a slight offset in the stonework at first-floor level, beneath this latter area of framing, that corresponds with the base of the framing at the northwest end of the block, a suggestion, perhaps, that this area has been subjected to modification.

17th-century central two-light chamfered mullioned window with rebated frame to ground storey. Timber-framed upper storey of closely-spaced studs containing diagonally laid brick nogging.

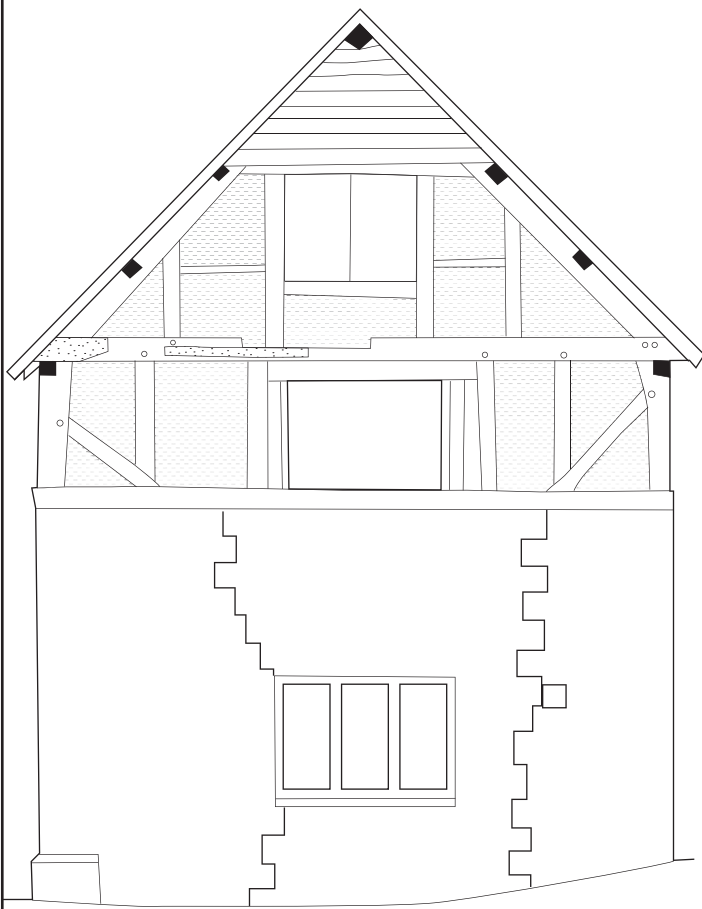
Fig.5 Southeast Facing Elevation

Mid-20th-century three-light wooden mullioned window at ground level. To the right of the window there appears to be a joint in the masonry, and above it the stone is grey rather than pink. These anomalies seem to correspond with the evidence of the 1930s photograph, which showed a carriage opening in this elevation, and suggest that a section of the wall at ground level has been rebuilt. Square-panelled timber framing above, the panels filled with horizontally laid bricks. Jowelled corner posts with short straight tension braces extending from post to the sill beam. The sill beam itself appears to be a replacement as there are no pegs in it corresponding with the posts, studs or braces. Tie beam and two collars with shuttered hatches to both upper floors. Weatherboarded apex.

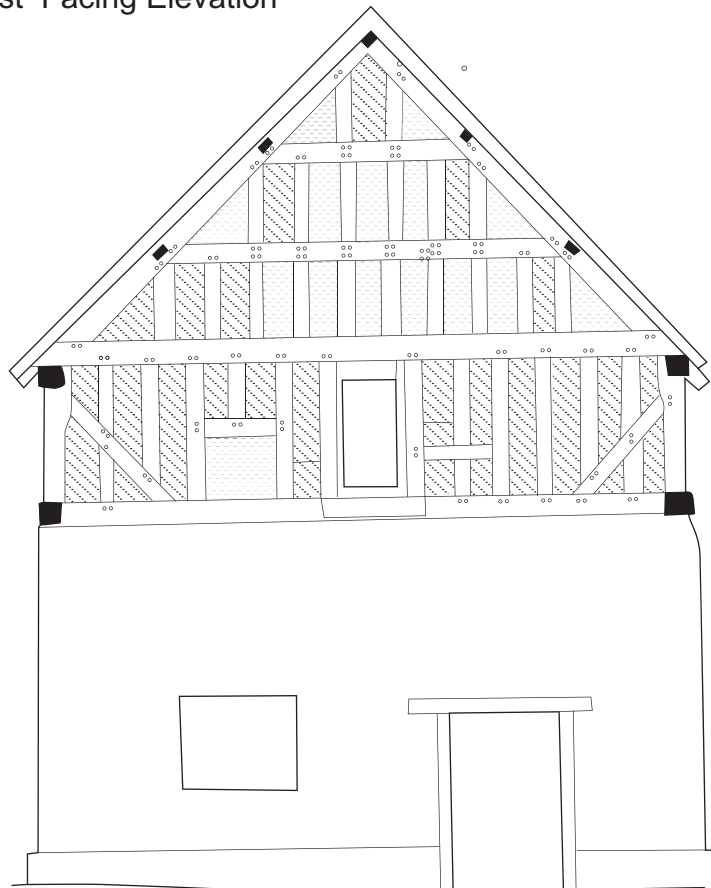
Fig.7 Northwest Facing Elevation

17th-century chamfered two-light mullioned window with rebated frame to ground floor left (Plate 15). Boarded door with timber lintel to ground floor right (Plate 16). The door jambs are well-cut but unmoulded. The plinth has been rebuilt in brick on the right-hand side, and to a lesser extent on the left-hand side. First-floor timber framing of closely spaced studs containing brick nogging laid diagonally or horizontally. Short straight tension braces between corner posts and sill beam. Central inserted hatch level between sill beam and tie beam. Blocked window to left with sill formed by sill beam, and blocked window to the right at a higher level with head level with tie beam. Tie-beam and double-collar roof.

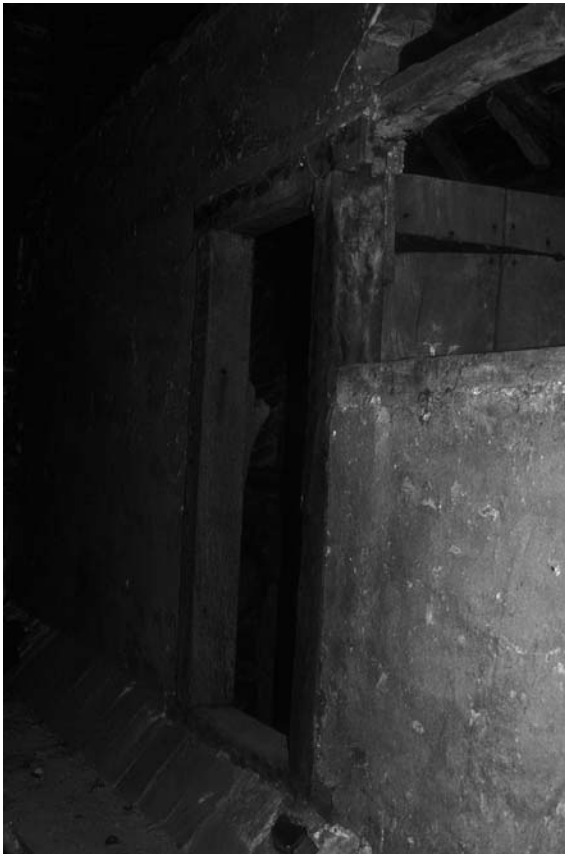
Plate 21

The first floor of the Northwest Block is also divided into two rooms by the upward extension of the brick partition wall noted at ground level (Plate 21).

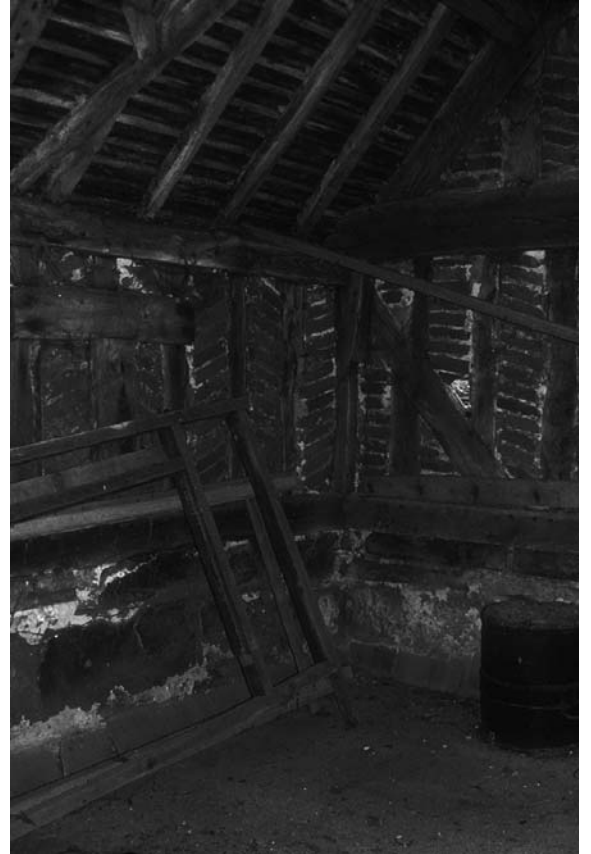
Plate 22

FF03b was the drying floor. The floor was of perforated ceramic tiles supported on a network of cast iron beams. The room was open to the roof, which carried two pairs of trenched purlins and a ridge piece.

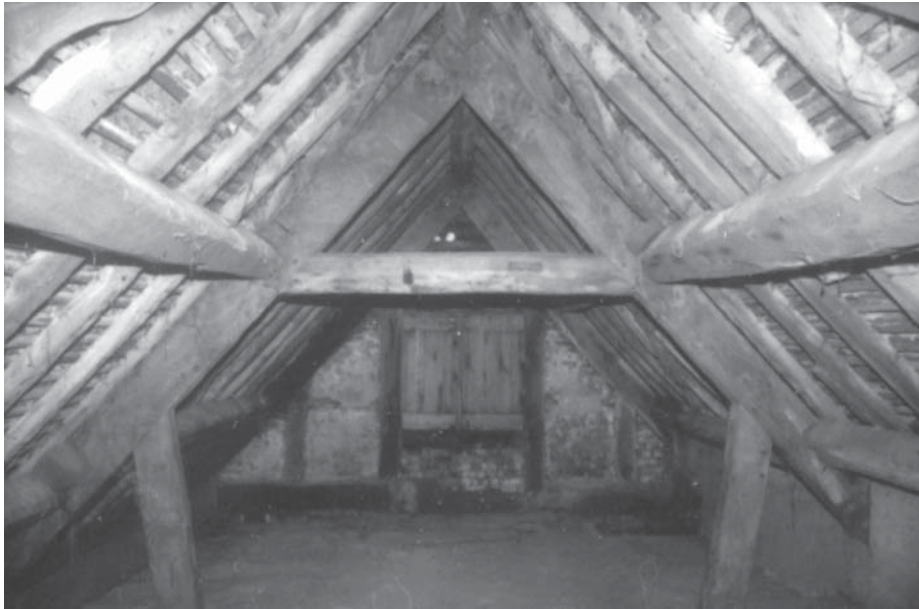
Plate 23

Situated directly above FF01, this room has an intermediate collar and tie-beam truss with a pair of raking struts. In the soffit of each rafter, immediately below the collar is a redundant inclined mortice containing the sawn-off end of a tenon, and indicating that there may have been a second pair of raking struts formerly. On the other hand, a third mortice in the soffit of the northeast rafter, though not in that of the southwest rafter, may suggest that these rafters are reused. In the centre of the truss the top of the tie beam, which protruded above floor level has been cut away to facilitate access between the two bays, so it is possible that the truss was partially closed originally. The roof has a series of very long raking windbraces (Plate 24).
