Project No. 1389

January 2006

78 Ablewell Street, Walsall, West Midlands
Historic Building Recording 2006

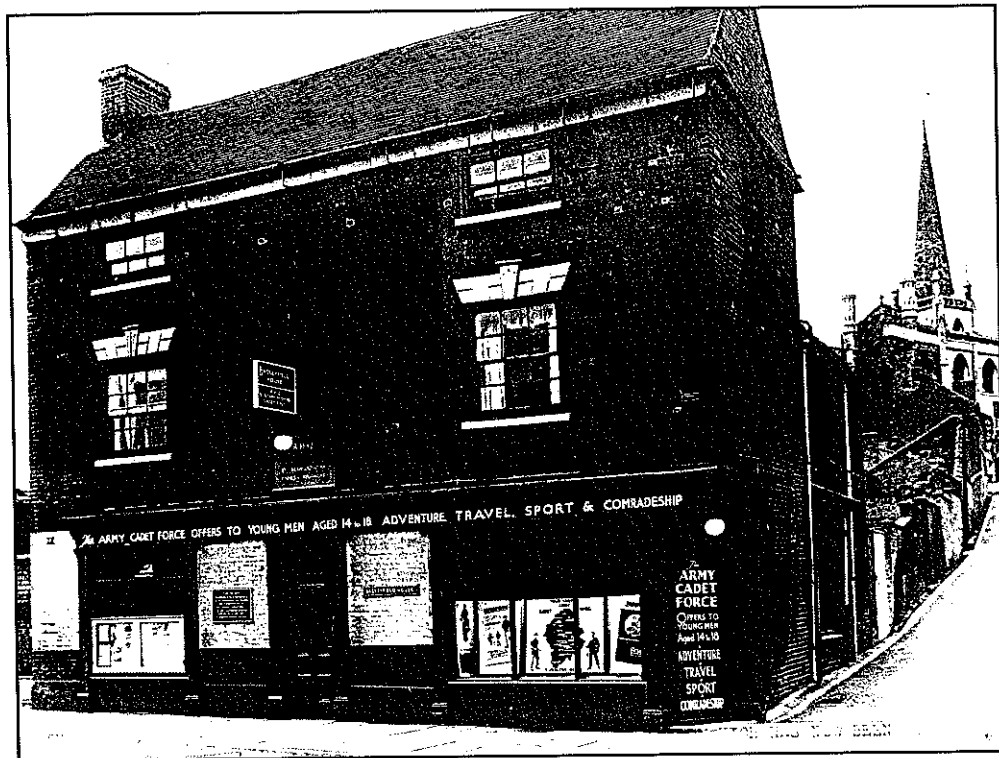
Fig.5 (1936)

The earlier form of the building can be seen in a photograph dating from the 1930s showing the north and east elevations of the building (Fig. 5). This shows the earlier layout of the ground floor, with a single central doorway, two large windows at either side, and a doorway on the northeast corner of the building. The north elevation shows a window at ground floor level of the northwest wing, which appears shorter than at the time of this survey. The first floor windows of the building are twelve-light sashes, whilst those of the second floor are six-light sash windows. A further photograph (Fig. 6) from September 1997 shows the current building being re-roofed.

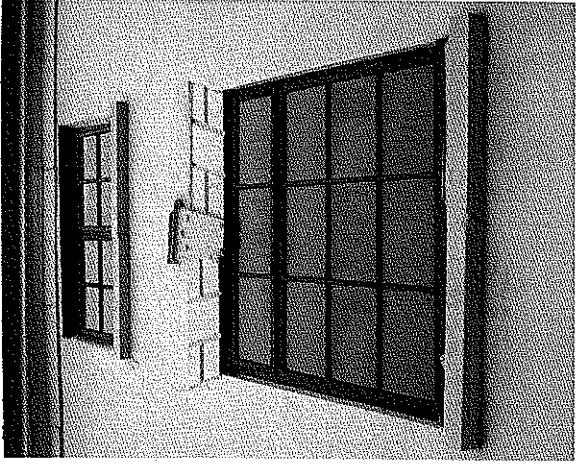
Plate 2

floor level, the building has two window bays, placed towards either end of the building. First floor level is emphasised by tall windows with moulded masonry sills and a masonry lintel having gauged blocks with chamfered rustication and a raised end moulded keystone (Plate 2). The windows, which date from the late 20th-century, have nine lower fixed lights with a top hung vent above, composed of three lights. These resemble, and have replaced earlier twelve light sash windows. At second floor level, there are two short casement windows, two lights high by four lights wide, placed directly above the first floor windows. These have the same moulded masonry sills as the windows on the first floor (Plate 3) but lack the ornate window head. Again they are late 20th-century replicas of earlier sash windows. At the top north corner of the elevation is a rectangular metal tie plate. At roof level there is a course of what appears to be masonry (Plate 4), which is partially obscured by wooden bargeboarding. Above this the roof has red/brown tiles and matching ridge tiles. At the south end of the building there is a short red/brick stack with a half brick step two courses in height one course from the top.

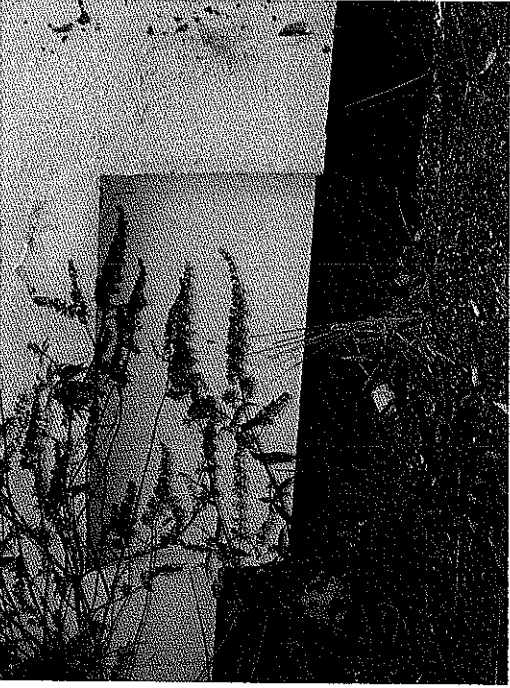
Plate 5

The south elevation of the building is again rendered with plaster and painted white. The current building on the site to the south is a modern supermarket and the construction of this has raised the surrounding ground level by over a metre. This can be clearly illustrated by the top of a blocked up doorway at the west end of the elevation of the main block (Plate 5), of which only the top half metre or so is visible. Above this the walls are featureless until roof level (Plate 6). The southwest wing is two stories in height, and has a red/brown tiled roof and ridge tiles. At its east end there is a short rise in the wall above roof level, presumably a feature relating to an earlier building to the south. The gable wall of the main block has a slight continuation of the masonry course from the east elevation at its east end (Plate 7) but otherwise is featureless until the ridge, where the red brick stack rises out of the plasterwork. The pitch of the roof is slightly convex, due to the replacement of the timber roof structure at some point in the 20th century.

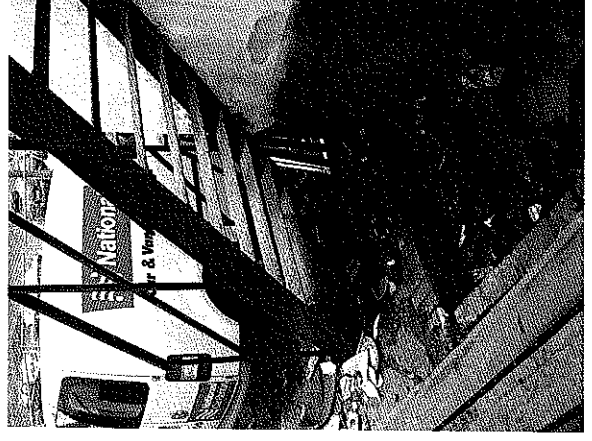
Plate 8

The south elevation of the northwest wing has short flight of three steps running downwards at ground level. Above this is a metal staircase running up to a metal balcony at the east end of the elevation (Plate 8). At first floor level there is a narrow frosted fixed pane window of late 20th-century date with blue brick sill towards the west end of the building. At roof level the block has a stepped row of stretchers topped by a stepped row of headers (Plate 9). The roof above has red/brown tiles and ridge tiles.

the wall at its north end (Plate 8), which line up with the blocked up doorway on the interior. This presumably went out of use at the same point as the insertion of the metal staircase to the first floor, which blocks it. At first floor level the staircase leads to a metal walkway, central to this is the current access to the upper floors. Above this the roof of the infill is made of bitumen felt. The west elevation of the main block is only visible from the second storey upwards. At second storey level there is a central window with a large lower fixed light and a top hung vent above. At eaves level there is a rectangular metal tie plate at the north end of the building, corresponding to that on the east elevation, above this is a stepped course of stretchers topped by a course of alternately projecting headers, with a course of stretchers above (Plate 11). Above this the roof is as the east elevation.

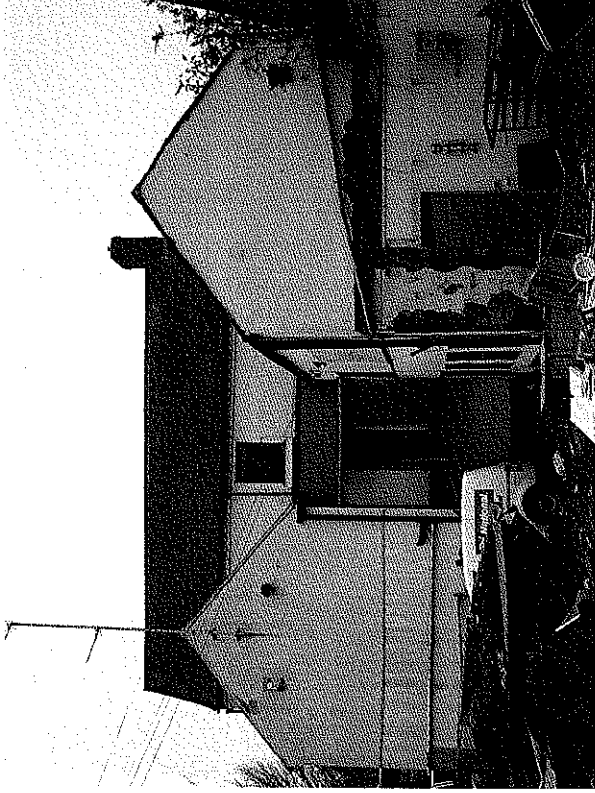
Plate 10

The west elevation of the building is largely taken up by two wings and a block of infill between them (Plate 10). The northwest wing is featureless on this side. At ground floor level the southwest wing shows the scars of an earlier building to the west, and a double skin of brickwork at ground floor level to support this. The north west corner of the block has the brickwork partially exposed and has a bevelled brick corner. To the north of centre at ground floor level there is a doorway originally joining this block to the building to the west. The small section of infill between the northwest and southwest wings is blank at ground floor level but has steps down to

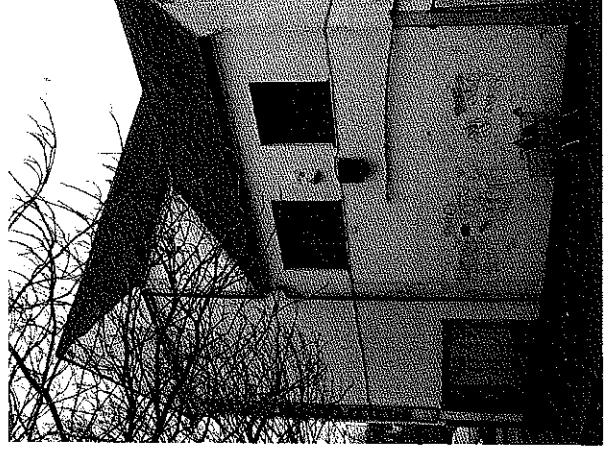
Plate 12

The north elevation of the building faces onto The Ditch, a road running upwards to the west, ground level at this side of the building rises by approximately 0.8 metres from east to west (Plate 12). At ground level there is a large single-pane window at the east end of the main block of mid to late 20th century date. The photo from 1936 shows this corner of the building canted at ground level, with a doorway (Fig. 5), but this is now imperceptible. At first floor level there are two windows on the northwest wing, both of mid to late 20th century date. The window to the east is a casement with a top hung vent above, with a large fixed pane to the west. The west window is frosted with a large lower fixed pane and a top hung vent above. At eaves level the northwest projection has a stepped row of stretchers topped by a stepped row of headers. Above this the roof has red/brown roof tiles and ridge tiles.

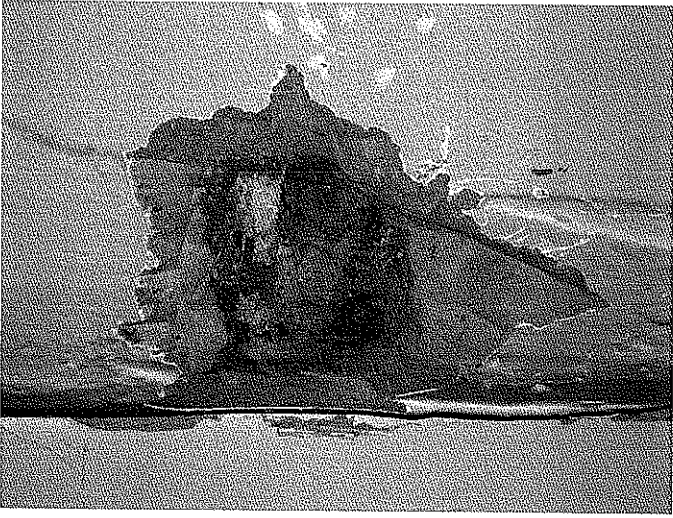
Plate 13

where the brick has become exposed, has a bullnosed brick corner (Plate 13). The south wall of the room has a doorway at the east end, with a segmental-arched head composed of fake stonework. The west wall of the room has a central doorway leading to the exterior of mid 20th-century date. The ceiling of the room is of white plaster decorated by the addition of fake black scantling joists. From the central N/S axis of the room the ceiling slopes downwards towards the west.

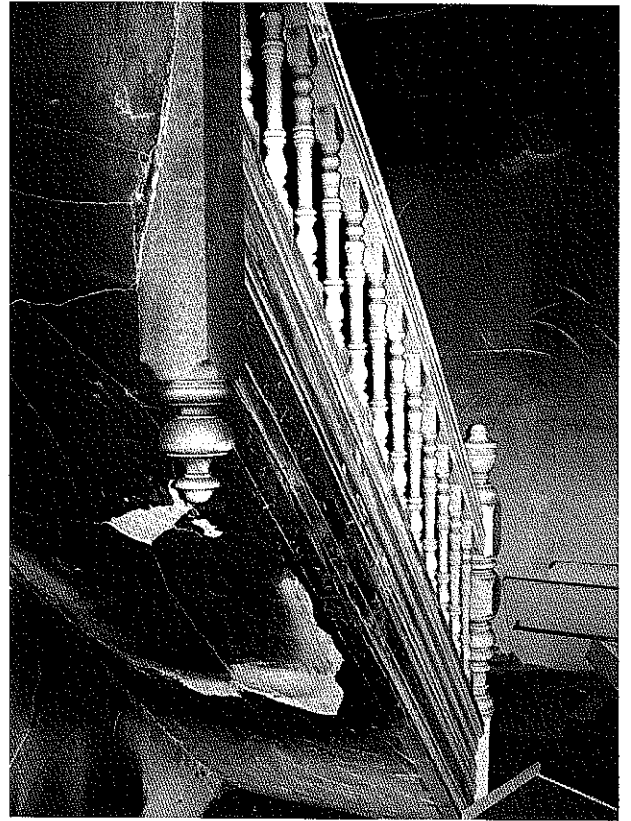
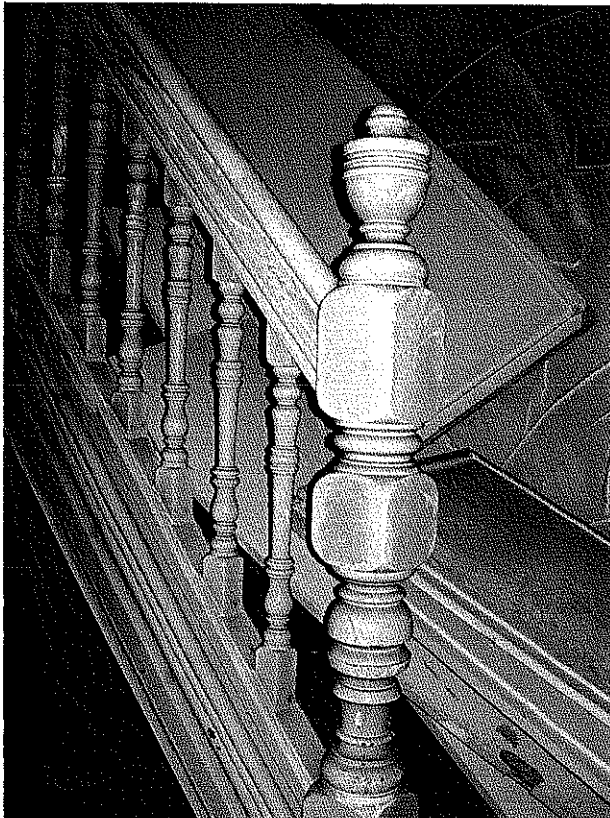
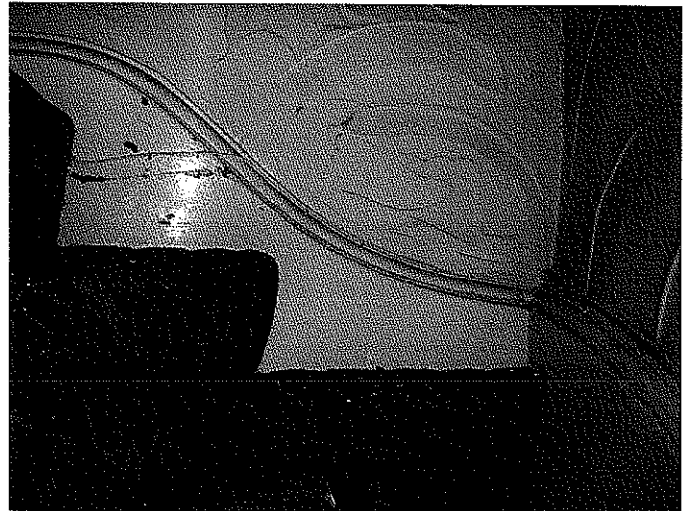
balusters and foot newel and closed string, and an open space below at the west end (Plates 18, 19, 20). The south wall of the room has a central doorway, the reverse side of that on the north wall of F2, again blocked up and made to look like a blocked window, with fake stone segmental arched lintel. The west wall of the room shows clearly the blocked segmental arched opening through to F1, with the corbels still evident. The ceiling of the room is covered by white plaster and fake black scantling joists, and is perforated in the northwest corner by the staircase.

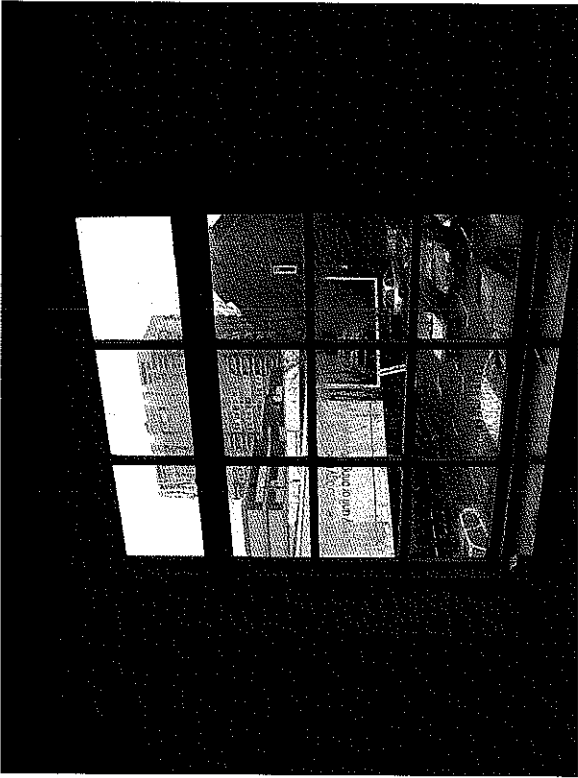
Plate 21

Occupies the north end of the main block. Hardwood joists running E/W, covered by hardwood boards, and carpeted. The east wall has a central window identical to that in F2, but without the reveal at the top (Plate 21). The south wall has a doorway at its east end with fake stone segmental arched lintel. The west wall has a large double opening through to F5. This forms the west wall of the main block, and at its base, running as a sill for the opening are three large timbers which run N and S through the base of the wall on either side (Plate 22). These lie directly above the boxed beam of G1 and were most likely inserted when the floor below was converted to one large open room. The ceiling of the room has a large central N/S boxed beam (Plate 23), the exact nature of which is unclear as it is heavily plastered. To either side of this, running E/W are fake black scantling joists.

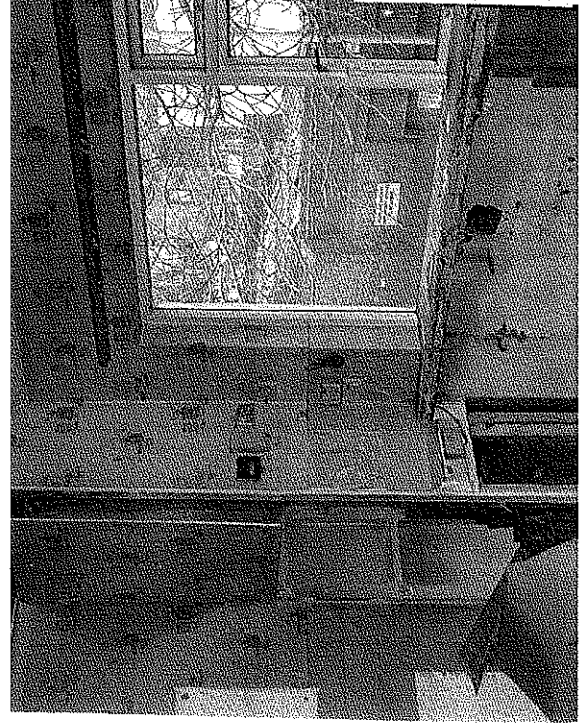
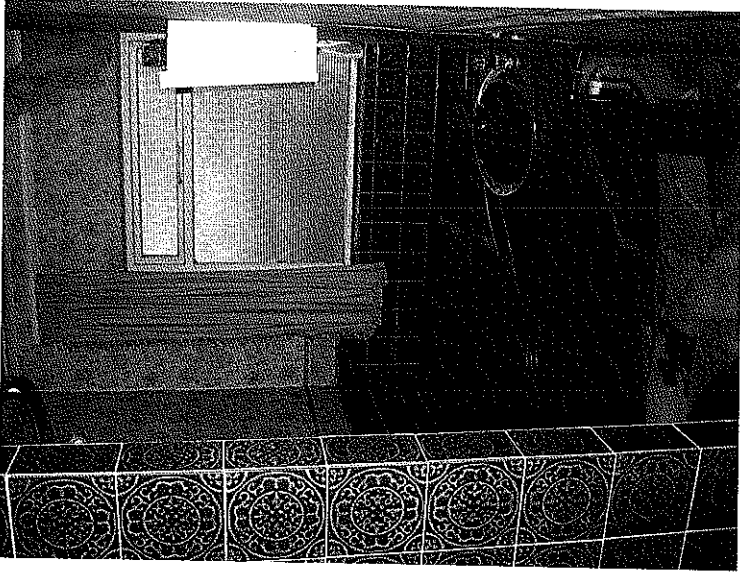
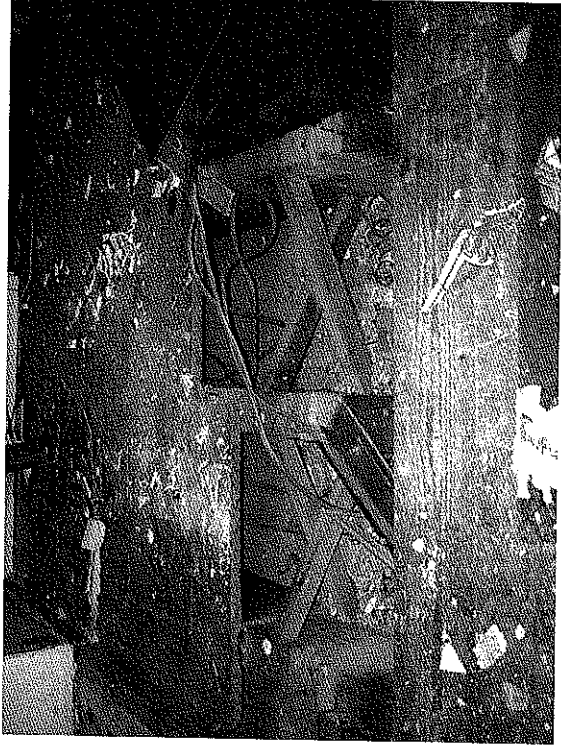
F5 was originally one large room has been subdivided by the addition of stud partition walls into a kitchen (Plate 24), bathroom (Plate 25) and corridor when the building was converted to flats. The floors are hardwood joists with herringbone struts and hardwood boards (Plate 26). The boards along the east end are roughly cut and stop slightly short of the wall to the east, which presumably is due to the insertion of the timber beam. The north wall of the room has a 20th-century frosted fixed pane window with top hung vent to the west, contained within the bathroom, and a 20th-century casement window with top hung vent to the east, contained within the kitchen. The east wall has a large double opening through to F4. The south wall has a small frosted window to the west, contained within the bathroom. At its east end, within the corridor section is a blocked doorway, imitating a blocked window with a fake stone segmental-arched lintel, the reverse of that on the north wall of F1. The roof structure above the rooms is visible through a hatch at the east end of the kitchen. It comprises a single purlin roof supporting common rafters. The west wall of the main block is also visible through this hatch, and an earlier roof scar can be seen beneath the line of the present roof (Plate 27). This suggests that either there was an earlier building in the place of the northwest wing or that the wing has been widened at some point, as the pitch of the previous roof scar suggests that the building would end at the wall separating the kitchen from the corridor.
