POTTERY FARM MUCKLOW HILL HALESOWEN WEST MIDLANDS

Archaeological Desk-Based and Historic Building Assessment 2009

### Project No. 1963

June 2009

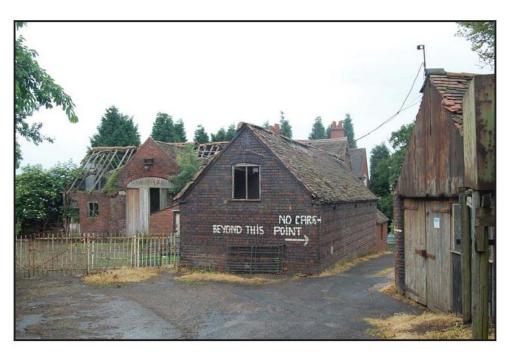
Plate 1: Pottery Farm from the northeast

2.1.1. Pottery Farm is situated close to the top of Mucklow Hill, on the west side of the road that now bears that name, approximately one mile northeast of Halesowen town centre, in the West Midlands conurbation, at NGR SO 9778 8471 (Figure 1). The buildings are situated to the west of The Old House, another grade II listed building, which is the former farmhouse to the present agricultural buildings. A track leads southwest from a bend in the main road, past the Old House to the south and agricultural buildings to the north to the main block of buildings that constitute Pottery Farm, which also lie on the south side of the track to the rear of The Old House (Plate 1).

7.1.1. The main group of agricultural buildings forms an L-shaped block, the main range occupied by a barn aligned northwest-southeast, with a stable wing projecting at right angles from the northwest end of the northeast front to enclose two sides of a roughly triangular fold yard (Plate 2). In the angle between the two ranges is a loose box, and behind (to the south-west of) the south-east end of the barn are two double pigsties, both facing southeast. Attached to the northwest end of the barn's southwest elevation is the current farmhouse. Opposite the entrance to the yard, on the north side of the track is an outbuilding that also forms part of the proposed development (Plate 1).

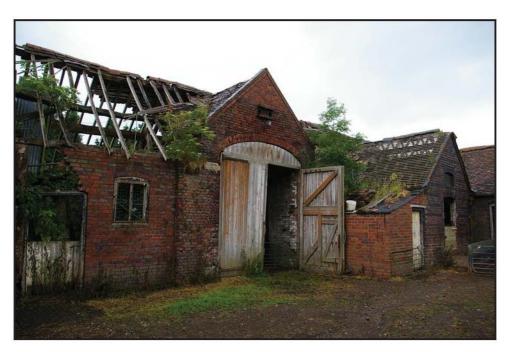
Plate 3: The barn and loosebox from the southeast

- 7.1.2. The barn is largely 19<sup>th</sup>-century in character with red brick walls and plain tile roof (Plate 3), although it is evident both from the exterior, and more prominently from the interior that the building has 17<sup>th</sup>-century origins, and was formerly of timber-framed construction. There is, incidentally, no good reason to suspect that there is any truth behind the statement contained within the statutory list description that the frame is 'reputed to contain timbers of Saxon origin'.

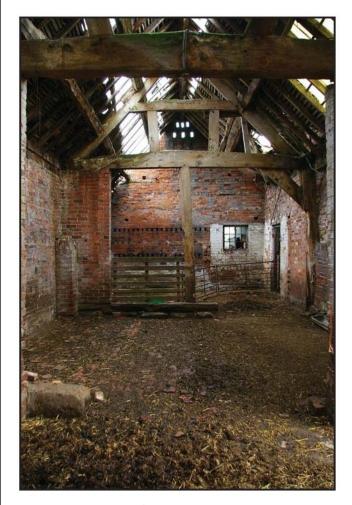
Plate 9: Barn interior from the south

- 7.1.12. The other two roof trusses are supported by stub walls on both sides (Plate 9); redundant pegs in the faces of both tie beams suggest that these frames also incorporated a vertical timber to each side, but no central member. Here, there is a different kind of roof structure consisting of tie beam trusses with raking struts extending from the tie beam to the principals. In Staffordshire, the earliest examples of this type date from the 16<sup>th</sup> century, and these, together with all the early postmedieval examples, are in barns (Peters 1988, 24). The difference in design is no doubt owed to the need to have free access between the threshing bay and the two adjoining bays even at these level, as the sheaves would have been piled up to roof height. The cross frames carry trenched purlins and a diagonally set ridge piece.
