Birmingham University Field Archaeology Unit  
Project No. 553.01  
August 2000

**Archaeological Recording at  
Tooley's Boatyard, Banbury, Oxfordshire**

by  
Christopher Hewitson  
with contributions by Stephen Litherland

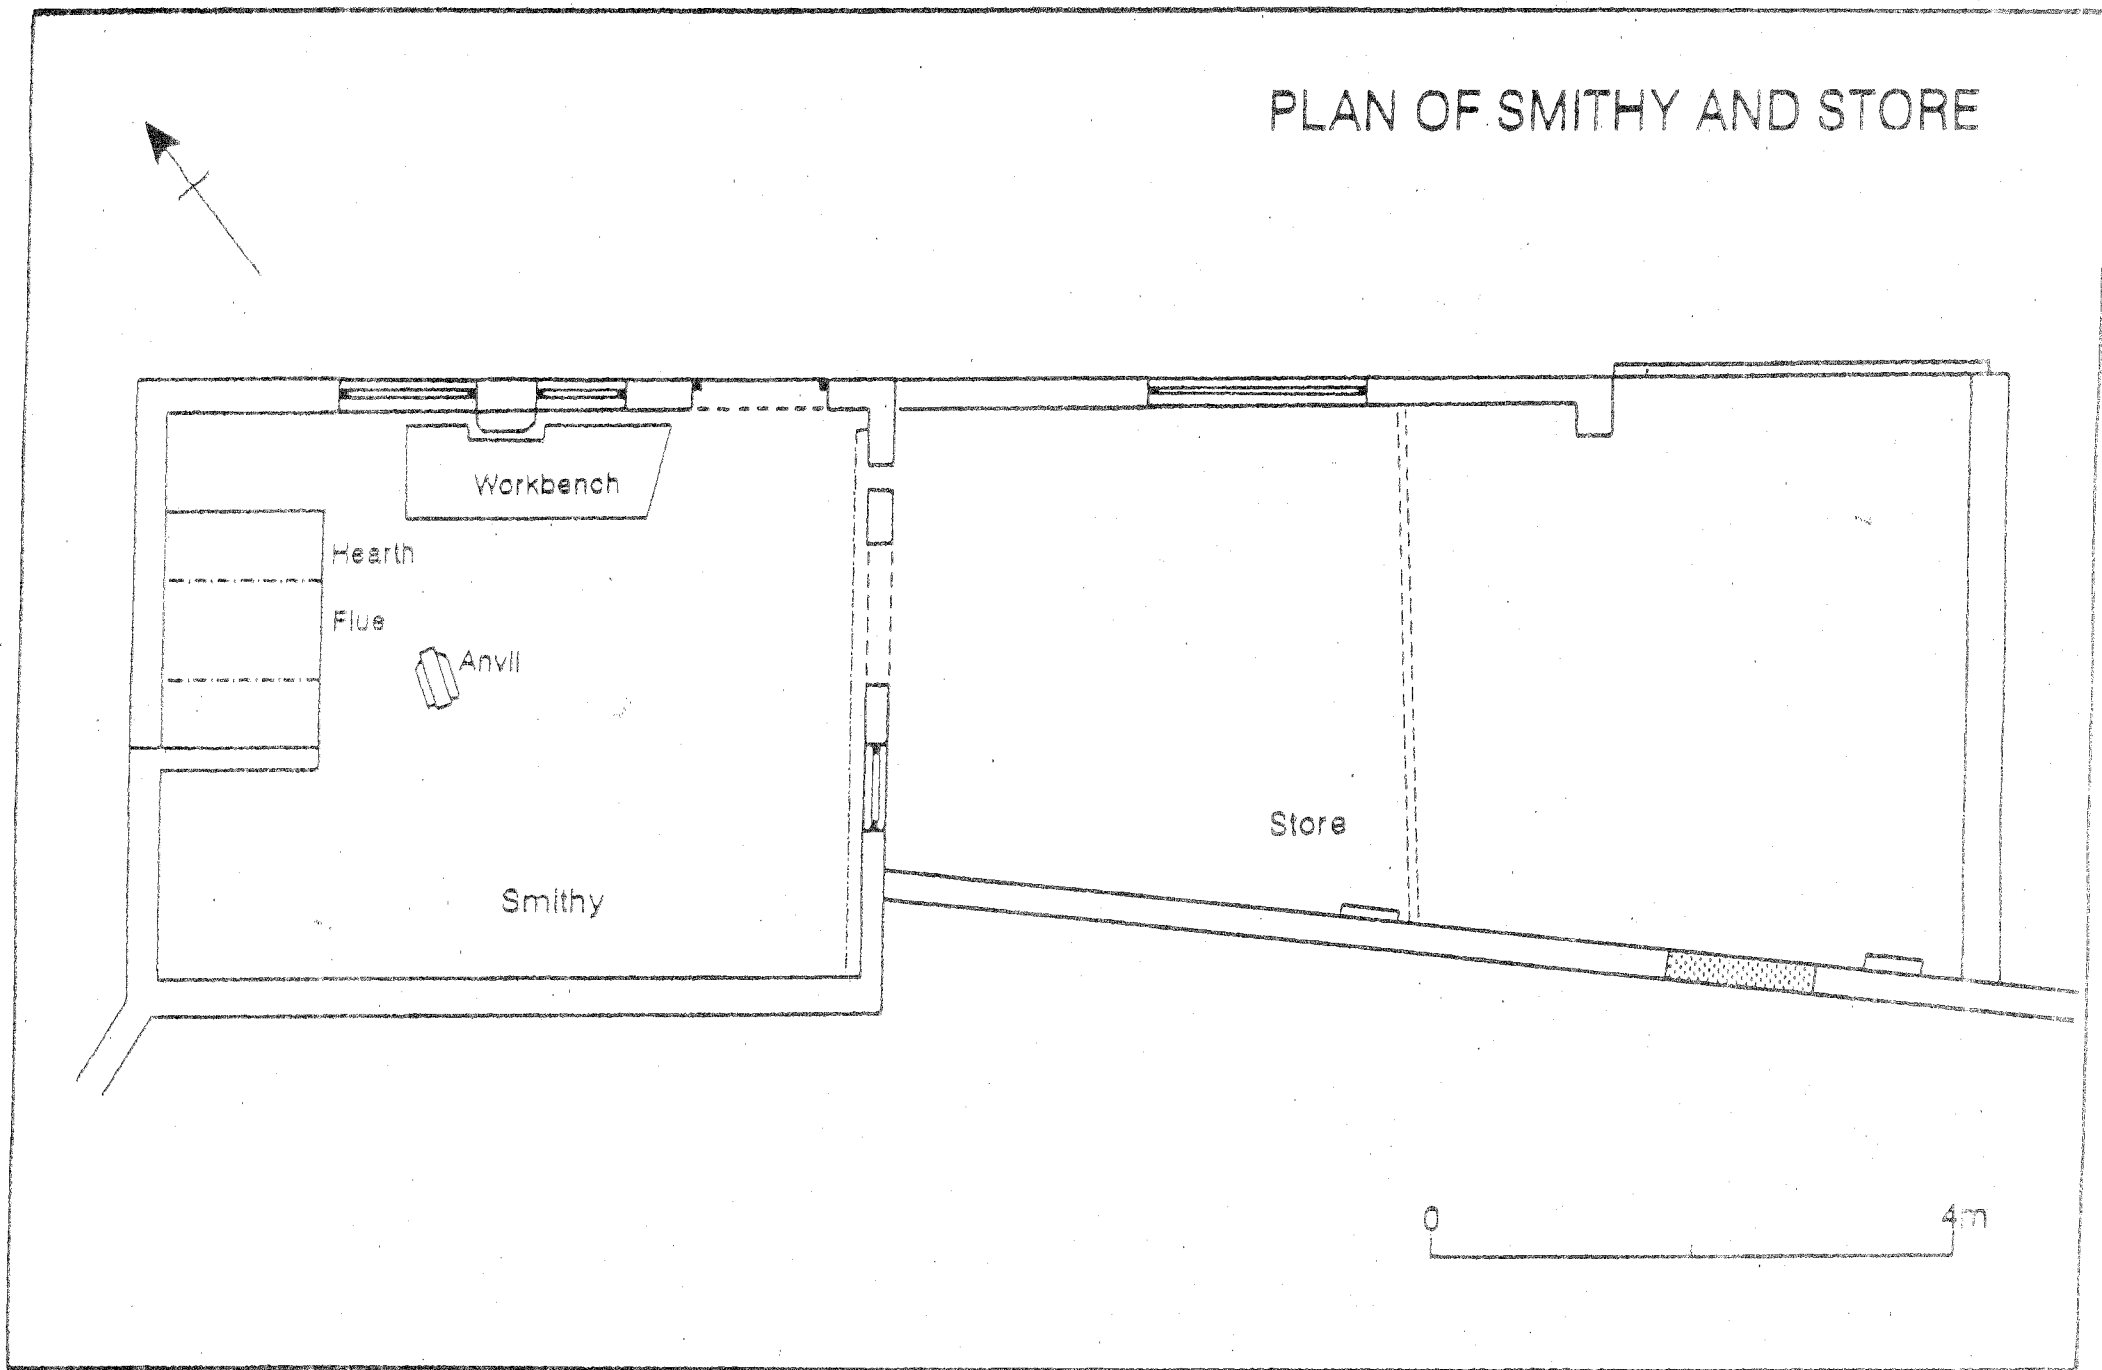
Figure 3: The Store (A) and Smithy (B)

Structure A was built against Structure B, the smithy and a former boundary wall of the boatyard to the west. The building was wider at its southern end, giving it a roughly trapezoidal plan. The earliest component of Structure A was the north wall that comprised the southern gable of the smithy. The west wall was built of clamped red brick, in a two-phase construction. The initial phase of the wall was c.2m high with crude Flemish-style bond brickwork, one-and-a-half bricks wide, supported by two buttresses placed centrally and slightly to the south. A blocked opening was centrally placed between the two buttresses. Attached to the wall were two iron rings for tethering horses. Several courses of cleaner-cut clamped bricks, with larger mortar joints served to raise the height of the wall. The south and east walls were both built of concrete-blocks and dated to 1947 (Barry Morse pers comm.). The east wall faced onto the yard. There were two openings; an eight-light steel framed window to the north, and a garage-sized sliding door to the south. The wall was a single block deep, but was buttressed at both ends for stability. The wall directly abutted the smithy and was not keyed-in. The south wall was plain with no openings. The corrugated steel roof was supported by a pair of north - south running purlins, supported by a centrally-placed joist rebated into the back and front walls. The southern wall acted as a truss, while a sawn-pine frame was bolted to the northern wall. There were two lights in the roof.

The development of Structure A started with the construction of the west wall against the south gable of the smithy. A structure in this position was depicted on the First Edition Ordnance Survey map of 1882 (Fig. 12), although the use of clamped brick would imply an early or mid-19<sup>th</sup> century date for its construction. The first building with a similar plan to Structure A was depicted on the 1922 Ordnance Survey Map (Fig. 14), although the concrete walls are clearly later. During Barry Morse's occupation the structure had been used as a carpentry store and workshop. However, earlier it had been used for stabling horses prior to shoeing in the adjacent smithy. However, by 1939 the Tooley's had let the smithy (Rolt 1944, 22), which may have been an indication of the decline of horse-drawn traffic in the inter-war period.

The smithy was originally a free standing, clamped redbrick building of single-phase construction, with some later alterations. The brickwork was in Flemish bond and the eaves were dentilated. The roof was of pitched red tile, with gables at the north and south ends. A single stack in the north wall served the smith's.

The east wall faced the yard. At the southern end was a plain doorway with a wood lintel. Further north, were two windows, under a single wooden lintel. The south window was a narrow eight-pane casement window, while the north window was wider and shorter with six panes. Both windows may have replaced a smaller unglazed opening, as light within a smithy was usually kept to a minimum to see the subtle changes in colour as the metal cooled. A doorway and a small window had been punched through the south wall, presumably when the precursor of Structure A was built. The west wall was blind, while the hearth, and associated smoke hood and stack above dominated the north wall (Plate I). An ash-hole, measuring 12 inches wide and 16½ inches tall was located to the west of the hearth. In front of the hearth was the anvil, an early example with evidence of repair (Barry Morse pers comm.). A work-bench was located under the window in the eastern wall to maximise light. The floor was brick paved with evidence of wear, principally by the hearth, the eastern doorway and the bench located at the eastern wall.

The two gables and a central truss supported the roof structure. The principal rafters were supported by a strut on either side, with a pair of iron ties extending from the apex to the tie beam symmetrically and equidistant from the centre and end of the tie beam. An iron plate held the principal rafters together at the apex. The smithy was one of the first buildings to be constructed c.1790, and has been statutory listed (Oxon. SMR 172a). The roof and chimney were re-built with advice from English Heritage in the 1980s. Alterations included the insertion of the doorway in the south wall that opens into Structure A. These alterations appeared to have been contemporary with the construction of the structure depicted on the 1922 Ordnance Survey Map (Fig. 14). The openings in the eastern wall were probably original with varying levels of alteration.

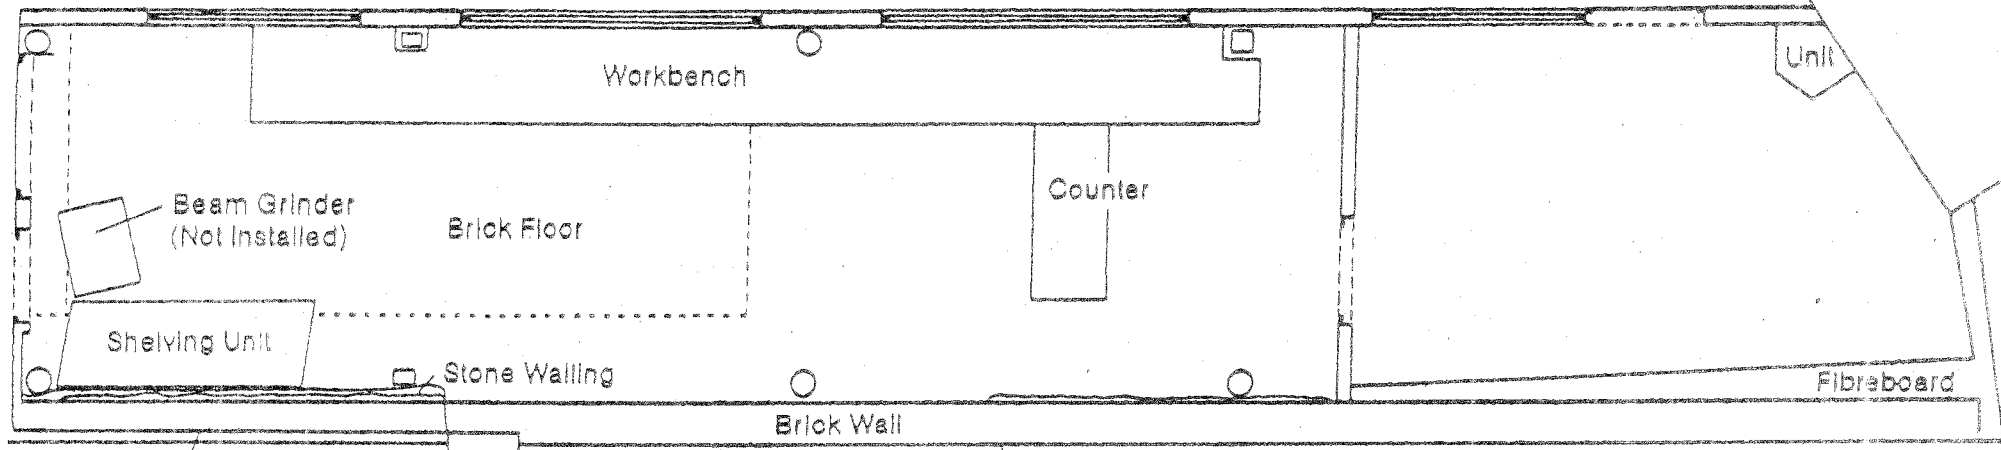
Figure 4: The Carpenter's Shop (C)

Structure C was a long thin lean-to structure built against the boundary wall of the boatyard that incorporated sections of ironstone walling and later phases of brickwork. There were two clear builds. The southern office section was clad with corrugated-iron sheets, while the longer workshop section was walled with re-used boat timbers. The frame of the building used recycled timbers throughout, including several cut-down telegraph poles. The roof was lined with corrugated-iron sheets.

The workshop had a counter at the southern end where the yard shop was stationed in Barry Morse's tenancy. A workbench ran the length of the eastern wall. The floor was a mixture of concrete screed and brick paviours. The brick floor extended c.5m from the northern end of the building and may be a survival of an earlier structure.

Structure C was visible on pictures of the boatyard compiled in the 1940s (Mackersey 1985). The ironstone wall within the build of the rear wall was earlier, probably dating back at least to the mid-19<sup>th</sup> century (Fig. 11). The southern room of the structure was originally a store, once containing the rechargeable glass batteries used in the crystal radio sets and commonly found on the boats in the 1920s and 1930s (Barry Morse per. comm.). The main part of the structure was a chandlery store for passing trade. Barry Morse used the store as an office during his tenancy with the main area relatively unchanged.

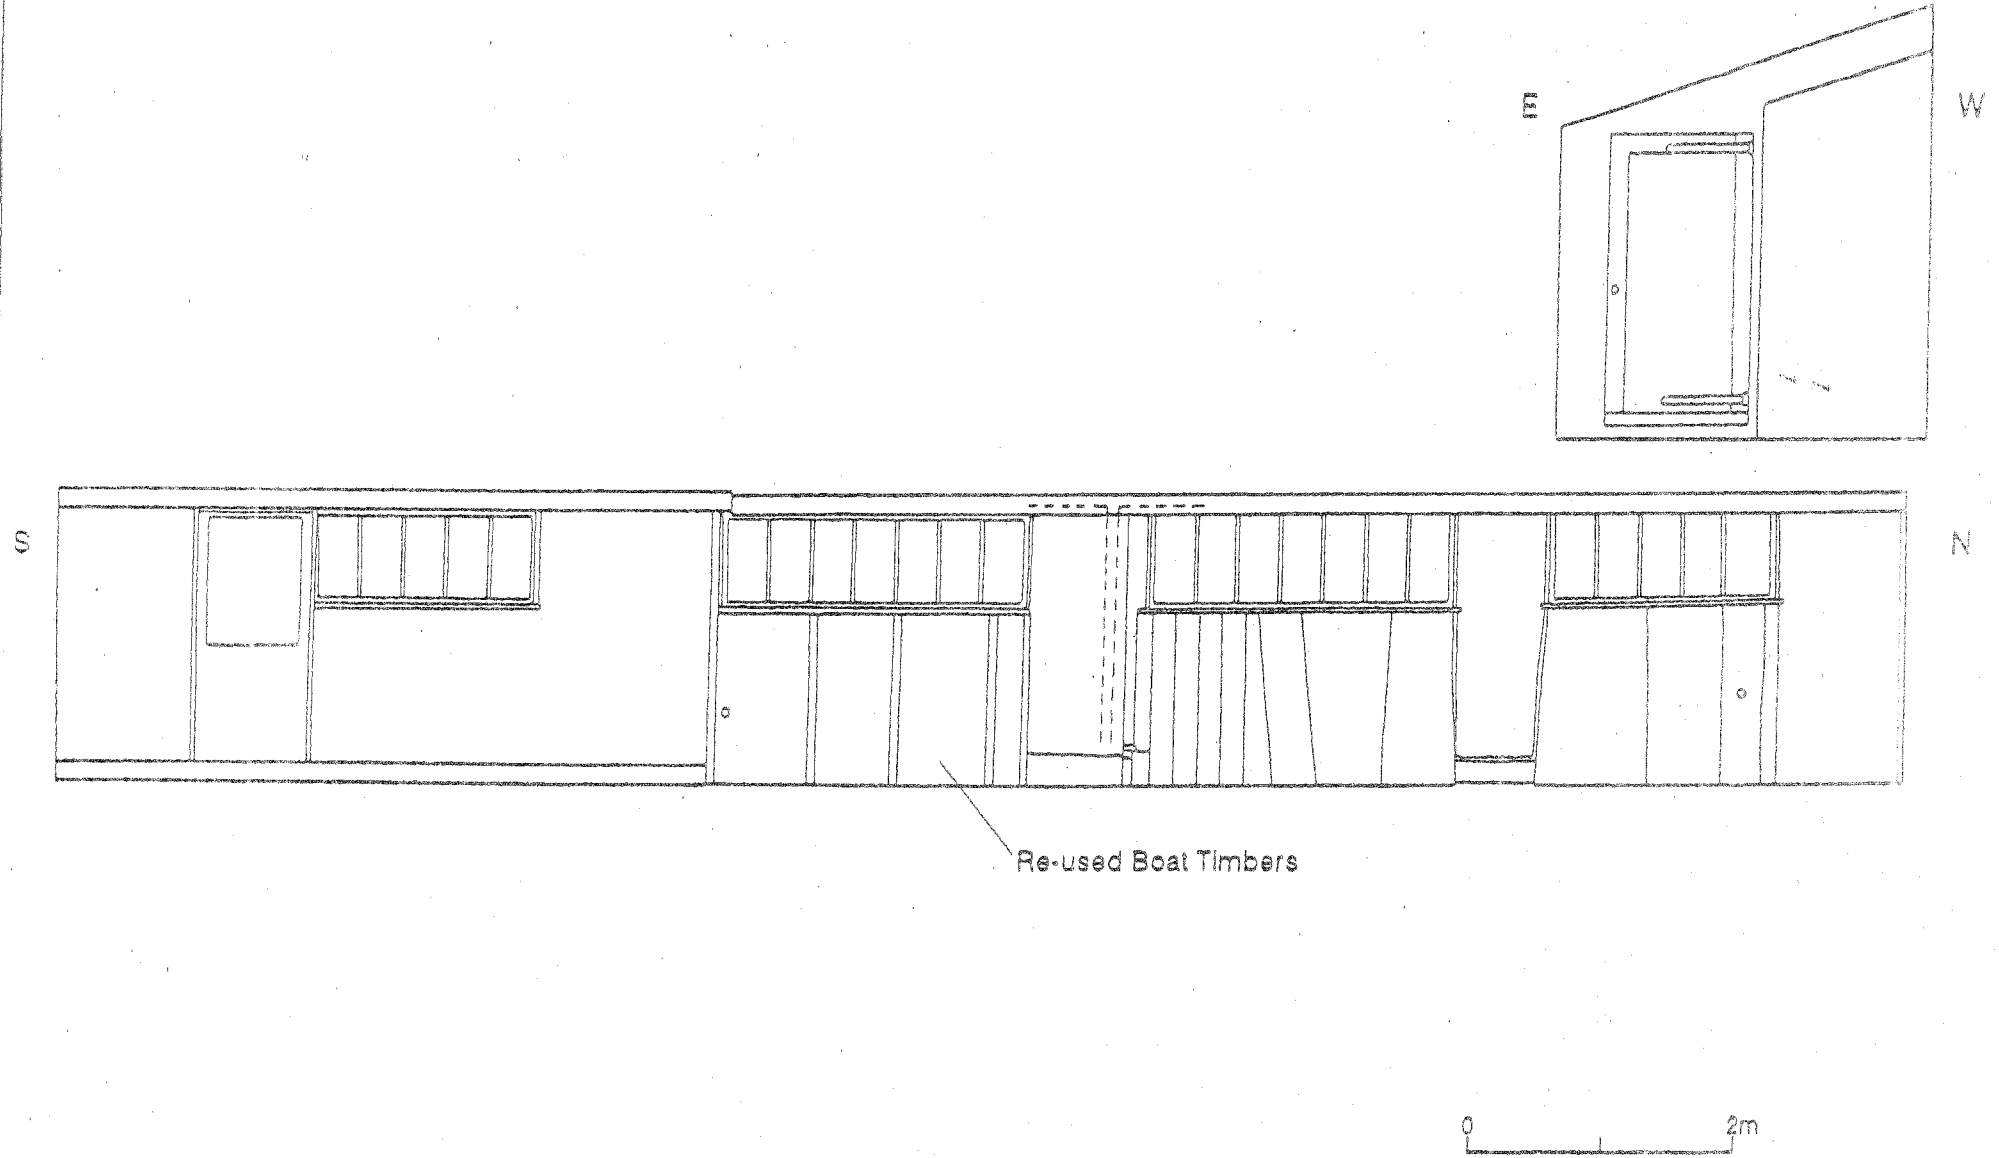
Figure 5: The Carpenter's Shop Elevation

The east elevation to the yard had a doorway entering the office and a five-pane window. Within the re-used timber section there were three further bays of windows, two of seven panes and one of five panes. The southern elevation abutted the smithy at an angle. The rear elevation was of red brick in English Garden Wall bond. The brickwork overlay a length of ironstone wall at the northern end of the structure. The north wall had two doorways, one entered the paint shop, the other opened onto the yard.

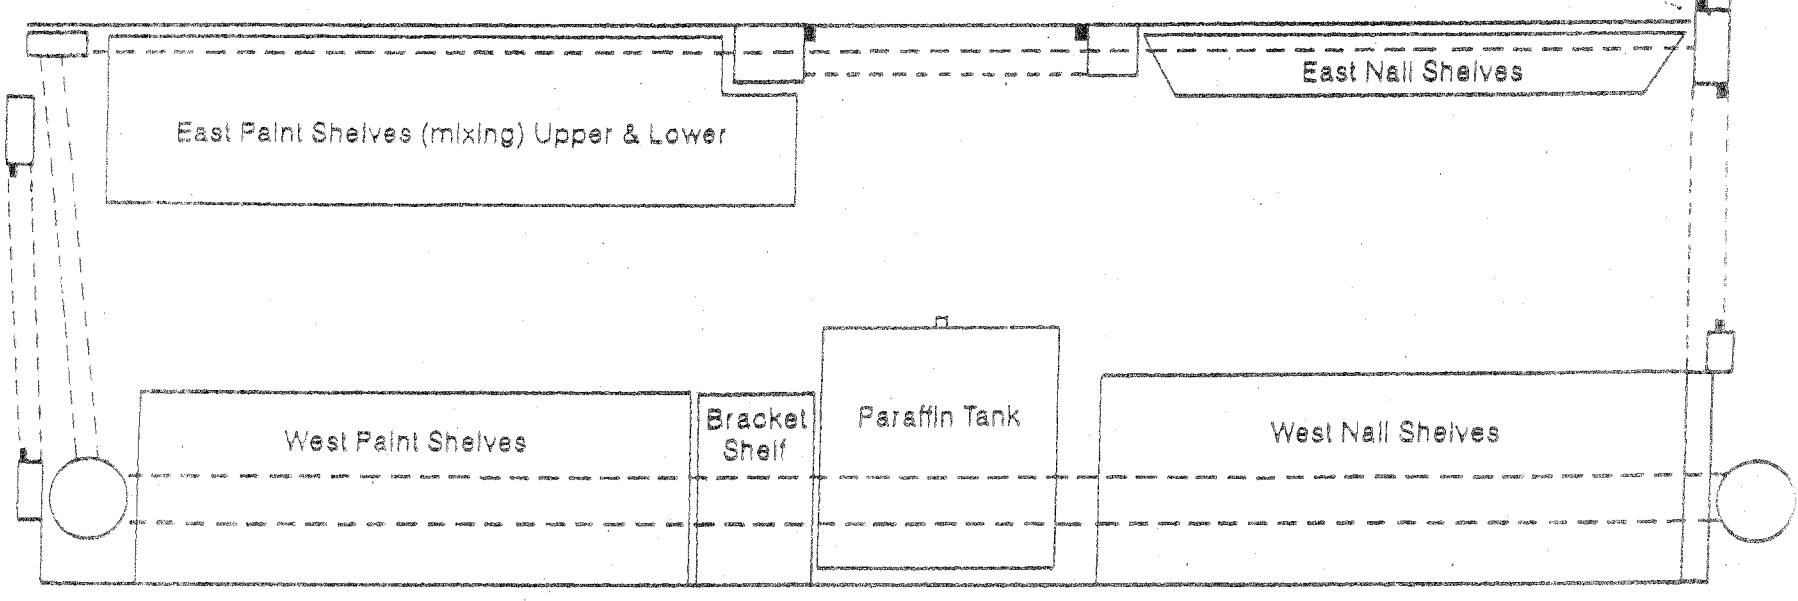
Figure 6: The Paint Shop (D)

A small lean-to structure acted as a corridor between Structures C and E. The rear wall was a continuation of the ironstone rubble wall that extended from Structure C into Structure E. The construction of the building was similar to that of Structure C with re-used timbers and a corrugated-iron roof. Doorways connected south to Structure C and north to Structure E. The front, eastern elevation had a single central doorway, which gave access to the yard. The door had a 'rainbow' patina of excess paint applied to the interior where different coloured paints had been tested (Plate IV).

The interior of the paint store was divided into two portions located north and south of a central entrance from the yard that was directly opposed by a paraffin tank. The southern portion had two opposing sets of shelves containing nails (Plate VIII). The northern half likewise had two sets of opposing shelves that housed a wide variety of tins of paint (Plates V, VI, VII and VIII).

This structure was another example of the temporary structures that feature largely in the Tooley's development of the boatyard, constructed from reclaimed materials from skips or demolition sites. Of a single-phase construction it post-dated the 1922 Ordnance Survey Map (Fig. 14). It was probably contemporary with the construction of the adjacent Machine Shop in the early-1930s. Much of the material contained within it, particularly the paints dated back to the 1950s and 1960s. The paraffin was used in stoves and lights on the canal boats.

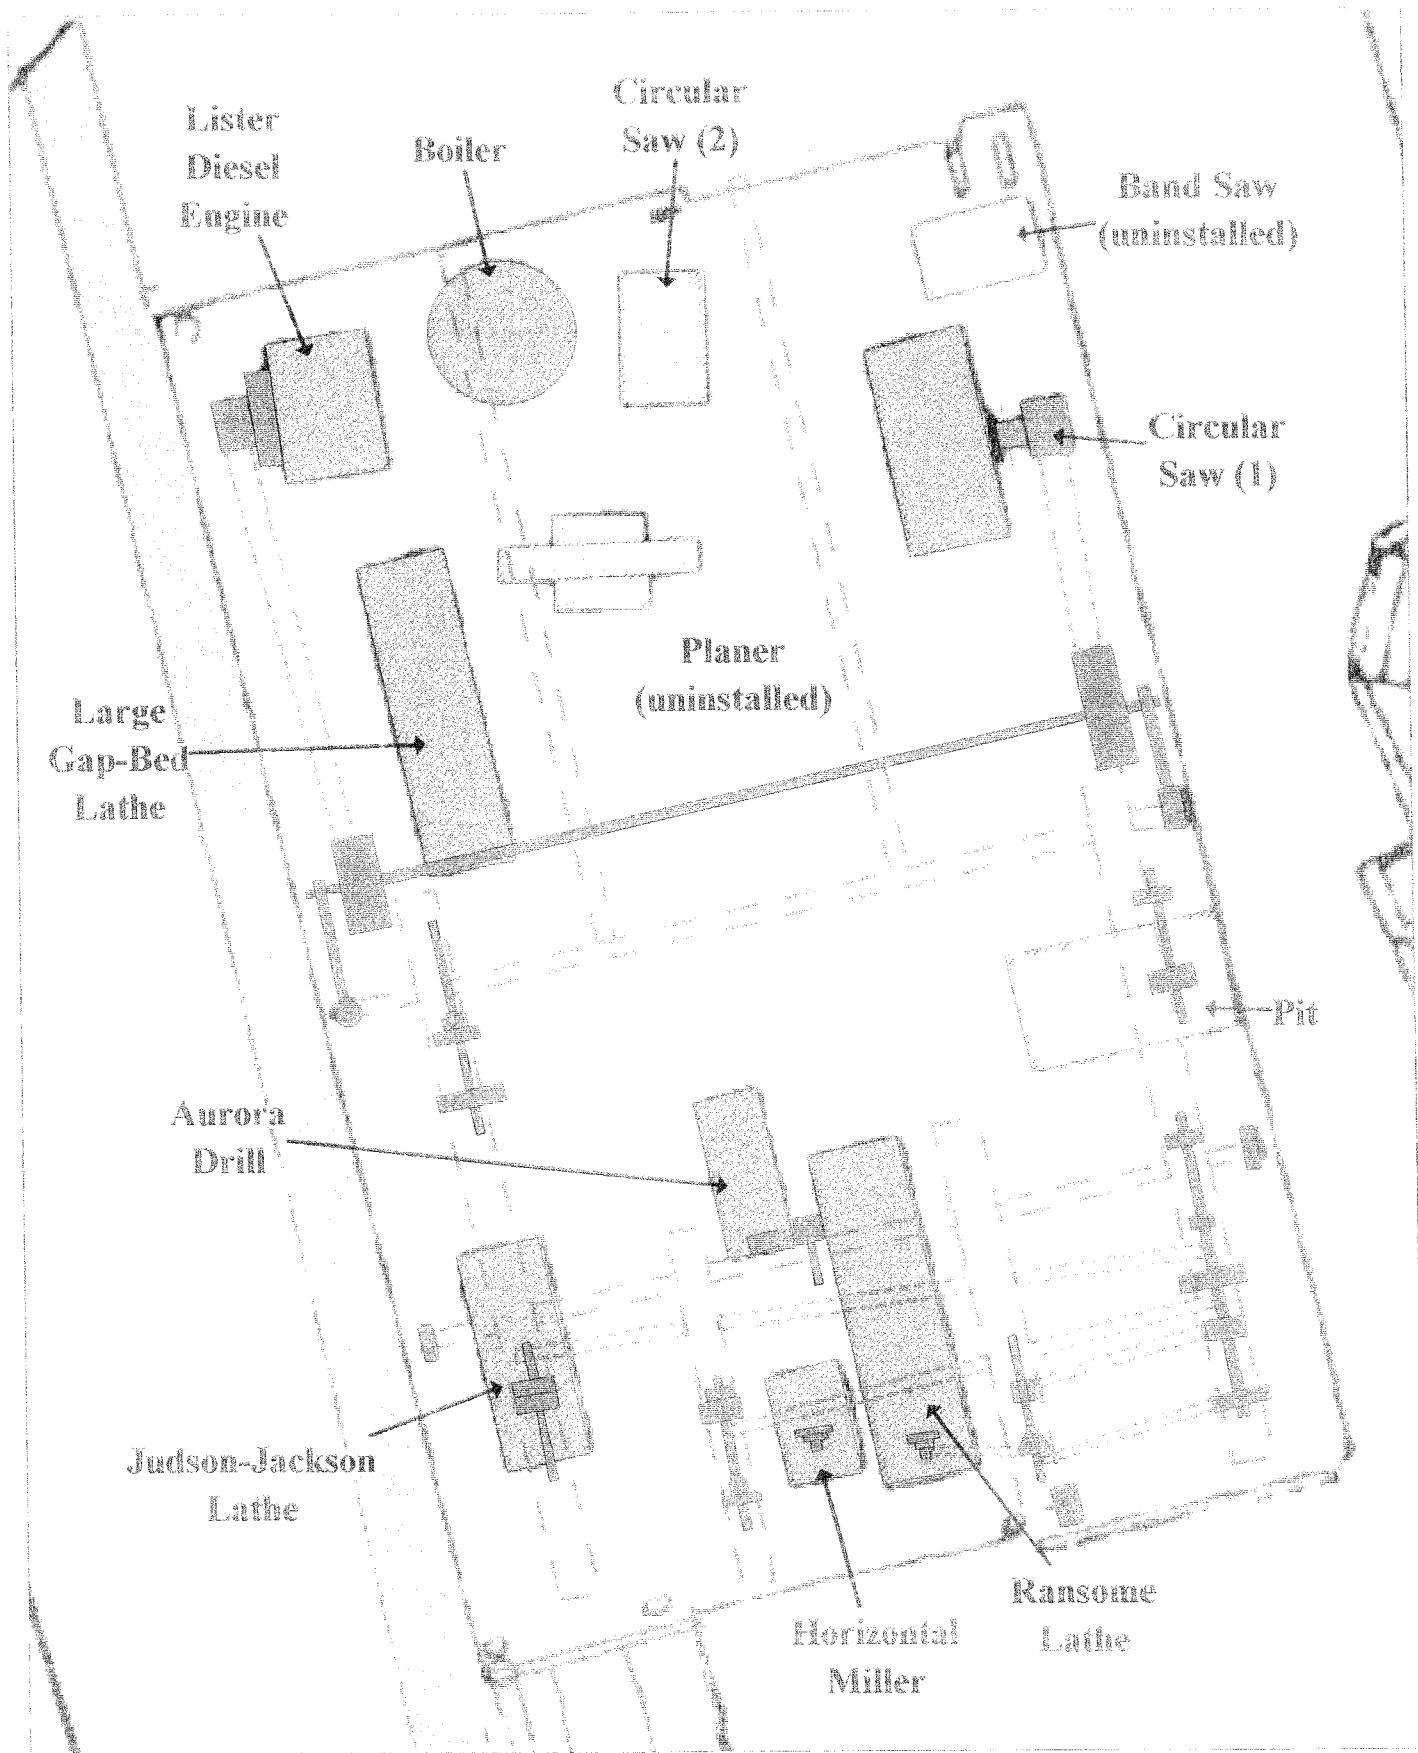
Figure 7: The Machine Shop (E), Machine Layout and Belt Layout

Structure E was also constructed using reclaimed materials and clad in corrugated-iron sheets. The framing was substantial, enabling it to support a power-boom assembly. Re-used roof trusses were placed centrally and at the north and south gables. The trusses were of king-post design, with a strut either side of the central post, and a central ridge piece. The timber frame was bolted to the floor. The average scantling of the posts was 10 inches by 3 inches.

The east elevation had two short, rectangular windows, a six-pane window to the south and an eight-pane window at the north, both located directly beneath the eaves. The southern elevation contained a single doorway into the Paint Store, but the main access to the Machine Shop was via a double-sliding door that took up the west half of this wall. The north wall had a similar-sized doorway with a large hinged door. The build of the west wall was a continuation of the ironstone boundary wall.

Several machines dominated the interior layout of Structure E. The layout of the machines was determined by the arrangement of the lay-shaft assemblies that powered them (Fig.7). There were two sources of power. In the north-west corner of the machine shop was a single cylinder Lister Diesel Engine that dated to the mid-1930s, and was reputedly the only new piece of equipment ever bought by the Tooley's (Barry Morse pers comm. Plate IX). The diesel engine drove a lay-shaft running the width of the building, attached to the posts of the central truss by two hinges, and supported in the centre of the room by hinges hanging from two longitudinal timbers, which connected the central and northern roof trusses. When the survey was carried out this lay-shaft drove a single machine, the circular saw located in the north-east corner of Machine Shop (Fig.8).

The rest of the machines were powered from the other main drive lay-shaft, which ran on a north-south axis. An electric motor powered this assembly that was located directly above the door in the south-west corner of the Machine Shop. The assembly was connected to four machines located in the southern half of the room; the medium sized 'Ransome Lathe'; the large floor mounted 'Aurora Drill'; the 'Horizontal Miller' and the small 'Judson-Jackson Lathe'. Each machine had an associated fast/loose shaft, except the drill which has a single drive located above the machine. Belts ran from the drive shafts to the main lay-shaft.

Against the west wall was a large 'Gap-Bed Lathe', and opposite, on the eastern wall was a mounting adjacent to a saw-pit for a reciprocating saw. Both these machines were positioned perpendicular to the diesel engine lay-shaft, but there were no mechanisms to utilise this power source.

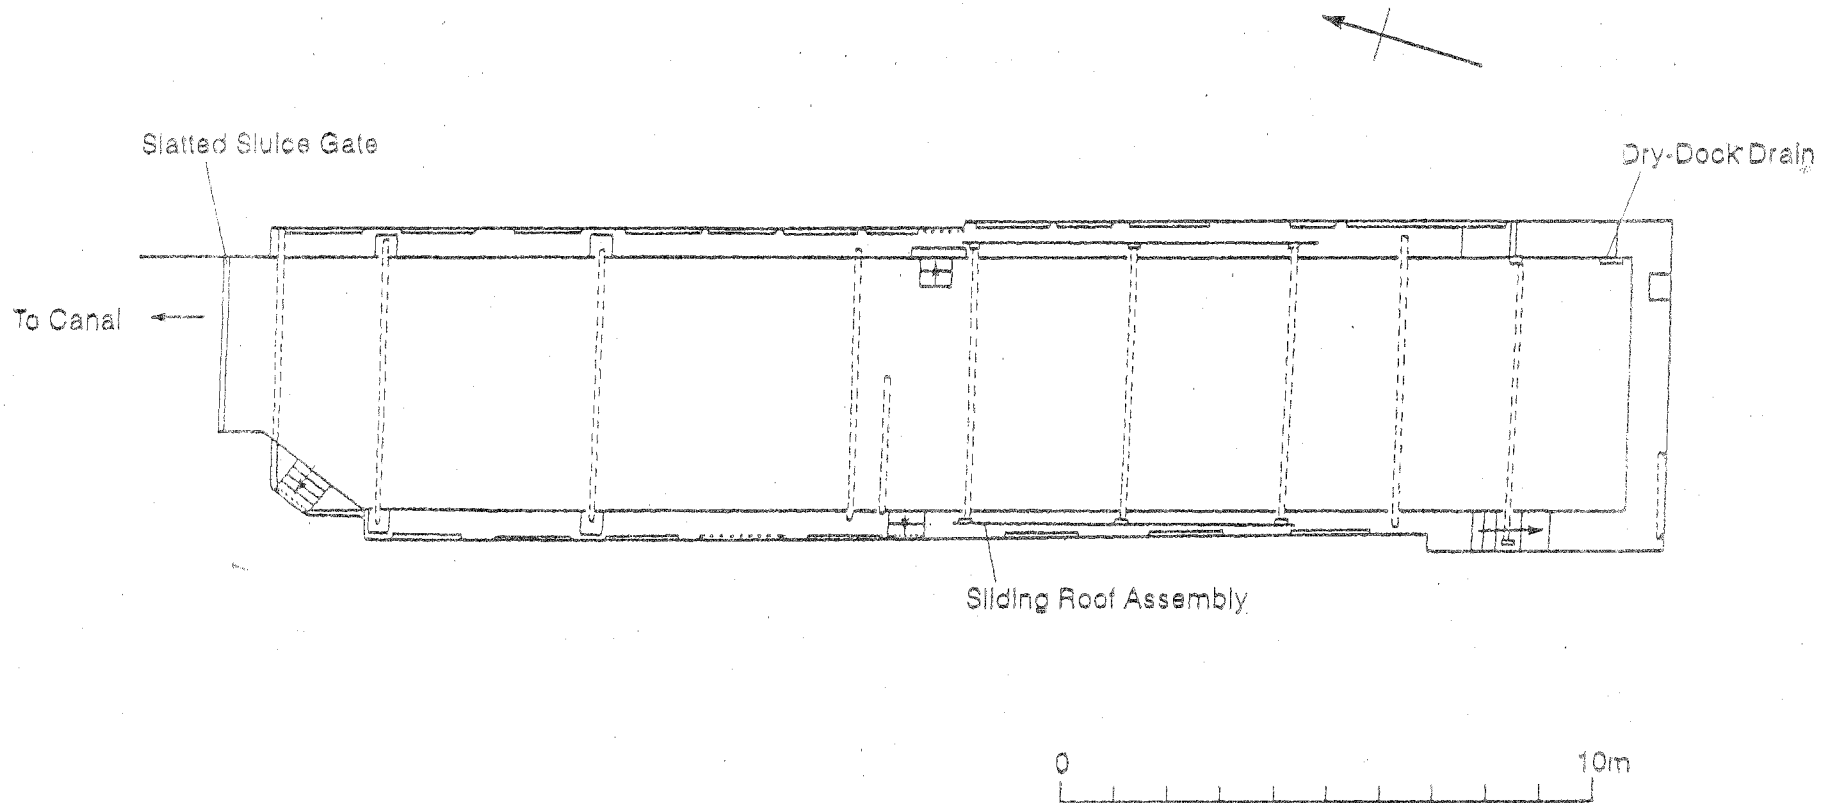
Figure 9: The Dry Dock (F)

Structure F, the Dry Dock consisted of an 86 feet long, and 16½ feet wide dry dock, with a depth varying from 4' to 4'6". Three planks at the northern end formed a cofferdam. Tooley's originally had a four-plank coffer dam, which Barry Morse had subsequently replaced. The top plank was removed in order to fill the dock with water from the canal. The dock had a concrete base that covered the remains of a brick paved floor (Plate XVIII). Barry Morse replaced an earlier mud floor in the 1990s. Along the side of the dry-dock two drainage channels carried away water that had leaked from the cofferdam. An iron sluice in the south-east corner allowed the water to drain under the canal and into the River Cherwell (Plate XVII). The culvert was constructed in elm that survives well when waterlogged, making an ideal construction material. However, it had been recently lined with a plastic pipe after dredging of the canal caused the elm culvert to become fractured. The sides of the dock were brick lined. The dock was extensively refurbished in the 1980s, when the brickwork at its southern end was entirely rebuilt.
