Historic Building Record:
Nash Works
Belbroughton
Worcestershire
(NGR 391874, 277183)

Planning Application Ref. B/11/1089

Souterrain Project SOU13-302

February 2014

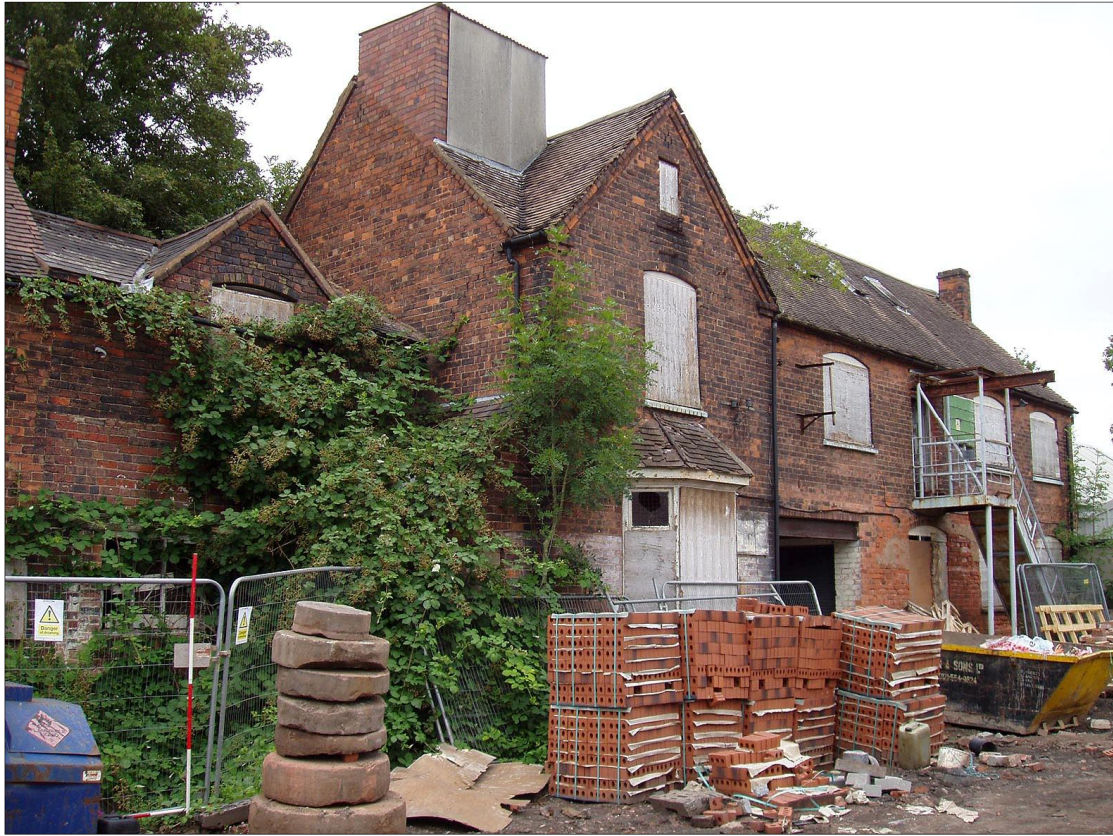
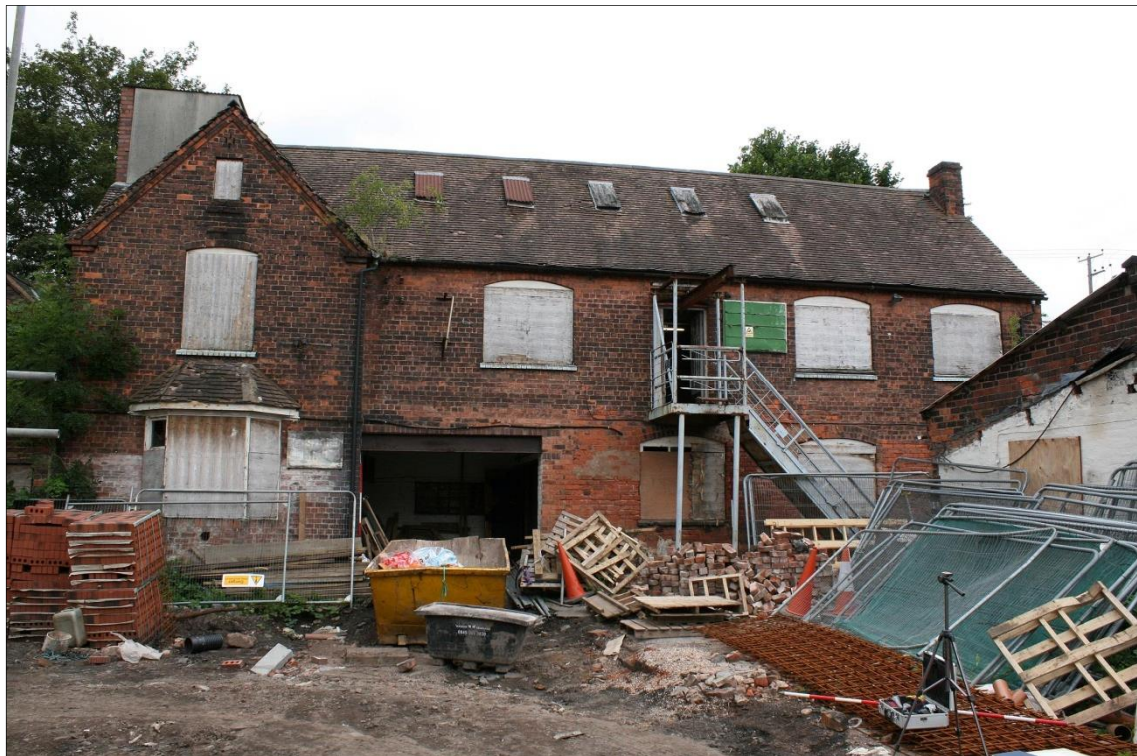
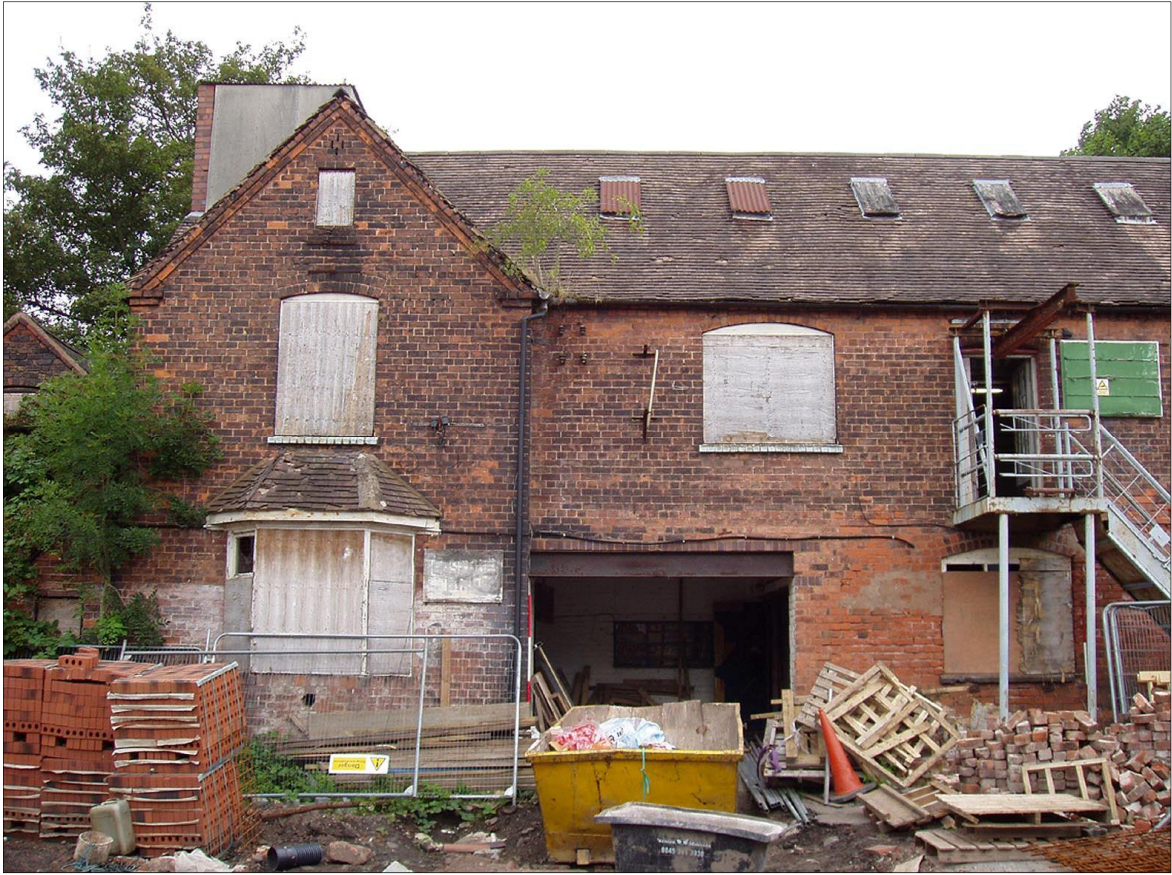
- 5.2 This is a rectangular two-storey brick-built structure with attic store (Fig.2; **1-3**). It measures approximately 13.42m by 6.62m, with its long axis aligned NE/SW. The external brickwork of Building A is English Garden Wall Bond (EGWB), comprised of three stretcher courses to every header course (3/1) (**1-5**). The brick dimensions are generally 0.24m x 0.08m x 0.11m. The roof is slated and has five simple rectangular casement roof-lights on its SE side. At the time of the survey these were concealed by protective metal sheeting. There is a chimney breast in the centre of the NE end wall, with a low stretcher-built stack (**5**). At the SW end of Building A, the upper part of a brick lift shaft protrudes from the SE side of the roof (**1-2**); a 20th century addition in Old English Bond (OEB). Views of the exterior of the NE end of Building A are obscured by neighbouring properties (**5**). The brickwork of the rear wall (i.e. NW) is EGWB; eaves-down there are thirteen courses at 3/1, and thereafter 4/1.

- 5.4 The main entrance to Building A is via a loading bay (Room 1) (**1-3**). A door in the SW wall leads to the administrative and services area (Rooms 3-6), whilst facing door in the NE wall provides the sole access to a ground floor workshop (Room 2).

- 5.5 The office area is fronted by a gabled structure (**1-3**), the ground floor of which (Room 3) has a bay window, while the first floor (Room 5) has a vertical single-mullioned, four-pane single casement window. Above the window opening is a segmented arch in double rowlock.

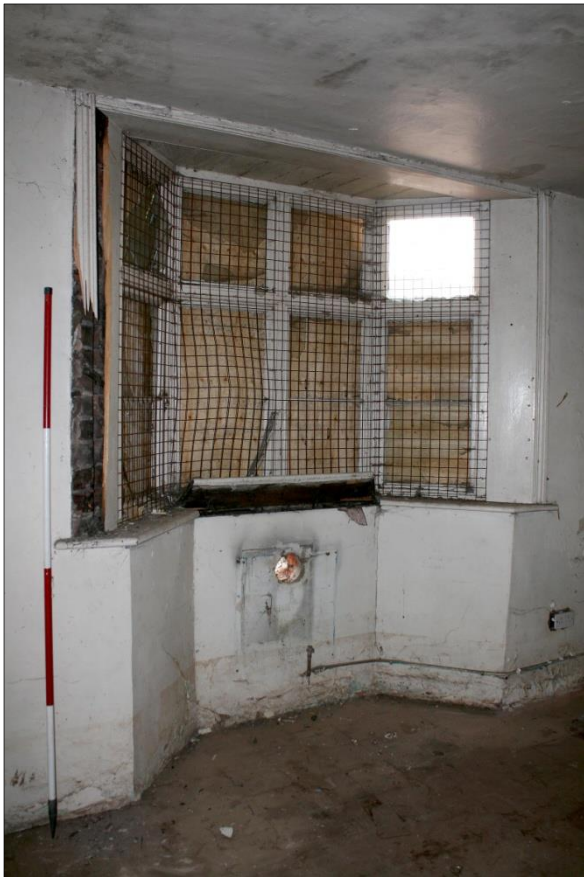
7

- 5.6 The bay-windowed room at ground level (Room 3) is rectangular and featureless, with rendered walls and quarry-tiled floor (each tile 0.23m x 0.23m) (**7**). A partition wall separates the room from a back room (Room 4) which has no natural light, but which serves as a thoroughfare between the loading bay and Building B (Room 10) and as access to the upper floors. There is a blocked staircase in the NW corner of the rear room (Room 4) that led to the first floor (**8**).

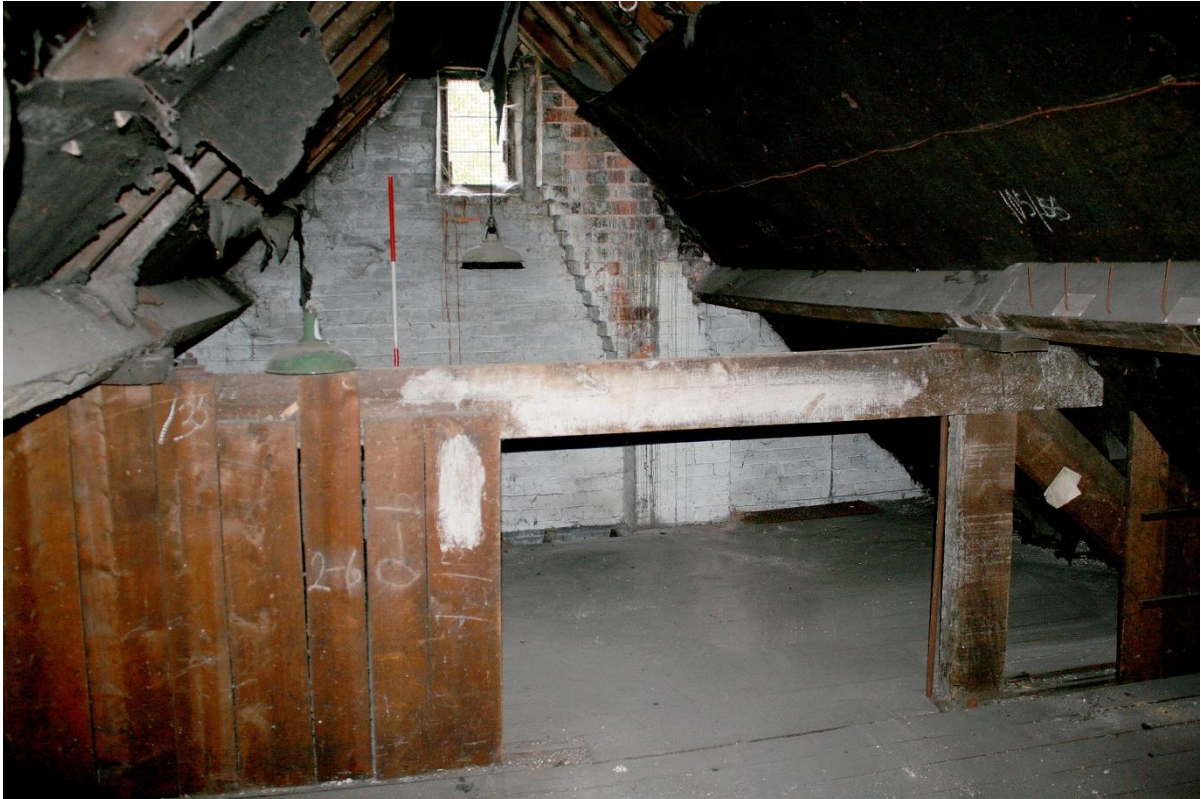
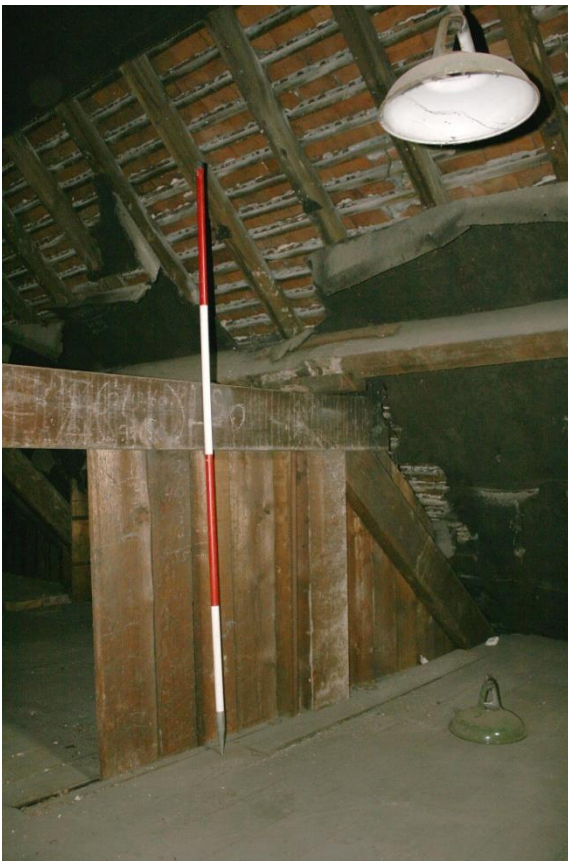
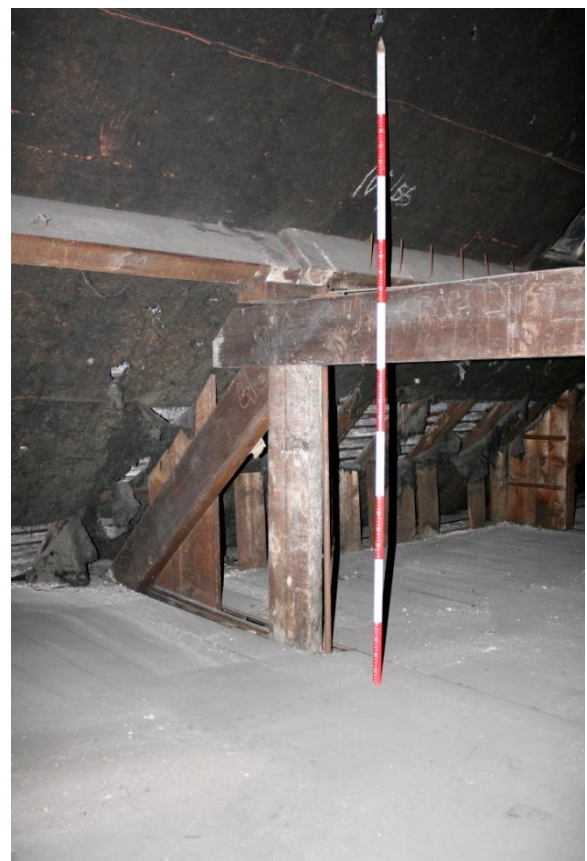
- 5.12 At the NE end of the attic, the first truss is a queen post type (**15-17**). The truss has been partly panelled to form partition between the 1st and 2nd bay (**15**). The main purlins on either side of the building are joined at the division of 1st and 2nd bay, the NW side held by an iron brace (**18**). The chimney breast is visible in the NE wall of the 1st bay (**15** and **19**).

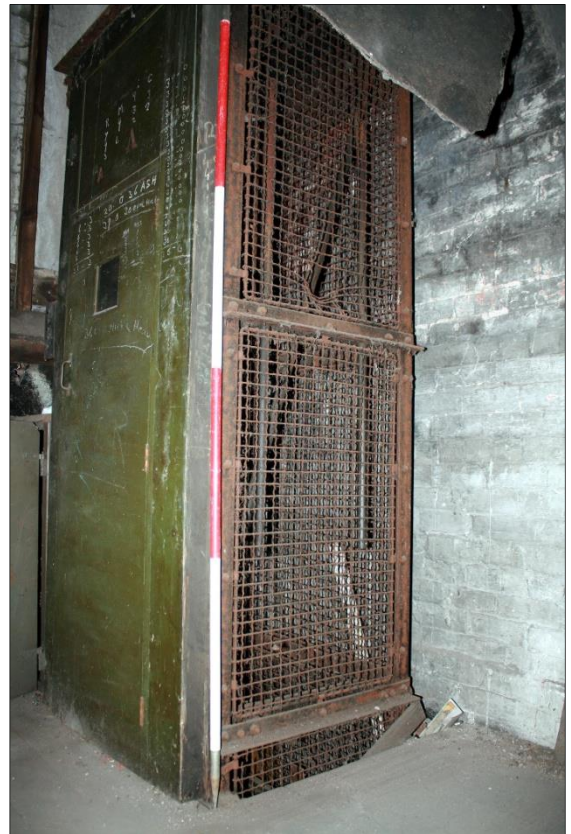
20

- 5.14 At the SW end of the roof space (5th bay) there is a landing bay for a cage lift which is located in the SE corner (**20**). The lift and operating mechanism remain intact.

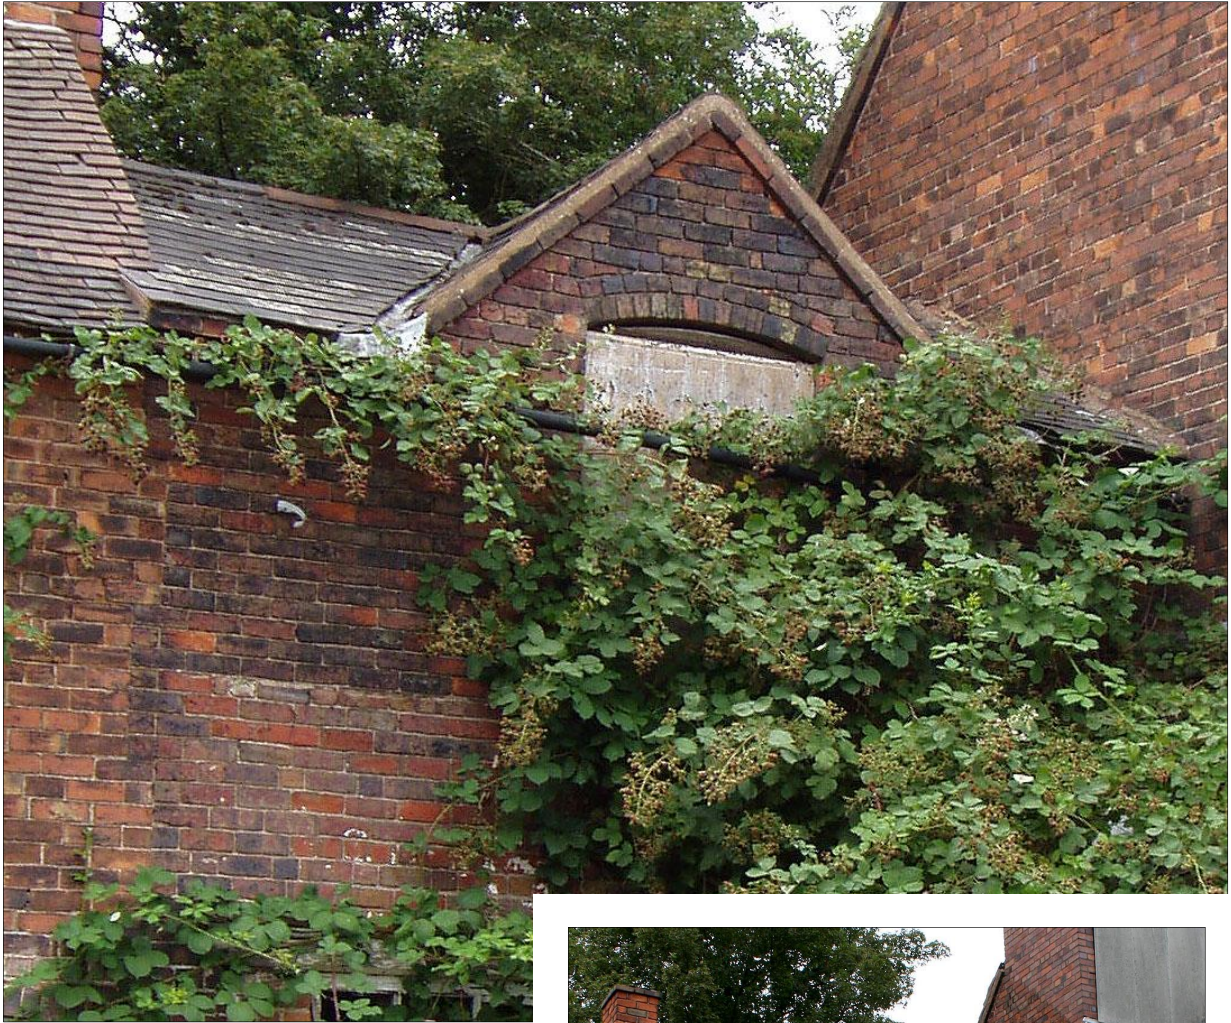
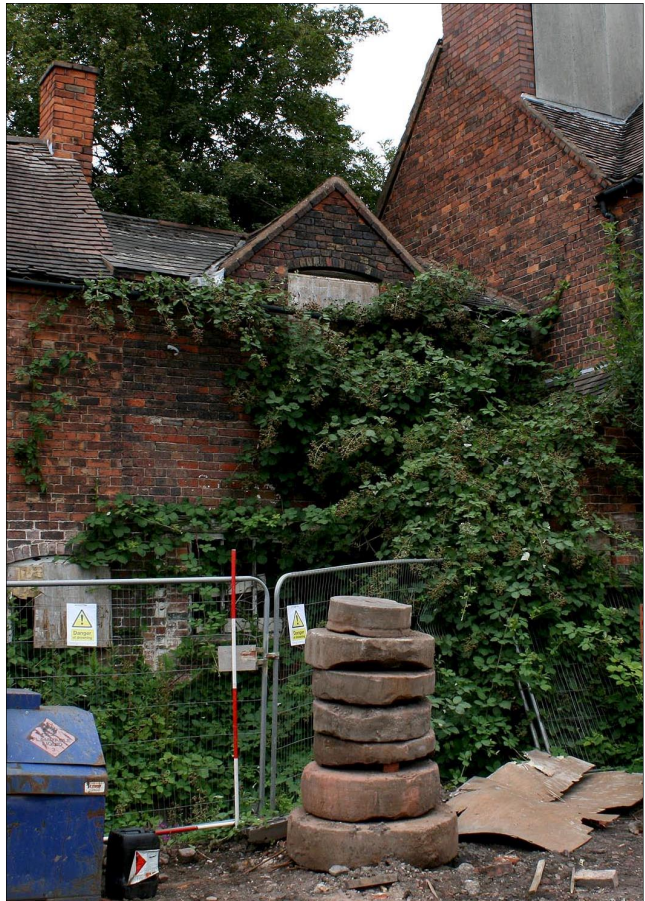
- 5.15 Adjoining the SW end of Building A is a two-story rectangular brick building with SE-facing gabled roof (Fig. 3; **21-22**). It was evidently not intended to match the design of Building A. Unlike the first phase, Building B is constructed of Flemish Stretcher Bond (FSB) throughout, with three courses to every header course (3/1). The bricks of the façade differ greatly from Building A (and Building C), having been 'reduced' during firing process. The result is a moreover darker red, but includes a quantity of blue-grey bricks, largely with vitrified faces (**21**). There is a three-course stepped and cogged eave, which is also present at the rear (**23**). It is probable that this decorative feature originally continued around the SW wall of the building. The roof is slated.

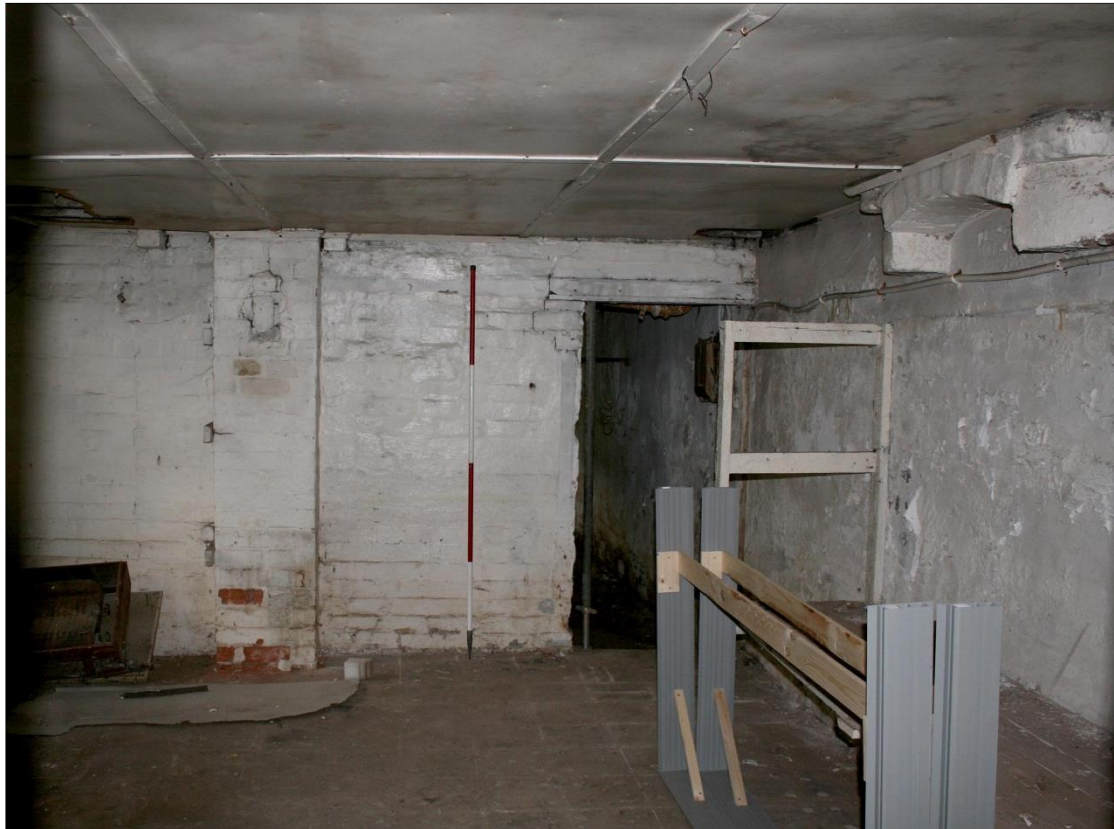
27

- 5.17 The ground floor of Building B consists of a single rectangular room, 5.02m by 4.08m (Room 10). It is lit by a five-mullioned twenty pane casement window, which has a horizontal lintel. The interior has a quarry-tiled floor (27), each tile measuring 0.29m x 0.29m. Tiles are missing from the central area, exposing an earlier floor of un-mortared bricks. In the upper NW wall there is a projecting segmented arch of brick between stone imposts (also projecting), with an internal width of c.0.72m (28). Although this appeared to be the upper portion of a doorway or a window there was no further evidence to confirm its function. At the rear (i.e. exterior) of the building only one of the sandstone imposts was visible, about 0.05m above ground level (29), but there is no evidence of the arch. In the centre of the SW wall is a chimney breast, the fireplace now concealed behind a later pillar (27).

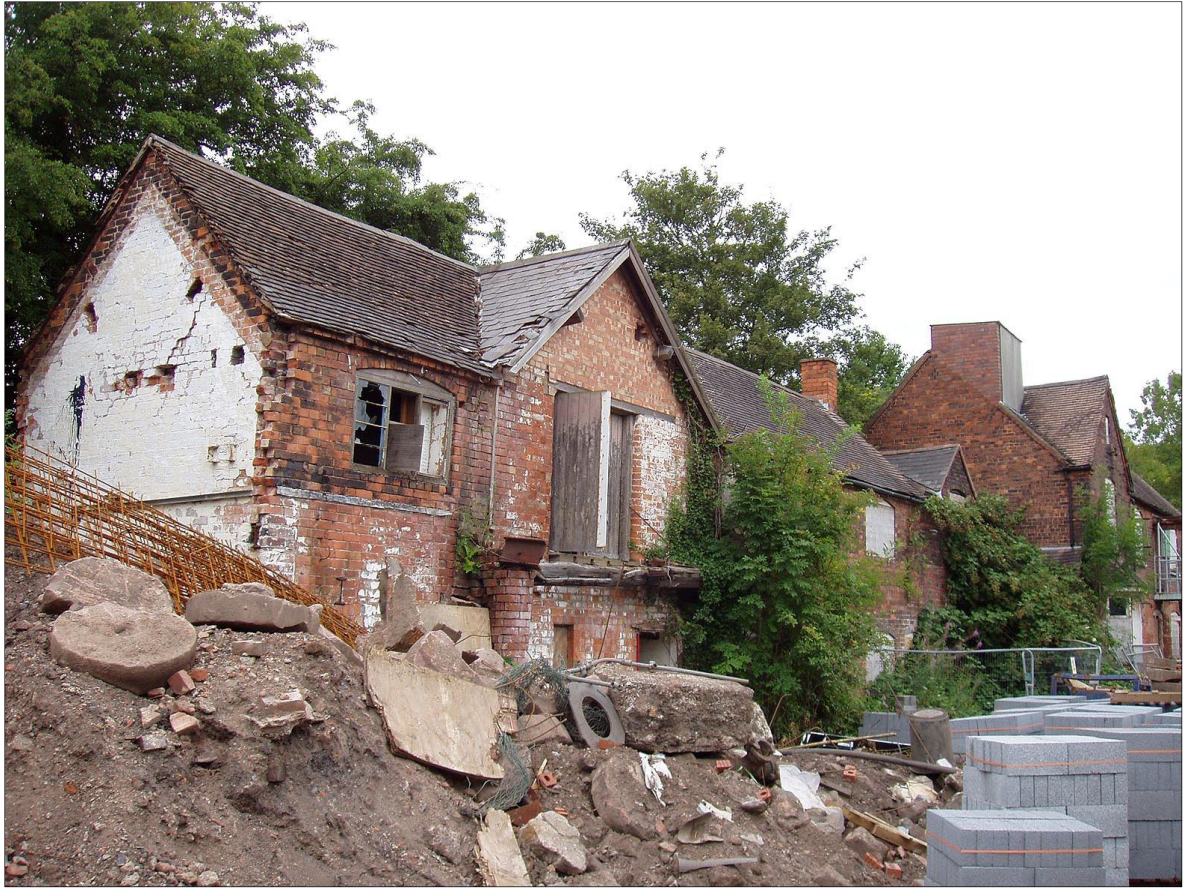
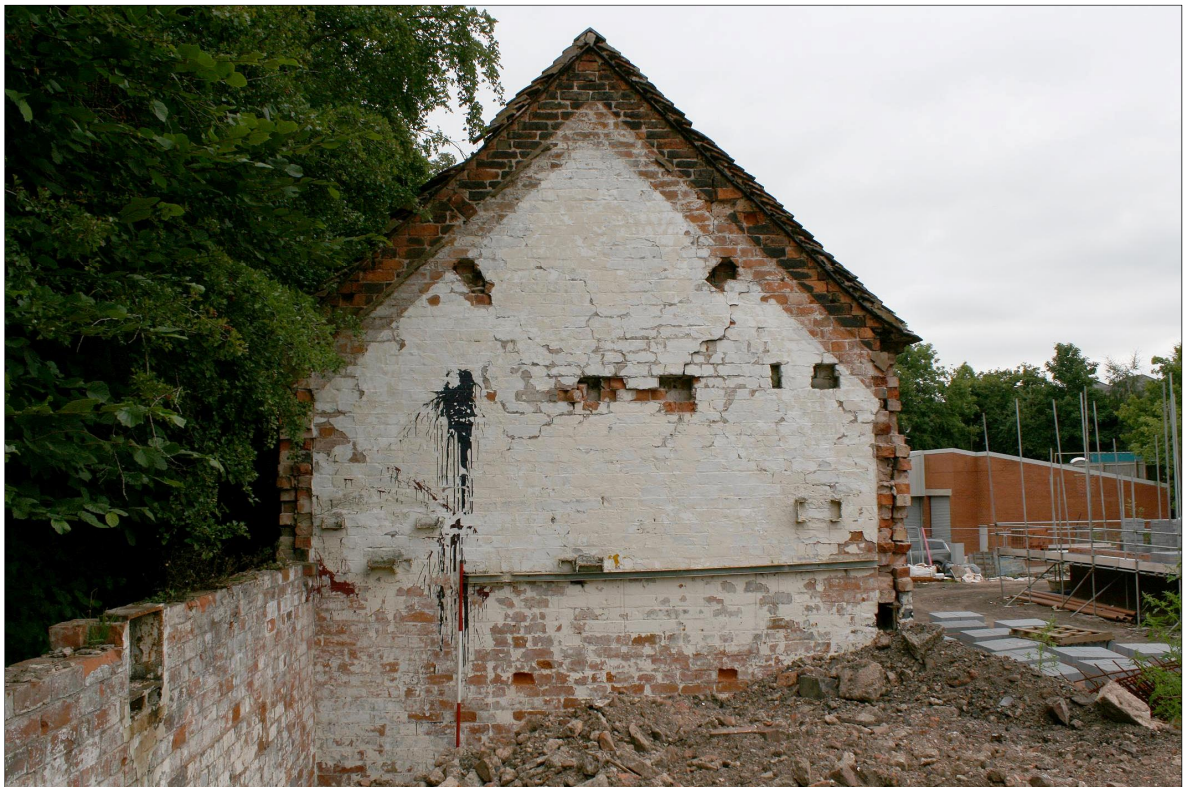
- 5.21 This is a two-storey building of 5 bays (Fig.2). An extension to the SW has recently been demolished exposing the gable end (30-31). The 4th bay (NE to SW) has a SE-facing gable with first floor loading bay (30 and 32). The building is presumed to have comprised a lower workshop (Room 12) and an upper storage area/workshop (Room 14). Each level is lit by four double-mullioned twelve-pane casement windows, three of which are on the NE side of the gabled loading bay (i.e. bays 1 to 3), the other in the 5th bay (Fig.3). Each of the window openings has a segmented arch composed of a single course of rowlock (32-35).
- 5.22 Apart from the gable, the brickwork of Building C is FSB, 3/1, except below the level of the ground floor window sills where it is FSB 5/1. Below the upper window openings there is a band

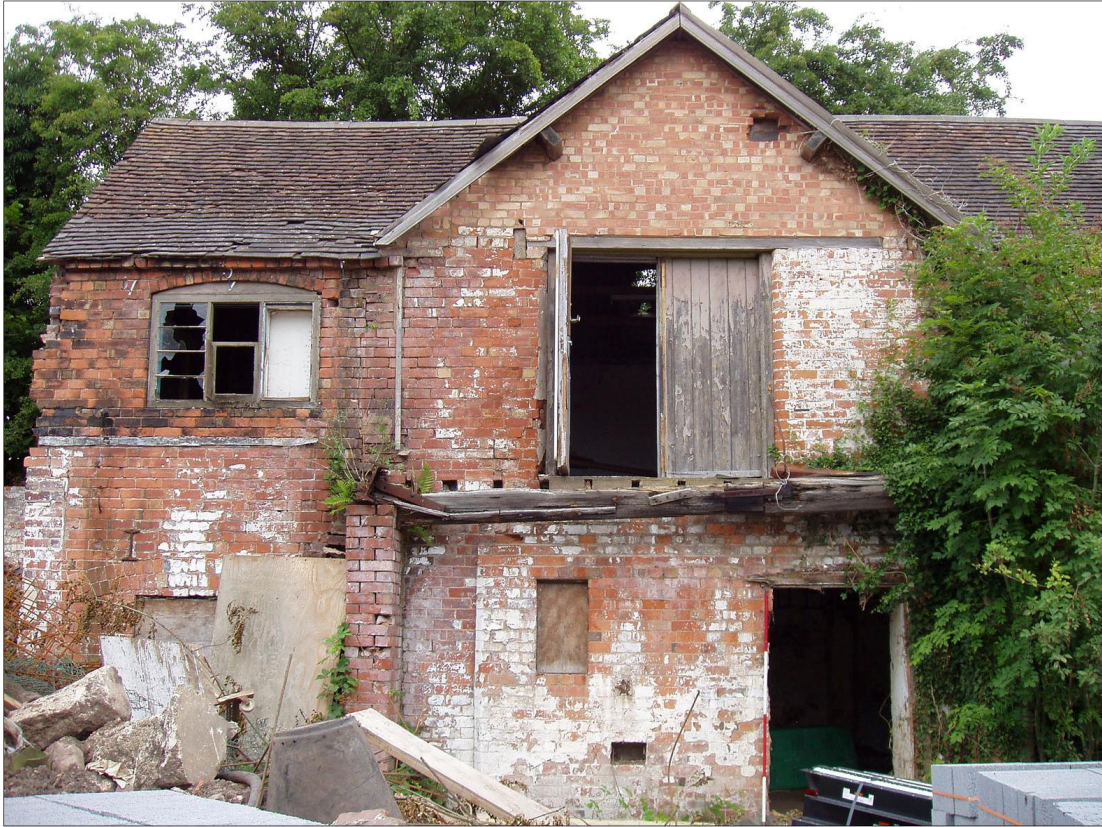
32

of headers which runs the length of the building. Beneath the overhanging eaves there is a band of stepped headers (32).

- 5.23 The gable (32) appears to have been an addition to Building C, although this could not be confirmed due to limited visibility and access. Unlike the rest of the building, the gable is built in a combination of English Bond (EB; the ground floor) and EGWB, 3/1, (the first floor loading bay). The infill of the upper gable is composed of modern bricks with kiln stacking marks, in a stretcher bond. These are separated by a single row of headers below the purlins. The rear of Building C is featureless (25). It is composed of FSB (3/1) and follows the same building line as Buildings A and B.

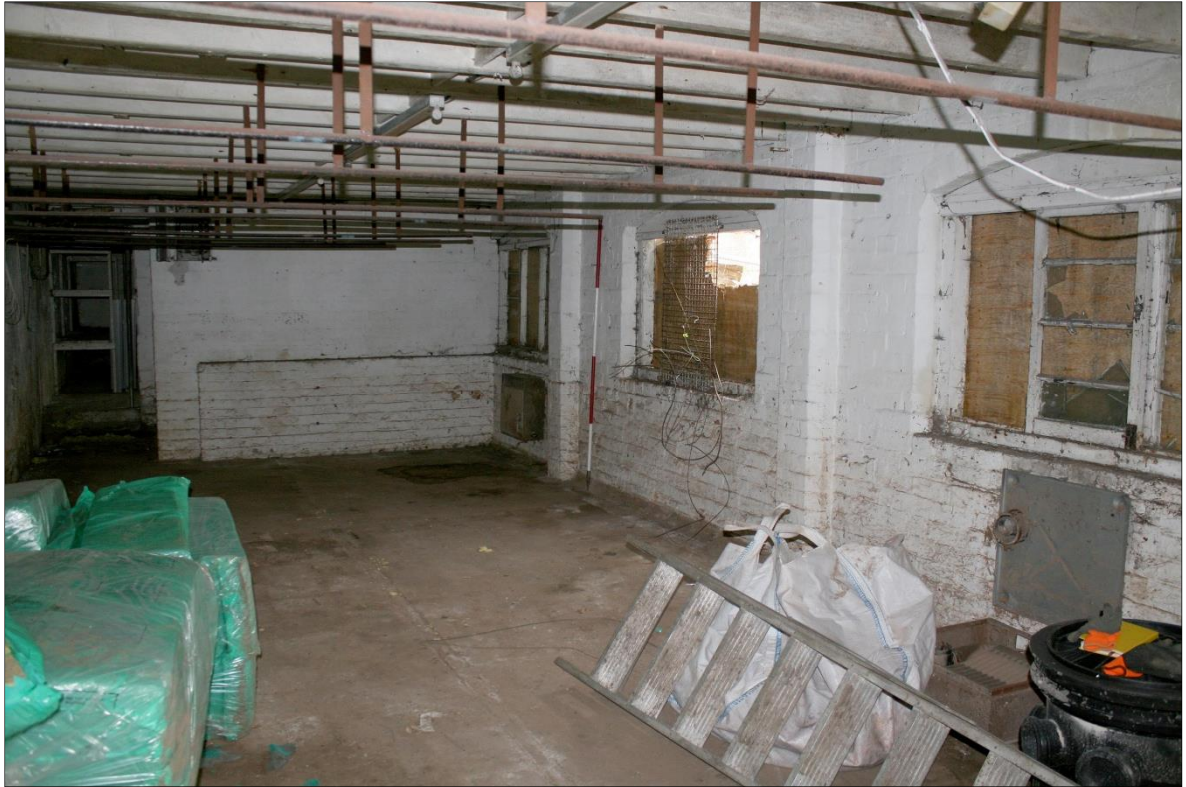
36

- 5.24 Room 12 (Fig.2) on the ground floor (36) has a quarry tiled floor of regular tiles (0.3m x 0.3m) above a concrete screed. The walls are whitewashed but un-rendered. There are iron or steel (painted) ceiling joists which rest upon brick buttresses on the front and rear walls.

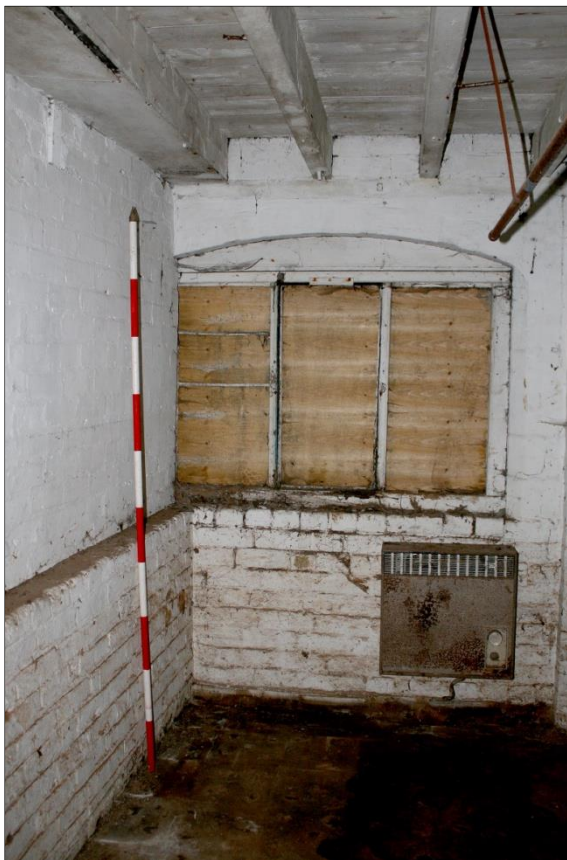
37

- 5.25 At the NE end of Building C is a small-single celled rectangular room, 2.9m by 1.3m (Room 13; 38). The access to this space is alongside the rear wall of Room 12 and across what appears to be a culvert, concealed by a sheet of steel. The floor of Room 12 has been lowered by 0.55m, cut into the sandstone bedrock. It is lit by a single rectangular window (1.05m x 0.84m), which was obscured by boards at the time of the survey. Incorporated in the NE wall of Building C (Room 13) is the rear of the chimney breast of Building B, Room 10 (38). It is probable that the sunken-floored cell was an addition/alteration to Building C, since the dividing wall intrudes upon the window frame of the 1st bay in Room 12 (37).

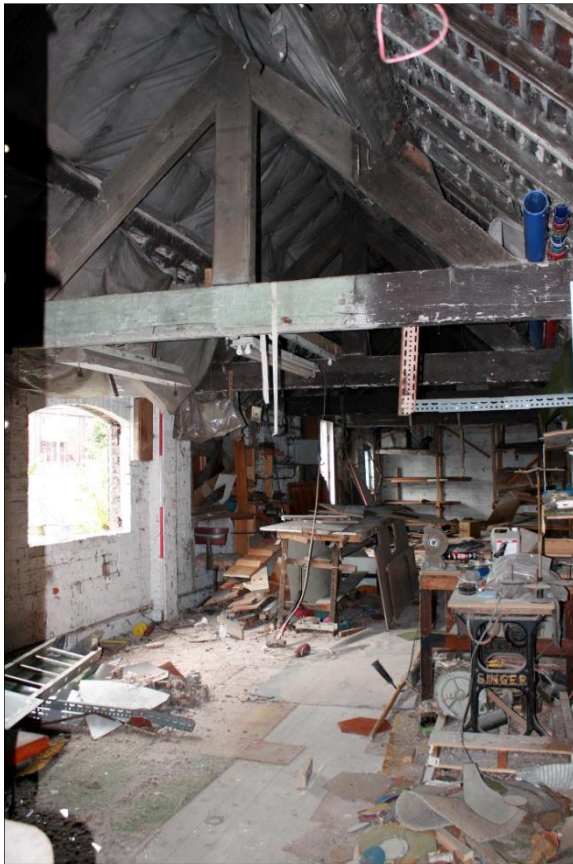
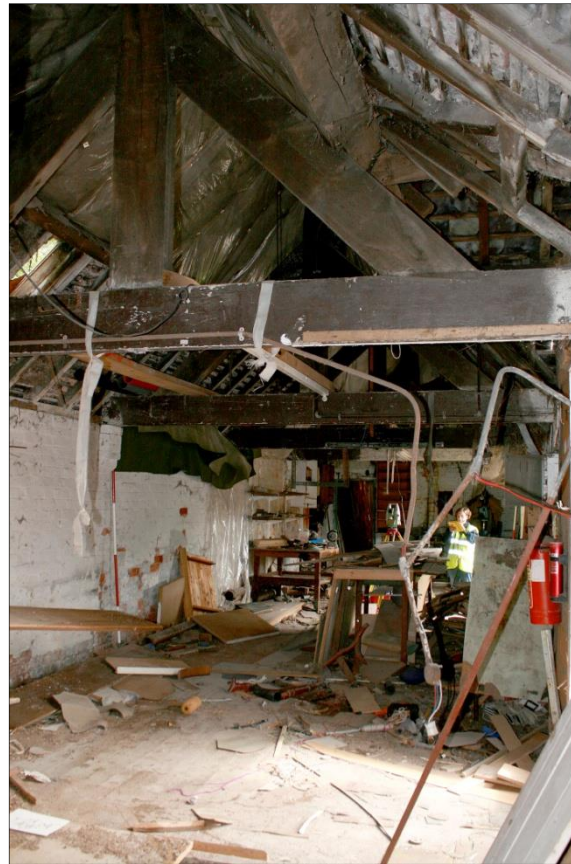
- 5.26 At the time of survey the first floor (Room 14) contained a number of fixtures, fittings and clutter from its most recent usage as a carpet/textiles manufactory (39-40). This included several 'Singer' sewing machines. There was little visible of the original structure. There are four roof trusses, all king post (39-42). The first and second truss (numbered NE to SW) are supported by brick pillar-buttresses on the front wall (44), while the third and fourth truss are supported by brick corbels on both front and rear wall (42, 43, 46, 47). In the NE wall a chimney breast was partly visible with a segmented arch behind it on either side (48) which was probably a part of the buttressing of the chimney, although there was too little of this wall visible to examine in detail (the other side of this wall, in Room 11 was also obscured).
