THE BREWHOUSE

ARCHAEOLOGICAL
INVESTIGATIONS

NATIONAL TRUST
SEATON DELAVAL HALL
NORTHUMBERLAND

NAA 20/92
April 2021

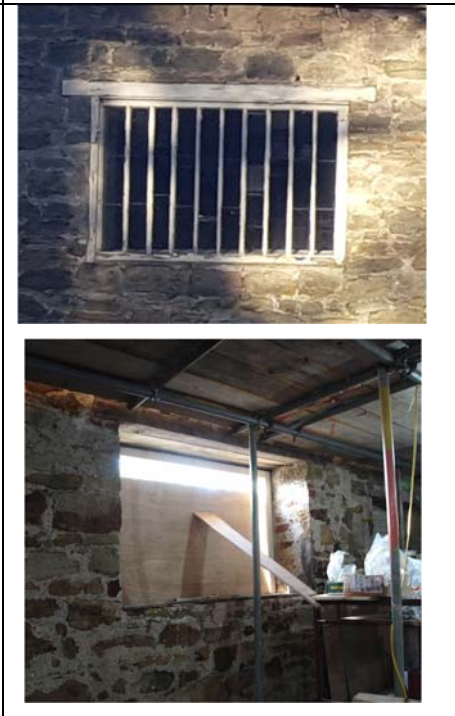
2	G1	Large window at the north end of the west-facing elevation. Similar in design to the carriage door and features in the cartshed ie. vertical glazing bars with timber lintel and cill. No indication of set surrounds, and proximity to ventilation slits suggest this was a much later addition. Unlikely the byre at this end would have originally included windows. Squared reveal without splay, supporting the interpretation of this as a later addition. No evidence of an earlier setting	Late 19th or 20th century?	Lintel replaced (modern not retained). Window casing repaired.

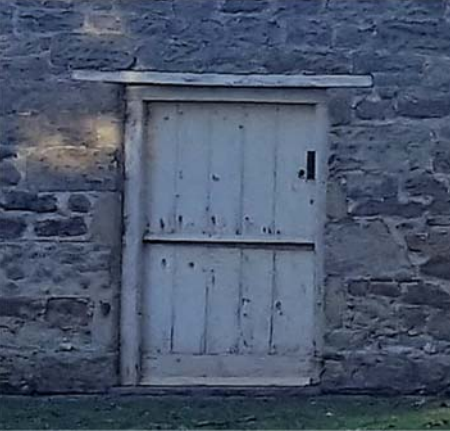
3	G1	<p>Door at northern end of west-facing elevation. One of two doors, set opposite each other, at this end of the building. Alternating long and short stone surround suggests this is original. Timber door and surround later. Timber lintel which like the others in building are surprisingly shallow.</p>	<p>Late 17th in origin with later door, lintel and frame (late 19th or 20th century).</p>	<p>Repaired and retained.</p>

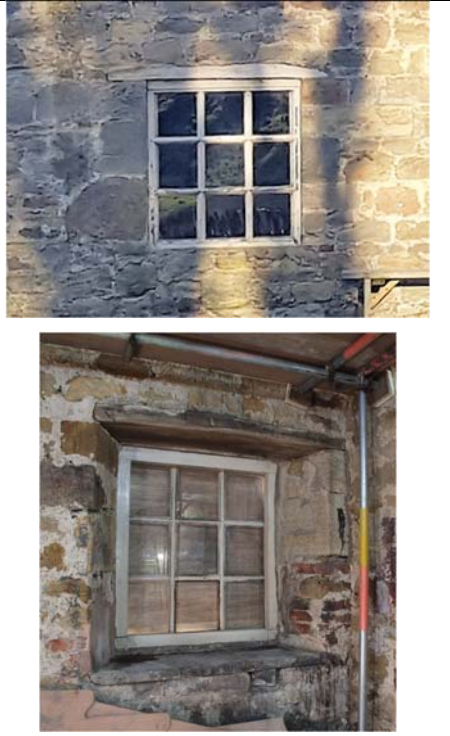
4	G2	<p>One of two windows at the southern end of the brewhouse. Set with alternating stone surround and shaped timber lintel (original). Three-over-three fixed pane window with timber frame. Evidence of external shuttering in the form of two metal cleats on each side. Indicates domestic use. Interior splayed and set with oak board cill. Plain sandstone reveal with some evidence of plaster or render.</p>	<p>Late 17th in origin. Frame and lintel likely to have been replaced but are early; possibly early 19th century.</p>	<p>Frame repaired, timber lintel retained.</p>

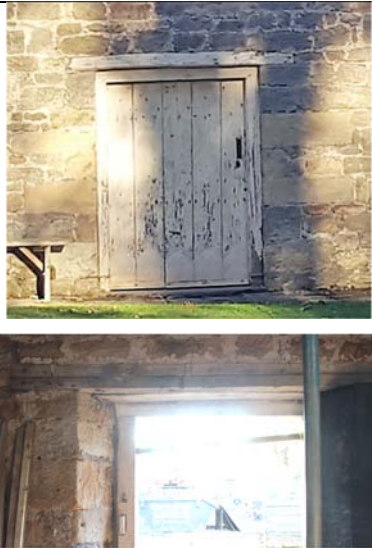
5	G2	<p>Door at south end of west-facing elevations. Set with alternating stone surround and very similar in style to door 3, although with a splayed interior. Panelled door with latch. Timber lintel and doorframe.</p>	<p>Opening 17th century in origin with later door late (19th or 20th century). Frame and lintel likely to have been replaced, date uncertain.</p>	<p>Light touch repairs. Lintel retained.</p>

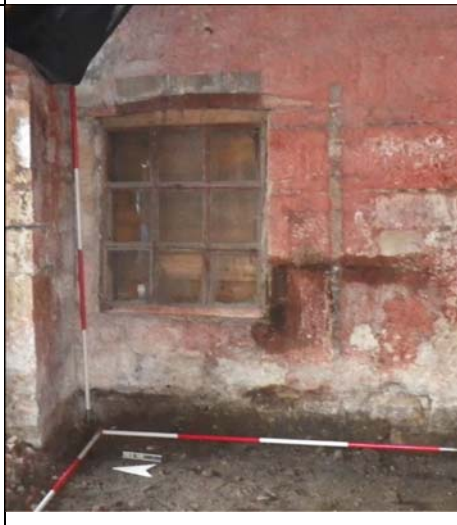
6	G2	<p>Second of the two windows flanking the doorway at the southern end of the west-facing elevation. Window originally looked out into the brewhouse yard but later obscured by 19th-century cartshed. The same design as window 4. Interior splayed and window previously blocked with timber plank panelling.</p>	<p>17th century in origin. Frame and lintel probably replaced but clearly pre-cartshed (1841). This helps to date other elements of this style.</p>	<p>Light touch repairs. Lintel retained.</p>

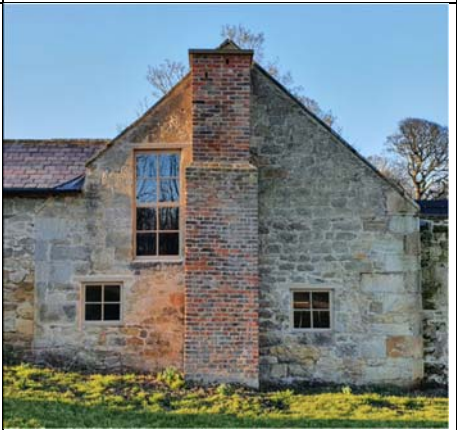
7	G2	Doorway to upper storey of the brewhouse converted to a large eight-over-two fixed-pane window, measuring c. 2m high. Surround is set with alternating long and short quoins and a stone threshold. External timber lintel modern but internal feature appears original and the same as windows 4 and 6.	18th century doorway added as part of brewhouse conversion. Date of current glazing uncertain, likely 19th century.	External timber lintel and wood cill replaced. Relatively modern and of negligible evidential significance. Internal lintel retained.

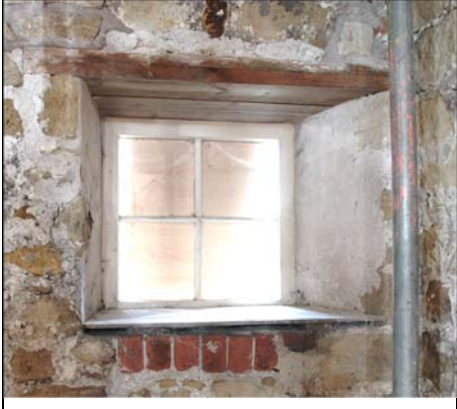
8, 9	G2	Two small two over two fixed pane windows inserted into the south gable. No evidence of a stone set surround. Interior set in a deep splay, reflecting width of the wall. Cill pine boards with evidence of graffiti. Lintels and frames quite modern.	18th century inserts. Glazing and timber elements later but of evidential significance.	Repaired with lintels retained.

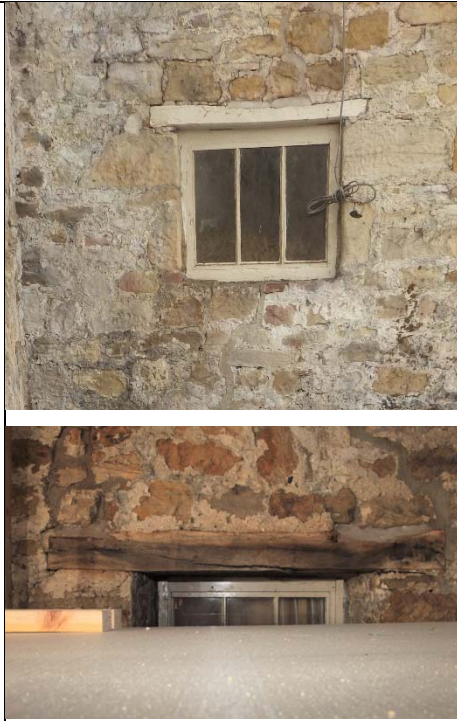
10	G2	<p>Small window at the southern end of the east-facing elevation. Set with alternating stone surround and adze cut lintel. Interestingly feature not splayed internally as are all of the other openings at this end of the building are. Suggests a later insert but quite early. Perhaps indicative of a specific function of this part of the building, maybe for food storage. Internal masonry cill with some surviving render or plaster and cill and reveal.</p>	<p>18th century (?) with later glazing and frame. Adze lintel probably original.</p>	<p>Light touch repair. Lintel retained.</p>

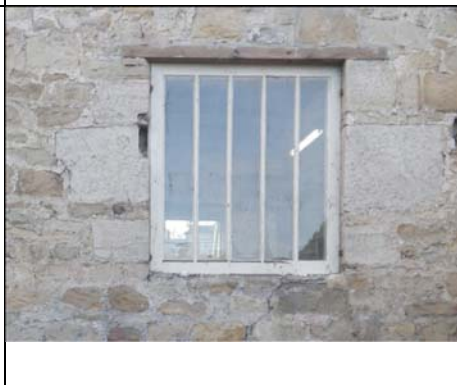
<p>Detail of internal lintel (retained).</p>
11	G2	<p>Original window at southern end of the east-facing elevation. Similar to windows 4 and 6 on the west side but with later modifications. Set with alternating stone quoins but no external cill. Both internal and external lintels are modern sawn timber. Splayed internal reveal without boarding but with stone cill. Some indication of plaster or render.</p>	<p>Late 17th century with 20th century frame and glazing. Lintel possibly earlier.</p>	<p>Fabric cleaned and retained.</p>

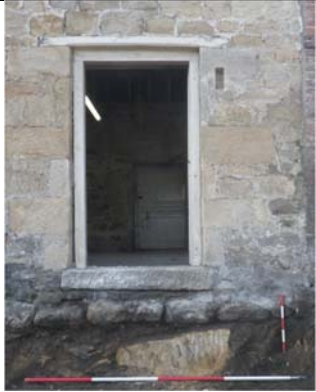
12	G1	Door at the northern end of the east-facing elevation. Set opposite door 3 but narrower in width, indicative of pedestrian rather than animal entry. Timber lintel with chamfered edge, and wooden door frame. Timber plank-panelled door. Square set reveal without splay, matching door 2.	Late 17th century opening with later door. Lintel and surround.	Repaired and fabric retained.

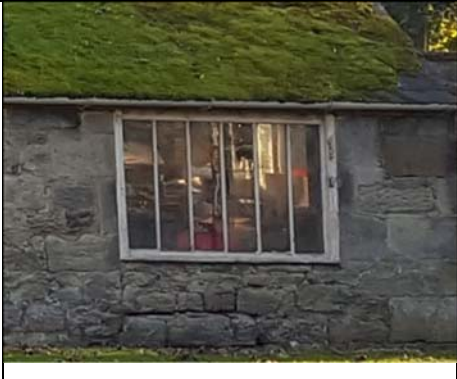
13, 14	G3	Two windows in the north-facing elevation of the cartshed, both the same in design comprising a rectangular fixed paned vertically glazed window, with six lights. These were set in an alternating stone surround but no cill. Internal timber lintel but not external, consistent with the roof being lowered slightly. Square reveal without splay.	Early 19th century (pre-1841)	Repaired and retained.

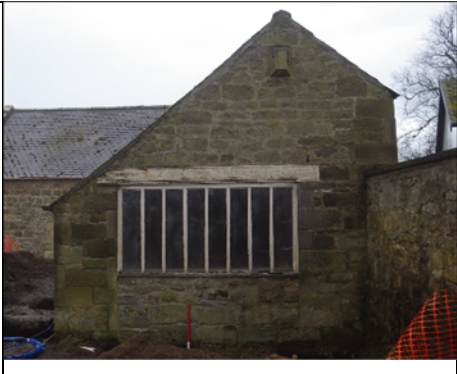
15	G3	Cart entry door in the west, gable end of the cartshed. Later converted as a window in a similar style to features 1,2,11,13, 14.	Early 19th century (pre-1841), later modified	Lintel replaced – watching brief maintained (see below).

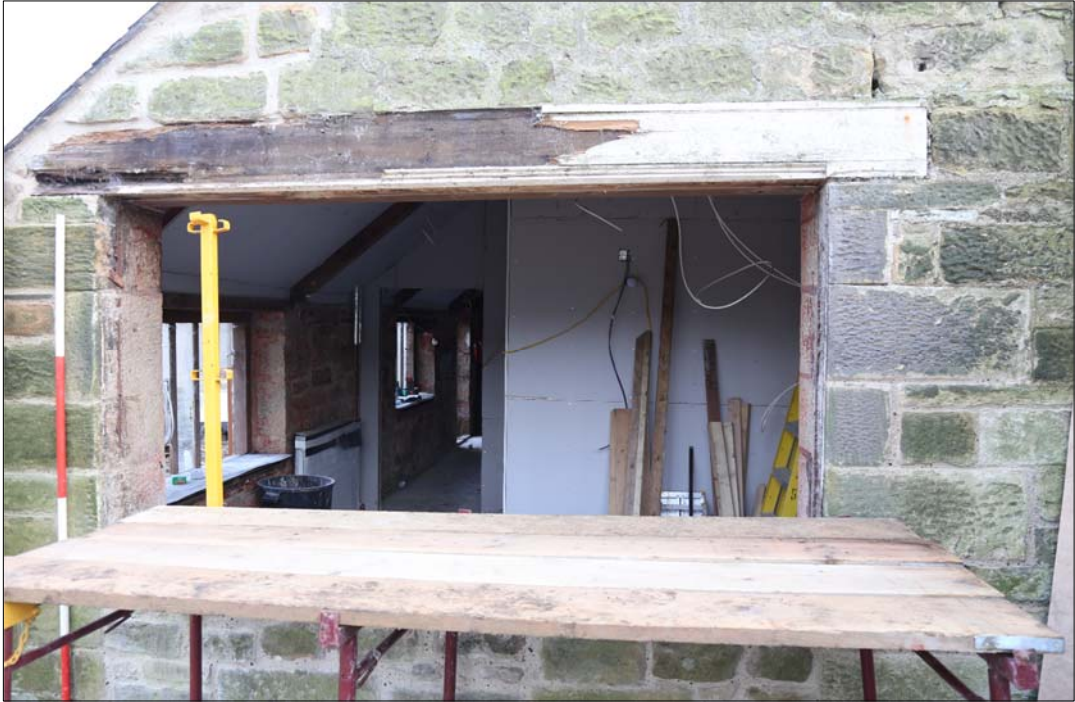
- 8.40 The unstable lintel on the west side of the cartshed (Building B; Fig. 7) was removed and replaced as part of the development. A watching brief was maintained during this work which identified evidence of various phases of strengthening and refacing of the lintel (Plates 19-22).

Plate 19: cartshed; west gable-end window lintel prior to removal.

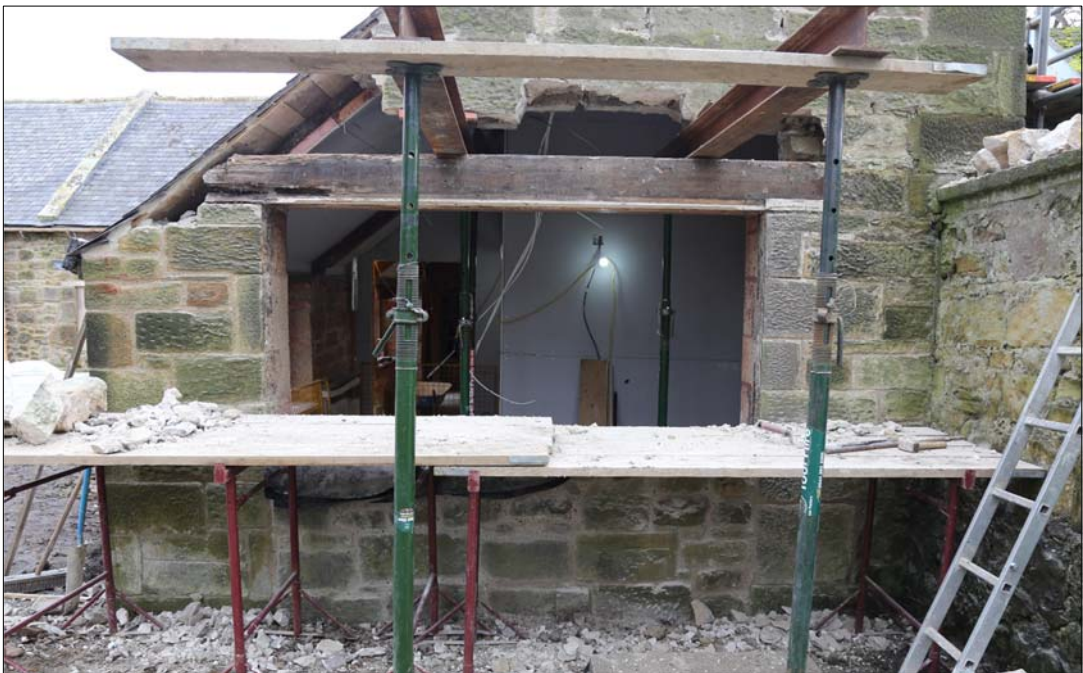
Plate 20: cartshed; west-facing gable-end window lintel during removal.

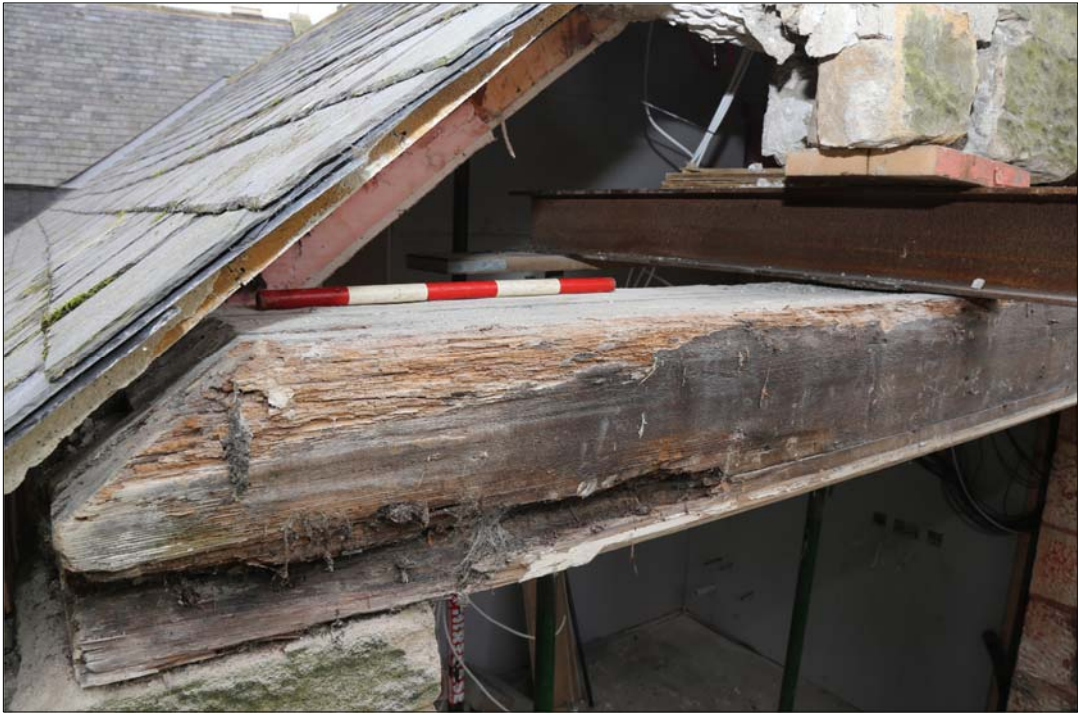
Plate 21: detail of northern end of lintel, cut to accommodate later roof line.

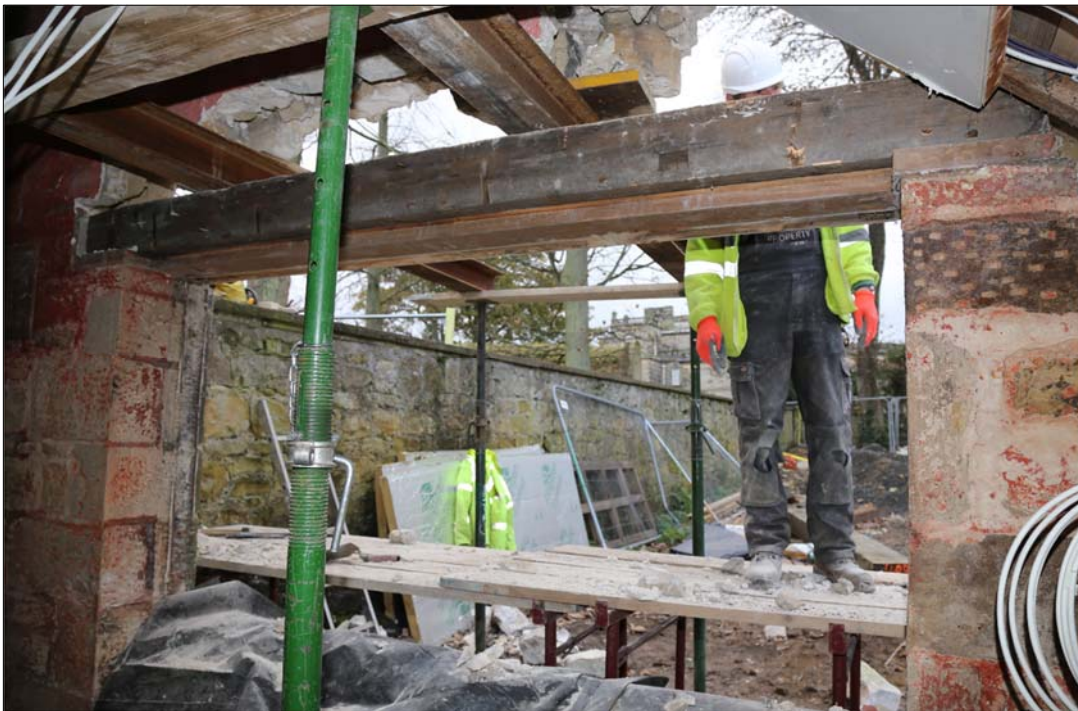
Plate 22: cartshed; east-facing view of gable-end window lintel during removal.

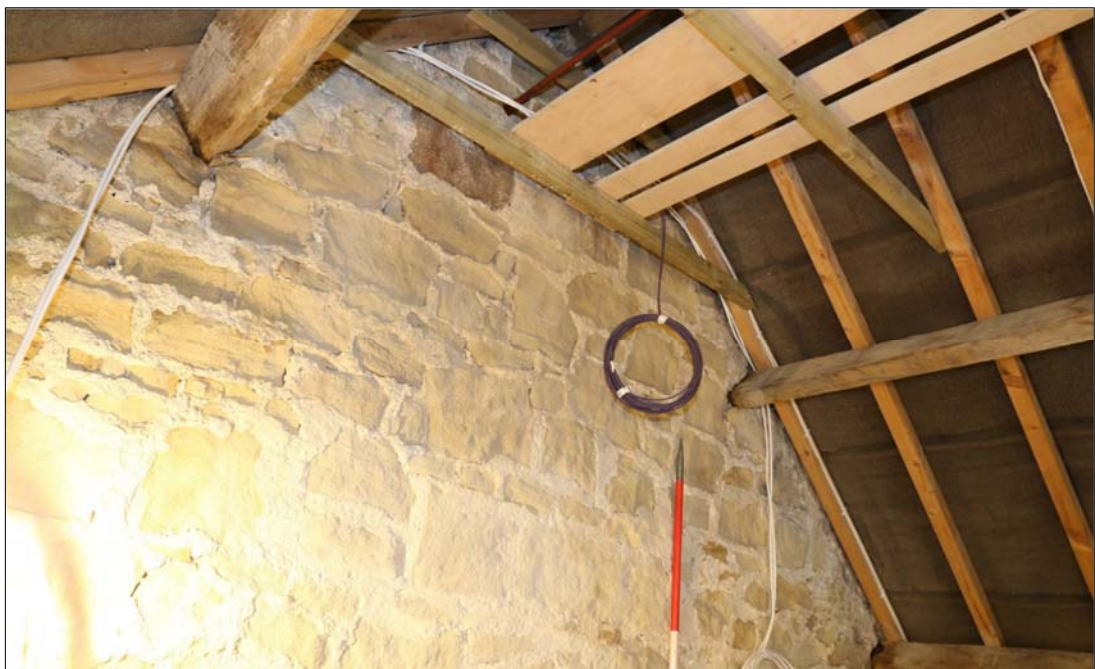
- 8.42 Within the main brewhouse building, it was noted after the 2016 survey that stonework at the apex of the partition wall dividing the two internal rooms (G1 and G2; Fig. 7) was significantly weathered on both faces. This pattern continued down the east side, suggesting that the fabric had been exposed to the elements for a period of time. While there is no specific record that the building was re-roofed, such localised weathering may be associated with partial roof loss at some point in the building's history, possibly indicative of a period of decline or abandonment. Such erosion would be conducive with prolonged exposure rather than a temporary event like the construction of the north façade.

Plate 23: north-facing side of the partition wall apex, showing differential wear of the stonework, with the mortar standing proud of the stone surface.

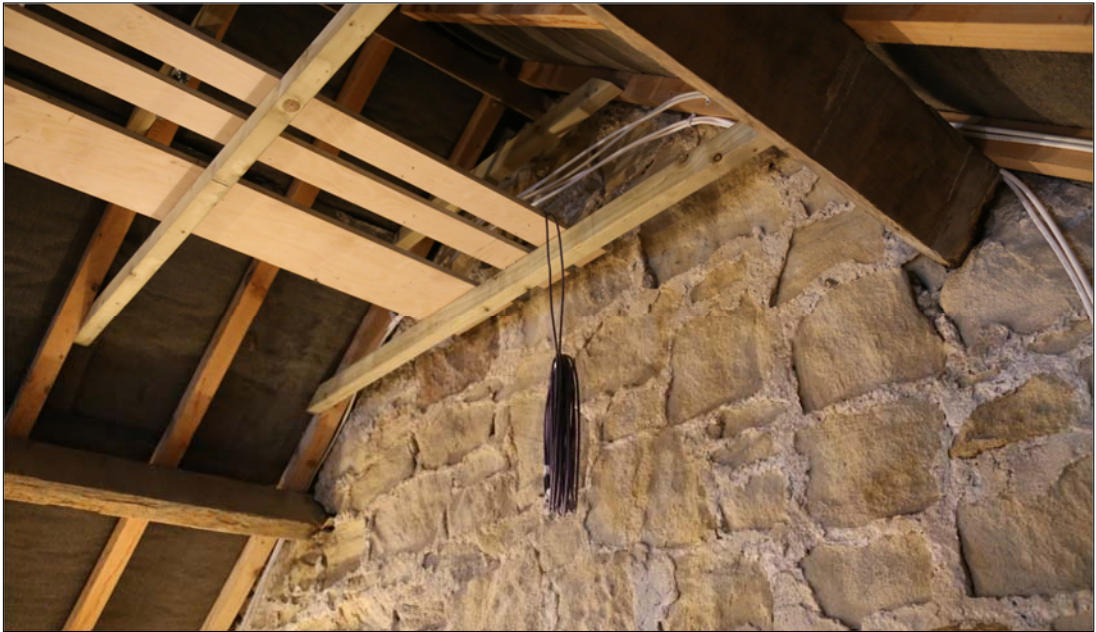
Plate 24: north-facing side of the partition wall apex, showing differential wear of the stonework.

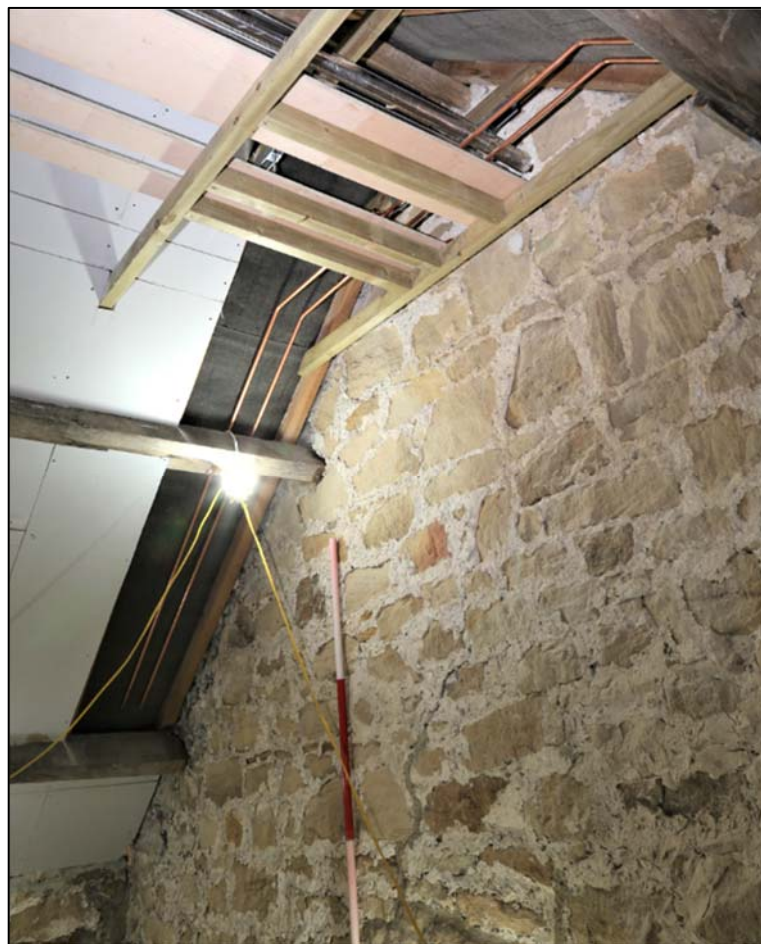
Plate 25: south-facing side of the partition wall apex, showing differential wear of the stonework extending down the wall.
