THE HALL

ARCHAEOLOGICAL
INVESTIGATIONS

NATIONAL TRUST
SEATON DELAVAL HALL
NORTHUMBERLAND

NAA 21/66
July 2021

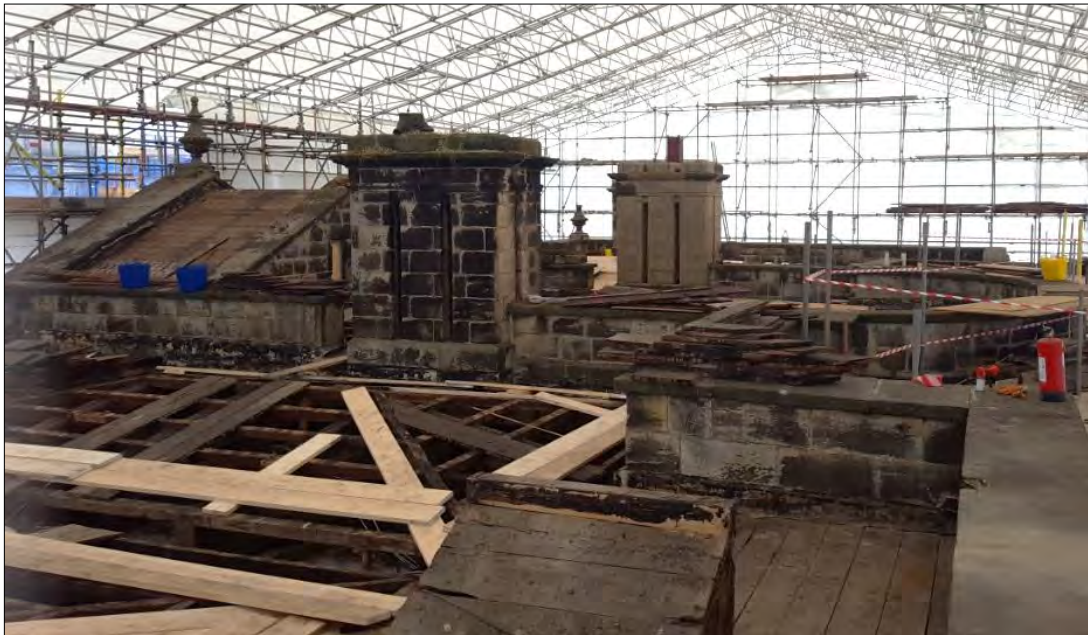
Plate 3: looking south-east across the west roof showing both main chimney stacks and the pediment chamber (130). The north stack (102) is clearly older than the south stack (103), the latter being replaced in the late 19th century.

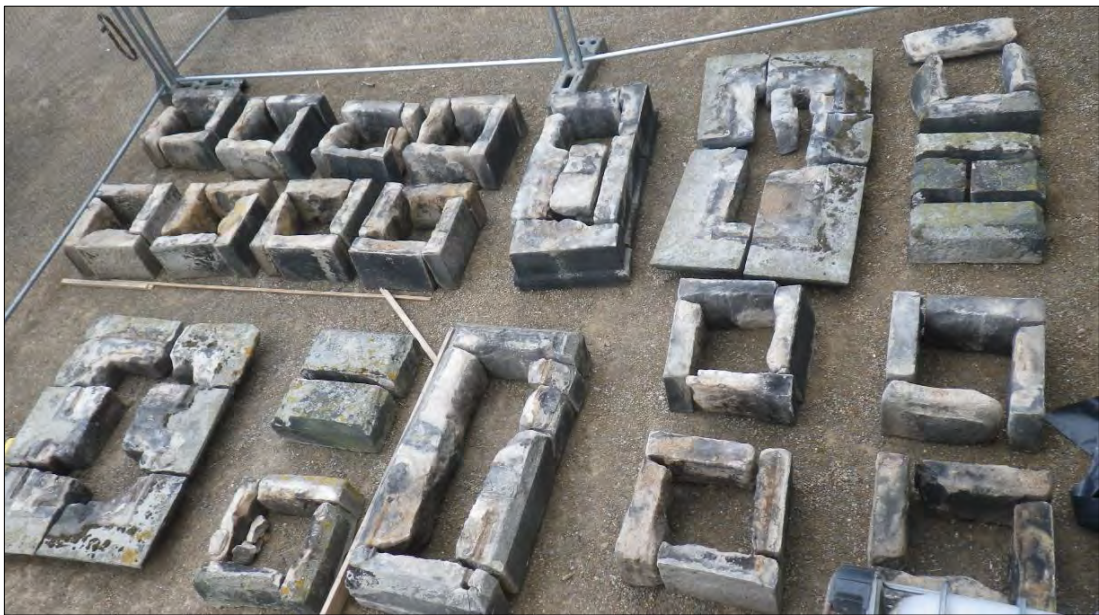
- 8.25 The sandstone coping stones of the other chimneys were also removed and stored prior to repair and reinstatement (Plate 7).
- 8.26 A low, stone parapet ran around the outer edge of the roof (101) to conceal views of the pitched sections from the ground, to create the illusion of a flat roof in the classical style. Evenly spaced along the top of the parapet were a series of decorative stone urns (Plates 8 and 9). This type of exaggerated roof adornment is typical of British Baroque and was used to great effect by Vanbrugh at both Castle Howard and Blenheim. The urns make a considerable contribution to the character and interest of the Seaton Delaval roof line. Twelve urns were recorded, positioned on the north and east parapet only.

Plate 7: chimney copings removed and awaiting repair and reinstatement.

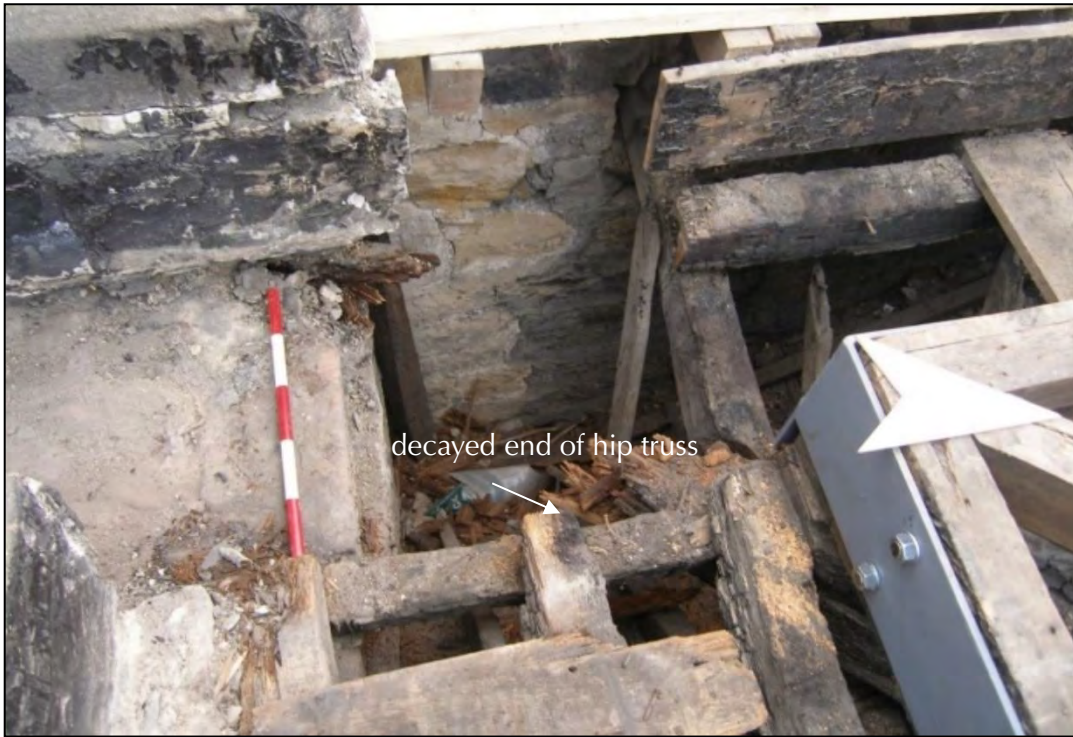
In the West Wing, the exposure of the roof revealed significant information regarding the layout and form of the original superstructure. The roof was constructed of softwood, probably pine imported from the Baltic to Seaton Sluice. Considerable variation in the colour and treatment of upper roof timbers indicated several phases of repair and modification, dating largely from the mid-19th to mid-20th century. However, much of the lower structure — tie-beams, ceiling joists and struts — were original, particularly in the central range. Evidence of damage attributed to the 1752 fire was identified on the east and south sides of the roof, with the most severe evidence of burning recorded on the south-west hip truss of the central range, which sits just above the kitchen.

Plate 32: view of decayed hip truss in the south-west corner of the central roof. The timber is located at the junction of three gutters, draining south past the wall.

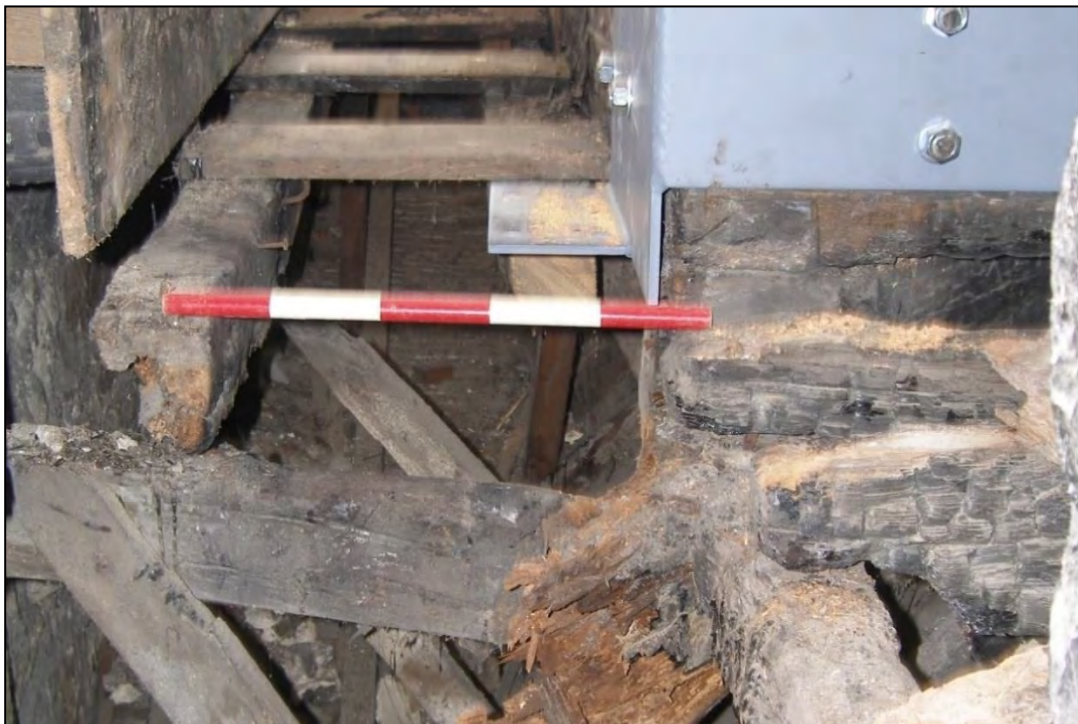
Plate 33: evidence of charring is visible on the timbers adjacent to gutter 121.

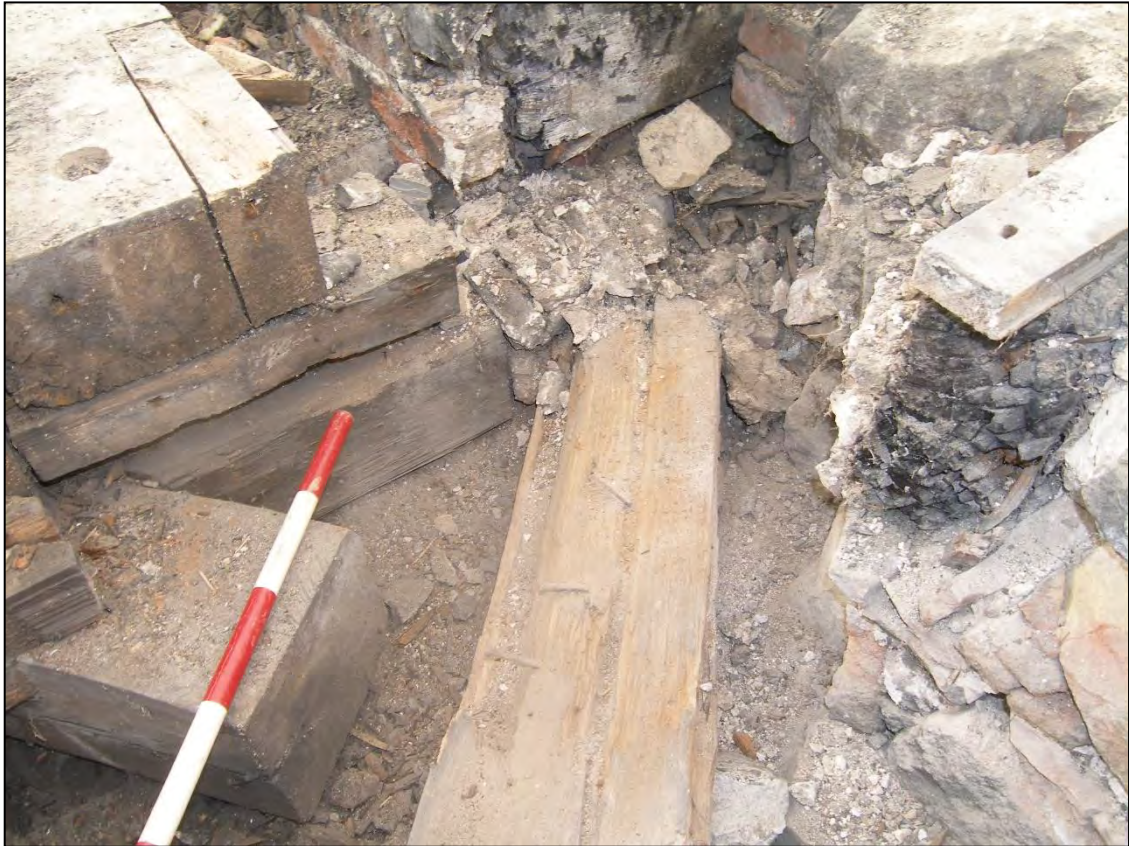
Plate 38: charring of the trusses of roof 145 visible at the junction of truss 203 and 204.

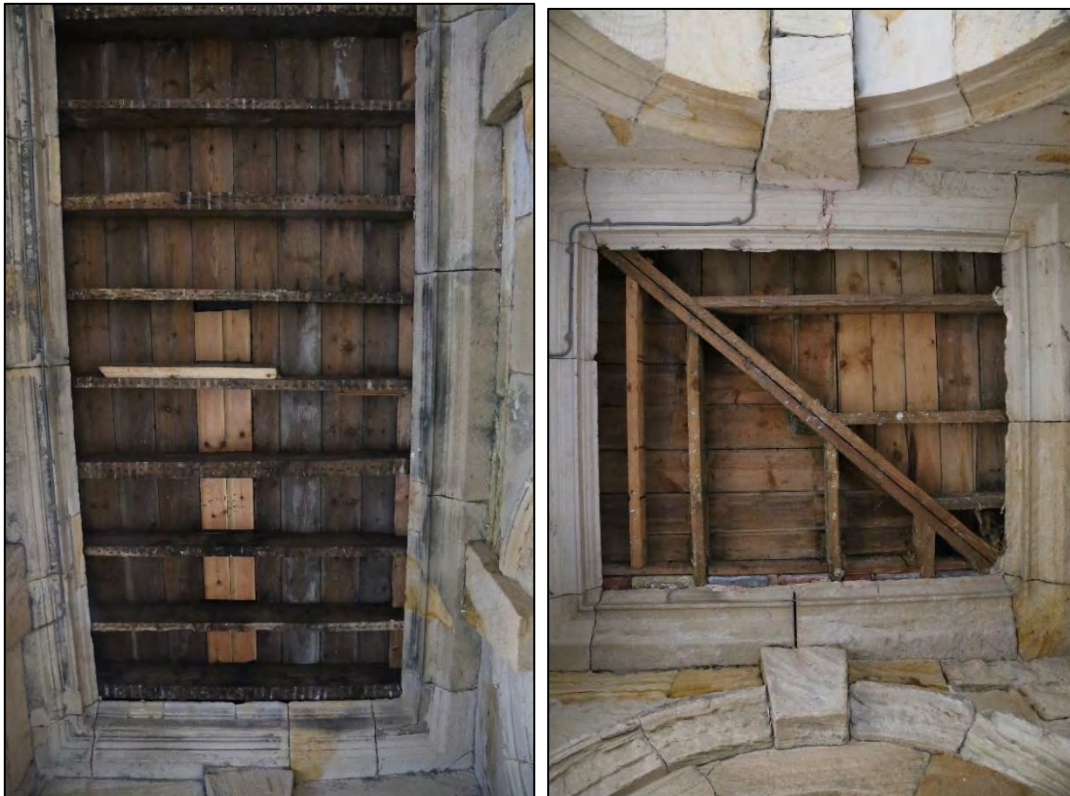
Plates 50, 51: (left) ceiling above the west arcade connecting with the Central Hall. A repair is visible on one of the joists; (right) the junction between the west arcade and the south arcade.

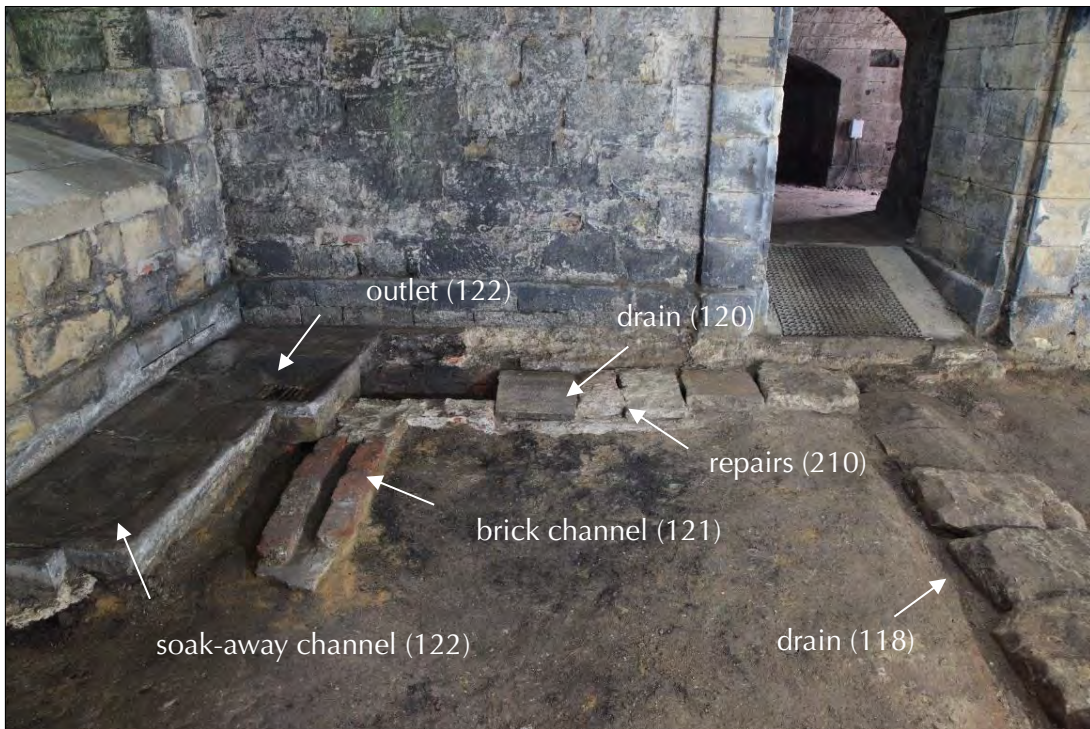
Plate 88: drainage area 122 and brick drain 121, with a phase of repair and alteration (210) to drains 118 and 120 visible along the north wall.

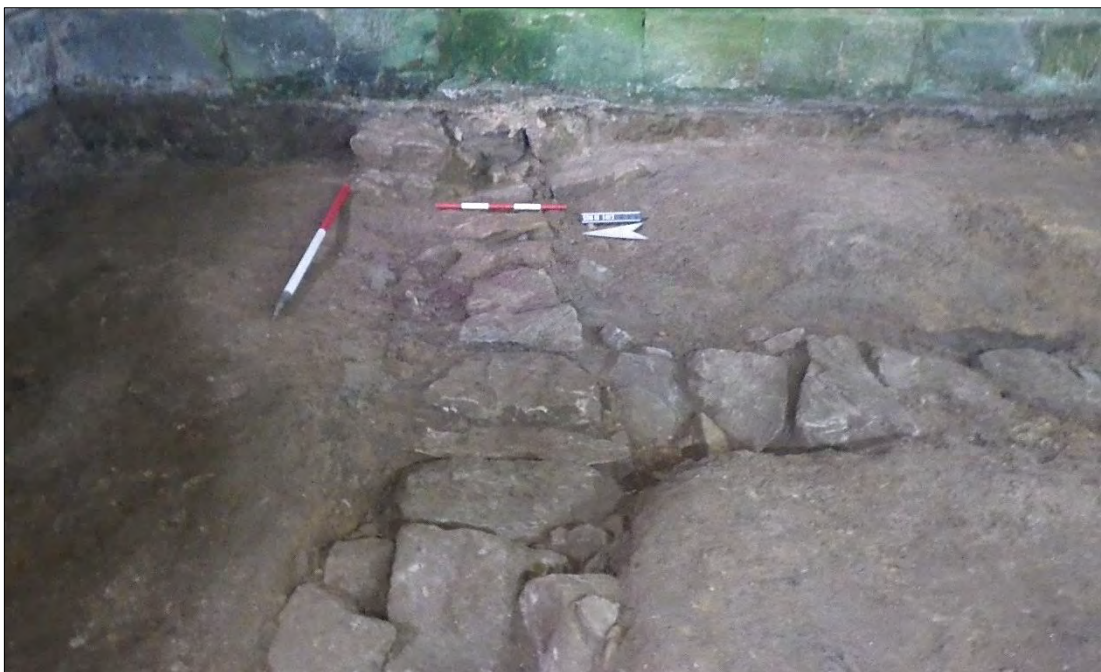
Plate 99: drain 136 and damage to the east wall caused during construction.

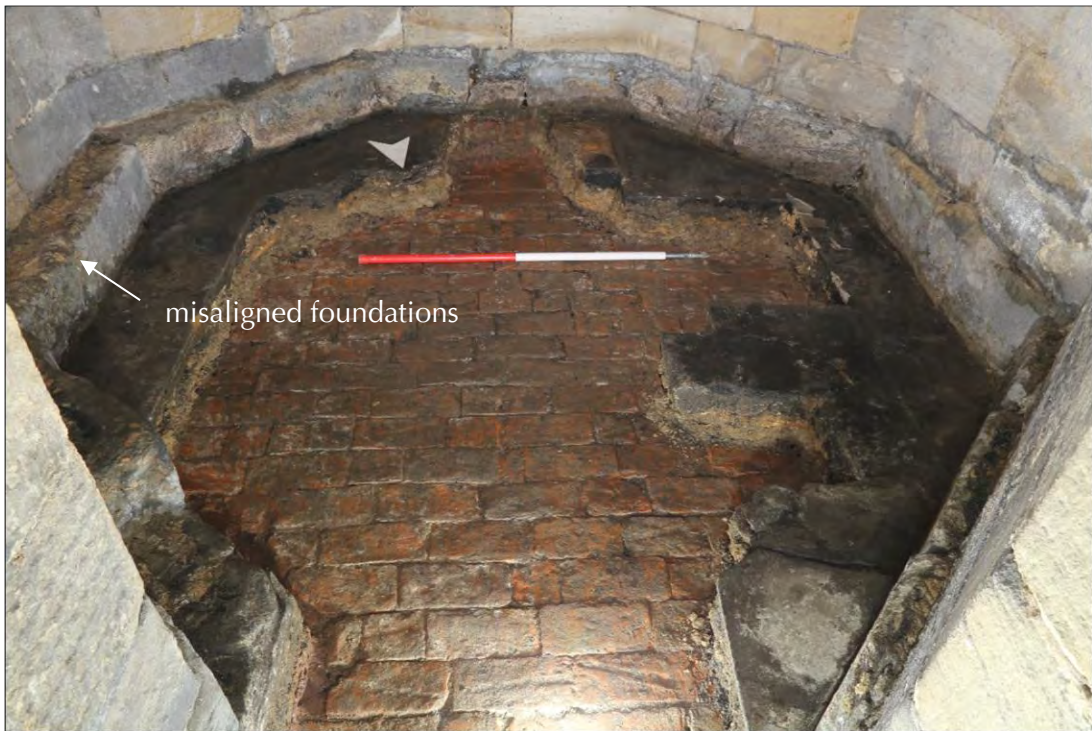
Plate 100: foundation course 201 and remains of floor make-up within the south-west turret, with groundwater seepage in brick surface 133 at the far wall.

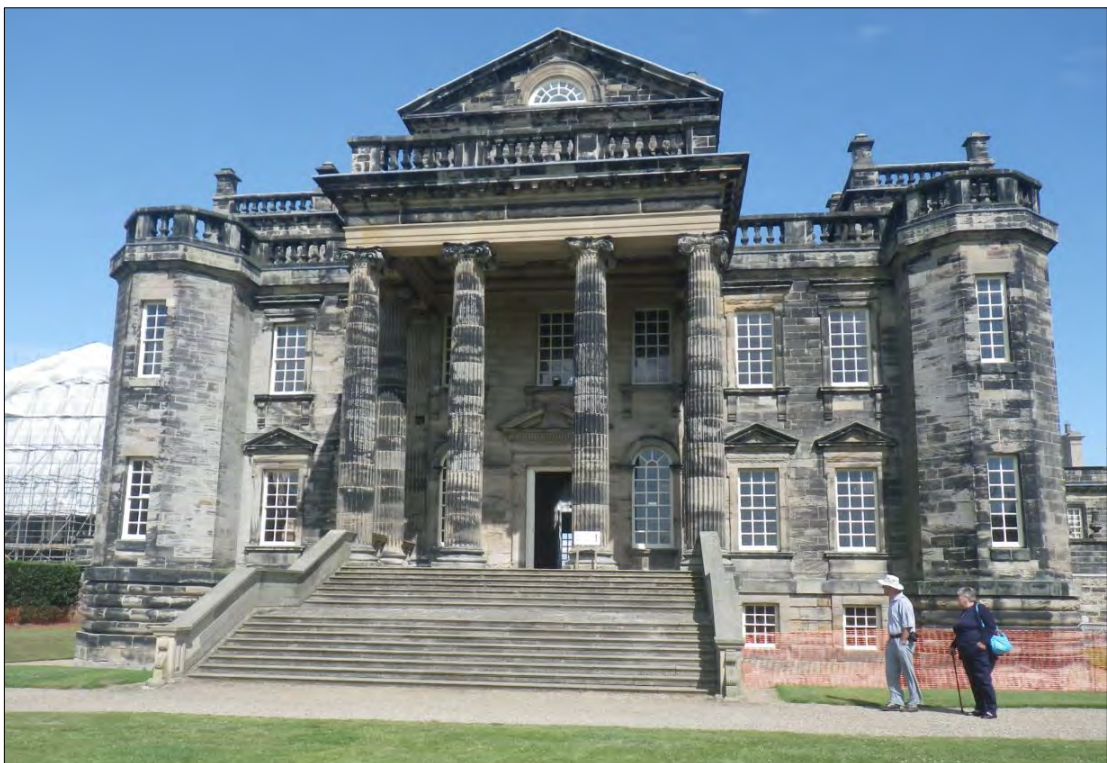
Plate 102: south portico steps prior to repair.

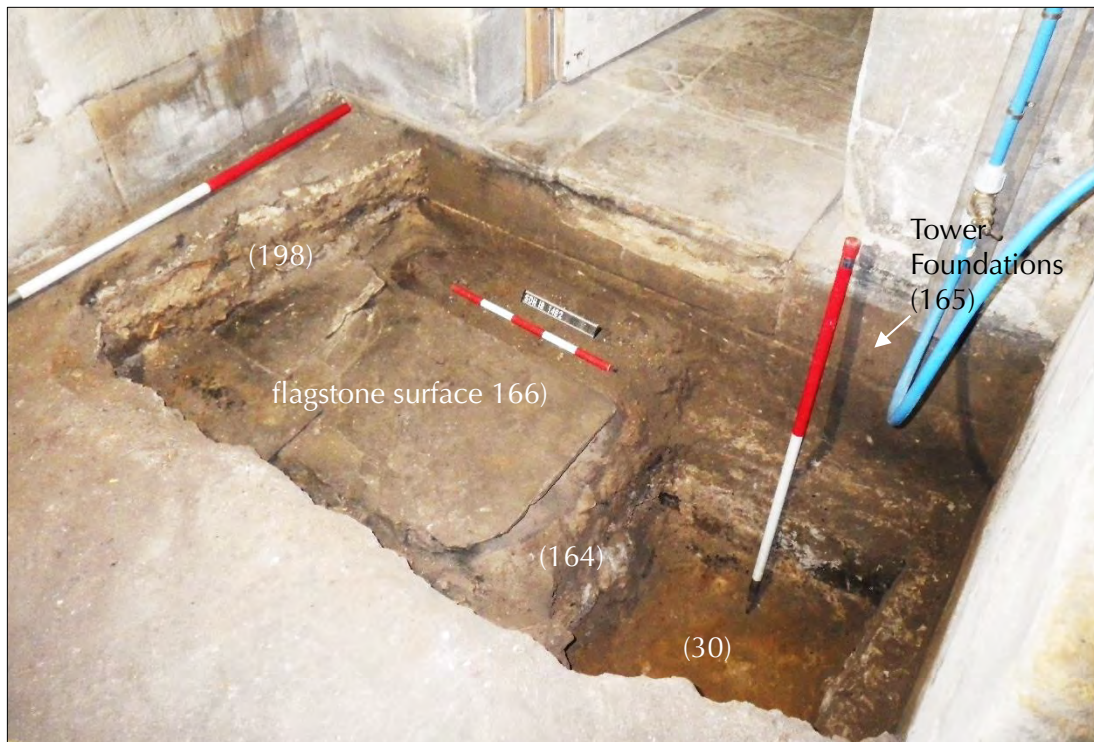
Plate 109: stepped excavation at the doorway to the west stair tower showing damage to the tower doorway, flagstone floor 166, and the tower foundations 165; facing south.

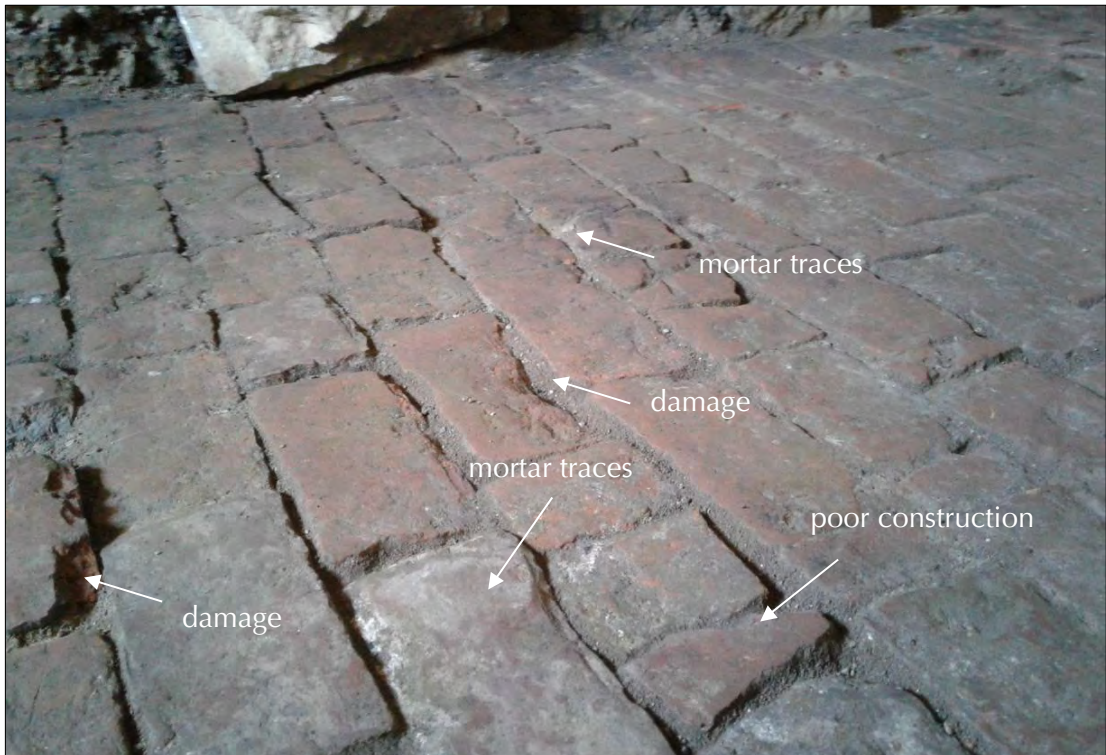
Plate 143: section of brick surface 133 in room B10 showing examples of mortar traces, uneven damage patterns and poor construction.
