ARCHAEOLOGICAL BUILDING
SURVEY REPORT

**THE BARN (BUILDING A),
TOWNHEAD ROAD,
DALSTON, CUMBRIA**

Project No.: 1168
Text: Matthew Town
Illustrations: Matthew Town
Edited by: Mary Fraser

ARCHAEOLOGICAL BUILDING SURVEY

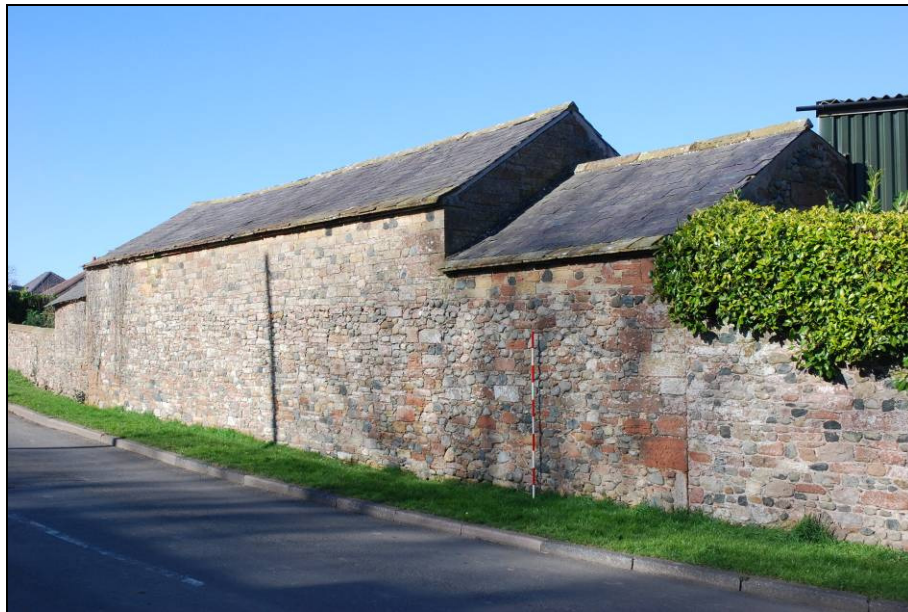
Plate 1: The Barn (Building A), from the south-east; the eastern extension lies behind the ranging pole

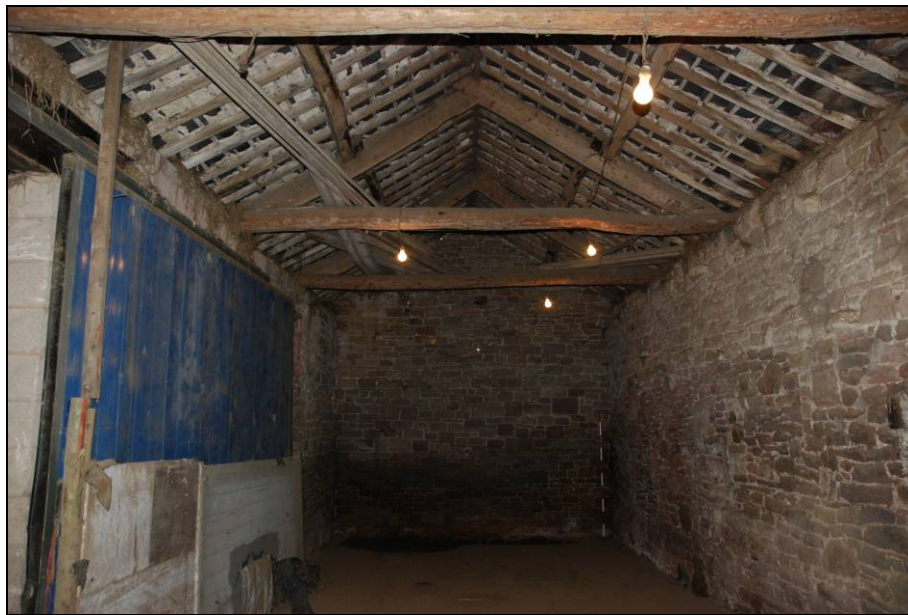
Plate 3: interior of main barn, facing east. Note burn-marks on purlins.

plan form. The interior of the main building comprises an open rectangular space, with two smaller extensions on the eastern and western ends (Plate 3). The interior floors have been extensively altered, with concrete floors inserted, and there is no evidence of any original fittings or divisions surviving within the barn. The building measures approximately 15.9m by 4.40m.

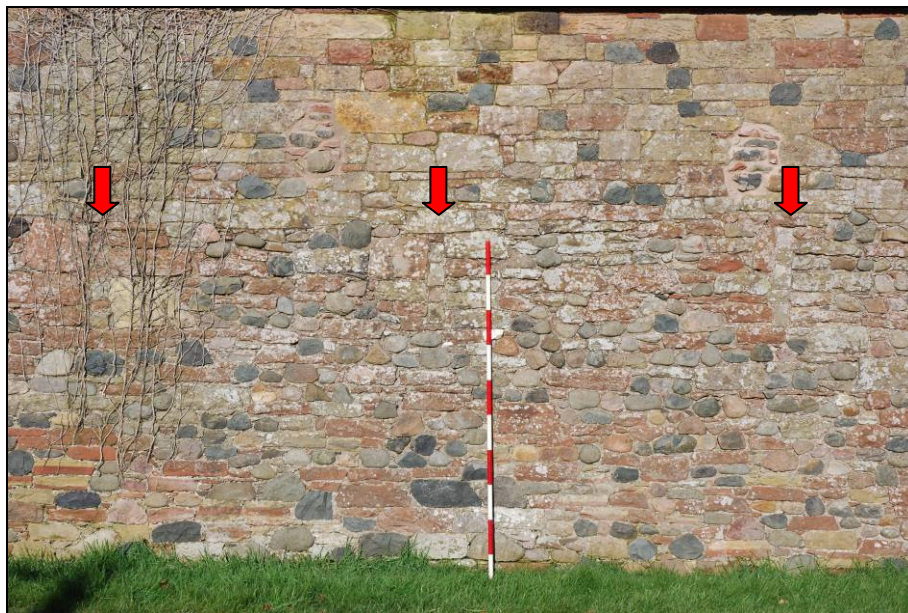
Plate 4: ventilation slits (arrowed); note rebuilt wall above ranging pole

- 5.3 Within the southern elevation, a series of ventilation slits were identified, measuring approximately 0.8m in height and 0.15m in width, with a stone lintel above, and in some cases a stone cill (Plate 4). These ventilation slits are arranged evenly along the wall, at a spacing of 2m; the exact number of ventilation slits is unclear, as these have been blocked with identical stone to the wall fabric, and in some cases the cills or lintels have been removed. Based on an examination of both the interior and exterior, approximately six slits are estimated. Brunskill (1982, 41) notes that ventilation to the

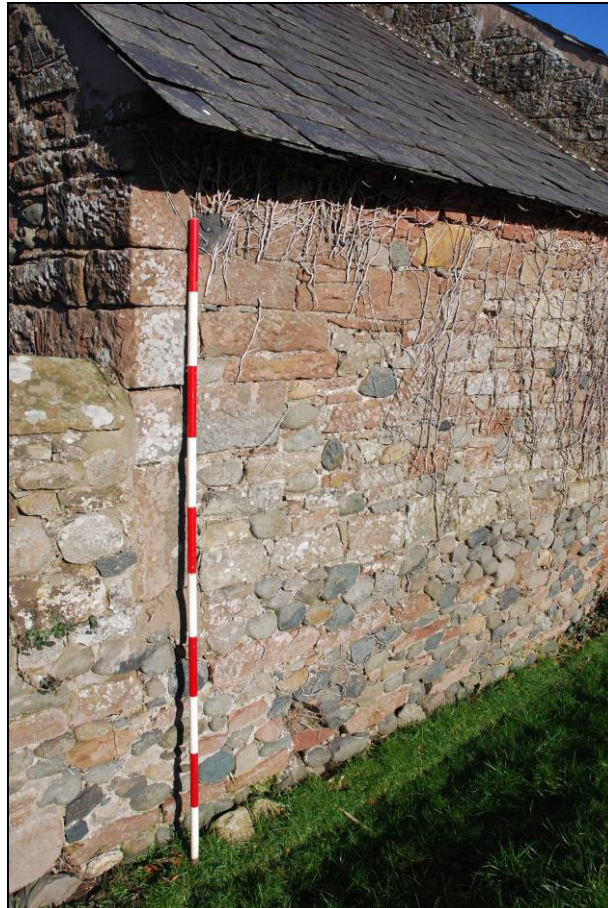
Plate 5: the western extension; note lower cobble wall

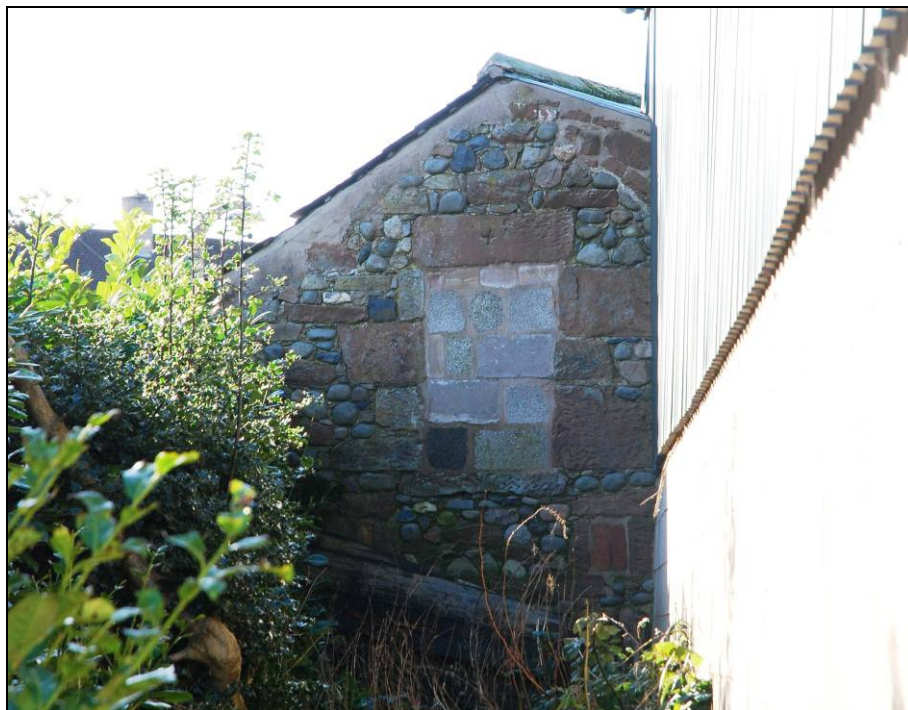
- 5.5 The west- and east-facing elevations of the respective extensions are largely obscured by later constructions or are otherwise difficult to access. The west facing elevation appears to be blind, with little evidence of discernible features. The east-facing elevation is more interesting, and includes at first floor level a pitching door within the gable, with a large stone lintel (marked with an incised cross), and alternating quoins for the surround (Plate 6). The door was used to transfer hay into a hayloft from a loaded cart, evidence for which is visible within the interior (see below). At ground floor level, beneath the pitching door, are two infilled but contemporary openings, possibly small windows. All the openings in this elevation have been infilled with well-dressed sandstone blocks. The north-facing elevation has now been entirely subsumed into a modern shed, and is discussed further below.

Plate 6: the east-facing elevation of the eastern extension, showing pitching door

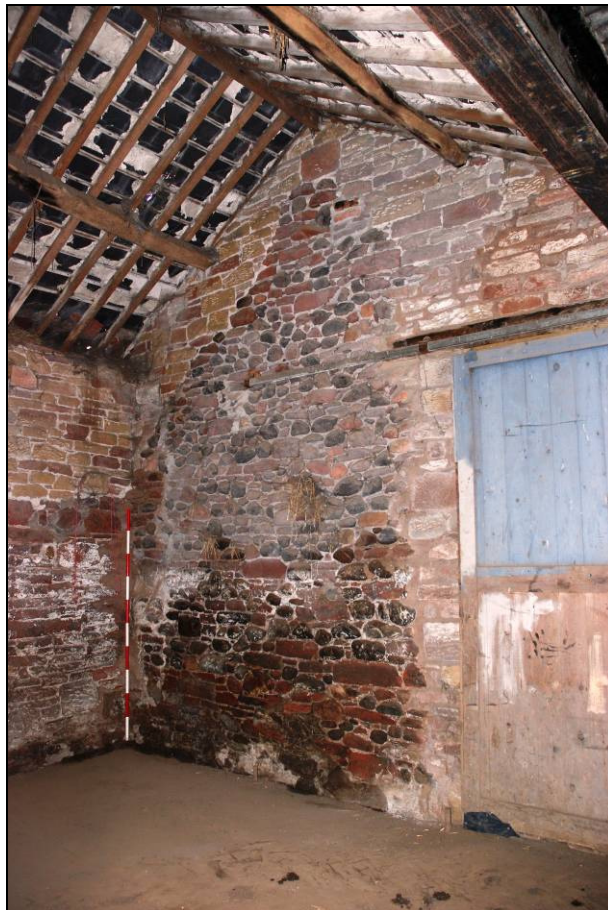
Plate 7: west wall of main barn; note former gable and heightened wall above, and extensive rebuilding around inserted door. Note also burning to purlin.

properly, and were also common in areas of high wind, as they break up the airflow and are less likely to be blown off. This is probably the case here, and would seem to reinforce the idea that the roof of the earlier building was also thatched. The west wall has been heightened, to give a shallower pitch to the roof, using the same construction material as that visible on the exterior. The north side of this wall has clearly been extensively modified, and a modern sliding door supported by a modern machine-sawn timber beam has been inserted through into the western extension; the stonework around this insertion is also clearly later (Plate 7).

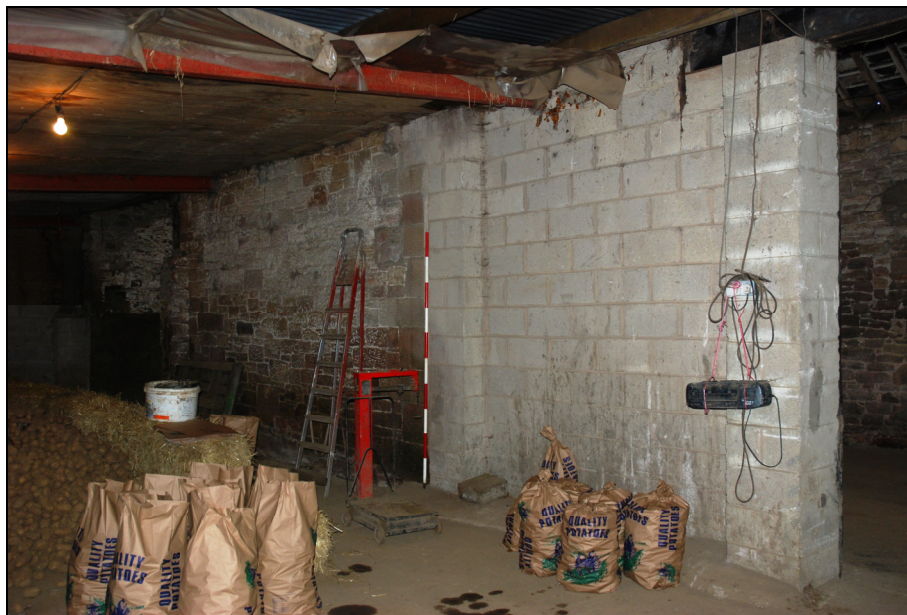
- 5.8 In contrast to the south and west walls, the northern and eastern walls of the main barn have clearly been completely rebuilt. The date for this is uncertain, but stylistically the rebuilding looks to be 19th century in date. The walls comprise random coursed squared and well-dressed sandstone blocks, with alternating rectangular quoins. All the stones have a tooled finish. The north wall may originally have incorporated a large central (?double) door. The western side of this wall has now been removed, but the eastern side of what appears to be a doorway is visible, now with a modern breeze-block wall abutting its west side (possibly originally blocking the double door - Plate 8). The removal of earlier fabric to the west of the breeze-block wall seems to correspond to the insertion of a very large doorway with a sliding door, supported by a steel roof-supporting joist. At the north-east corner of the main barn is a short projecting stub of walling, which may mark the position of an early exterior enclosure wall.

Plate 8: rebuilt north wall of main barn, note position of original door at ranging pole

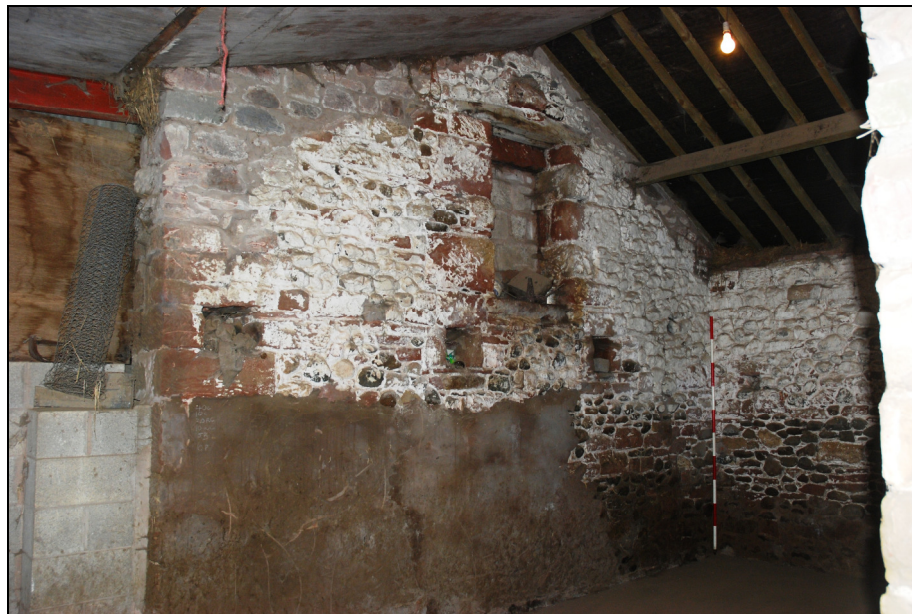
- 5.9 The interior of the eastern extension measures 3.39m by 4.98m, and has no surviving interior partitions or features. The east wall of the extension includes four large sockets for floor joist beams

at about 1.4m above the modern floor and at a spacing of 1.2m, measuring 0.35m by 0.25m. The southernmost of these has now been blocked. The sockets originally would have held beams which crossed transversely and were socketed into the original east wall of the main barn, now lost since the wall was rebuilt (Plate 9). The floor was clearly replaced after the rebuild, and a line of three much smaller sockets is visible above the earlier ones, with corresponding examples in the rebuilt wall. The pitching door, which is now blocked with stone, has a large timber lintel and stone cill. The southern wall is largely featureless. The heightening of the roof is clearly visible here, as the earlier interior walls are white-washed, whilst the heightened walls are not. The northern wall appears to have been entirely removed, probably when the 20th century metal barn was constructed.

Plate 9: east wall of eastern extension

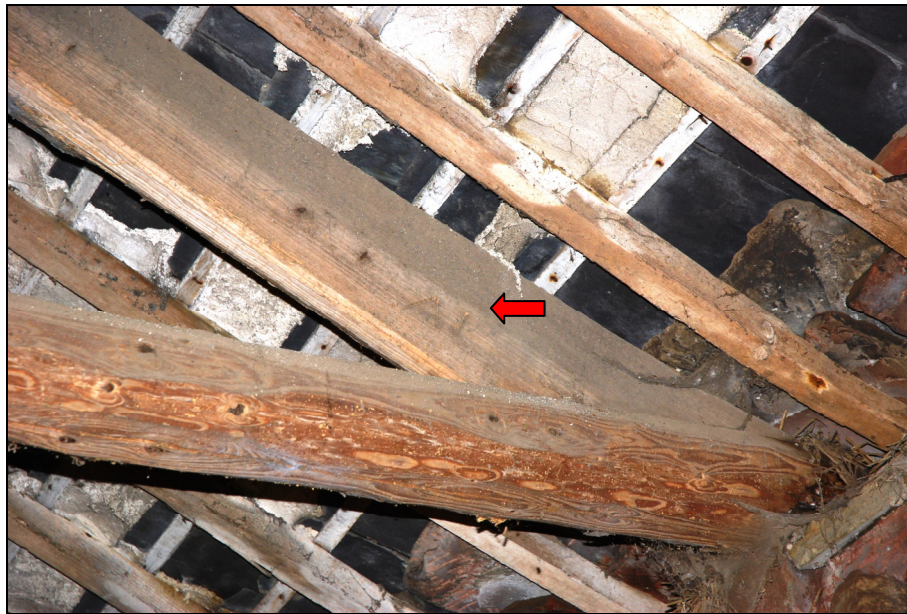
The purlins, and the main tie beam of the trusses, seem to be original hand-tooled timbers and look to be of some age; these have clearly been reused from an earlier roof. The purlins bear evidence of burning, and if they have been reused within the same structure, indicate the building may have been destroyed by fire at some point. In contrast, the rafters of the roof truss are made of machine-sawn timber, and bear evidence of carpenters marks as Roman numerals (Plate 10). Though notoriously difficult to date, these became less common after the early to mid-19th century. The roof coverings of both the western and eastern extensions, and the main barn, have clearly been relaid in recent times, with the historic slate covering now supported by machine-sawn purlins and rafters. The presence of sandstone flags within the exterior roof coverings suggest the roof may originally have been thatched.

Plate 10: carpenters marks on rafters (arrowed)
