## WATCHING BRIEF REPORT

WITTON HALL FARM  
WITTON GILBERT  
COUNTY DURHAM

NAA 2017/134  
October 2017

**WITTON HALL FARM, WITTON GILBERT, COUNTY DURHAM**  
**ARCHAEOLOGICAL WATCHING BRIEF REPORT**

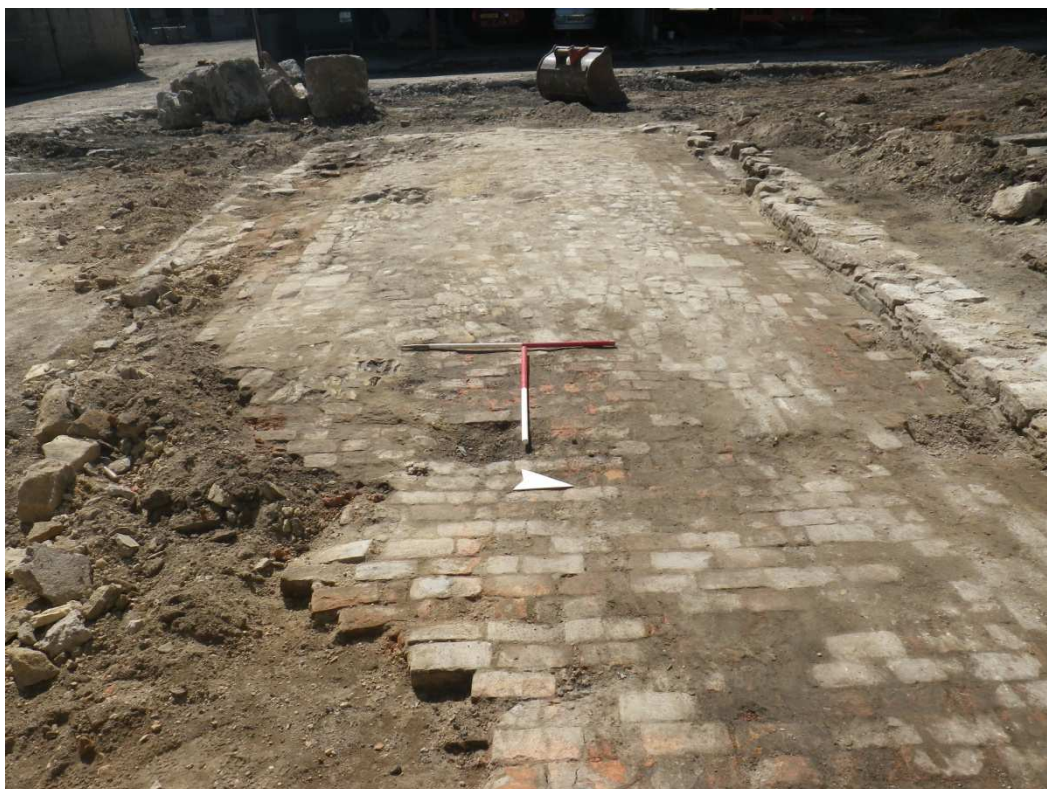
Plate 1: Barn **05** looking south-west towards the entrance.

- 6.3 The barn itself measured 11.5m by 6m with a large entrance on its south-western face. The outer walls (**09**) were constructed from sandstone blocks, identical to the granary building, and were constructed two courses wide with an internal rubble core. The north-western wall survived two courses high, while the south-eastern wall survived to only a single course high. The north-eastern wall of barn **05** was not visible, as the concrete butting against the barn was left in situ to avoid damaging the existing structure. It was not clear whether the building included the western wall from the granary. The corners of the south-western wall survived to one course high and incorporated a cobbled threshold (**06**) with three padstones (**12**), which likely formed an entrance into the structure.

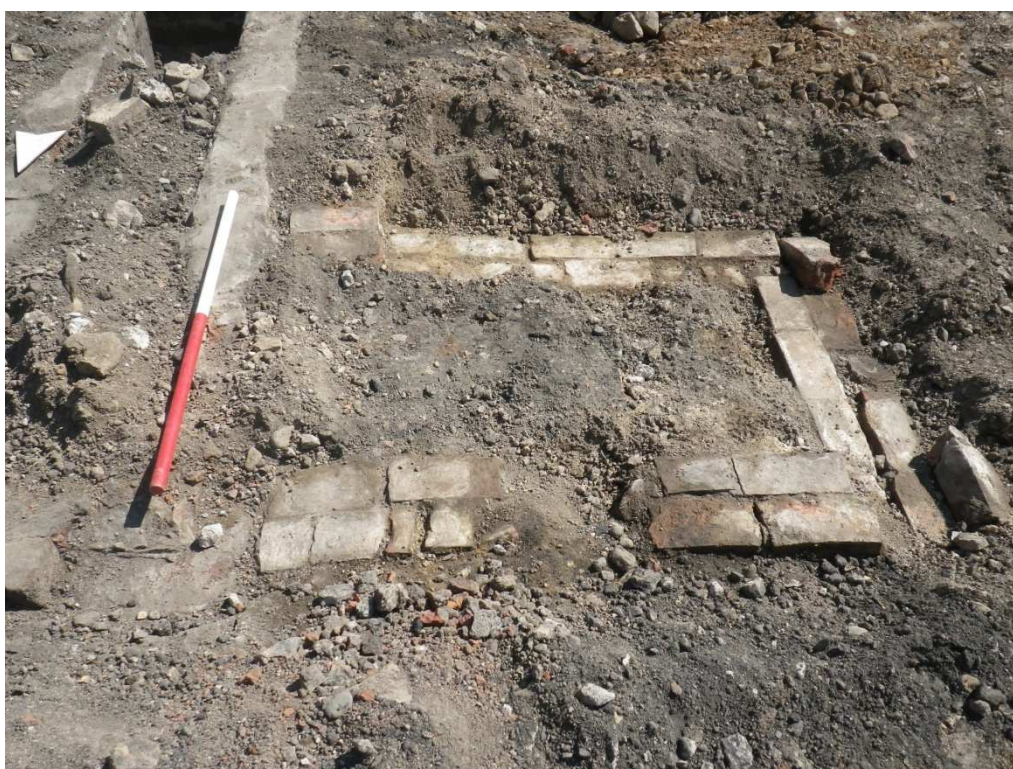
- 6.11 A further wall foundation was recorded to the north of the foundations of structure **02**. This set of foundations (**03**) were constructed in the same manner, with re-used bricks set in concrete, and formed an L-shape. The north to south aligned portion of the wall foundations formed a rectangular shape, with the material inside (**14**) containing butchered animal bone and bottle glass. A small section was dug through this material to record the depth of the wall foundations, which were in excess of 1m deep. On the south side of the foundations was a small square brick structure (**04**; Plate 2) that visibly butted up against **03**, and was clearly a later addition. The structure measured 1m by 1m and was constructed using machine made bricks that were markedly different to those within barn **05**. It was likely that this structure was a small manhole.

*Plate 2: Manhole **04** abutting wall foundations **03**.*

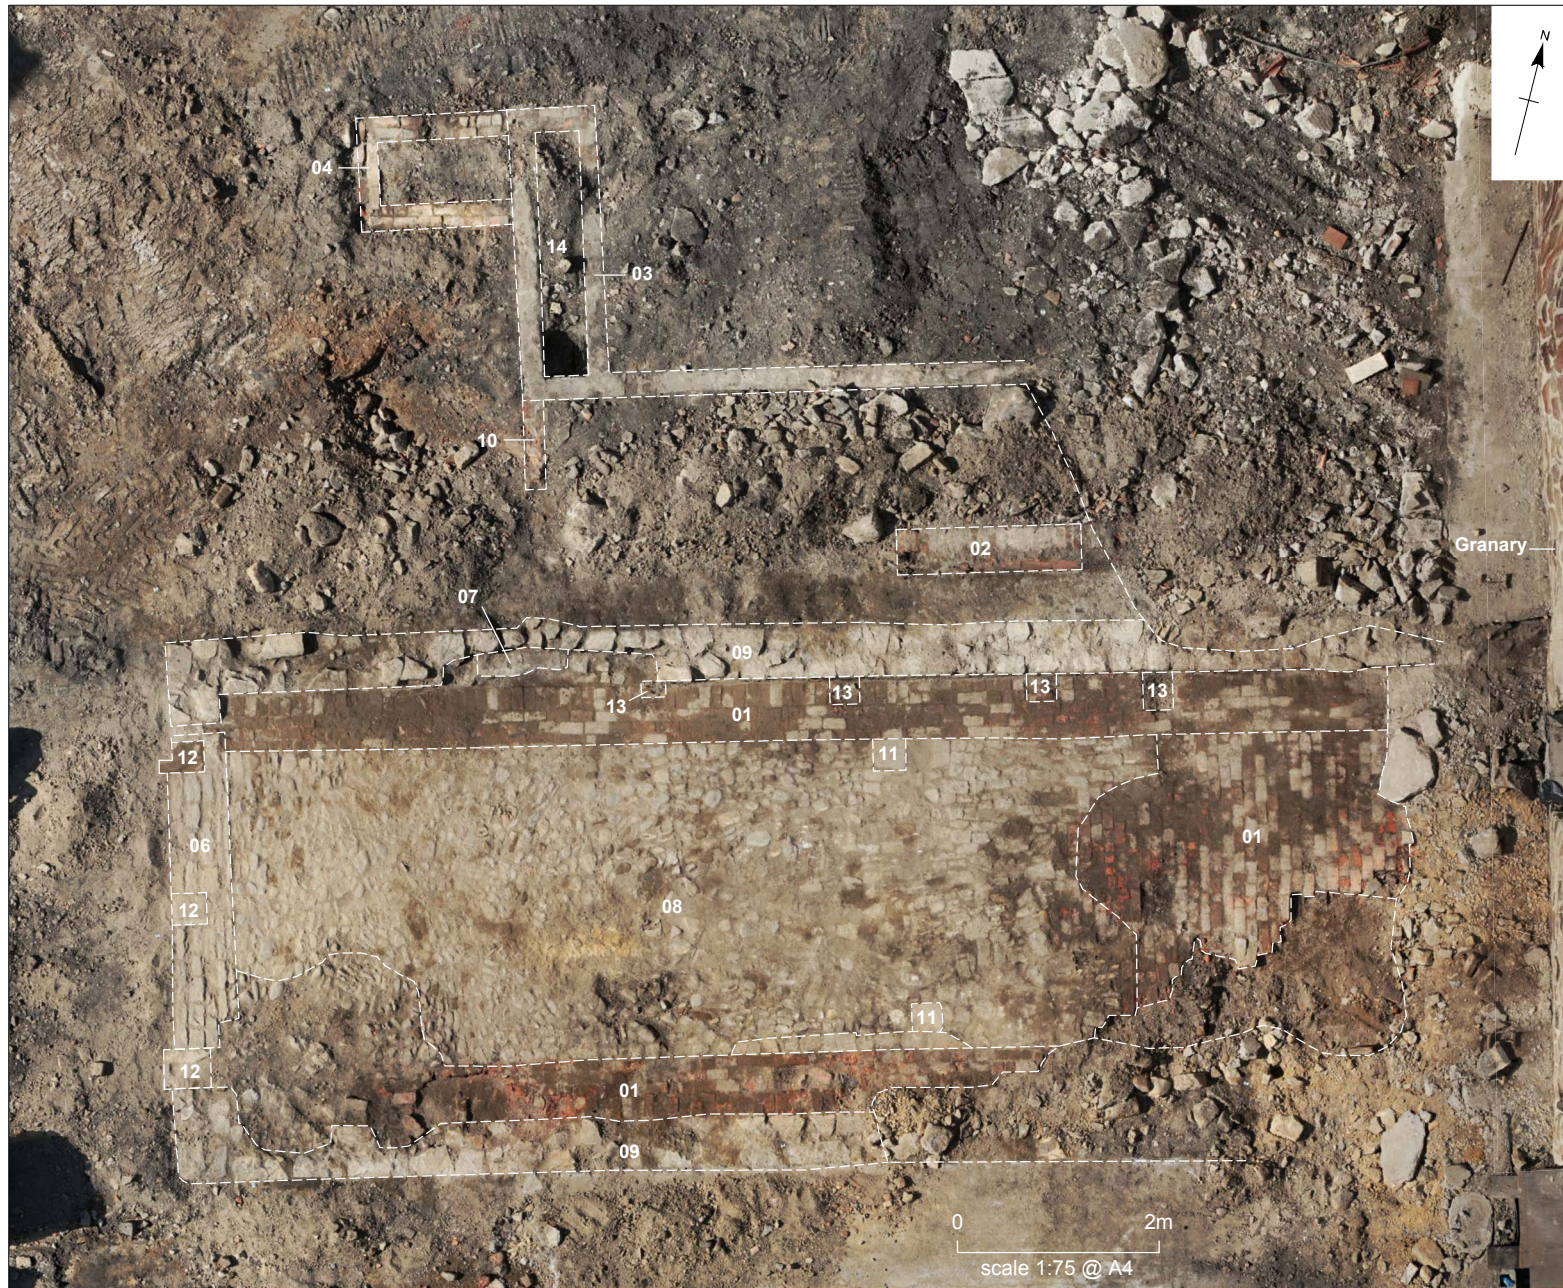
Figure 3

- 6.10 To the north of barn **05**, two further structures were recorded (**02** and **03**, Figure 3). Structure **02** consisted of a northeast to south-west aligned section of wall foundation measuring 0.7m long. The foundations were aligned parallel to the north-western wall of barn **05** and were probably related; however, none of the above ground structure survived. A long section of land drain was cemented on the south side of the wall foundations, which was cut in half to form a gutter. The foundation itself was constructed of the same type of bricks as the interior of barn **05** but set within thick concrete. It was likely that the wall foundations were later than barn **05** but re-used the same bricks.

Witton Hall Farm, Witton Gilbert: scaled orthophoto of Barn (05) foundations.

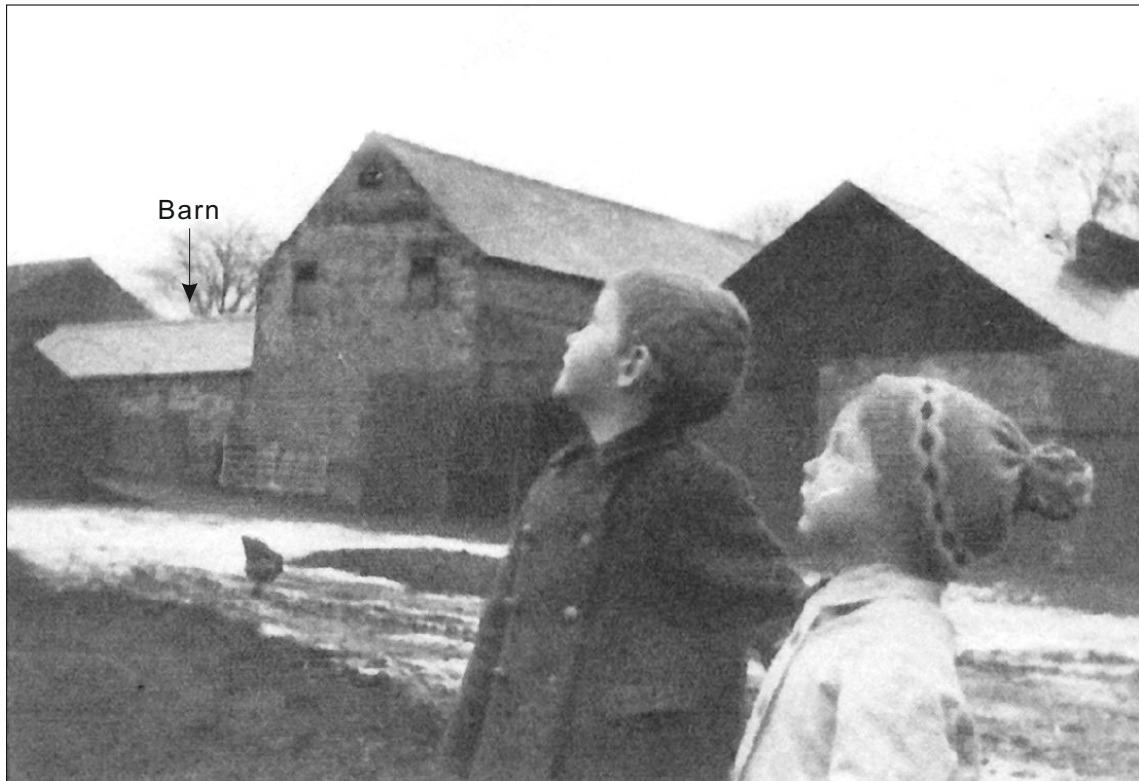
- 6.8 A large rectangular stone setting (**07**) was recorded as built into the north-western wall of the barn and likely formed a small doorway, probably original to the barn. A similar sized doorway was depicted on the south-eastern wall in earlier photographs of the structure provided by the client (Plates 3 and 4). This doorway was not visible during the investigation, as the eastern corner of the building was missing.

*Witton Hall Farm, Witton Gilbert: photograph showing Barn 05* Plate 3

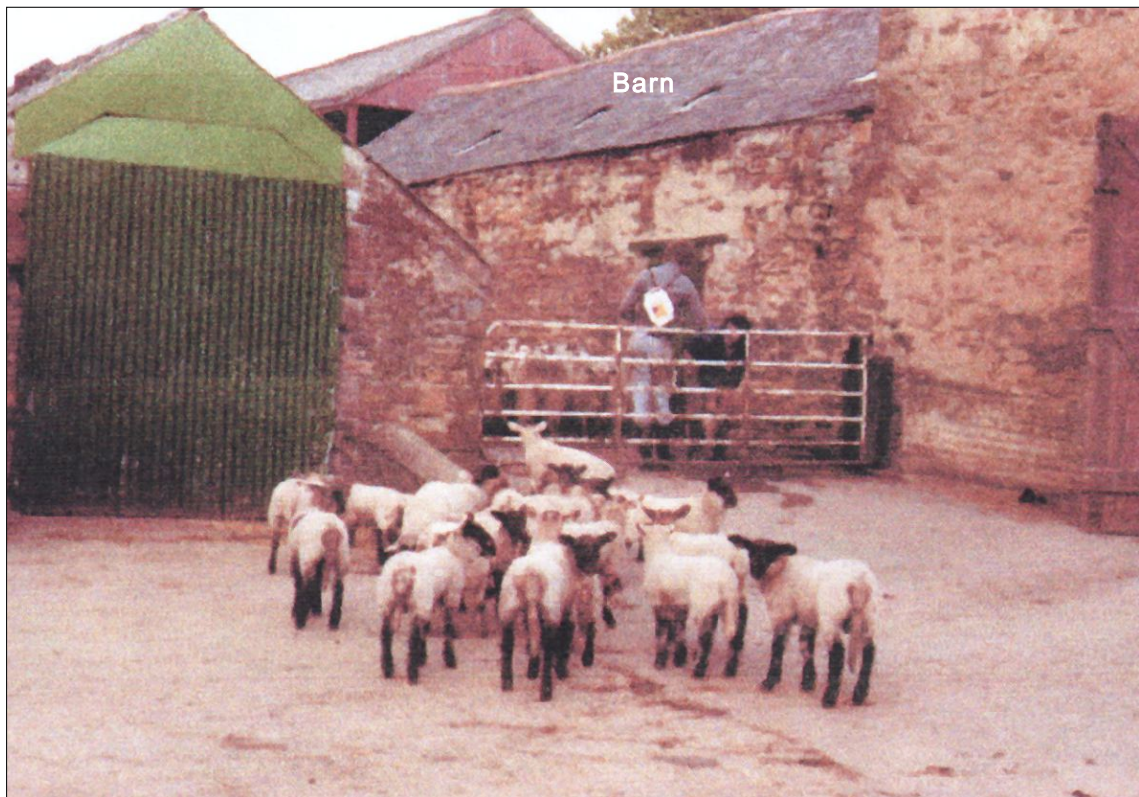
*Witton Hall Farm, Witton Gilbert: photograph showing Barn 05* Plate 4
