ARCHAEOLOGICAL BUILDING ASSESSMENT AND SURVEY

ALL SAINTS' CHURCH
ALL SAINTS' ROAD
SHILDON
CO. DURHAM

Project No.: 1403

QUALITY ASSURANCE				
Project Number	1403			
Report Number	17–125			
Manager	Matthew Town			
Draft	Matthew Town			
Graphics	Dawn Knowles			
Edit	Dr Hannah Russ			
Authorised	Dr Freddie Foulds			
Issue 1		13-11-2017		
Issue 2		21-11-2017

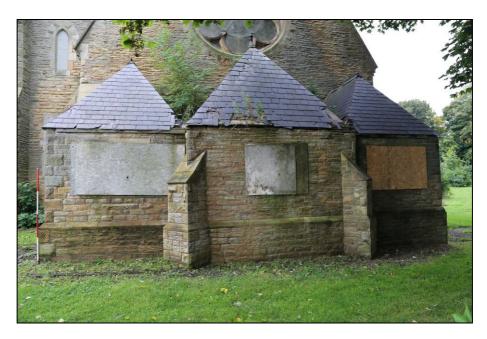
Plate 9: the narthex, All Saints' Church

In contrast to the main church building, the narthex has a simple hipped Welsh slate roof with roll-topped ceramic ridge tiles, with a lotus finial topping the earlier roof (Plate 9).

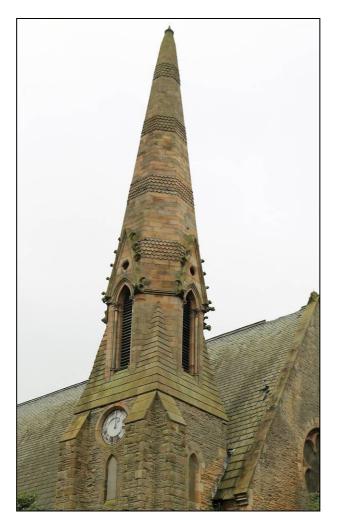
Plate 10: the church spire, facing south-east

5.6 The church tower displays the same style of construction up to the belfry stage, and is topped with an octagonal broach spire built of finely dressed ashlar sandstone, with four bands of fish-scale tiles. There are four louvred lancet windows on the cardinal faces, each with rounded piers supporting crocketed capitals and two-centred arched hood moulds. Each of the windows has crocketed gablets with a small oculus, above projecting gargoyles, with a moulded band at the junction between the belfry stage and spire (Plate 10).

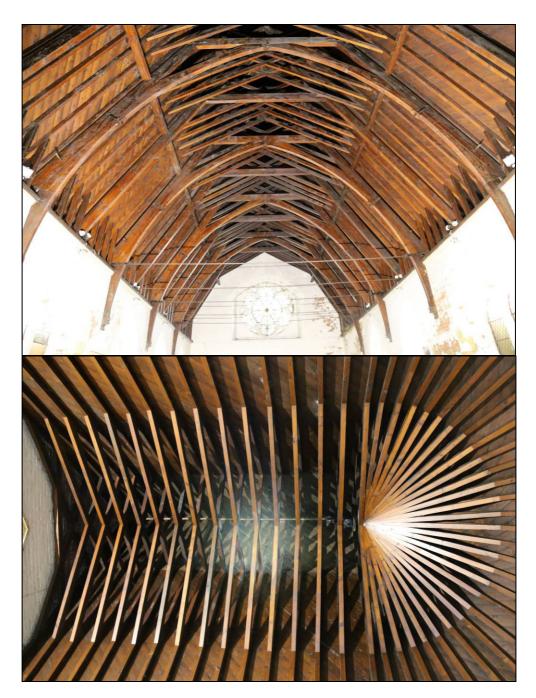
Plate 11: the nave roof, facing west (top) and chancel roof, looking up (bottom)

at the western end of the church, dividing the entrance lobby of the church from the main seating, though this is now only visible as a faint scar. The floor has been entirely excavated away by minidigger during the previous aborted conversion attempts, and replaced with a concrete pad (Race *pers. comm.*); the woodwork was also stripped out and burnt. None of these original features survive, therefore. The roof of the nave has four principal trusses with arch braced collars, and is a very impressive structure (Plate 11).

- Access to the chancel is by means of a large pointed arch, which extends to the ceiling, with alternating ashlar sandstone quoins on each side of the arch (Plate 12). The arch comprises roll-moulded hoodmould with headstops, set above crocketed capitals on rounded columns. The chancel walls are mostly obscured by later thermal insulation and battens, but the areas exposed seem to indicate similar brickwork to the nave, and the wall plate is the same. The floor in the chancel survives, and comprises small square quarry tiles (mostly obscured under later cement and debris). At the eastern end, there are two steps (in ashlar sandstone) leading up to the altar, and the tiling here has an ornate *fleurs-de-lys* and rose pattern in red, cream and blue (Plate 13). The roof of the chancel comprises a tight network of close-set trusses supported by struts projecting from the wall-plate, with cross-braces across the top. The roof is a very distinctive feature (Plate 11).

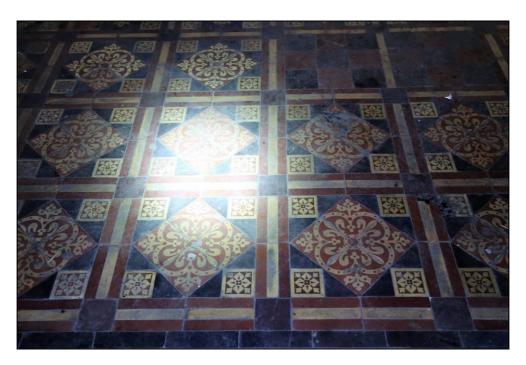
Plate 13: the altar floor – detail of tiling

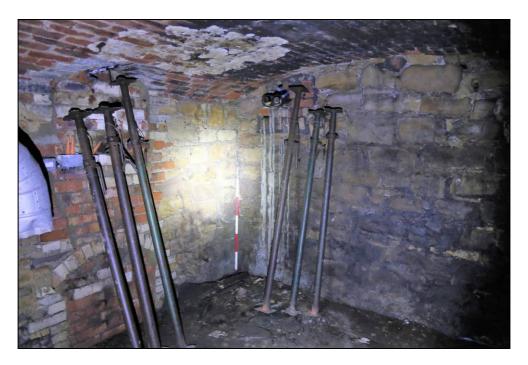
- 5.13 Beneath the north transept is the boiler room, which was accessed by means of a flight of nine worn stone steps, down to a doorway in the eastern wall (Plate 15). The stairwell is protected at ground level by means of an iron grate, which appears to be a later (20th century) addition; originally the void was secured by sandstone coping with iron railings along the edge, but these had been sawn off (probably during the 1940s war effort). The base of the stairwell is flagged, and these flags extend through to the doorway, with a (later) concrete floor in the room itself.

Plate 15: boiler room, with blocked firemouth and later alteration above

5.14 The walls of the boiler room comprise roughly dressed, random coursed, stone blocks, which support a vaulted brick ceiling; there were some iron fixings set into the ceiling, of unknown function. The boiler room has a coal chute in the north wall, with sandstone coping and shaped sandstone blocks forming the chute. The coal chute has been blocked by a modern breeze block wall. The south wall incorporates the opening for a boiler at ground level, which has been clearly altered from the original structure as there is brick infill around the boiler opening (the boiler opening

was later bricked up completely). The void originally accommodated 'Haden's Patent Warming Apparatus', which was described in a patent lodged 15th February 1842 by George Haden, an engineer, of Trowbridge, Wiltshire⁷. The apparatus comprised an iron stove front, with a square chamber to the rear, in which were affixed large numbers of closely-set iron plates, either flat, zigzagged or curved in profile. Air for the system was drawn through to the chamber by means of a pipe to the exterior. The process worked as follows: the heat from the fire in the stove below the plates heated them, causing them to expand and heat the air passages between the plates. This increased the speed of the passage of air, which rapidly pulled the colder air from the exterior via the feed-pipe, warmed it between the plates, and passed it up through the apparatus. The heated air was drawn up and collected in receiver pipes, which then transmitted it around the church. The boiler, along with the fireplace in the north transept, were connected to the chimney, seen externally extending out of the north side of the chancel roof. The coal-fired boilers clearly went out of use sometime in the 20th century, to be replaced by a modern boiler, the base of which was visible in the south-eastern corner of the boiler room.

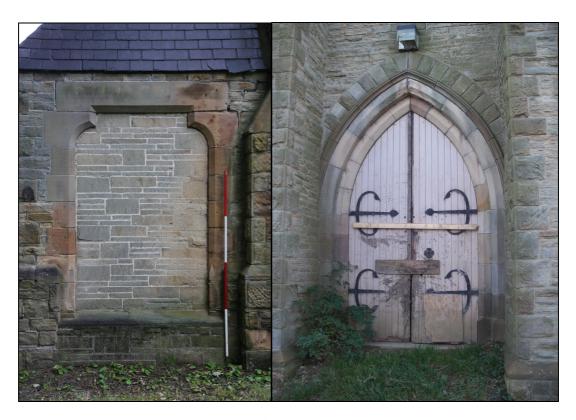
Plate 19: blocked doorway to narthex (left) and doorway into church tower lobby (right) (© Stubbs Family⁸)

- After the narthex was built, another doorway was added on the south side; this does not appear to have been the main access point to the church after the construction of the extension, which was served by the access door to the lobby of the tower (see below), and probably only served as a back door to the church, before it was blocked with modern stonework (Plate 19). The doorway has ashlar quoins with chamfered edges which extend to the lintel.
- 5.22 The main access, after the blocking of the door into the narthex, appears to have been through the doorway into the lobby of the church tower (Plate 19). The modern security measures make this door

very difficult to see, but a photograph posted online shows it to be a panel door with elaborate trident-style hinges. The door surround mirrors that of the main church door on the west side, without the hoodmould. Internally the door frame is heavily braced, ornate iron hinges and lock mechanism with cross detailing (this has been removed but the stain from its location still exists). Internally, both the internal door arch and the doorway through to the nave are pointed arches in chamfered sandstone, with flattened brick and sandstone arches above the recesses.

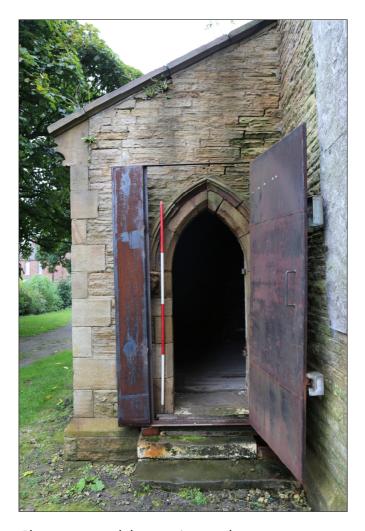
5.23 The exterior doorway to the north transept has a pointed chamfered arch, with chamfered ashlar quoins, and a hoodmould and headstops (Plate 20). The original door has long been removed and replaced with a modern steel door to stop access to the church. Internally the door sits within a recess with a flattened arch and sandstone quoins. The internal doorway through to the church replicates the structure of the external doorway, but with alternating brickwork between the sandstone in the flattened arch. The internal door on the church side also has a hoodmould, with a scrolled headstop, with chamfered sandstone quoins.

Plate 20: external doorway into north transept
