ARCHAEOLOGICAL WATCHING
BRIEF REPORT

THE NORTH OF ENGLAND
LEAD MINING MUSEUM

KILLHOPE, COUNTY DURHAM

NAA 12/78
August 2012

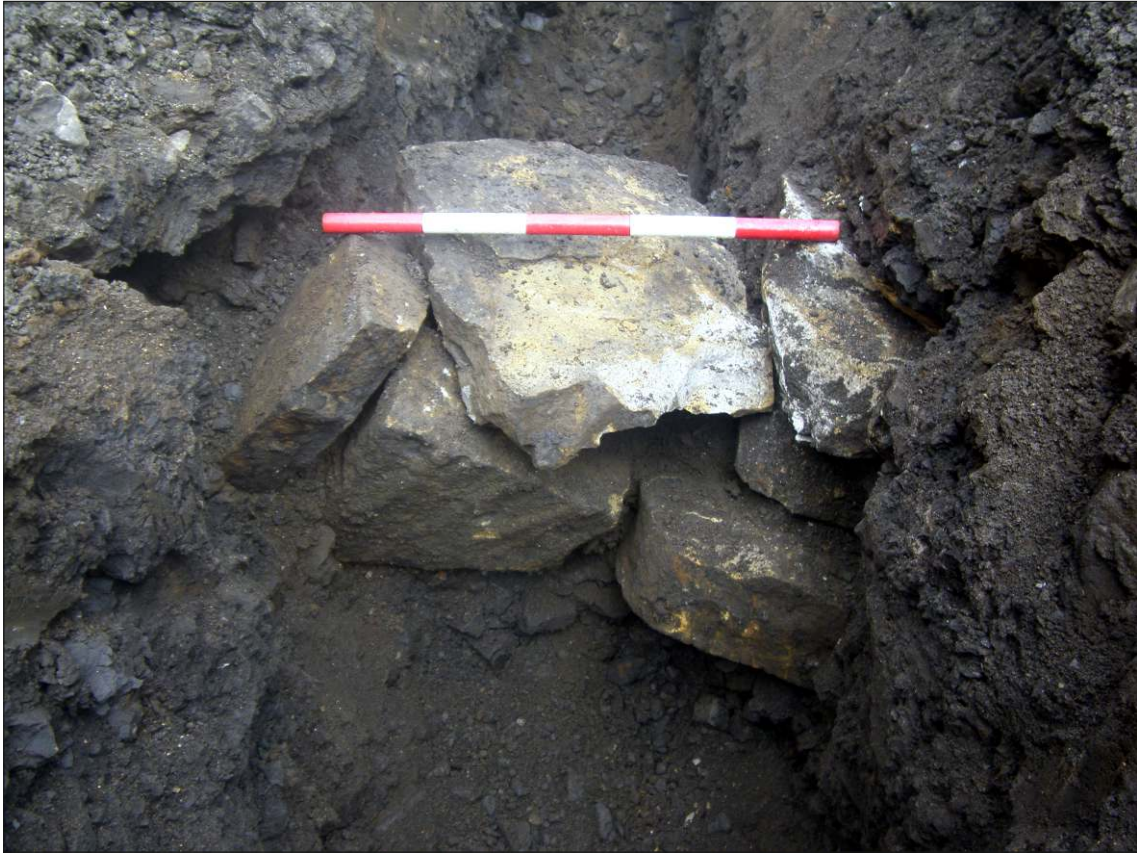
Plate 3

- 6.5 A rudimentary wall foundation (11) had been cut into the shale deposit described above (Plate 3). It was composed of three rough courses of undressed sandstone with no bonding material, stood to a height of 0.4m and measured 0.48m in width. The wall footing was aligned with the north-western wall of the mine shop, but was too insubstantial to form a structural element of the building. It may have enclosed a yard in front of the building but no opposing wall was identified within the excavated trench. The wall remained *in situ* as the protective duct for the water main was inserted beneath without causing any damage.

*North of England Lead Mining Museum, Killhope:
wall foundation 11, south-east facing elevation*

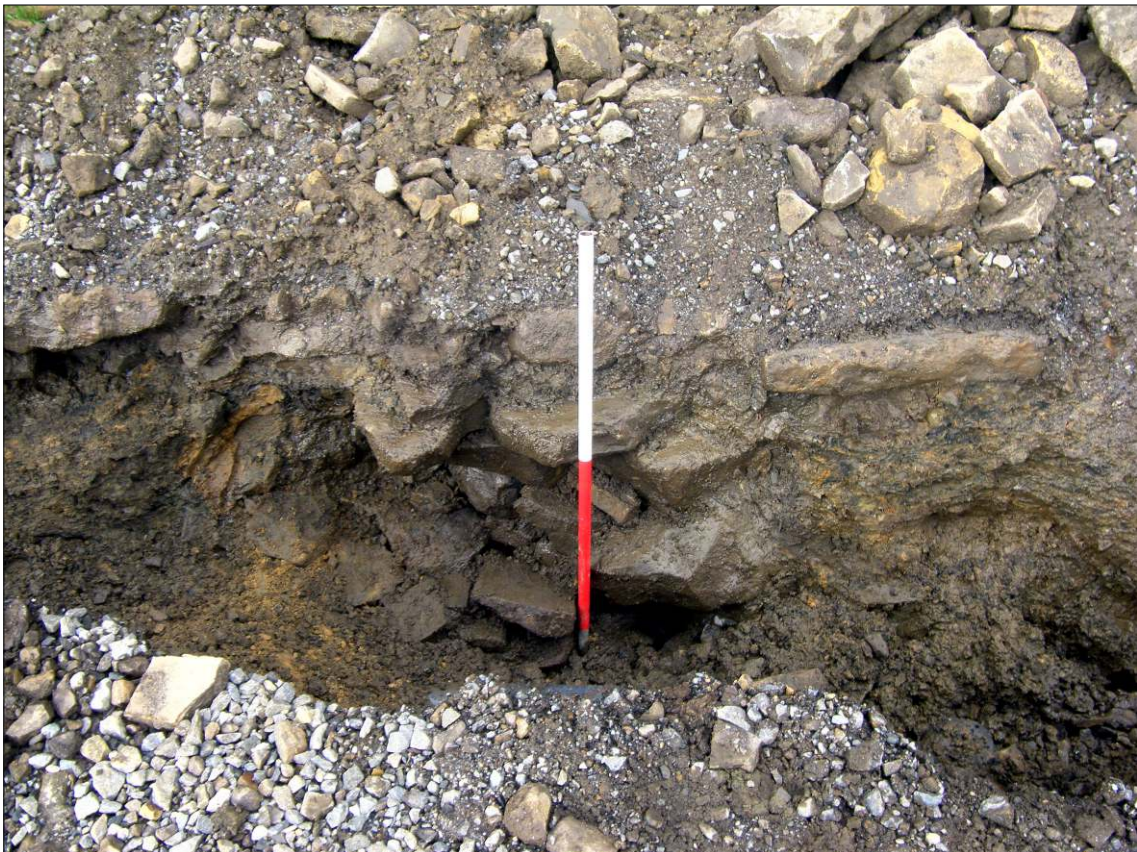
Plate 4

- 6.6 The remains of a further wall foundation (15) were encountered to the south-east of the mine shop in the north-east facing section of the excavated trench (Plate 4). It stood to a height of 0.68m with a width of 1.38m and was composed of four rough courses of undressed sandstone blocks, which varied in size from 0.1m by 0.1m by 0.05m to 0.5m by 0.2m by 0.3m. There was no formal bonding material but dark brown sandy clay (17) was present in some areas between the stones and appeared to have leached in. The wall footing followed the alignment of the reconstructed retaining wall along the north-western edge of the washing floor and may have been the precursor to this wall extending further to the south-west. The north-western face of the wall foundation had been cut into boulder clay (04), whereas the opposing face was abutted by loose deads (02). This would indicate that perhaps the washing floor originally extended further to the south-west and that the area had been significantly landscaped prior to the construction of the made path for visitors during the early 1980's.

*North of England Lead Mining Museum, Killhope:
wall foundation 15, looking south-west*

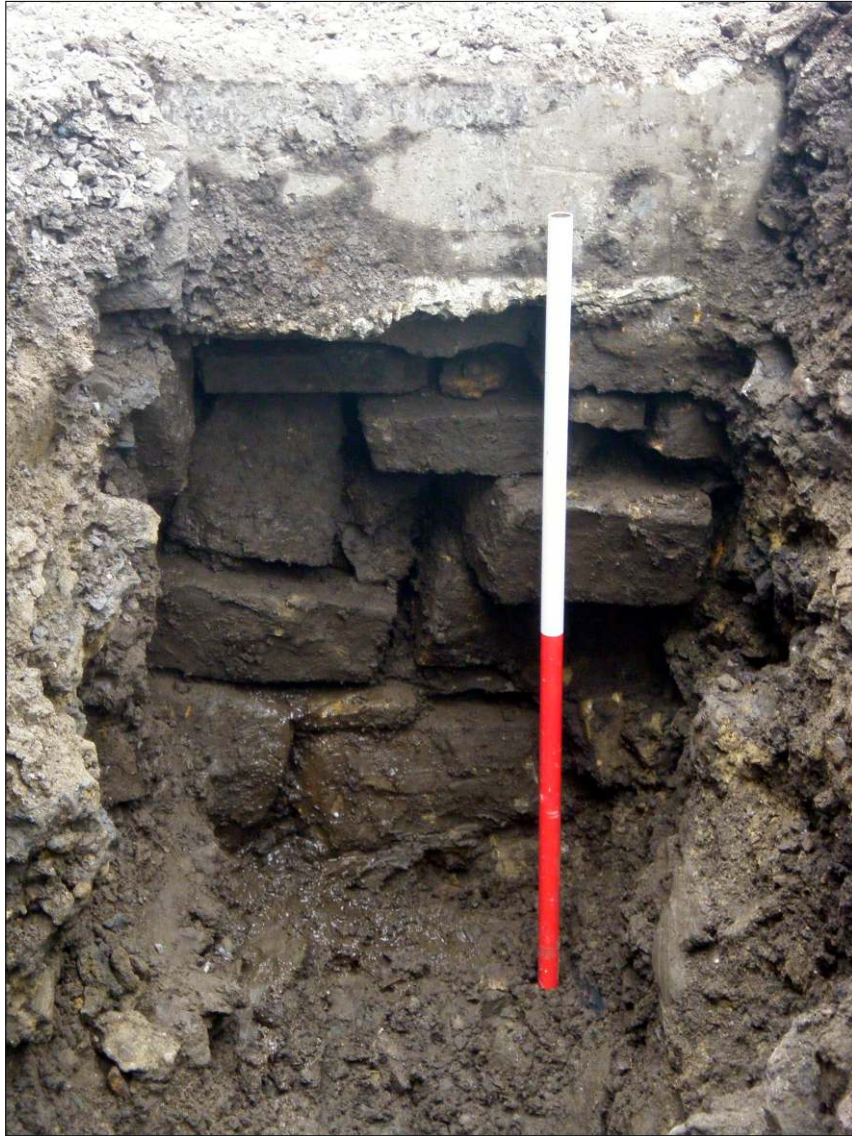
Plate 5

- 6.7 The course of the water main crossed two stone-built culverts within the area of the made path. One culvert (09) was located in front of the mine entrance and carried run-off water from within the mine down to the washing floor (Plate 5). It was contemporary with the use of the mine and comprised a linear stone built chamber, oriented from south-west to north-east, which encased a wooden launder carrying the water. The stone element of the culvert measured 1.2m in width by 1m in depth and was composed of six rough courses of undressed sandstone blocks measuring 0.2m by 0.1m by 0.15m on average. There was no bonding material between the blocks but the top surface of the culvert had been covered with 0.3m of concrete to protect it from damage where the path passed over it.

*North of England Lead Mining Museum,
Killhope: rear of culvert 09, south-west
facing elevation*

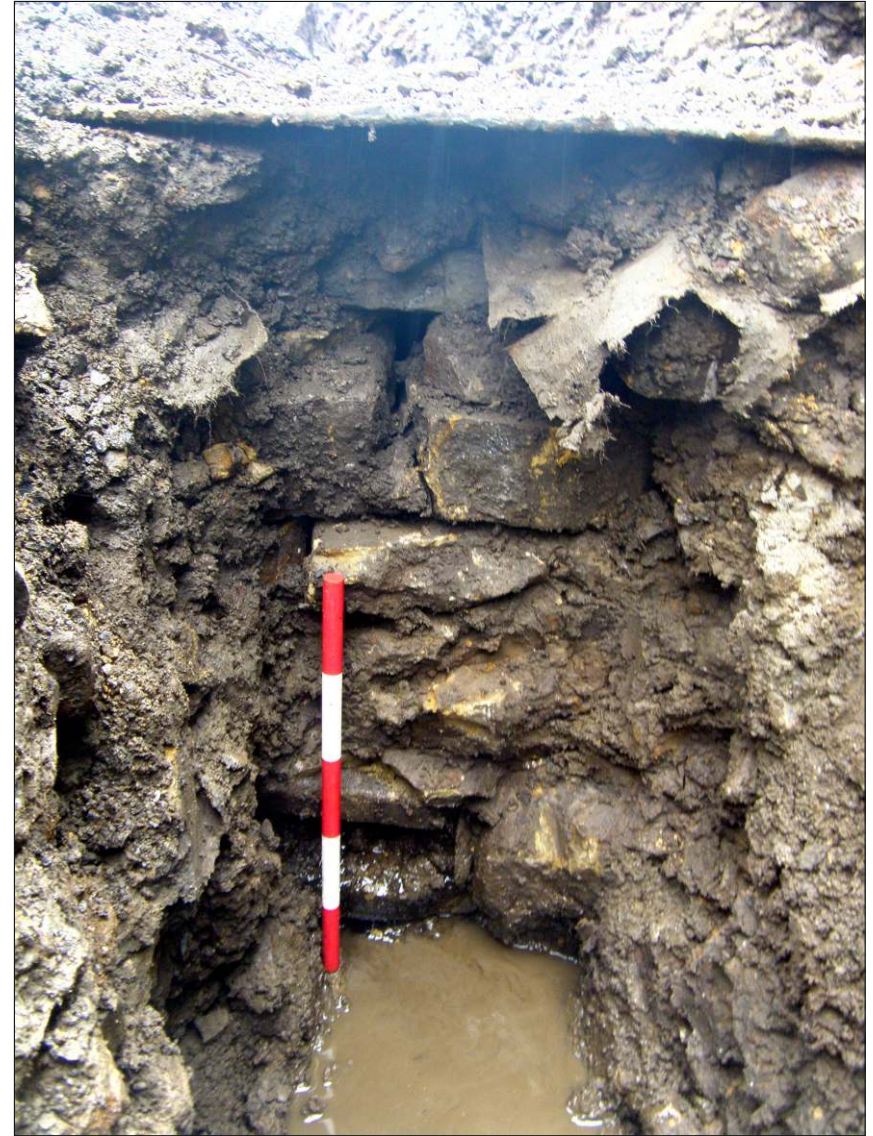
Plate 6

- 6.8 The other culvert (07) was located to the south-east of culvert 09 and was on broadly the same alignment (Plate 6). This culvert had been built during reconstructive works in the early 1980's, presumably to replace an existing drain that was too ruinous to function, and formed part of a circular water system that fed the water wheel on the jigger house from reservoirs further up the hillside. It was of similar dimensions to the previous culvert but comprised only the sandstone chamber, without a wooden launder. It was capped by an iron road-plate where it passed beneath the made path.

*North of England Lead Mining Museum,
Killhope: rear of culvert 07, north-west
facing elevation*

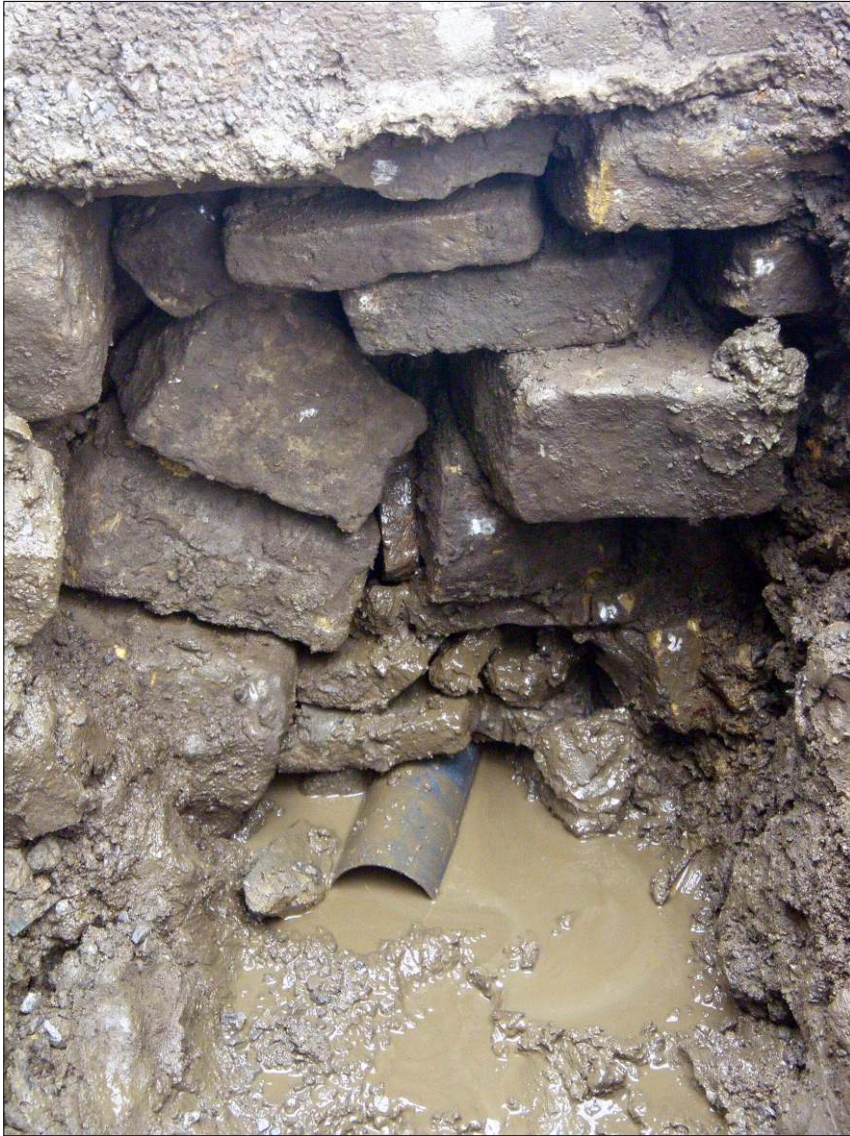
Plate 7

North of England Lead Mining Museum,
Killhope: culvert 7 with pipe duct

- 6.9 Due to the depth of both culverts (07 and 09) it was impossible to pass the duct for the water main beneath the stone superstructures. Instead, in each case a couple of sandstone blocks were removed from each face of the culvert and the duct was passed through, causing minimal disturbance to the integrity of the structure (Plates 7 and 8).

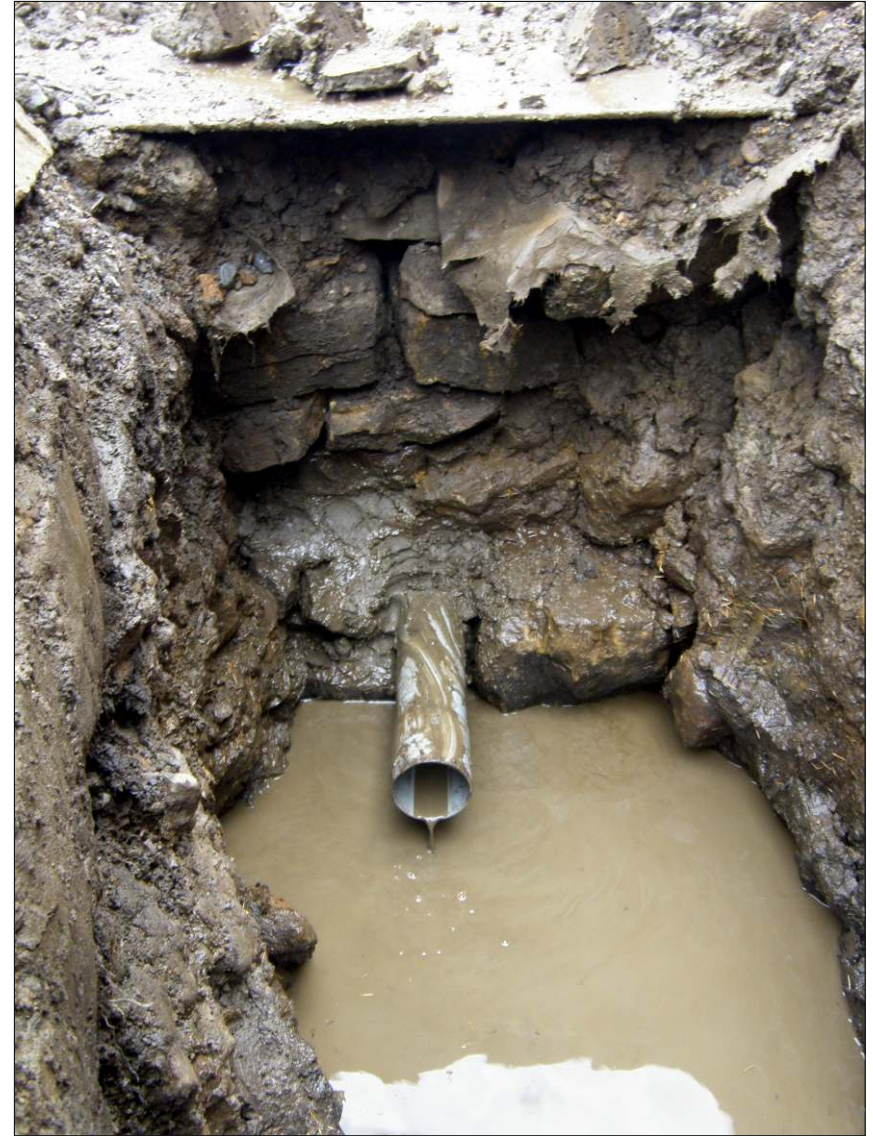
Plate 8

North of England Lead Mining Museum,
Killhope: culvert 9 with pipe duct
