BUILDING RECORDING

THIRLEY COATES FARM  
HARWOOD DALE  
NORTH YORKSHIRE

Report No: **NAA 19/07**

# THIRLEY COTES FARM, HARWOOD DALE, NORTH YORKSHIRE

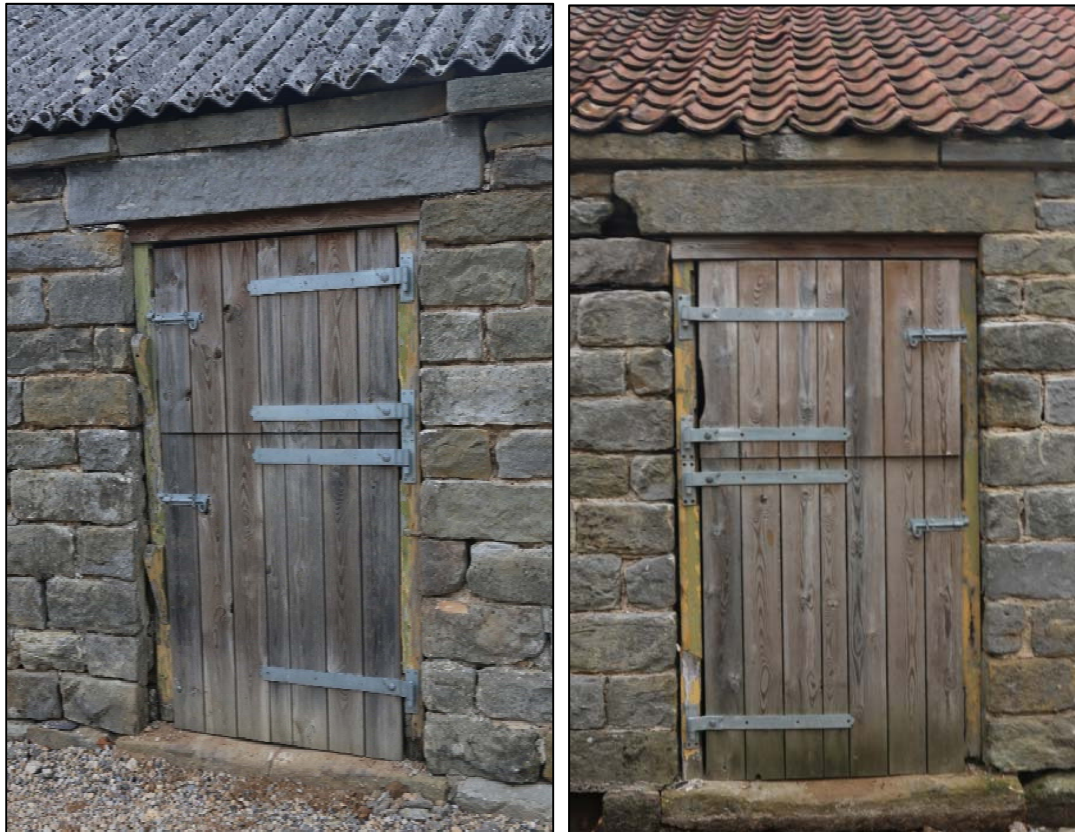
- 5.17 The lintels above doors 102 and 401 have a broken corner: the lower north corner on 102 and the lower south corner on 401 (Plates 17 and 18). These appear to have been broken during quarrying or extraction prior to erection and are not considered to be indicative of reuse.

*Plates 16 and 17: oblique view of door 202 with the wooden latches (in yellow) on the left side of the door frame (left) and door 401 showing broken lintel (right).*

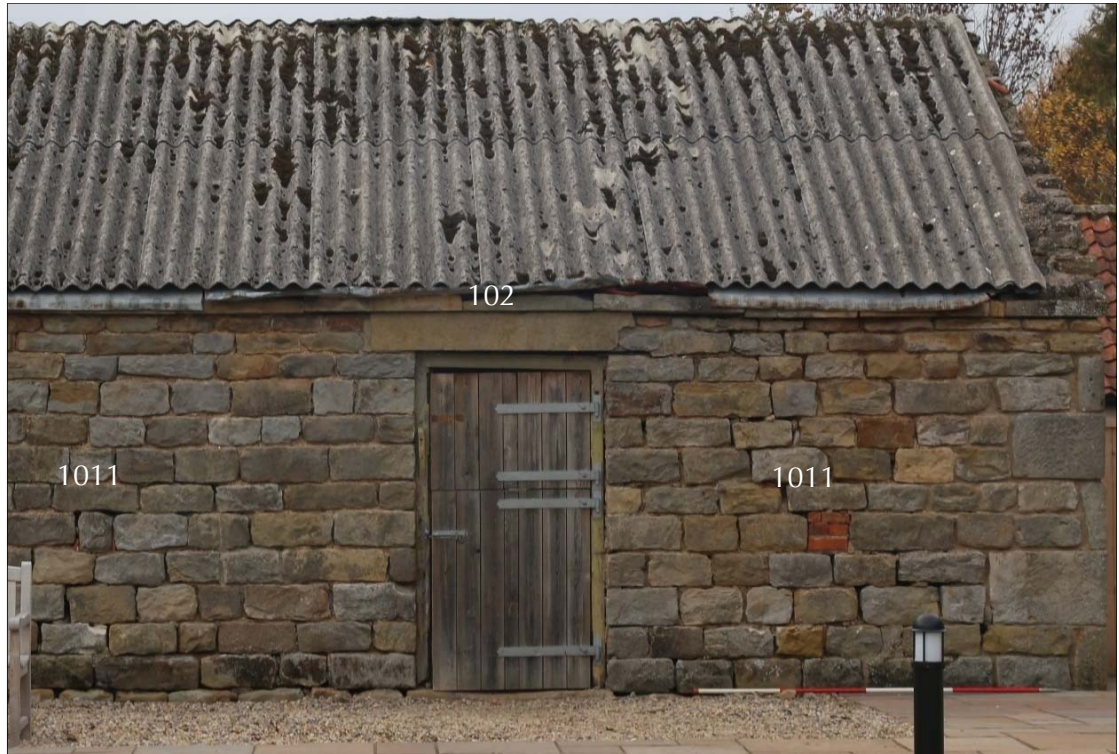
*Plate 18: broken lintel above door 102 of the east elevation. On either side of the door are filled niches 1011; the north one is filled with brick, the south with stone.*

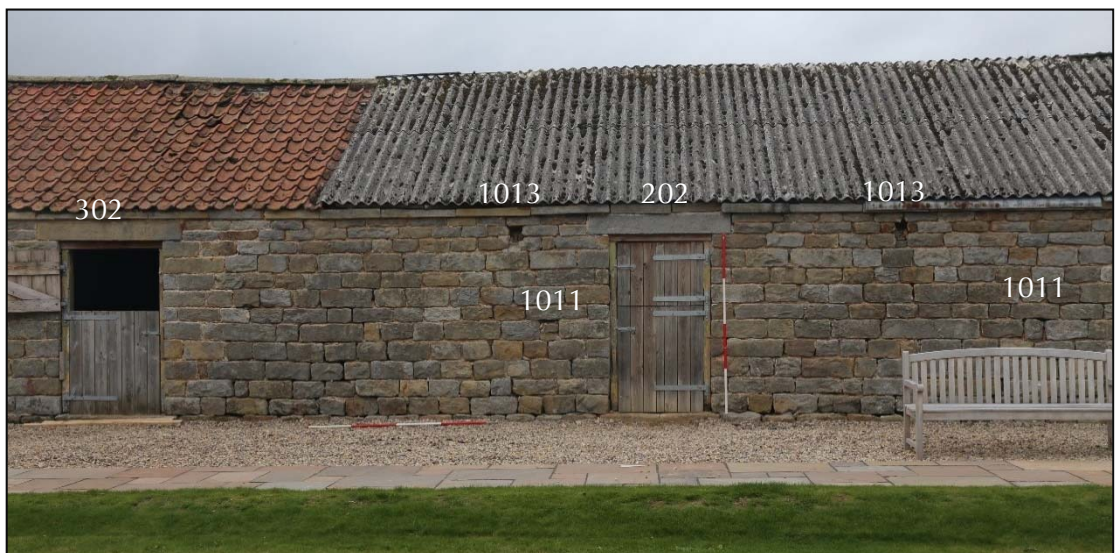
*Plate 19: centre of the east elevation (1010) of the west range. Visible ventilation holes (1013) flank door 202.*

- 5.19 There are two further openings (1013) just below the eaves line at the north end of the building, probably associated with ventilation (Plate 19). The evidence therefore suggests that there was a specific activity being undertaken at this end of the building, although the nature of this is not clear.
- 5.20 On the east (courtyard) side of the range a stone foundation course projects forward of the wall (Plates 16, 18 and 19) but there is no evidence of a cobbled or flagged walkway like that associated with the south range (2301). Instead, the modern gravel surface laps up against the wall footings.

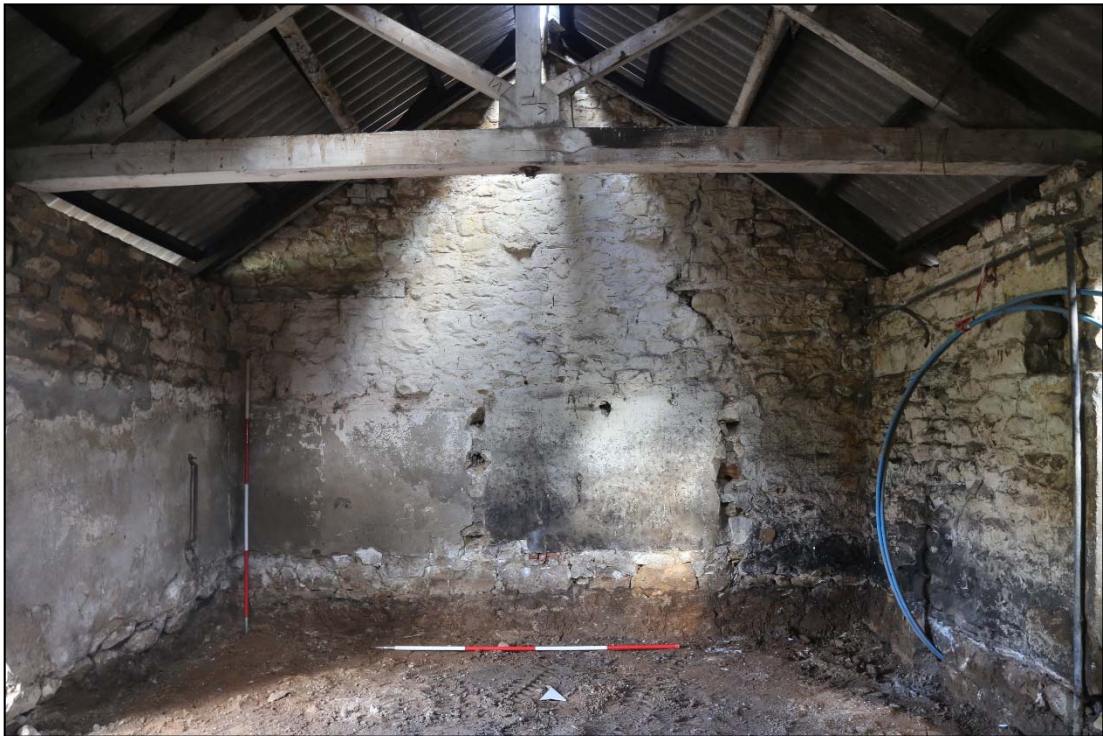
*Plate 27: north wall of room 100. Linear joist holes (111) are visible as scars on the wall. Two horizontal timbers (110) are visible in the wall above the joist holes.*

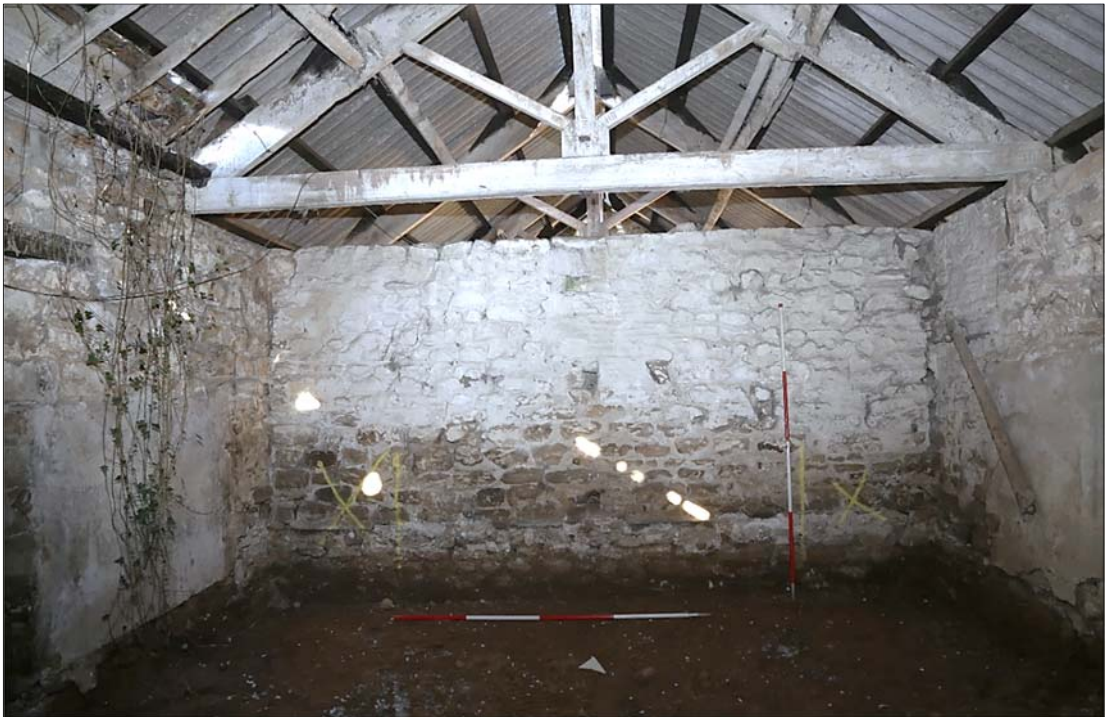
*Plate 31: north elevation of room 200. A line of joist holes visible in the centre of the north wall are associated with former stall divisions. Render is visible on both the east and west walls.*

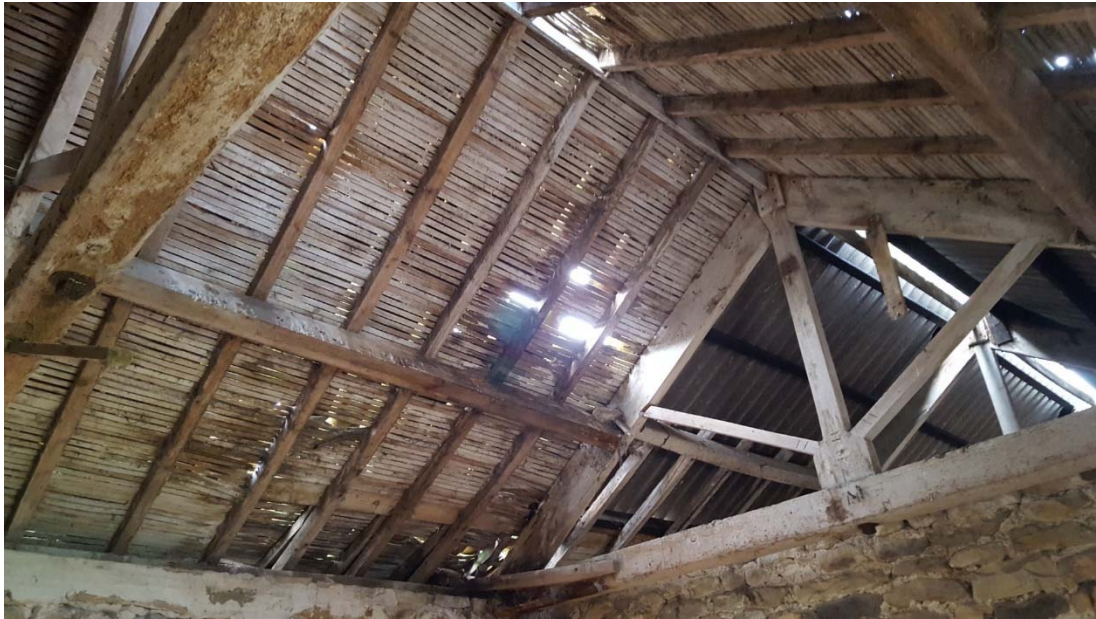
- 5.34 The south-central room measures 5.0m by 5.5m and is rough rendered in places rather than lime washed, indicating phases of repair. The room has two trusses (108); the north one, marked 'II', is located 0.2m south of the north wall. This marks the division between pantile and later corrugated metal roofing. The southern truss is marked 'I' and supports what appears to be the original lath and plaster work (Plate 32).

*Plate 32: division between corrugated iron roof and lath and plaster roof in room 300.*

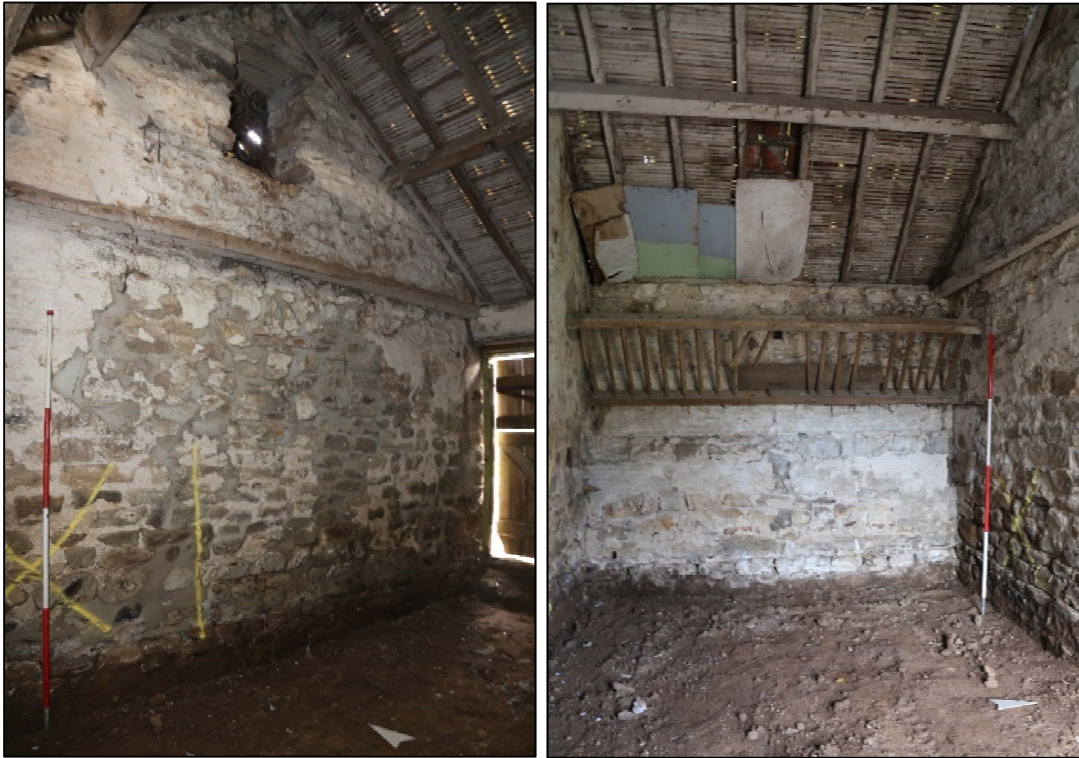
*Plates 36 and 37: (left) oblique view looking north-east along the north wall, room 400 (loose-box). The former floor beam is clearly visible, as well as window (405) set below the apex; and (right) looking west towards the hay rack (402) and trough remain (403).*

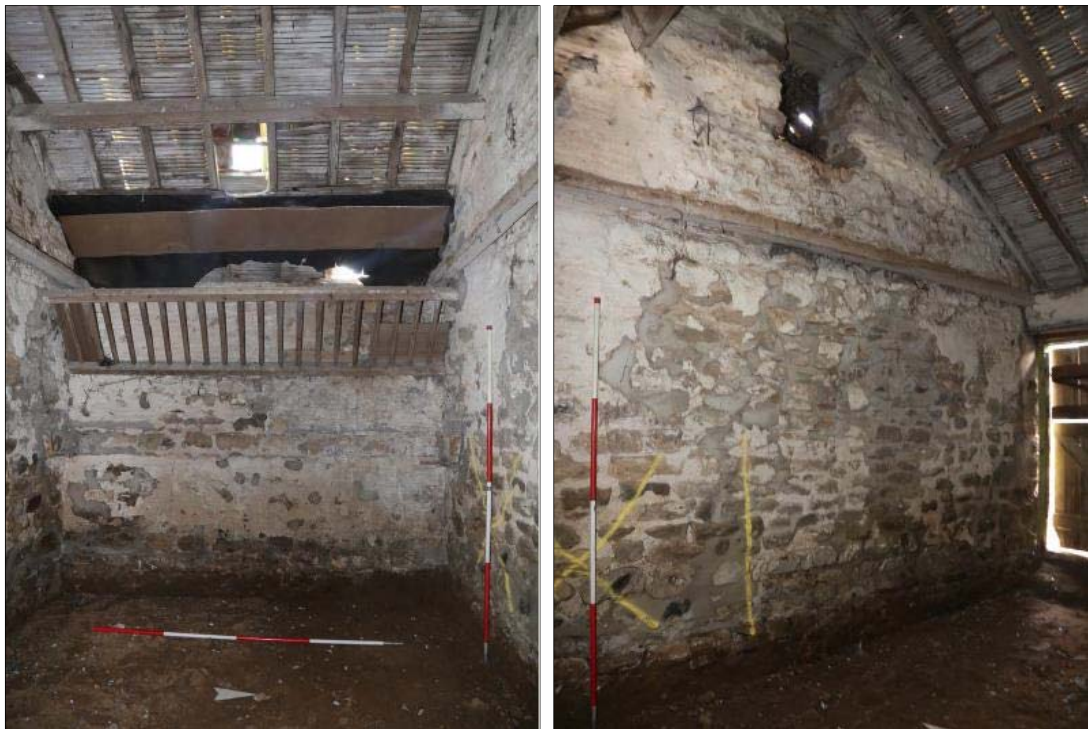
*Plates 39 and 40: view of loose box 500 looking west showing in-situ hay rack (502) and oblique view of north dividing wall, showing opening 405 providing access between the two rooms at this level, as well as ventilation.*

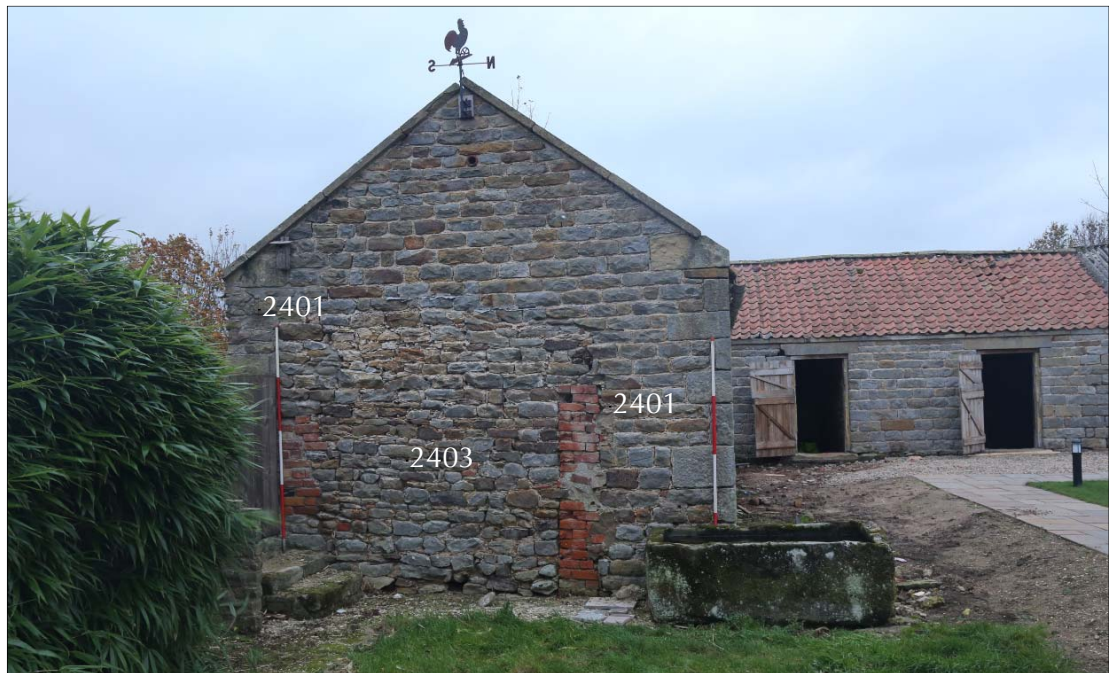
- 5.47 There is clear evidence on the east end gable of a former structure extending east from the existing range (Plate 44). There are two vertical wall scars (2401) set slightly to the south of the centre of the gable. Between these two elements is a section of rubble-built infill (2403) which highlights a cat-slide roof scar. These elements suggest that the missing structure originally formed an integral part of the extant range. The footings of the demolished building remain visible, extending east toward the farmhouse. The 1912 OS map shows a building in this location incorporated into the south range. It is still shown on the 1953 modern OS but was demolished prior to 2010 (Fig. 4).

*Plate 44: east elevation of the south range showing the walls scar (2401) and the rubble infill (2403).*

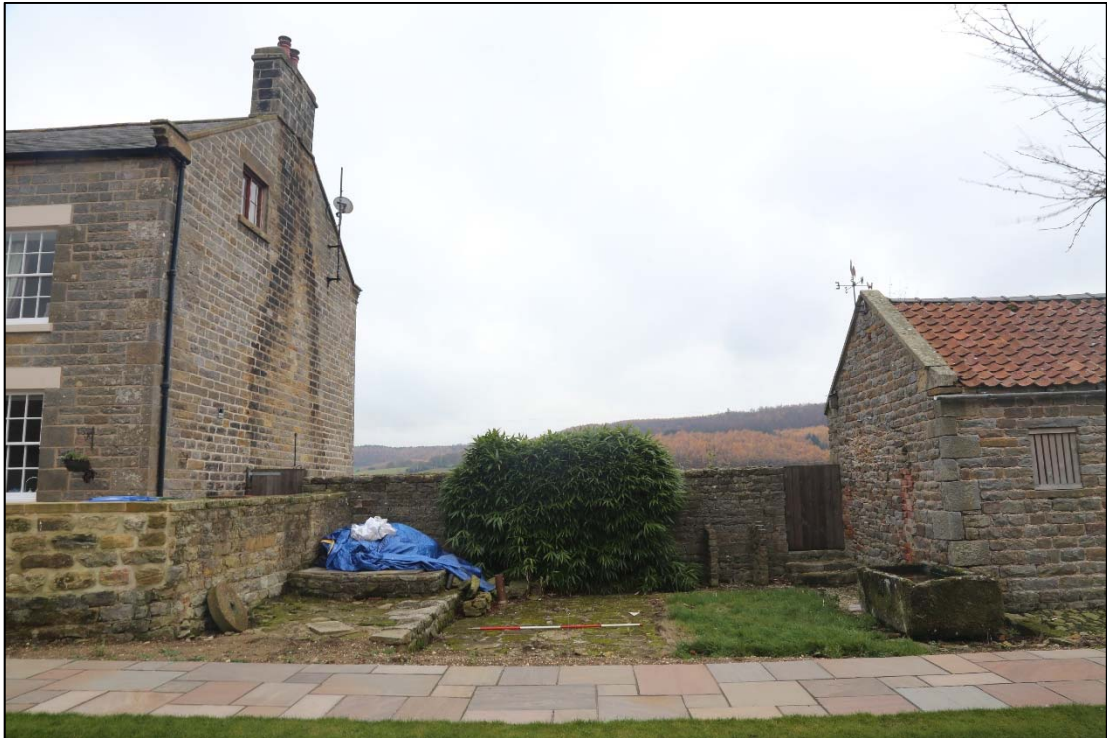
*Plate 61: building footings between the south range and farmhouse associated with the south range extension. This building may have originally served as an implement shed or pigsty.*
