BUILDING SURVEY

TWO SMALL FARM BUILDINGS AT WHAW CHAPEL

ARKENGARTHDALE

NAA 16/96 August 2016

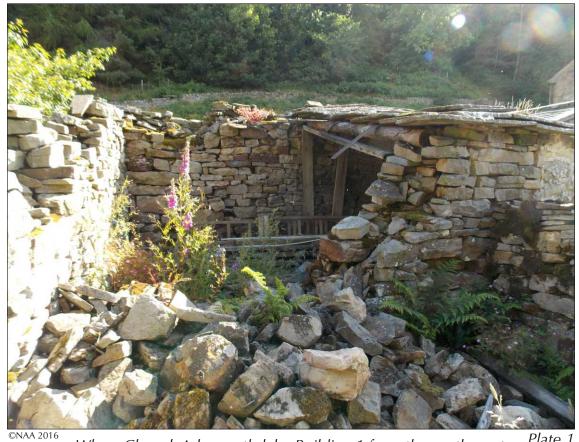
4.2 This was a single celled building with a single-pitch roof sloping to the southwest (Plate 1). Although now partially collapsed, the original structure measured approximately 6.95m (24'9") long, north-west to south-east, by 2.3m (7'6") wide, and had a maximum internal height of 2.1m. The irregularity of the ground to the exterior prevented accurate measurement of the external height. The surviving walls were constructed of two faces of irregularly coursed cobbles, some roughly shaped, with a rubble core. On the south-western wall, both faces of the central section had been mortared and pointed to provide additional stability (Plate 2). Much of the stone was gritstone, but limestone and sandstone were also present. The north-western end of the building has collapsed in the last decade, revealing that the south-western wall was not bonded into the north-western wall, instead butting against it. This suggests that Building 1 was added to an existing boundary wall.

- 5.5 The walls and roof Building 1 had suffered from several episodes of collapse and were in an unstable condition.

¹⁶ Whaw Chapel, Arkengarthdale: Building 1 from the south-west Plate 1

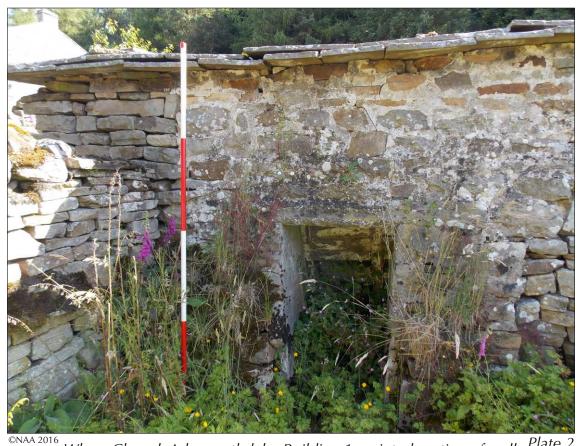
- 5.2 Building 1 appeared to have been constructed within an existing walled enclosure, utilising two of the drystone walls and adding a third, while the fourth side was open. The central section of the south-western wall of the building had been mortared on both sides, and this section also contained the buttressed sheep creep, and the two earliest roof rafters. To either side of this central section, the walling was of drystone construction and the rafters were modern machine-cut timbers.

^{4 2016} Whaw Chapel, Arkengarthdale: Building 1, pointed section of wall Plate 2

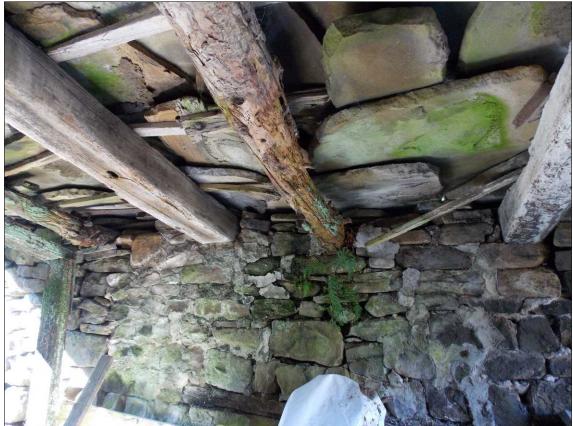
Plate 3

- 4.4 The floor of Building 1 comprised 'York Stone' sandstone flags, a typical example measuring 700mm by 600mm by 60mm thick. These were set on a thin screed of mortar, directly over the compacted earth floor. While at the time of the survey most of the flag stones had been lifted up, it could be seen that the entire floor must originally have been flagged. Like the floor, sandstone flags had been used for the roofing, which was supported on simple rafters and battens. The roof had been re-built on several occasions, but it was likely that two of the rafters were original, comprising roughly-dressed timbers (Plate 3), one retaining its natural round shape at the north-eastern end. Later additions comprised pine trunks complete with bark, and modern machined timbers. The battens were similarly a mixture of old, hand-made elements and modern replacements. Most of the roof flags had originally been pinned with wooden pegs, although few were extant.

- 5.3 This variation in building technique might indicate that a small, almost square building had later been extended for a change of use. The whole structure had been re-roofed at least once, such that the pegs in the individual roof flags were either missing or no longer in contact with the supporting laths.

Whaw Chapel, Arkengarthdale: Building 1, roof joists

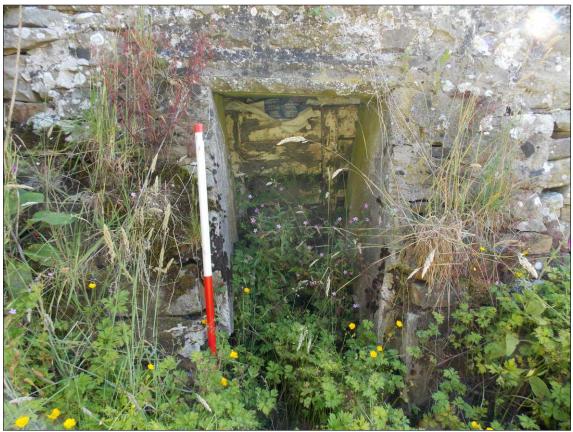
Plate 4

- 4.5 The only surviving access into Building 1 was a 'sheep creep' set between two external raking buttresses on the south-west elevation (Plate 4). Both the inner faces of the buttresses and sheep creep had been rendered to provide additional waterproofing. The access measured 0.7m wide and 0.9m high on the inner face, although the land surface to the south was some 0.35m lower than the internal floor, resulting in an outer height of 1.25m. The adjacent enclosure here had a sunken appearance, which has been suggested to represent the site of a sheep dip.

- 5.4 There had been some speculation that this building was the remains of a covered sheep-dip (Lewis 2016), but the flagged floor with no visible pit, and the small aperture of the sheep-creep, suggests that this was not the case: the latter would have restricted the movement of sheep exiting the building. The presence of a depression within the adjacent yard, thought to be an external sheep dip, suggests that the narrowness of the sheep-creep was intentional, to control the rate at which sheep arrived at the dip.

Whaw Chapel, Arkengarthdale: Building 1, sheep creap

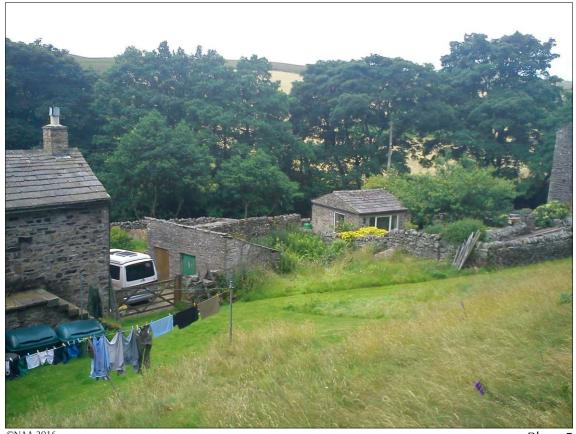
4.6 This was a double celled building with a single-pitch roof sloping to the northwest (Plate 5). Externally the structure measured approximately 5.07m (16'2") long, north-east to south-west, by 3.4m (11'2") wide, and had a maximum external height of 3m. As the ground rose to the north-east, the building was effectively partly sunk into the hillside at its north-east end. The walls were 0.5m to 0.6m thick, constructed of two faces of mortared and pointed, irregularly coursed, roughly shaped blocks (Plate 6), presumably with a rubble core. Externally, the northern corner of Building 2 was cracked, and several stones had fallen out. 4.7 The roof of Building 2 was composed of sandstone flags in a diminishing course, and had been re-built using modern, machine cut timbers: two purlins at 1.35m (4'6") centres, supporting rafters at 0.41m (16") centres; and then battens. As with Building 1, most of the roof flags had originally been pinned with wooden pegs, although few were extant. The apex and south-western edge of the roof had 30cm (1') wide coping stones, each up to 0.9m long. As the roof had been rebuilt, it is uncertain whether these were original, and whether they once continued along the north-eastern edge. Coping stones were absent from Building 1.

- 5.6 This structure was better preserved than Building 1, having been maintained until relatively recently as a store. However, there were several areas of cracking which might eventually lead to the collapse of the building. The walls were fully mortared and pointed, lime-washed internally, and the building had a well-constructed flagstone floor.

^{©NAA 2016} Whaw Chapel, Arkengarthdale: Building 2 from the north-east with Plate 5 Chapel on extreme right

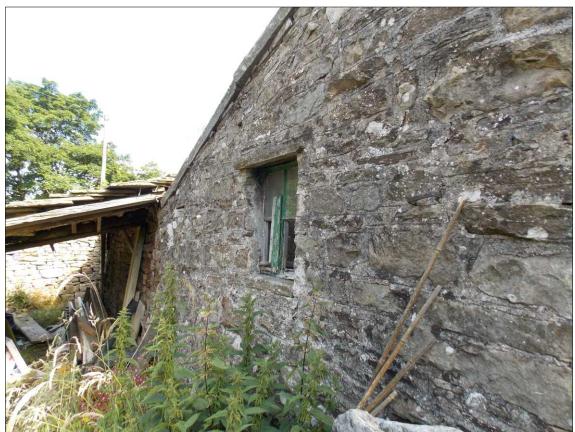
Plate 6

- 4.9 The room was lit by a single, fixed four-paned window (Plate 6) on the southwestern wall at a height 1.48m from the floor. On the opposite, internal wall was a recess (Plate 7), located towards the rear of the room some 0.75m off the floor. It measured 0.36m wide, 0.3m high and 0.25m deep, and may have housed a light. At the foot of the rear wall of Room 2A was a 'hatch' leading to the small enclosure at the rear of the building (Plates 8 & 9). In the Heritage Statement (Lewis 2016), this was interpreted as an entrance for livestock; however, its internal measurements, only 0.4m high and 0.48m wide, would preclude any livestock except poultry. The 'hatch' flared to the north-east so that it was 0.15m wider on the outer face of the wall. The top of the hatch was also corbelled outwards so that the outer aperture was higher than the inner; while this was not visible at the time of the survey, it was recorded on a photograph in the Heritage Statement (*ibid.*).

- 4.10 Internally, above and to the south-west of the hatch were the scars of a box-like structure, with a groove in the floor and walls and a plinth on the north-western and south-western walls (Plate 8). This seems likely to have been the supporting box and seat(s) for an ash or earth closet (toilet). The surviving wall above this feature was cracked and beginning to bow outwards, and there was further cracking externally around the window.

Whaw Chapel, Arkengarthdale: Building 2 showing window and stonework

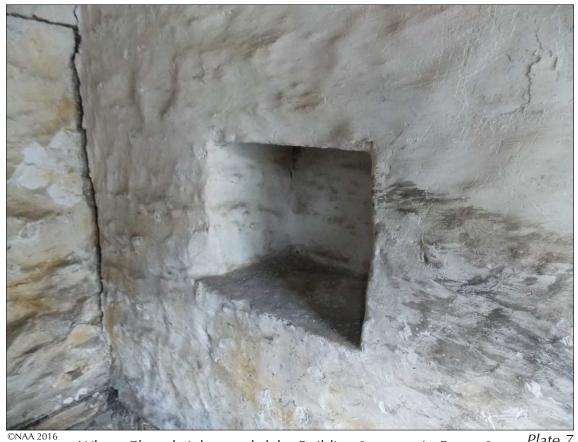
²¹⁶ Whaw Chapel, Arkengarthdale: Building 2, recess in Room 2a Plate 7

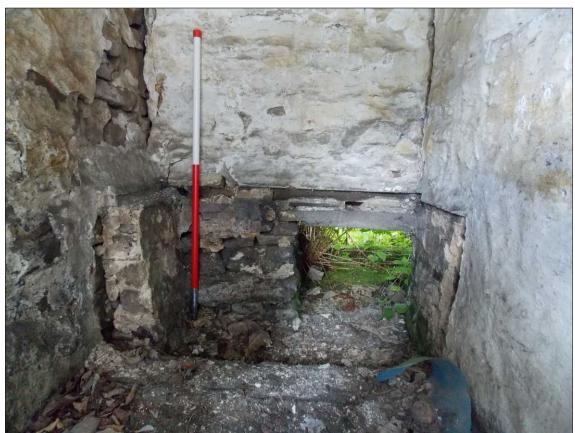
Plate 8

- 5.8 Of the two rooms within Building 2, Room 2A appears to have housed an earth closet toilet, although the internal structure had been removed. An alternative interpretation was as an animal shed (Lewis 2016), perhaps for chickens. Room 2B, with no windows, may have been a store. At some time a stove or boiler was installed, evinced by the hole in the roof flags for the stovepipe, and sooting of the walls within that part of the room. A small hole at shoulder height may have served as ventilation. This room may therefore have been used at some time as a wash house or for preparing animal feed.

Whaw Chapel, Arkengarthdale: Building 2, location of former structure, Room 2a

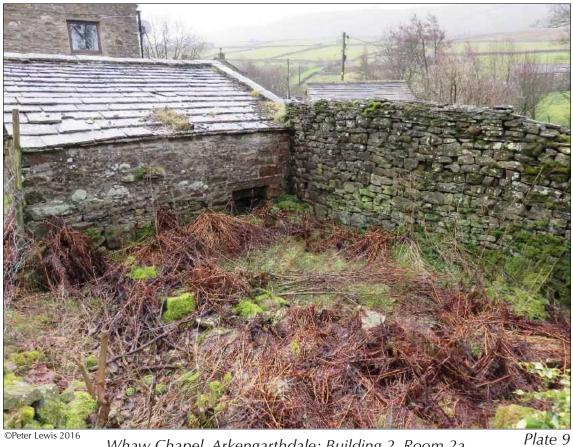
Whaw Chapel, Arkengarthdale: Building 2, Room 2a hatch from outside

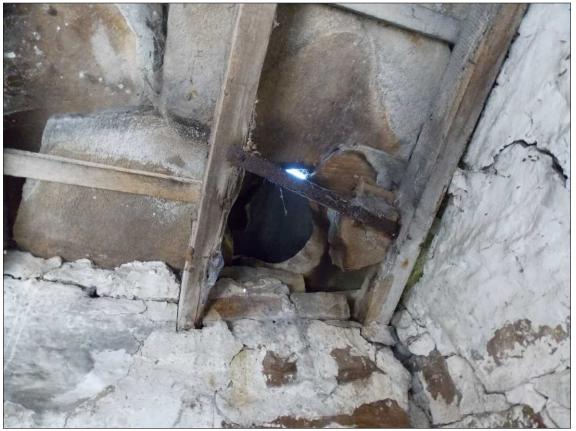
4.9 The only other feature within Room 2B was an elliptical hole, measuring 0.3m by 0.2m, cut through two adjoining roof tiles in the extreme northern corner (and subsequently covered by a thin slate: Plate 10). The walls below this hole were smoke blackened, suggesting that there had been a stove or boiler whose pipe exited through the roof.

Plate 10 Whaw Chapel, Arkengarthdale: Building 2, Room 2b, stove-pipe outlet
