ARCHAEOLOGICAL
MONITORING REPORT

THE MILBANK ARMS,
BARNINGHAM, COUNTY
DURHAM

Project No.: 1444

NAA 18-79
June 2019

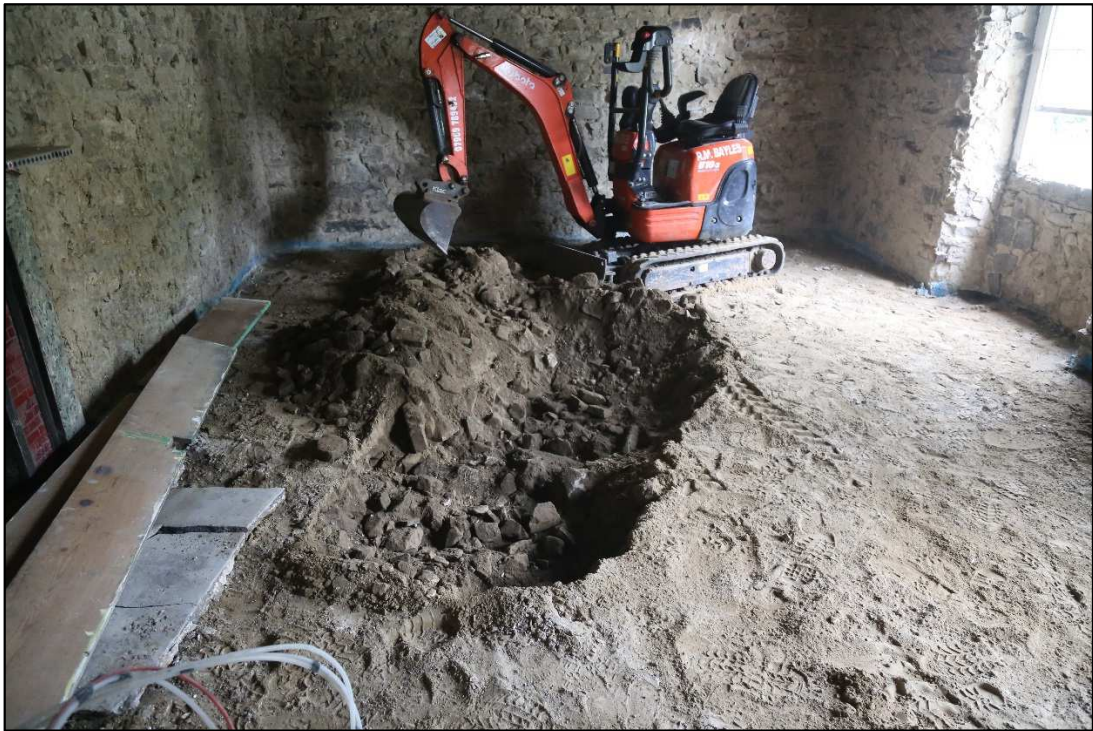
Plate 4: Test pit 2

- 6.5 This trench was machine-excavated within the eastern room of the main structure (Plate 4). It measured c.3m by 1m by up to 0.3m deep. A loose deposit of large stones (rubble) was encountered; this was overlain by up to 0.1m of sand. No significant archaeological features, deposits or artefacts were uncovered.

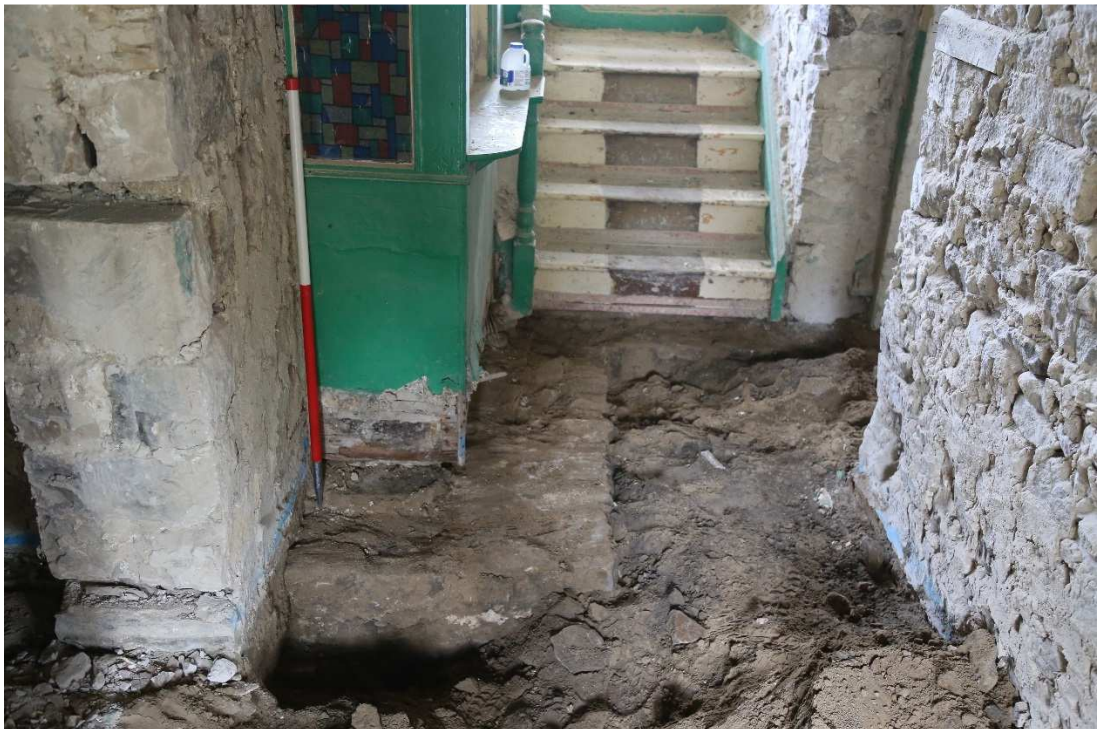
Plate 5: Wall 1 encountered within the main building

- 6.10 This wall (1) was a remnant of the original outer wall of the inn and was probably removed to ground level during alterations associated with the construction of the rear extension between 1838 and 1857. A single sherd of early 19th-century pottery was recovered from the sandy rubble infill to the east of the wall. This rim fragment was from a Yellow glazed earthenware plate or shallow dish.

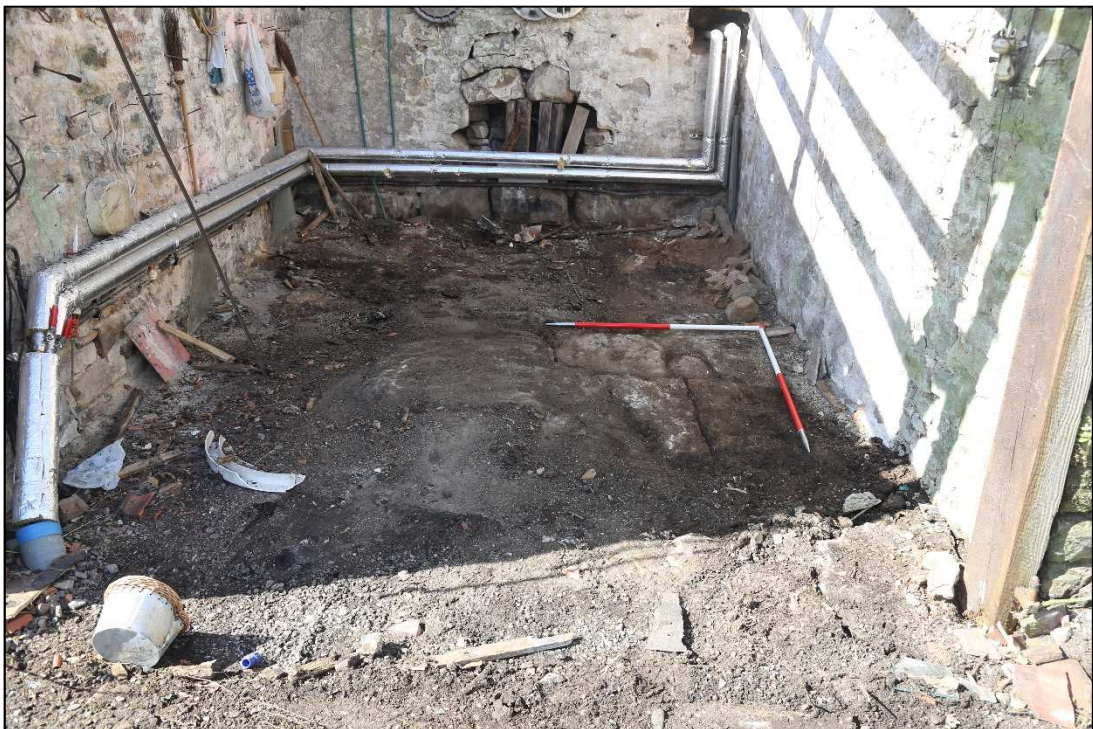
Plate 8: The garage floor and back wall

- 6.14 The remnants of an older wall or foundation was visible at the base of the rear wall. The garage construction seemed contemporary with the adjoining coal store and measured approximately 3m by 4m internally.

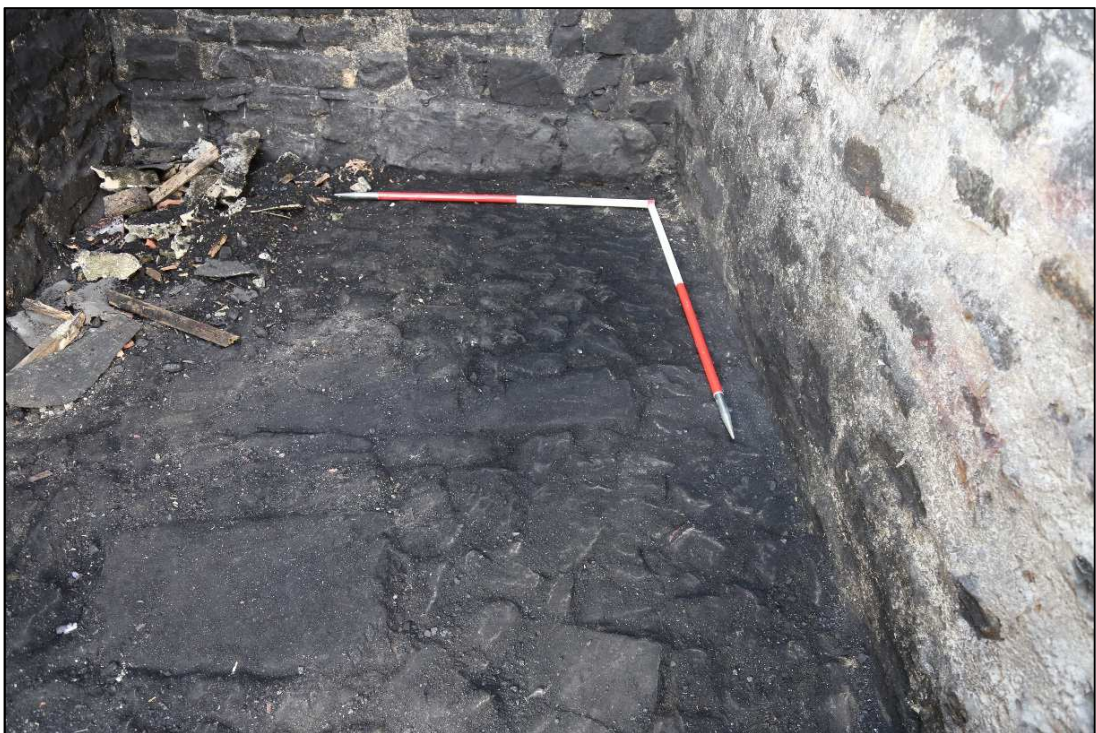
- 6.15 This room was smaller than the garage and set c.0.9m back from its western edge. It had an east-facing doorway and considering the black soot staining its floor and walls had probably been used to store coal. Internally it measured 2m by c.2.5m and had a cobble and stone floor with a diving line of stone running north-northwest to south-southeast (Plate 9).

Plate 9: Cobble and stone floor inside the coal store.

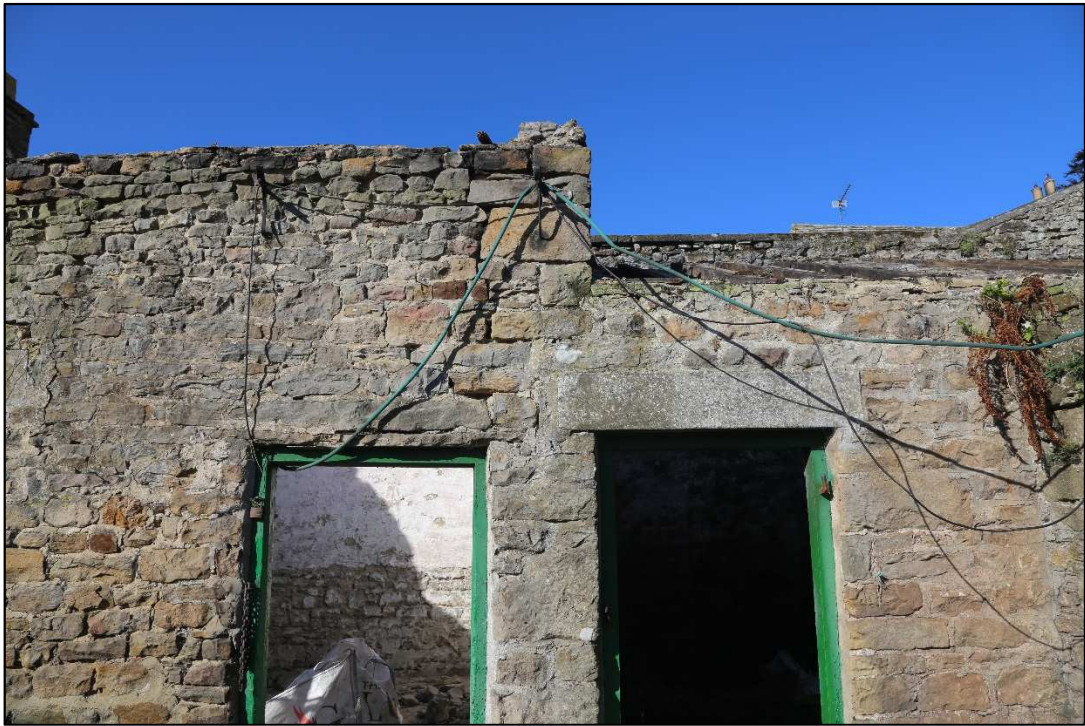
- 6.16 The line of older wall or foundation at the back wall continued approximately half way across the width of the coal store. The southern half of this wall seemed to represent a blocked former entrance. The coal store was formed by two walls that abutted the back wall and a front wall that was contemporary with the southern wall of the garage. These walls, and those of the garage, formed what seemed to be a discrete structure that was initially separate from the later structures to the south (see discussion). When the later structure was constructed, however, the front wall was keyed into the coal store wall above the door (Plate 10).

Plate 10: Point where the later 'kitchen' wall was keyed into the walls of the coal store.

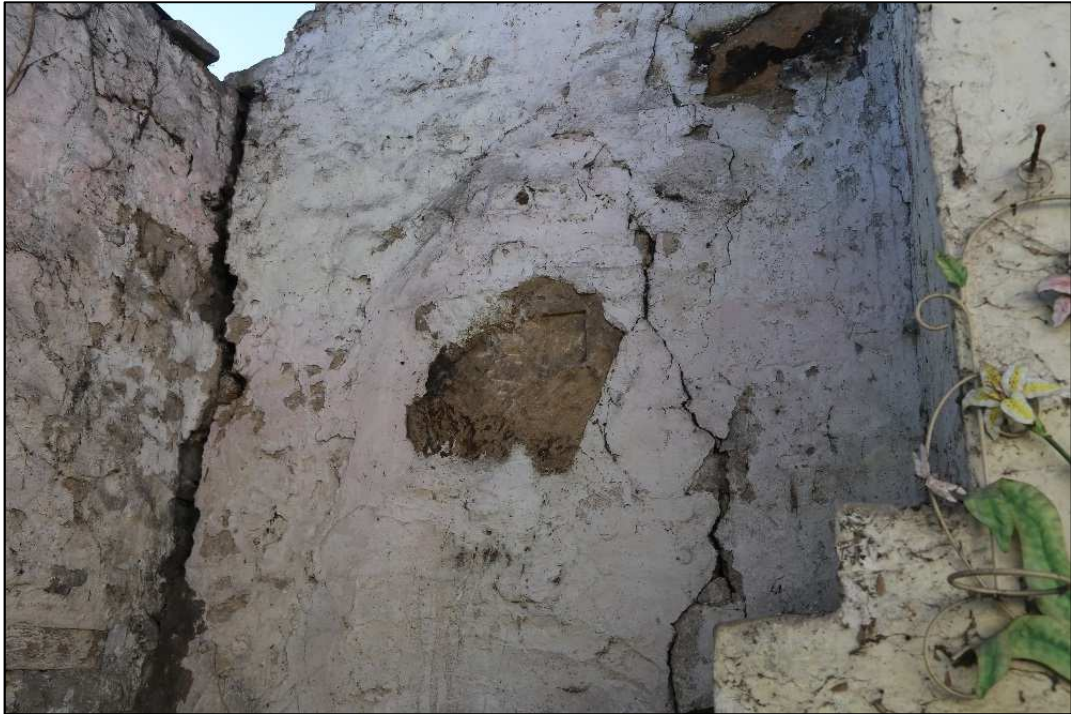
Plate 11: Reused stone within south wall of the 'kitchen'

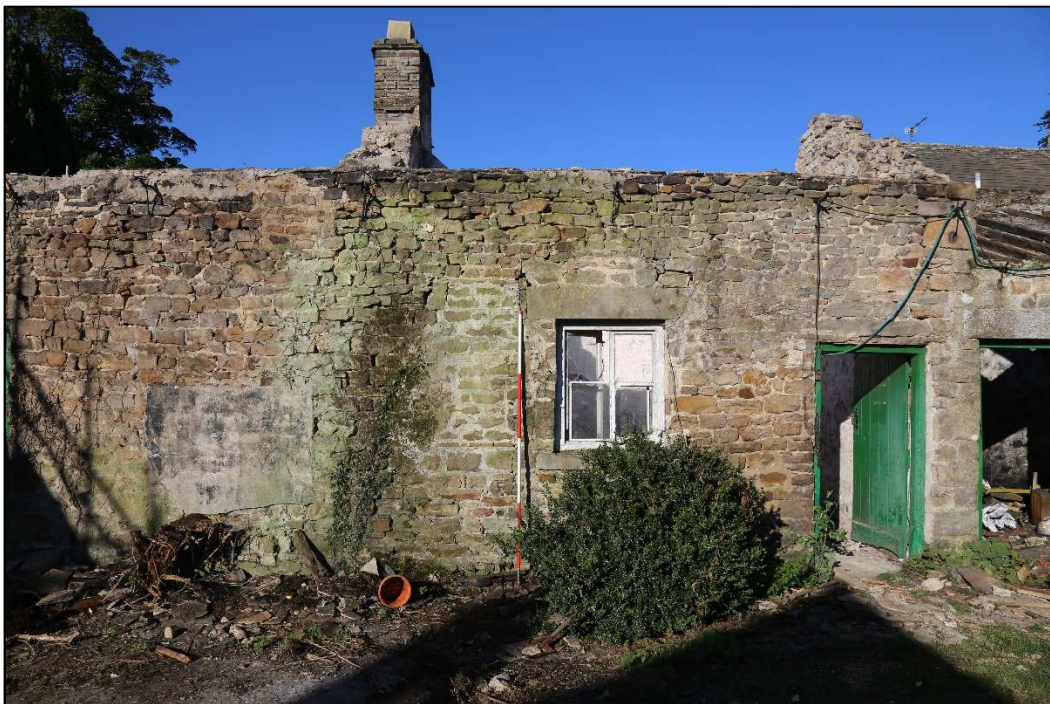
- 6.20 The scar of a blocked window visible in the front wall of this room (Plate 14) probably related to the insertion of the southern wall and the moving of the window to its present position c.1m to the north.

Plate 14: Blocked former window in the front wall of the 'kitchen'

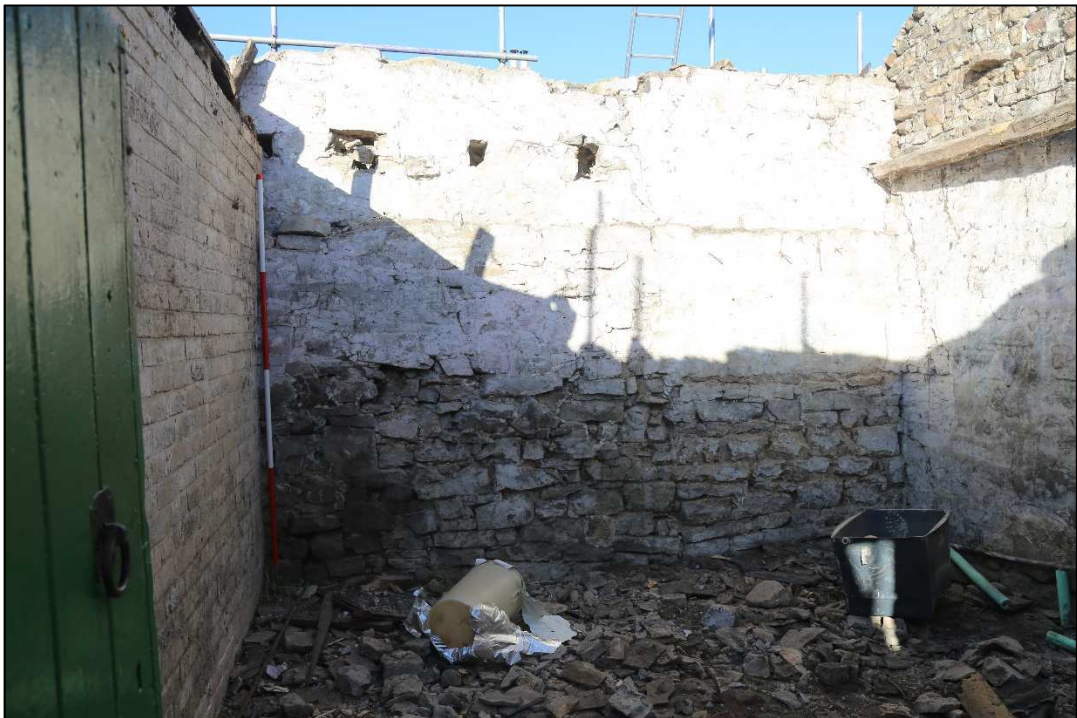
- 6.22 The floor of this room was a mixture of cobble and stone and the back (western) wall again showed indications of an earlier structure (Plate 15). The lower 2m of the back wall was c.0.1m wider than the upper section and probably represented an earlier incarnation (see discussion). The scar of an infilled former west-facing doorway was visible, extending from the north-western corner some 1.5m southwards. Above the wider section of wall slots for former roof beams were visible, a single beam remained *in situ* prior to demolition.

Plate 15: Rear wall of the store room showing early wall and infilled doorway

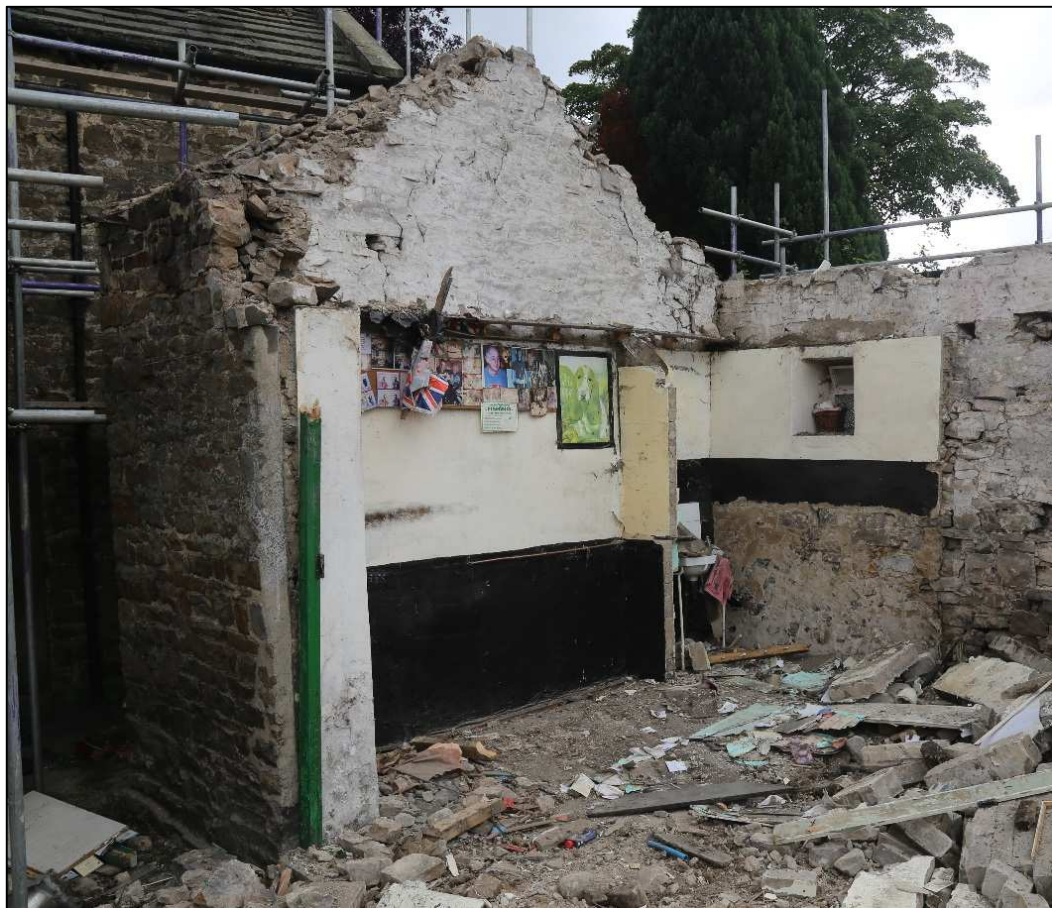
- 6.24 The latest alteration to the outbuilding prior to the development seemed to be the construction of a gent's toilet at its southern end (Plate 16). A brick wall partitioned off an area 2m by c.3.75m internally. The interior of this was plastered and a plasterboard wall partitioned off an area for a basin and toilet. During this phase of alteration, a door was added to the front (eastern) wall next to the entrance to the store room and a window was inserted into the rear wall. A drain for a communal urinal was added against the southern wall.

Plate 16: The gent's toilet partly demolished showing plaster facing and partition wall

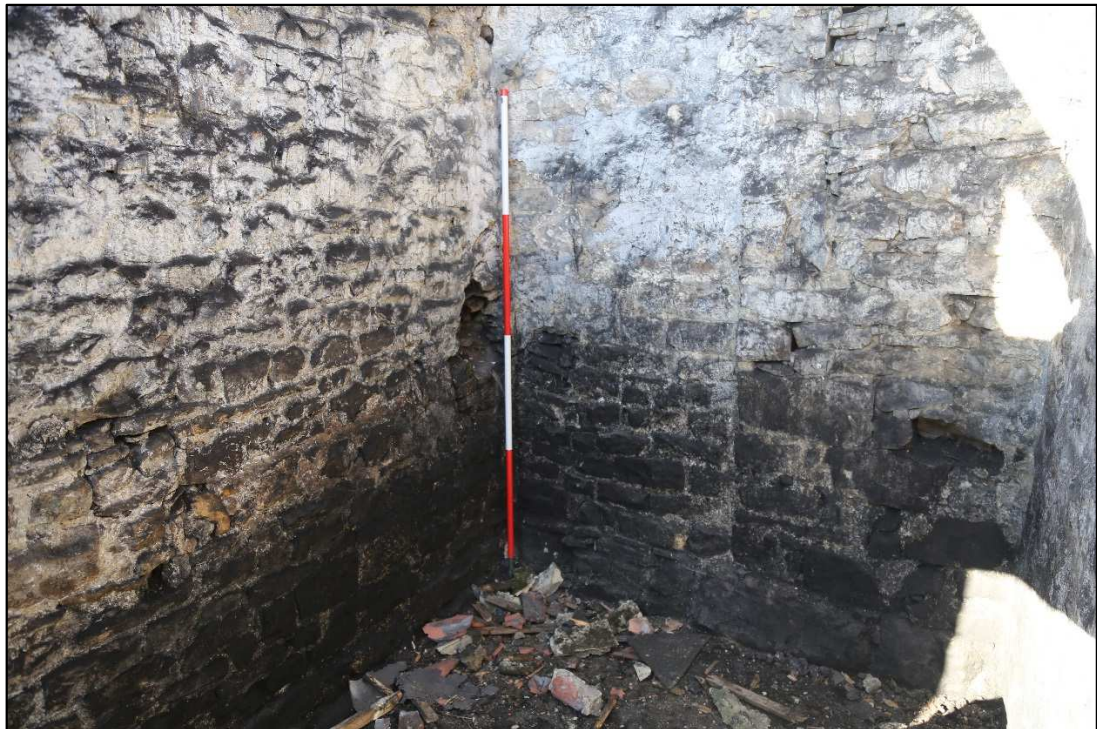
Plate 17: blocked entrance in the rear wall of the coal store

- 7.4 At some stage, the west facing doorways were blocked (see Plate 17) and the walls that comprised the garage and coal store were built up against the rear wall. Again, no other contemporary walls were apparent. The southern wall of the coal store at the time of monitoring was part of the next phase of construction (Plate 18). It is therefore unclear whether these originally extended southwards to form a structure with the wider wall element at the rear of the store room and gent's toilet. Mapping evidence (Fig. 6), however, suggested that this was the case.

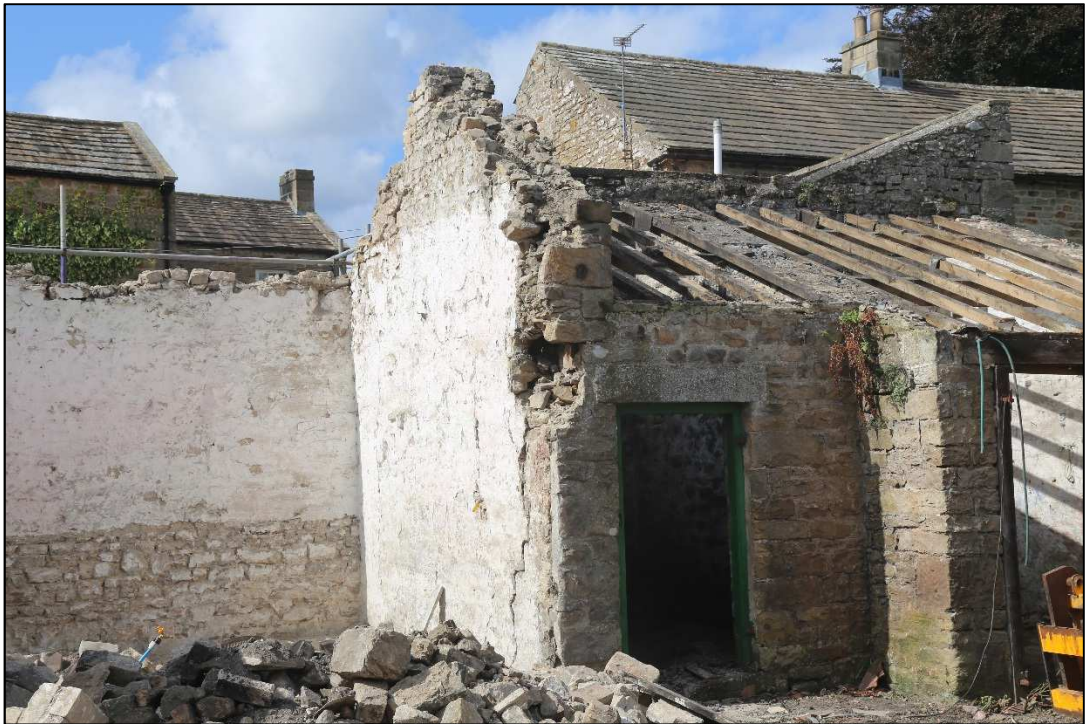
Plate 18: The garage and coal store. The crack in the southern wall indicates where the Phase III replacement joins the original wall.

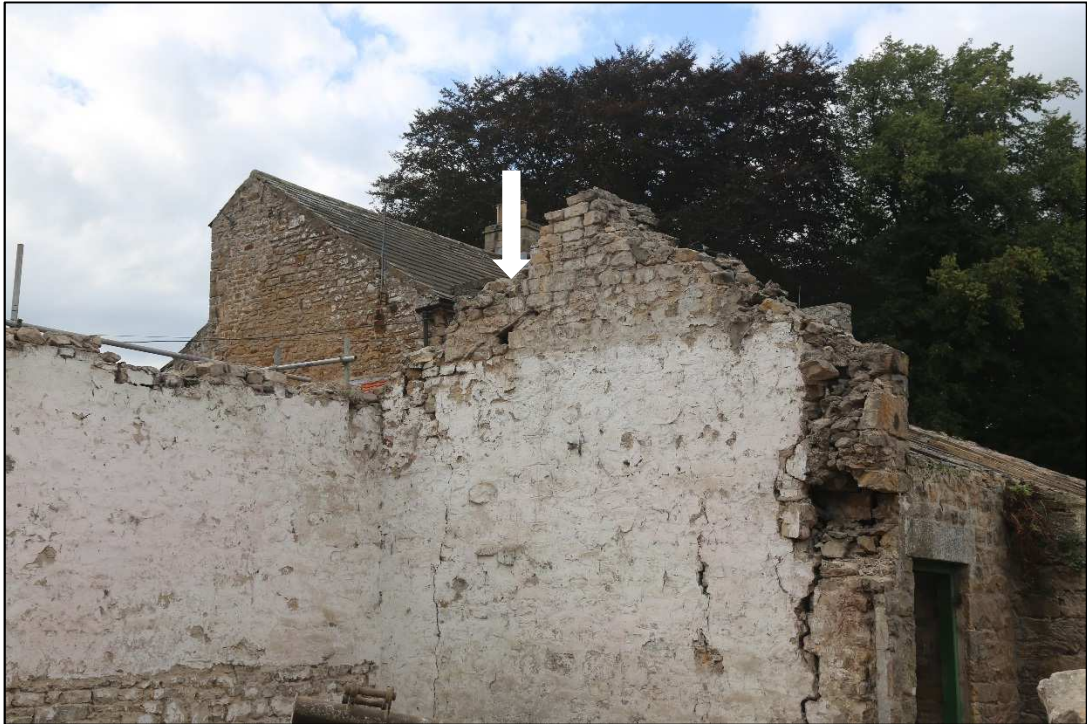
- 7.6 The outbuilding was probably lower in height during this phase. This was apparent in the front elevation along most of its length (see Plate 14) but also a remnant of a lower earlier roof was visible in the southern wall of the coal store (Plate 19).

Plate 19: The southern wall of the coal store showing the sloping remnant of an early roof
