BUILDING RECORDING

NEWBIGGIN HEARSE HOUSE,
NEWBIGGIN,
COUNTY DURHAM

19/64
June 2019

**NEWBIGGIN HEARSE HOUSE
NEWBIGGIN, COUNTY DURHAM
BUILDING SURVEY**

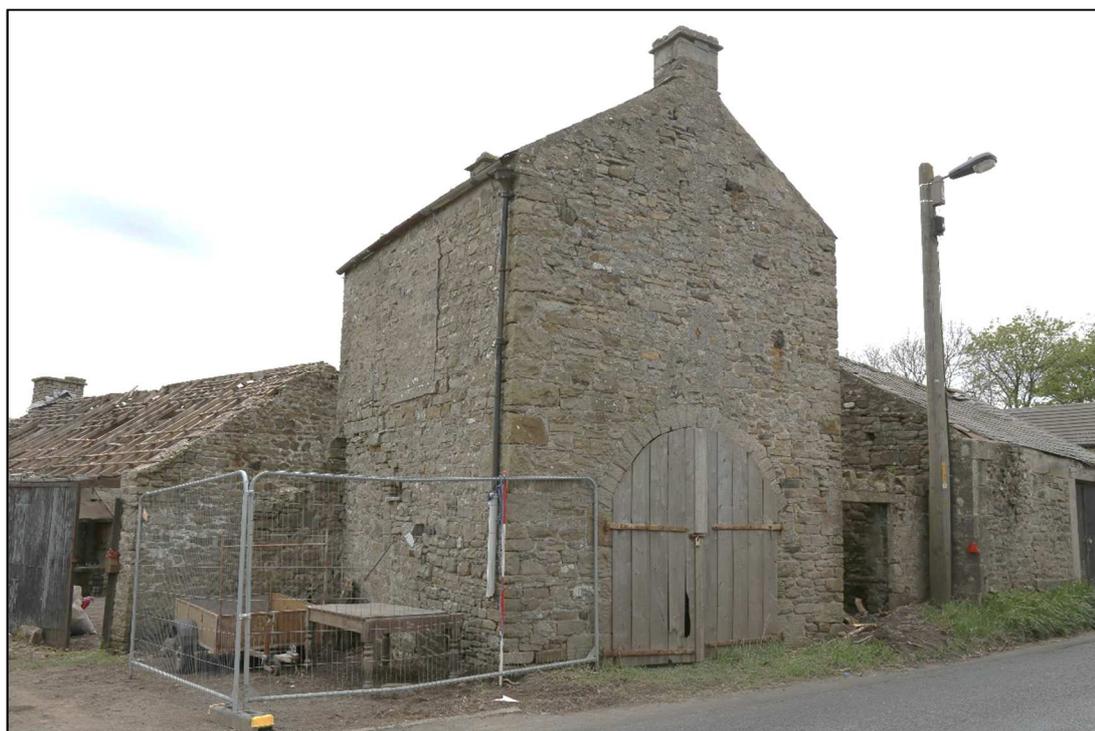
Plate 1: exterior of the hearse house with the workshop in the rear looking south-west.

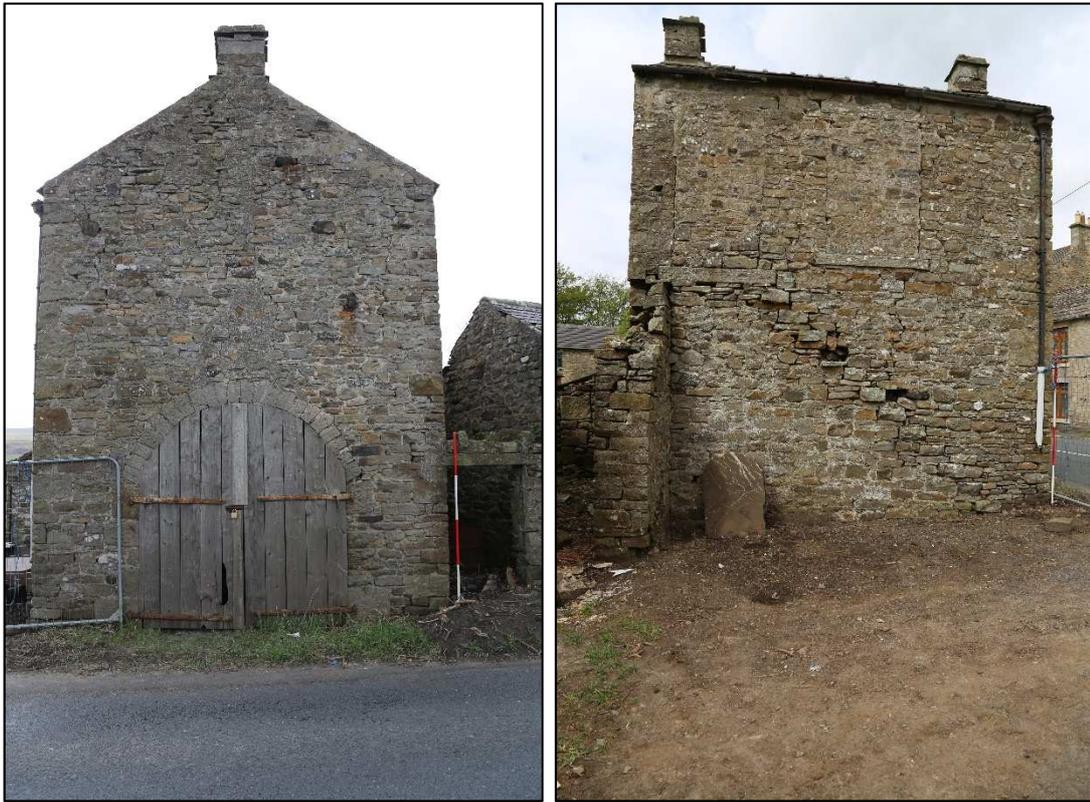
- 5.3 The north elevation (Plate 2; Fig. 3) is the front of the Hearse House and faces onto the B6277. The elevation is gabled, with a square chimney **1012** at its peak and a small side doorway **1011** with access to the space between the Hearse House and the adjacent garage (part of the adjoining property). It is possible that this doorway is a later addition. The elevation contains large, arched double doors, that would have provided access for the hearse. The double doors **1112** are contained within a large stone arch **1111** with voussoirs and quoins. The east elevation has discontinuous quoins on both corners.

Plates 2 and 3: north (left) and east (right) elevations of the hearse house. The blocked window, door, and the scar left by the stairs is visible.

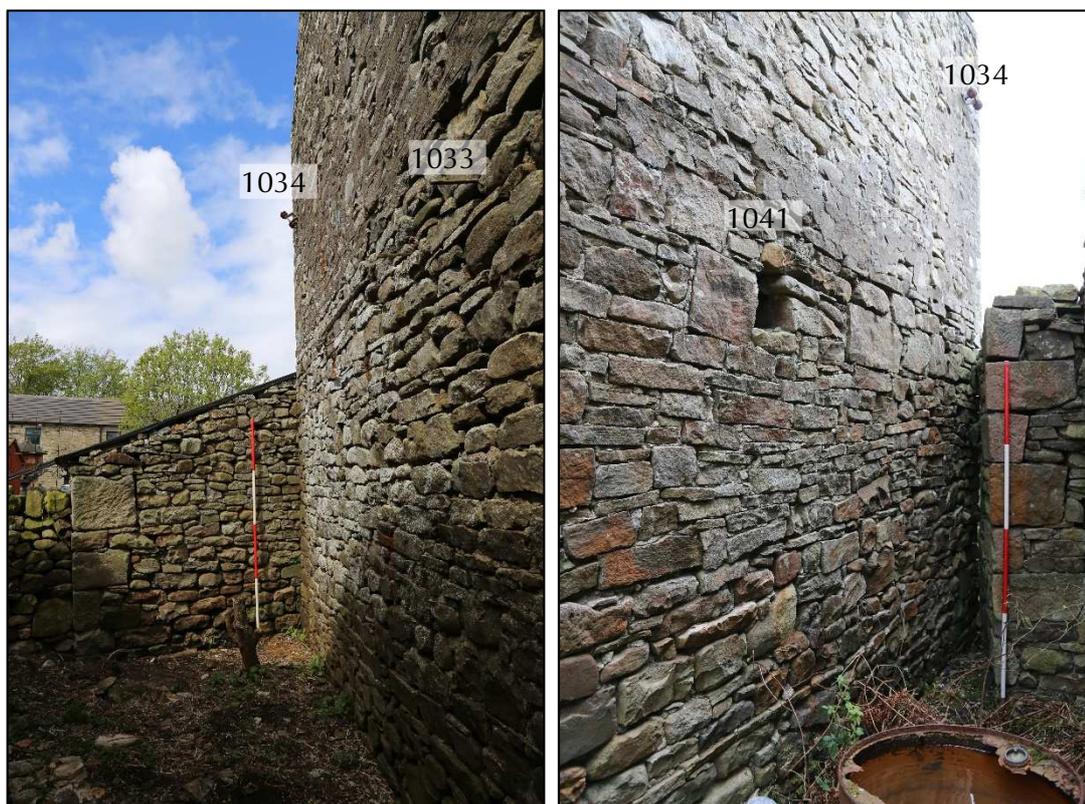
- 5.5 The south elevation (Plate 4; Fig. 4) is gabled and capped by a chimney **1031**. No evidence of a fireplace was found in the interior, so it is assumed that the chimney forms a purely decorative purpose to match that on the north elevation. Two terracotta vents **1131** are evident along the wall above a horizontal building scar **1032**, formed from the remains of mortar along the wall. The presence of metal pegs **1033** and an electrical fitting **1034** imply the previous existence of roof structure in the space between the hearse house and the workshop that may have housed a woodshed for the forge.

Plates 4 and 5: oblique views of the south (left) and west (right) elevation. The metal pegs and electrical fitting are visible and labelled on the south elevation. The niche is evident on the west elevation.

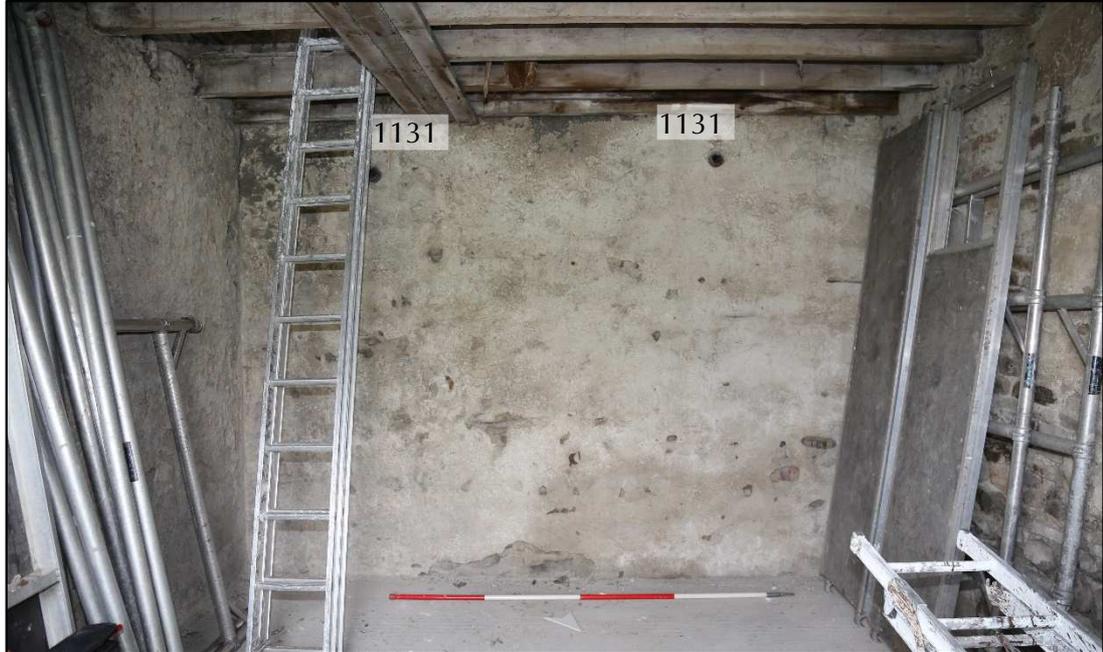
Plate 6: south wall of first floor with the terracota vents and ladder hatch visible.

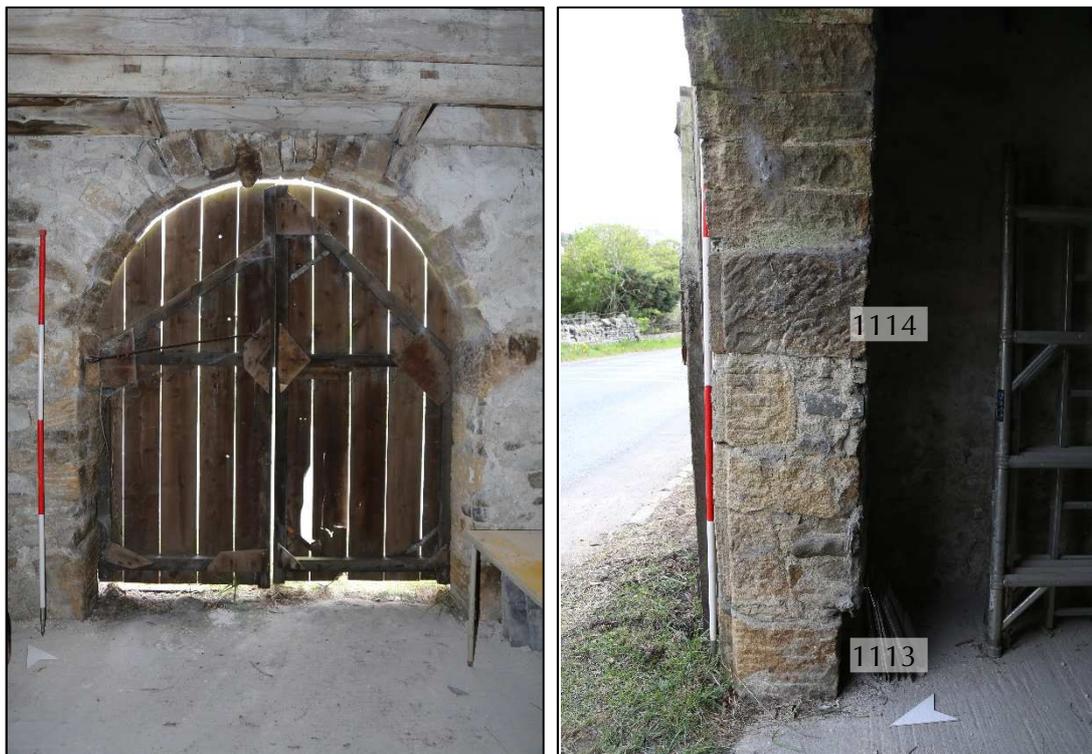
- 5.8 The doorway of the hearse house (Plate 7) is the distinguishing feature of the first floor. The wooden door **1112** is intact and fits, when closed, into a groove on the outside of the doorway arch **1111**. Within the archway (Plate 8) are small wooden remains **1114**, the use of which is unknown. In the lower east corner of the doorway is a small niche **1113**, also serving an unknown function.

Plates 7 and 8: view of the doorway arch (left) with the niche and wooden remains visible (right).

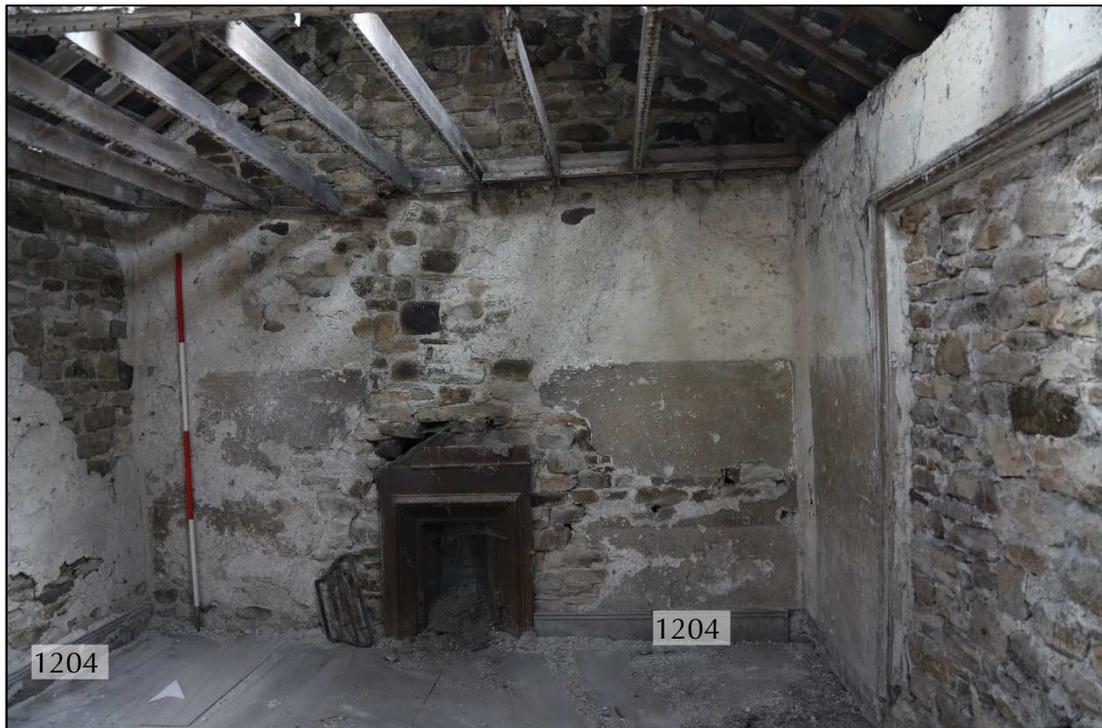
- 5.9 The first floor (Plate 9; Fig. 4) would have once been a well-lit reading room with light streaming in from the now-blocked window **1221** and door **1222** located on the east wall. The only source of light is now the skylight **1202** (Plate 10) which lies south of a single truss **1201** that supports the roof (Fig. 6). It is uncertain whether this skylight is a later addition, but it is likely. Joists are visible on the north side of the roof structure indicating the original ceiling level. This level matches that of the plaster on the south wall. The floor consists of wooden planks, some of which are damaged and unstable.

Plate 9: north elevation of the first floor.

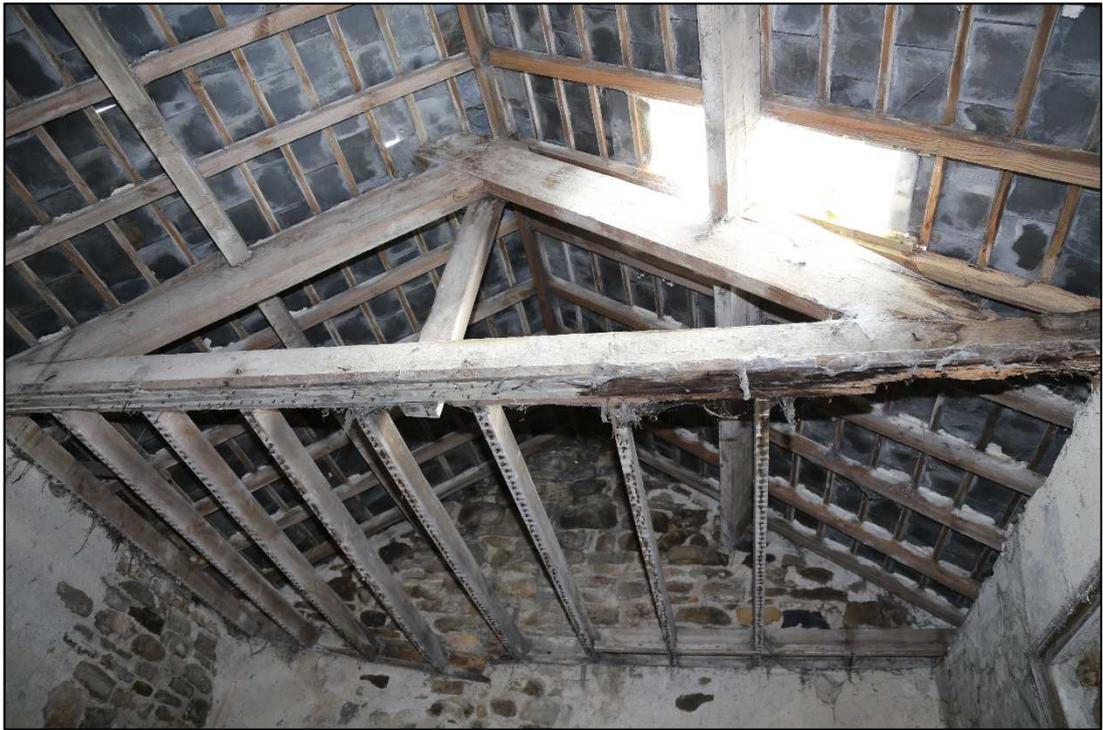
Plate 10: truss, joists, and skylight looking north.

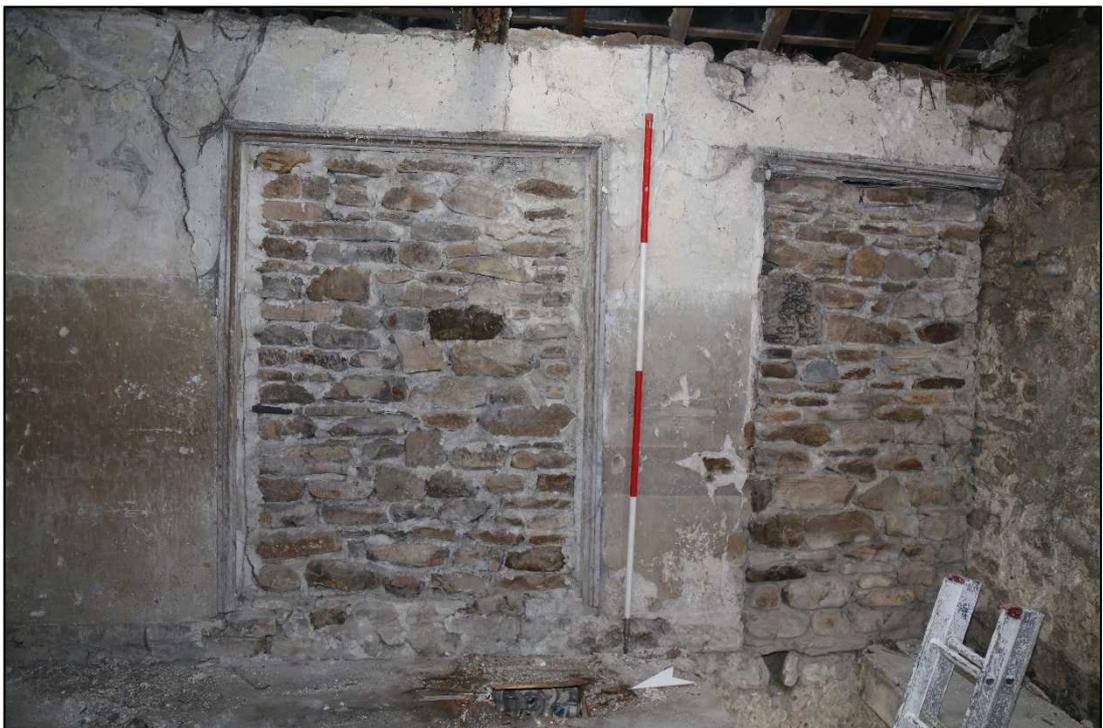
Plate 11: east wall of the first floor. The window and door are blocked but still retain their doorframes.

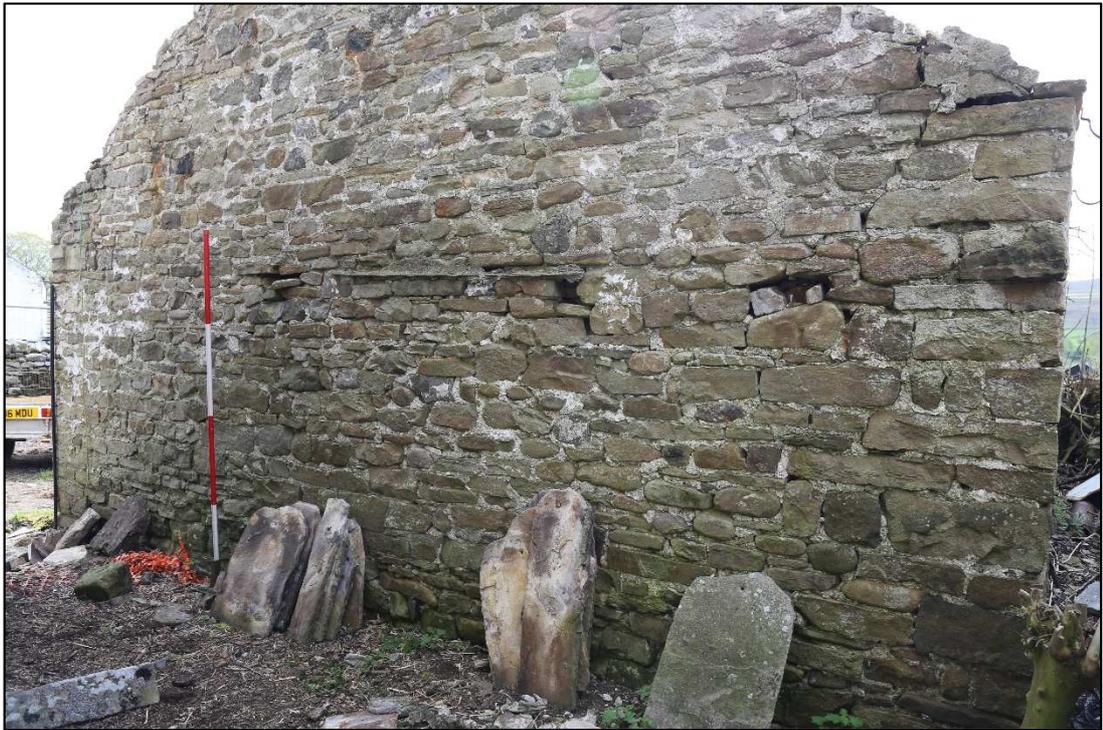
- 5.11 The north elevation (Plates 12 and 13; Fig. 7) has a gable end and contains a single horizontal building scar **2011** created from the remains of pointing similar to the building scar on the south-west elevation of the hearse house and it was likely caused by the creation of a shelter, perhaps for a woodshed for the forge.

Plate 13: north elevation of the workshop with the evident horizontal scar.

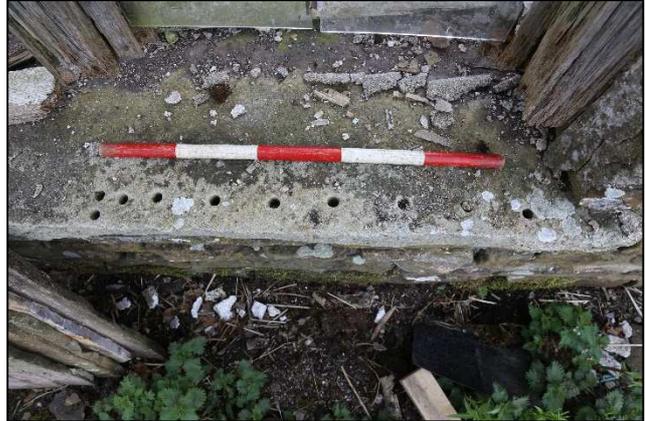
- 5.12 The east elevation (Plate 14; Fig. 8) is the front of the workshop. A large sliding corrugated-metal door **2121** provides the only access into the building. Beside it are two windows **2122** and **2123** with stone lintels and sills. The north window **2122** has round holes cut into the north half of the sill (Plate 15) which may have been used for a shutter. These holes are not replicated elsewhere.

Plate 15: holes on the sill of the north window.

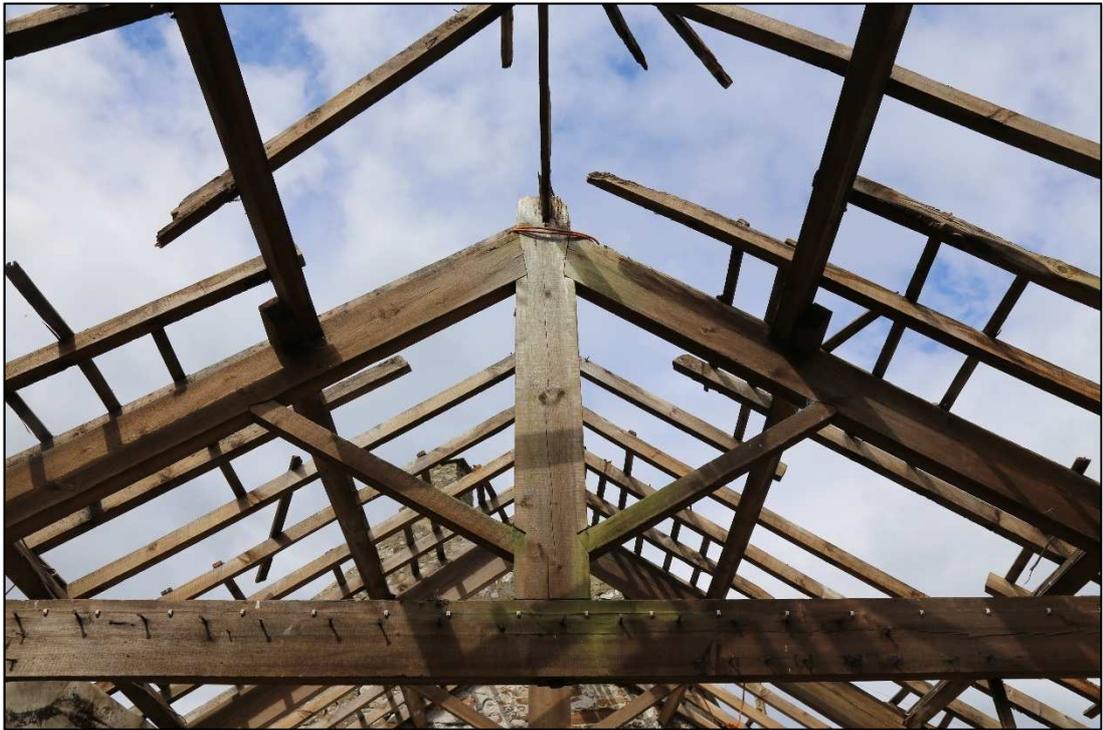
- 5.15 The workshop was once protected by a stone-flagged roof, which has now been removed due to safety concerns with the flags now stacked on the flagstone floor **2101** (Plate 17). The roof structure **2102** remains and consists of three king-post trusses with offset purlins that join at the middle truss (Fig. 11; Plate 18).

Plate 18: roof structure of the workshop. The purlins are offset and join at the truss.

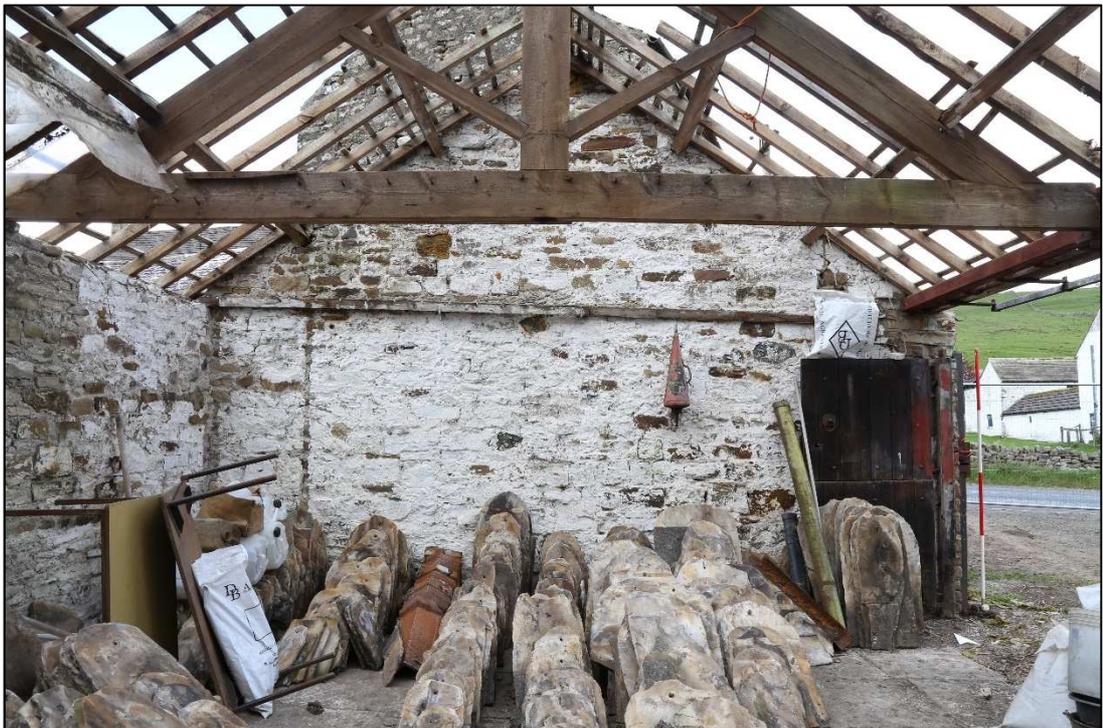
- 5.16 A wooden beam **2112** across the north wall (Plate 19) is in line with the top of the door; and is lined with nails, perhaps used to hang tools. Similar nails are found on the north and central trusses and may also have been used to hang implements or to support a partition wall. Below the beam on the north wall is an old fire extinguisher **2152**.

Plate 19: north wall of workshop with the red, conical extinguisher beside the old door.

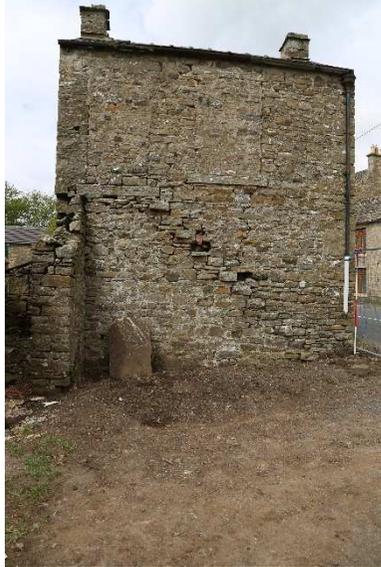
1021	stair scar	A scar along the east wall indicates the presence of 13 steps up to the door to the reading room. Each stair is approximately 0.3x0.17m. The stairs begin 0.7m from the north corner of the elevation.		See above

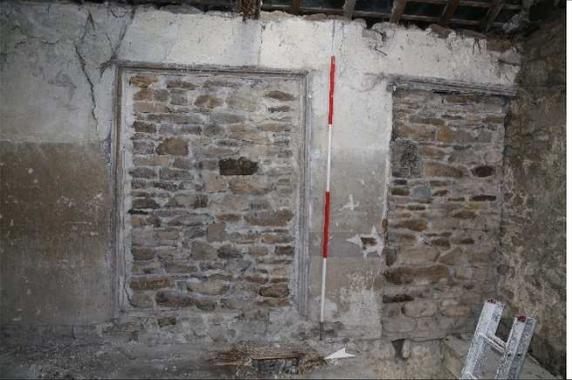
1221	blocked window	Nearer the centre of the wall is a large blocked window. It measures 1.35m across and approximately 2m high.	1222 - blocked door 1223 - moulding

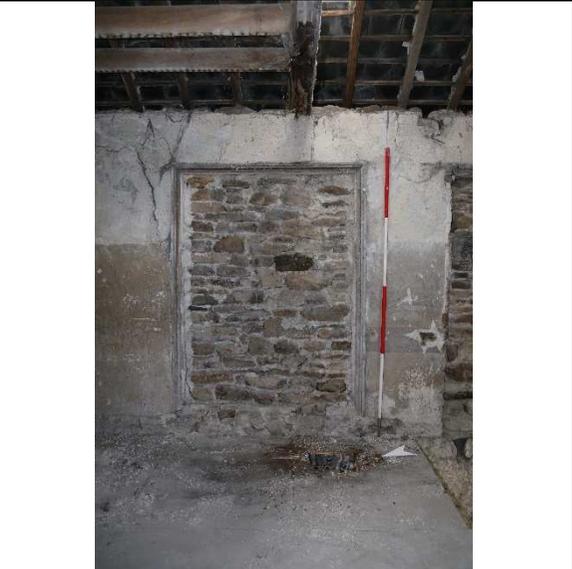
Context	Name	Description	Related Features	Photograph
1222	blocked door	The blocked door abuts the south-west wall and runs approximately 1m wide by 2m high.	1223 - blocked window 1021 - stair scar 1223 - mouldings
