HISTORIC BUILDING
RECORDING

ONE STRAWBERRY PLACE
NEWCASTLE UPON TYNE

prepared for
BAM

NAA 20/70
August 2020

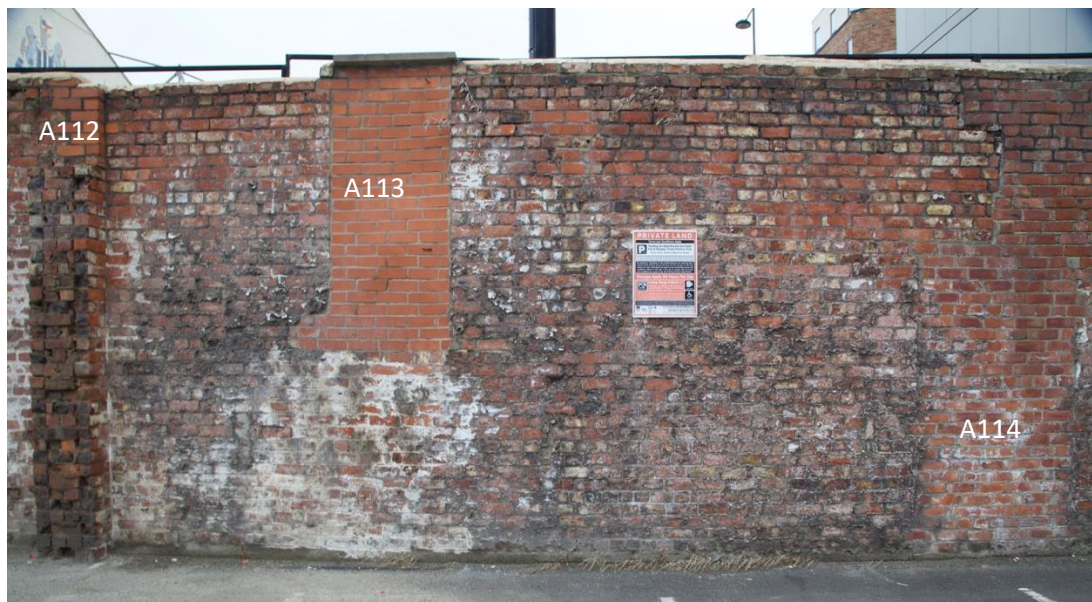
- 5.3 Plot A is bounded by a tall (5.11m) brick wall **A100** showing several phases of repairs and interventions (Figs 12–13). The wall is not one continuous construction, but rather the older, south elevation, **A110**, is of older brick in English Garden Wall bond and shows several phases of repair. It spans a length of 29.5m and is abutted to the east by wall **A120**, a modern addition in stretcher bond that was constructed concurrently with the adjacent student accommodation block. To the west, the wall abuts wall **B100**, indicating wall **A100** may be a later construction.
- 5.4 On the south elevation, a horizontal building scar **A111** descends wall **A110** 5.36m east of its west end. This scar is likely to have been caused by a repair to the wall, with

the later addition of new bricks. However, the bond and brick types are similar on both sides of the scar indicating it may be an early intervention, similar in construction to the remainder of the wall. Another, more obvious building scar **A112** can be seen running down the middle of elevation **A110** (Plate 1). This scar protrudes 0.25m from the wall and is the remains of a wall that extended southward into the former depot in Plot C. Further east along the wall is the blocked opening **A113**, which has been filled with modern brick in stretcher bond, evidence of a more recent repair. Another, more complex set of building scars **A114** show two phases of repair. The lower section is of common bond. It is found between both building scars and then devolves into stretcher bond near the top of the wall, indicating a second, more uneven phase of repair.

*Plate 1: Wall **A110** looking north. The wall remains **A112** are visible on the left with the blocked door **A113** in the centre and the muddled scar **A114** on the right.*

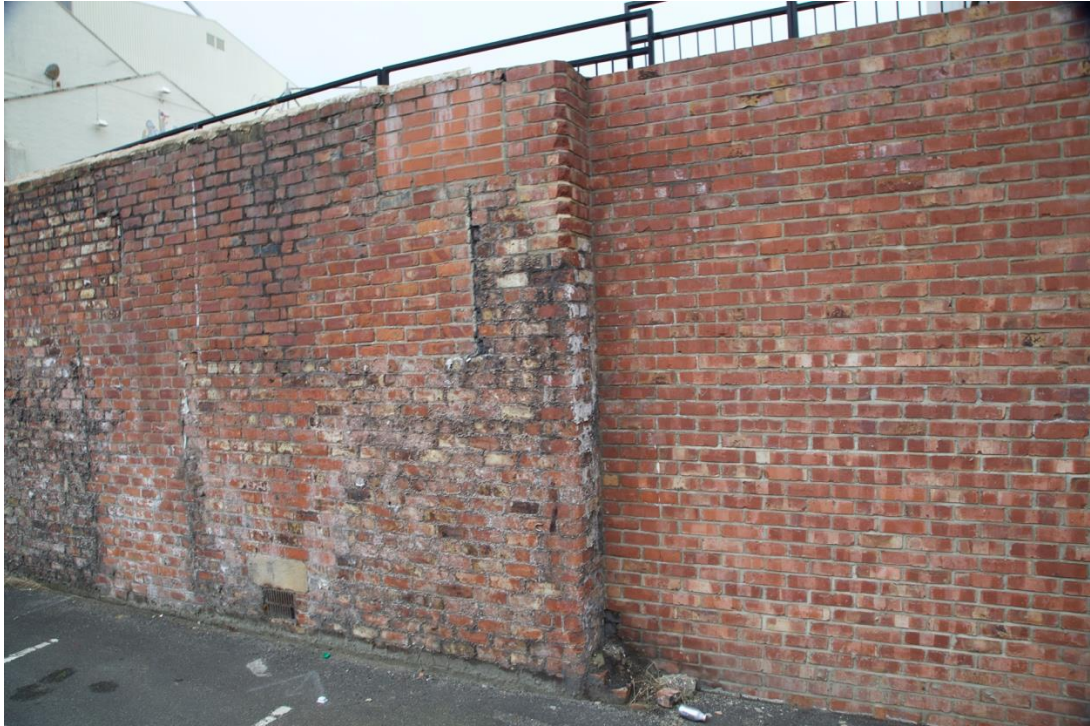
- 5.5 The joint **A116** between walls **A110** and **A120** has a slight offset; elevation **A110** is set 0.43m out from wall **A120** (Plate 2). The bricks of wall **A110** are rounded-off near the joint indicating that the wall would have culminated naturally prior to the addition of wall **A120**. However, the presence of a few bricks at the base of this joint indicate a wall footing of another addition prior to the modern wall **A120**. However, the footings abut wall **A110**, demonstrating that whatever wall these bricks belonged to, it post-dated wall **A110**.
- 5.6 The north elevation **A130** of the wall is 0.89m high and is alike the south elevation **A110** showing bricks in English bond, with occasional repairs of modern brick to match those of elevation **A110**.

Plate 2: Wall joint A116 looking north-west.

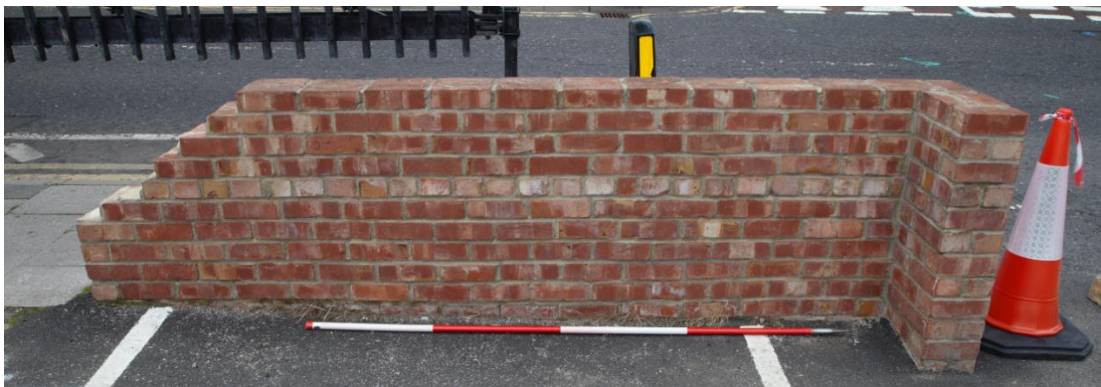
- 5.7 On the north boundary of Plot A is a short section of brick wall **A200** that separates the car park from the pavement (Plate 3). This wall is constructed of similar brick and bond to wall **A120** and is likely to date from creation of the car park.

Plate 3: Modern wall A200 on north end of Plot A looking north.

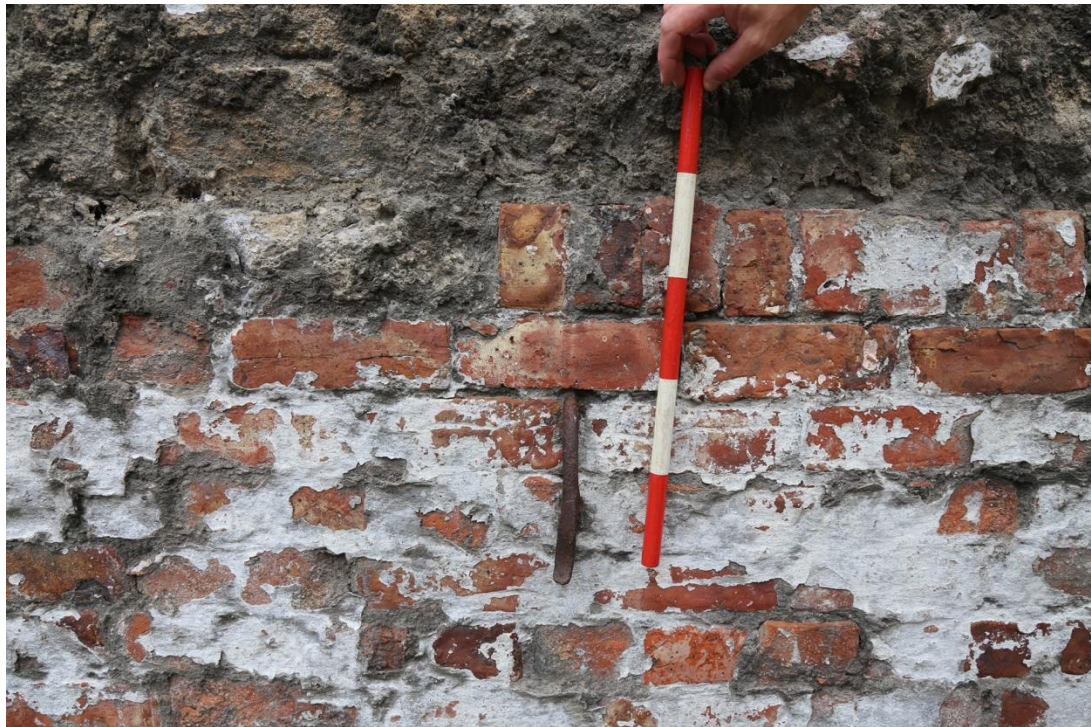
- 5.9 Wall **B100** is 4.6m high and 19.3m long, consisting of several different constructions divided into three sections (Figs 14–15). A lower level of brick in English Bond is found on both the north **B110** and south **B140** ends of the east elevation. This brick construction rises approximately 1.9m and 1.3m respectively above current ground levels.
- 5.10 On the south side of **B140**, this brick wall gives way to stonework **B150** at a very uneven boundary. Small amounts of slate are present at the boundary as possible means of damp-proofing. On the north section, **B120** a similar boundary would have been found, but most of the stonework has been replaced with brick repairs **B121** in stretcher bond. A single metal rod or hook **B141** (Plate 4) is now bent back into the south brick wall. This hook was most likely used to tie items to the outside of the wall.

*Plate 4: uneven boundary between **B140** and **B150** with the rod **B141**.*

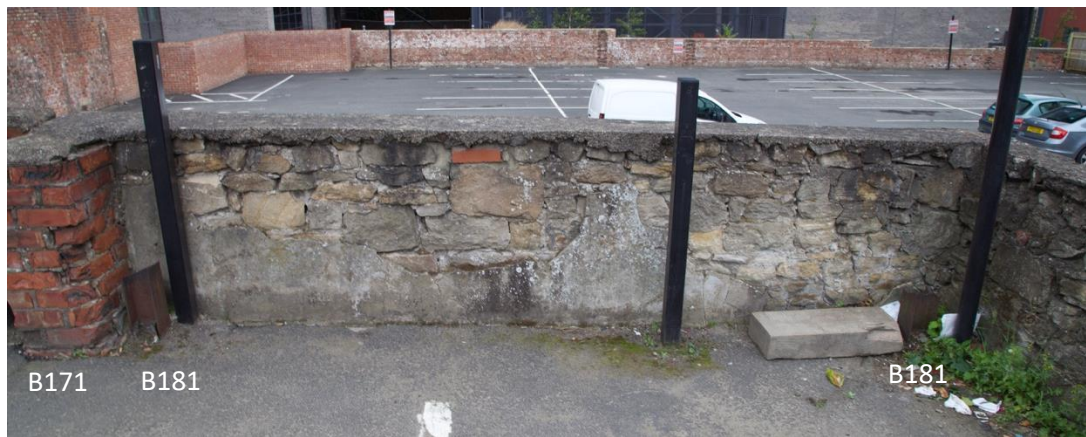
- 5.12 The west elevation of wall **B100** is similar to the east elevation (Fig 16). The north-most section **B160** is largely covered in concrete with only a few bricks visible. The middle section **B170** is 1.2m tall and is of brick in stretcher bond, although the bricks are older than the reverse elevation **B130**. On the south side of this section are the remains of a wall, now extending 0.35m west and rising 0.5m above the floor of Plot B (Plate 5). The south section **B180** is of stone, like the reverse elevation **B150**. On either side of this section are large iron beams **B181** protruding from the asphalt c.0.3m (Plate 5). They are likely to have been related to the internal use of the building.

*Plate 5: Wall elevation **B180** looking east. The wall plinth **B171** is visible on the left along with the iron beams, **B181**, on either side of wall **B180**.*

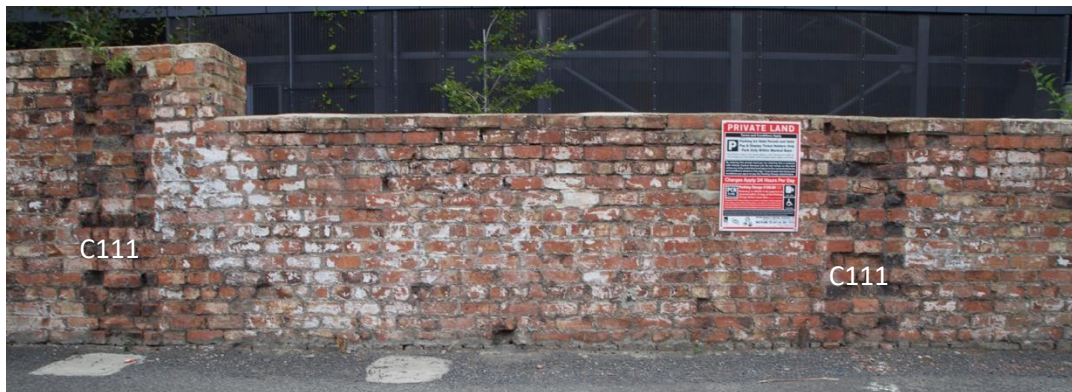
- 5.16 The west elevation **C110** is of brick in English Garden Wall bond (Figs 17–18). It has two visible scars **C111**, each 0.64m wide and spaced 5m apart (Plate 6). These scars were probably caused by previous walls that abutted **C100** and were later removed. Most of this wall appears to be from a single phase of construction with few discernible archaeological features.

Plate 6: the two wall scars C111 looking west.

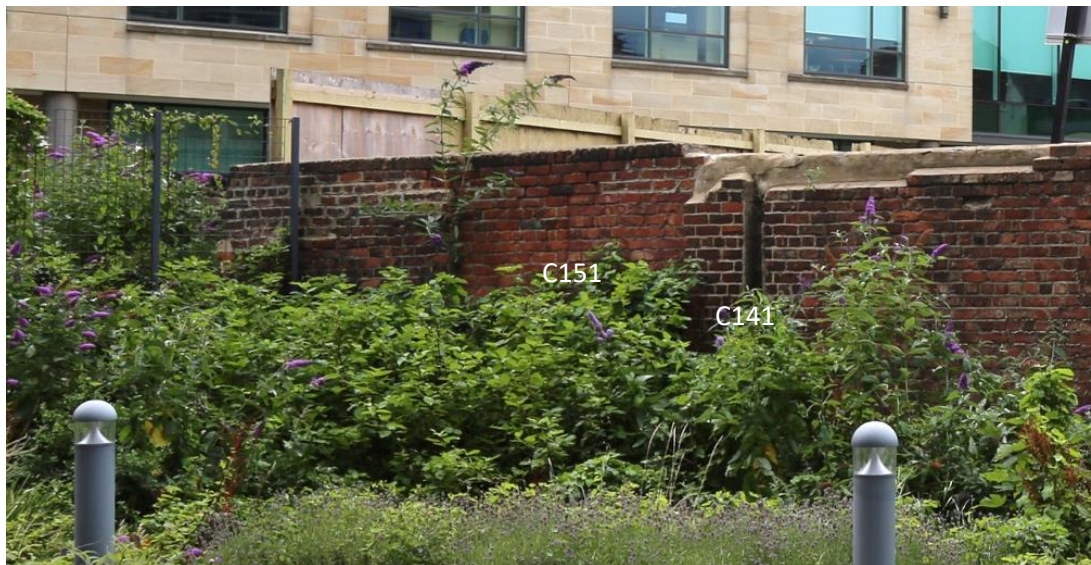
- 5.18 The rear elevation of wall **C100** was not surveyed with photogrammetric survey due to access. Photographs of the wall were taken as near to the wall as possible (Figs 19–20). On the east elevation **C140** are two long grooves **C141** c.0.15m wide and deep, running the entire length of the wall. The brick edges around the top of the grooves are uneven (Plate 7), indicating some damage caused as a result of their creation, and that they are a later addition. They were possibly used to accommodate drainpipes.

Plate 7: The rear of wall C100. The scar C151 is visible extending down into the foliage. It is located just south of the groove C141.

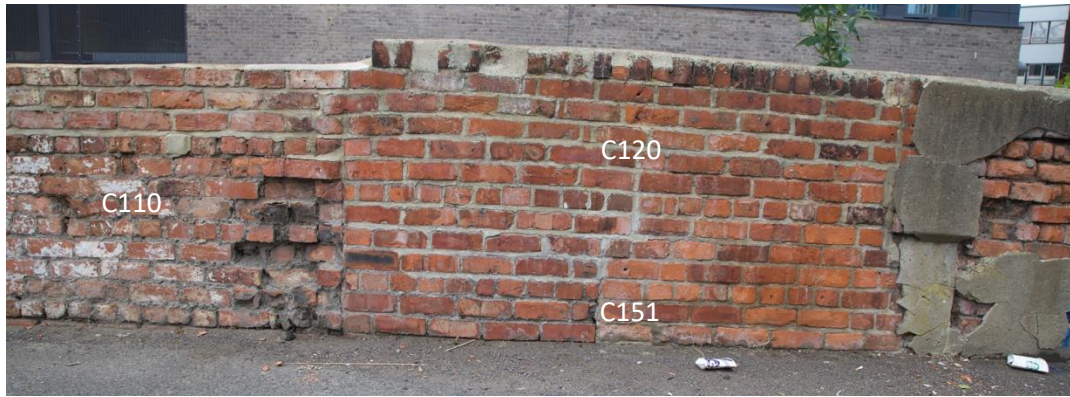
- 5.19 Near the south end of wall **C110** is a separate section of wall **C120** (Plate 8). This section is 2.9m long and is also of English Garden Wall bond, but its courses are offset to those of **C110**. The rear of this section **C150** is slightly thinner (0.3m) than wall **C110** (0.43m). It also contains a vertical scar **C151**, which descends the length of the wall but stops a few courses before the top due to what is likely a more modern repair (Plate 7).

Plate 8: the south end of elevation C110 looking east. The section C120 is visible along with a short section of the wall scar C151, which is more visible on the rear elevation.

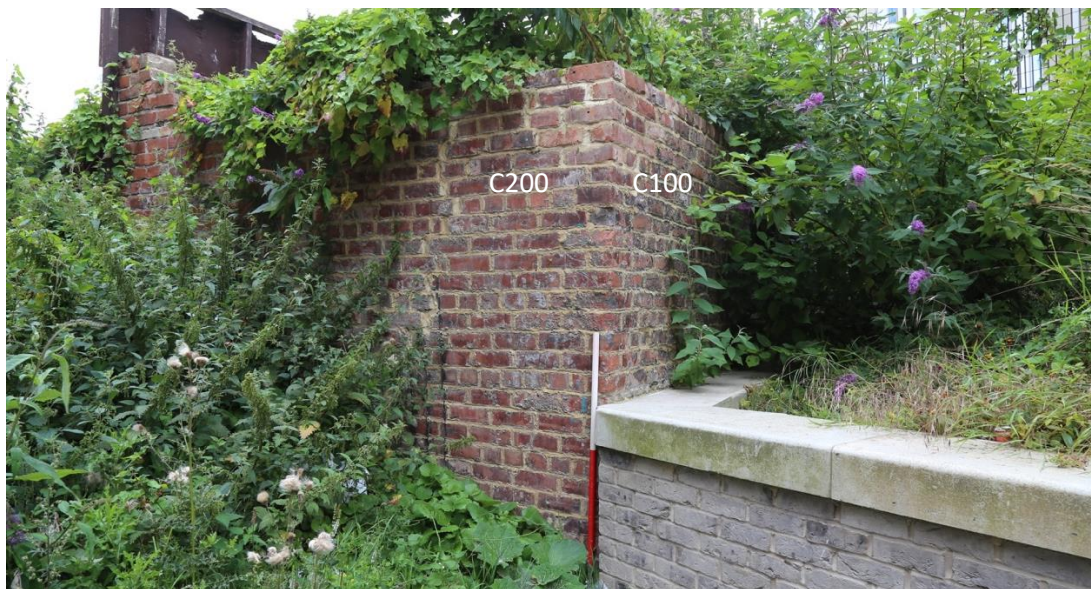
- 5.20 In the very south-east corner of the PDA is a short section of wall c. 2.5m high constructed in brick in a variant of English Garden Wall bond (Plate 9). At the time of survey, the wall C200 was largely covered in vegetation, but photographs from the DBA (NAA 2019) indicate the wall extends c.3.75m to the west before disappearing under the earth mound that supports the south end of Plot C. A clear repair is evident in the DBA photographs showing a scar that runs down the central section of the wall.

Plate 9: The corner of walls C100 and C200 looking north-west.

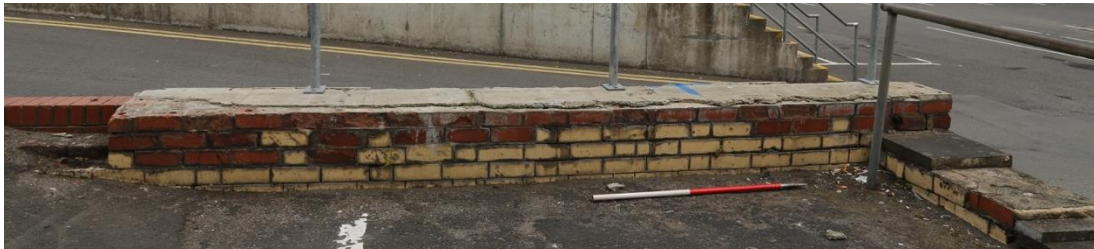
- 5.22 The south elevation **D110** is low at 0.4m high and contains only five courses of both yellow glazed bricks and red bricks, the latter placed as a result of a later repair. The wall is constructed in Flemish Garden Wall bond with two full courses of yellow brick below interspersed courses of red and yellow brick (Plate 10). The final course is all unglazed red brick in stretcher bond.

Plate 10: The south, internal elevation D110 of the baths and wash houses looking north.

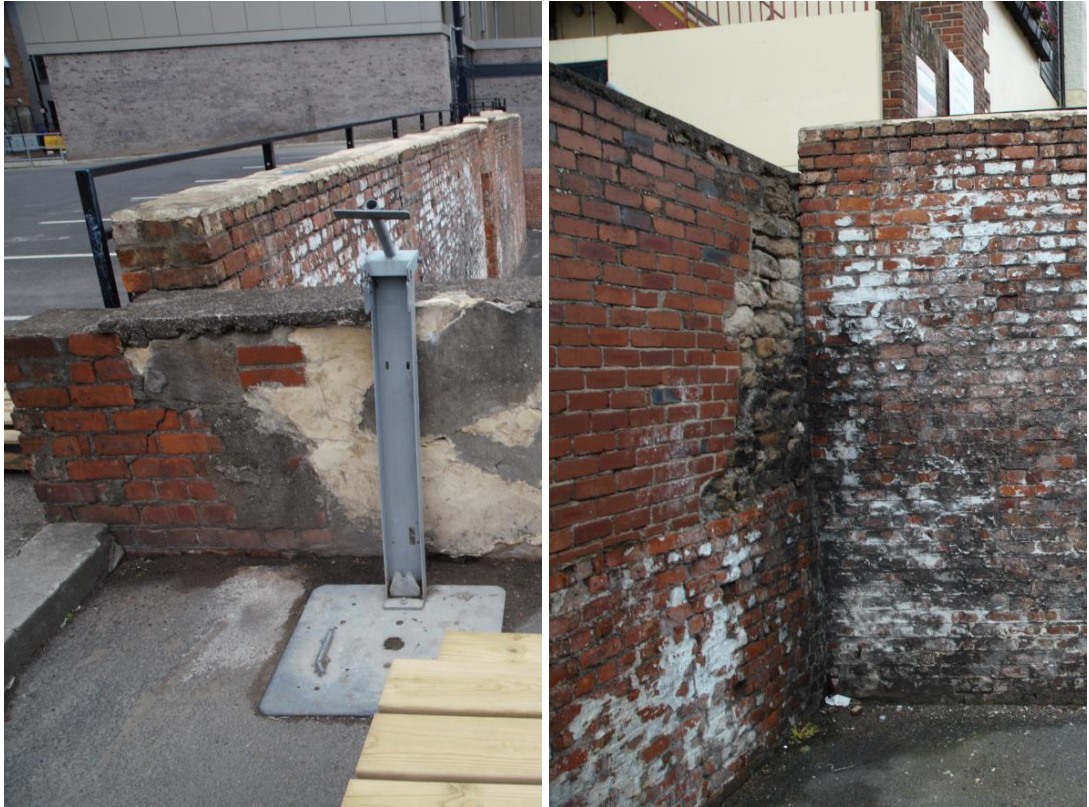
6.2 There is no evidence on the 1830 map of wall **B100**. However, the join at this wall (Plates 12 and 13) indicates that wall **A100** was built against wall **B100**. A small section of wall **B100** extends north. There is no indication of the presence of a wall oriented north–south across the alley immediately north of the garden wall **A100** on the 1830 or any subsequent map. It is possible that this section of wall only appeared during the later repairs to the wall evident in the stretcher bond of **B121**.

*Plate 12: (left) Join of wall **A100** and **B100** looking east; Plate 13: (right) join looking north*
