CHURCH OF OUR LADY,
SEATON DELAVAL HALL
ARCHAEOLOGICAL MONITORING
OF REPAIRS TO THE
SOUTH-WEST BASTION
AND HA-HA WALLS

Mosedale Gillatt Architects
for Historic England

NAA 21/74
August 2021

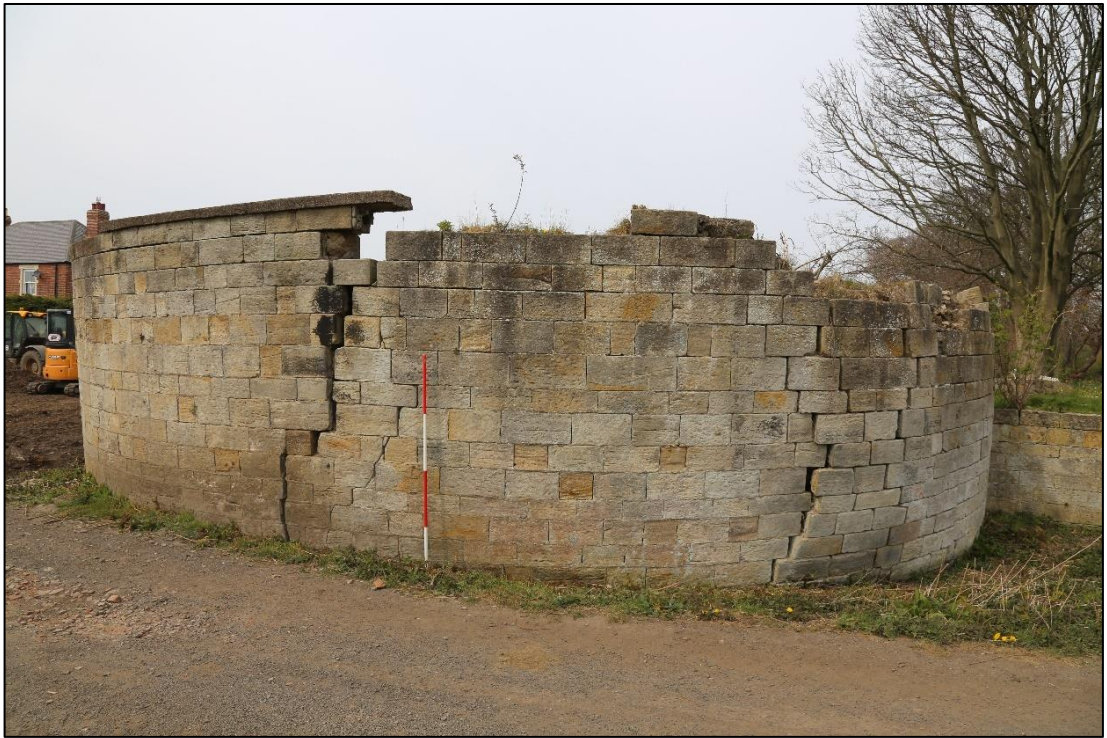
Plate 4: east side of the south-west bastion, looking north-west, showing large vertical cracks and a bulge on the right-hand side.

8.4 The primary focus of the conservation works was the dismantling of the eastern arc of the bastion, where subsidence had caused significant shifting of the masonry, causing

- 7.11 The eastern arc of the bastion was almost entirely dismantled and rebuilt, with geotextile mesh inserted between the courses at intervals. The geotextile extended into the backfill within the bastion in order to tie the inner and outer masonry, rubble core and clay infill together and prevent further subsidence. Where the inner foundations were retained, they were repointed before the bastion was backfilled with its original spoil. The ashlar facing was reinstated and, where the original blocks were missing, new sandstone facsimiles made.

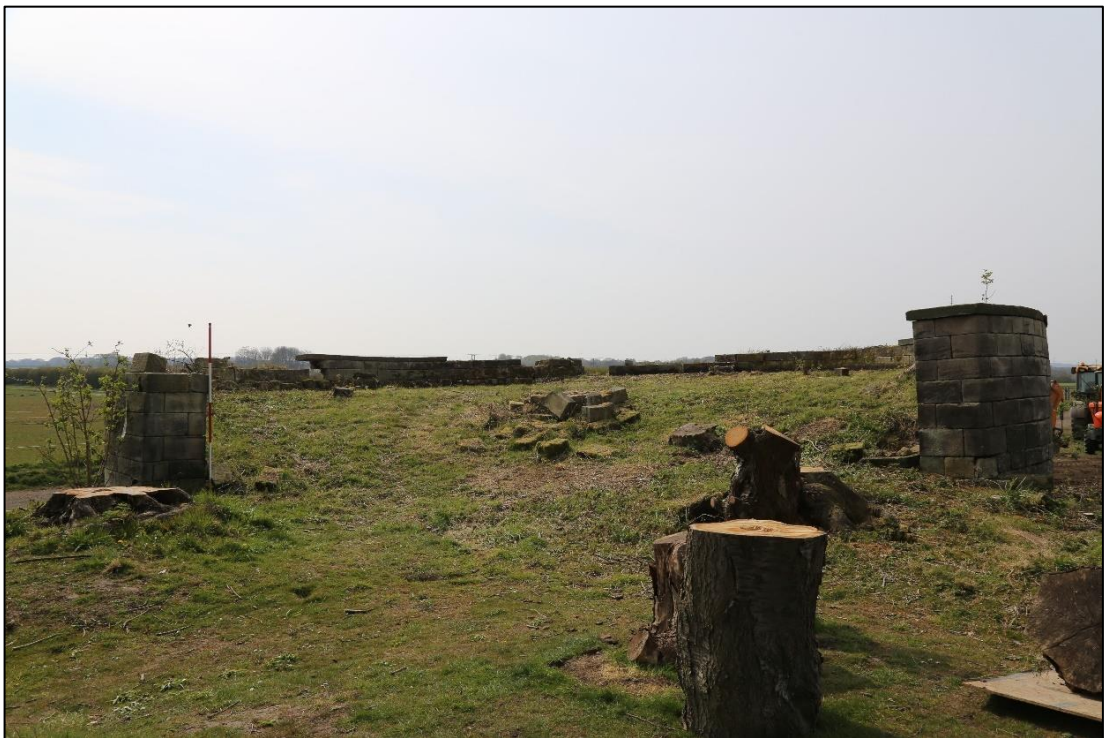
Plate 5: interior of the south-west bastion, looking south-west, showing tumbled stone of central statue plinth.

- 8.21 The upper courses that would have formed the decorative element of the plinth superstructure were scattered around the base in a haphazard fashion (see Plate 5). The plinth would have been constructed of three courses of dressed stone that, when assembled, featured a rectangular plaque on each face of the base. Chamfered stone slabs with moulded edges were placed along the top and bottom of the structure. There were notches in the upper slabs, some of which featured in situ fragments of iron that presumably once anchored the statue to the plinth (Plate 16).

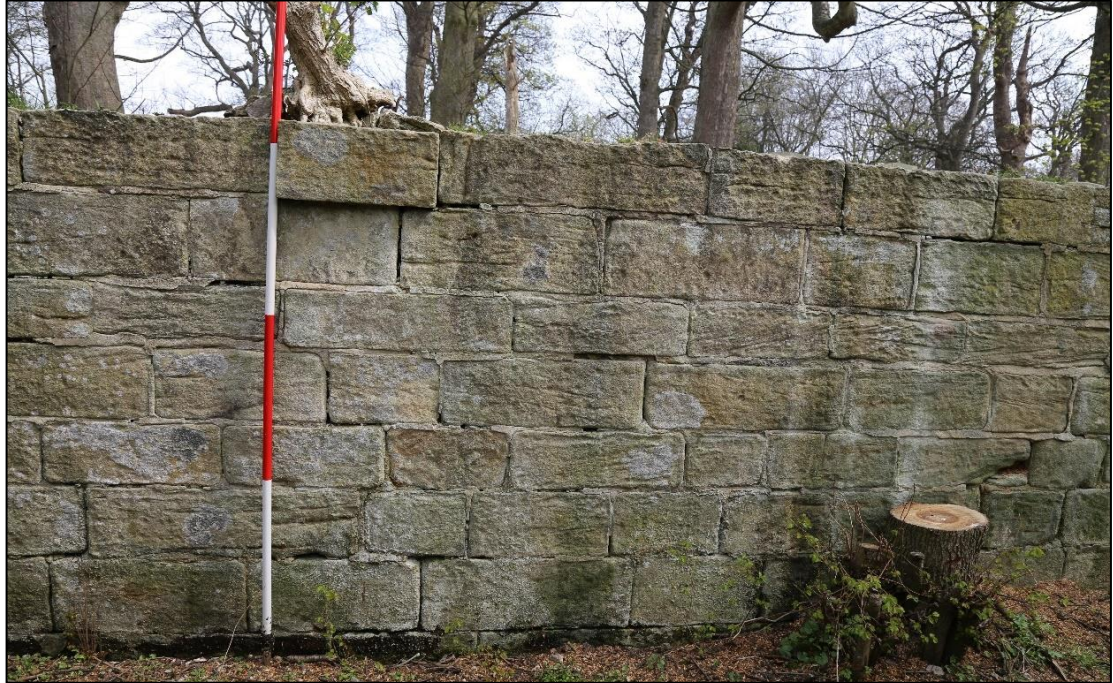
- 8.27 Section 1 (Plates 19–20) was located c.5m south of the churchyard boundary and had been disturbed by tree-rooting. Six courses of ashlar facing were removed over a span of 3m.

Plate 19: pre-intervention photograph of Section 1.

8.26 In all instances, the ashlar facing was removed along with the old mortar, the roots of the trees were cut back and treated to prevent regrowth and then the facing replaced, with each course being topped with wire mesh and lime mortar to tie the facing into the rubble revetment behind.

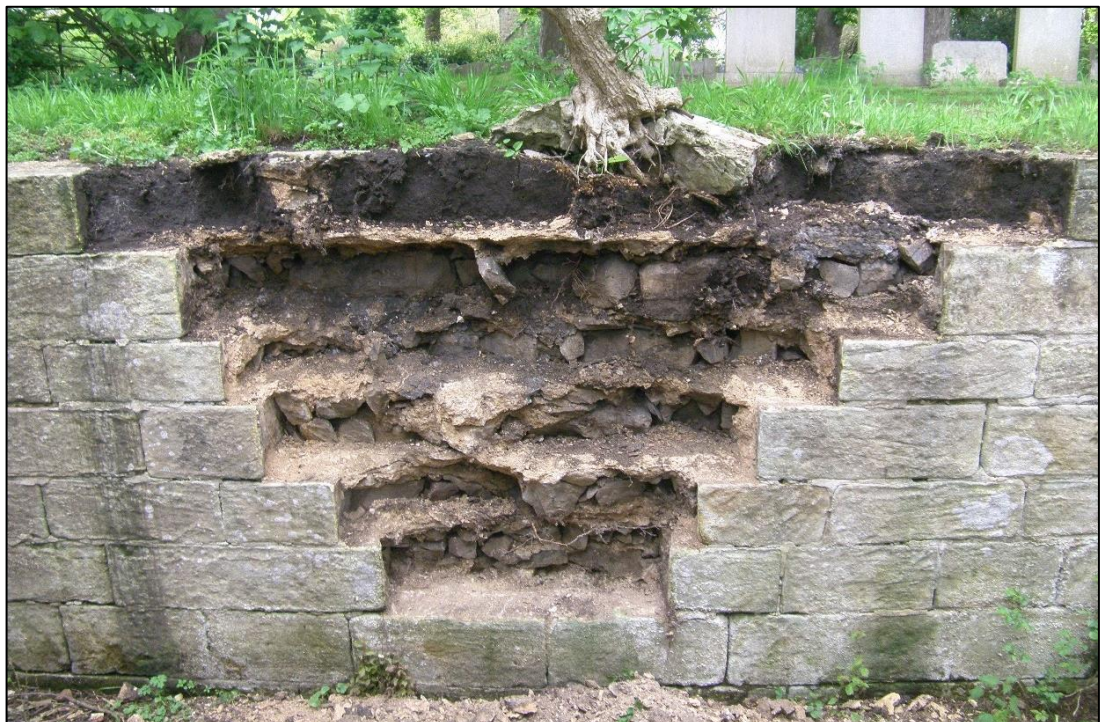
Plate 20: Section 1 of the west ha-ha after removal of the ashlar facing.

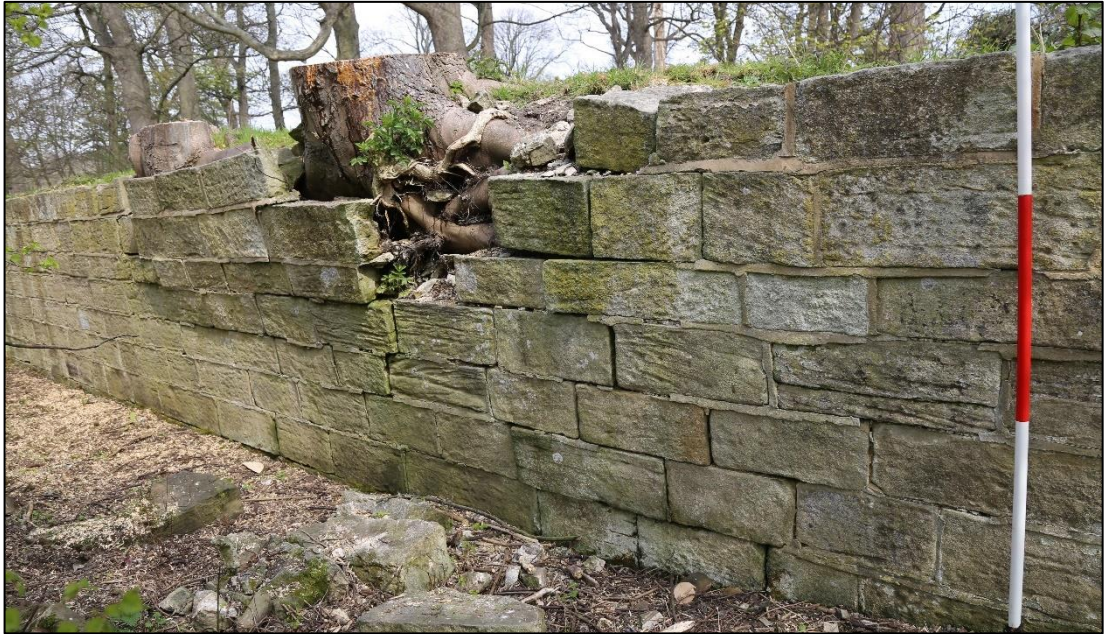
- 8.28 Section 2 (Plates 21–22) was located c.12m to the south of Section 1 and had suffered extensive disturbance from the rooting of two mature trees. The rootlets had grown along the mortar beds and through the rubble core behind. Six courses of ashlar facing were removed over a span of 8m.

Plate 21: pre-intervention photograph of Section 2.

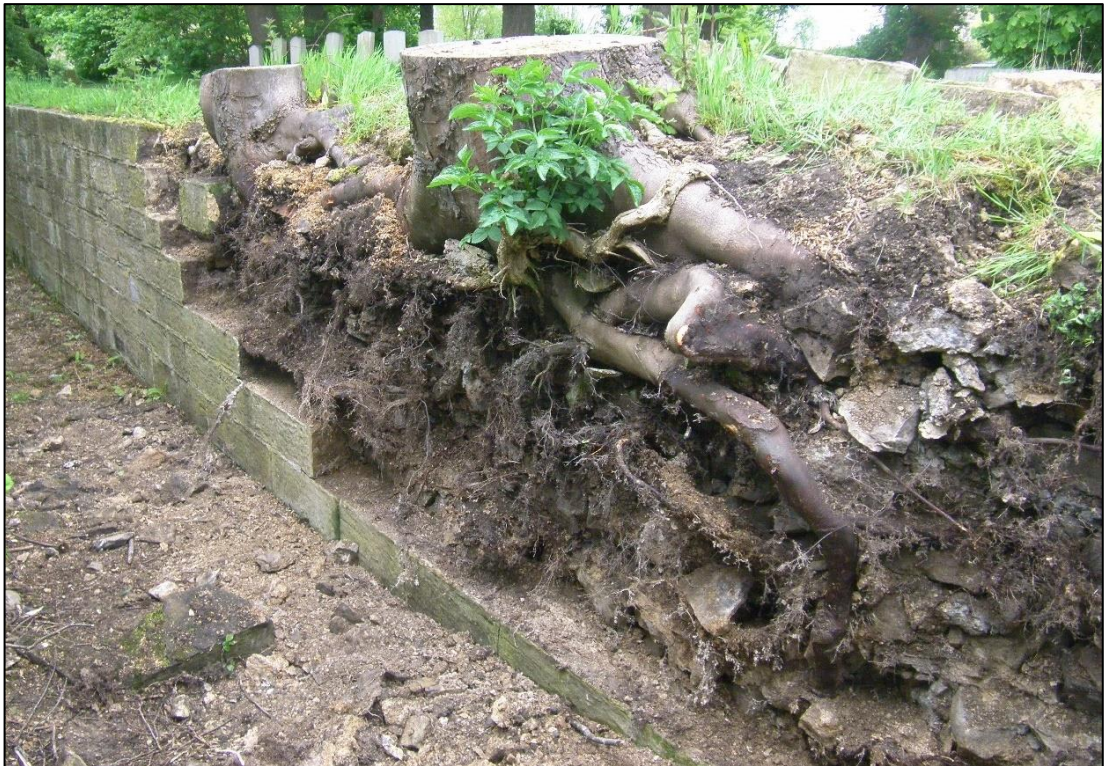
Plate 22: Section 2 of the west ha-ha after removal of the ashlar facing.

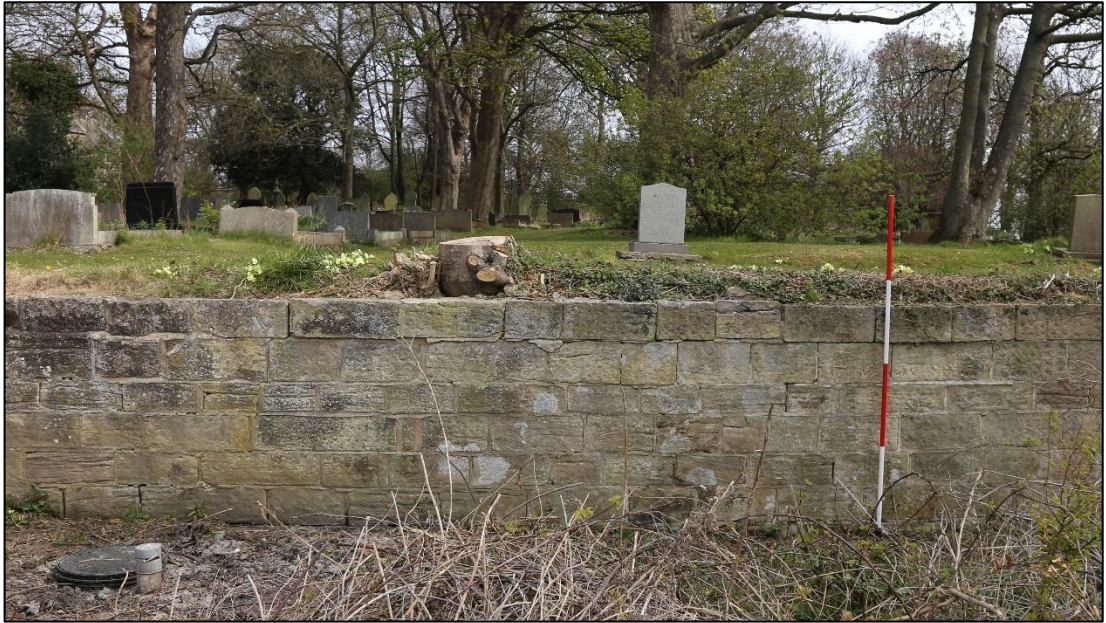
- 8.29 Section 3 (Plates 23–24) was located c.10m to the south of Section 2 and had suffered disturbance from the roots of a large mature tree and perhaps from the installation of a modern septic tank in the ha-ha ditch directly below. Four courses of ashlar facing were removed over a span of 4m and the tree root cut back so it was flush with the rear of the ha-ha wall to allow the ashlar to be replaced.

Plate 23: pre-intervention photograph of Section 3.

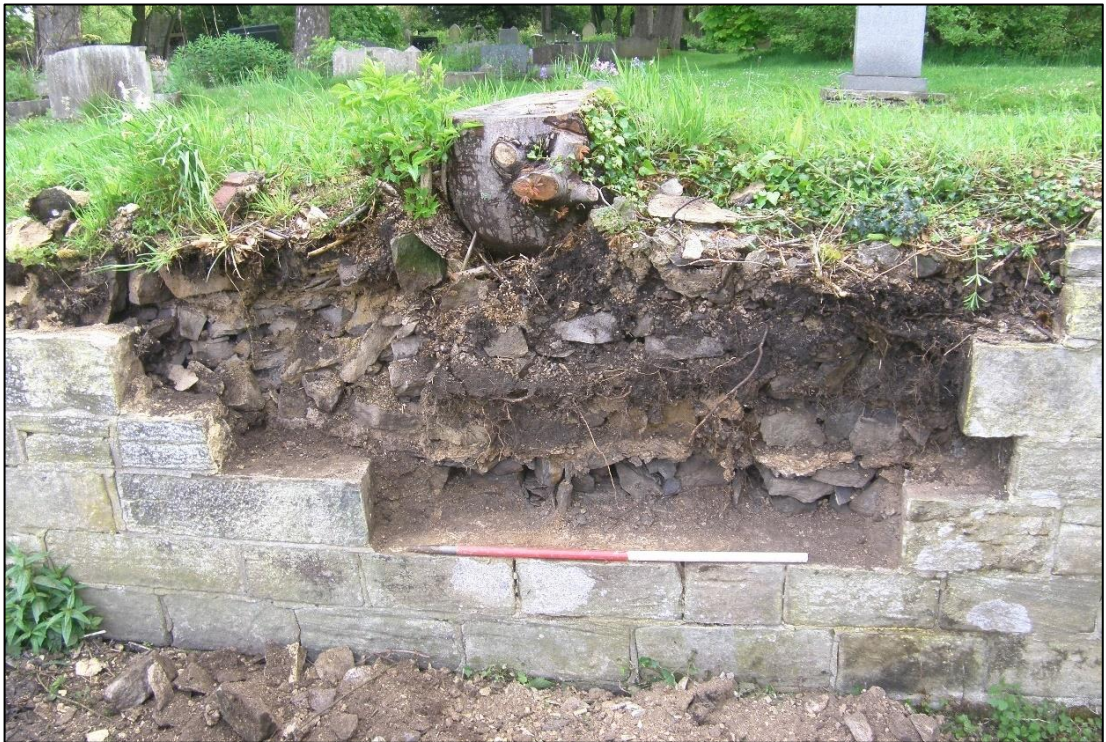
Plate 24: Section 3 of the west ha-ha after removal of the ashlar facing.

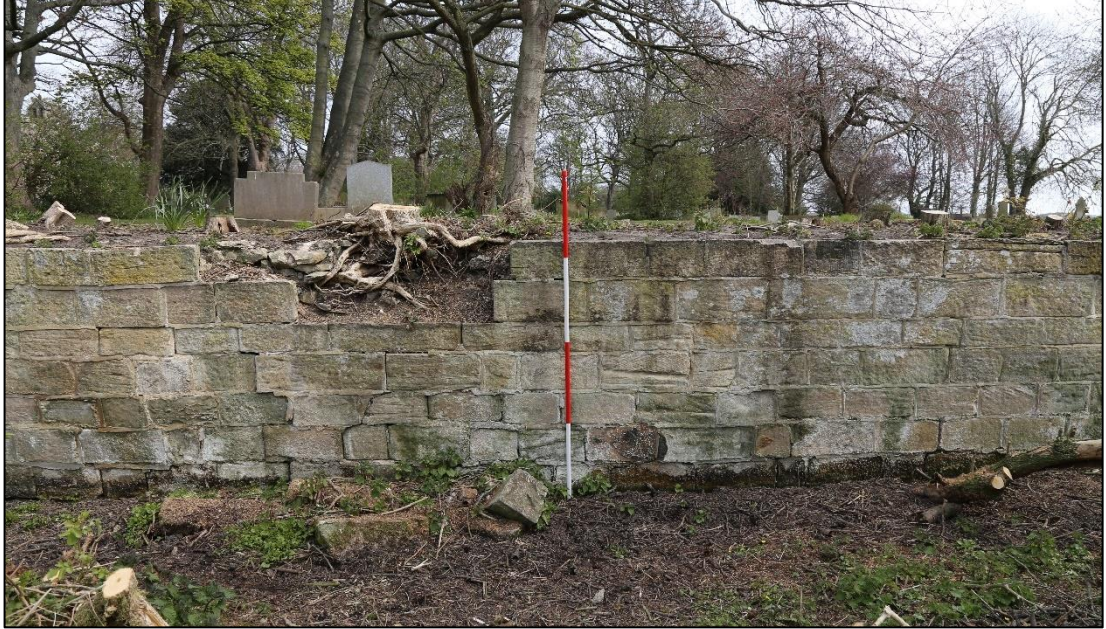
- 8.30 Section 4 (Plates 25– 27) was located c.10m to the south of Section 3 and had suffered substantial root disturbance. Four courses of ashlar facing were removed over a span of c.10m and the root systems removed.

Plate 25: pre-intervention photograph of Section 4.

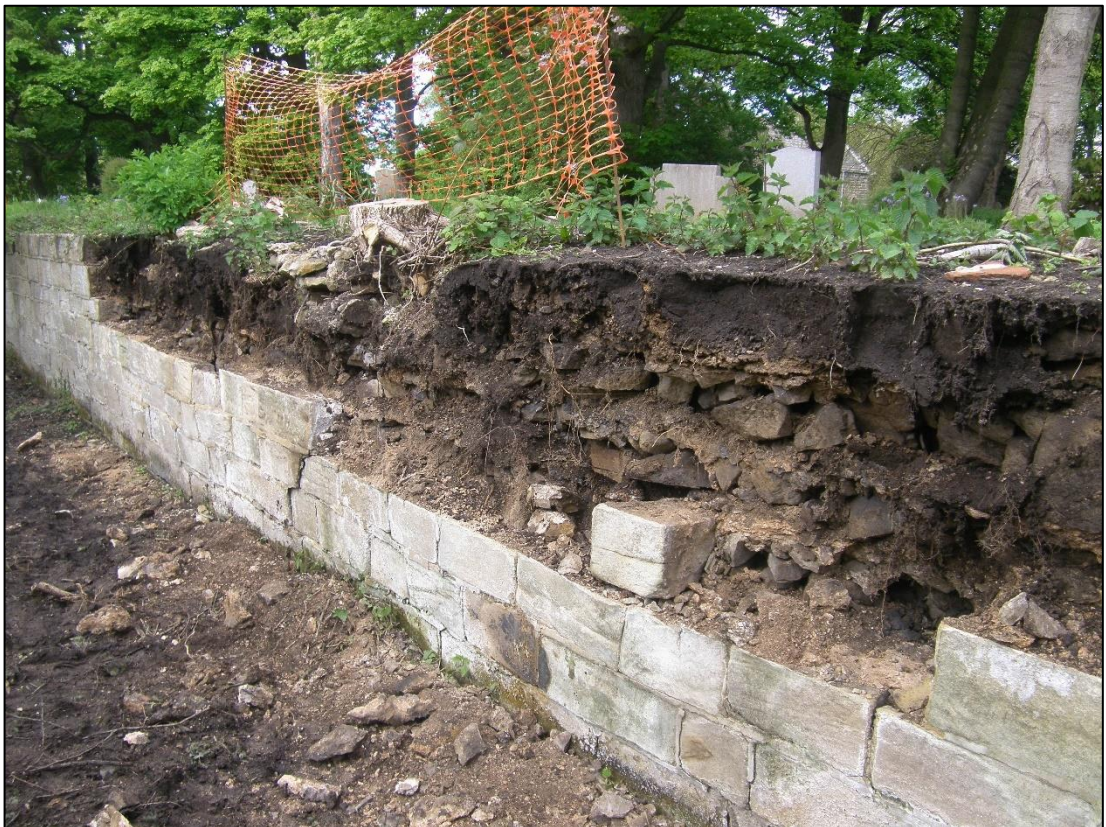
Plate 26: Section 4 of the west ha-ha after removal of the ashlar facing.

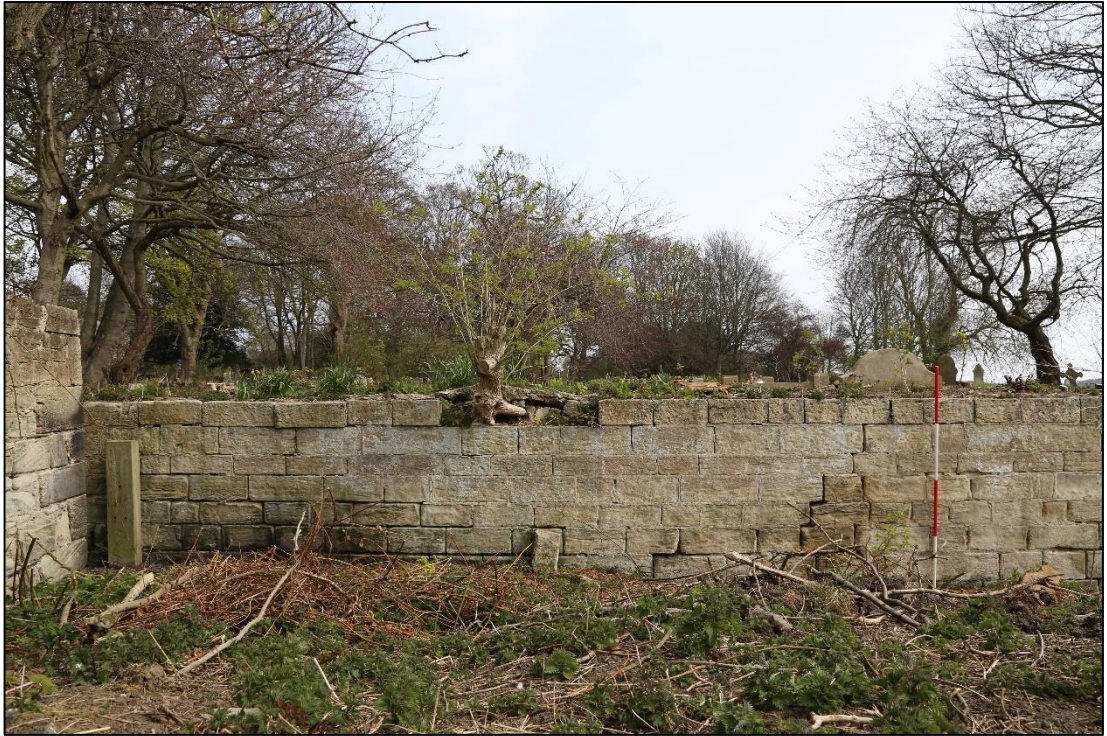
- 8.32 Section 5 (Plates 28–29) was located c.3m to the south of Section 4 and had suffered disturbance from the excavation of two 20th-century graves directly behind the ha-ha wall and from a semi-mature tree set in the wall directly to the north of the graves. Six courses of ashlar facing-stones were removed over a span of c.6m and demonstrated that the excavation of the graves had left the rubble revetment behind intact. The roots were removed, and the tree stump cut back before the facing stones were replaced.

Plate 28: pre-intervention photograph of Section 5.

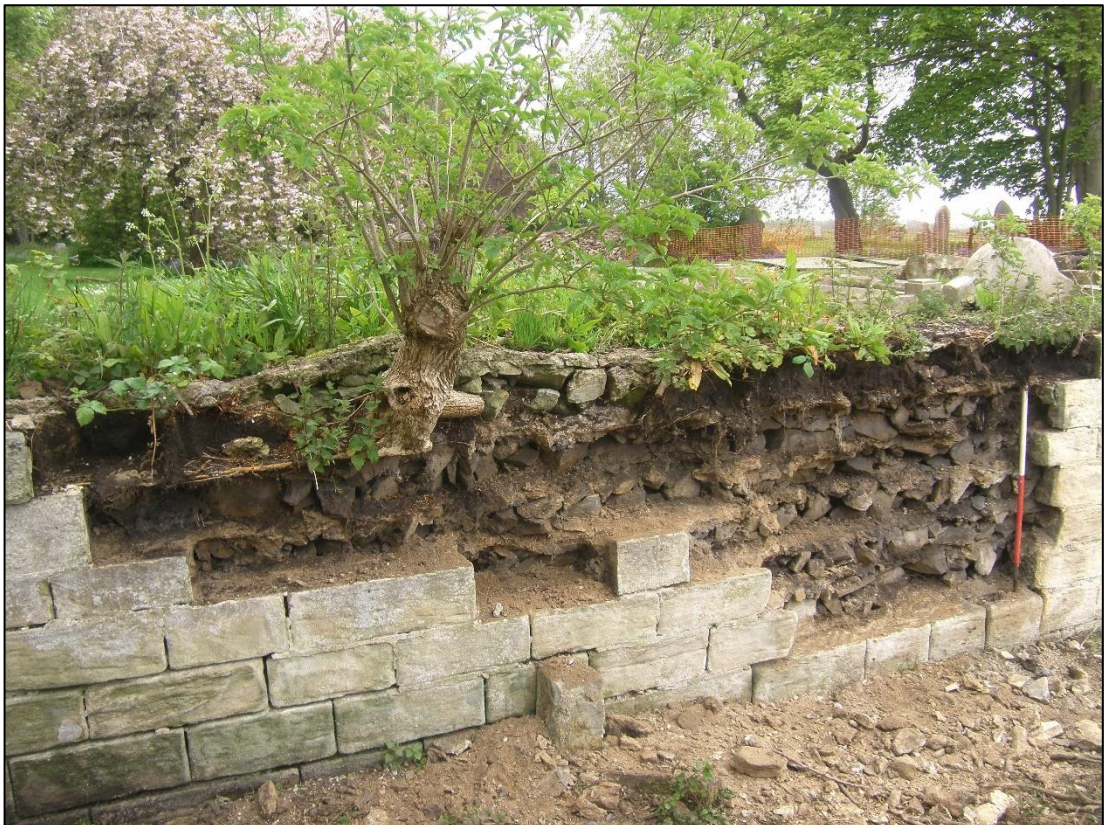
Plate 29: Section 5 of the west ha-ha after the removal of the ashlar facing.

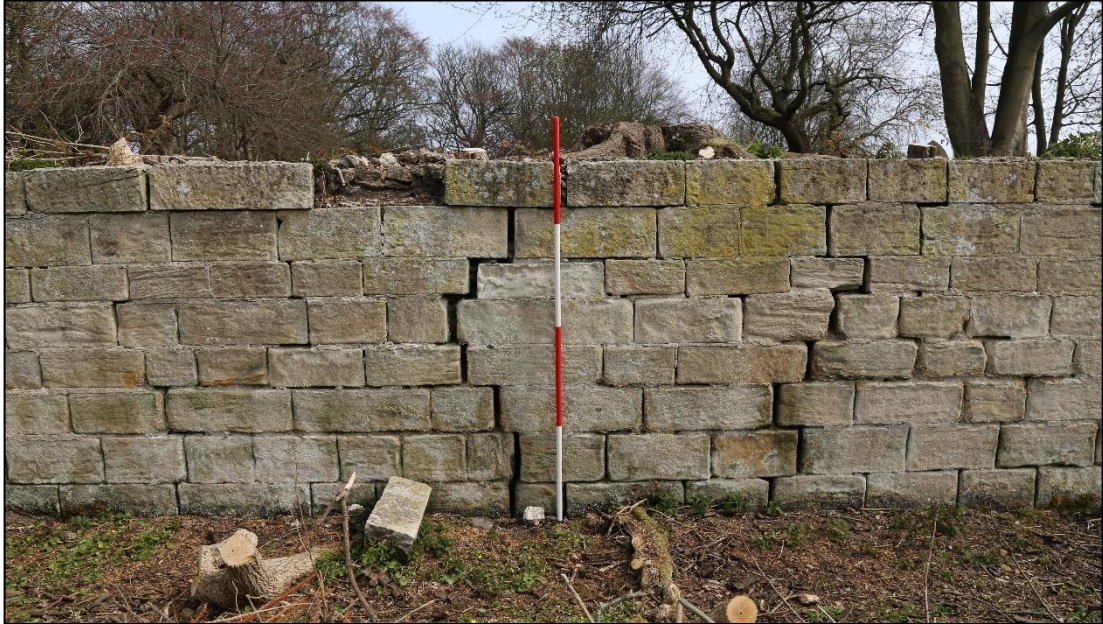
- 8.33 Section 6 (Plates 30–31) was located c.10m south of Section 5 and c.7m north of the south-west bastion and had suffered disturbance from the root system of a large, mature tree. Seven courses of ashlar facing were removed over a span of 3m.

Plate 30: pre-intervention photograph of Section 6.

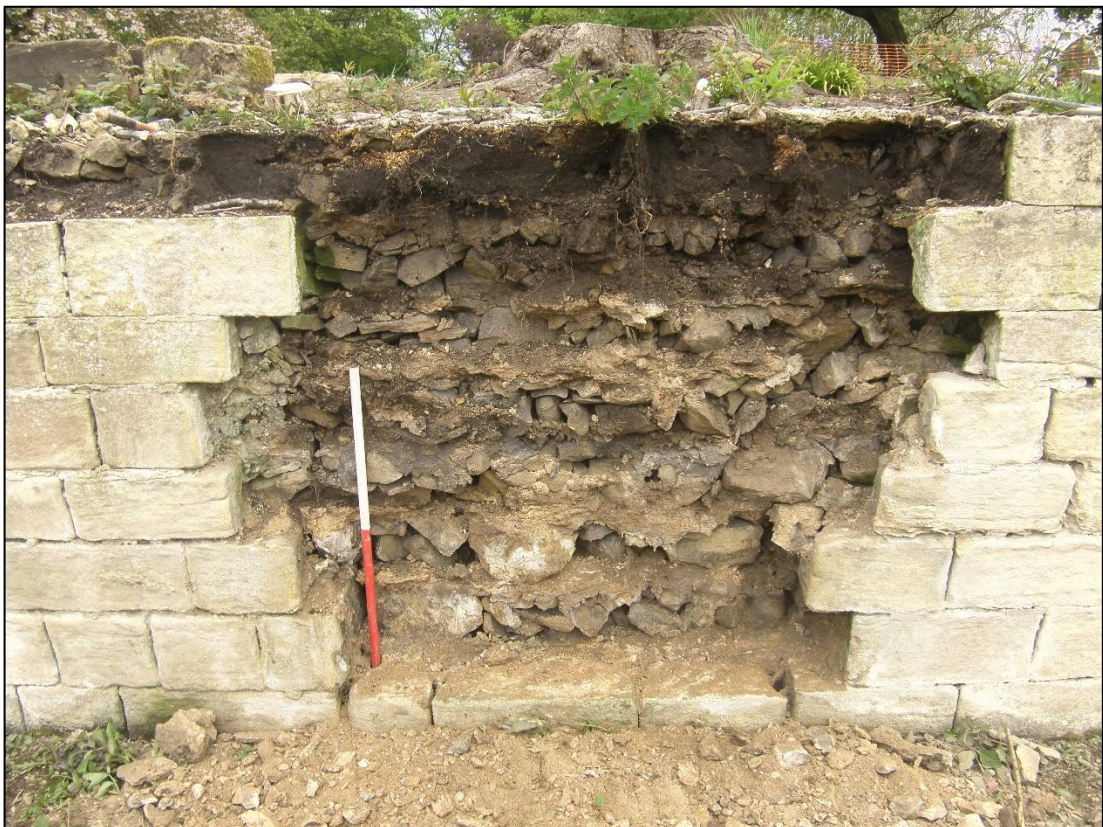
Plate 31: Section 6 of the west ha-ha after the removal of the ashlar facing.
