BUILDING SURVEY

THE METHODIST CHAPEL, HORSEMARKET, MIDDLETON-IN-TEESDALE

> NAA 18/85 October 2018

THE METHODIST CHAPEL, HORSEMARKET, MIDDLETON-IN-TEESDALE, COUNTY DURHAM BUILDING SURVEY

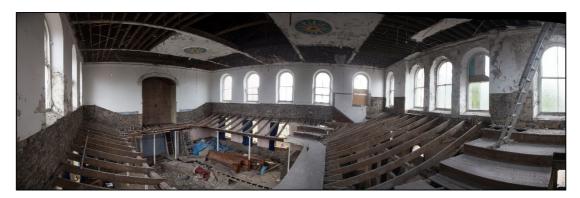
Plate 1: panorama of the chapel interior from the south-west corner.

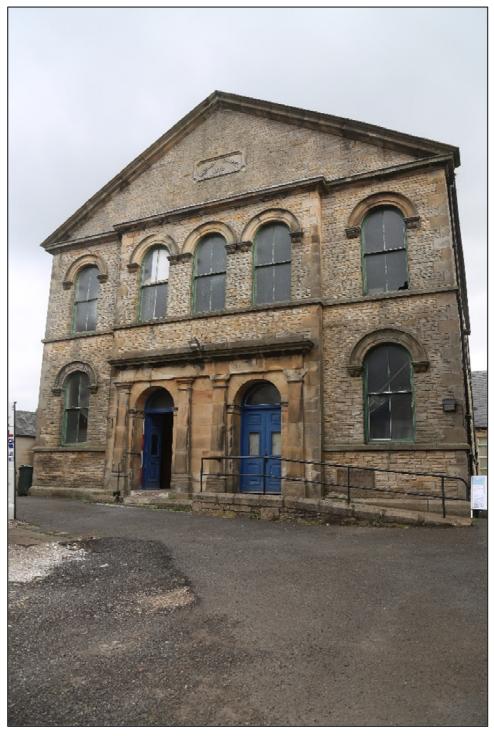
- The south elevation forms the front of the building (Plate 2), which faces onto Horsemarket. It is of cut and dressed sandstone with large quoins and two front doors (111), both of which are flanked by neo-classical pilasters. Above and on each side of these doors are arched windows with carved drip-moulds that end in fluted corbels (112). The five windows of the upper storey are separated from the two on the lower storey by a string course. Another string course appears below the lower-storey windows. The doors and pilasters, along with the central three windows of the upper storey, protrude slightly from the façade. Above the windows is a plain pediment with a central plaque reading 'Wesley Chapel 1870' (113).

Plate 2: front elevation of the Methodist Chapel looking north.

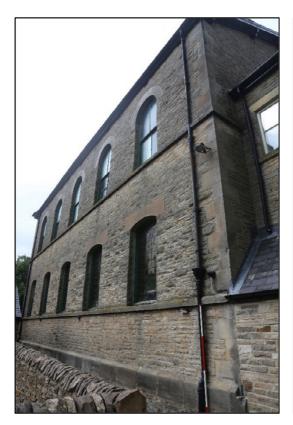
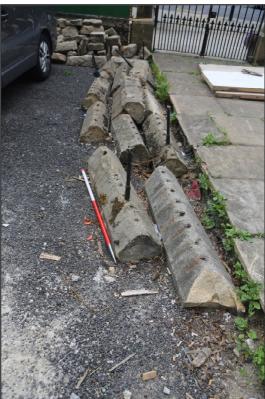
5.8 These elevations mirror each other and are composed of ten windows, five on each storey (Plate 5). The lower windows (121; 142) have a segmental arch set into ashlar headers. The northern four windows on each side have stained glass, while the southern windows have four plain glass panes. The windows of the second storey (122; 141) are rounded, also with ashlar headers, each with four plain glass panes, some of which have been boarded up. The two string courses of the south elevation continue on both the east and west, acting as the base for the windows.

Plate 5 and 6: (left) view of the east elevation looking south; (right) remnants of the stones and railings that formed the chapel yard.

wall around this chapel yard were still visible, having been placed off to one side, some of which still have railing stakes extending from them (Plate 6 and 7).

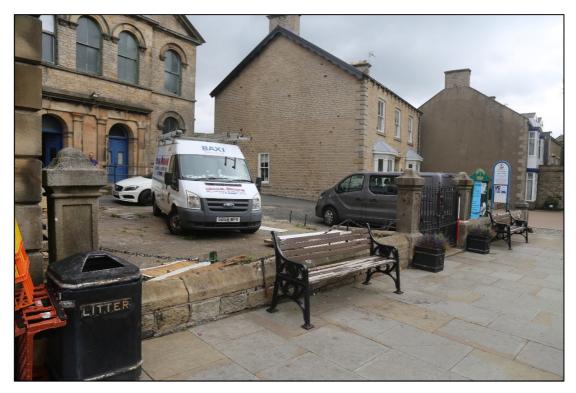
5.10 What was formerly a chapel yard lies between the Chapel and Horsemarket and is set apart from the street by two gates and a low wall. This space also formerly held a gate or fence that separated it from the chapel entrance. Stones pertaining to the boundary

Plate 7: view of the chapel yard from Horsemarket looking north-east.

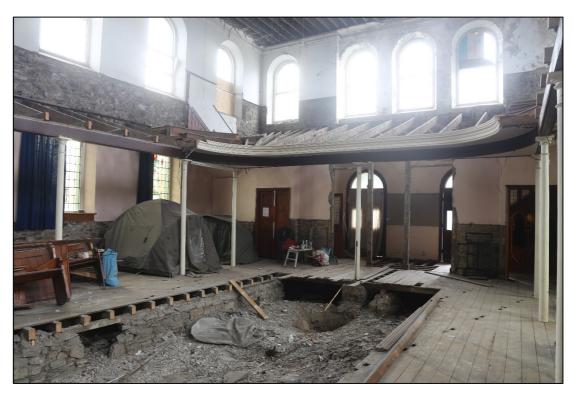
Plate 8: view of the south-east corner of the auditorium and gallery above with the door to the east narthex visible.

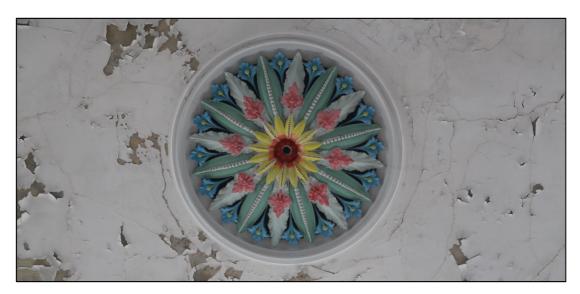
Plate 9: one of two ceiling roses above the auditorium.

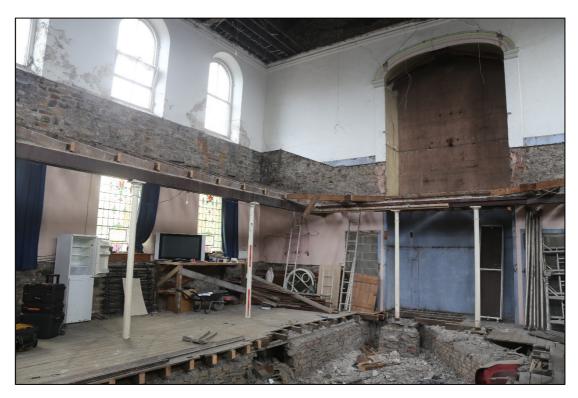
5.13 The north wall (Plate 10) contained a central alcove (211) covered by an archway adorned with colourfully painted moulding. The plaster wall of the alcove had been painted to resemble ashlar stone blocks. On either side of this alcove were blocked doorways (215) that formerly provided access to the vestry and coffee room. Beside the western blocked door was the remains of paint in a floral pattern (214).

Plate 10: view of the north-west corner of the chapel.

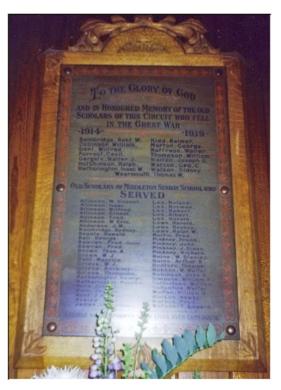
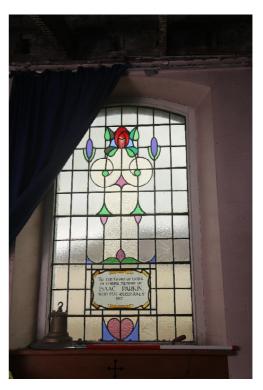
5.14 On the western side of the north wall, the scar of a war memorial plaque was clearly visible. This is the probable location of a World War I war memorial that was displayed in the chapel (Plate 11).

Plate 11 and 12: (left) World War I war memorial (Raine 2013); (right) commemorative window dedicated to Isaac Parkin.

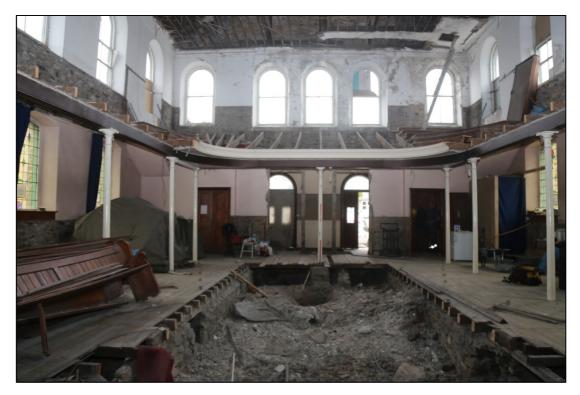
Plate 13: view of the south wall of the auditorium with the narthexes to the east and west.

- 5.16 The south wall was largely covered by the east and west narthexes (see below), each of which was accessed via double doors to the north (Plate 13). On the eastern side, the doors (231) were of solid wood with an iron twisted door handle. The west doors had been removed and placed to one side. Both west doors contained an upper panel of geometric coloured glass set into wood.
- 5.17 This wall also contained five fixed four-pane windows (233—corresponding to 112 outside) above the two large exterior doors (234—corresponding to 111 outside), with rounded fanlights and two rectangular windows on each door panel. Beside the western

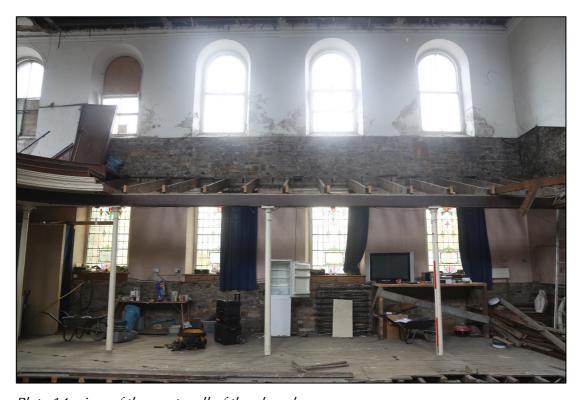
5.18 The west wall reflected the east wall, with five upper windows (242—same as 122 outside) and four lower windows (241), each also containing a memorial (Plate 14). From north to south, the windows commemorated the following: John and Mary Hyslop (died 1885 and 1880 respectively); Robert and Catherine Walton (died 1915 and 1914); Jacob and Mary Readshaw (died 1912 and 1903); and John and Jane Robson (died 1930 and 1931). Vents to provide heating were visible just below the gallery.

Plate 14: view of the west wall of the chapel.

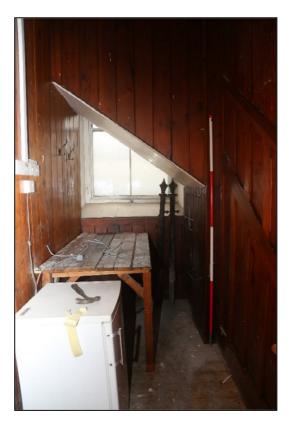
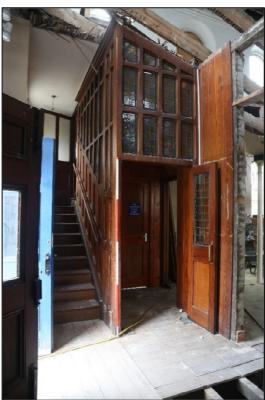
5.19 The east narthex was most likely used as a cloakroom, evidenced by the hooks lining the wall (Plate 15). On the eastern wall is a window, partly cut off by the stairs. Below the stairs is a space (251) that has partially been used for storage and is accessed only via a cramped hole. The west end of the west narthex has been converted into a modern

Plate 15 and 16: (left) interior of the east narthex as seen from the west; (right) view on the west narthex from the stairs to the east.

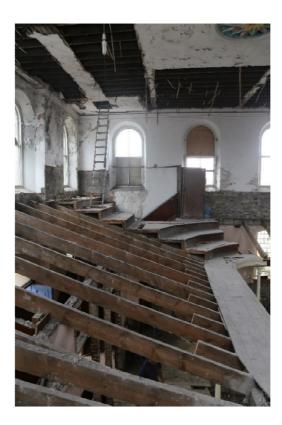
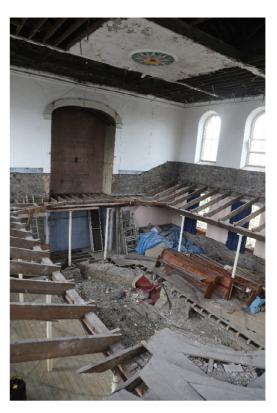
- 5.21 The gallery (280) had been mostly removed by the time of survey, yet evidence of its original form remained. The gallery fully encircled the auditorium with seven rows of risers, presumably holding seven rows of pews along the south wall, with the east and west walls holding four pews (Plate 19). The gallery spanned across the north wall, but it is uncertain what it held (Plate 20). Access to the gallery was provided by the stairs on the east and west of the south wall.

Plate 1 and 20: (left) view from the east entrance to the gallery looking west. The remaining risers of the gallery are visible by the entrance; (right) view from the west gallery access looking north-east.
