ARCHAEOLOGICAL WATCHING
BRIEF REPORT

**NENTHEAD LEAD MINES,
NENTHEAD, CUMBRIA**

NAA 15/91
February 2016

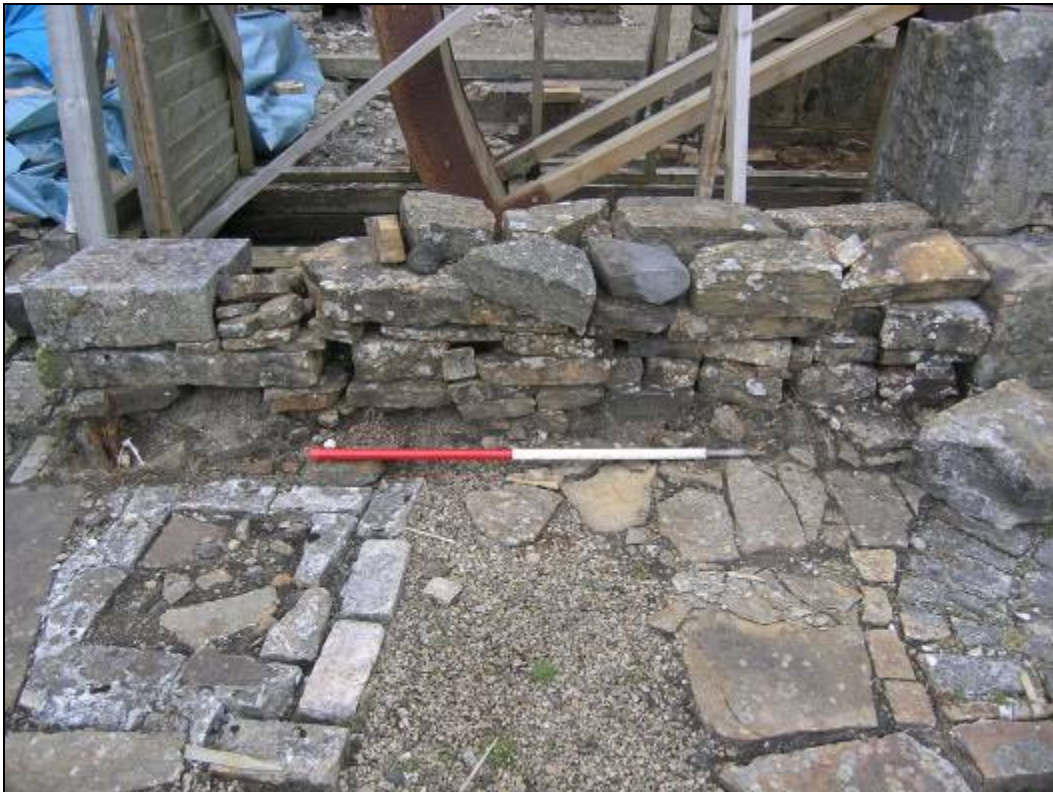
Plate 1: Smelt Mill Feature 1 pre-intervention image of section of wall to be dismantled and rebuilt.

- 4.4 Smelt Mill Feature 1, Plate 1, was located directly adjacent to the northwest of the wheel pit and encompasses a section of low wall butting up against the stone footing for the axle of the wheel pit (Countryside Consultants 2013, fig. 28). The structure had suffered significant loss of mortar and had become highly vulnerable to further degradation.

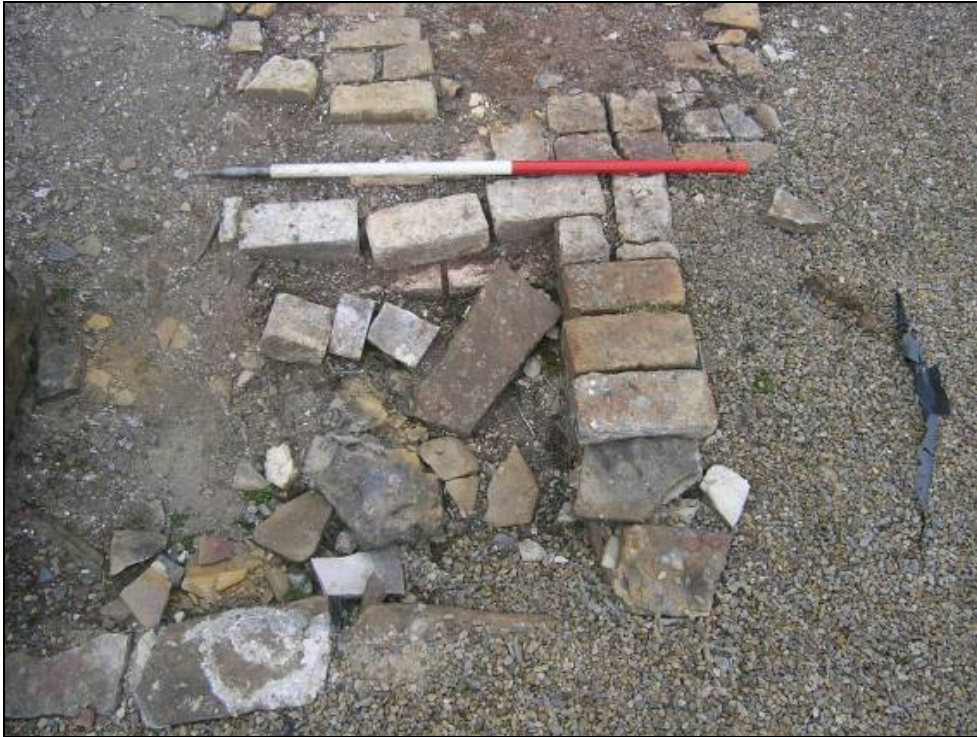
Plate 2: Smelt Mill Feature 2 pre-intervention.

- 4.9 A watching brief took place on the 17th of July 2014 to monitor the clearance of loose debris from around this structure. It was proposed that 20 bricks were to be uplifted and re-bedded back into their original position. The top course of brick was removed down to a solid bearing and the loose bricks re-bedded back into place using lime mortar, Plate 3. No features of further archaeological interest were uncovered underneath the top coursing of brick.

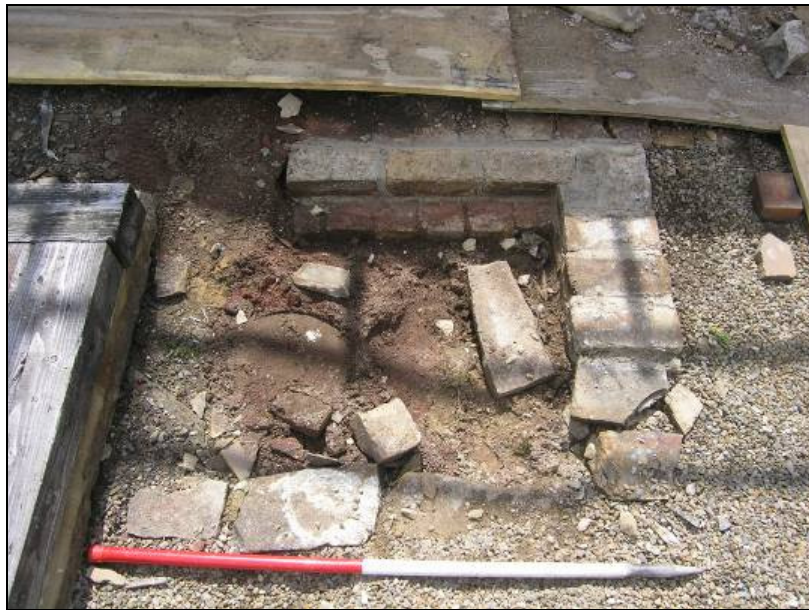
Plate 3: Smelt Mill Feature 2 post-intervention.

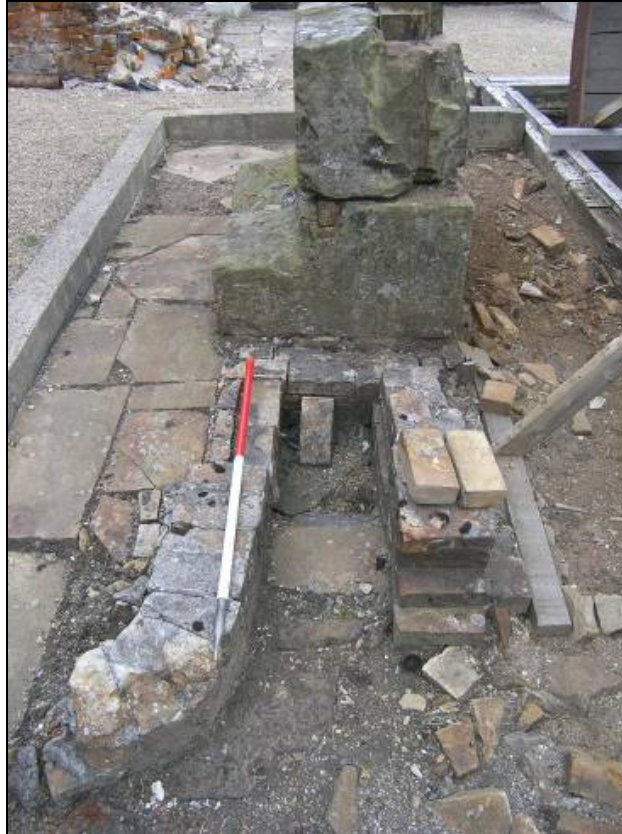
- 4.10 Smelt Mill Feature 3, Plate 4, was located immediately adjacent to the southeast side of the wheel pit in the main smelt mill complex and is highlighted in the management plan (Countryside Consultants 2013, fig 28). Similarly to the rest of the structures in and around the wheel pit this feature had suffered a loss of mortar causing the top courses of brick to come loose and had become highly vulnerable to collapse and further degradation.
- 4.11 The structure was built in brick and butted up against the footing for the axle of the wheel pit on the

Plate 4: Smelt Mill Feature 3 prior to consolidation.

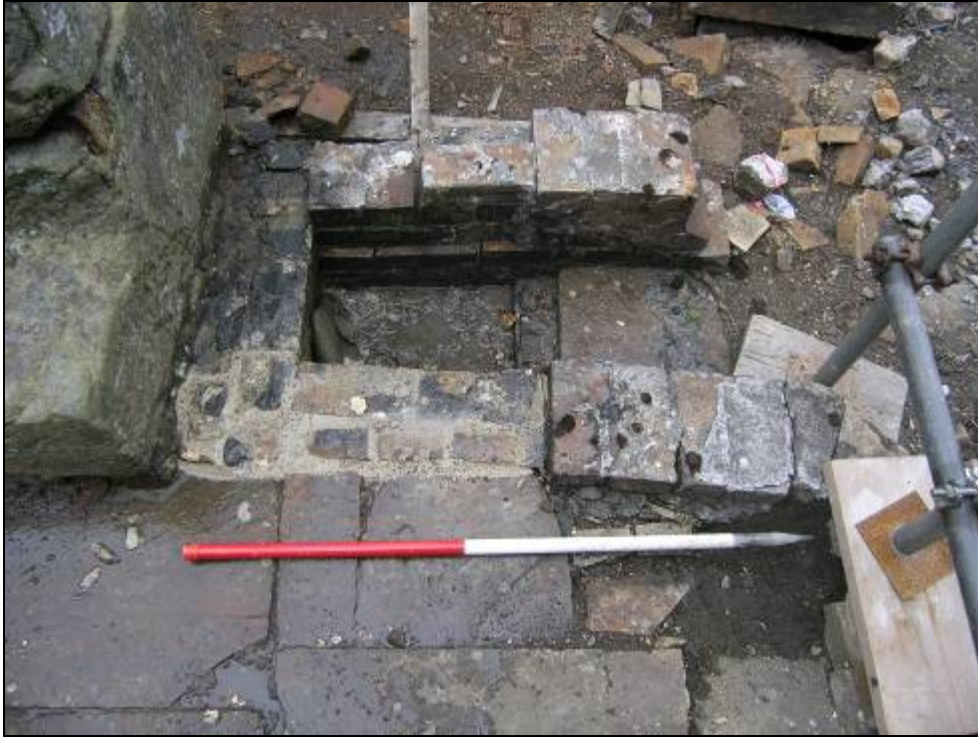
Plate 5: Reconsolidation of structure with scaffolding to the right.

- 4.13 Reconsolidation of this feature was carried out without an attending archaeologist. Subsequent conversations with contractors from William Anelay revealed only further coursing was uncovered under the course of bricks removed. However, more of the iron plate discussed above was revealed and then re-covered by the re-bedding of the above courses of brick. Approximately 12 bricks were uplifted to sound bedding and re-bedded using lime mortar. The curved section of the southeast wall was not consolidated due to the improper placement of the supporting scaffolding for the spine wall, which has caused the mortar on this section of wall to crack (Plate 5).

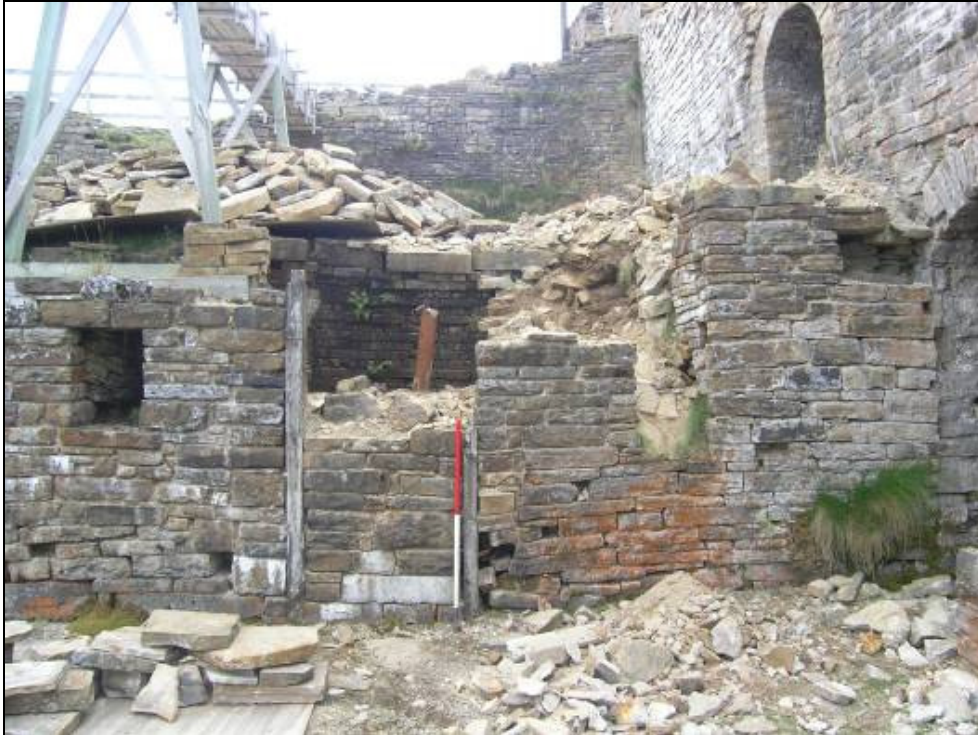
Plate 6: Smelt Mill Feature 4 showing bricked up door and timber frame.

- 4.16 After consultation with contractors from William Anelay it was decided that loose masonry from inside the structure was to be removed and any bricks that were obviously part of the structure on the back face were to be left *in situ*.

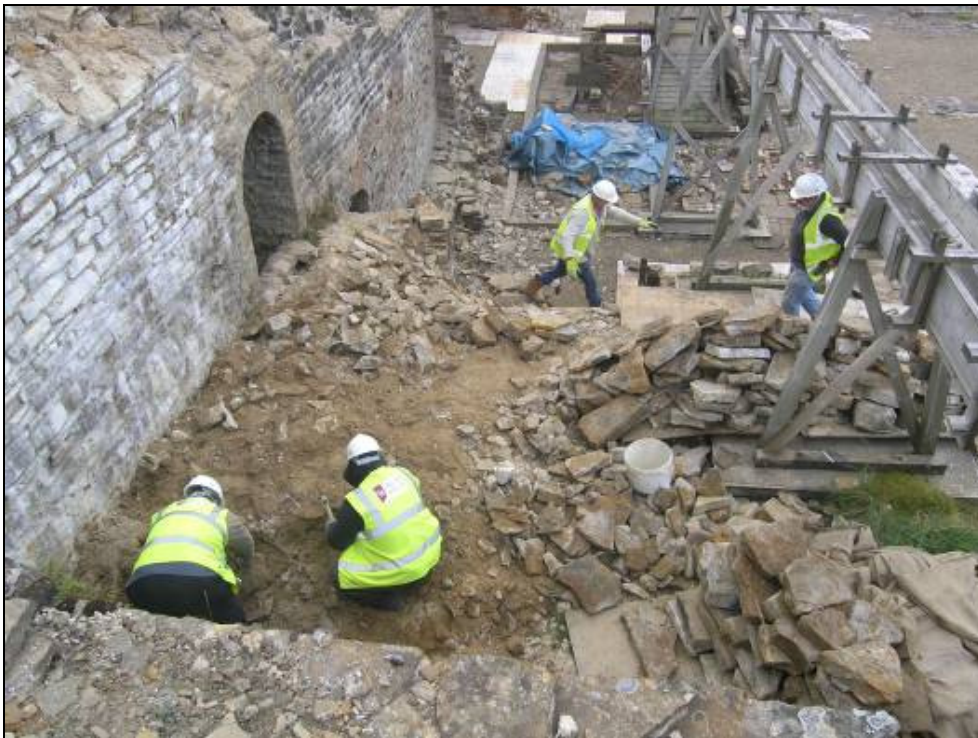
Plate 7: Smelt Mill Feature 4 debris clearance.

- 4.17 Under closer inspection of the cleared structure of it was apparent that no further consolidation was required as the area was stable.

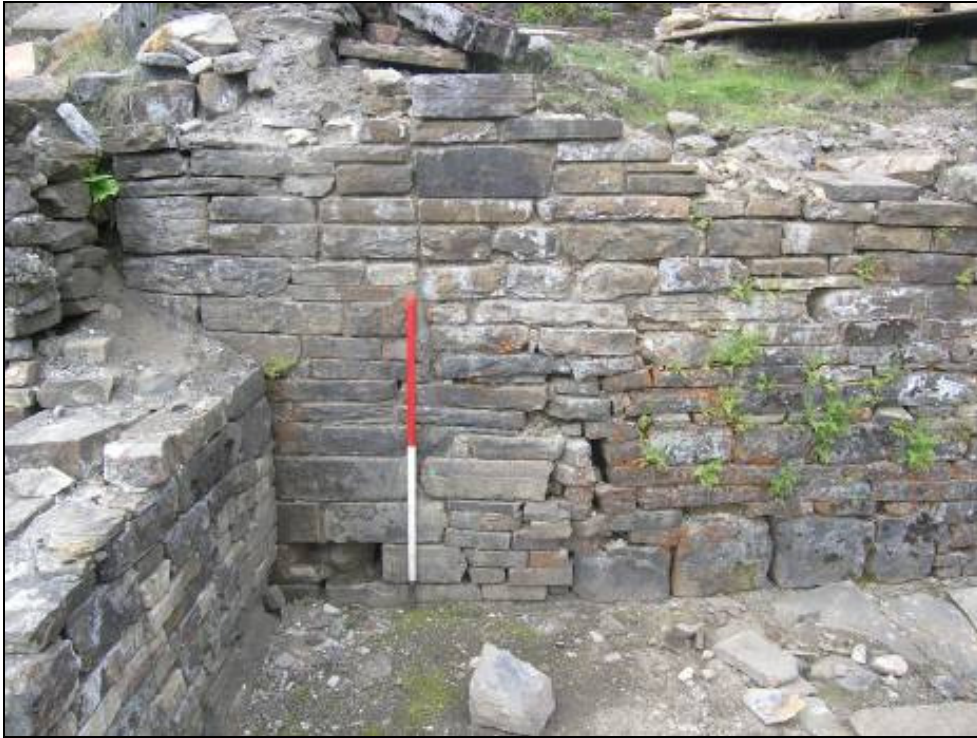
Plate 8: Smelt Mill Feature 5. Note two voids either side of ranging pole. Wall of Building A butting against.

- 4.18 Smelt Mill Feature 5, Plate 8, was located against the northwest corner of the smelt mill building adjacent to Building A at NY 78412 432887 (Countryside Consultants 2013, fig. 33). Some concern was raised with this section of wall as to whether the voids highlighted were a structural feature or a defect in the wall likely to cause future damage to the northeast wall of the smelt mill.
- 4.19 Under further consultation between William Anelay it was apparent that these voids were in fact defects in the wall and not structural. The wall itself had undergone numerous phases of rebuilding and repair, possibly associated with the addition of Building A.
- 4.20 Due to time and weather constraints this section of wall was not consolidated. It was not considered that this section of wall was in immediate danger and was stable. However, future consolidation was recommended.

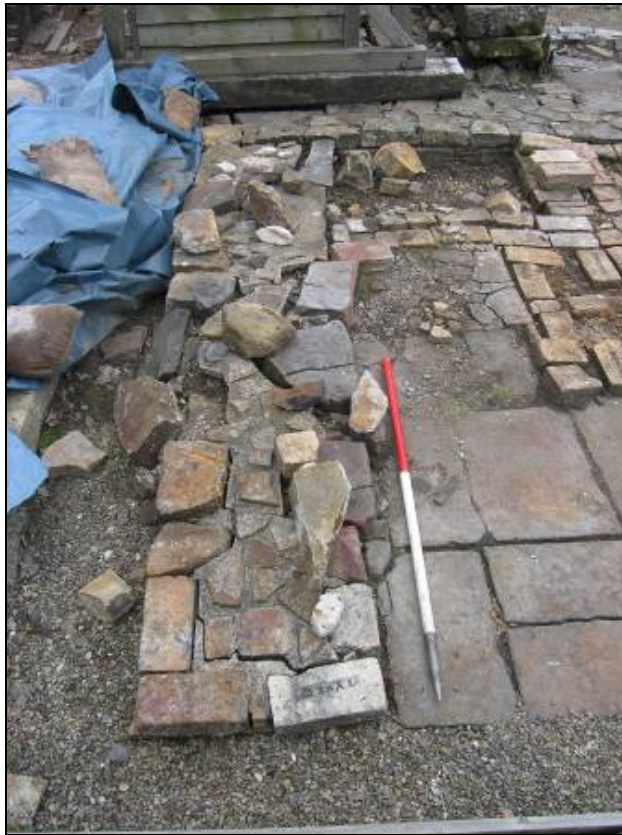
- 4.21 Smelt Mill Feature 6, Plate 9, was located to the northeast of the wheel pit and measured 2.71m by 0.54m and was located at NY 78418 43293 (Countryside Consultants 2013, fig. 29). The wall had suffered significant loss of mortar and had become highly vulnerable to further degradation.
- 4.22 The structure was visible as two courses of roughly faced limestone blocks of various sizes arranged in a roughly squared coursing pattern. The wall butts up against the central wall of the smelt mill complex and was part of the fume hood overlying the ore hearth. Unusually the end of the structure has been squared off, possibly rebuilt, in bricks of various different types indicating that the wall has undergone at least one other building phase.

Plate 9: Smelt Mill Feature 6 pre-intervention.

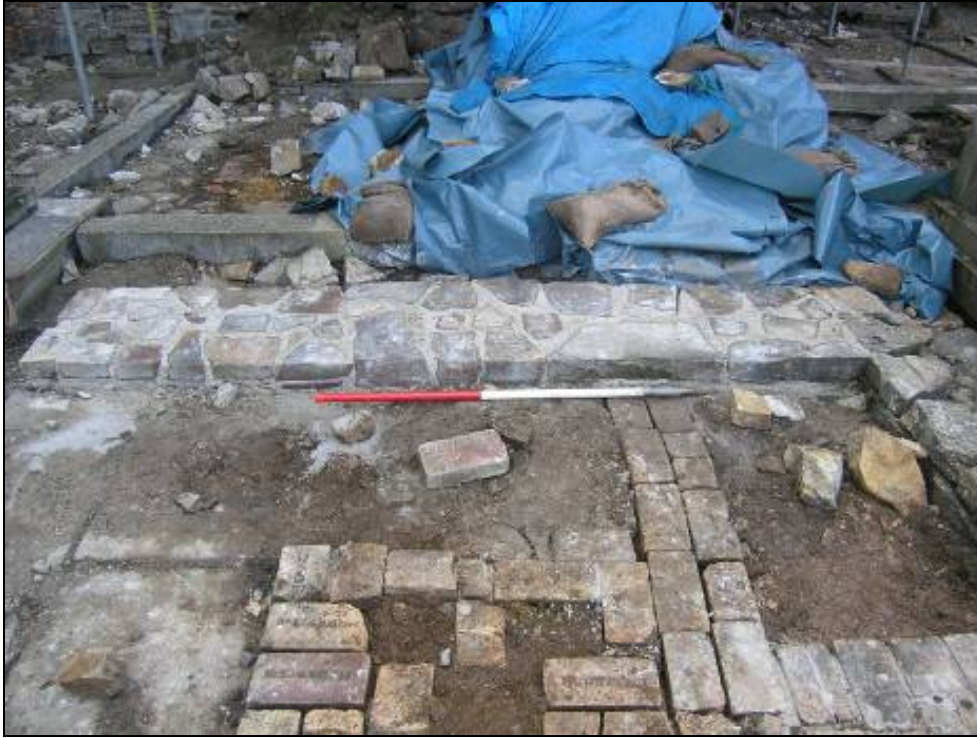
Plate 10: Smelt Mill Feature 6 post-intervention.

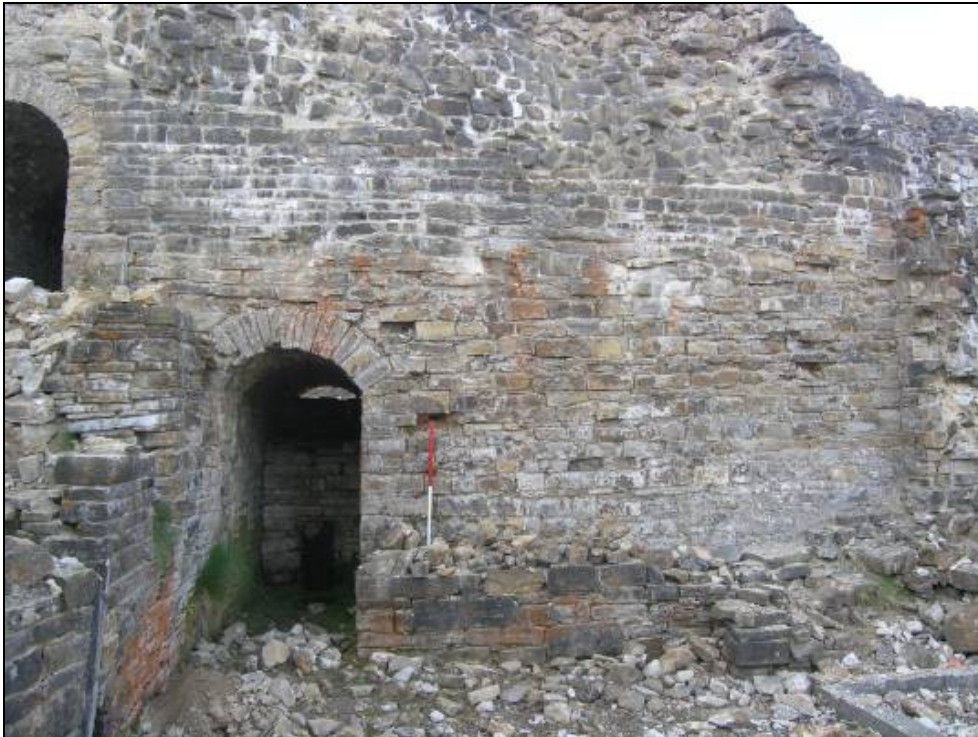
Plate 11: Smelt Mill Feature 7 showing wall butting against northwest face of spine wall.

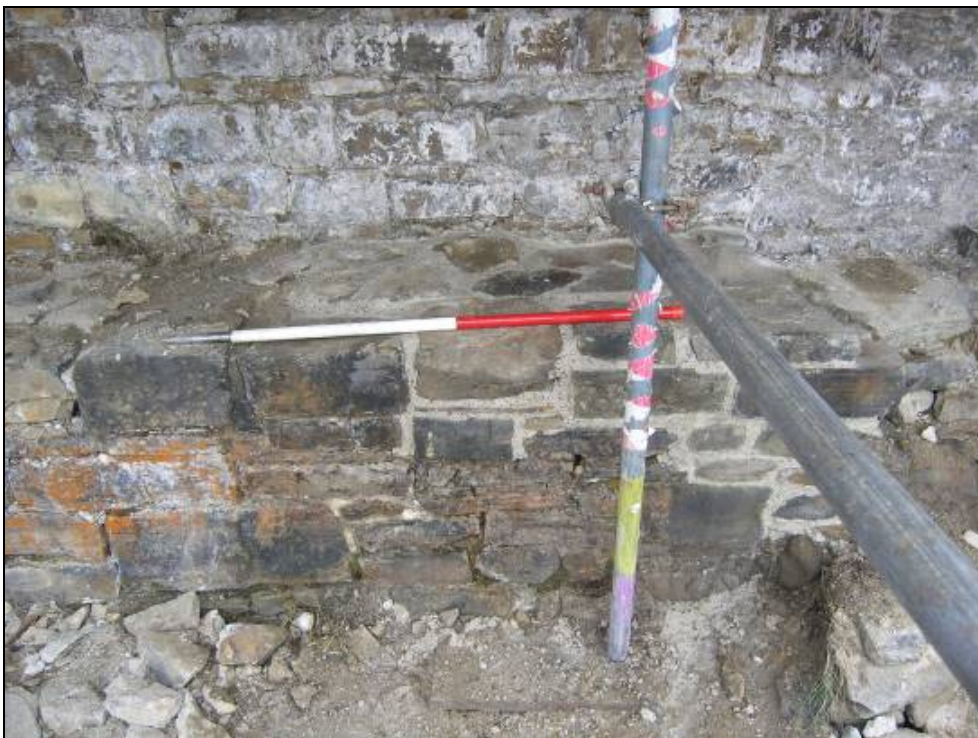
Plate 12: Smelt Mill Feature 7 post-intervention.

- 4.27 After the clearance of the fallen spine wall debris it became clear that no other features of archaeological interest were present and the remainder of the collapsed wall was rebuilt to the same height and specification as the surviving left corner, Plate 12.

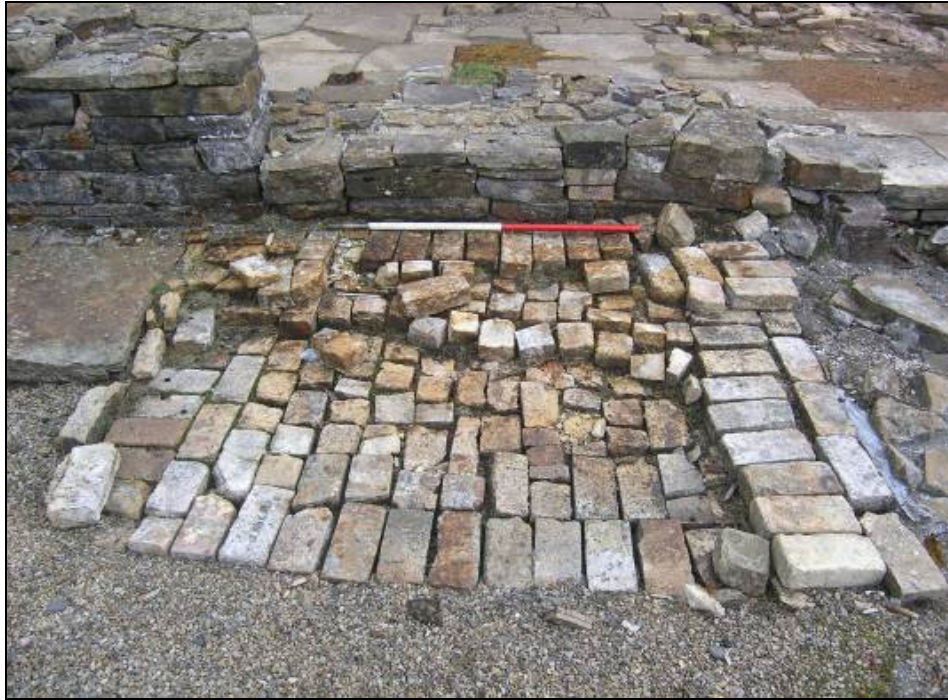
- 4.30 Feature A1, Plate 13, was located on the southeast wall of Building A at the northeast end of the structure and measured 2.8m by 1.5m. It was located at NY 78421 43297. The structure had suffered significant loss of mortar and had become highly vulnerable to further degradation.

Plate 13: Feature A1 pre-intervention.

- 4.32 A watching brief was carried out on June 24th 2014 to monitor the removal of loose material and the re-bedding back into original positions. Bricks were removed down to a solid bearing and re-bedded into their original positions using lime mortar, Plate 14. No further features of further archaeological interest were uncovered beneath the top coursing of bricks.

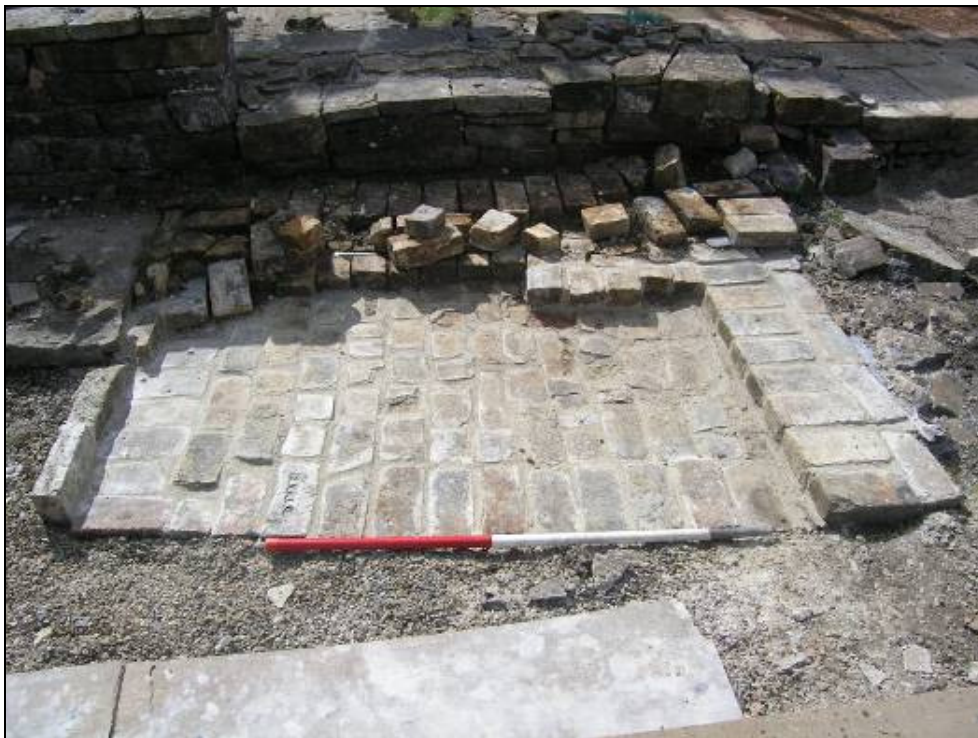
Plate 14: Feature A1 post intervention.

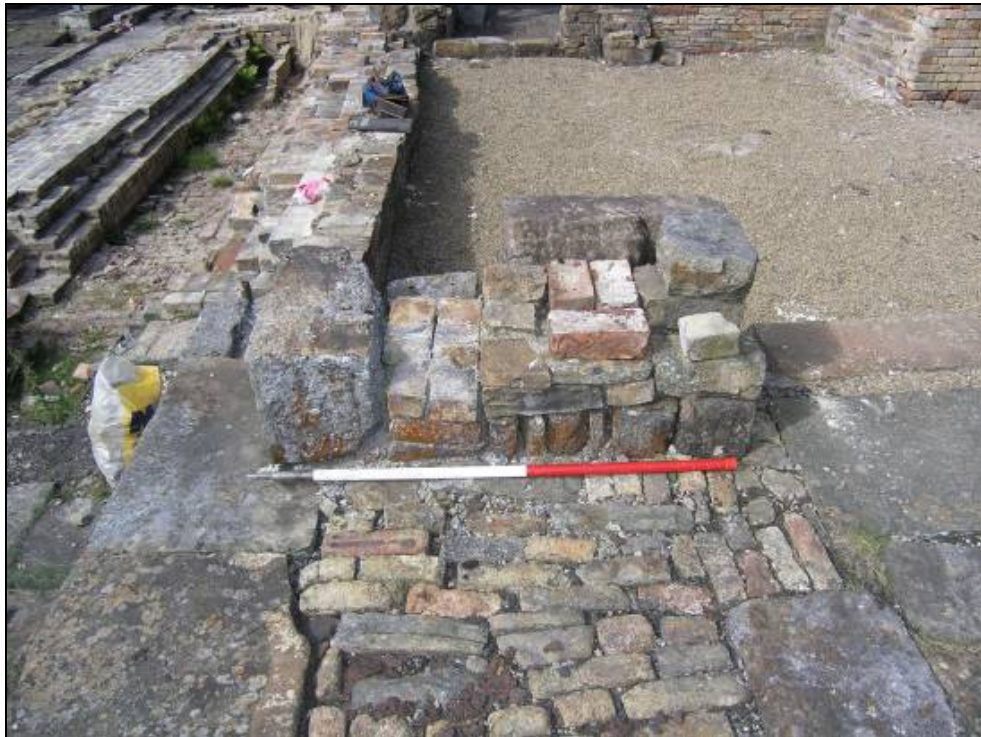
Plate 16: Feature B1 showing loose bricks not consolidated.

- 4.36 Feature B1 was located on the southwest end of Building B adjacent to the loading bay and measured 1.21m by 0.60m and 0.95m high, Plate 16. It was located at NY 78431 43282 (Countryside Consultants 2013, fig. 8)
- 4.37 This structure represented a blocked up door way into buildings B-F and had suffered significant loss of mortar. After consultation with William Anelay it was recommended that this structure be reconsolidated as it stands in the future.
- 4.38 No further consolidation was carried out on this structure, as it is mostly stable except for a few loose bricks on top which do not look to be part of the original structure.

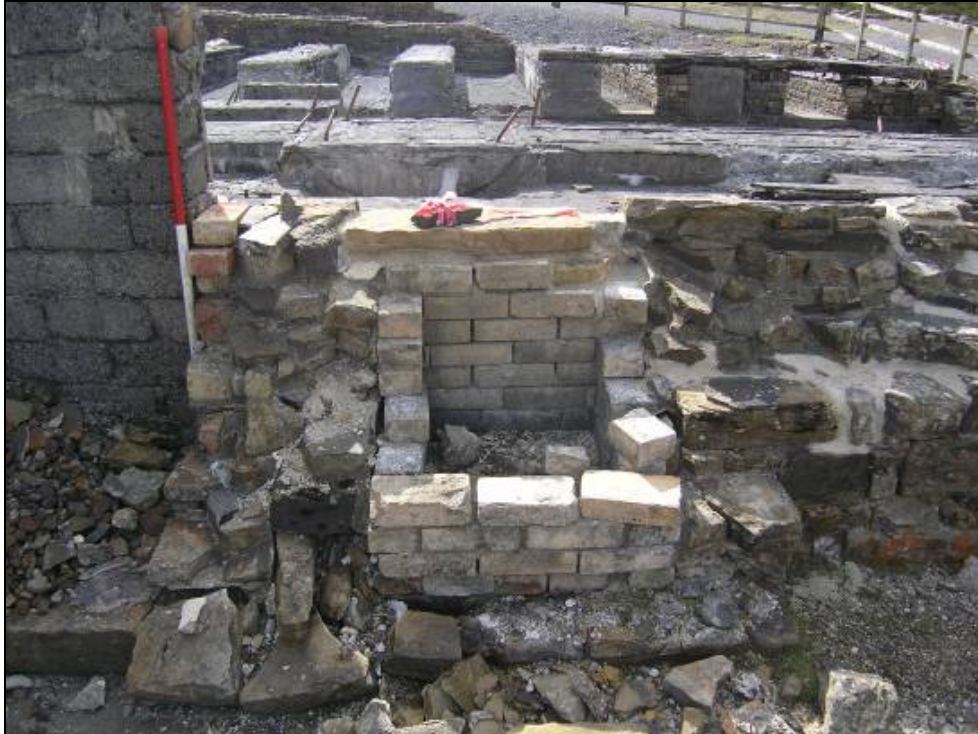
Plate 18: Feature C1 post-intervention.

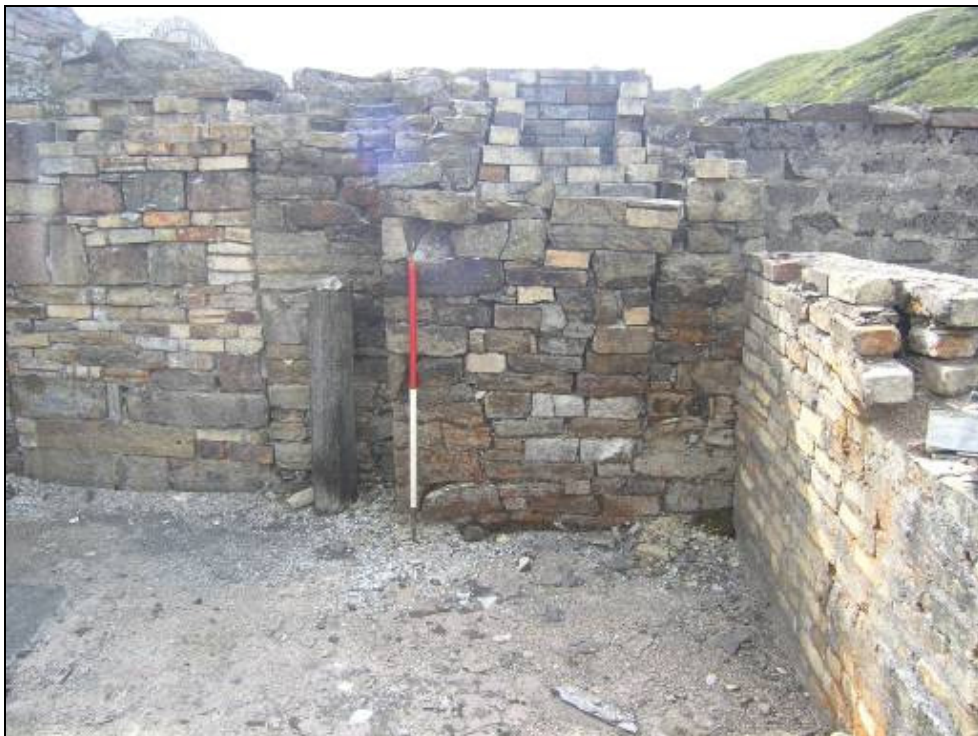
Plate 19: Feature C2 pre-intervention.

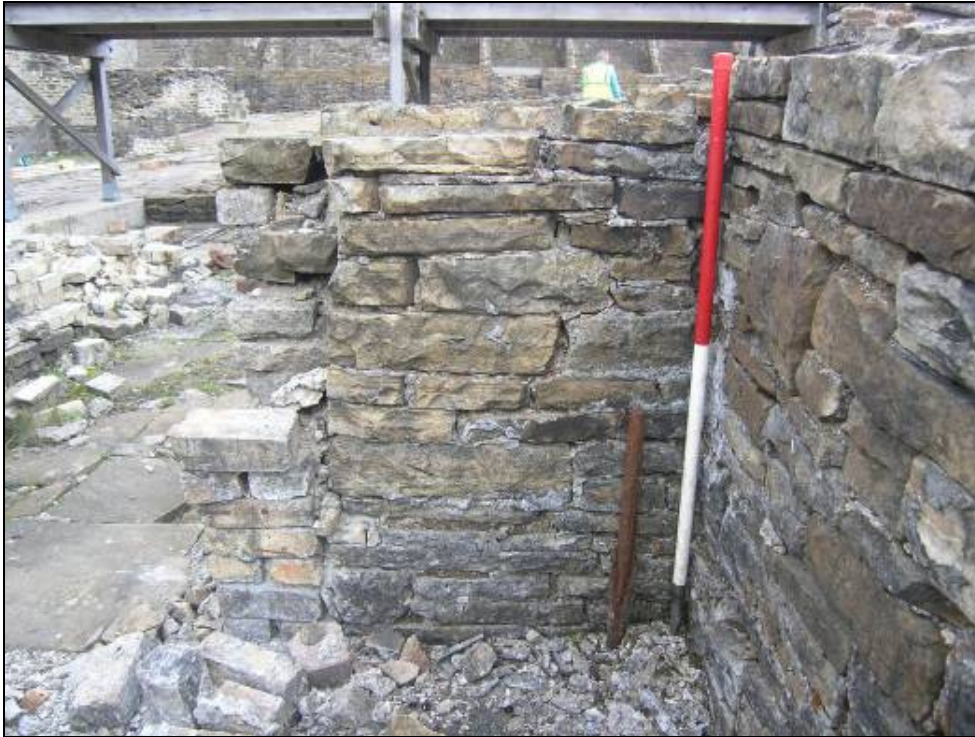
- 4.49 Feature D1, Plate 21, was located at the eastern corner of Building D adjacent to the compressor bases at NY 78417 43259 and measured 0.44m by 0.30m by 1.10m high (Countryside Consultants 2013, fig. 21). The corner of this structure had suffered a collapse due to loss of mortar.

Plate 21: Feature D1 pre-intervention showing doorway into Building H.

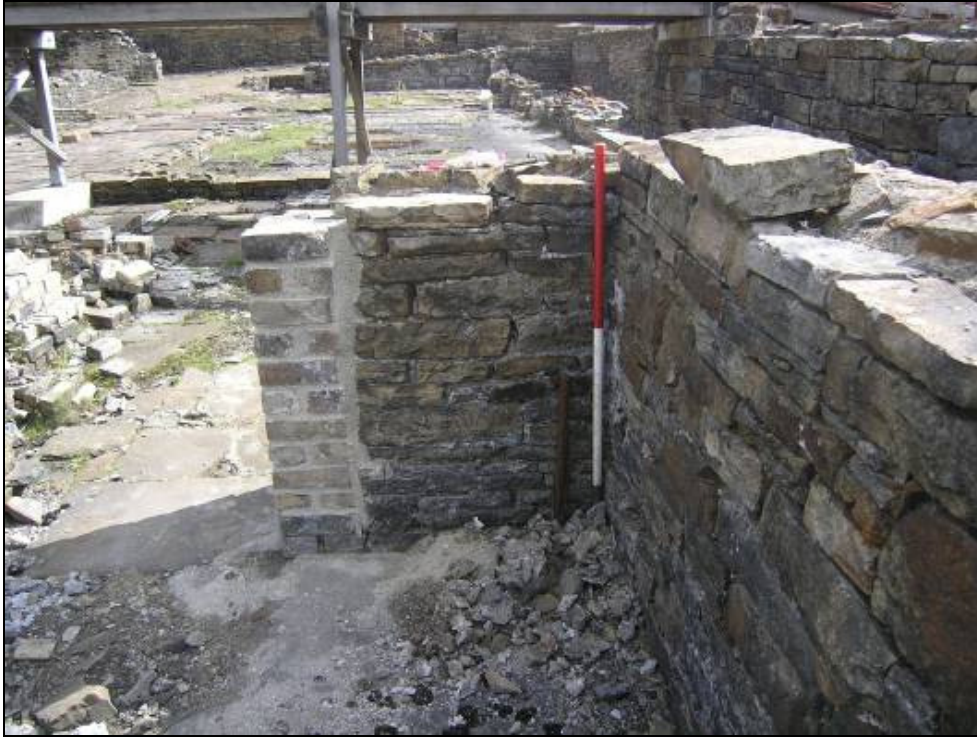
Plate 22: Feature D1 post intervention

- 4.51 The section of collapsed corner was taken down to a solid bearing and rebuilt using bricks salvaged from the immediate area that looked as if they had originally come from this section of wall. It was unclear how extensive this rebuild originally was. Judging by the amount of nearby fallen brick it was decided to rebuild the entirety of the corner up to the top of the existing limestone wall, Plate 22.

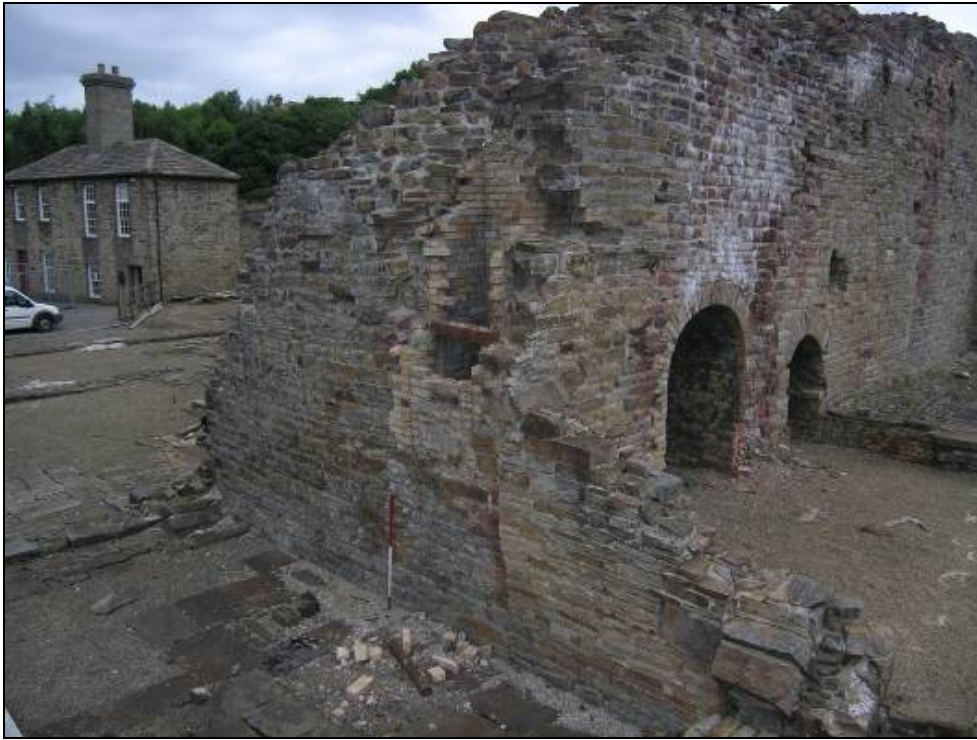
- 4.53 Feature F1, Plate 23, was located at the southwest end of the spine wall that incorporated the north-western wall of Building F at NY 78417 43279. This elevation was considered under threat because of a general lean forward by 200mm. The masonry on the whole was in good condition bar the top courses around the chimney flue which were subsequently re-bedded prior to the consolidation work on the main face of the wall.
- 4.54 It was proposed that this face of the spine wall was to be restrained using cintec anchors and pattress

Plate 23: Building F1. Southwest end of spine wall prior to anchor installation.

plates. A program of watching briefs and monitoring was initially put in place for the installation of the cintec anchors. However, due to the number of holes and size of the holes being drilled, a full watching brief was not possible and only a small number of holes were monitored. Some concern was raised that the drilling work may come across additional flues or other features within the spine wall. Under close inspection of this end of the spine wall no other features could be determined other than the bricked up furnace and associated chimney.

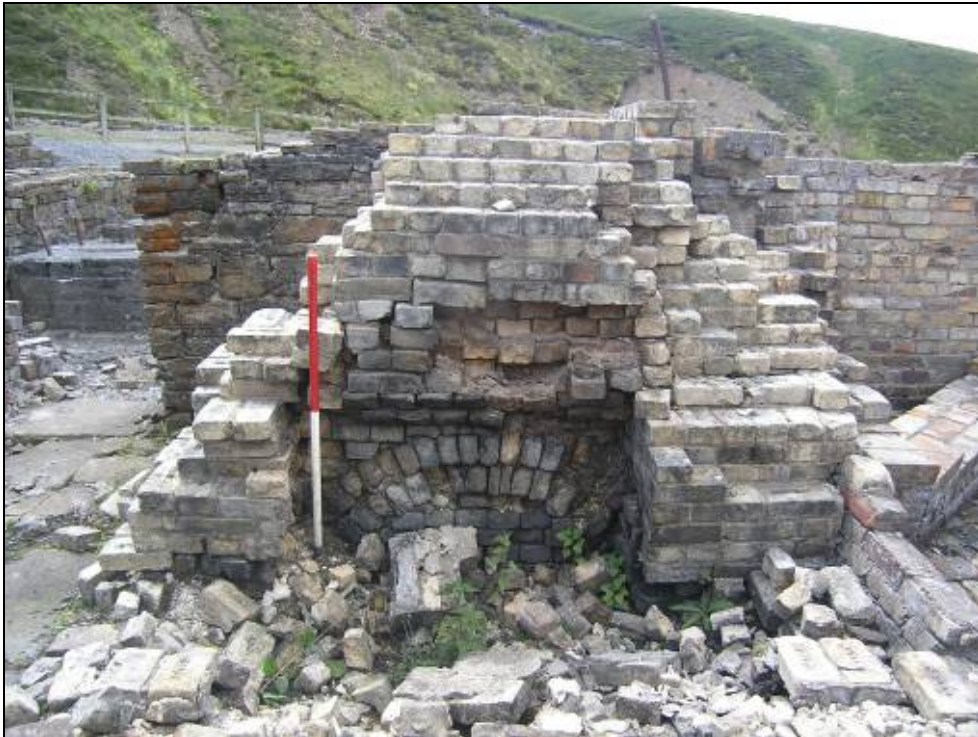
Plate 24: Feature H1 pre-intervention.

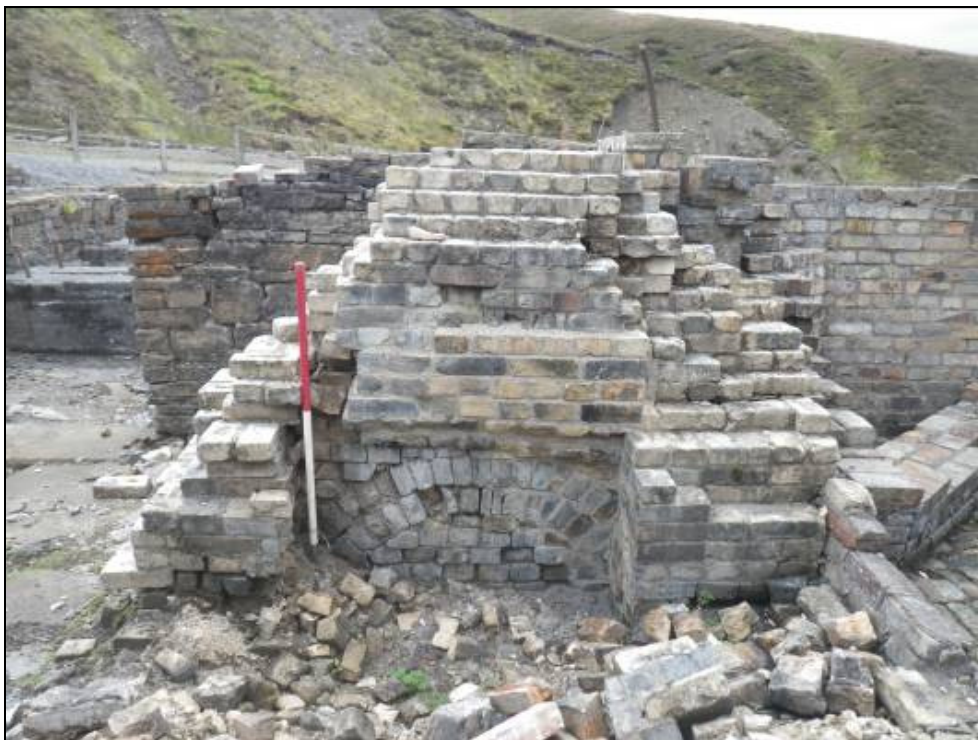
Plate 25: Feature H1 post intervention.

- 4.58 Under further consultation between Countryside Consultants, William Anelay and Northern Archaeological Associates, it was decided to undertake additional work on this section of the chimney around the bricked up arch. A further 0.5 by 0.5m section of the arch was reconsolidated as concerns were raised that the poor condition of the underlying brick work would cause the recently re-pointed section to collapse, Plate 25.

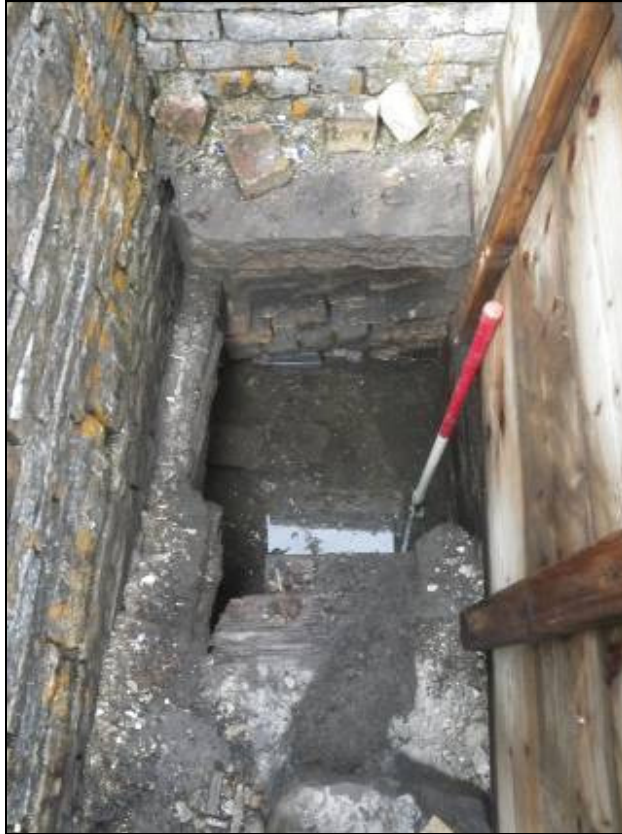
Plate 26: Drain structure beneath Feature H2.

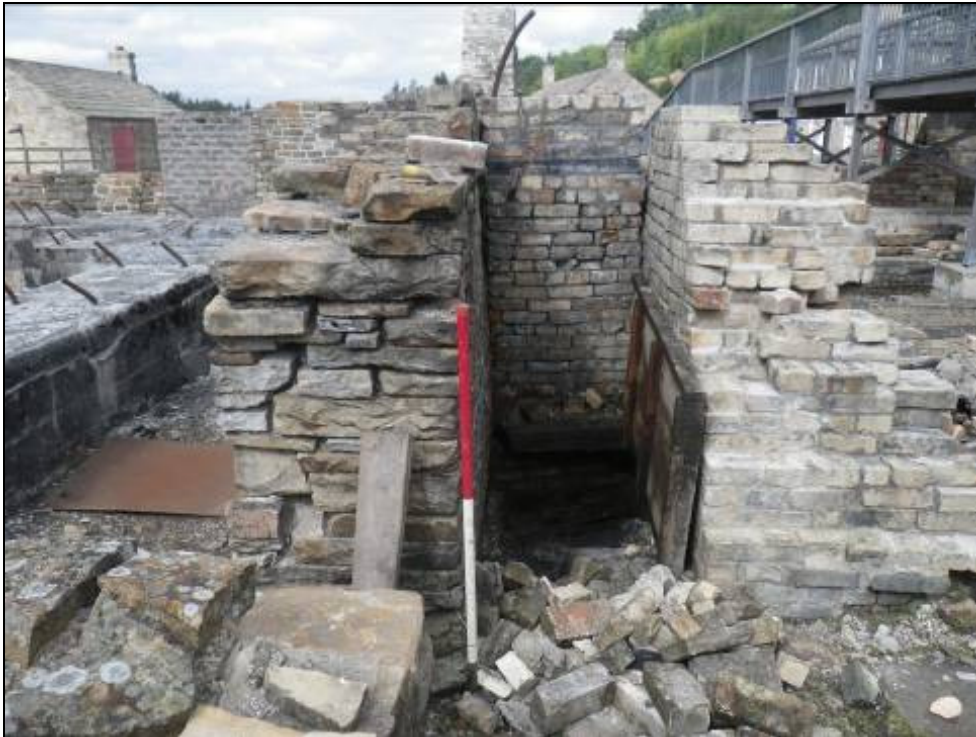
Plate 27: Feature H3 northwest elevation pre-intervention.

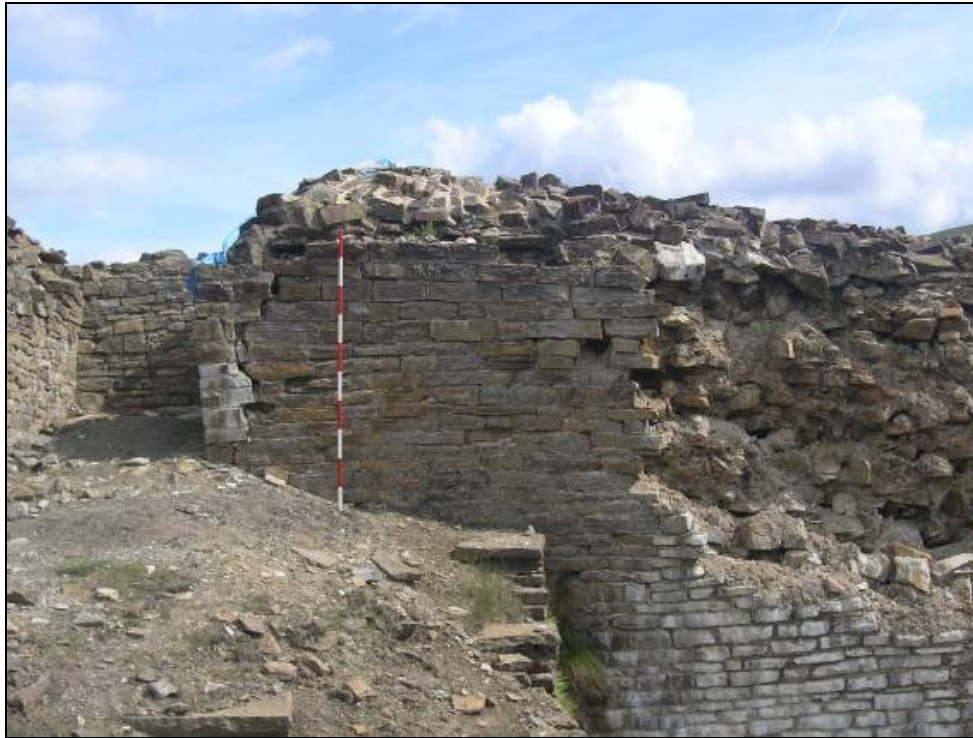
- 4.66 Spine Wall Feature 1, Plate 29, was located on the northwest face at the northeast end of the spine wall adjacent to the inspection chamber at NY 78436 43294. It incorporated a section of the outer skin of the spine wall approximately 3.2m long and 2m high.
- 4.67 It was comprised of 19 courses of even coursed large well dressed stone. Although not specifically highlighted in the management plan (Countryside Consultants 2013) it was felt that this section of the spine wall posed significant threat to the underlying structures. A section of the spine wall immediately to the southwest had previously collapsed causing a great deal of damage to the structures beneath (see Smelt Mill Feature 4)

Plate 29: Spine Wall Feature 1 pre-intervention.

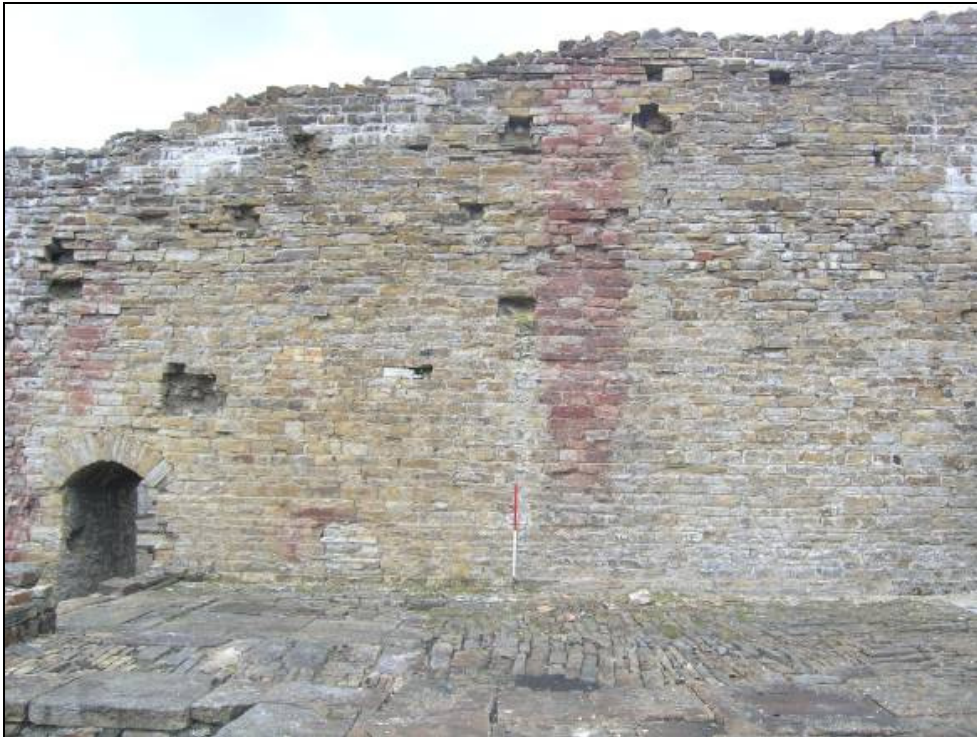
- 4.70 Spine Wall Feature 2, Plate 30, was located along the south eastern face of the spine wall around buildings B and B-F. A large number of voids in the face of the spine wall were identified (Countryside Consultants 2013, fig. 51).
- 4.71 It was proposed that a number of these voids be filled up by deep tamping. Under further inspection of these voids it became clear that they were of an archaeological origin and not defects in the face of the spine wall. A number of these voids, specifically those around the heat effected red section of the spine wall, were actually used to house a free standing flue taking waste gases away from Building B and into the horizontal flue. The majority of the remainder of the voids represent the old roof line of Building B sloping down to the arched entrance to the southwest of the building.

Plate 30: Spine Wall Feature 2 pre-intervention.

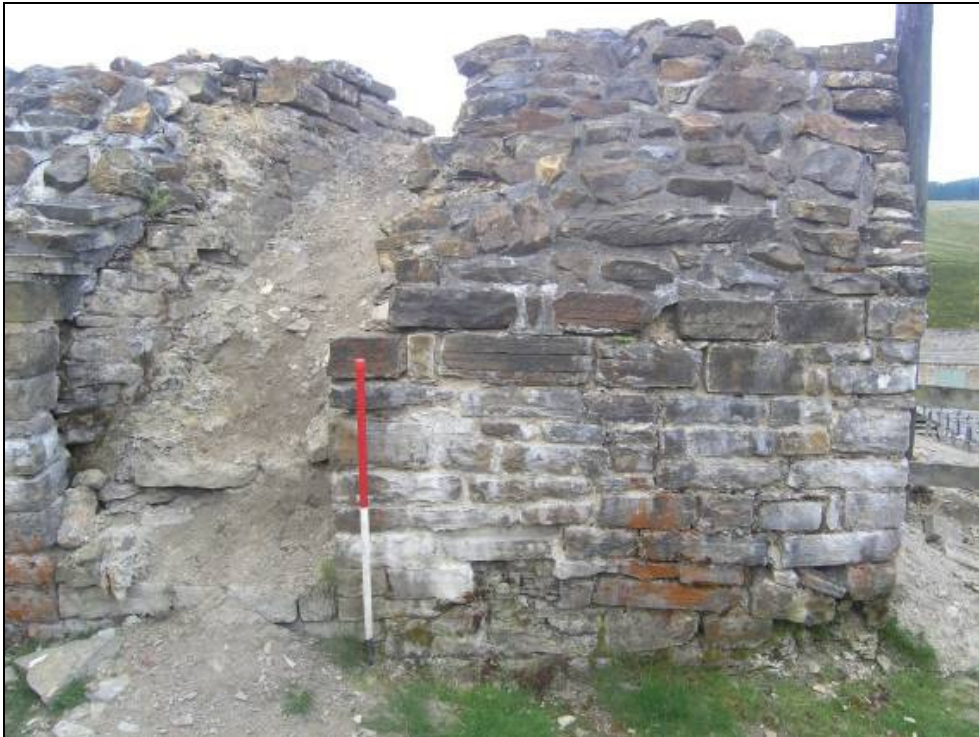
- 4.73 Spine Wall Feature 3, Plate 31, was located at the very north-easterly limit of the spine wall adjacent to the track way at NY 78440 43298 (Countryside Consultants 2013, fig. 48). The structure had suffered loss of mortar and was vulnerable to further loss through natural erosion.
- 4.74 The structure stood up to 11 courses high at 1.22m and was constructed of roughly faced limestone blocks in a roughly squared coursing pattern. In the centre of the wall was an opening approximately 1.02m wide which housed a staircase.
- 4.75 An extensive amount of work was scheduled (Countryside Consultants 2013, fig. 48) for this section of spine wall. The northwest corner and a section of the wall to the left of the staircase had open joints and as a result were highly vulnerable to collapse.

Plate 31: Spine Wall Feature 3 pre-intervention.

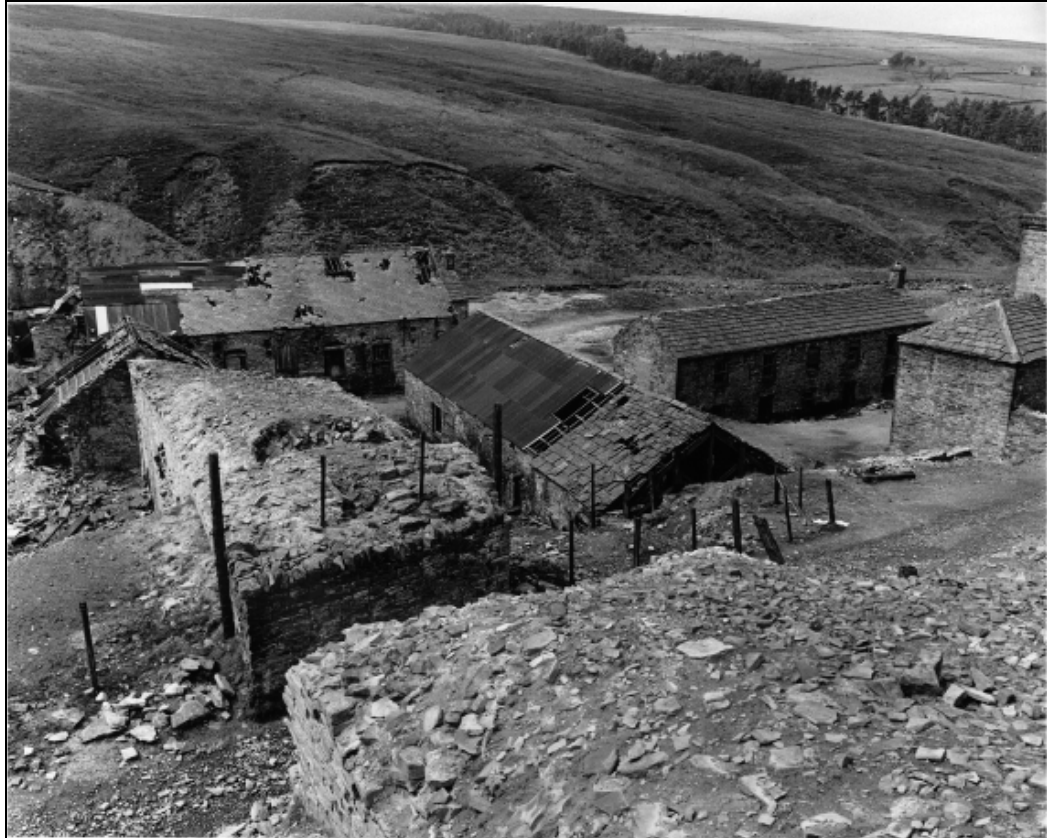
Plate 33: Photograph showing blocked up staircase.
