ARCHAEOLOGICAL WATCHING
BRIEF REPORT

**NENTHEAD LEAD MINES,
NENTHEAD, CUMBRIA**

NAA 15/91
February 2016

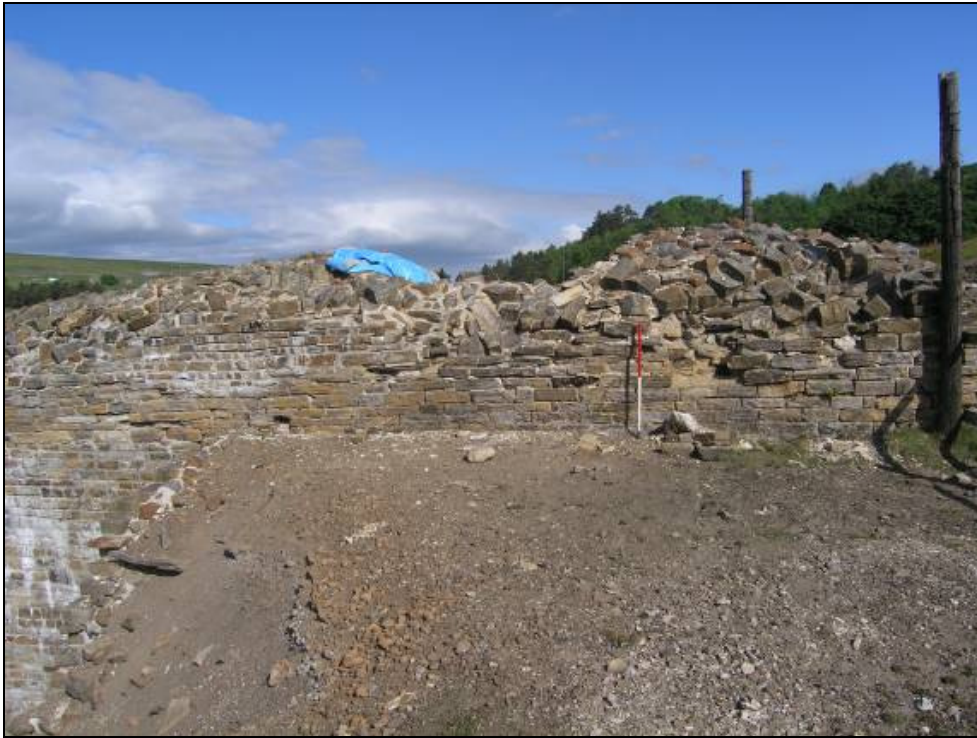
- 4.79 Spine Wall Feature 4, Plate 34, was located on the southeast face of the spine wall at the northeast end opposite the bingsteads at NY 78443 43304 (Countryside Consultants 2013, fig. 49). This section of spine wall had suffered loss of mortar and was vulnerable to further loss through natural erosion.
- 4.80 This section of wall stood up to twelve courses high down to four courses at its lowest point and incorporated an area of approximately 8.25m by 1.15m. The wall consisted of faced limestone blocks in an even coursing pattern.
- 4.81 Approximately nine courses of the wall were rebuilt up to 1m from the ground level, Plate 35. No features of further archaeological interest were uncovered during the dismantling of this section of the spine wall, other than rubble infill consistent to that observed elsewhere.

Plate 34: Pre-intervention image of Spine Wall Feature 4 to be rebuilt.

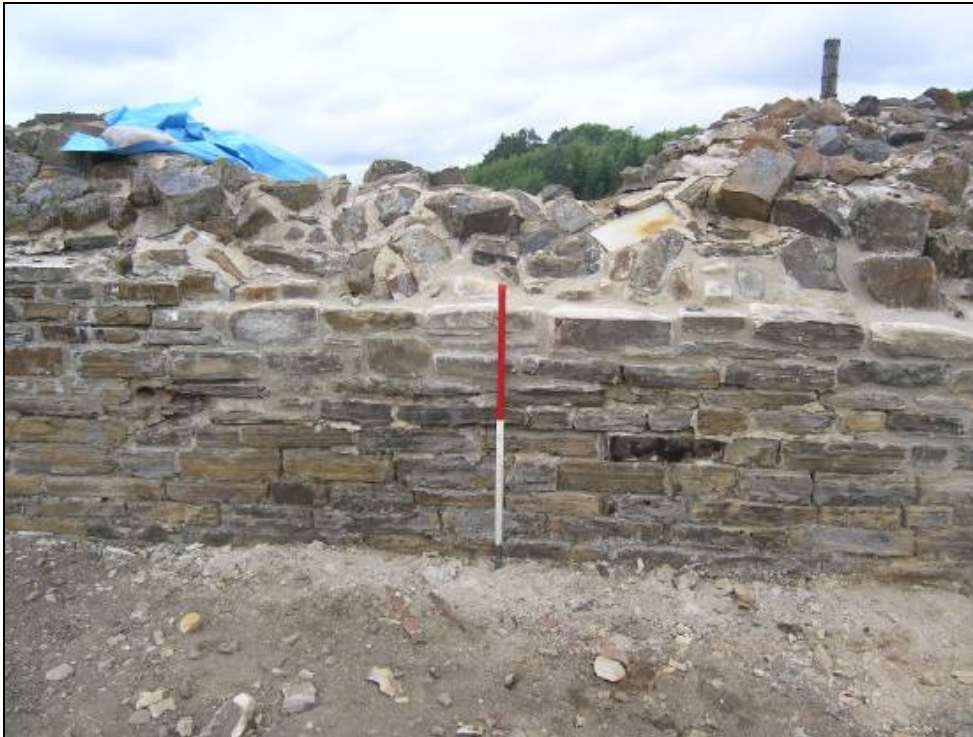
Plate 35: Spine Wall Feature 4 post intervention.

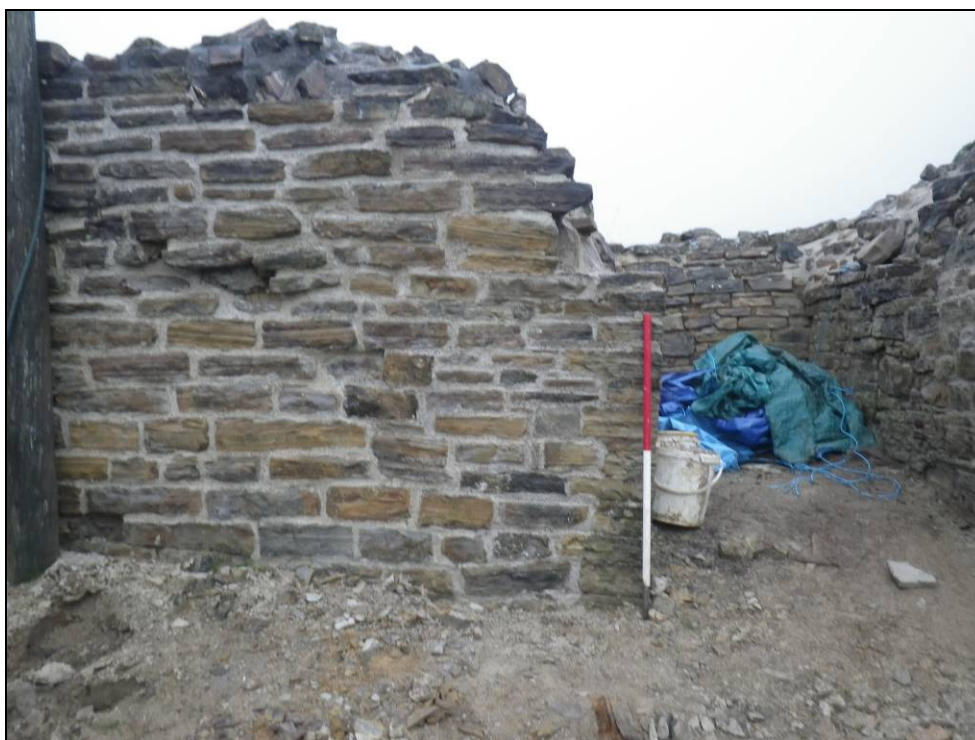
Plate 36: Spine Wall Feature 5 - wall - post intervention.

- 4.82 Spine Wall Feature 5, Plate 36, was located on the northwest face of the spine wall adjacent to the inspection area at the northeast end of the spine wall at NY 78436 43294 (Countryside Consultants 2013, fig. 40). This feature incorporated three separate areas each highlighted in the management plan (Countryside Consultants 2013, fig 40), comprising two corners and a section of wall. The wall, shown in Plate 36, had suffered a general loss of mortar and the joints around both corners had opened up causing a large crack that ran across the wall. The wall face in general had also suffered a general loss of mortar and was highly vulnerable to further loss through natural erosion. This section of wall was not dismantled as it was not deemed necessary, but instead re-pointed *in situ*.

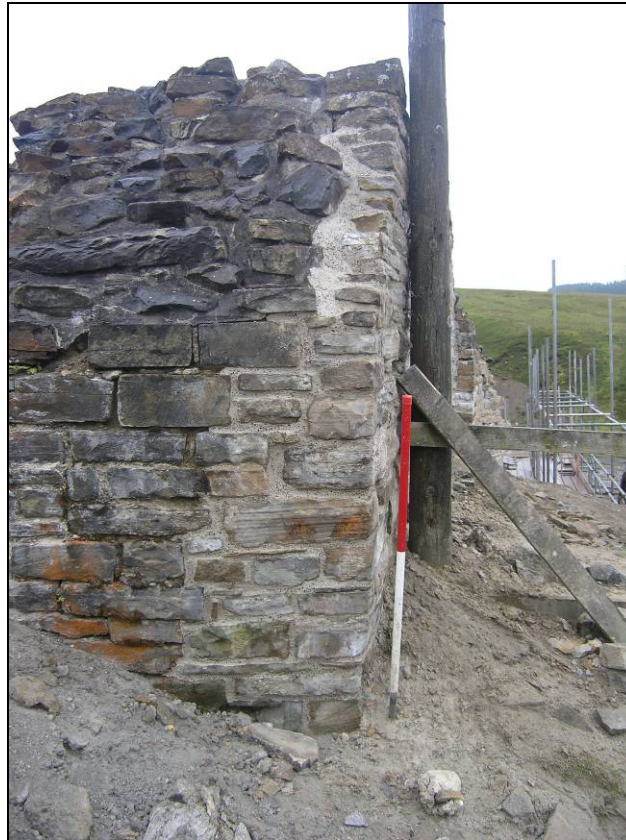
Plate 38: Spine Wall Feature 5 post intervention.

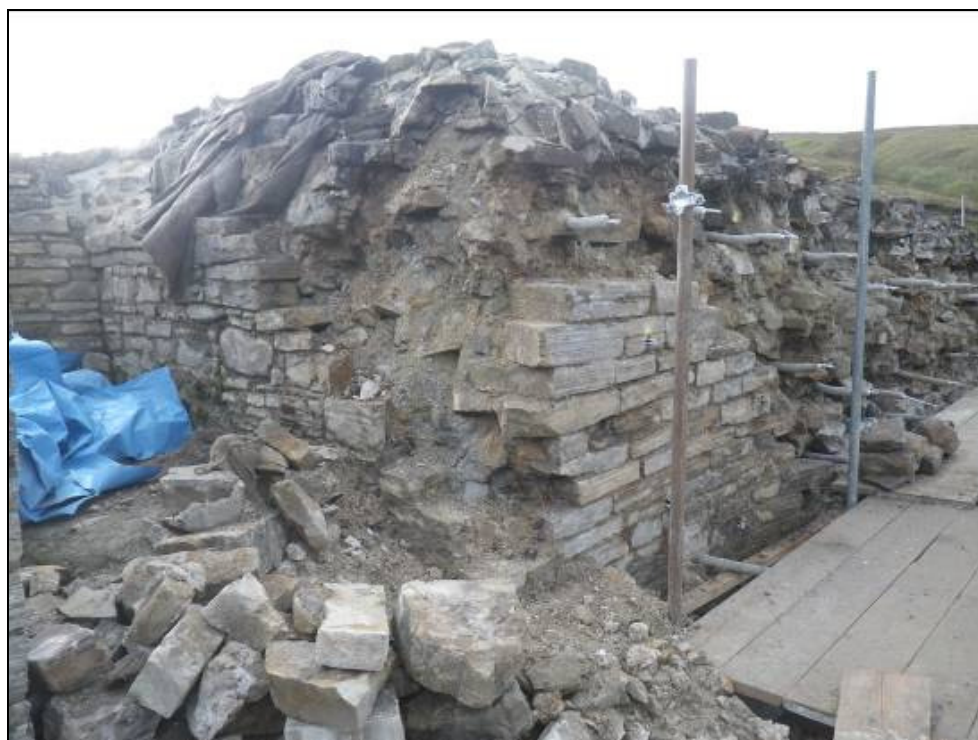
Plate 39: Site visit 21/10/14 showing dismantled corner.

- 4.84 A further watching brief was due to take place on the opposite corner, Plate 39, (Countryside Consultants 2013, fig. 40). Due to the placement of the scaffolding supplied to install the cintec anchors, a watching brief did not take place. During a site visit on the 21st October 2014 it was noted that the corner had been taken down ready for re-consolidation. Under further inspection of the area removed, no features of archaeological interest were apparent and only further rubble infill was observed, which was consistent with the remainder of the structure.

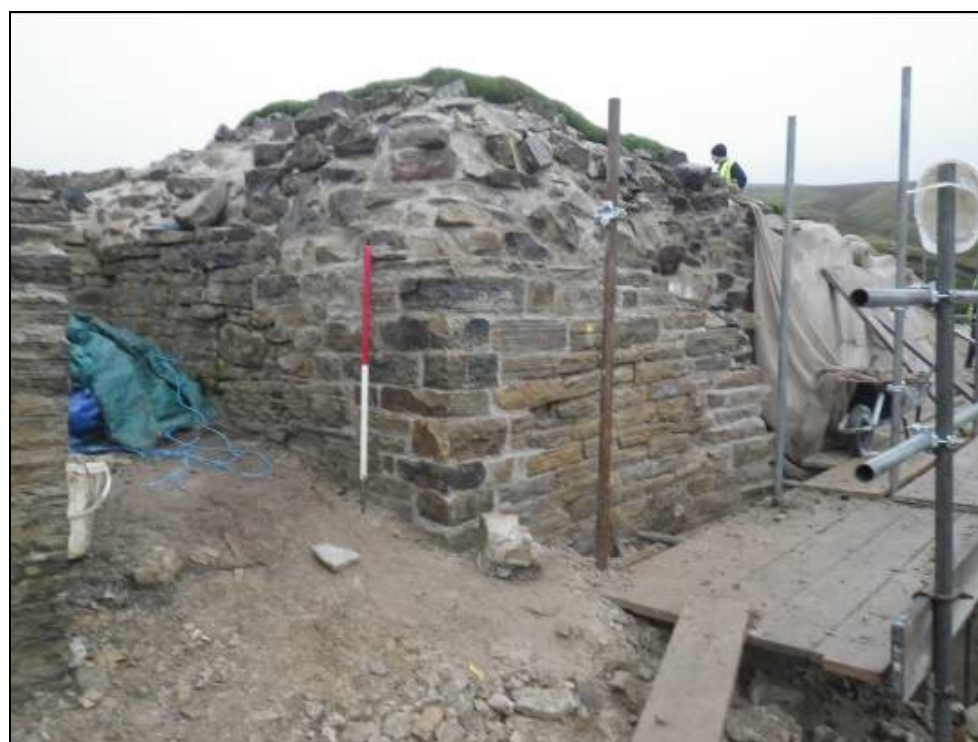
Plate 40: Rebuilt corner and face of spine wall.

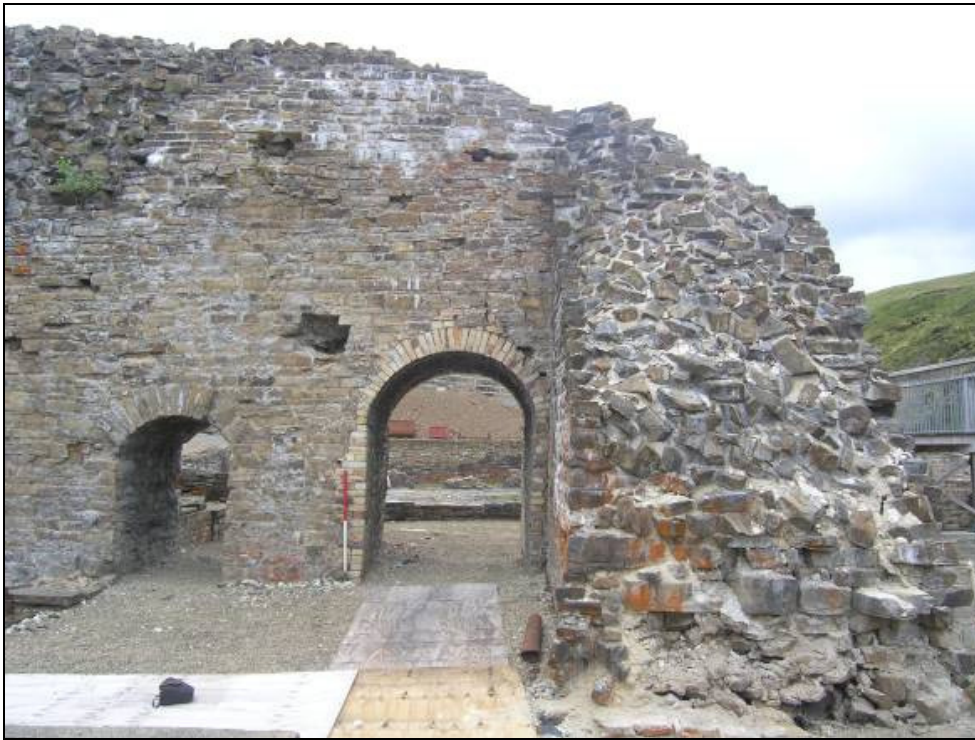
- 4.85 Spine Wall Feature 6, Plate 41, was located on the northwest face of the spine wall towards the southwest end opposite the smelt mill wheel pit (Countryside Consultants 2013, fig. 43). Numerous voids together with an area of bulging were visible in the face of the spine wall and it was proposed that the wall be dismantled around the bulge and built back up again once a solid bearing had been established.
- 4.86 The outer skin of the spine wall was taken down and rebuilt around the sections that were bulging, Plate 42. It was thought that there may have been the remnants of a flue behind this area, however only rubble infill was observed at this point.

Plate 41: Spine Wall Feature 6. Section of bulging spine wall above archway with series of voids.

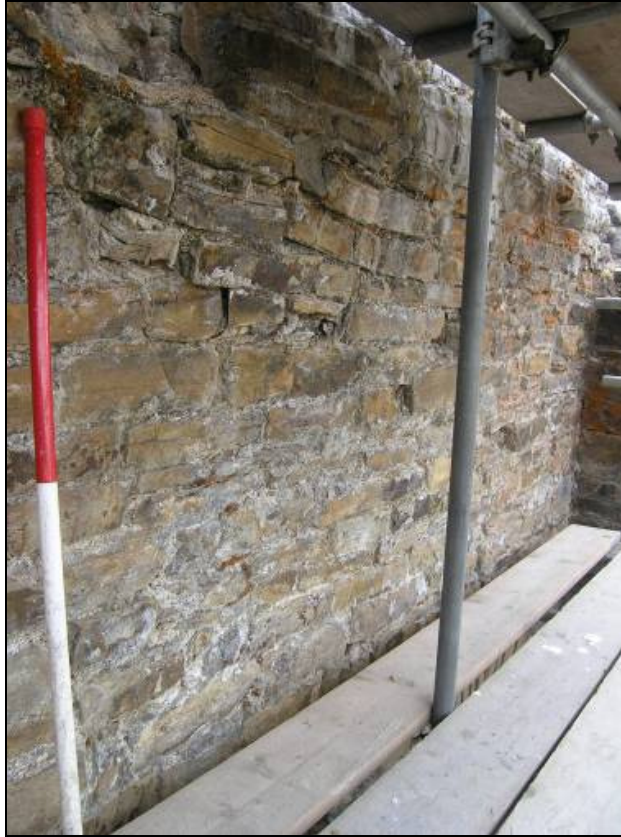
Plate 42: Spine Wall Feature 6 post intervention (area at top of image).

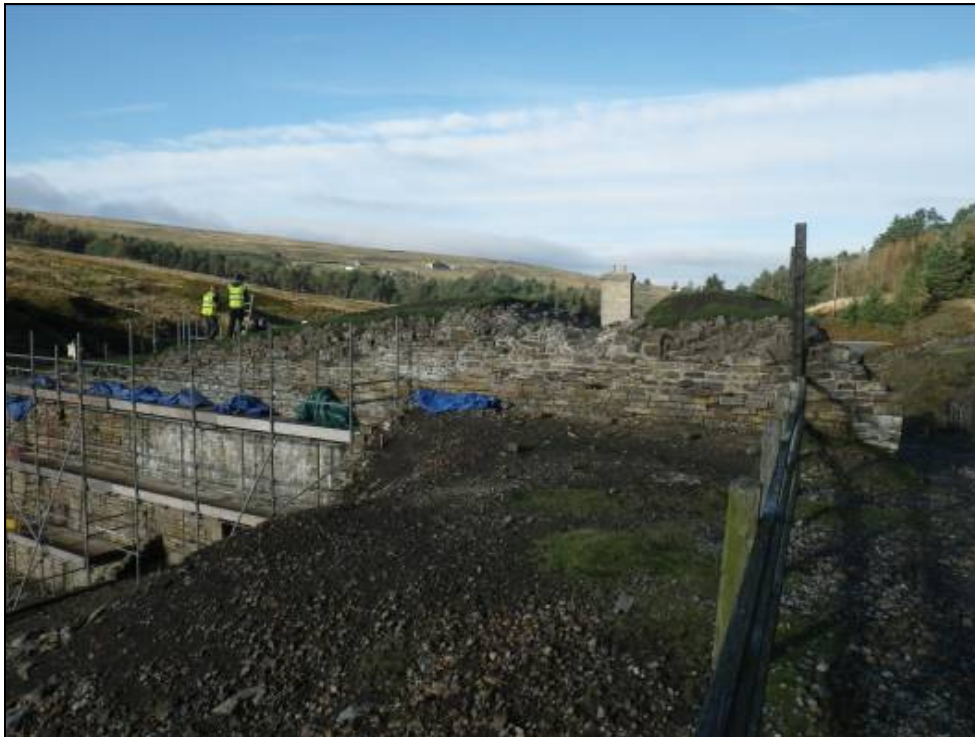
- 4.89 Spine Wall Feature 8 incorporated the pre-existing hard capping covering the top of the spine wall. The hard cap installed in 1998 had subsequently failed causing water penetration leading to a collapse of masonry on the northwest elevation of the spine wall. The failed hard capping was to be rectified by the installation of a soft capping across the entirety of the spine wall.

Plate 44: Installation of spine wall soft capping.

- 4.90 The main benefit of the soft capping is that it provides a thermal blanket for the underlying stonework, which prevents moisture fluctuations. In turn this prevents the freeze and thaw effect, which can cause structures to deteriorate rapidly, particularly in exposed areas such as Nenthead.

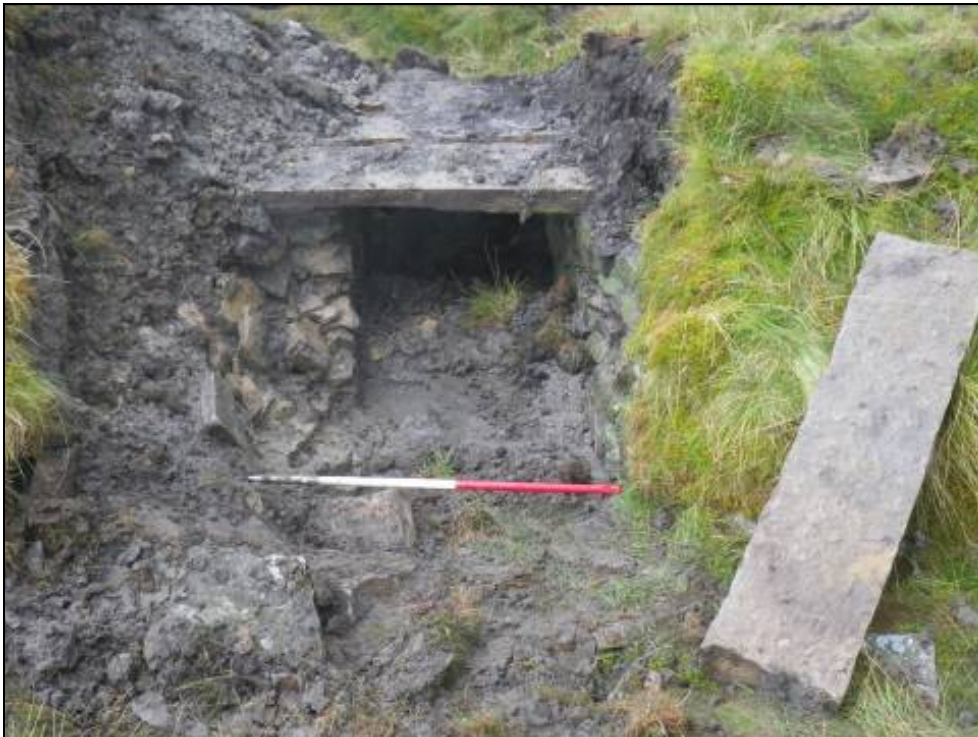
- 5.5 Flue 01 was located at NY 79287 42932 adjacent to the collapsed chimney stack at the northeast end of the line of the flue (Countryside Consultants 2013, fig. 68) and represented an access tunnel or crawl space/manhole used to access the inside of the flue for cleaning. The north eastern wall of the access tunnel had washed away causing the lintel capping to fall inwards completely blocking the structure, Plate 46.

Plate 46: Removal of fallen lintel to expose collapsed wall.

- 5.7 A watching brief took place on the 20th August 2014 where a JCB using a toothless ditching bucket was used to strip the natural soft capping, which was placed to one side for re-instatement. The underlying topsoil was removed by machine and the collapsed lintel was lifted using a strap attached to the ditching bucket to reveal the collapse underneath. The underlying structure was then cleaned off by hand and photographed to reveal the full extent of the consolidation work required.
- 5.8 The damaged section of the north eastern wall was taken down to a solid bearing and rebuilt up to the level of the opposite wall using locally sourced limestone blocks. The collapsed lintel was then put back in place and the soft capping reinstated.

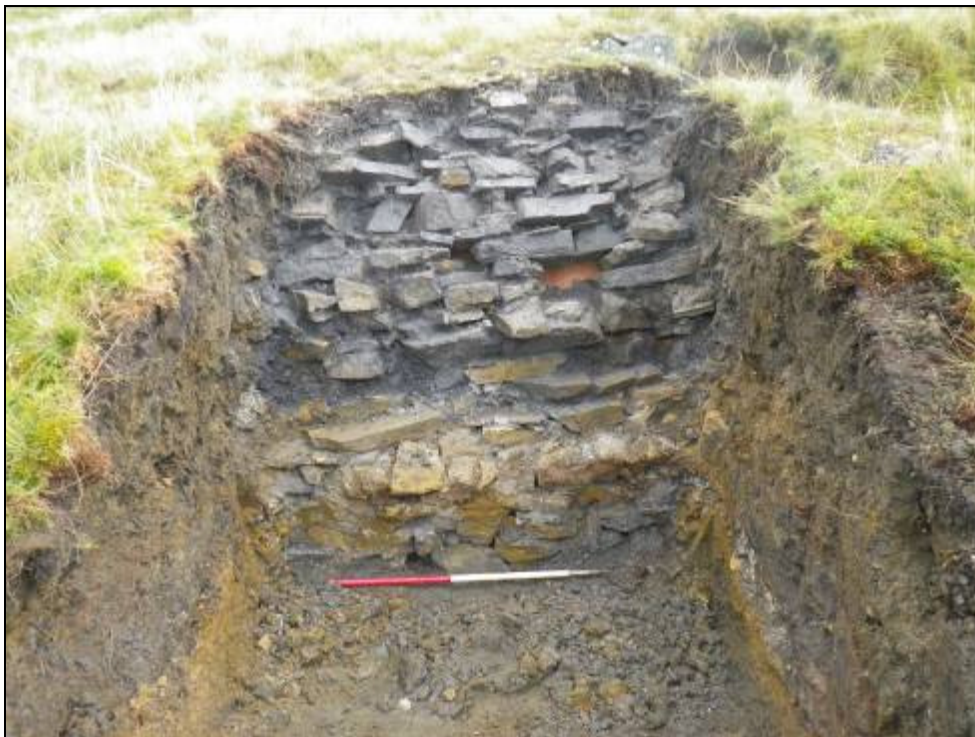
Plate 47: Exposed vaulting and supporting wall.

- 5.9 Flue 02 was located at NY 79051 43125 and represented a well preserved section of vaulted flue, Plate 47 (Countryside Consultants 2013, fig. 72). A lack of natural ground cover, as a result of livestock movement, had exposed areas of masonry around both portals of this section of vaulting. On top of the flue numerous voussoirs had been punched through also as a result of livestock movement. A further void in the vault arch around the southeast wall of the flue was also noted.
- 5.10 A timber former was installed to support the vault and the slipped voussoirs pushed back into position. In addition to this, it was recommended that the void be filled up using a selection of the fallen voussoirs from inside the vault. This was achieved by excavating through the exterior bank to

expose the vault on the outside face and inserting the missing voussoir.

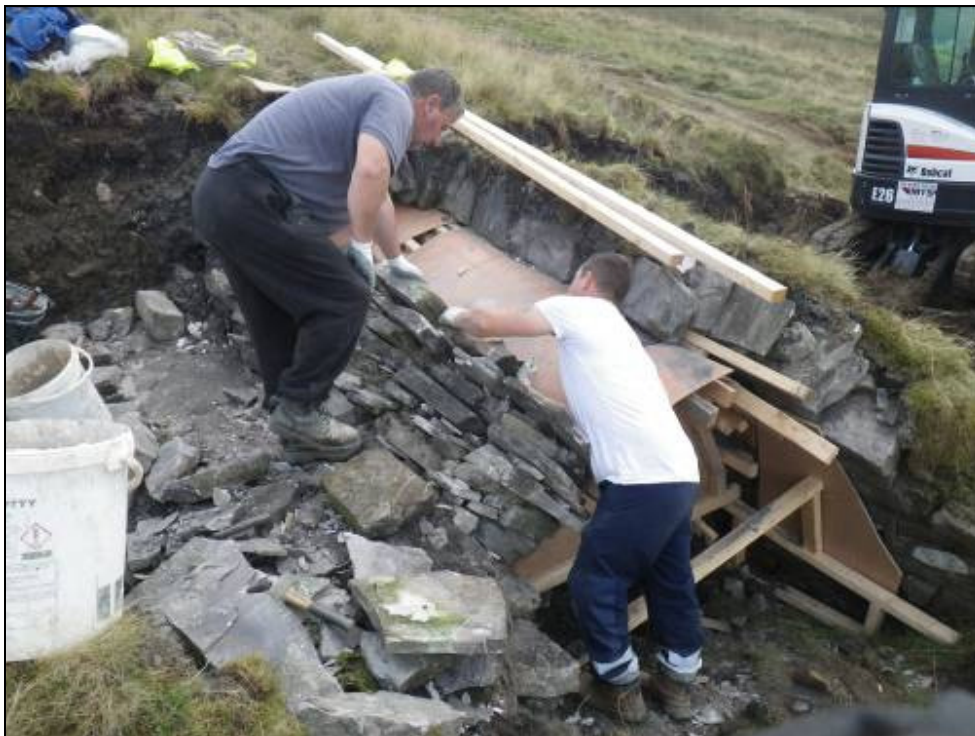
Plate 50: Flue 05 being rebuilt around timber former.

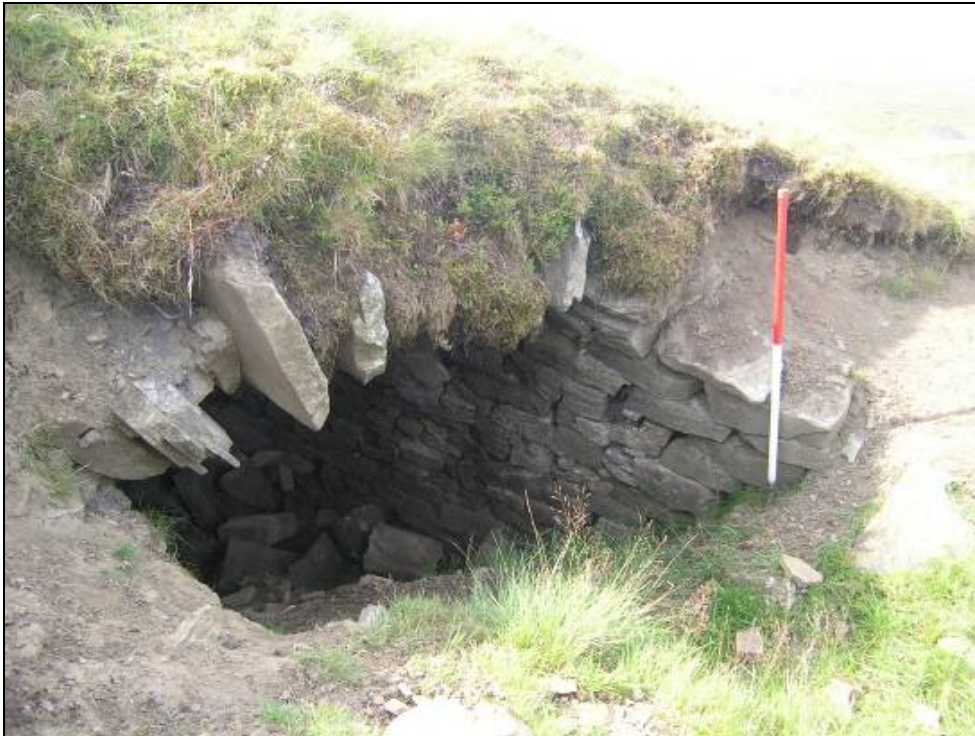
Plate 51: Flue 06 downhill portal showing areas of subsistence.

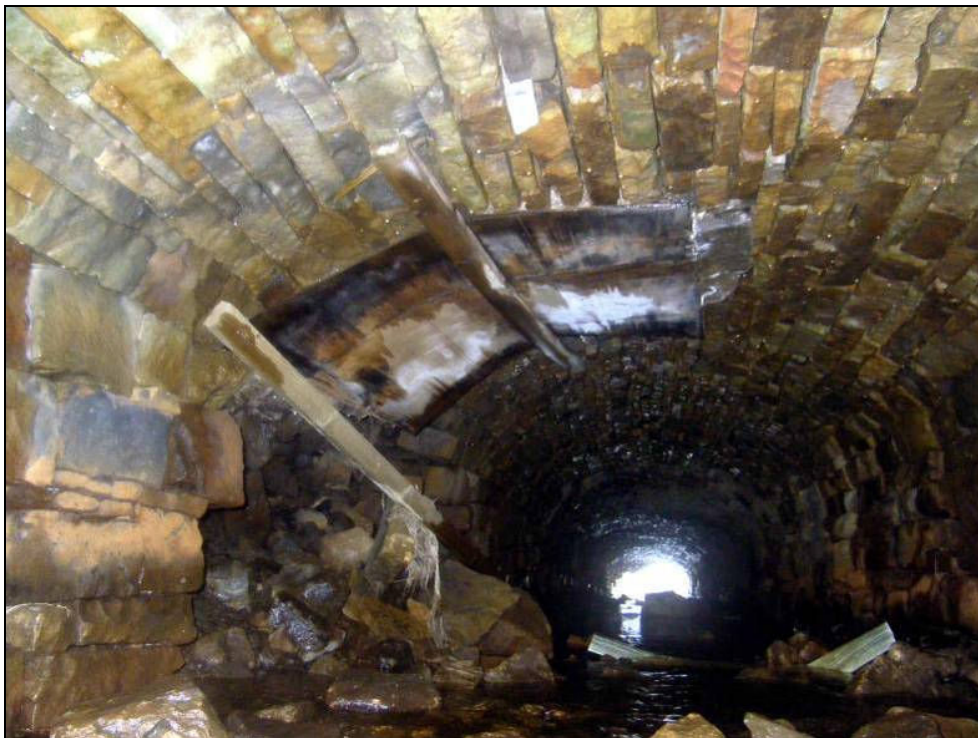
Plate 52: Collapsed voussoirs and side walls with previous NPHT repair above.

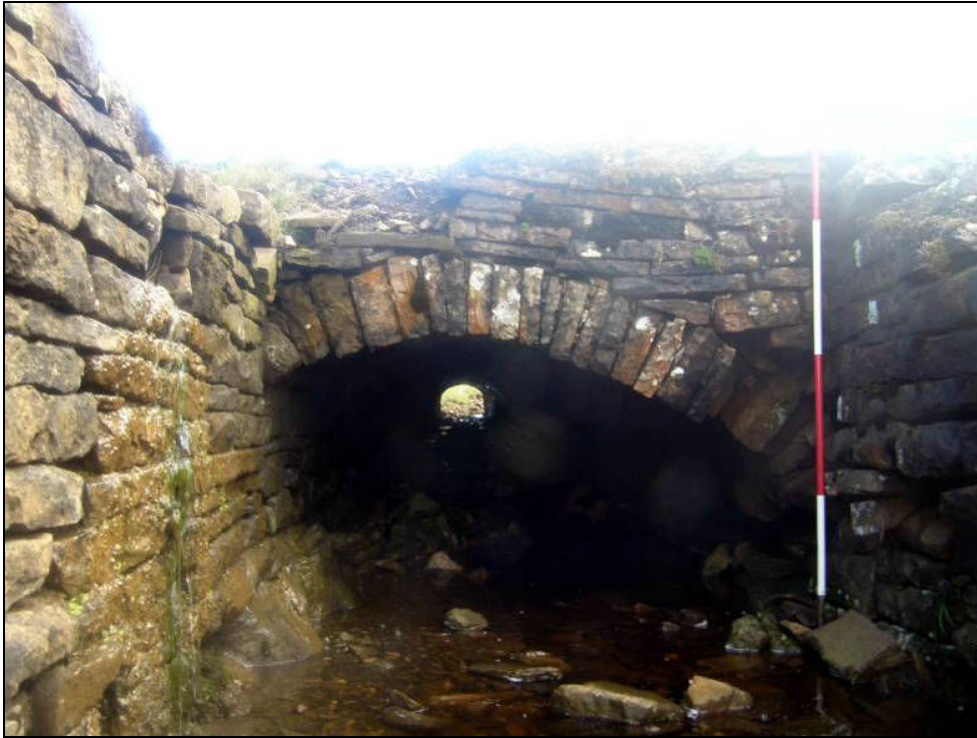
Plate 53: Downstream culvert entrance showing off centre arch.

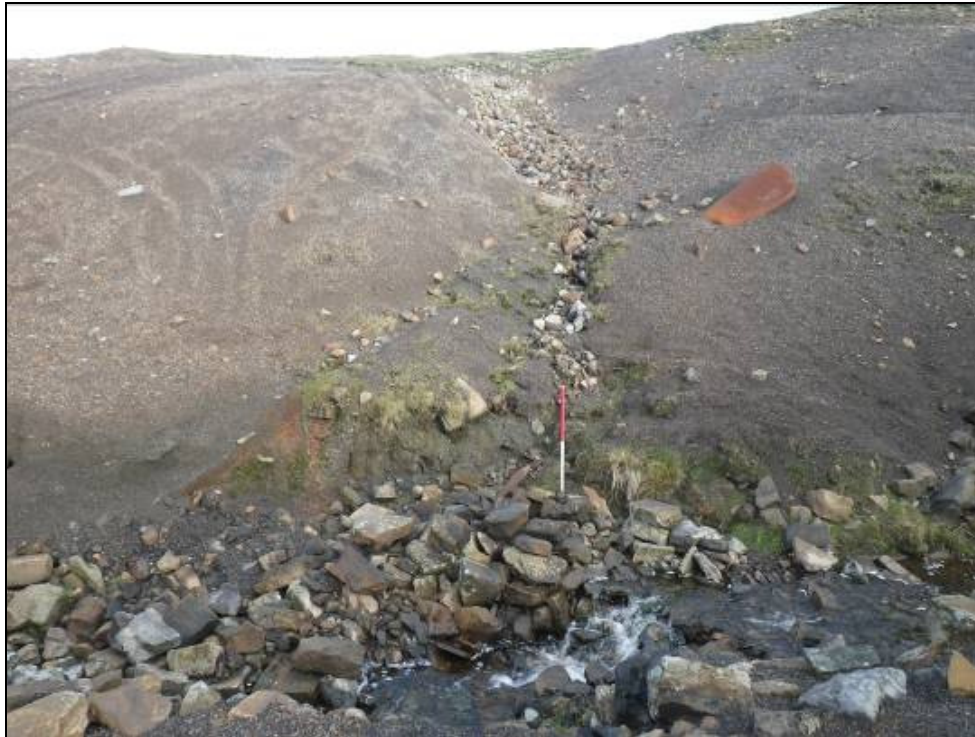
Plate 60: Water runoff from quarry track with collapsed section of culvert in foreground. Note large quantities of material behind remains of culvert wall.

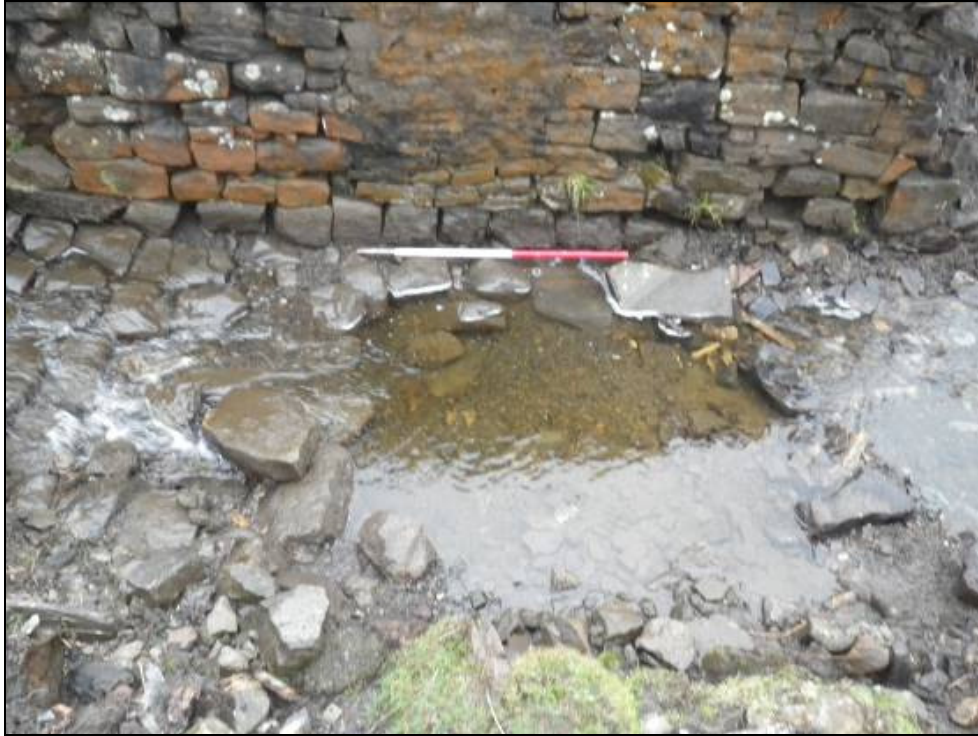
Plate 61: Section of washed out cobbled base with washed out wall footing at bottom of image.

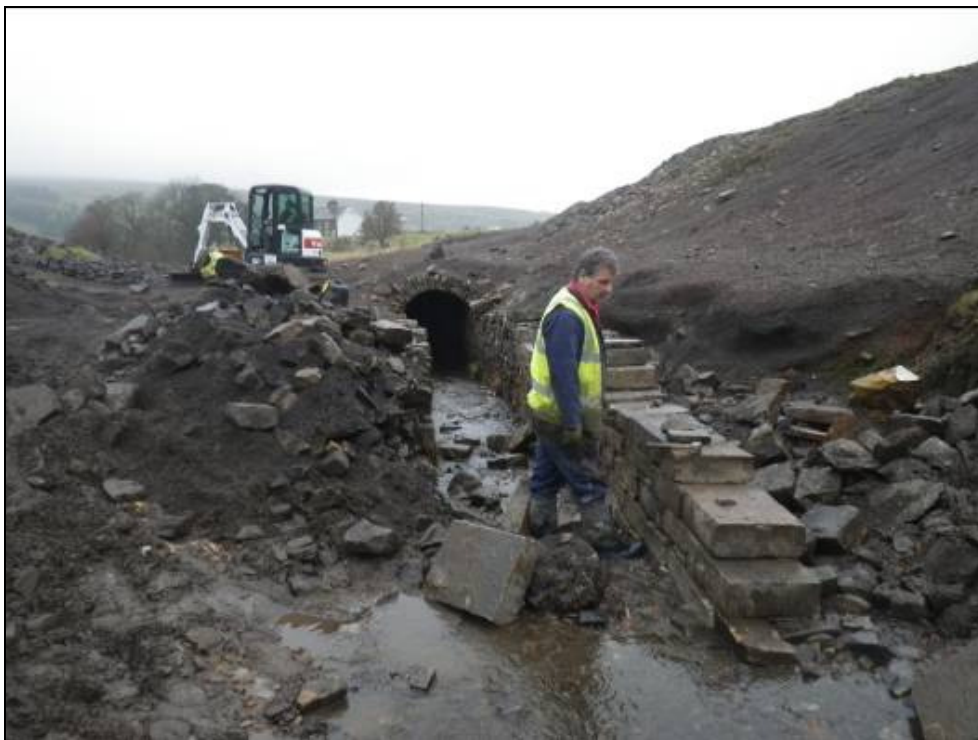
Plate 62: Photograph taken during rebuilding of collapsed wall. Machined section to the left of the image.

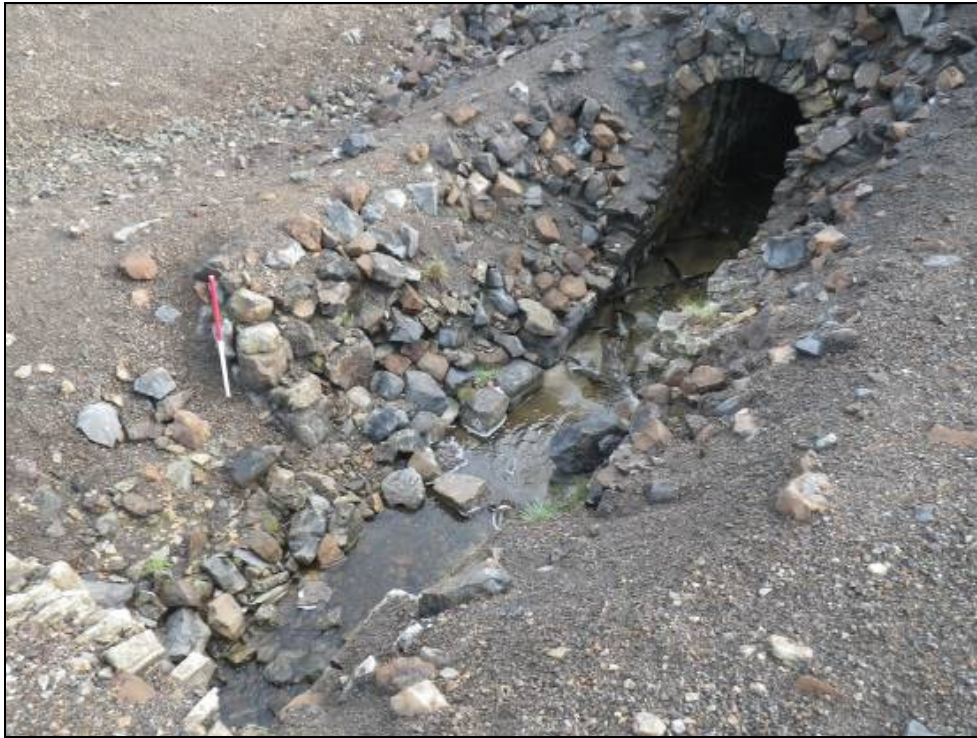
Plate 64: Western section of Rampgill Burn culvert pre-intervention.

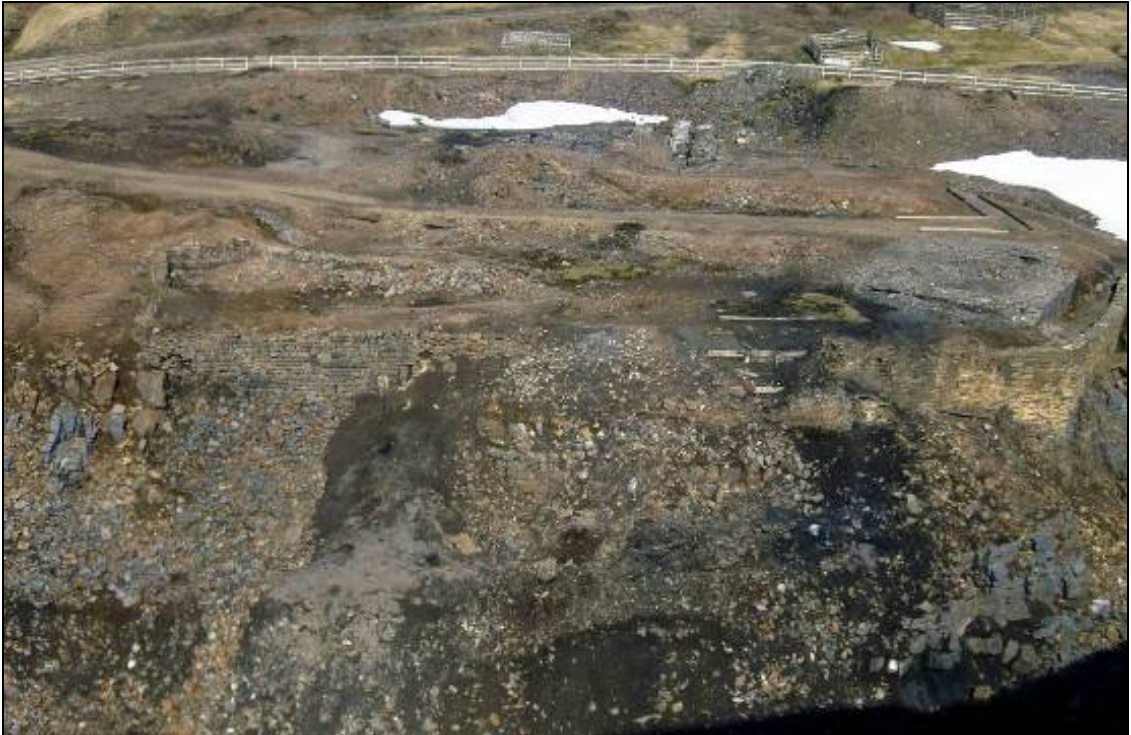
Plate 65: Section of retaining wall to left of image pre-consolidation. Note consolidated retaining wall to the right of the image.

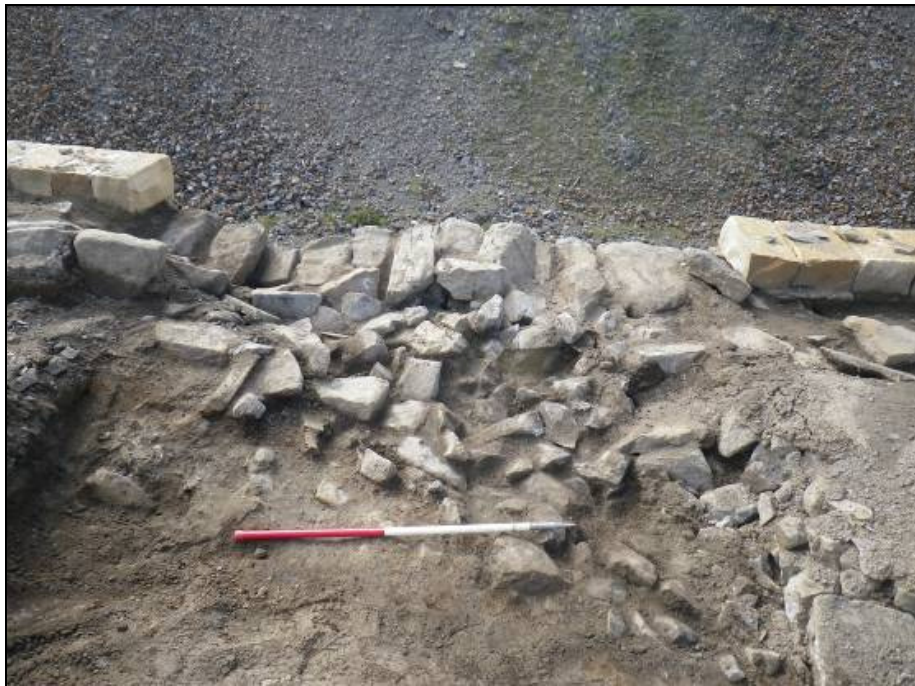
Plate 71: Large deposit of limestone blocks used to repair edge of dressing floor.
