**FORMER
MINISTRY OF DEFENCE DEPOT**

**KILLINGWORTH
NORTH TYNESIDE**

NAA 14/24
September 2014

**FORMER MINISTRY OF DEFENCE DEPOT
KILLINGWORTH, NORTH TYNESIDE
BUILDINGS SURVEY AND ASSESSMENT OF SIGNIFICANCE**

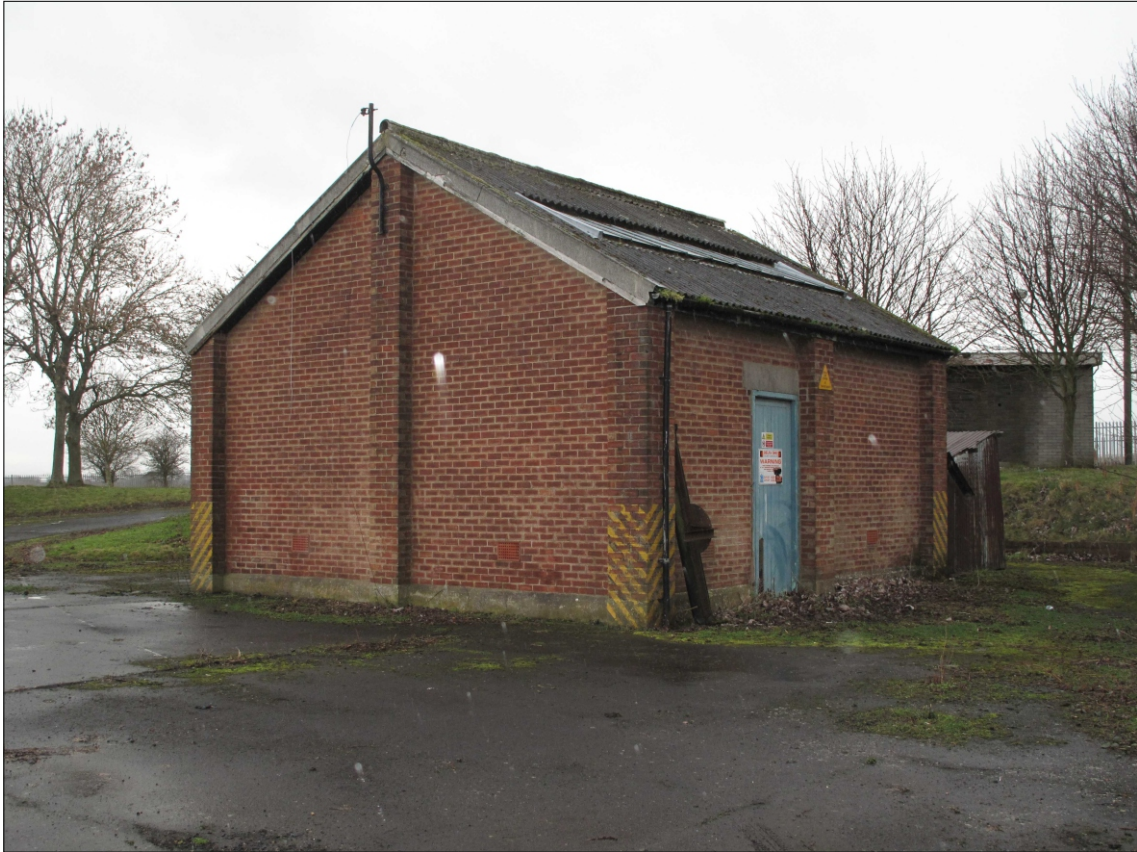
Plate 3

- 7.23 Externally, the building would seem to be in reasonable condition although it has not been maintained for a number of years and is beginning to deteriorate. One of the rainwater downpipes is missing, and the guttering has become blocked but it was not possible to assess whether the roof structure was still watertight although the roof-lights are unbroken. The doorway on the northern wall still retains its planked door; that on the southern side has been boarded up.

Former Killingworth Stores: Building 4, showing eastern and northern elevations

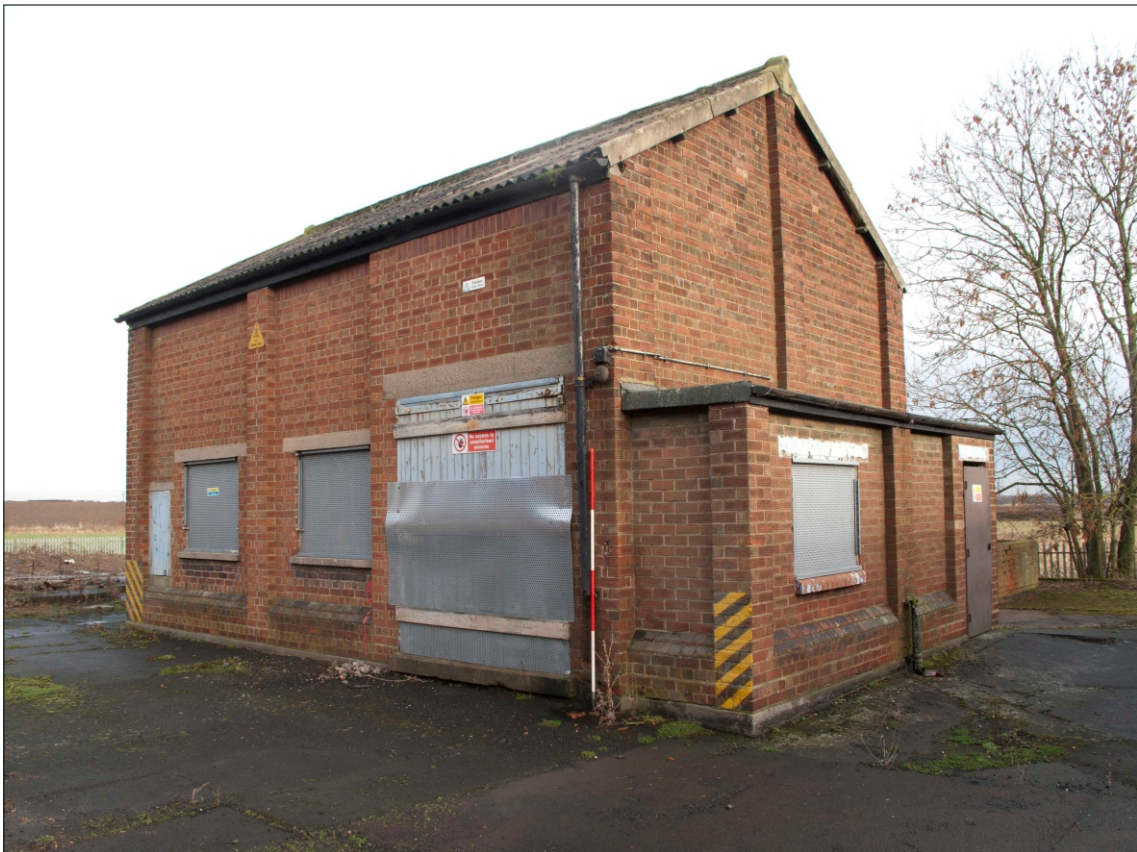
Plate 4

- 7.55 Outwardly the building is in reasonable condition, with wall and roof fabric both intact. The rainwater goods are in poor condition through lack of maintenance and the brickwork of the fuel tank bunds is spalling quite significantly in places. In addition to the presence of asbestos, there is also likely to be ground contamination issues arising from the use of this building as a generator house, which will probably have affected the ground both beneath and around the building.

Former Killingworth Stores: Building 10, showing western elevation and flat-roofed entrance portico on the southern gable

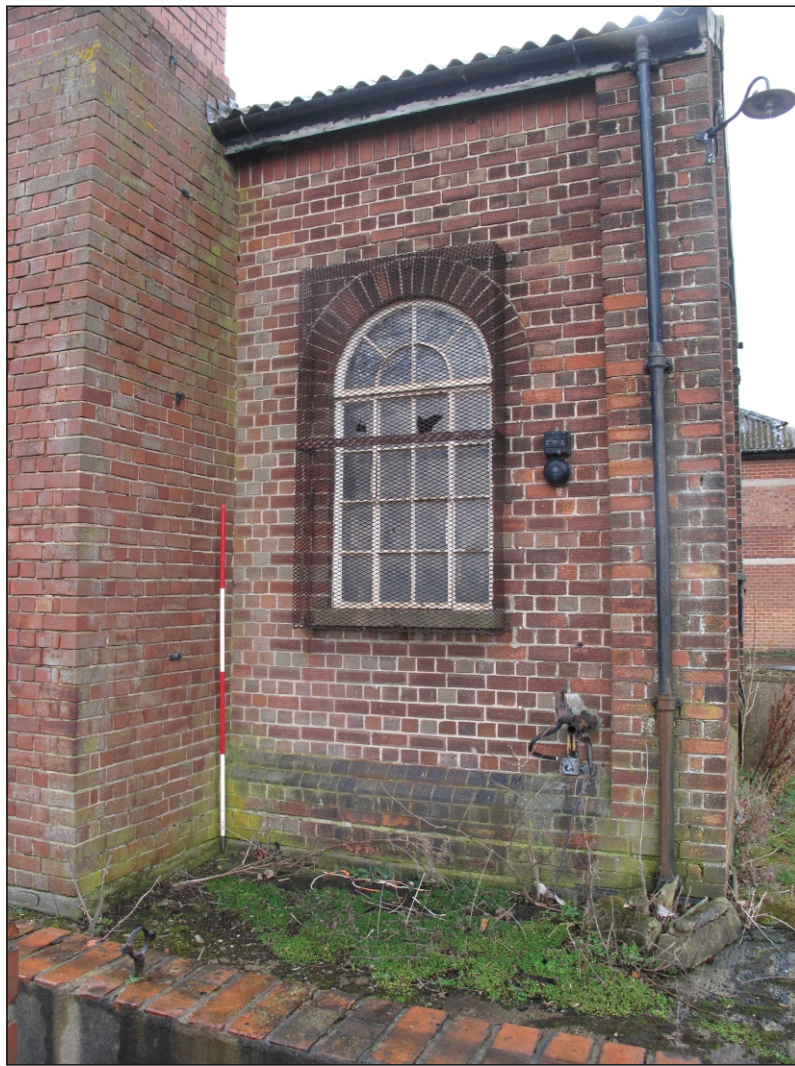
Plate 5

Former Killingworth Stores: Building 10, north bay of the eastern elevation, with arch-headed window and chimney to left

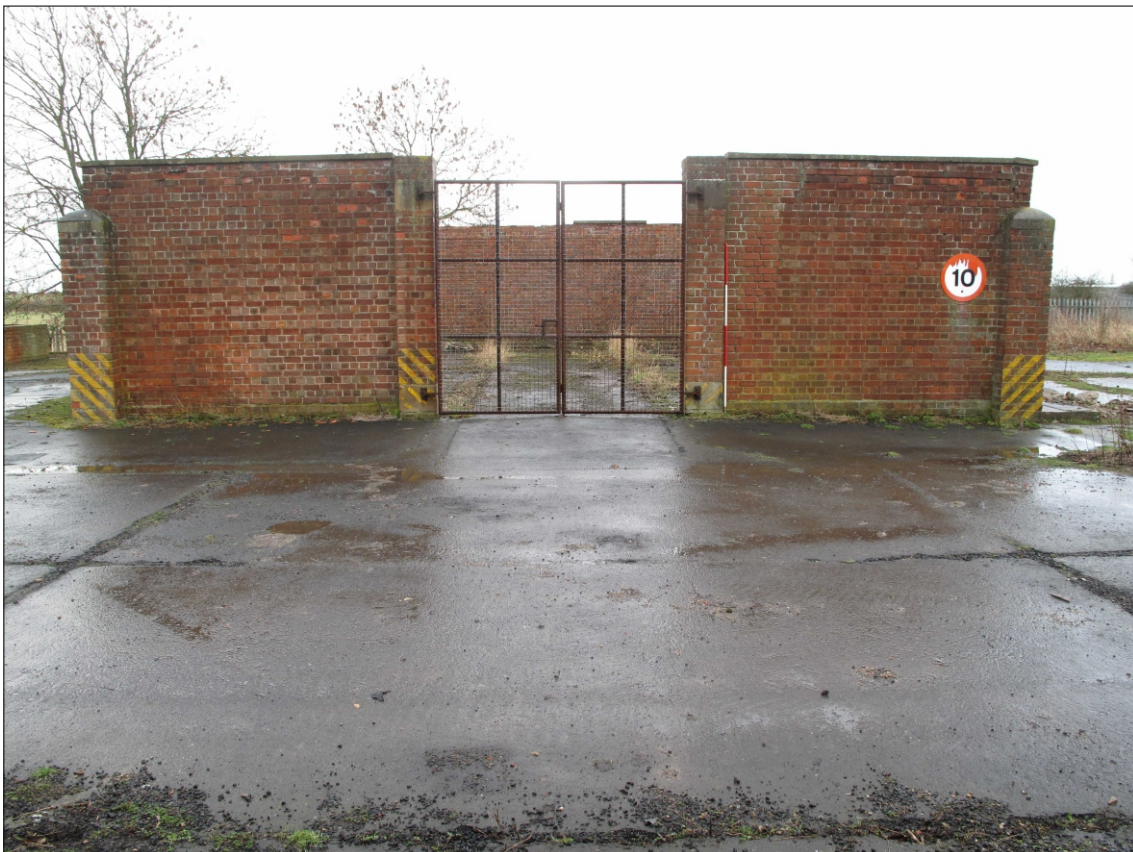
Plate 6

- 7.62 The structure is in reasonable condition, although the upper brickwork in the south-west corner is unstable, and several of the concrete capping slabs are missing.

Former Killingworth Stores: Building 11, showing entrance in western elevation and corner pillars

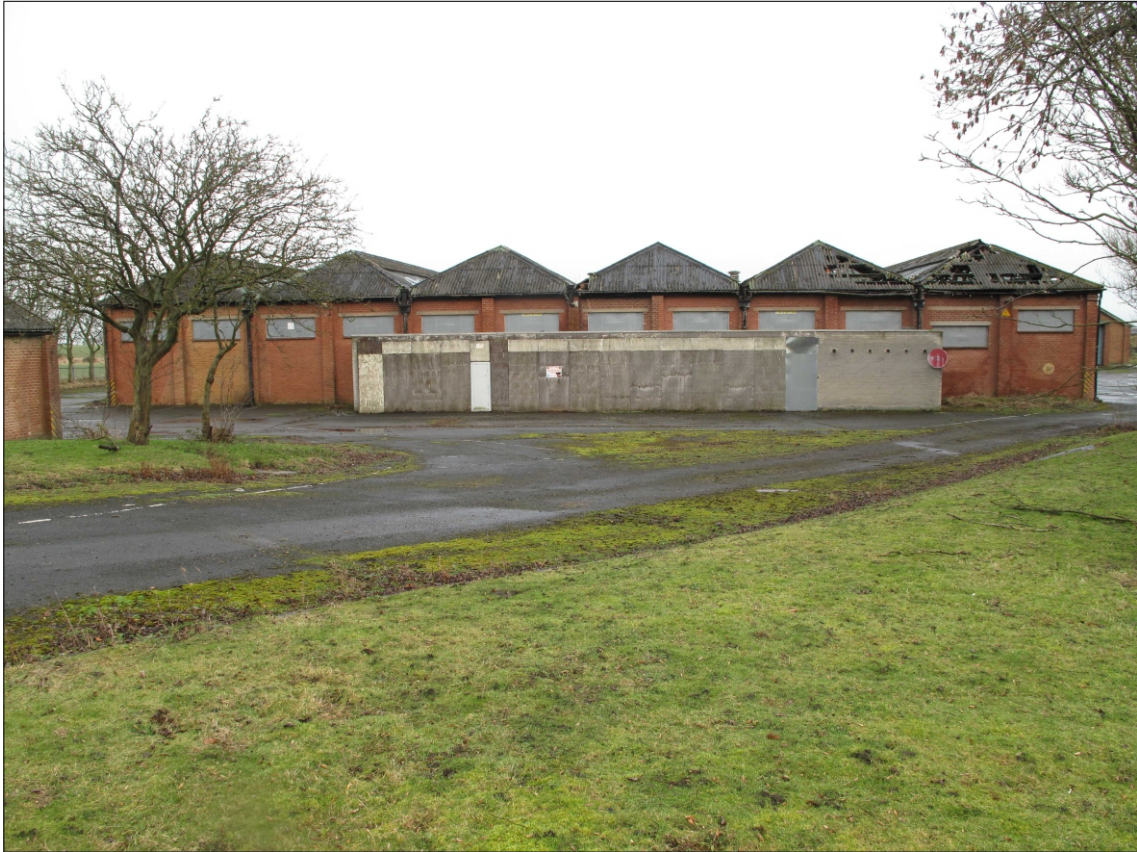
Plate 7

- 7.86 Externally, the building is in reasonable to poor condition. The roof has several holes, and the south-west corner in particular is in very poor condition with large areas of perforated asbestos sheeting. With the exception of the building's east end, the walls are in good condition. The east end shows evidence of instability, possibly as a result of subsidence, with cracking apparent in the latest visible repairs. The metal doors are in reasonable condition, although localised rusting is visible. Windows which have not been covered all have several broken glass panes, although the frames appear in reasonable condition. Two of the rainwater down-pipes are partly missing, and the guttering has become blocked.

Former Killingworth Stores: Building 12, western elevation

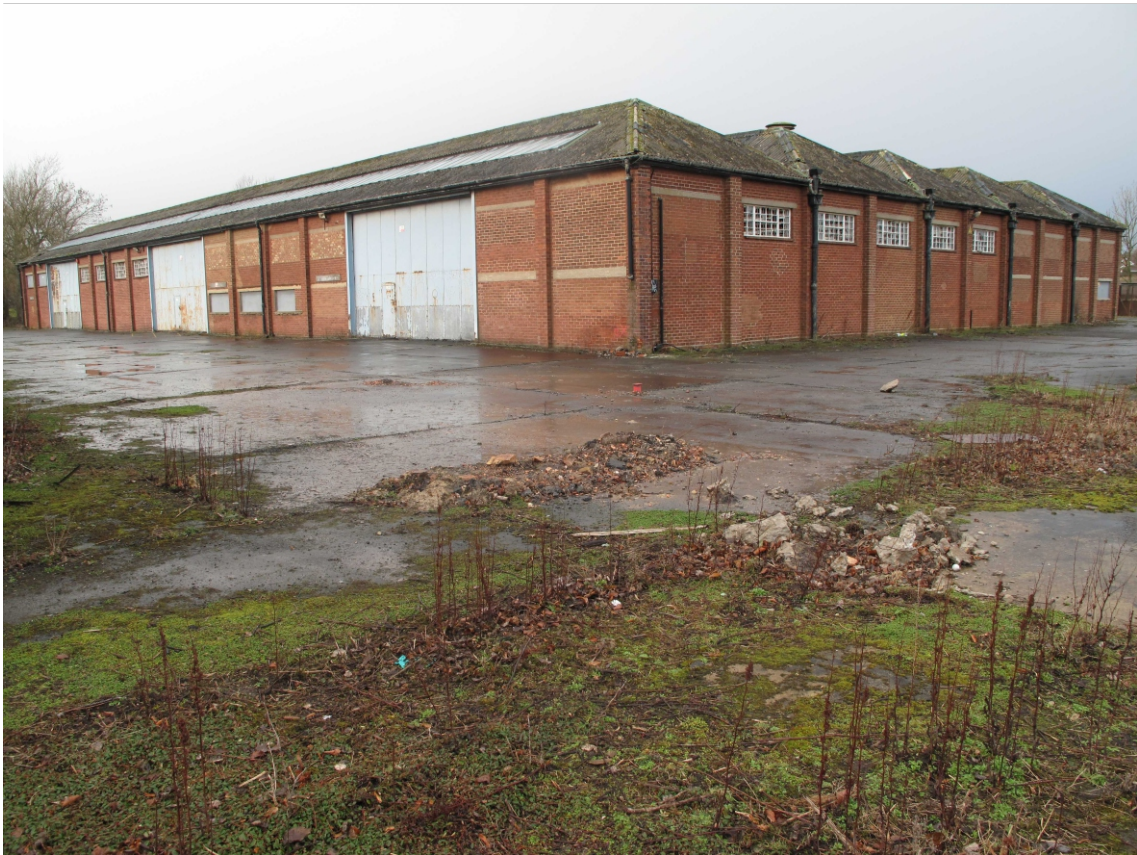
Plate 9

- 7.79 Several of the brick pillars defining the aisles have cracks extending their full height indicating subsidence at this end of the building. Four of the pillars have been wholly rebuilt, while part of the north-east corner pillar (of the fifth aisle from the south) has also been rebuilt. The brick

Former Killingworth Stores: Building 12, eastern and southern elevations

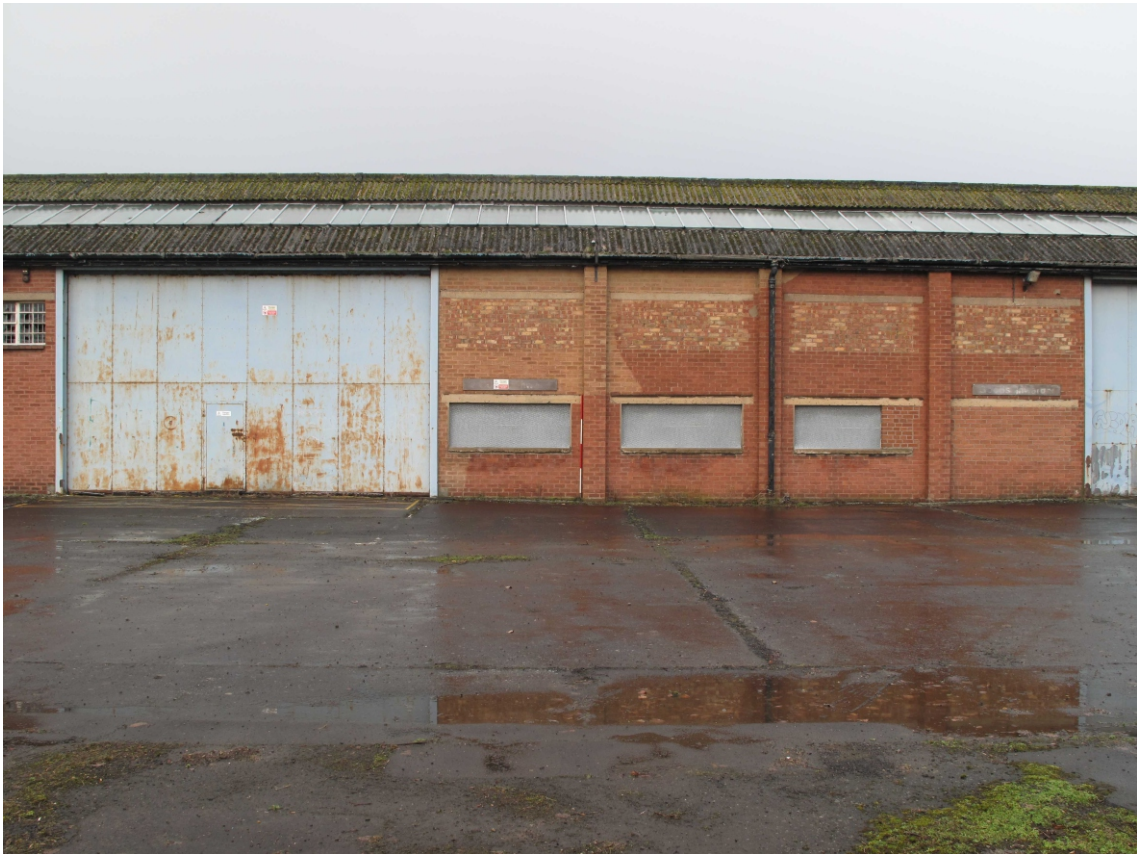
Plate 11

Former Killingworth Stores: Building 12, centre of southern elevation, showing vehicle access door and altered window arrangement

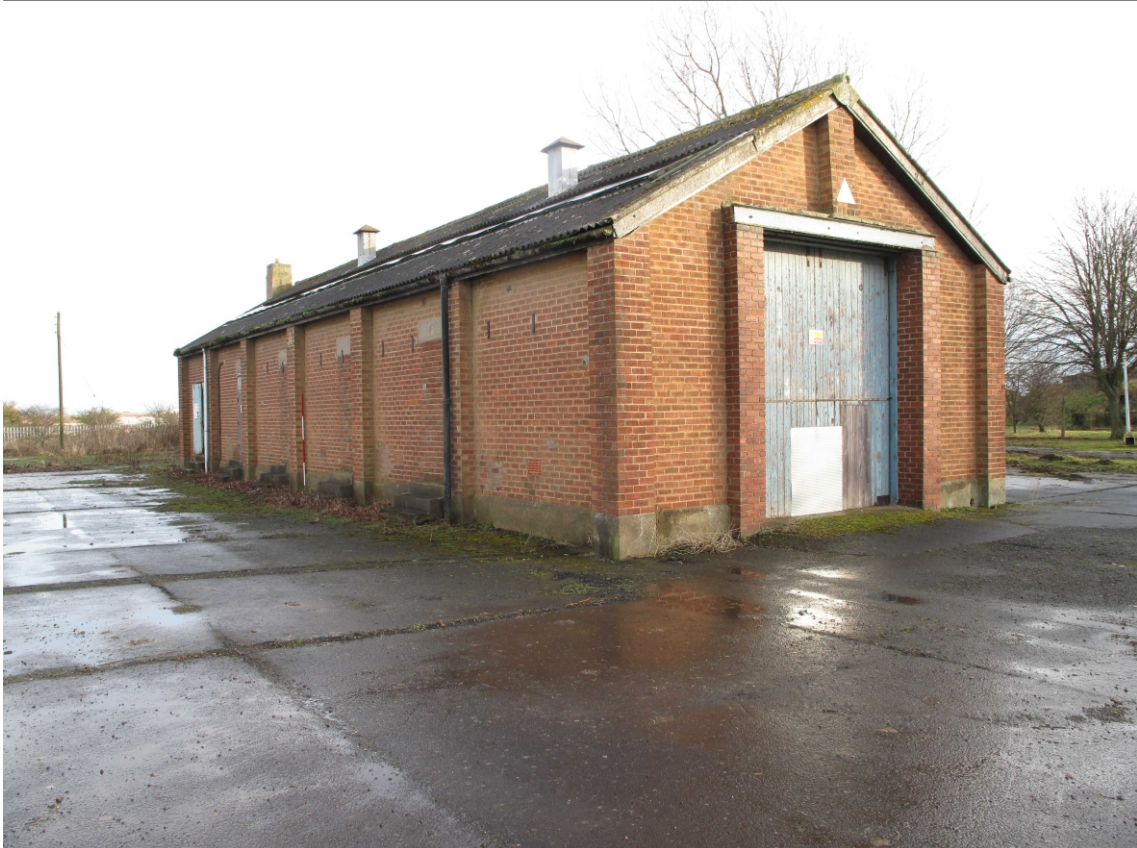
Plate 12

- 7.110 The walls of the original structure and later extension are in mostly good condition, although some of the cement rendering is loose or missing. The remaining doors, where visible, are in moderate to poor condition, with the vehicle door in the best state of repair. The roof has some damaged or missing asbestos sheets.

Former Killingworth Stores: Building 14, showing vehicle door in west gable and series of entranceways along north side

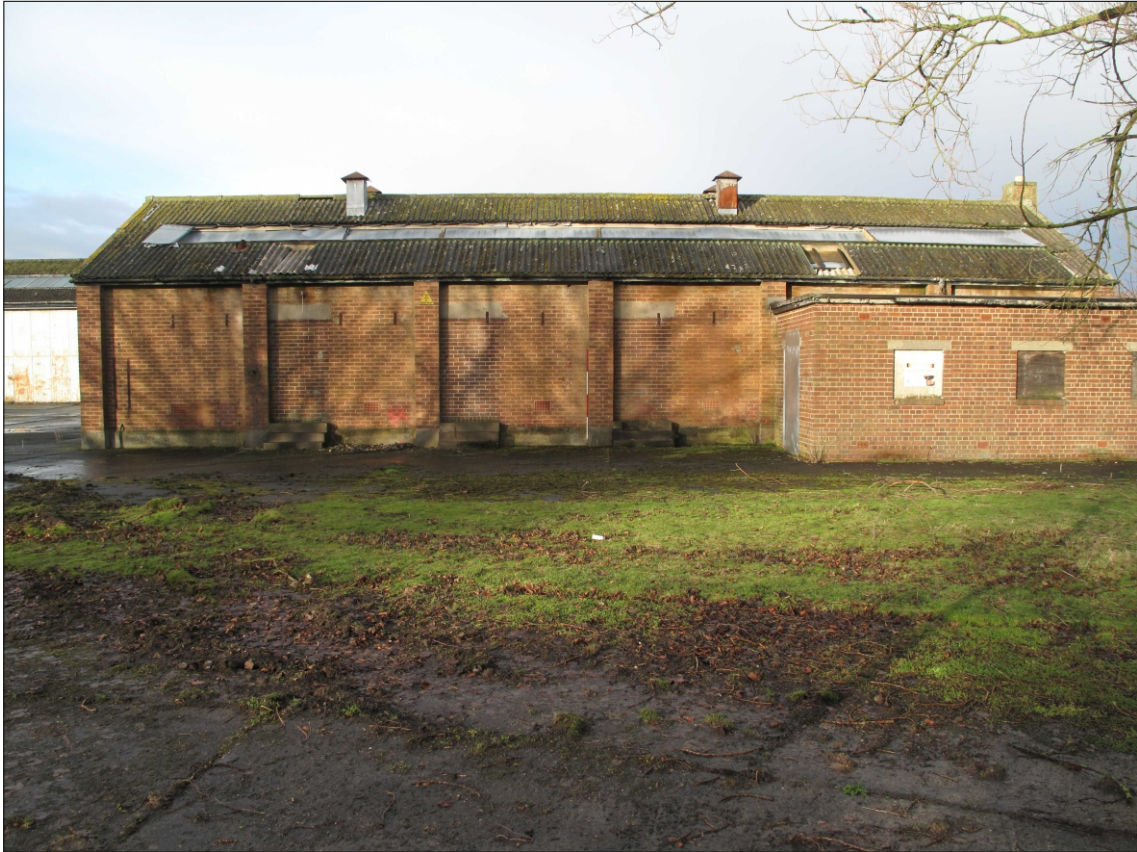
Former Killingworth Stores: Building 14, blocked entranceways and later extension on southern elevation Plate 13

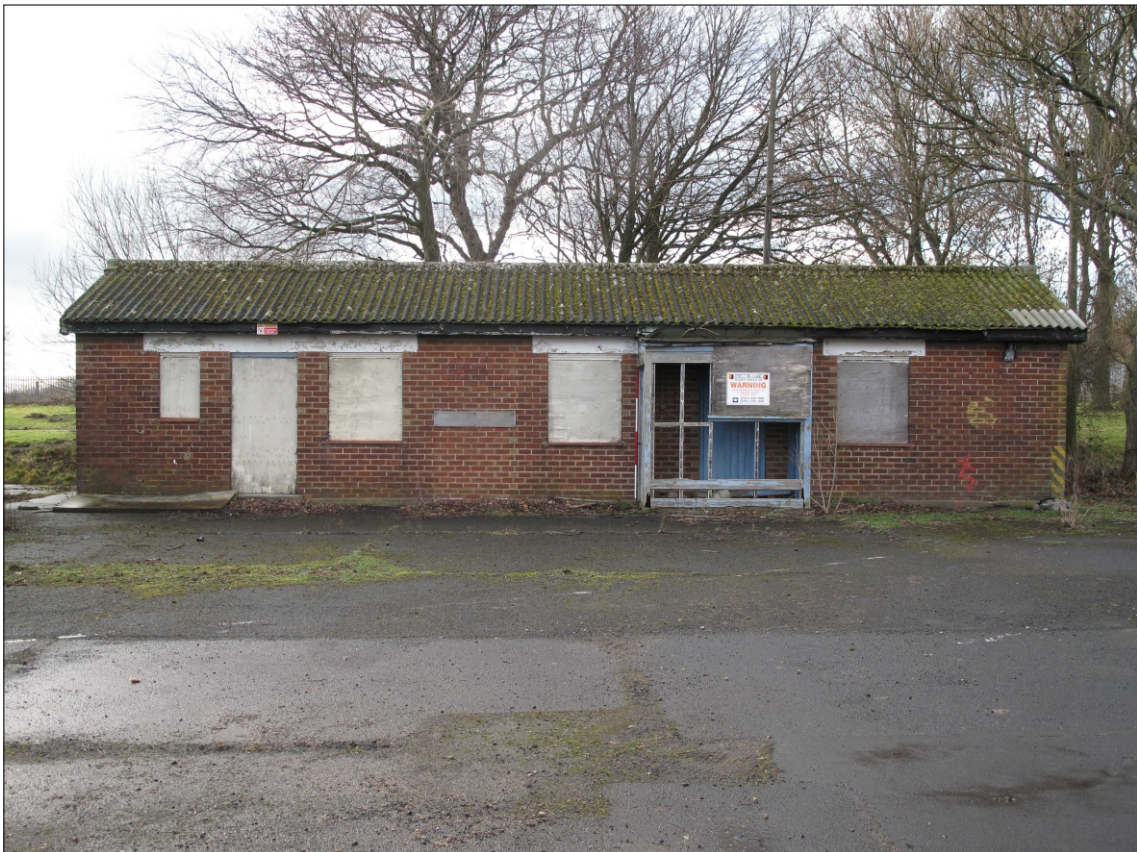
- 7.124 Outwardly, the building, with the exception of the front (wooden) porch, is in reasonable condition, with walls and roof intact. Guttering and down-pipes are however largely missing and the most of the wooden panels of the front porch have been broken.

Former Killingworth Stores: Building 16, eastern elevation Plate 14
