**PHASE 2 BUILDINGS SURVEY
AND
WATCHING BRIEF**

**FORMER
MINISTRY OF DEFENCE DEPOT

KILLINGWORTH
NORTH TYNESIDE**

NAA 15/70
February 2016

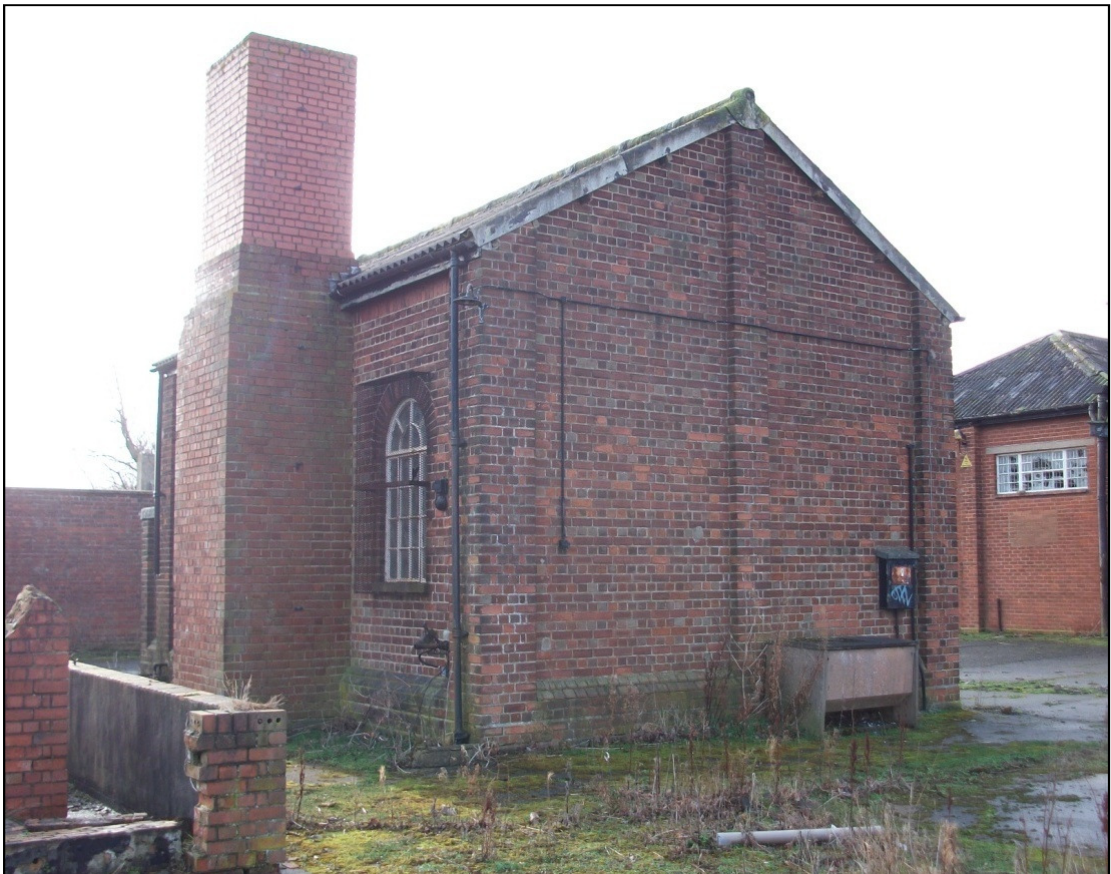
Plate 15: the north-east corner of Building 10, illustrating the later addition to the chimney, the original windows, and its relative position to the former bunded fuel tank. Building 12 can be seen in the background

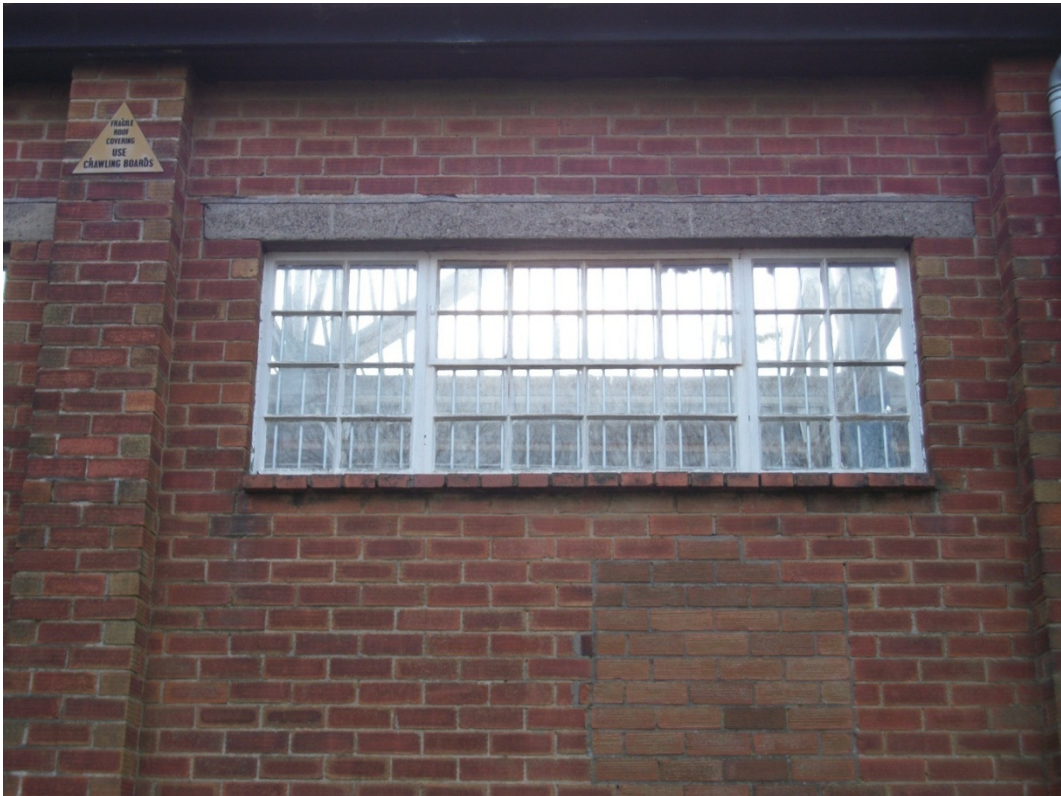
Plate 25: an original window with a pebbled concrete lintel and brick sill. Some brick patching can be seen below it

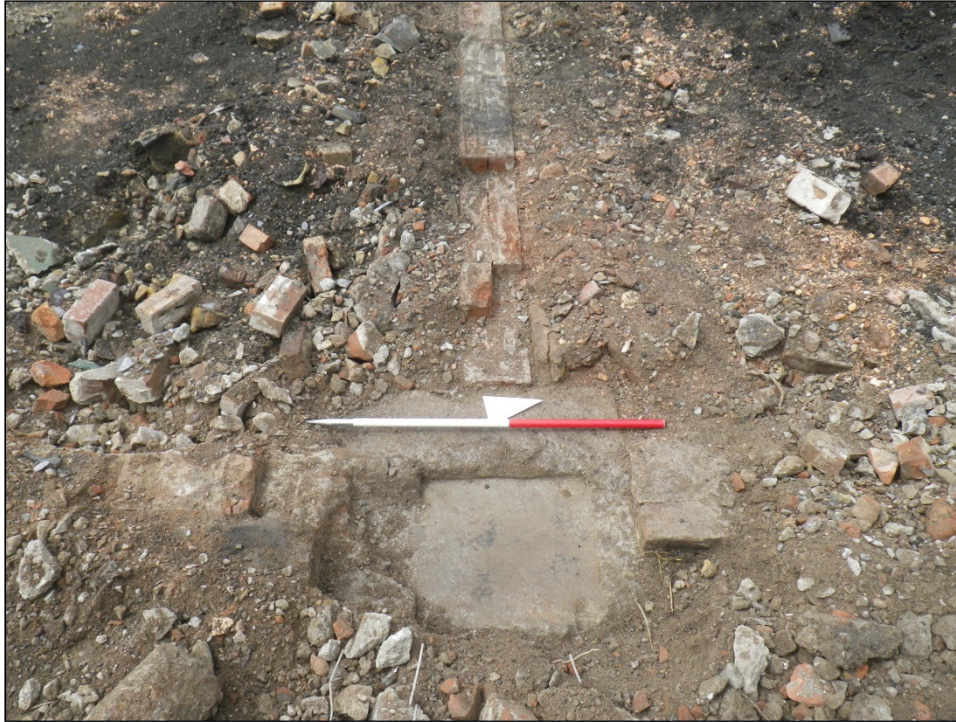
Plate 26: pillar rebuild in eastern elevation, identified during the watching brief

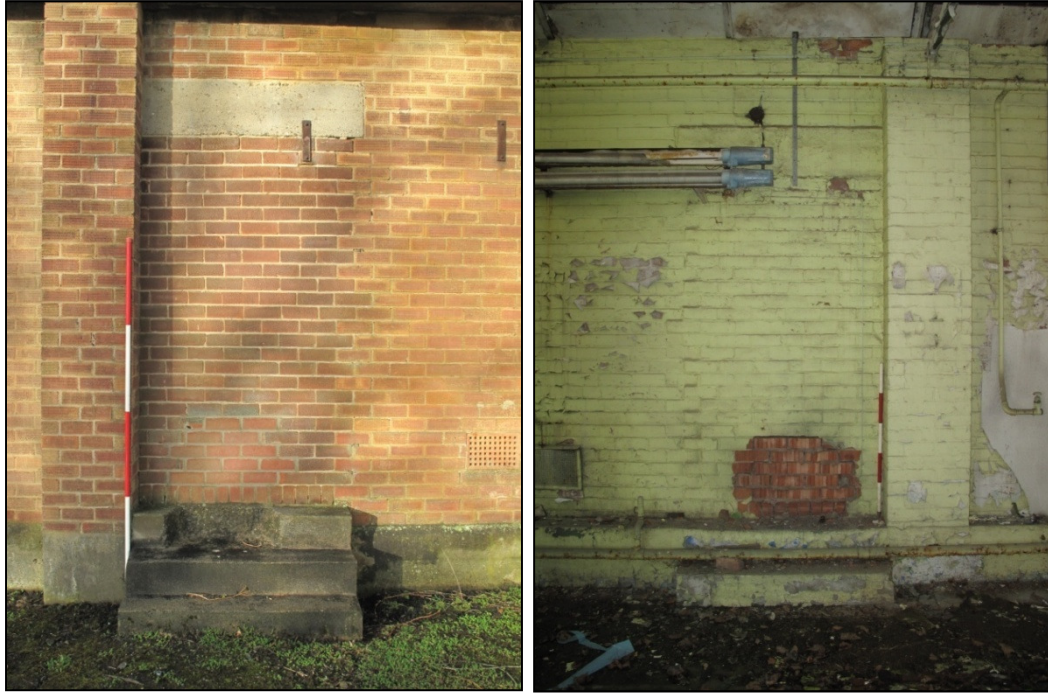
Plate 40: (left) brick patching on one of the southern pedestrian doors. (Right) interior view of same door

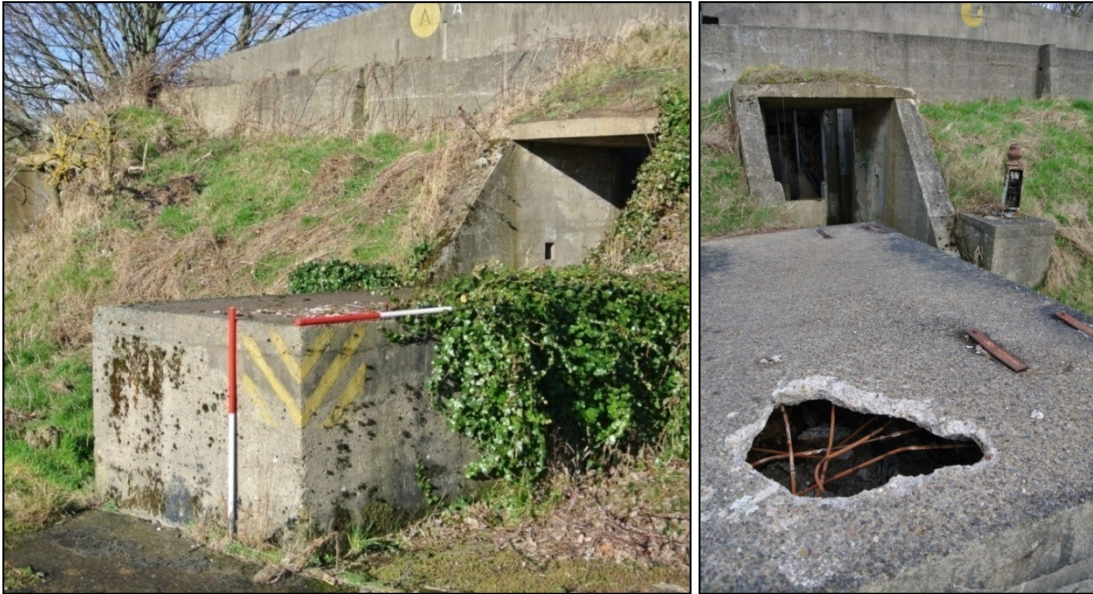
Plate 66: a loading platform outside Bunker A (left). (Right) the damaged loading platform outside Bunker B, revealing the internal reinforcement. Note base in background supporting lamp post

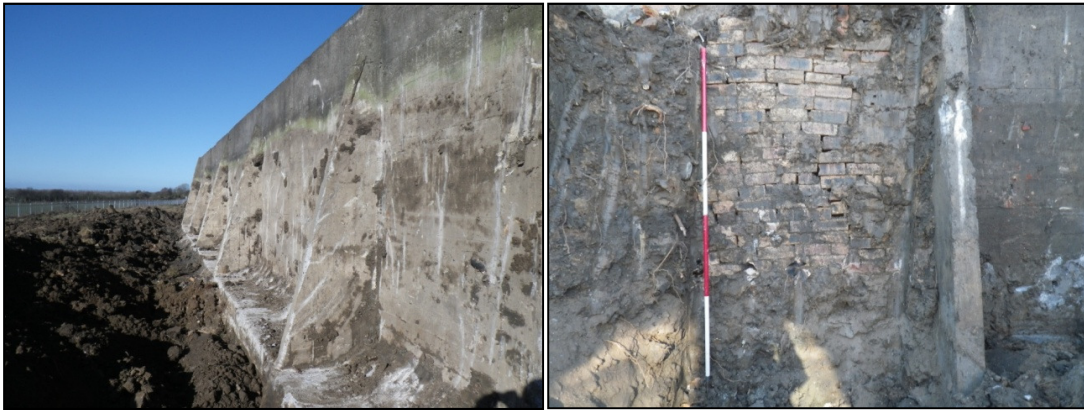
- 5.240 In between each buttress a single skin of loose brick was observed (Plate 69). Each skin of brickwork was poorly constructed with very little bonding and collapsed shortly after machining. These extra skins of brick appear to have been stacked up against the sides of the retaining walls, and were presumably put in position to minimise damp soil lying directly on the concrete walls, so as to aid drainage. The bricks themselves were all frogged with either a central Seghill stamp (Seghill Colliery Brickworks) or an HMC stamp (Hartley Main Colliery – NAA 2014, 19).

Plate 69: south facing elevation of retaining wall after removal of bund (left) and stacked bricks against retaining wall (right)
