THE CURTAIN RISES  
THE WALLED GARDEN

ARCHAEOLOGICAL  
INVESTIGATIONS

NATIONAL TRUST  
SEATON DELAVAL HALL  
NORTHUMBERLAND

NAA 21/31  
October 2021

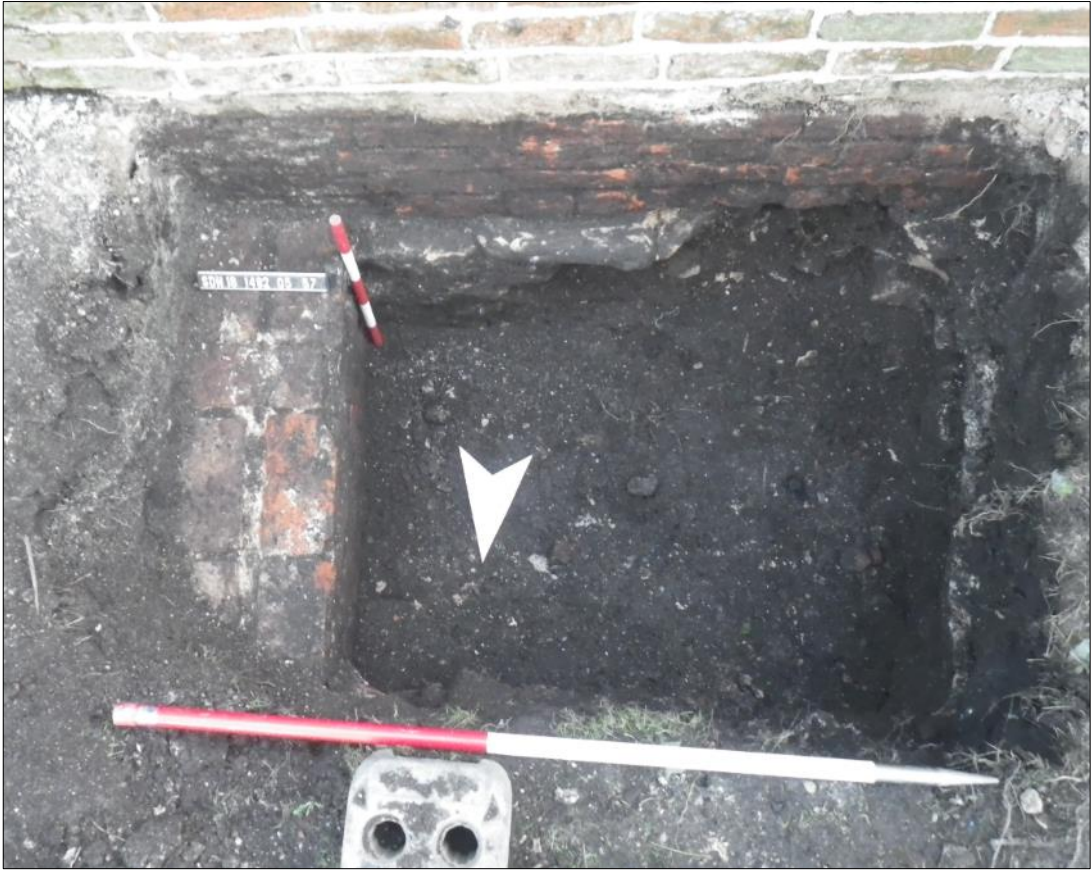
- 6.3 The remains of a second wall (57) were observed extending north to south along the eastern edge of the FP1. This abutted the lower foundations of the garden wall and was probably the west wall of the boiler or furnace house associated with the late 18th-century glasshouse, first shown on the 1818 estate plan (Fig. 6). Both walls were constructed of handmade red brick, measuring 0.24m by 0.12m by 0.06m. The extant boiler house building (177) to the west is a much later structure relating to the 20th-century greenhouse (Fig. 9).

*Plate 2: FP 1 – buttress trench showing the stone foundations of the garden wall and wall of the 18th-century glasshouse boiler house.*

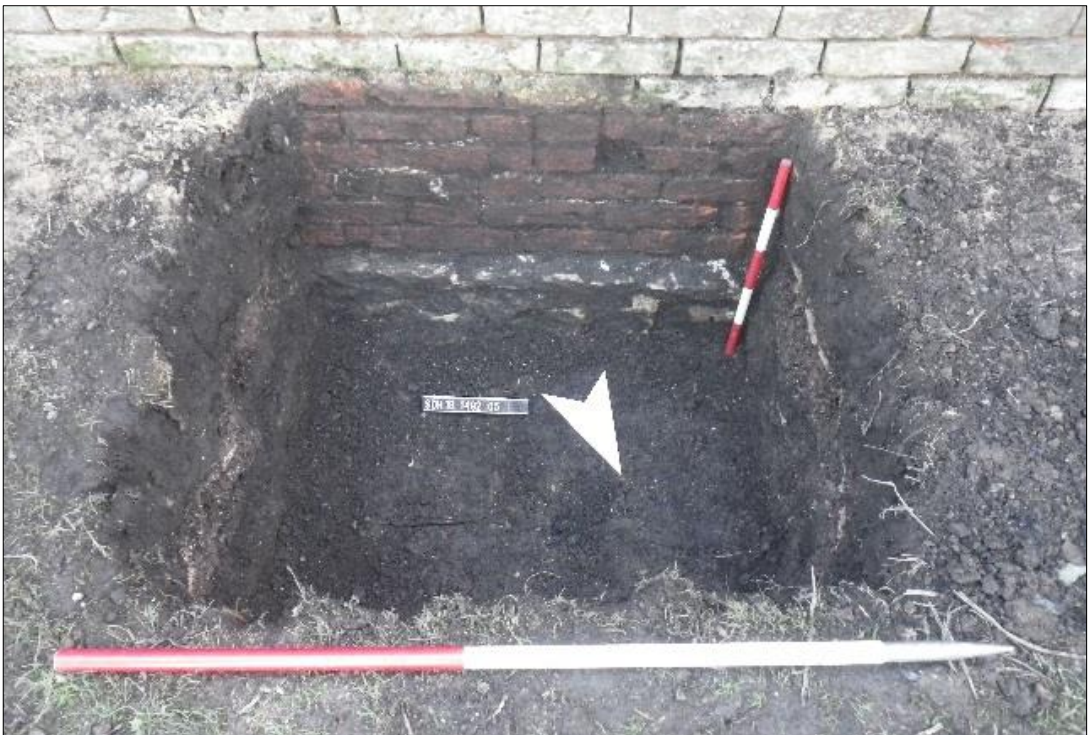
*Plate 3: FP 2 – buttress trench showing the wall foundations.*

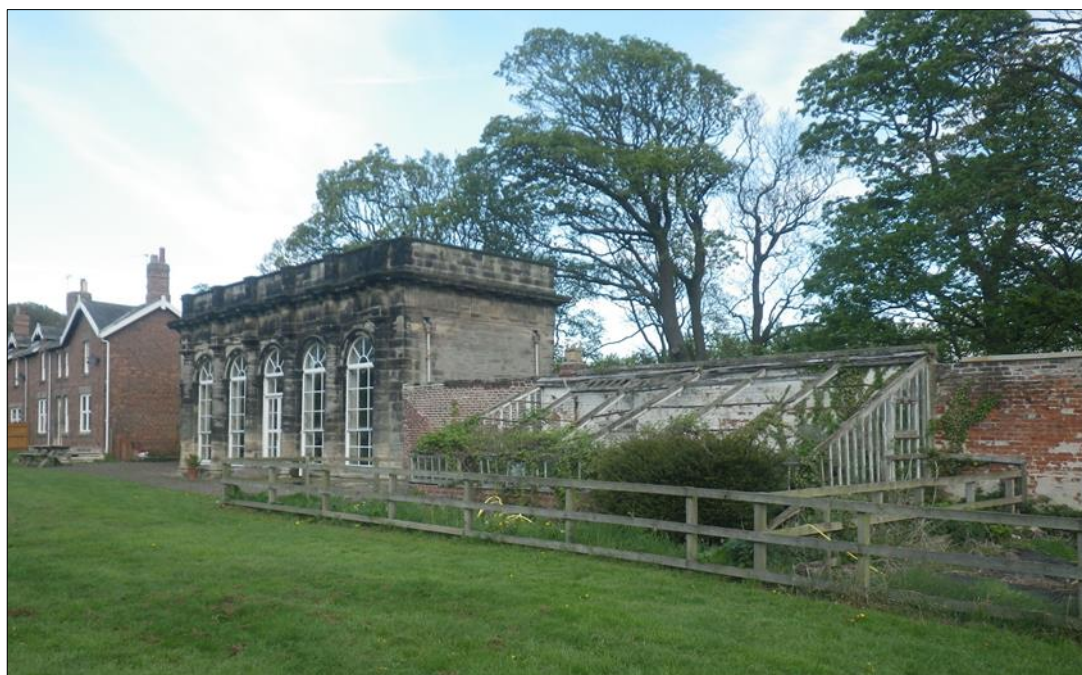
- 6.6 Within the interior of the garden the early 20th-century greenhouse (58) shown on the 1920 OS (Fig. 9) was in a state of collapse and overgrown with brambles (Fig. 11; Plate 4). This presented a potential safety hazard and was of limited historic significance. The structure was carefully dismantled under archaeological supervision as part of the AWP 5 works. The greenhouse was 9m by 3.8m in plan comprising a superstructure of timber and glass sitting on a 0.75m-high modern brick wall, laid in common bond. It had an entrance (175) to the south-west (Plate 5).

*Plate 4: greenhouse prior to dismantling, looking north-northeast.*

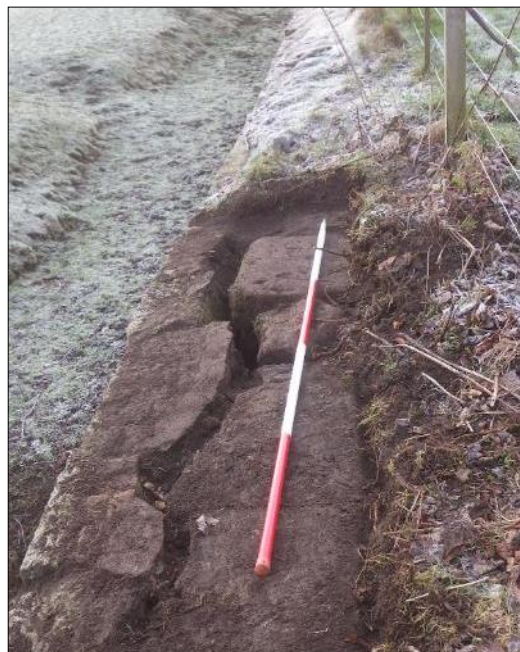
- 6.9 In February 2019, archaeological monitoring was conducted during the repair of a damaged section of the ha-ha wall (34) to the south of the north-east bastion (Fig. 11). The installation of ceramic salt-glazed drainage pipe, probably in the late 20<sup>th</sup> century, had caused the gradual collapse of the wall face leading to instability.
- 6.10 Turf was cleared from the top of the structure in order to assess the damage. The coping stones had already been removed, probably when the drainpipe was originally installed, and as a result rainwater had penetrated the core of the wall, contributing to its collapse

*Plate 9: damage to the ha-ha wall.*

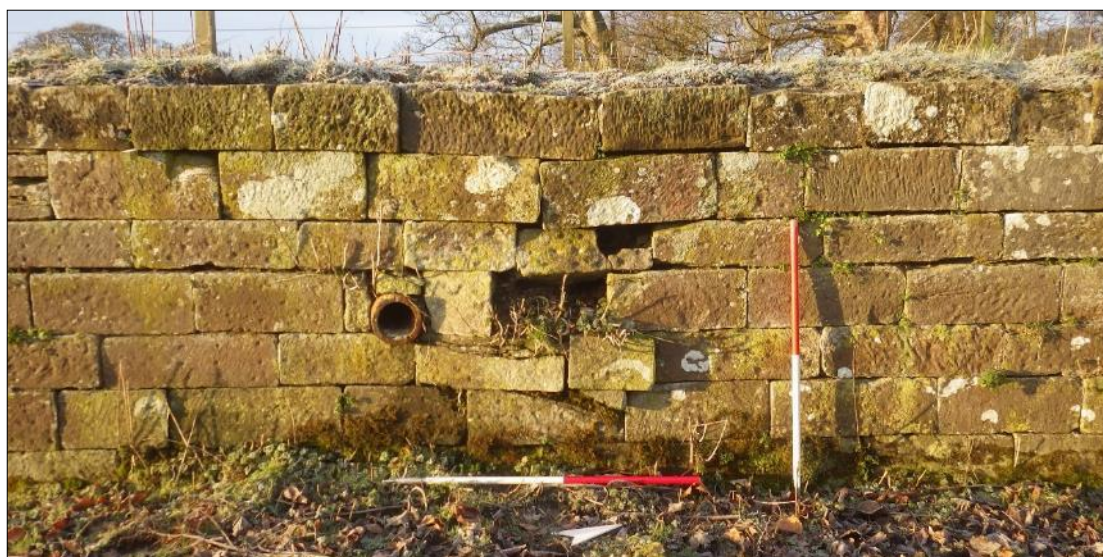
Plate 10: ceramic drain and damage to the south-east face of the ha-ha wall.

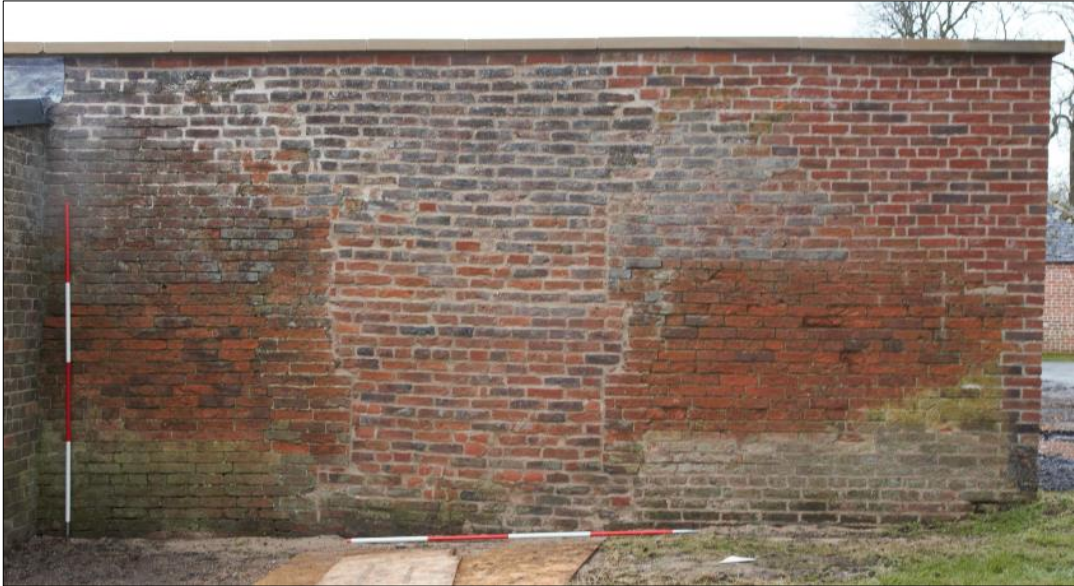
in width and 2.2m high with no evidence of a door frame or case (Plates 11 and 12). However, the shape of the blocking – larger at the base, centre and top sections – suggests it may very likely have originally featured a stone architrave similar to that of the door 311 at the southern end of the east wall (Plate 13).

*Plate 11: blocked doorway (211) at the west end of the north wall after consolidation.*

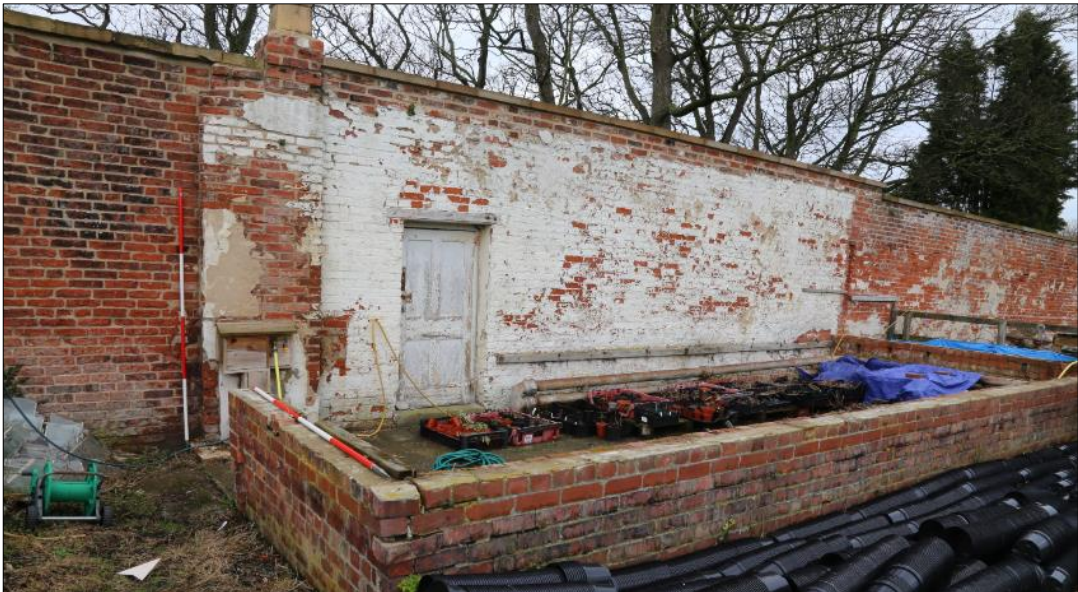
*Plate 23: remains of 20th-century greenhouse.*

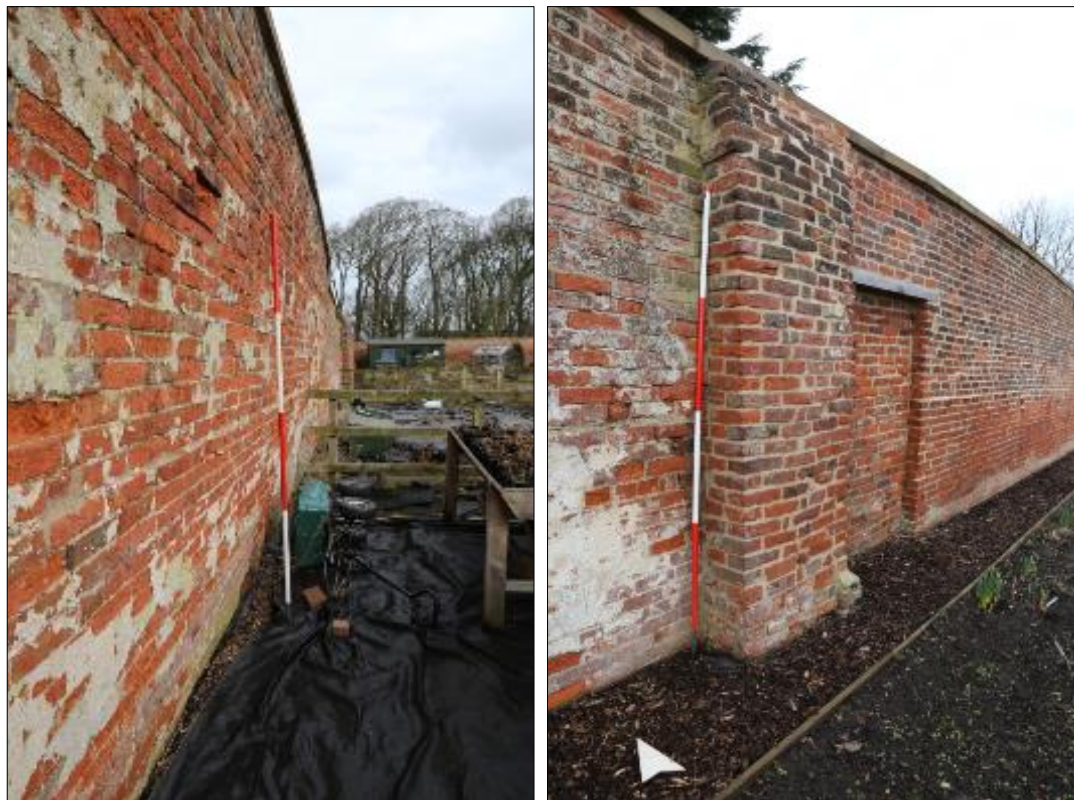
- 6.30 East of the greenhouse, a glance along the wall showed the structure bowed significantly inwards and then out, forming an undulating line until it reached the east wall (300) (Plate 24). This instability was possibly caused by the early 20th-century demolition of the 18th-century glasshouse which would have provided a degree of structural support. Traces of mortaring and limewashing associated with the former building remained visible on the wall. Many of the brick faces in this section were badly damaged and falling off, possibly caused by humidity inside the former glasshouse.

*Plates 24 and 25: (left) wall leans inwards where the former 18th-century glasshouse once stood; (right) brick pier 242 with blocked door 221 beyond.*

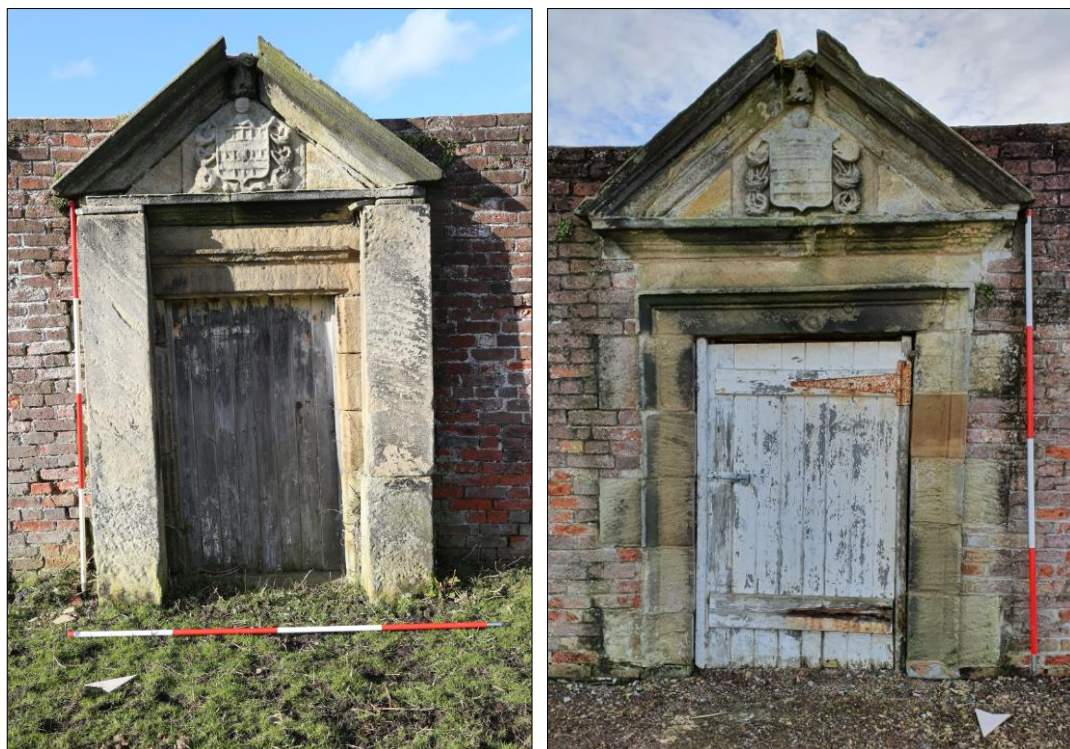
*Plates 35 and 36: (left) south-facing; (right) north-facing side of door 413.*

- 6.42 A door (413), with ornate late 17th-century reused decorative doorcase, was located c20m east of the west boundary of the Gardener's Cottage gardens (Plates 35 and 36). This was the former entrance into the south slip from the main body of the walled garden. The 1808 plan shows a central path running along the short axis of the garden, linking the Orangery with 413. As such, the decorative doorcase would have formed a distinctive focal point on the south side of the garden. The size and quality of the doorcase, resplendent with the Delaval ram's head crest set in a broken pediment, obviously came from a high-status building. It was perhaps salvaged from the former Stuart hall and incorporated in the garden not only for its aesthetic value but as a relic of the ancestry of the Delavals; setting them apart from the new moneyed industrialists and coal barons (even if their wealth was now coming from remarkably similar sources).

- 6.44 On the south-facing side of the door the pediment was supported on two massive stone square-cut pillars that stood proud of the door surround (Plate 35). These were erected to support the failing cornice but in themselves seem of some considerable antiquity. Problems with the substantial piece of masonry may therefore have occurred quite early in the history of the garden. There was the potential that the pediment was separate from the surround, with the two pieces brought together as a composite feature, although both seem to match well and do form an integrated unit, especially when viewed from the north side.

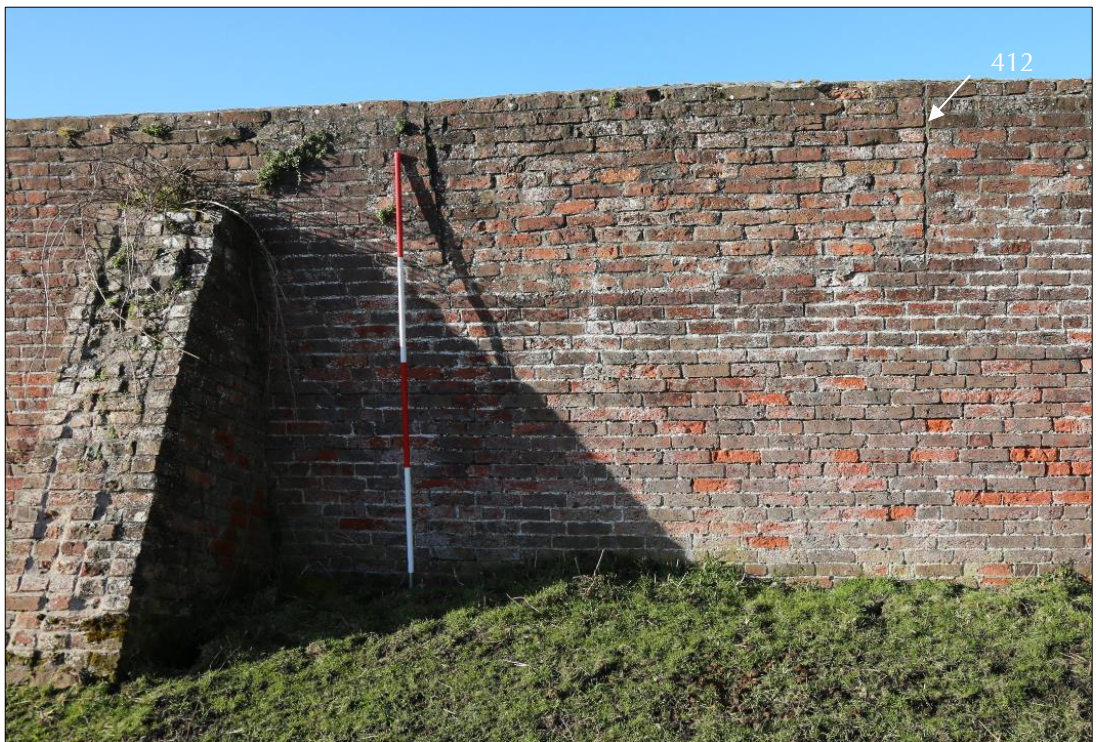
*Plate 38: buttress and rectangular infilled brick panel (412).*

- 6.46 Located approximately 1m east of the buttress was a rectangular area of brick infill (412) (Plate 38) which measured c.2m in length and extending 0.75m from the top of the wall. It was unclear what this related to as nothing was shown in this location on the historic maps and plans. The two vertical joints on each side of the feature were too well defined to simply be an area of wall repair, and the brickwork was slightly recessed, especially on the west side. There was no apparent trace of the feature on the north-facing elevation

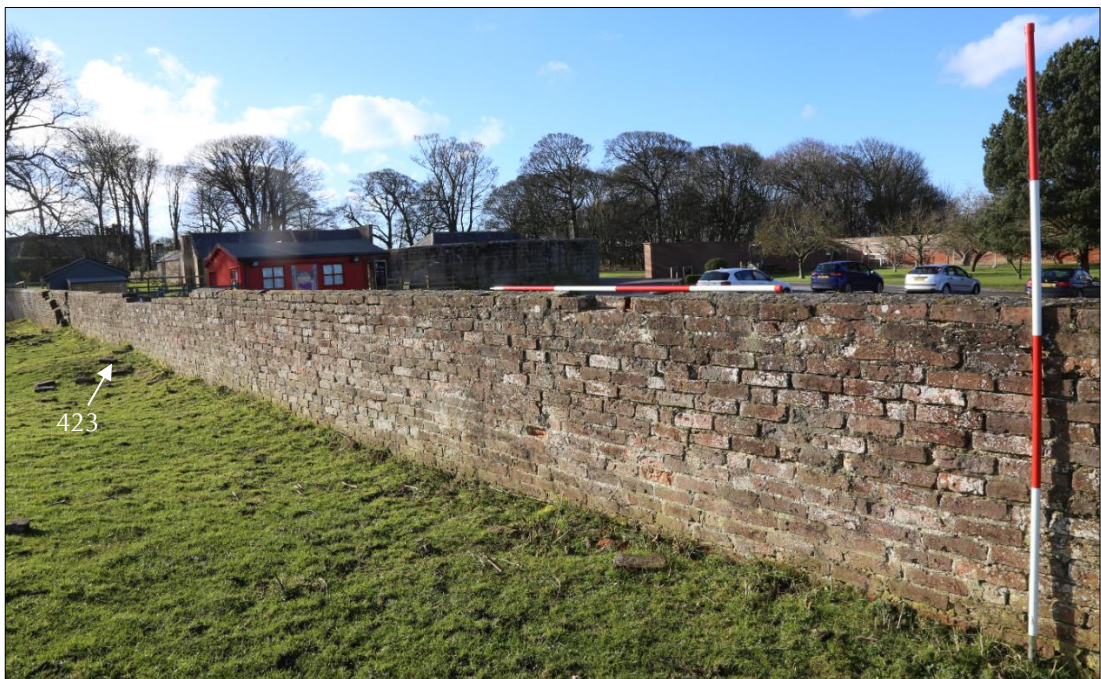
*Plate 43: rebuilt section of south wall (**416**) with buttress **423** visible.*
