Building Recording Addendum

Job Number:	18.1267
Project:	The Abbey Public House, St Helens
Client:	Joseph Holt Ltd
Date:	29 May 2019

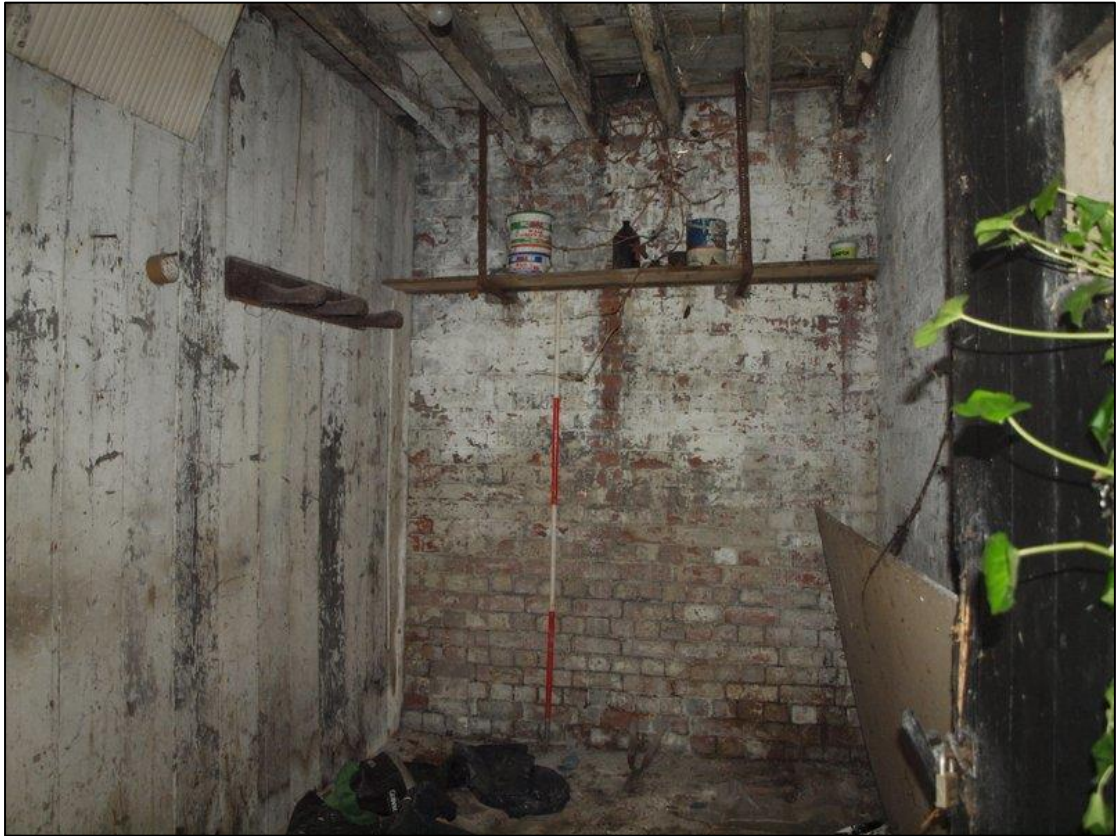
- 4.1 The previously inaccessible room lay at the northern end of the second bay, accessed via a timber door in the east wall. This led into a narrow room with whitewashed brick walls. To the west the timber partition wall was present. The floor was concrete and the ceiling open to the timber joists of the decayed floor above.

Plate 1: Interior of ground floor room

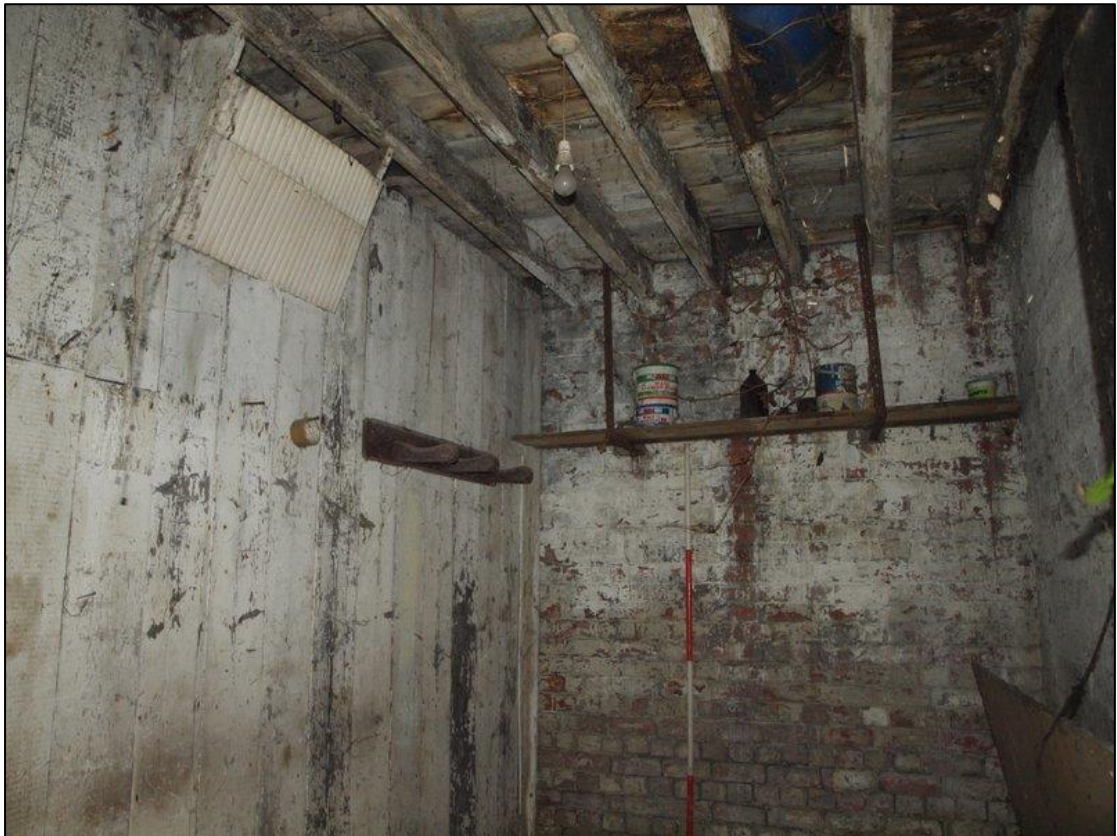
Plate 2: As above showing ceiling joists

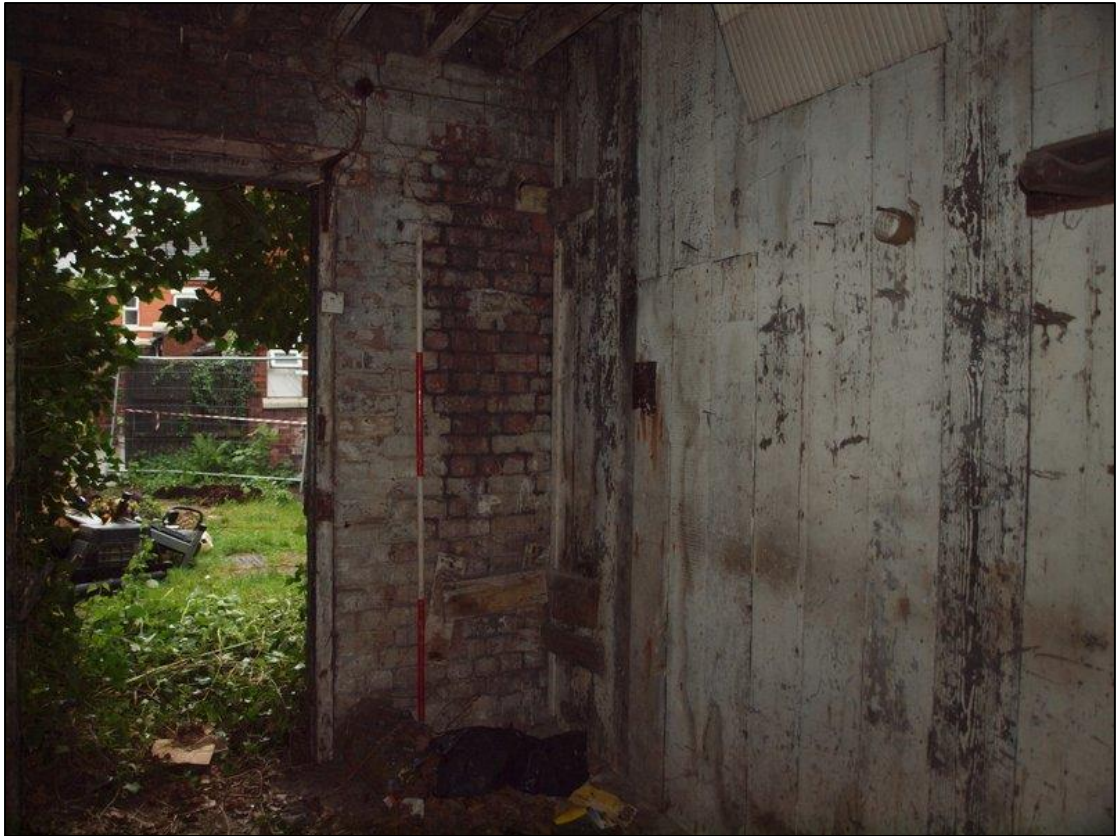
Plate 3: Ground floor room showing doorway

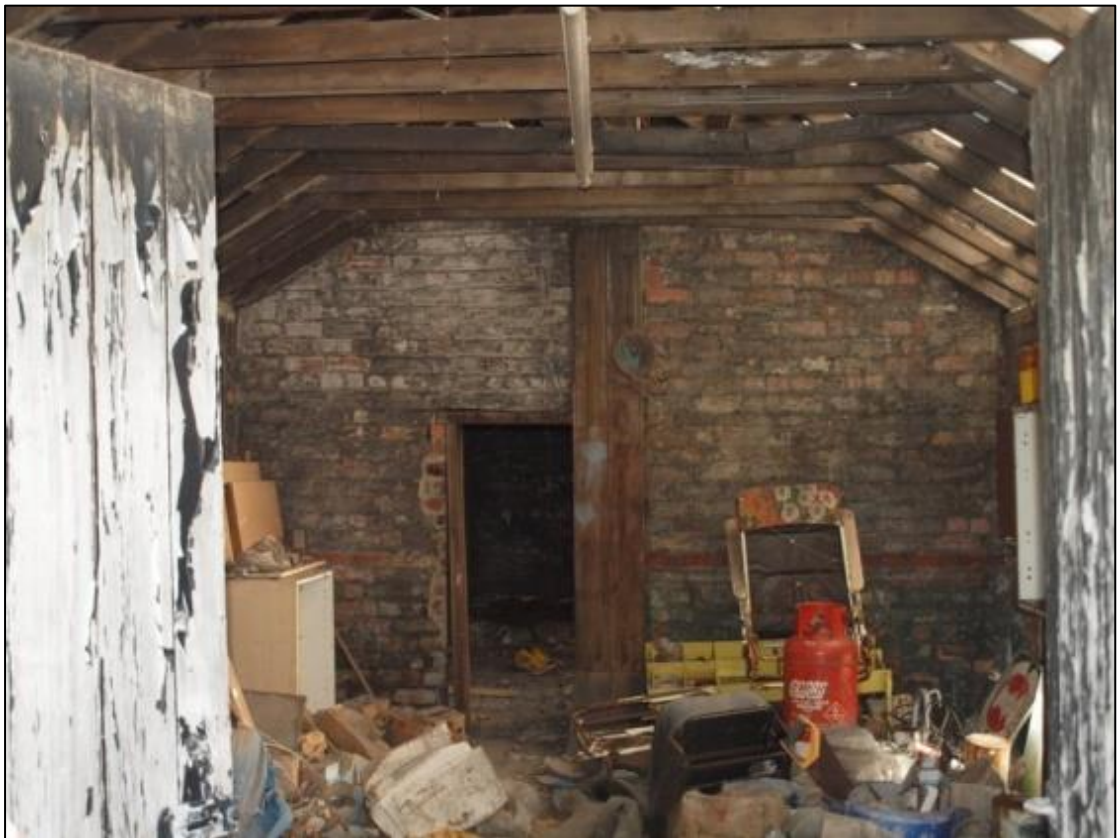
- 4.2 The first floor was accessed via the main doorway in the south elevation. The floor to the room was bare boards and the ceiling open to the modern machine cut timber trusses. All of the walls were bare brick and to the east the circular pitching eye and the timber framed portrait window were visible. To the north was a cross wall with a personnel doorway inserted, slightly west of centre. To the east of this a timber chute projected into the room.

Plate 4: Southern room of first floor

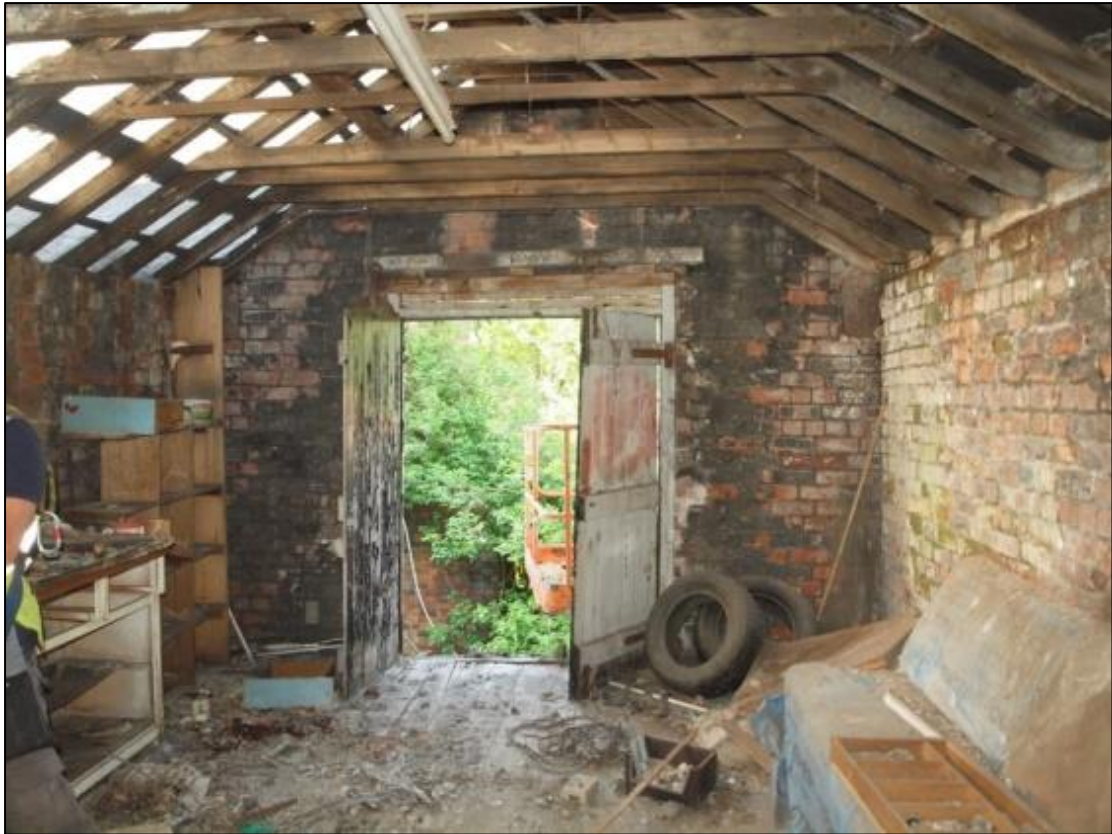
Plate 5: Southern room of first floor looking south

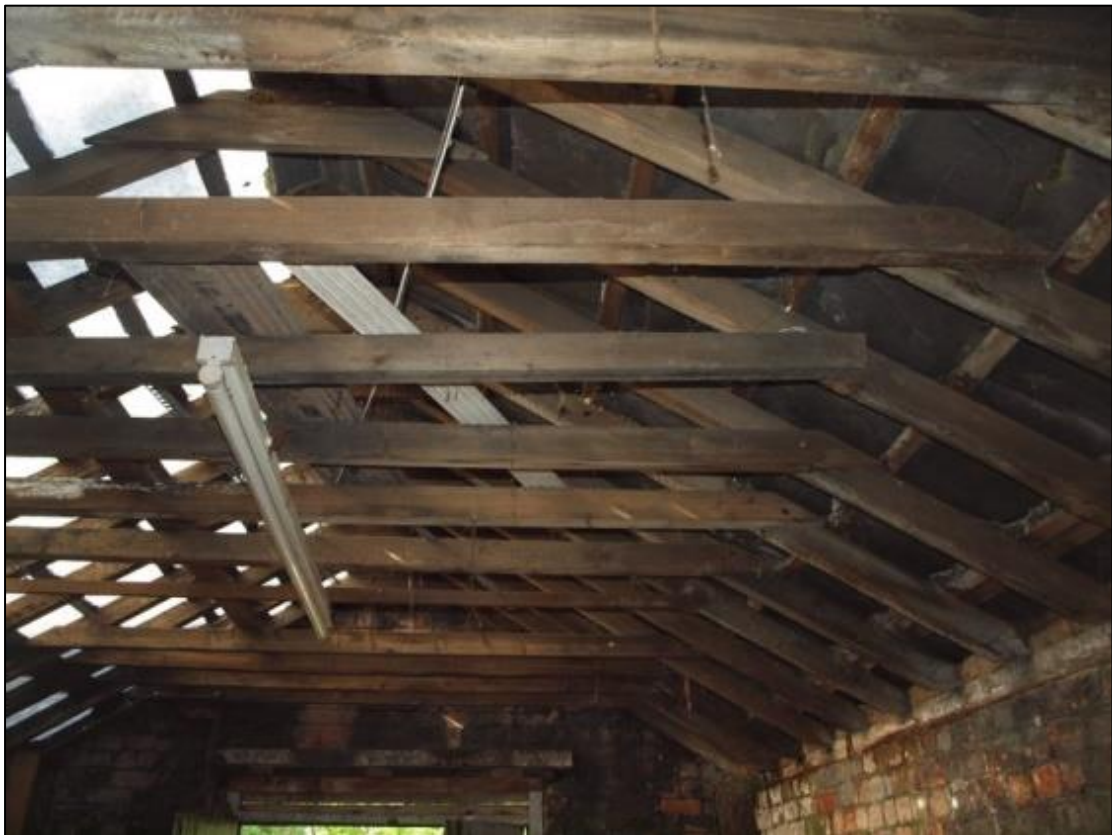
Plate 6: Detail of modern roof trusses

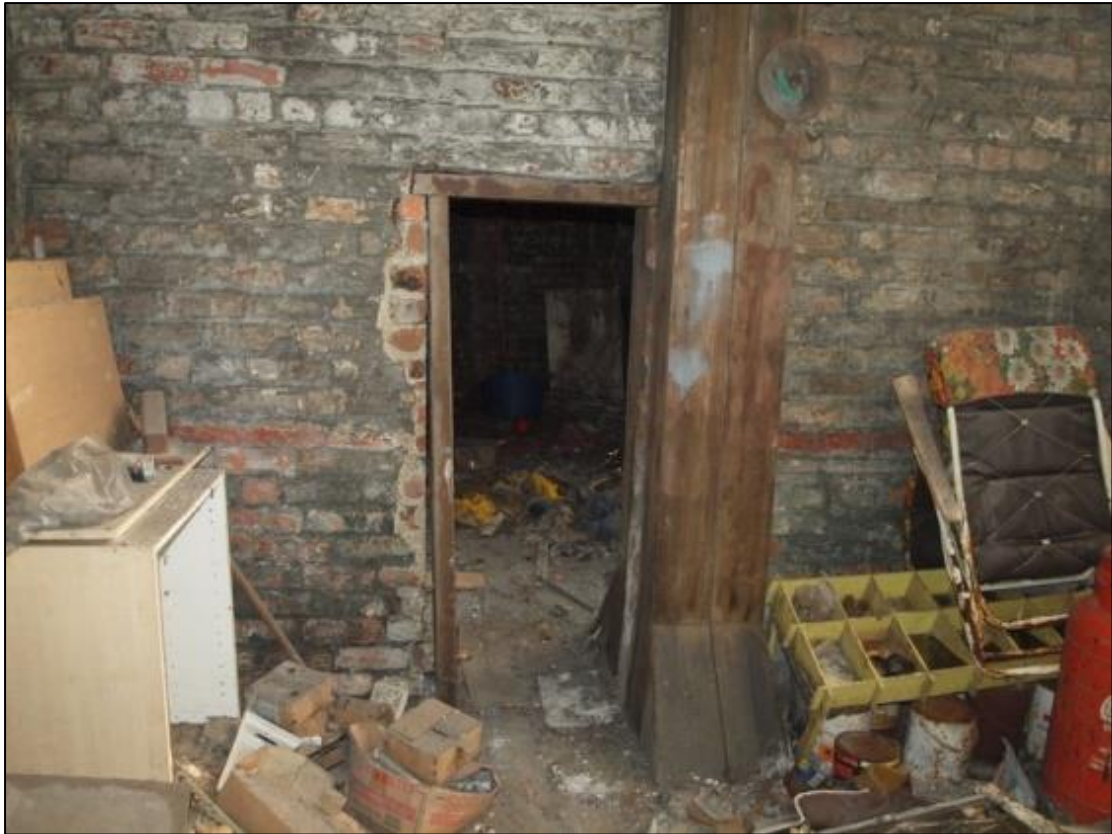
Plate 7: Detail of inserted door to north room

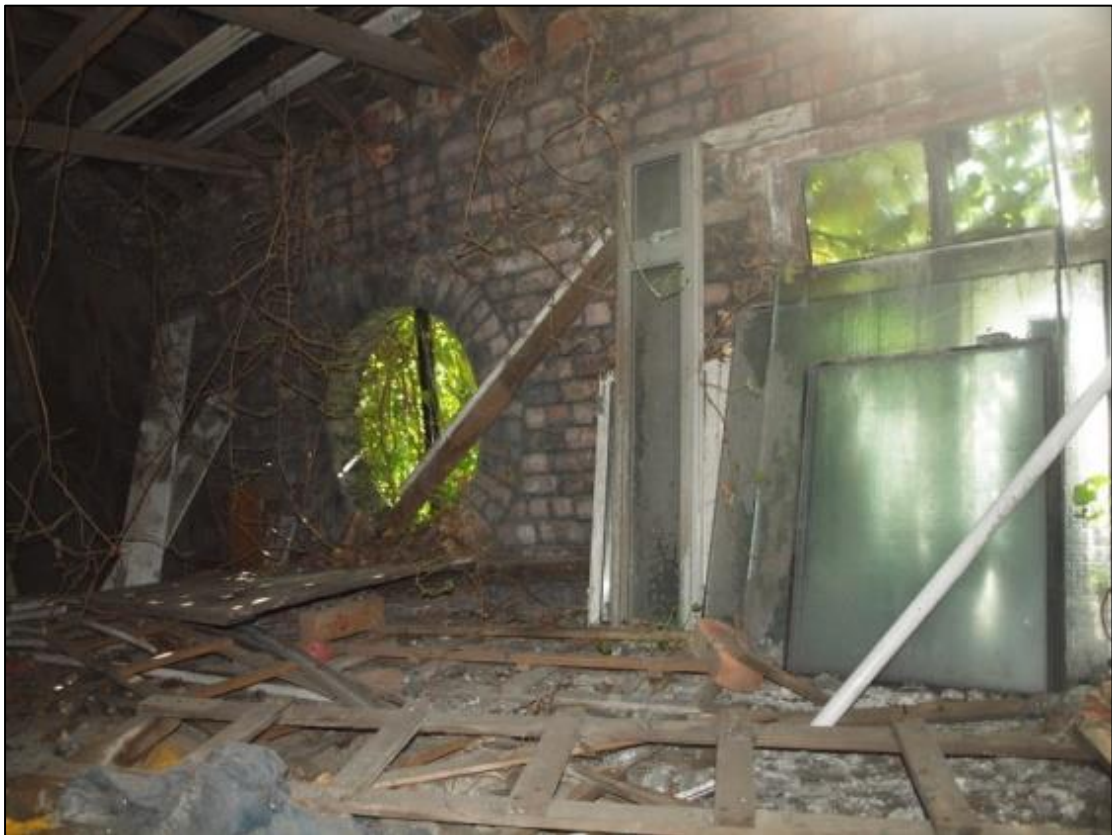
- 4.3 Through the doorway in the north wall gave access to a further first floor room. Here the walls were again bare brick and the ceiling open to the modern trusses. In the east wall the timber framed portrait window was visible, as was a circular pitching eye to the north of it, masked from the exterior by foliage. In the north wall a blocked doorway with rounded jambs lay to the west side.

Plate 8: North room of first floor

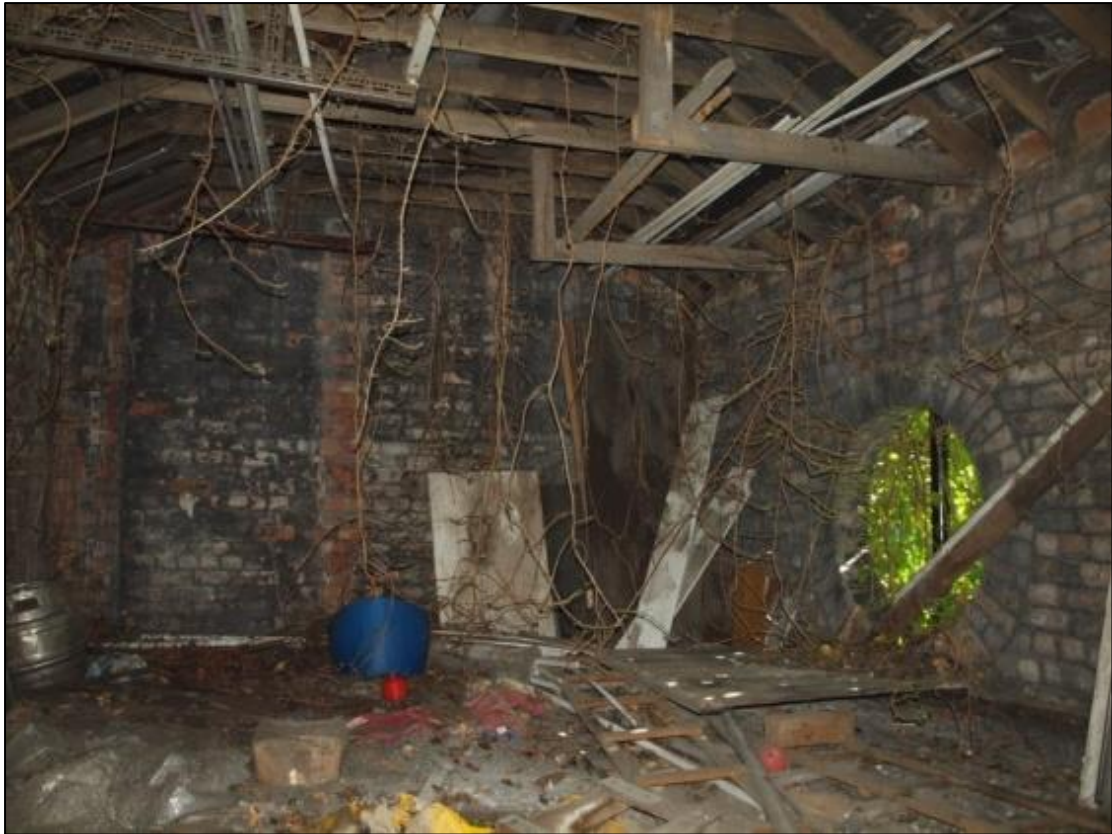
Plate 9: North room of first floor

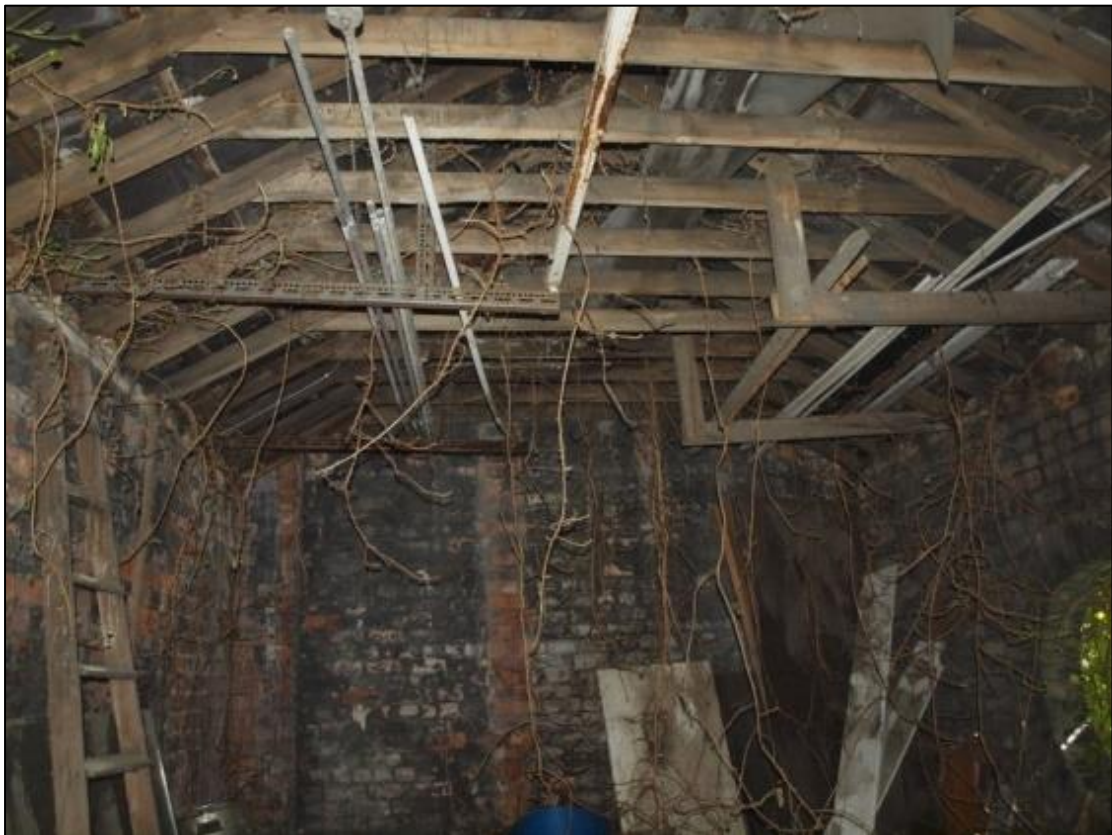
Plate 10: Roof trusses of north room

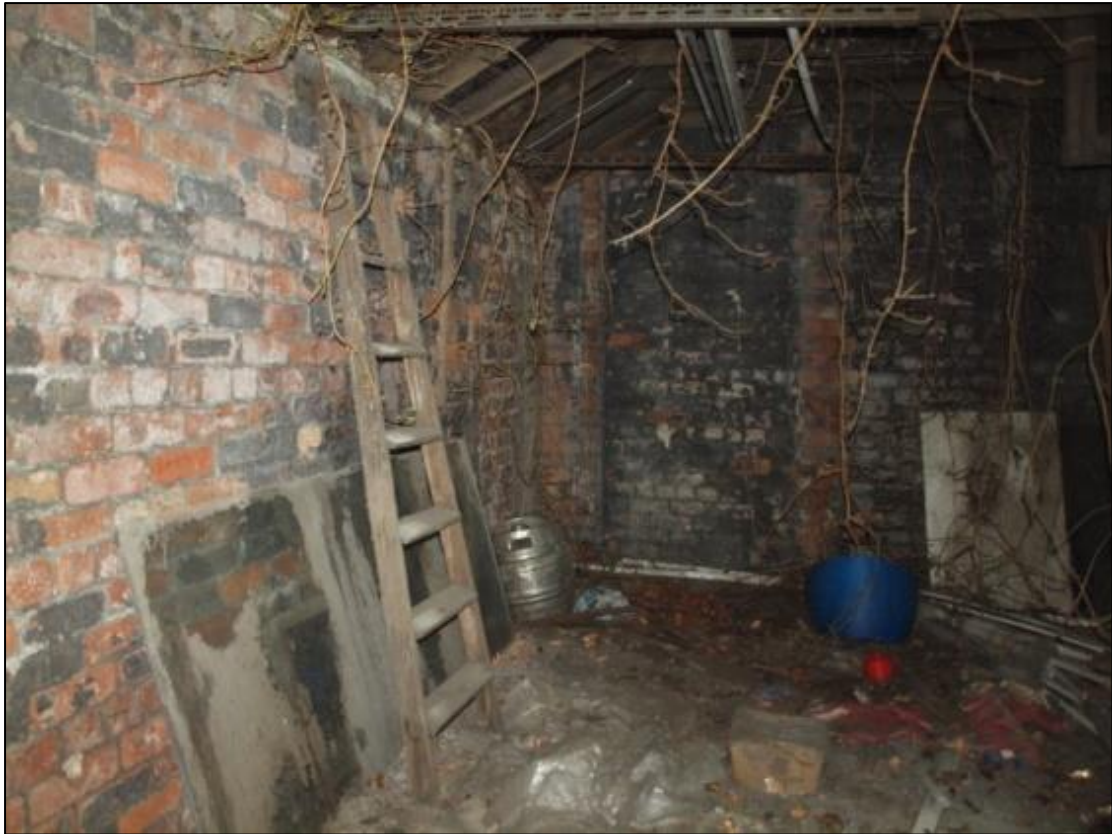
Plate 11: Blocked opening in north wall of north room

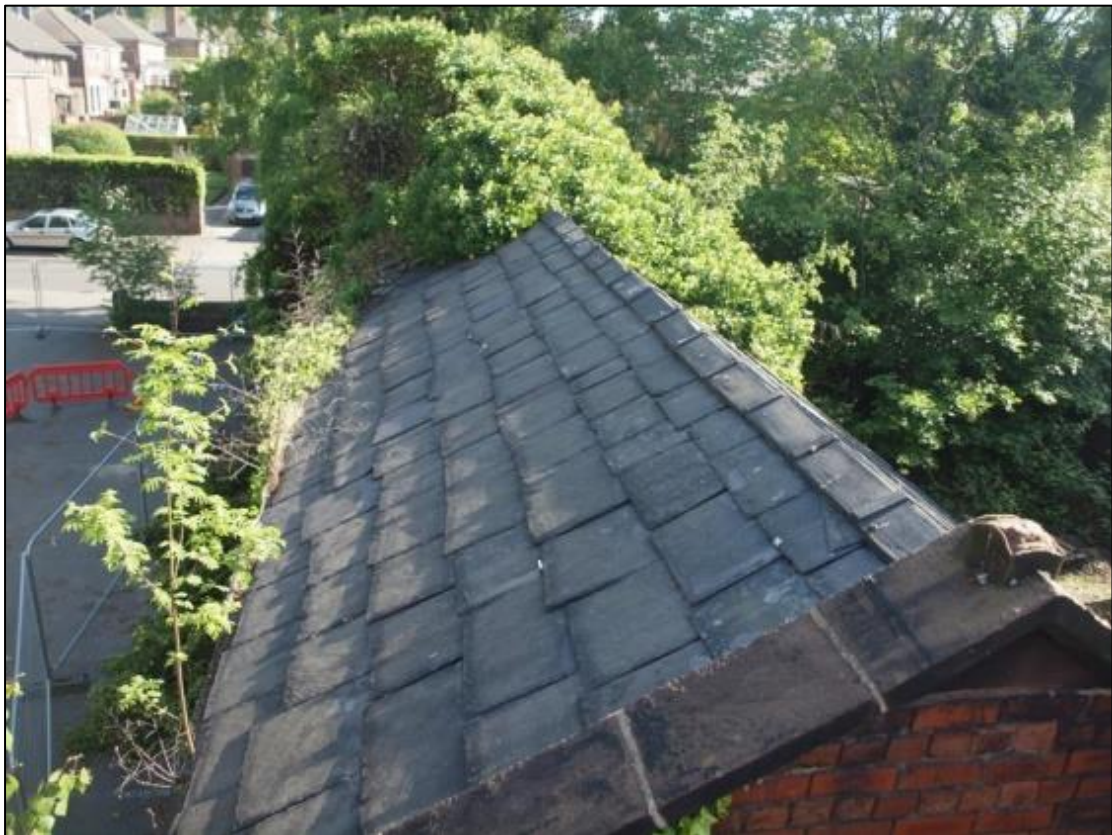
Plate 12: Detail of slate roof

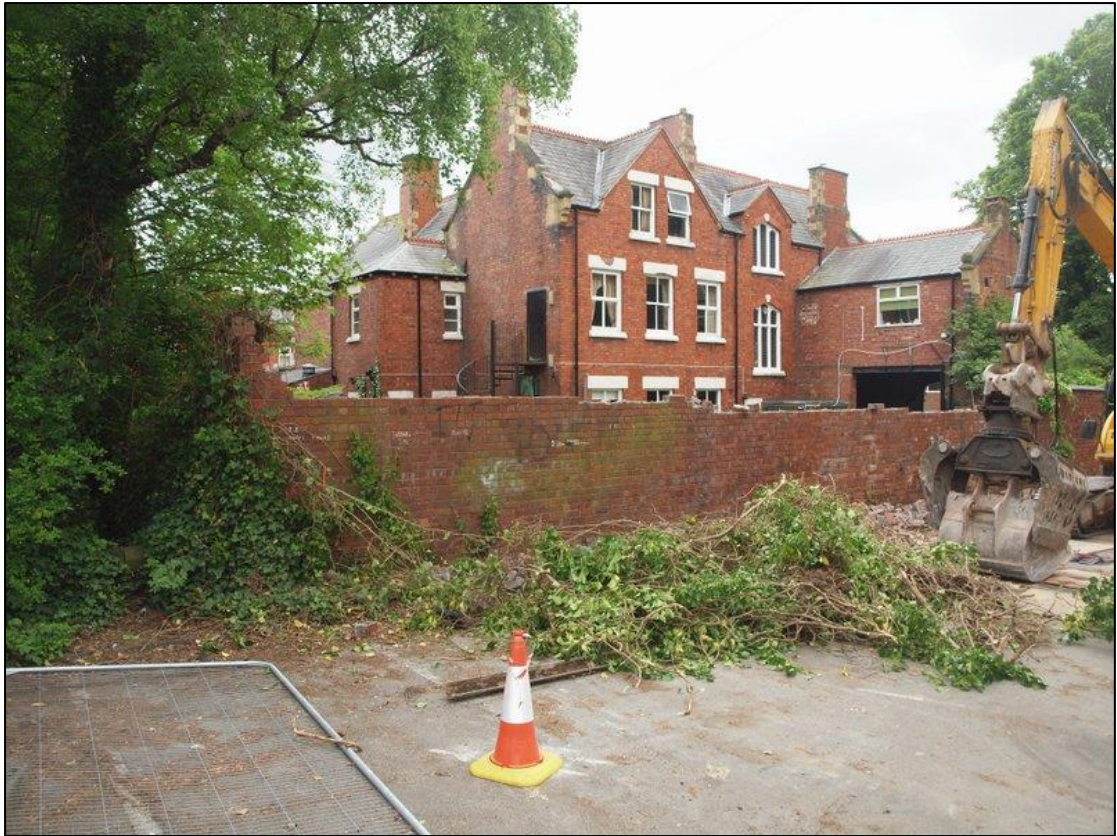
Plate 13: Building after partial demolition
