Hallmark Developments (Northwest) Ltd

Dexine Rubber Works, Rochdale

Level 2 Archaeological Building Survey

22 November 2019

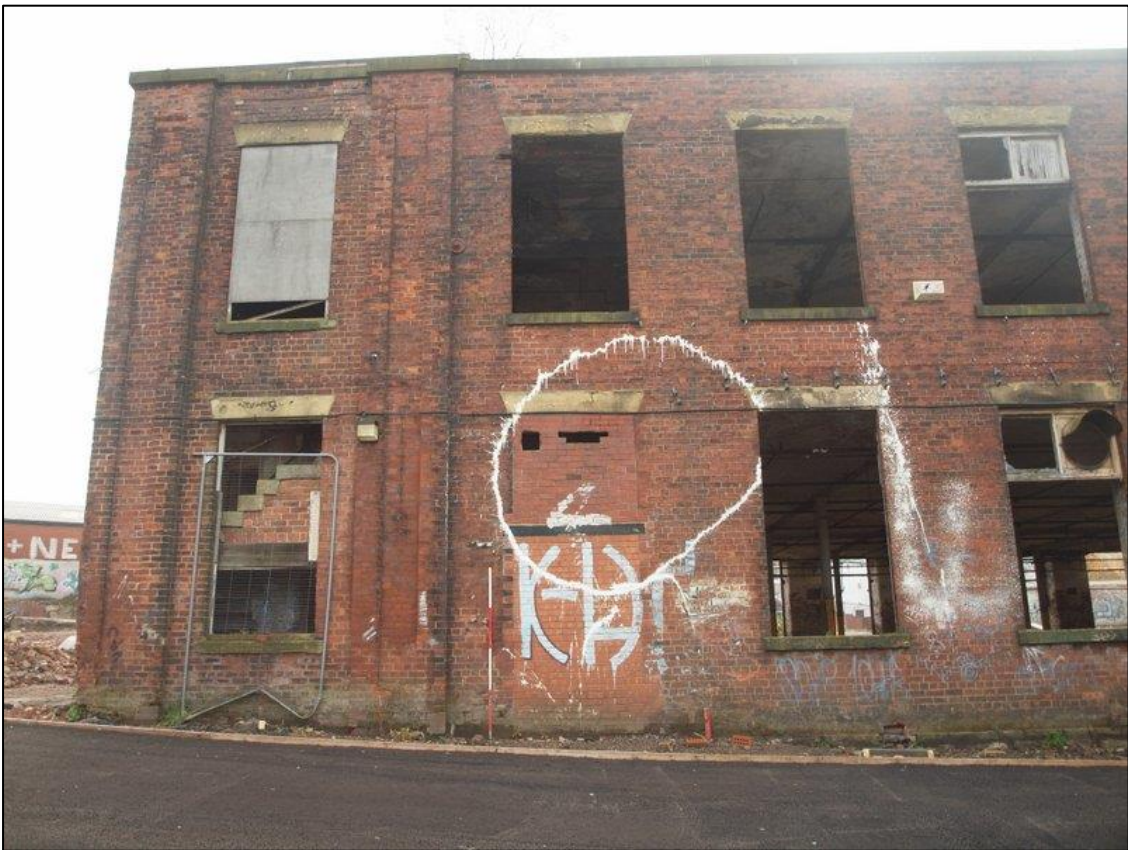
Plate 4: Northwest elevation bays 1 to 4, with staircase cutting across the bay 1 ground floor window.

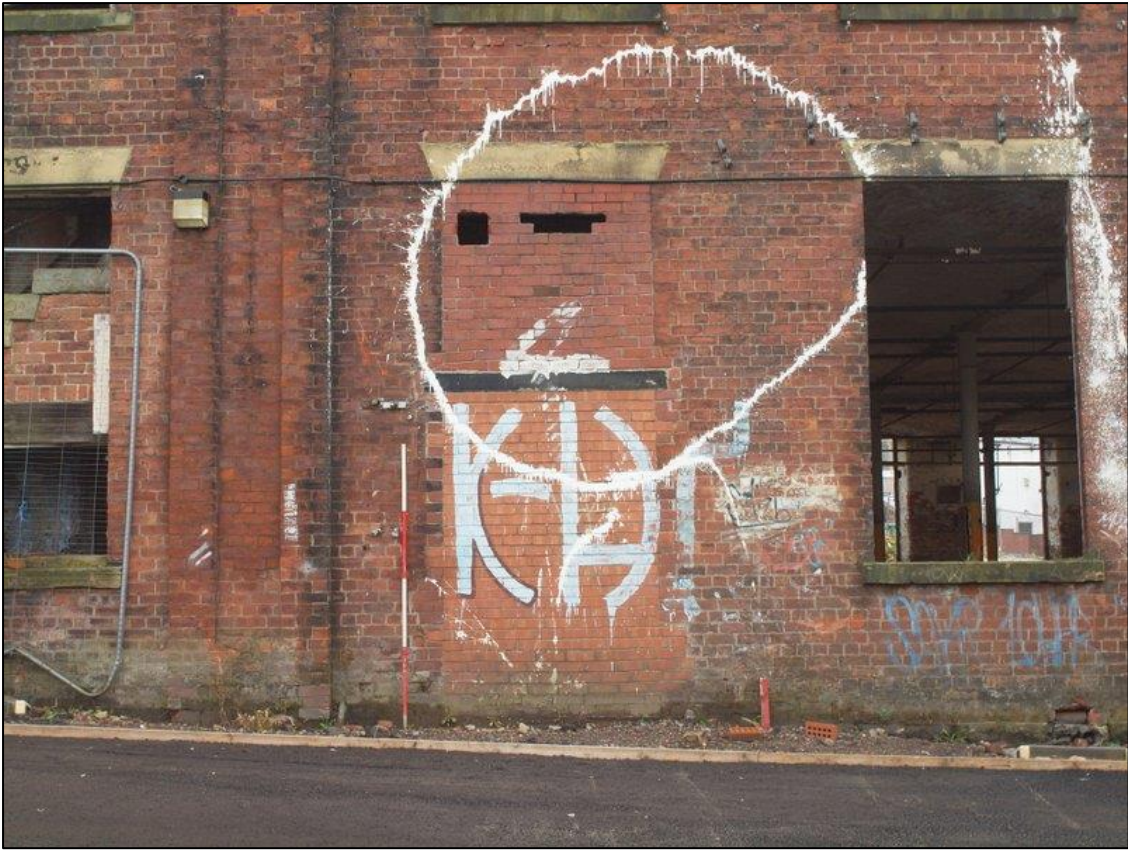
Plate 5: Detail of ground floor bay 2 showing blocked window with blocked inserted doorway

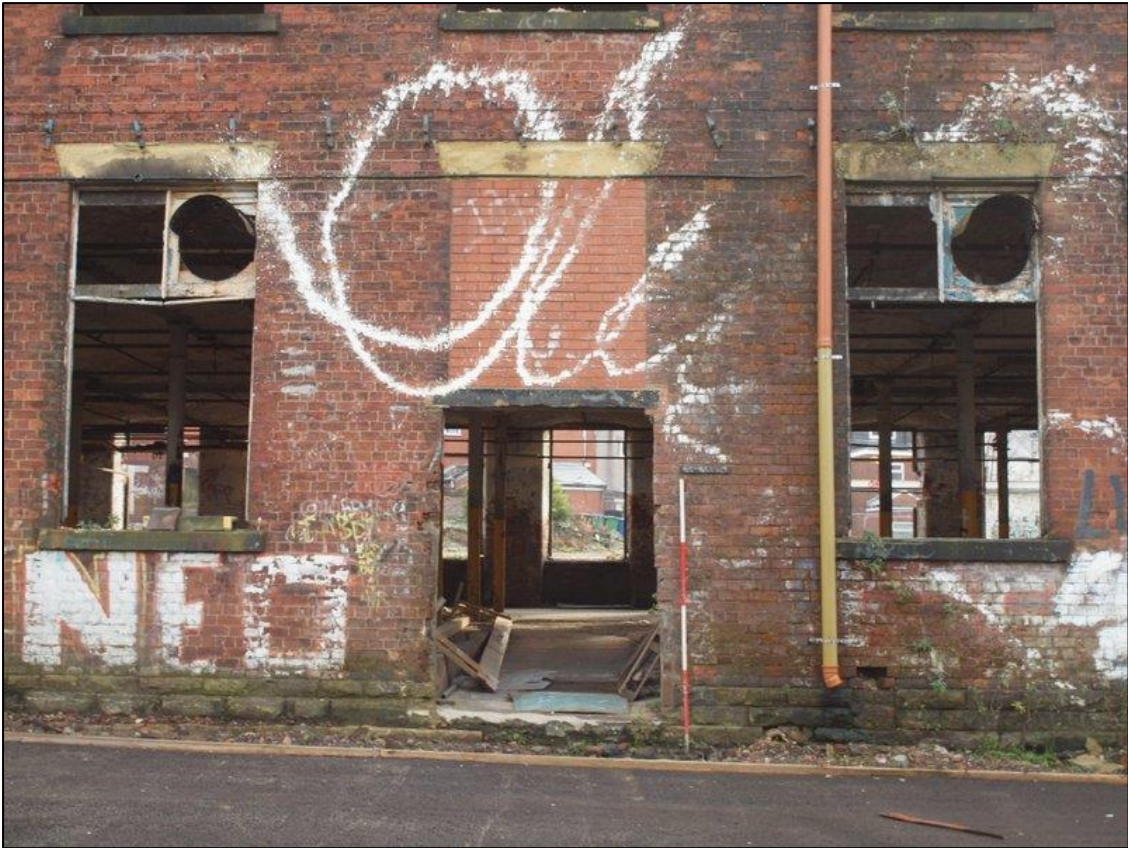
Plate 7: Detail of inserted doorway in bay 6

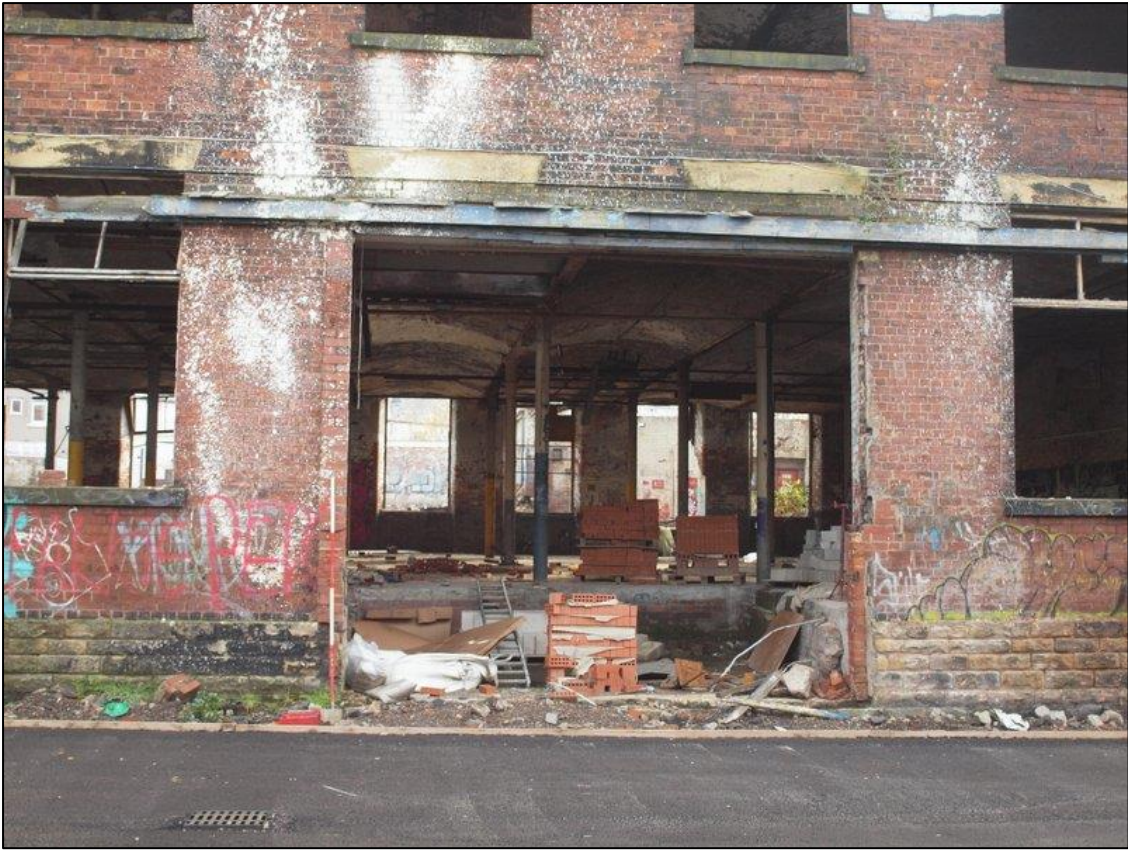
Plate 9: Detail of inserted doorway in bays 13 & 14

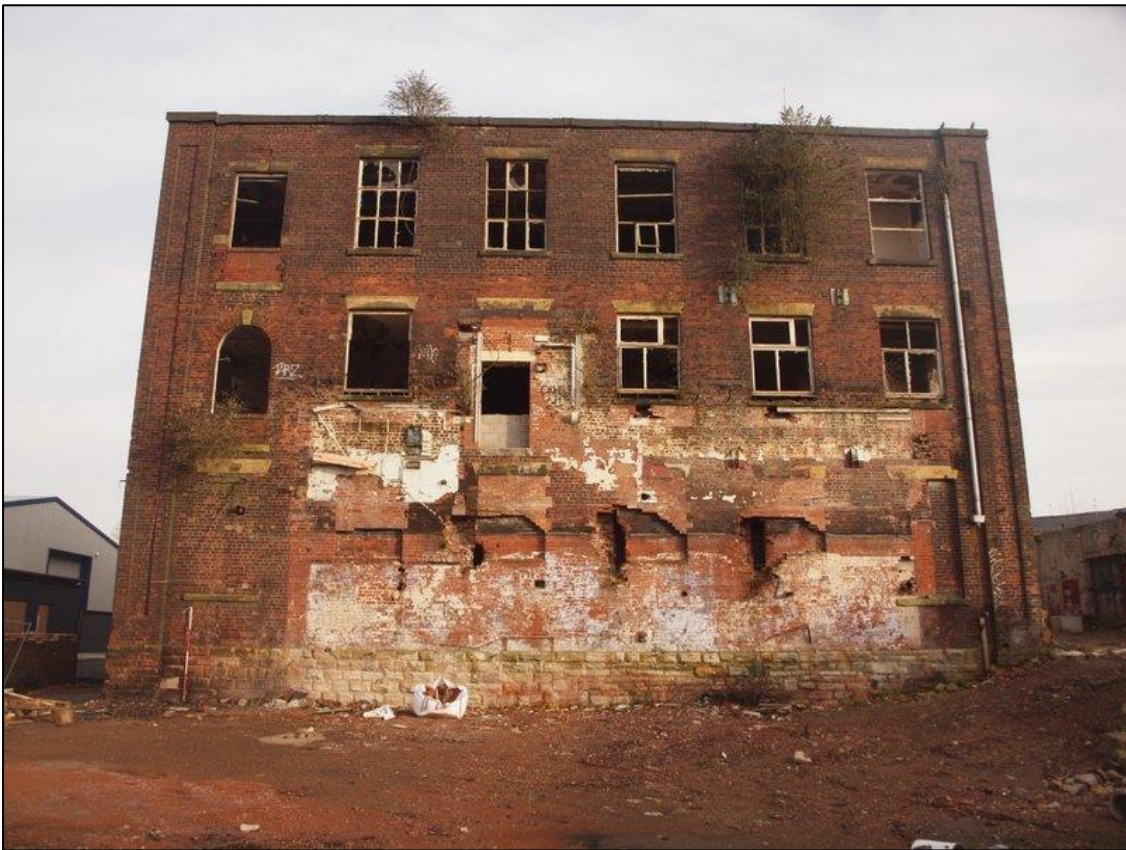
Plate 16: Southwest elevation showing ghost of removed building at ground floor level.

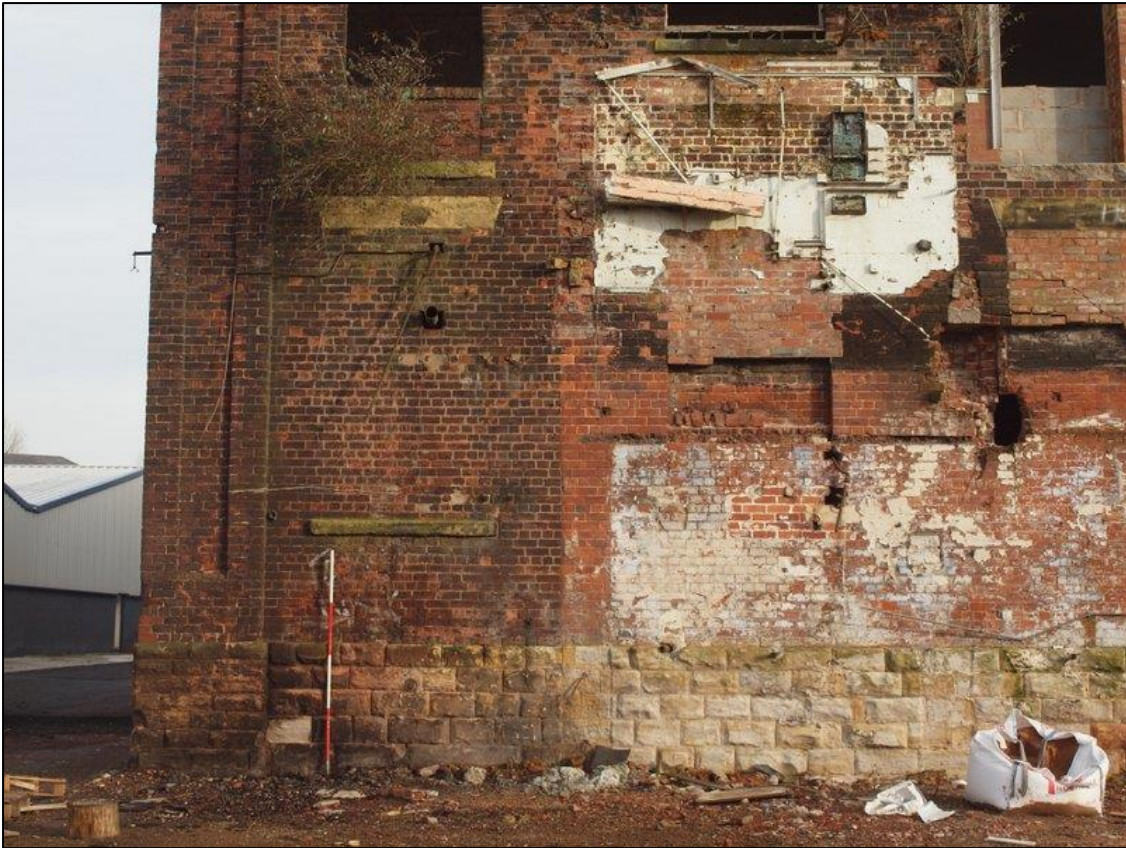
Plate 17: Blocked window in bay 1 at ground floor level

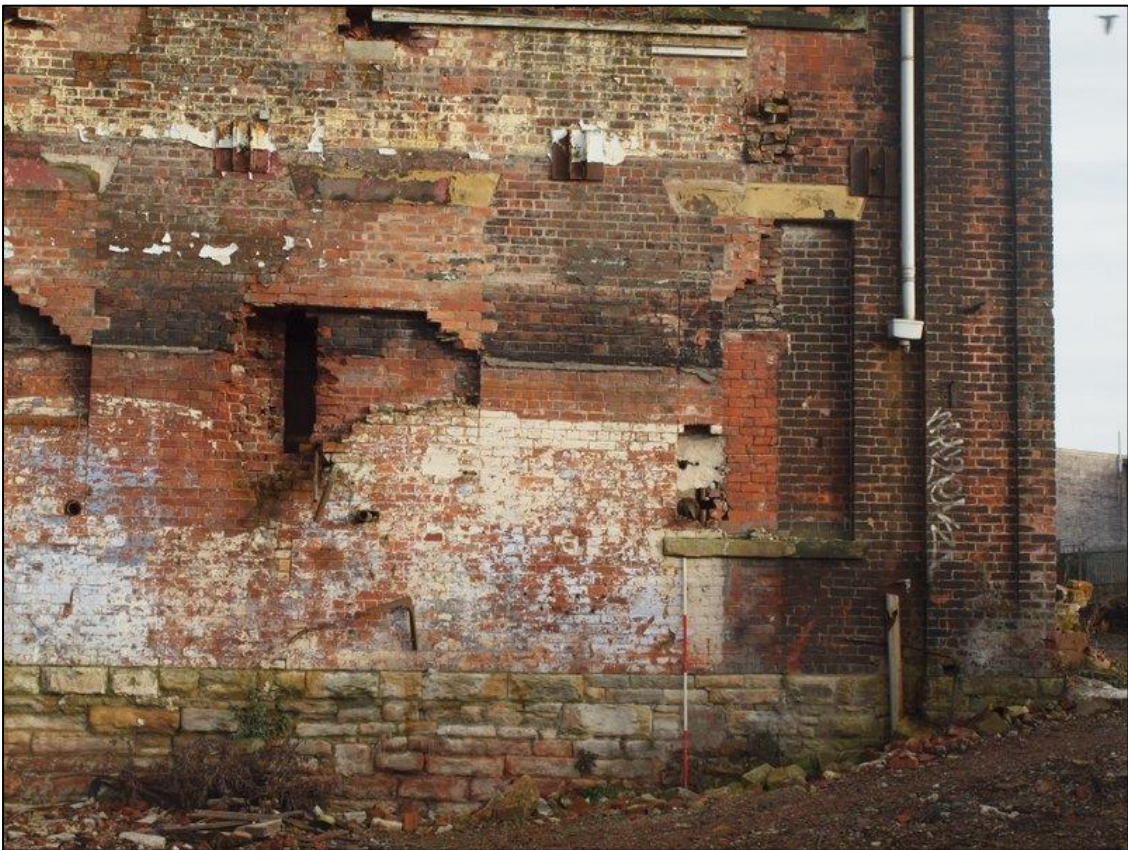
Plate 22: Detail of bays 5 & 6 at ground floor level showing blocked window and ghost of former building.

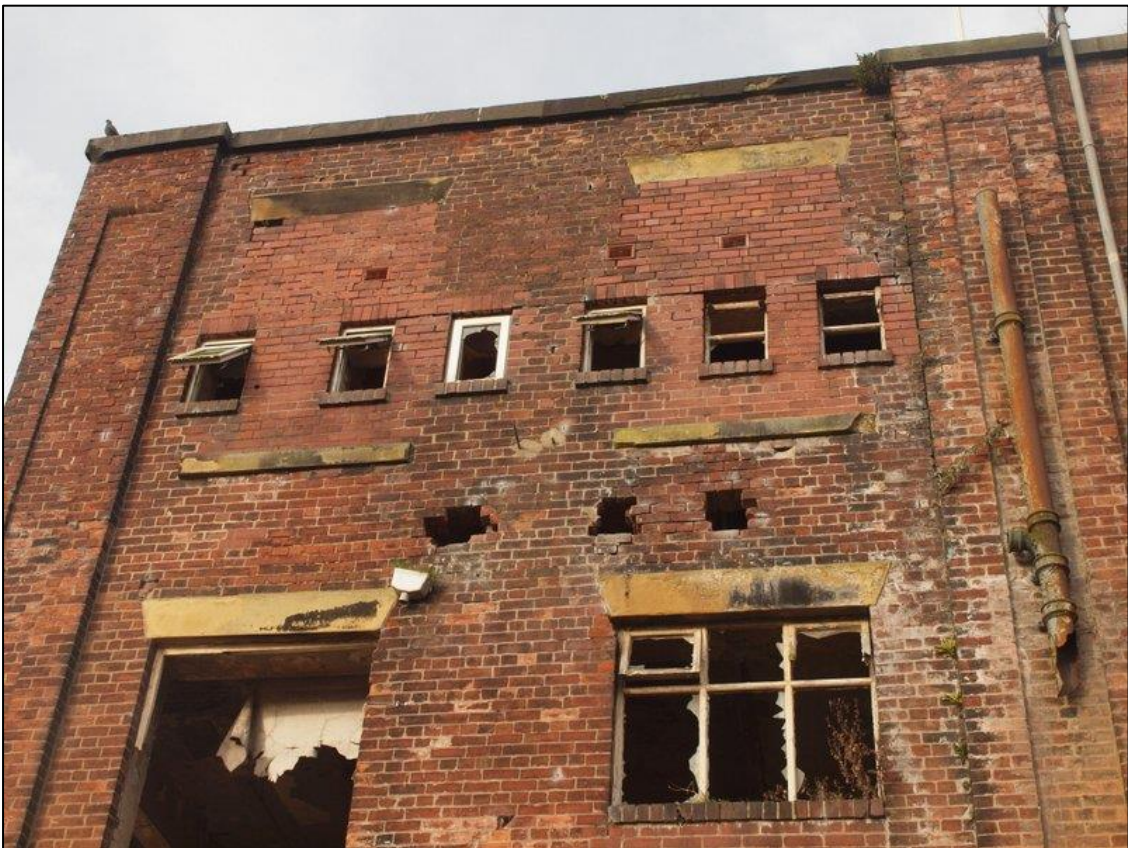
Plate 26: Second of boiler house showing blocked and inserted windows

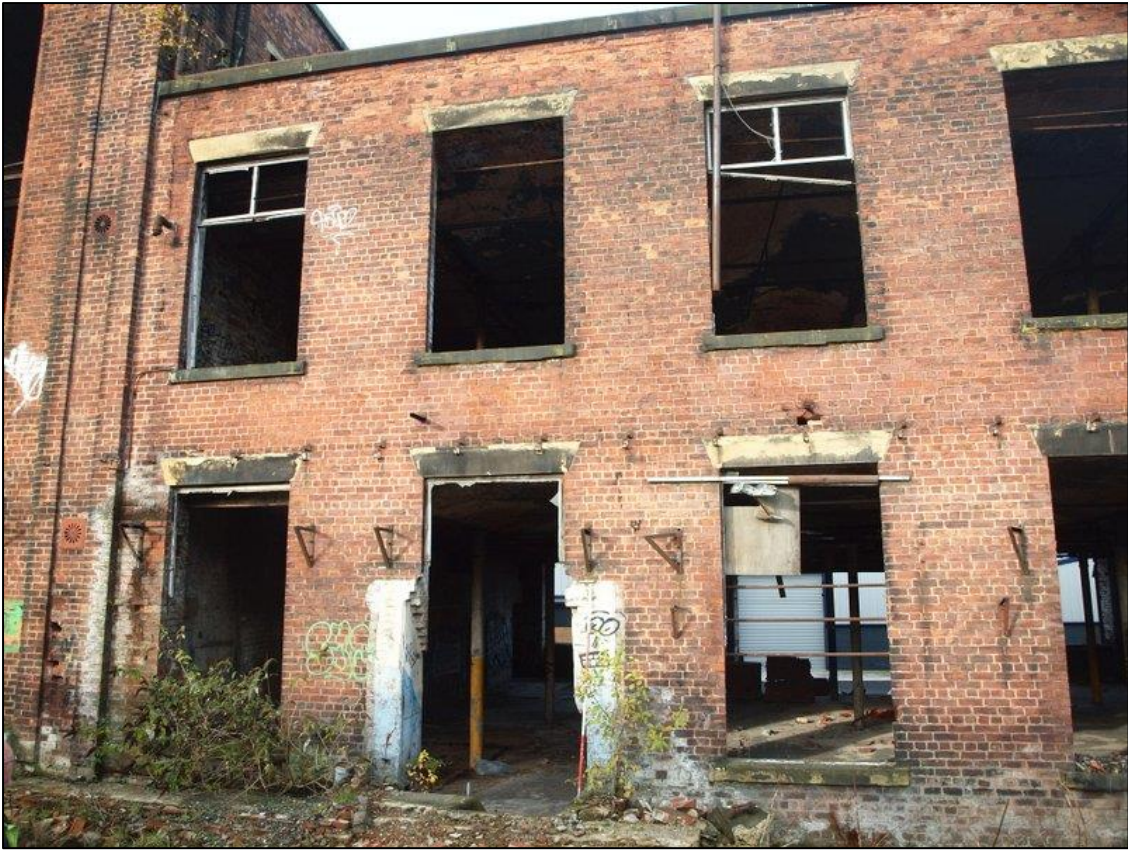
Plate 29: Southwest elevation bays 1 – 3, showing inserted doorway in bay 2

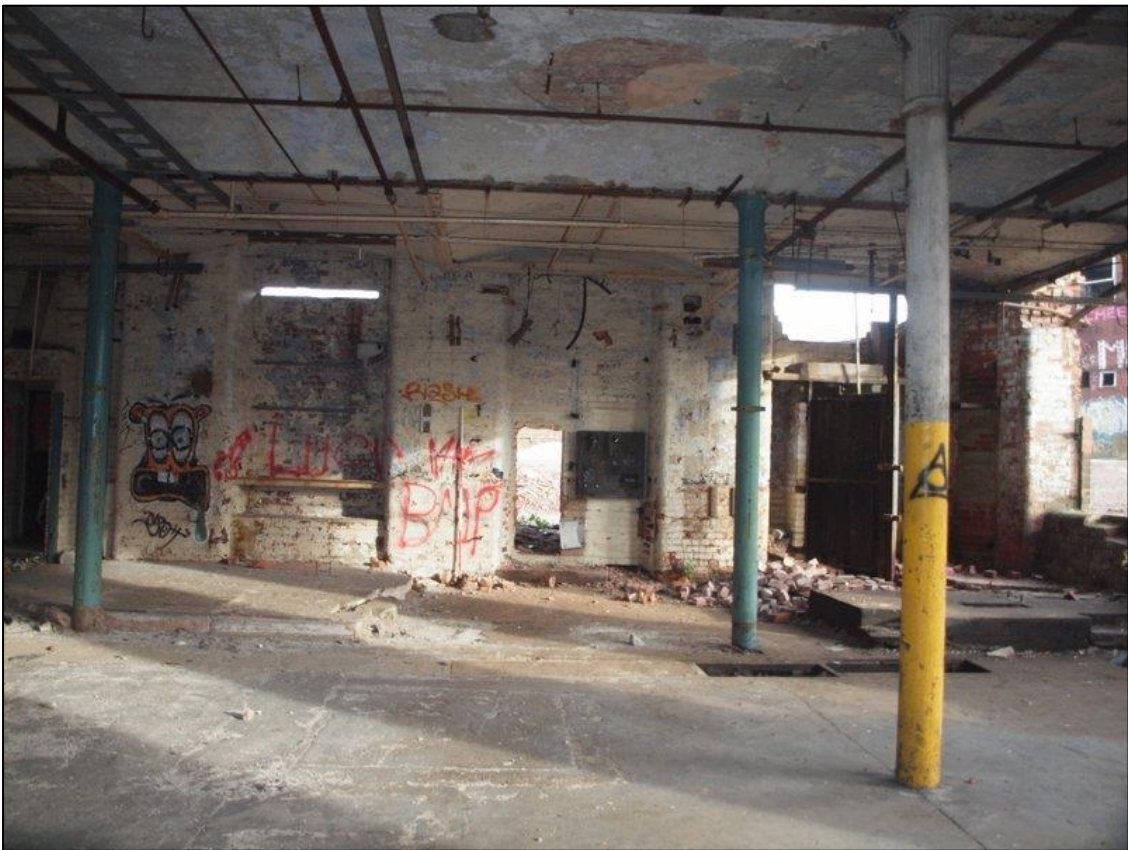
Plate 42: Eastern end of northeast wall showing inserted doorways

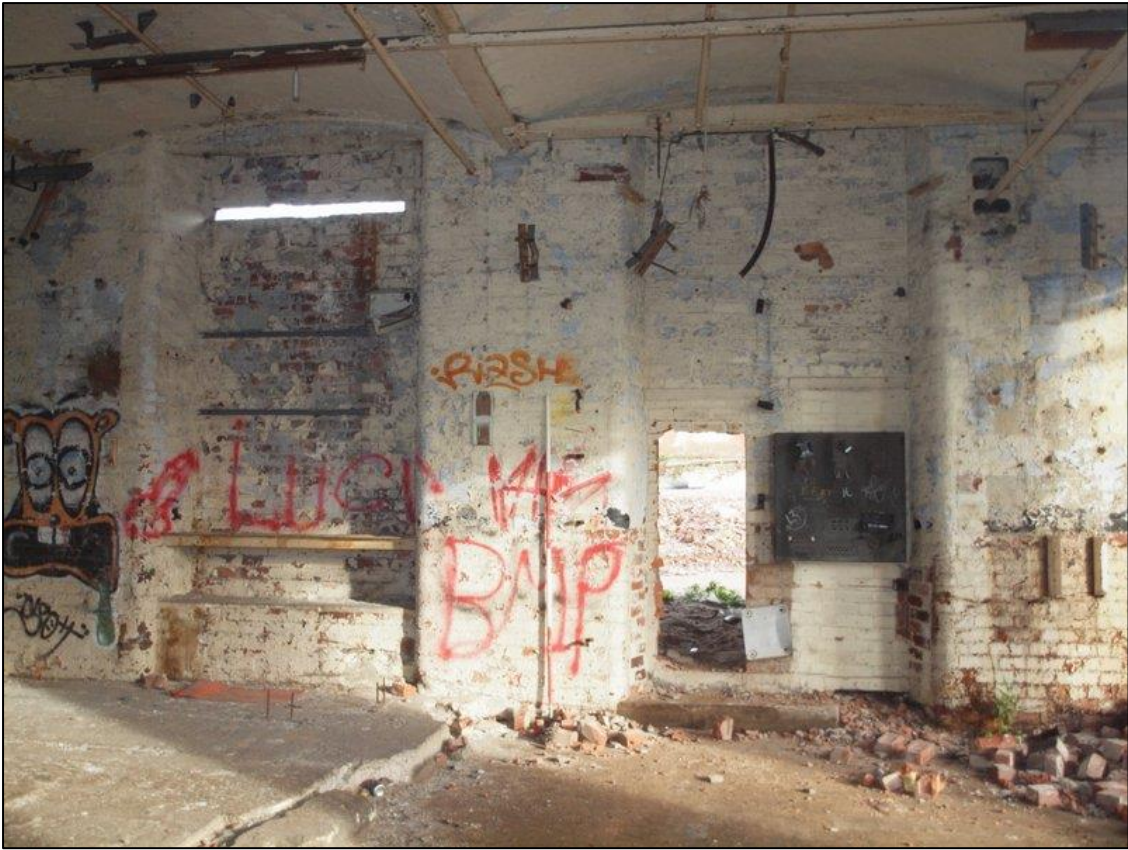
Plate 43: Detail of inserted doorway shown above

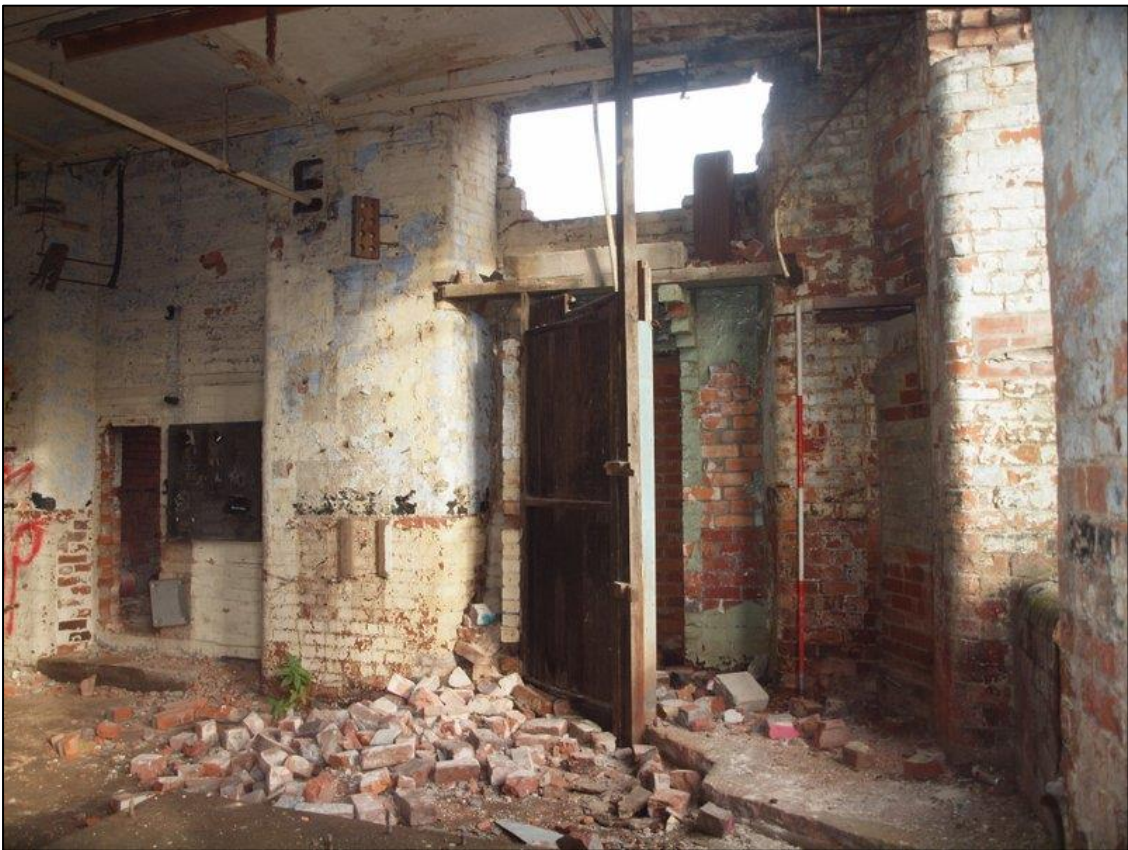
Plate 44: Detail of inserted doorway behind timber screen

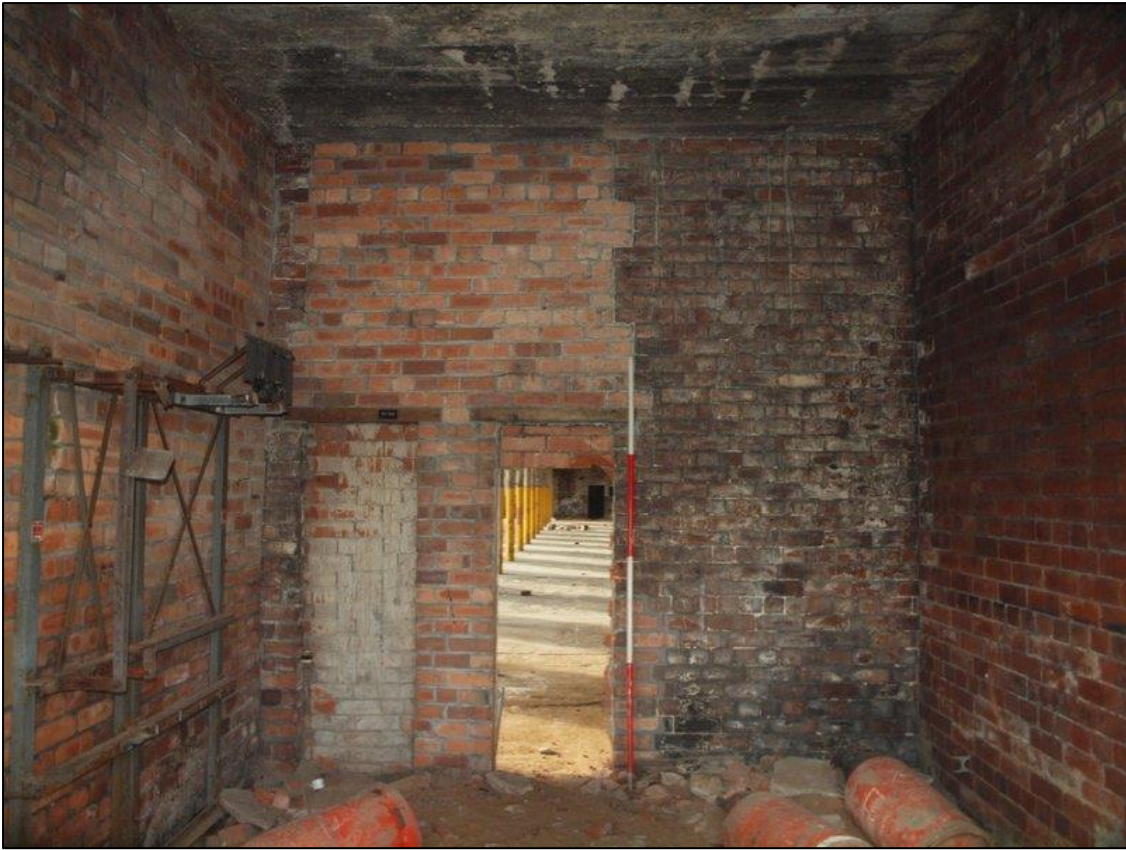
Plate 47: Storage room in extension showing inserted doorways and blocked window

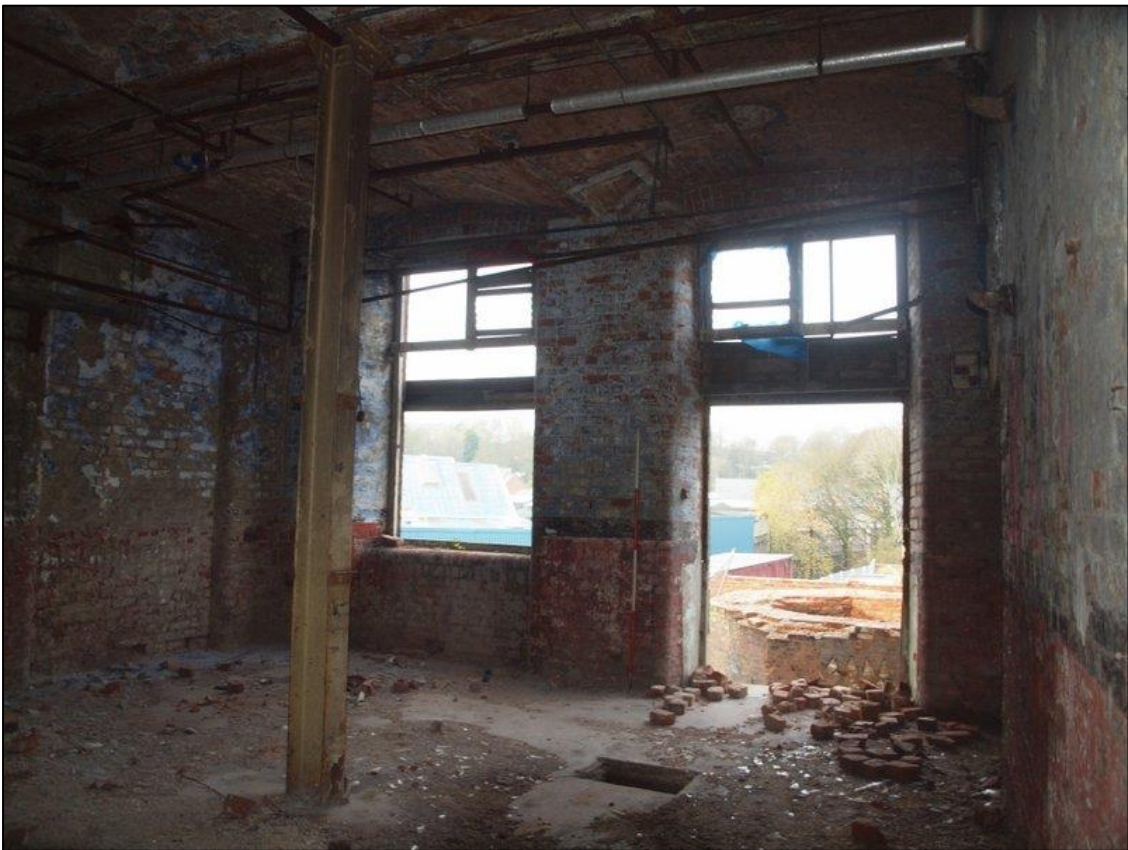
Plate 64: Inserted doorway to northwest elevation

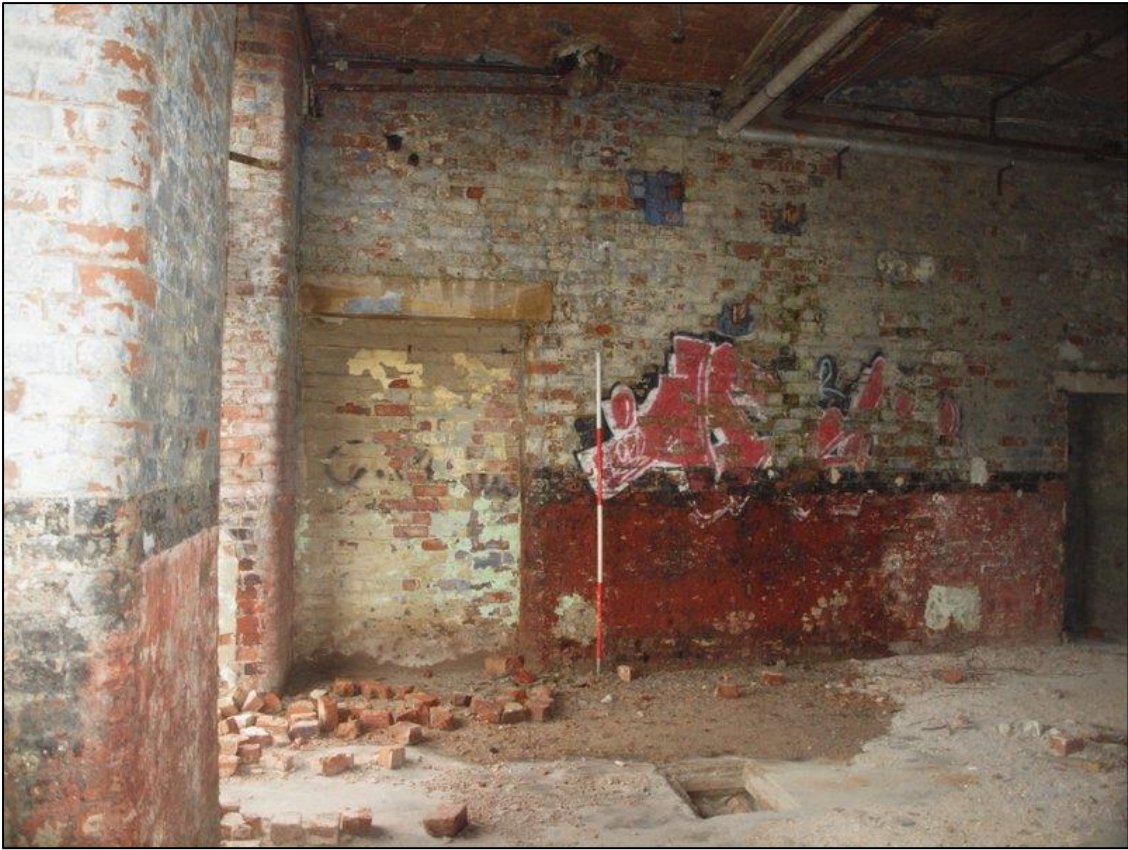
Plate 65: Blocked doorway to engine house

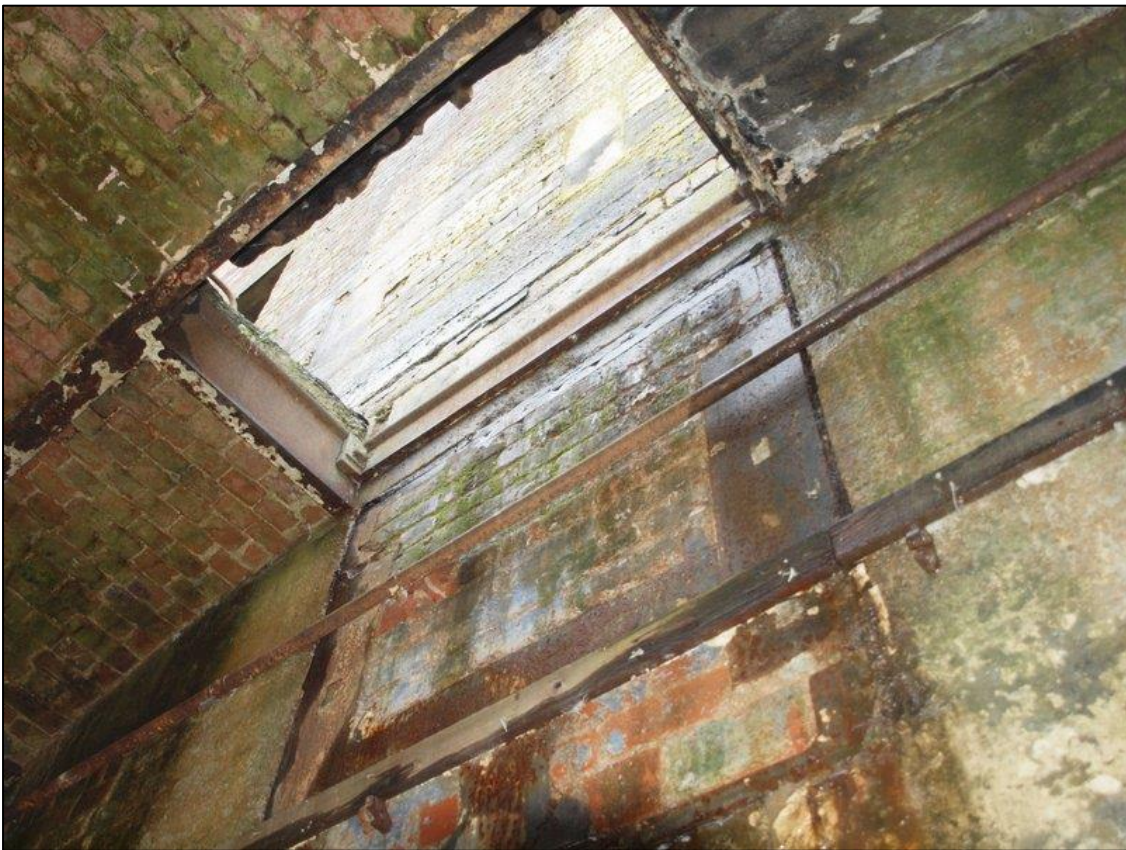
- 7.3 The building was initially built as a three story mill, with the top story removed in the 20th century. Hadrill et. al. (2007) records that the then site manager, Mr. Murphy, stated that it was removed in the 1940's due to it being unsafe. The evidence for this removal is the rebuilding of the top of the wall on the main elevations, showing a subtle change in brickwork and mortar. The sandstone coping is likely therefore reused. There is also the defunct vertical line shaft at first floor level, showing where power was transmitted up to the floor above.

Plate 74: Detail of hole in ceiling for power transmission to floor above
