North End Farm

Wase Homes Limited

Archaeological Building Survey

28 September 2022

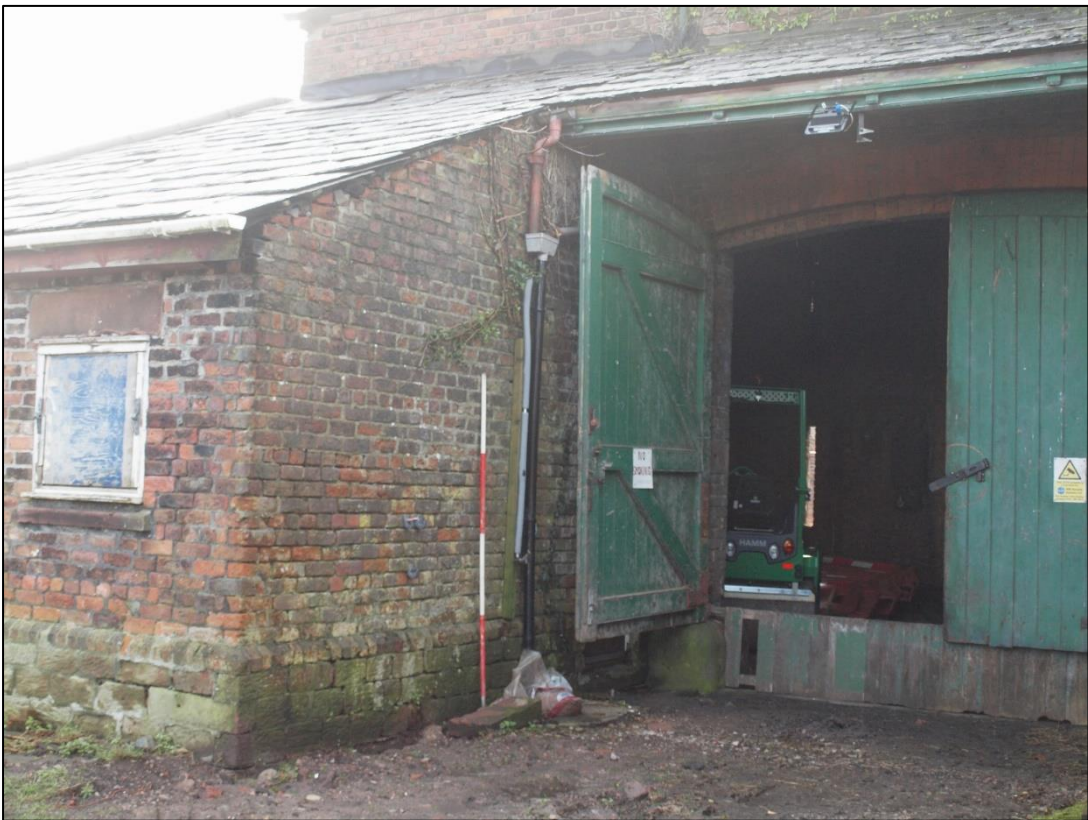
Plate 5: Barn door

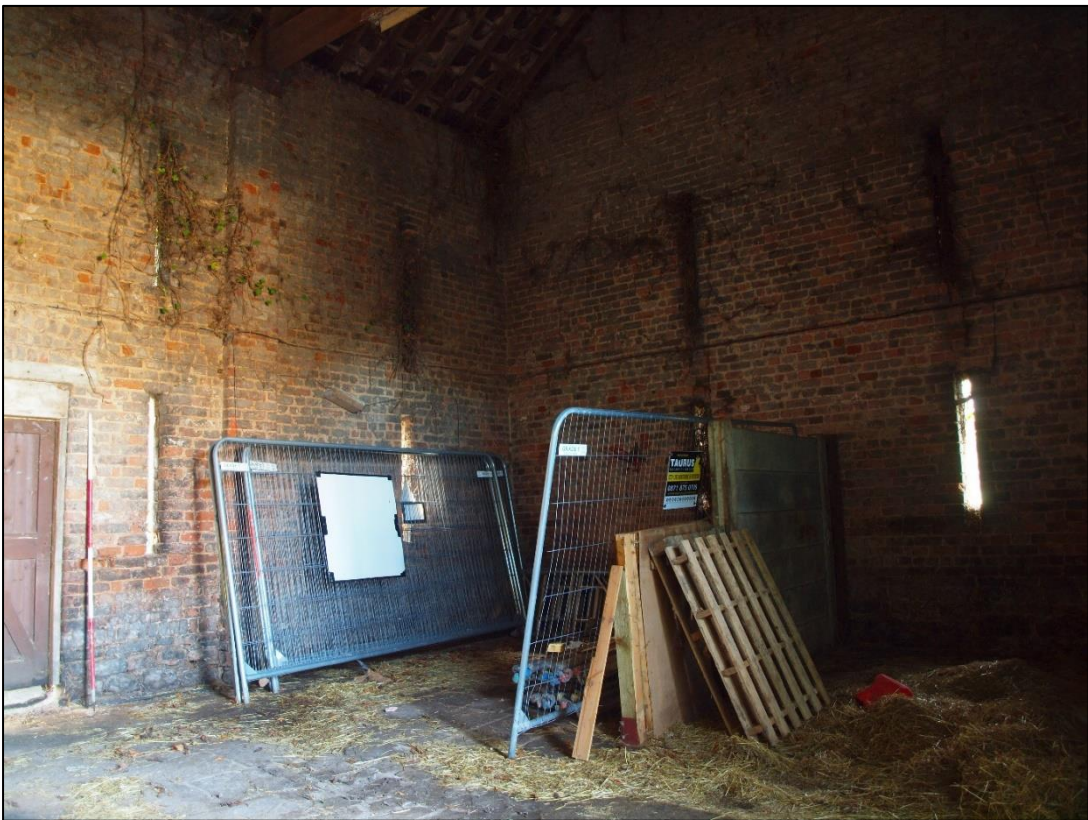
Plate 21: Inserted windows detail

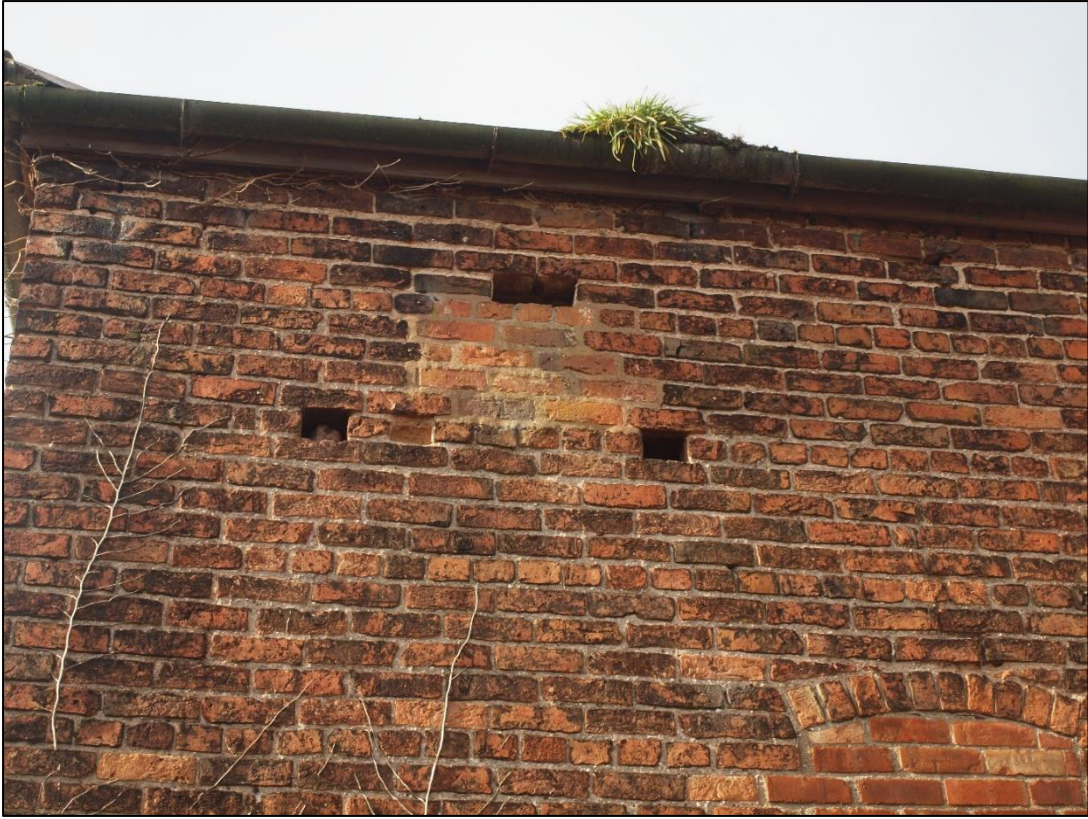
Plate 38: Blocked window at first floor level

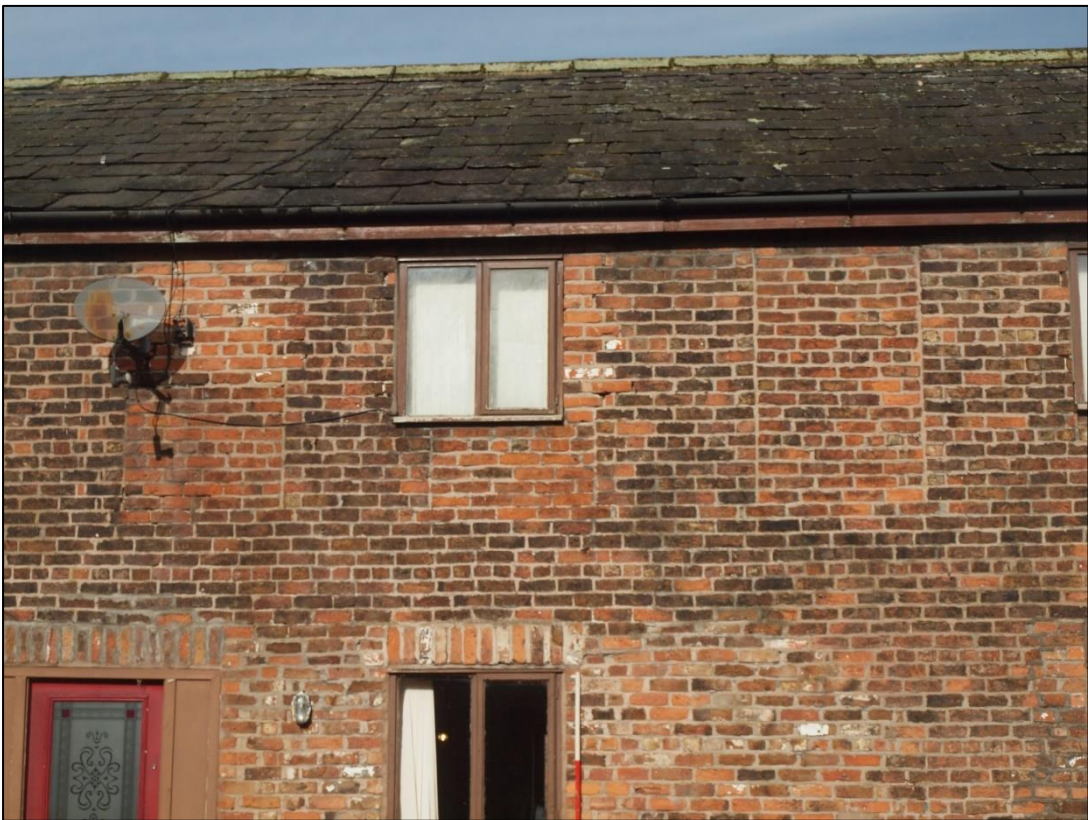
Plate 51: Rebuilt ground floor section of wall

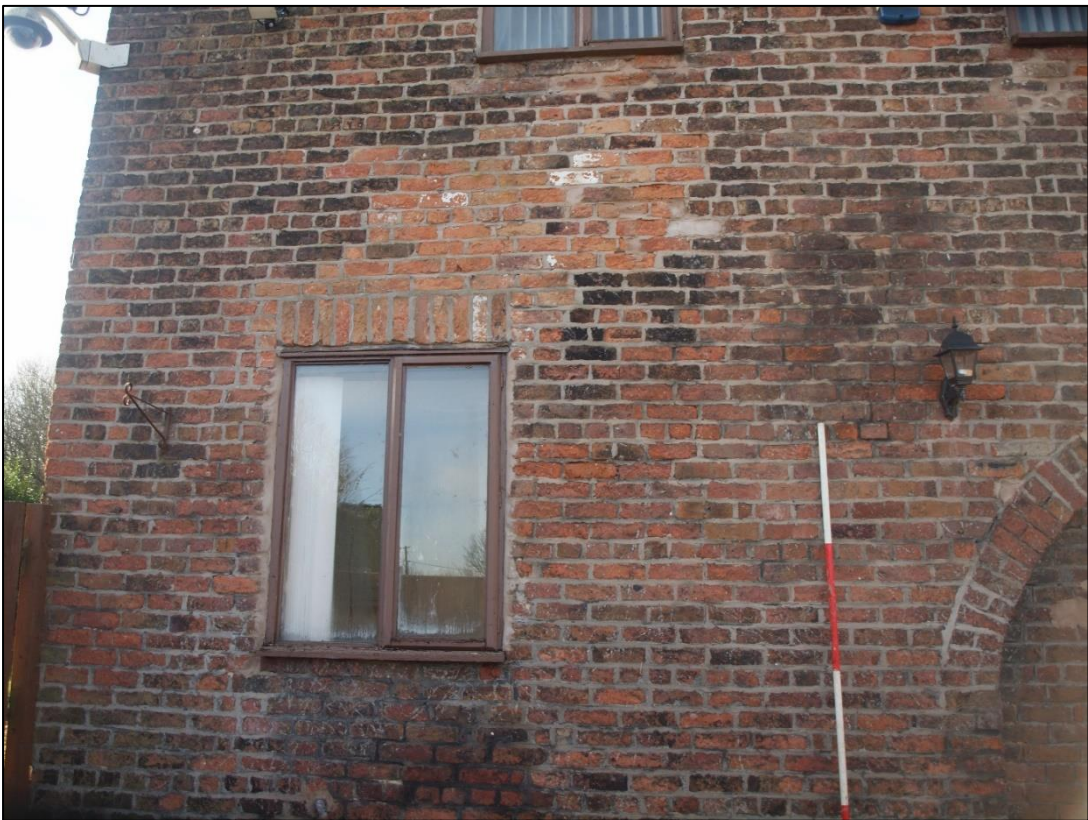
Plate 57: Inserted first floor window

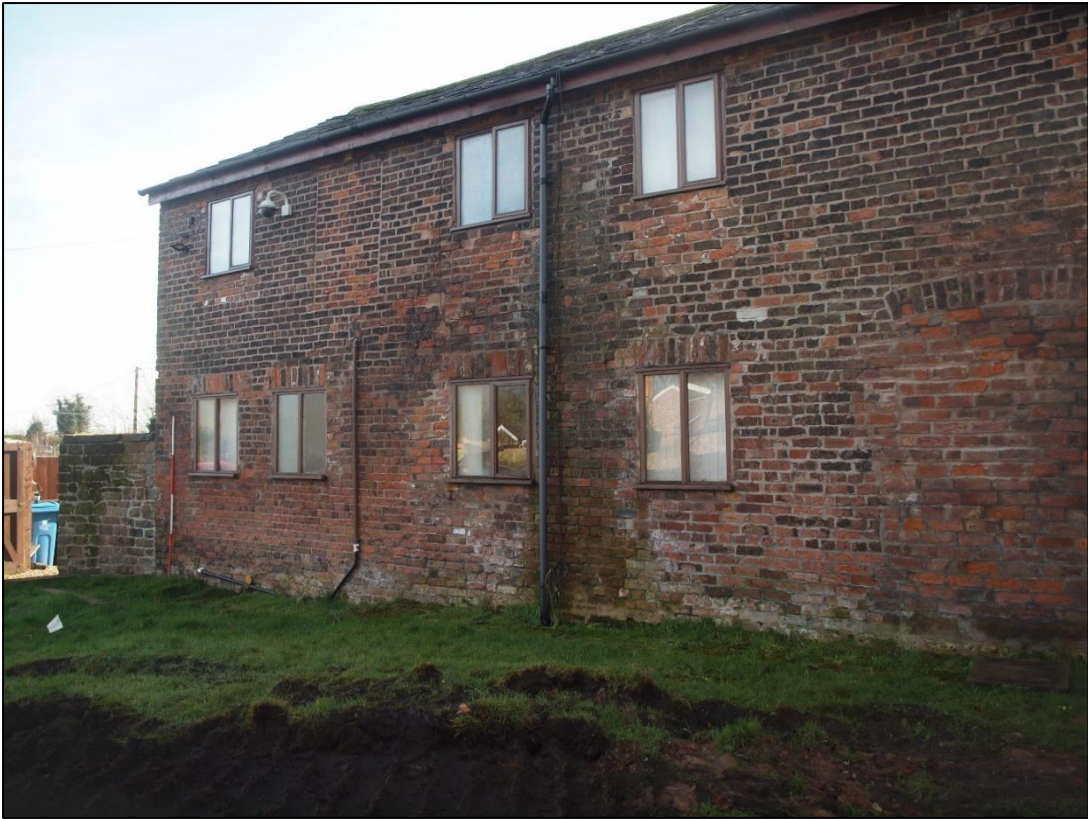
Plate 58: Altered ground floor window

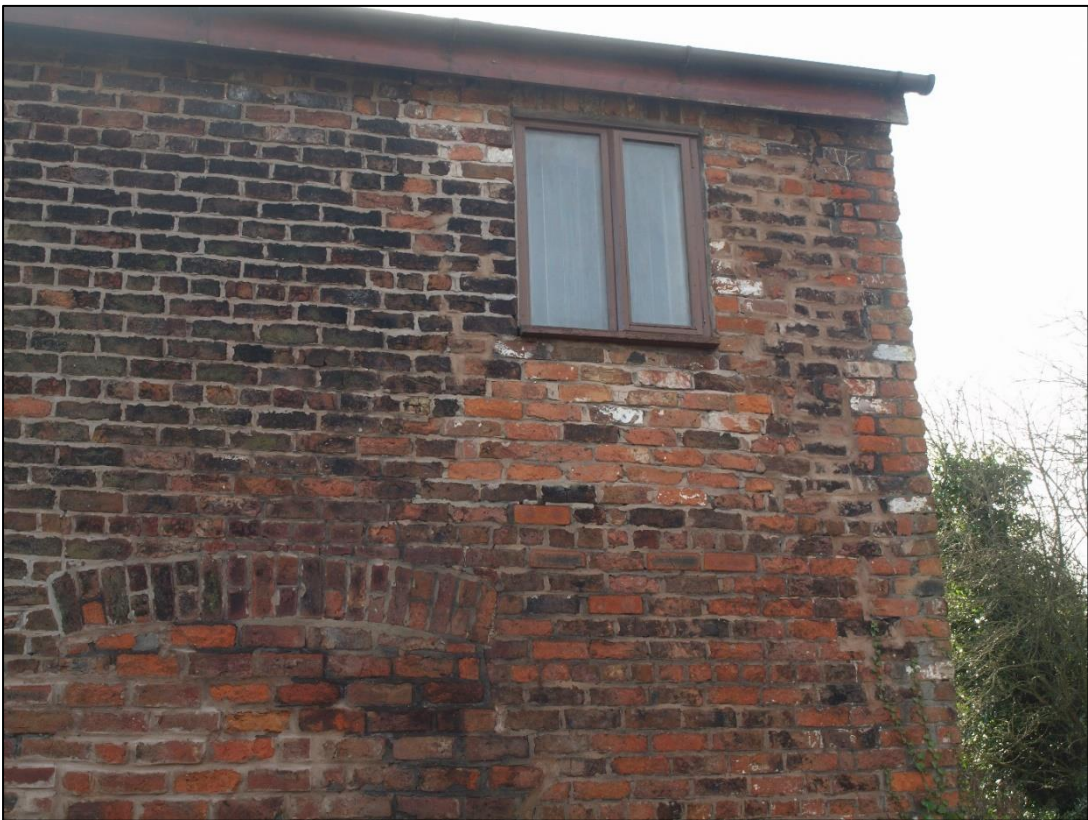
Plate 61: Blocked doorway detail

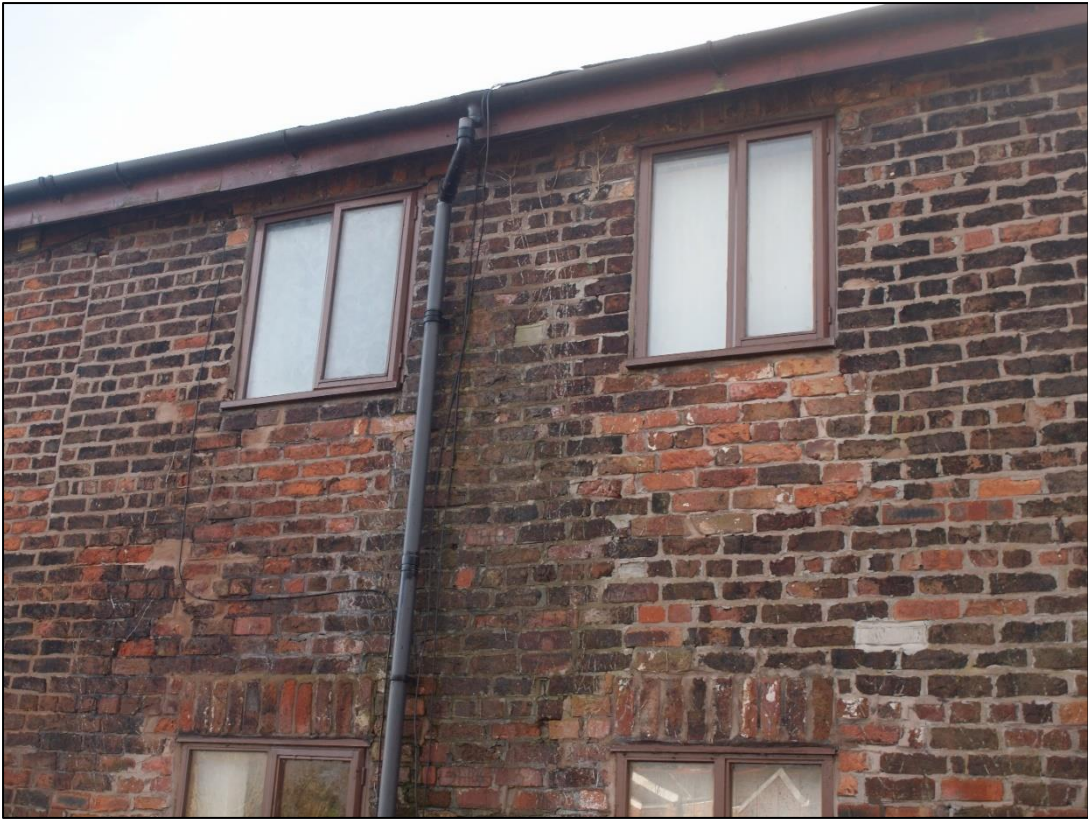
Plate 62: Inserted first floor window

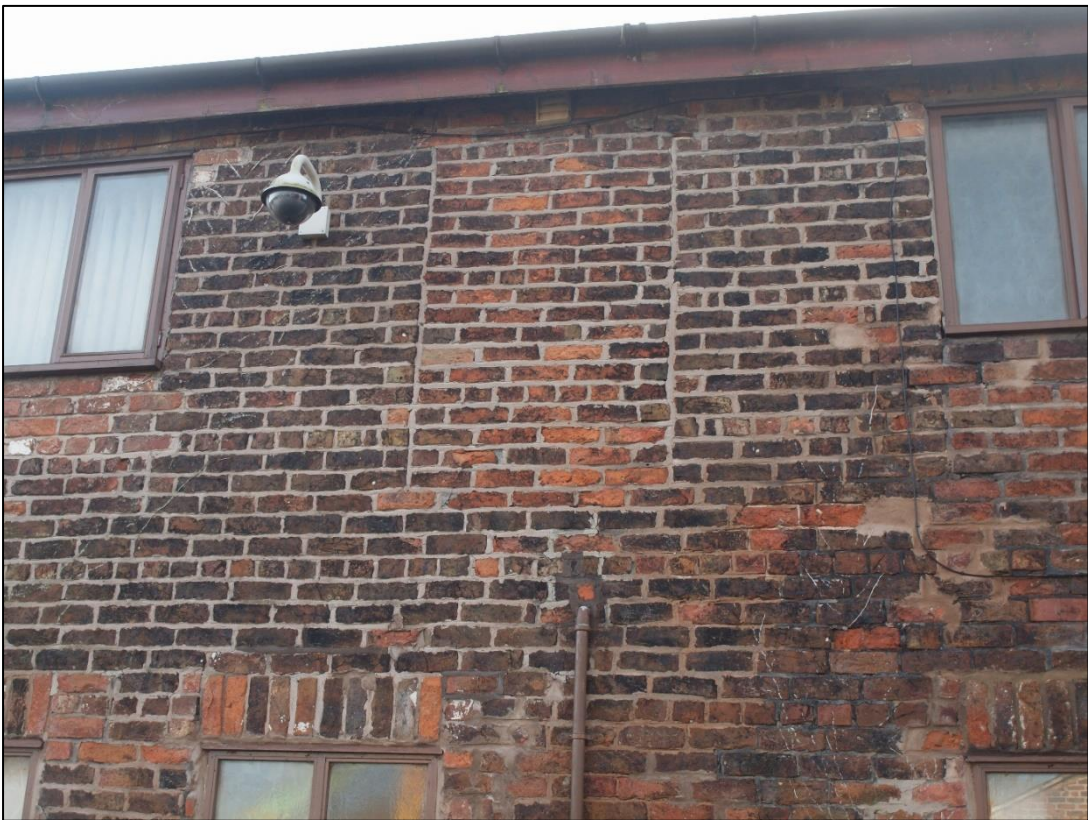
Plate 63: Inserted first floor windows

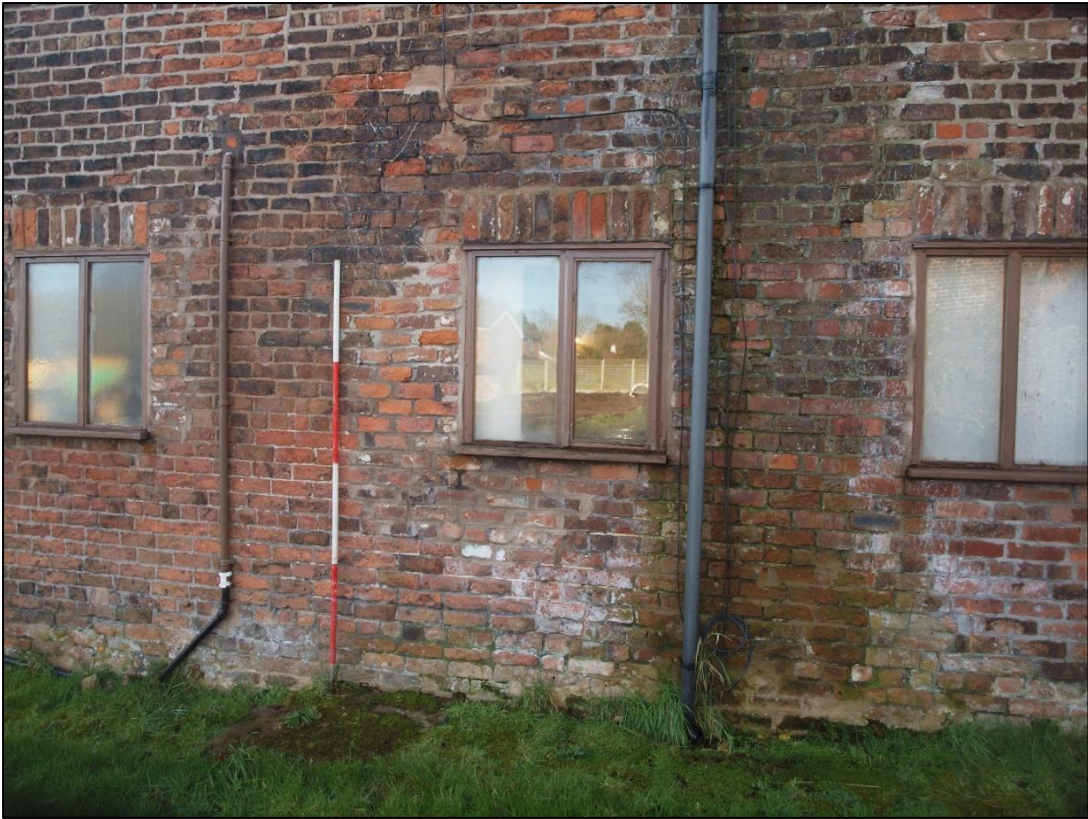
Plate 64: Blocked window detail

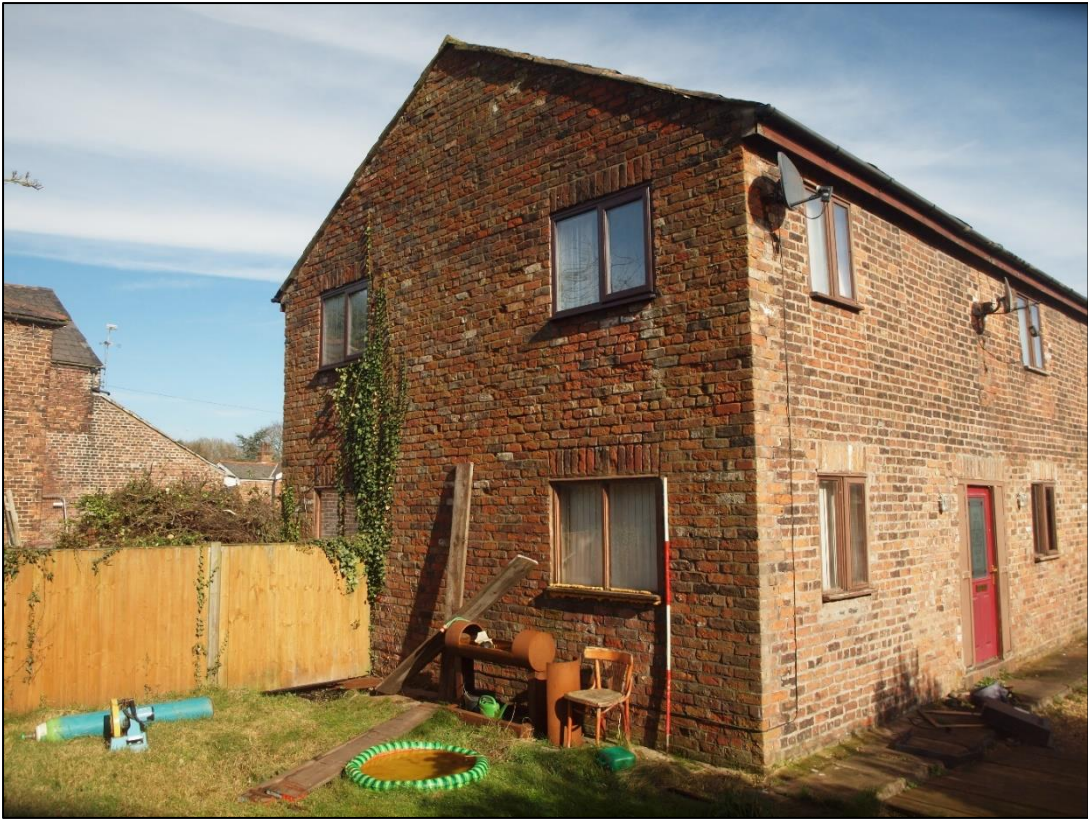
Plate 66: Southwest gable

- 6.19 Southwest elevation (plates 66 - 67). This forms the other gable end of the building, with two windows to ground and first floor levels. The elevation appears to be a later rebuild, as evidenced by the rough joints found on the southeast and northwest elevations

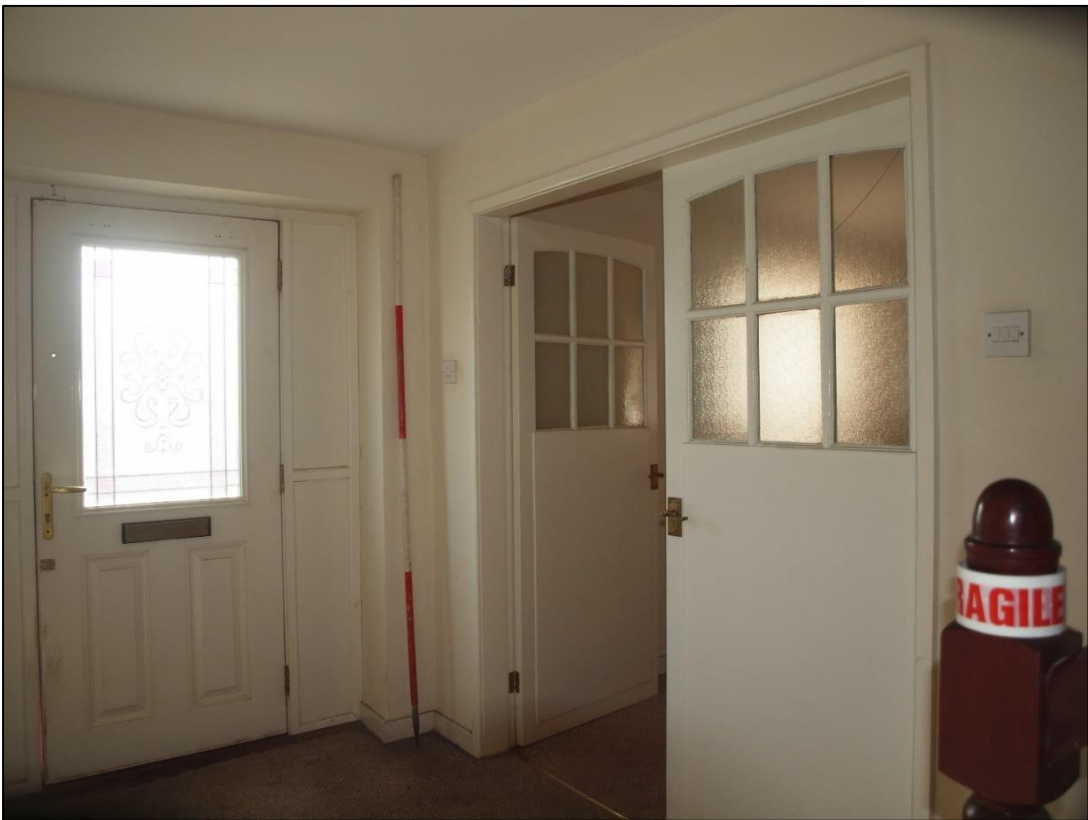
Plate 73: Inserted modern staircase

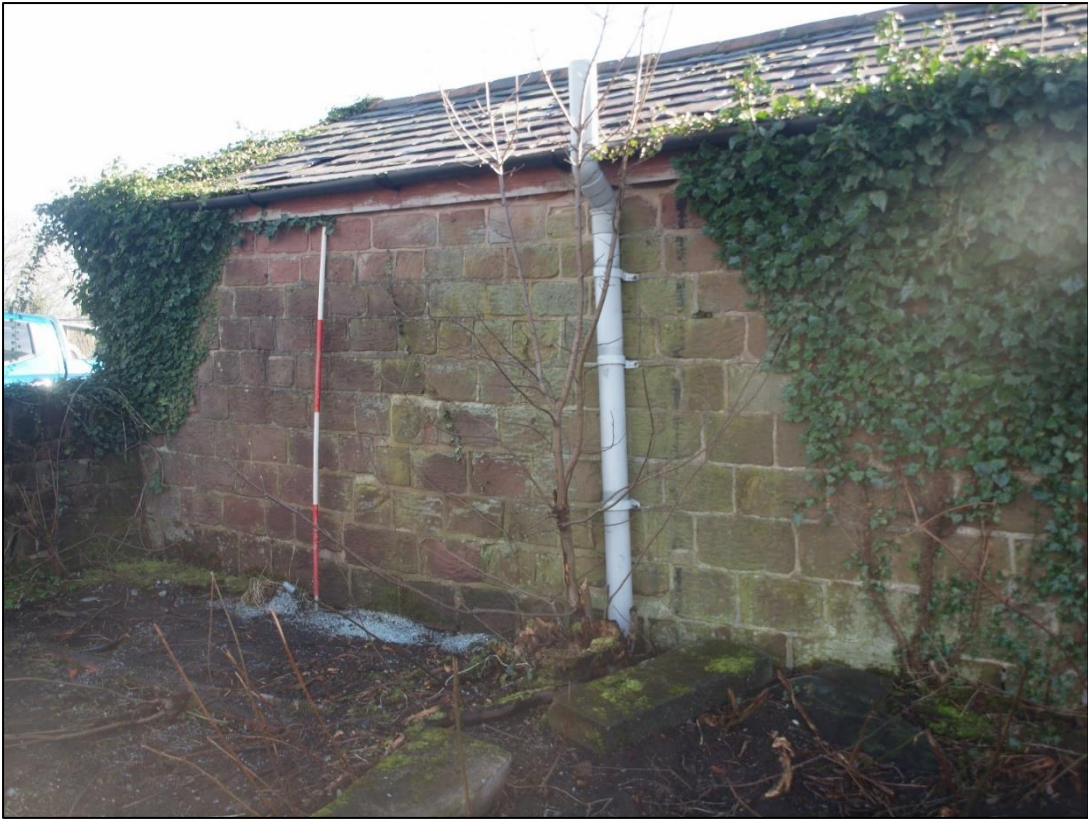
Plate 96: Blocked doorway detail

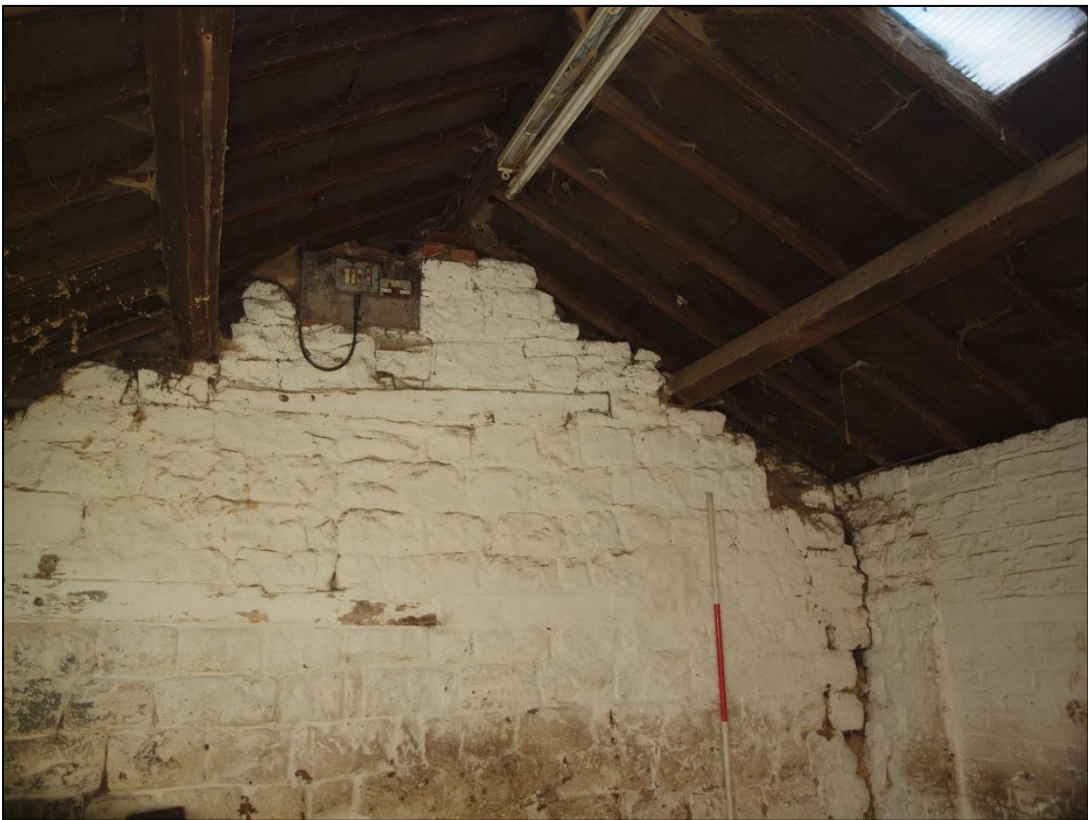
Plate 99: Interior showing blocked doorway in northwest elevation

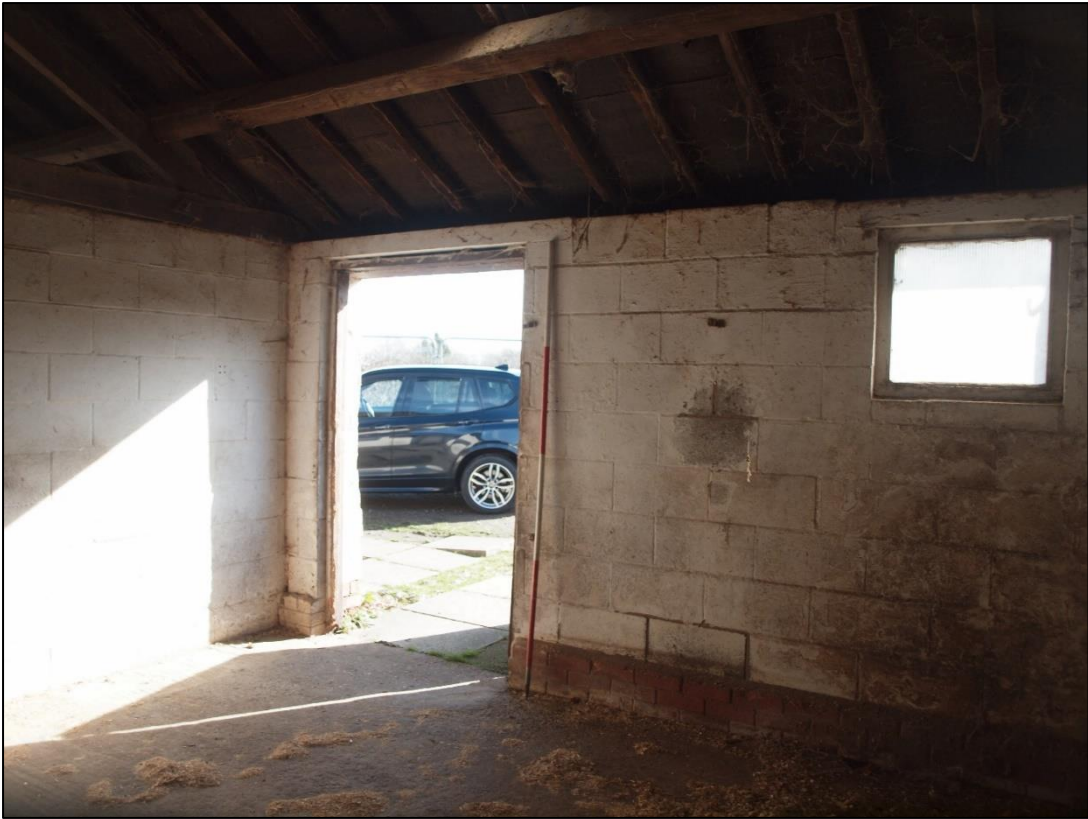
Plate 102: Inserted dividing wall below truss

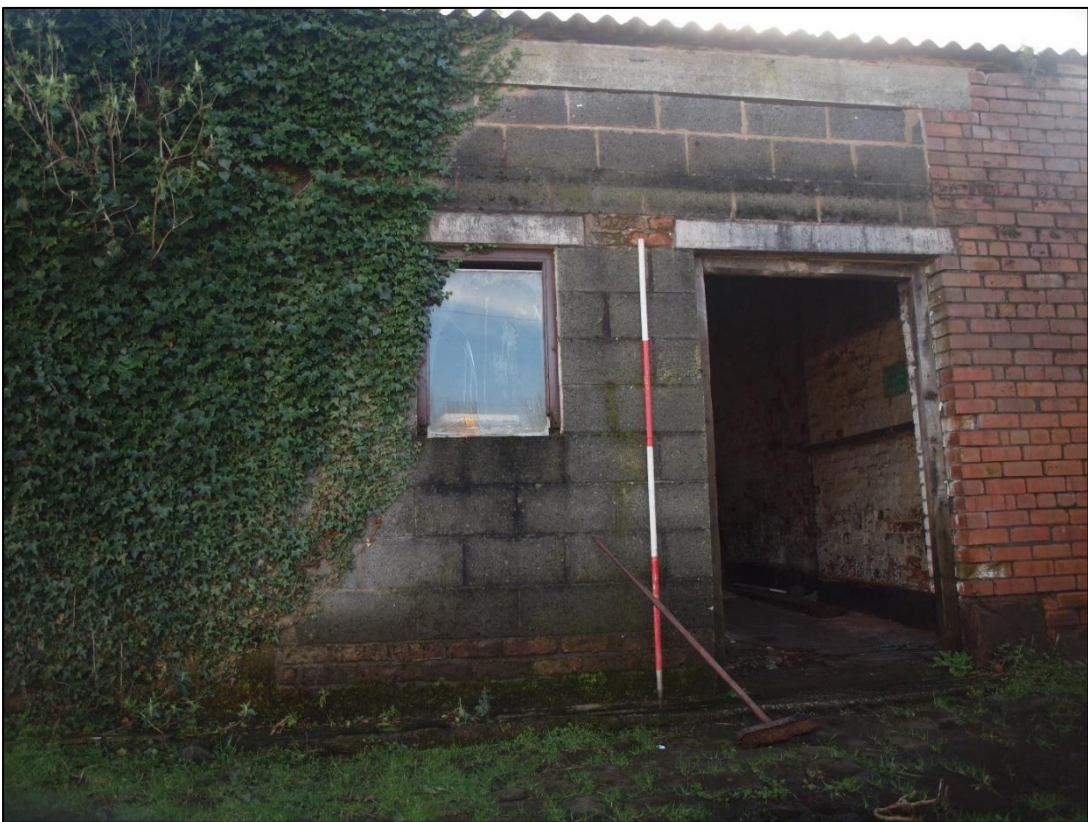
Plate 107: Central section built in concrete block

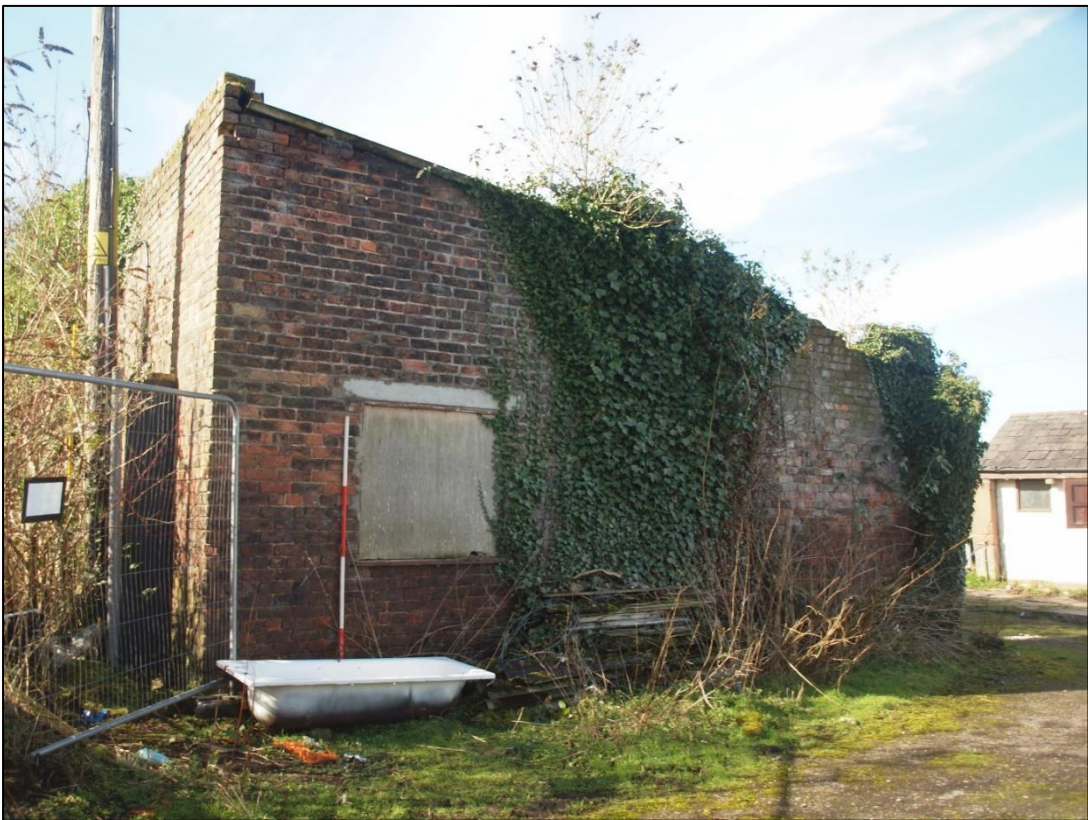
Plate 109: Western end constructed of modern brick

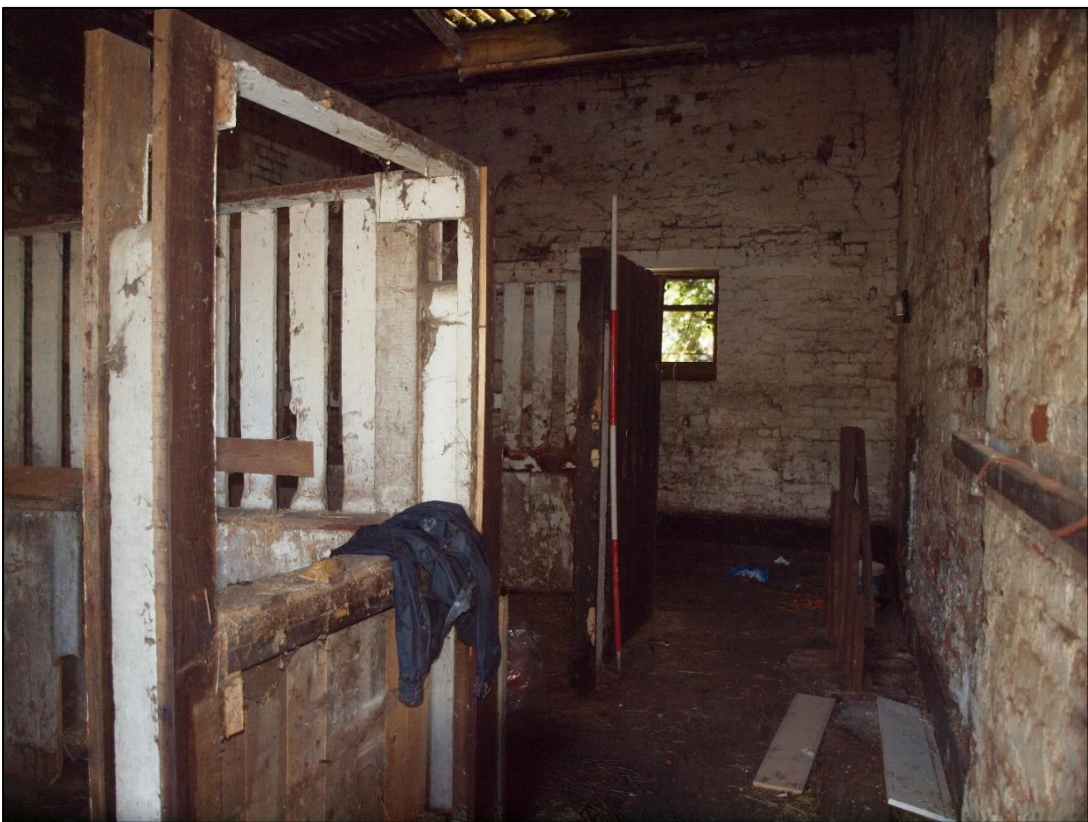
Plate 115: Derelict eastern unit showing timber stall

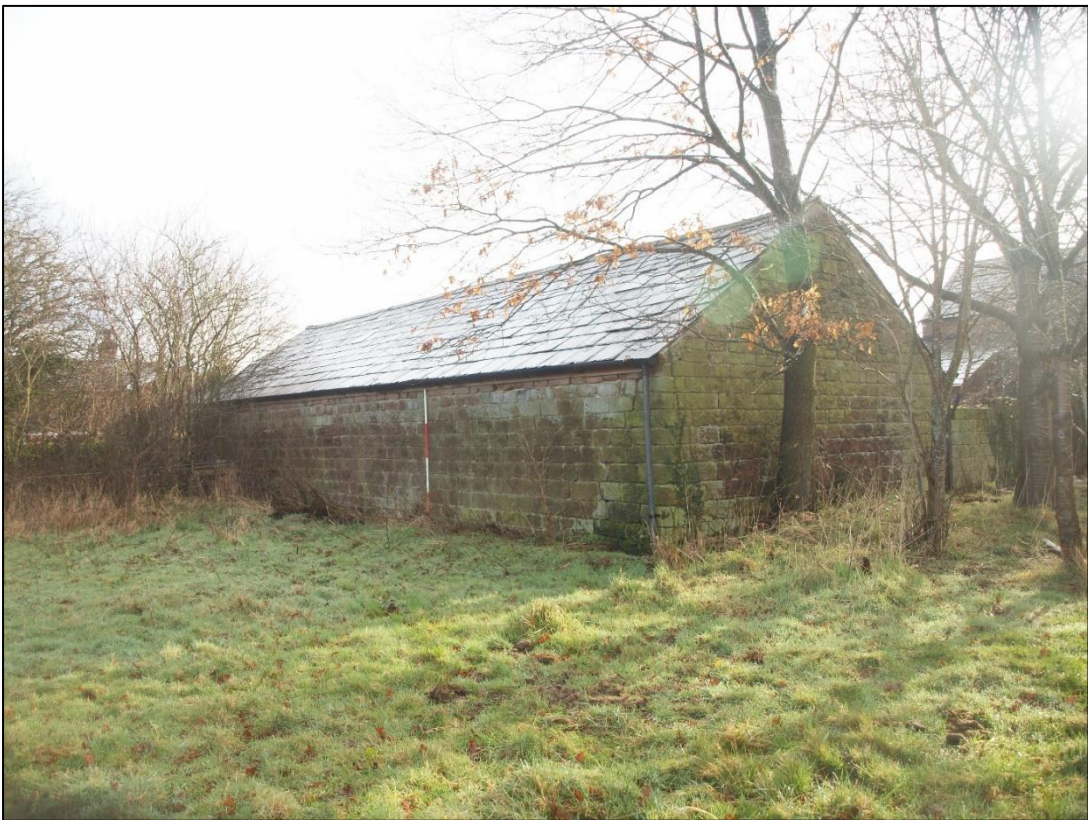
Plate 131: Northeast gable

- 6.36 Northeast elevation (plate 131). This forms the gable end of the building. To the south side the building is constructed in a shaped and coursed sandstone rubble. A rough joint runs up the face, and beyond this the face is different. The construction is similar, although the coursing doesn't match in places. Towards the apex, the construction is different again, with the rubble being unshaped and only occasionally brought to course. All of the shaped sandstone shows tooling marks, or rustication marks. No other features are present.
