**The Ha Ha, Cowdray Ruins, Easebourne, nr.
Midhurst, West Sussex**
Report on an Archaeological Investigation
January 2006

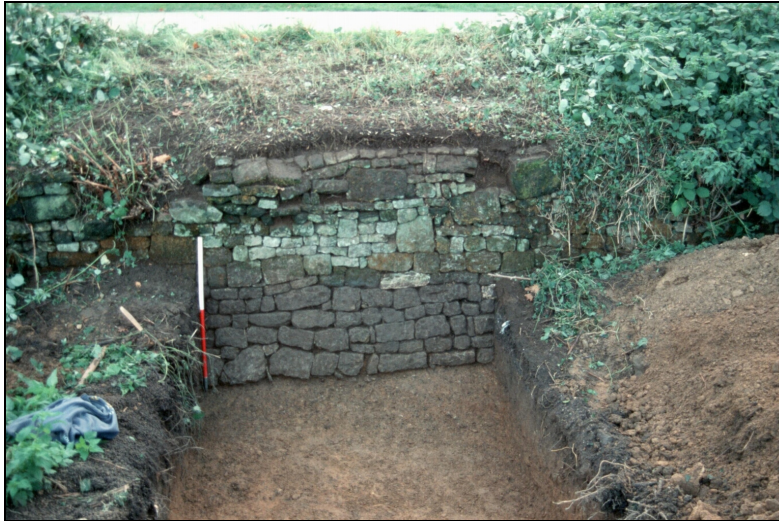
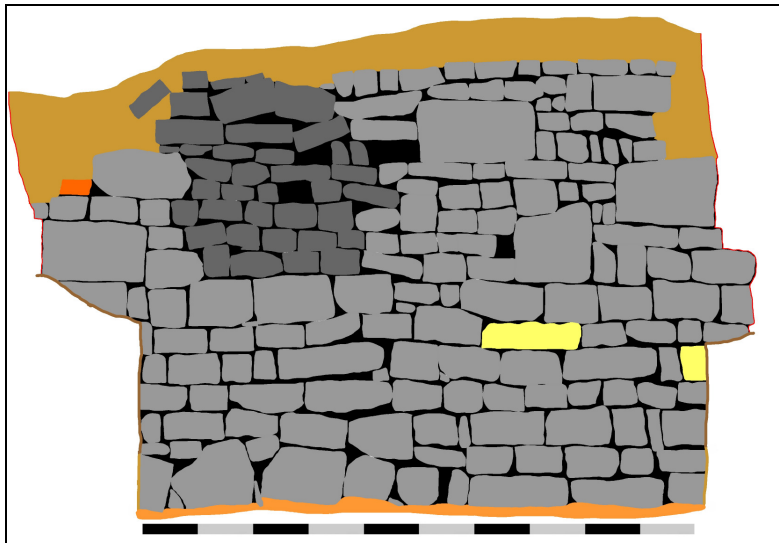
Fig.5 Photograph of the ha ha wall in trench 1, looking south-west. The scale is 1m.

Fig.6 Elevation drawing of the ha ha wall in trench 1. The scale is 2m. Stones in dark grey indicate a bulging out of the wall, while those in yellow are Caen/Malm stone, with the red being a brick. The orange at the base is the natural gravel, while the brown above the wall is modern topsoil.

3. The condition of the wall at this point is fair, there is an area of stonework towards the top of the wall which is bulging out due to root disturbance with an adjacent section already collapsed from the same cause, however the foundations and much of the walling is stable. The main threat in this section is that from the trees, scrub and climbing plants which are growing on top of, on and below the wall.

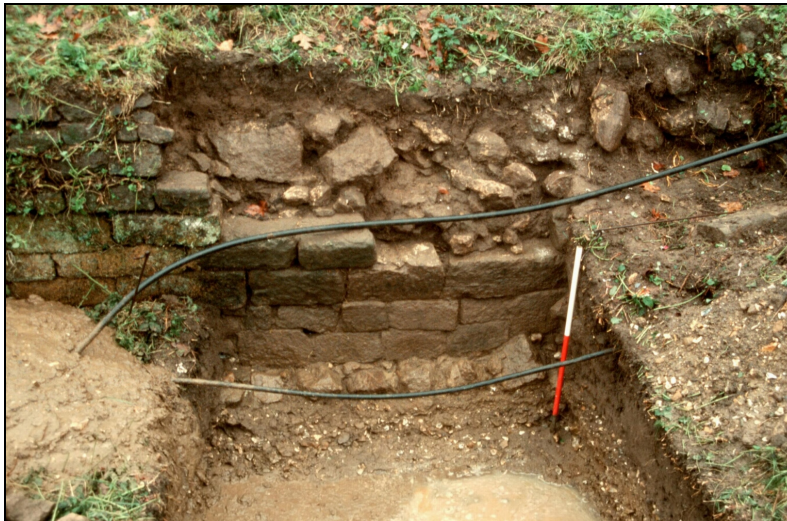
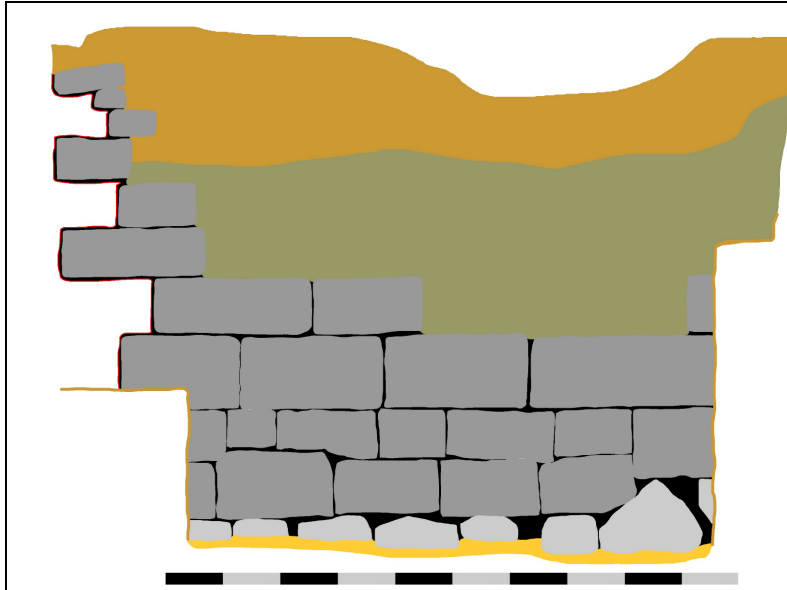
Fig.7 Photograph of the ha ha wall in trench 2, looking west. The scale is 1m.

Fig.8 Elevation drawing of the ha ha wall in trench 2. The scale is 2m. Stones in light grey are the horizontally laid foundation stones. The orange at the base is the natural gravels, the brown at the top is modern topsoil, while beneath it in grey/green is the rubble backfill behind the wall.

3. The upper part of the ha ha wall at this point has completely collapsed, although the remaining stones at present seem fairly stable. The reason for this collapse is unclear, it is unlikely to be due to root damage, since the ivy cover here is not very mature, and there are no trees or scrub. There are records of large trees on or near to the ha ha falling and damaging the wall in the past and it is possible that this is one such area. The use of any collapsed stretch as a later pathway would cause further collapse, although the current grass cover makes this now unlikely.

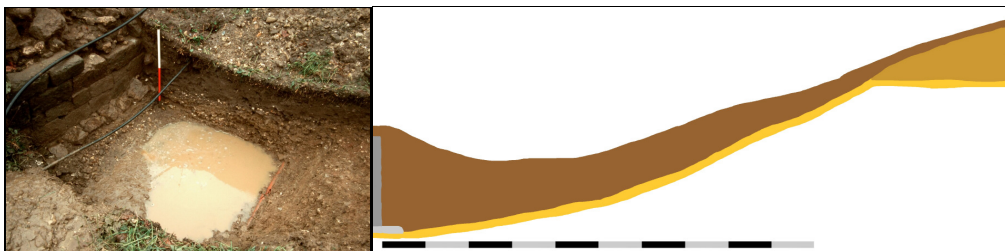
Fig.9 To the left is a photograph of the ha ha ditch in trench 2, looking north-west, the scale is 1m. To the right is a section drawing of the same ditch, the scale is 4m. The orange at the base is the natural gravels, the brown at the top is modern infill, while to the right can be seen the topsoil of the Lawns extending eastwards.

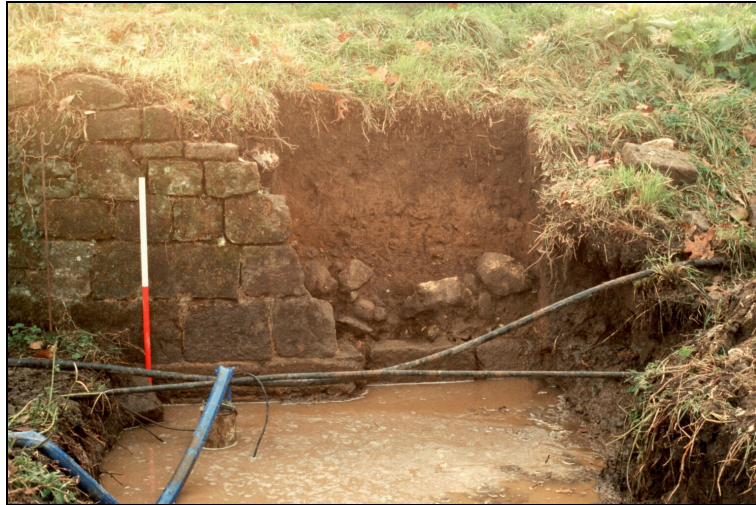
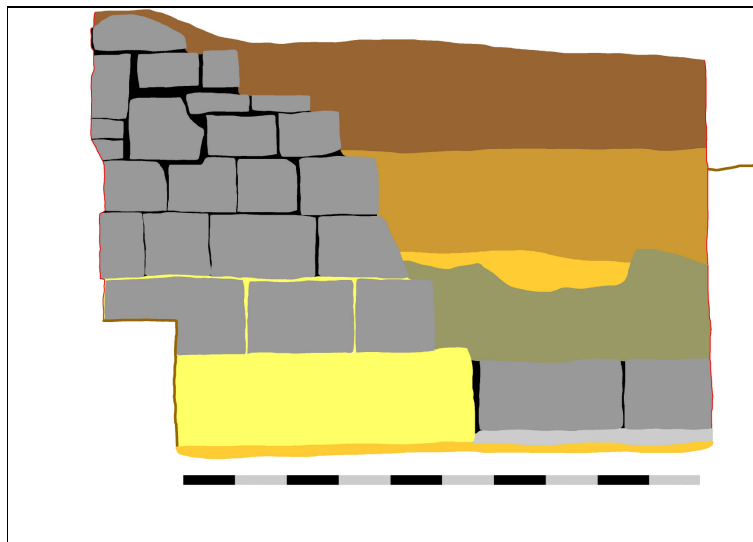
Fig.10 Photograph of the ha ha wall in trench 3, looking west. The scale is 1m.

Fig.11 Elevation drawing of the ha ha wall in trench 3. The scale is 2m. Yellow indicates mortar ed work, the large block at the base being a mix of mortar with stone and brick. The orange at the base is the natural gravels, the brown at the top is modern topsoil, while beneath it in light brown is the natural sand above natural gravel. In front of these in grey/green is the rubble backfill.

3. At this point on the ha ha the walling in the northern half of the trench had almost completely collapsed, with none of the second phase stones remaining and only one course of the first phase. The remaining wall in the southern half of the trench appeared to be stable. The reason for the first collapse of this stretch of wall is uncertain, but the second wall probably gave way to the weight of water built up behind it. What was overlooked by those constructing this new face was that whereas the old dry-stone structure allowed water to seep through relatively freely, this new mortared wall created a significant barrier. The amount of water which builds up in this area was easy to see at the time of this project.

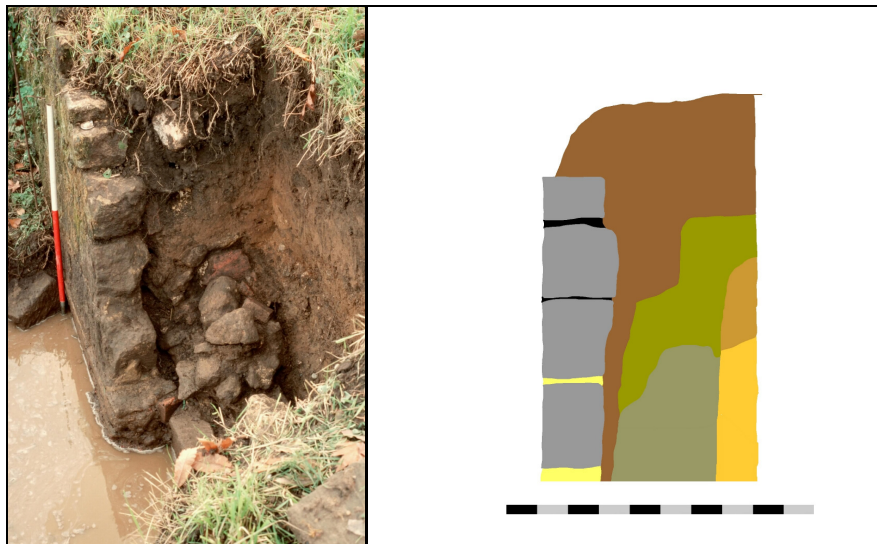
Fig.12 To the left is a photograph of the ha ha wall in trench 3, looking south, the scale is 1m. To the right is a section drawing of the same wall, the scale is 1m. The orange at the base to the right is the natural gravels, with, in light brown, the sand above. To the left of these in grey/green is the rubble infill behind the phase 1 wall, and above it in green collapsed soil from the first collapse. The wall shown is the second phase wall, with behind it and above it the current topsoil.

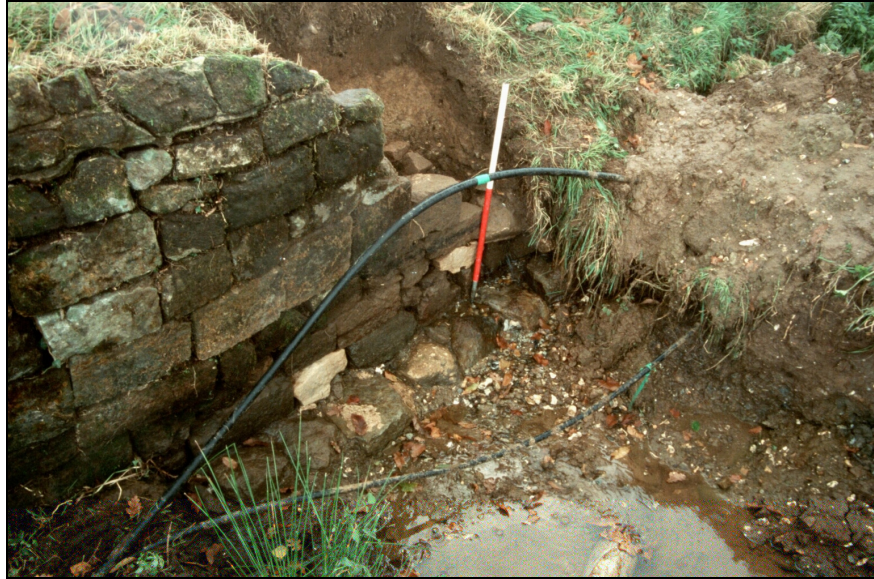
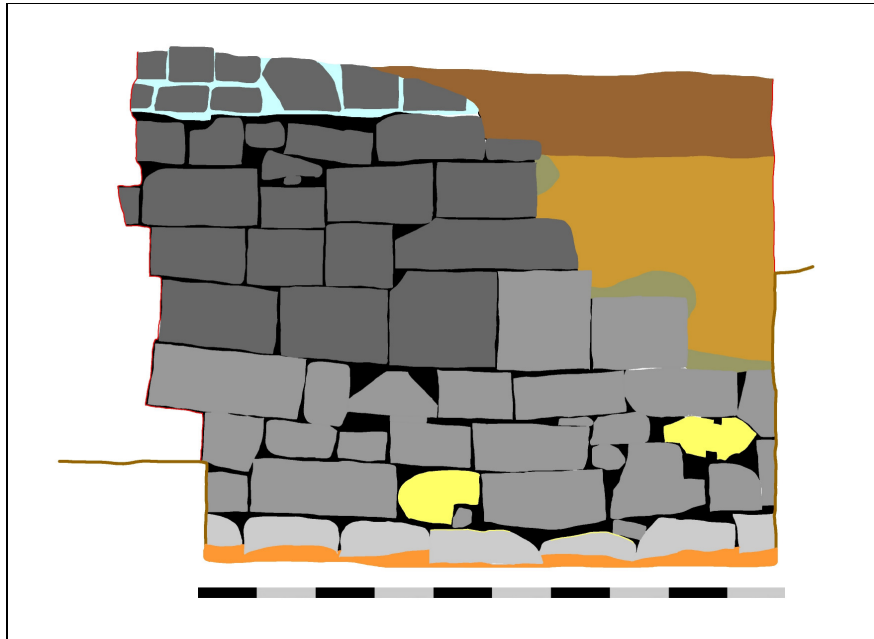
Fig.13 Photograph of the ha ha wall in trench 4, looking north-west. The scale is 1m.

Fig.14 Elevation drawing of the ha ha wall in trench 4. The scale is 2m. Stonework in dark grey indicates the bulging out of the wall, that in light grey are the foundation stones and in yellow are Caen or Malm stone blocks. The orange at the base is the natural gravels, the brown at the top is modern topsoil, while beneath it in light brown is the natural sand, below this is the grey/green of the rubble behind the wall. At the top of the wall in light blue is the modern mortar.

3. To the north of the trench the wall had collapsed down to its third course. Despite the fact that the wall seems to have been un-mortared at this point it likely that this is a result of the large amount of water flowing from behind the wall at this point. This would seem to be more than just groundwater, and could be from a broken land drain. An aerial photograph taken in 2001 (see figures 2 & 3) seems to indicate a buried feature running towards this point in the ha ha wall, and it could be that this is a blocked conduit. In the southern half of trench the wall still stands to its full height, however it is noticeably bulging out at this point leaving the top two mortared courses split off from the rest. It would seem likely that this is a result of the same process that has caused the collapse of the wall to the north. This may mean that it is now stable, if pushed out of line, since the water flows freely out of the collapse. If this collapse were to be rebuilt the water problem should be addressed.

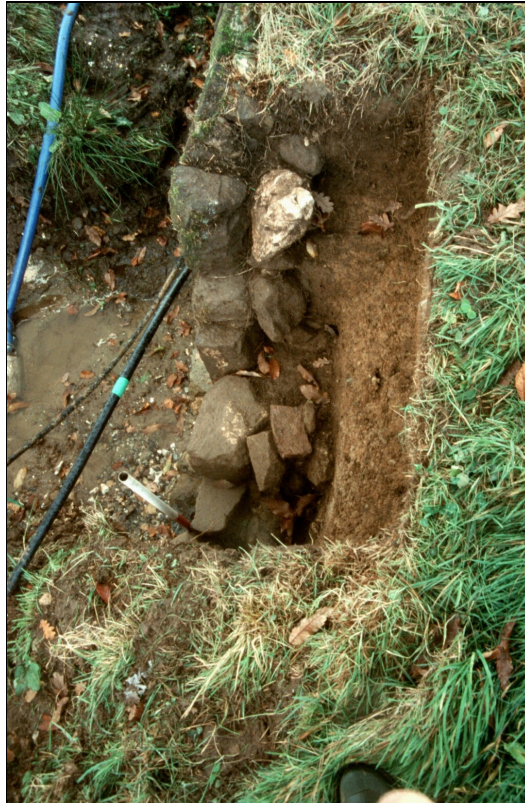
2. Trench 4 presented the clearest cross-section of a stretch of original ha ha wall, its construction being the same as seen elsewhere: a bed of horizontal stones, a dry-stone wall of irregular dressed blocks roughly coursed, a rubble in-fill behind composed of stones and bricks, and the whole placed against a gravel and sand trench edge. Included within the wall at this point were two dressed Caen or Malm stone blocks clearly from the ruins, together with at least three other shaped stones of local sandstone. All the other blocks were dressed and of local sandstone. The top two courses of the wall had been re-lain in a hard white mortar in more recent times. The ha ha ditch had a similar profile to the other trenches.

Fig.15 Photograph of the ha ha wall in trench 4, looking south, showing the original construction. The scale is 1m.

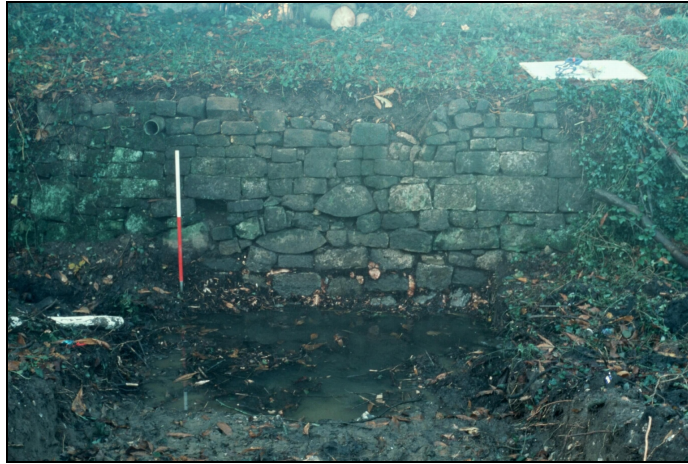
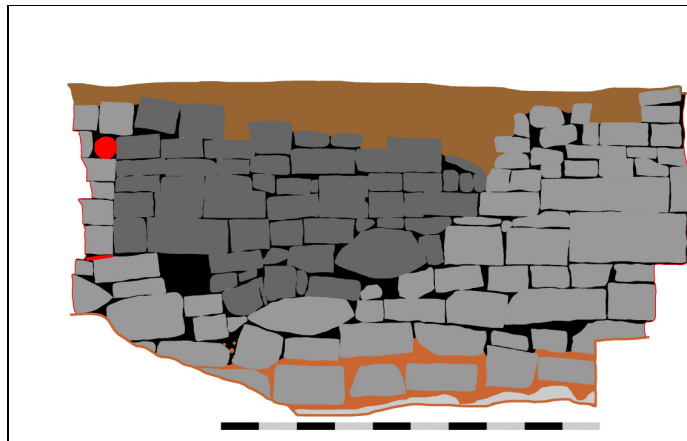
Fig.16 Photograph of the ha ha wall in trench 5, looking west. The scale is 1m.

Fig.17 Elevation drawing of the ha ha wall in trench 5. The scale is 2m. Stonework in dark grey indicates the bulging out of the wall, that in light grey are the foundation stones. The brown at the base is roots, while the brown at the top is modern topsoil. The circular red is a modern pipe from the toilet block, while below it the rectangular red is a roof tile.

3. The condition of the wall here is threatened by the mature trees which sit above the wall at this point. A combination of root action and broken branches has led to collapsed sections and bulges in the stonework, while the stones at the base of the wall are surrounded by a compact network of roots.

5. If backfilling is considered unacceptable for the future of the ha ha then the first priority must be the prevention of further collapse of the wall. The trees at the north and south ends, together with associated scrub and climbing plants should be removed if such further collapse is to be prevented. It is all too apparent that long term neglect in the form of a failure to keep trees and vegetation off the ha ha has led to its current poor condition. If a repeat of this is to be avoided then regular future clearance needs to be carried out once the current crop of trees has been removed. The damage caused by the expanding rabbit burrows will also need to be addressed, with the only effective treatment being the removal of the rabbits. The other significant identified problem, that of poor drainage, will also need to be addressed, but it is not seen as urgent as the other two factors, and may indeed be a problem dealt with by the collapse of the mortared sections of the wall, which were impeding the flow of the water. It is perhaps most sensibly left to be carried out in the next phase of works as discussed below. The only other threat that could be identified is that from the unofficial paths crossing the ha ha at points where the wall has collapsed, this is not considered a significant problem since the wall in these places is now protected by a layer of soil and turf and further deterioration seems to be minimal. Obviously it would be better if members of the public could be encouraged to use the properly established paths, but this would be hard to enforce.
