Holywells Park, Ipswich, Suffolk
Stable block refurbishment, remodelling of Cliff Lane
entrance and continuing work on the icehouse
IPS 768

Archaeological Monitoring Report

SACIC Report No. 2015/016

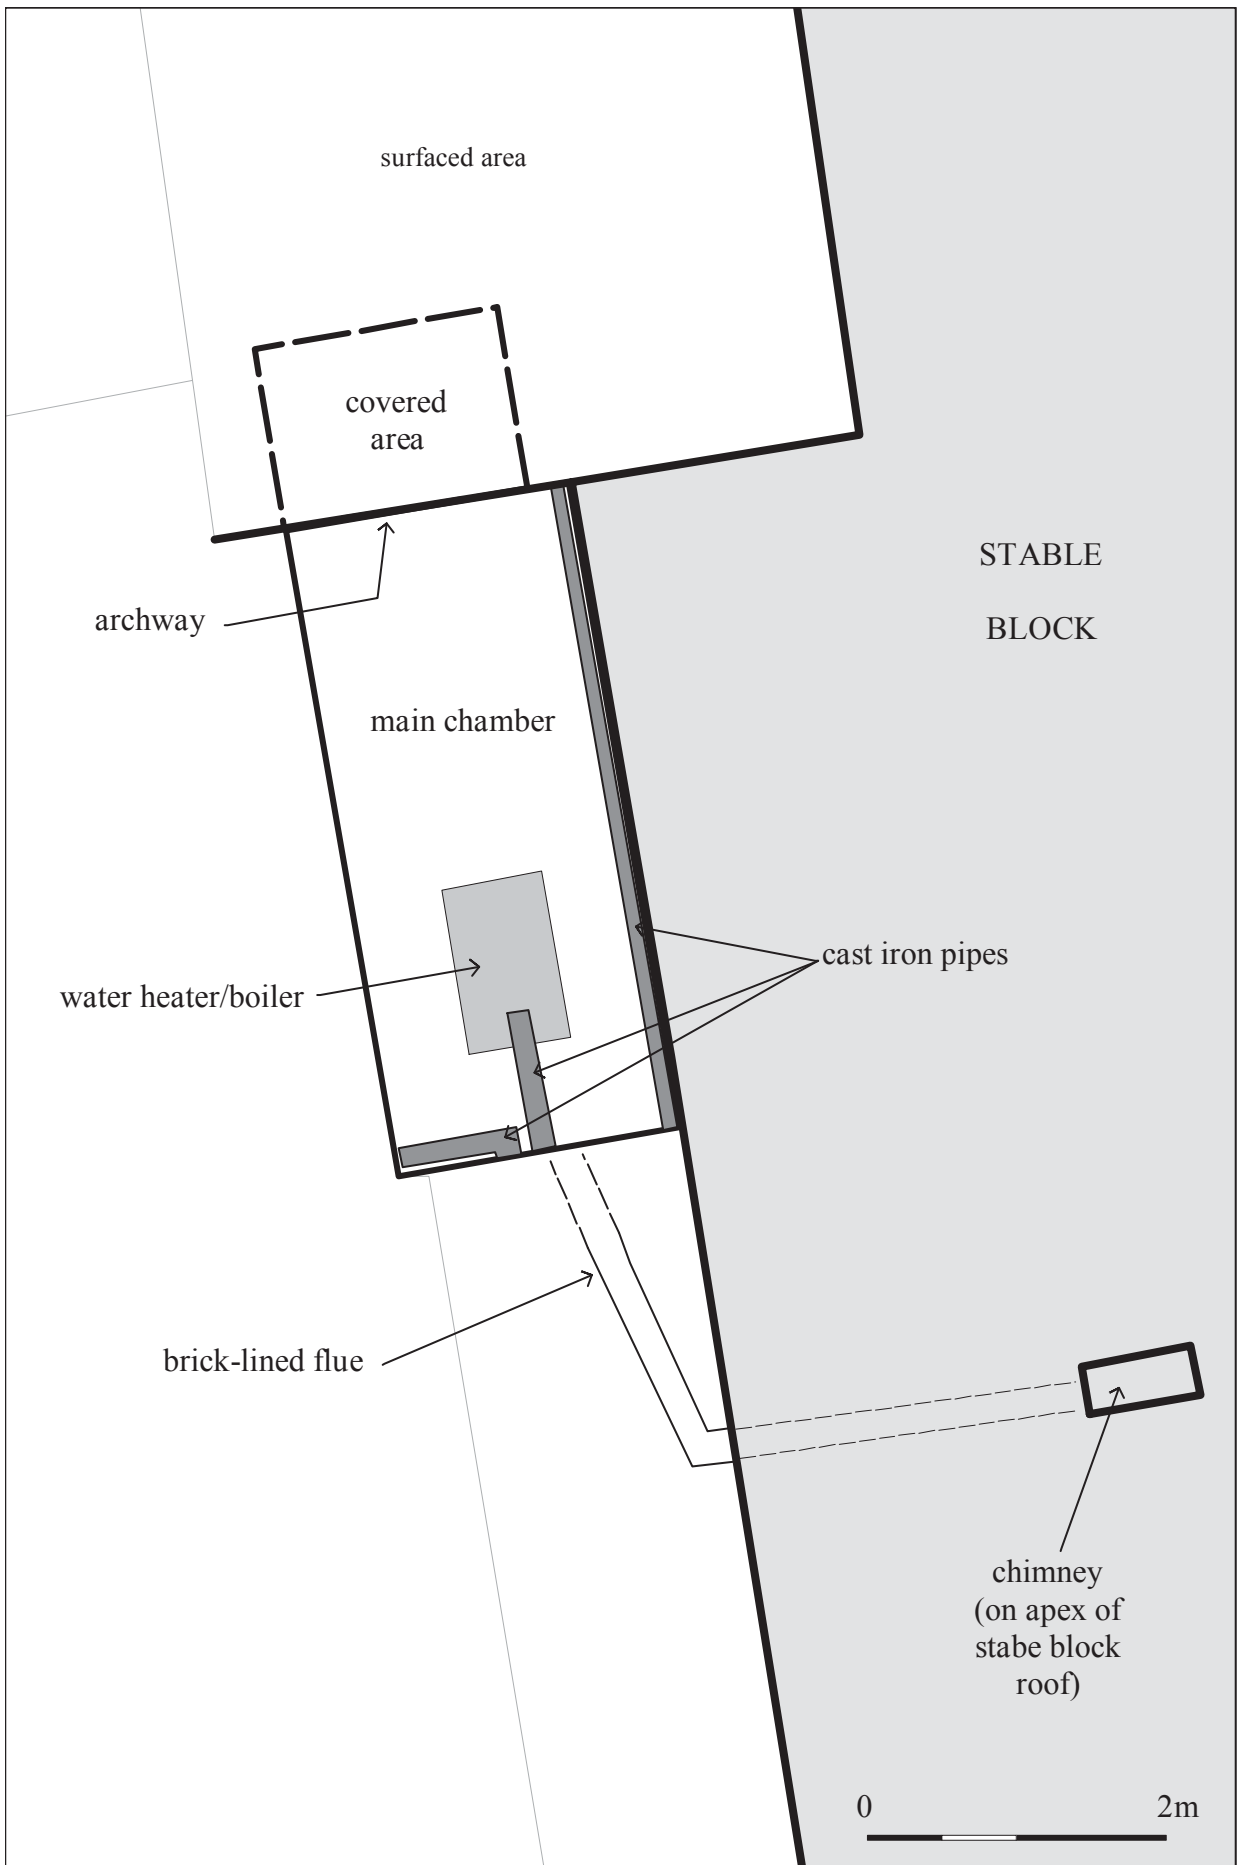
Figure 3. Plan of boiler house (1) on west side of stable block

Excavations undertaken on the west side of the stable block revealed a subterranean chamber immediately adjacent to the building (Fig. 3). It was located in a corner formed by a short length of wall running west from the northwest corner of the stable block, and the stable block's west wall. The chamber was constructed of red brick and measured just under 2m in width and 4.35m in length (plate 6). A narrow extension to the north of the chamber was accessed through an arched opening through the north wall at just below ground level. This northern extension, which was located under the surfaced yard area in front of the stable block, measured 1.64m by 1.2m (plate 7). At the time of discovery the chamber, and its northern extension, were filled with sand and gravel that contained frequent building rubble and numerous fragments of roofing slate, glass and other debris. This area of the boiler house was being lowered by the contractors a limited distance in order to create space for a new equipment room. As it was not necessary to fully empty the chamber the floor was not seen and its depth not established.

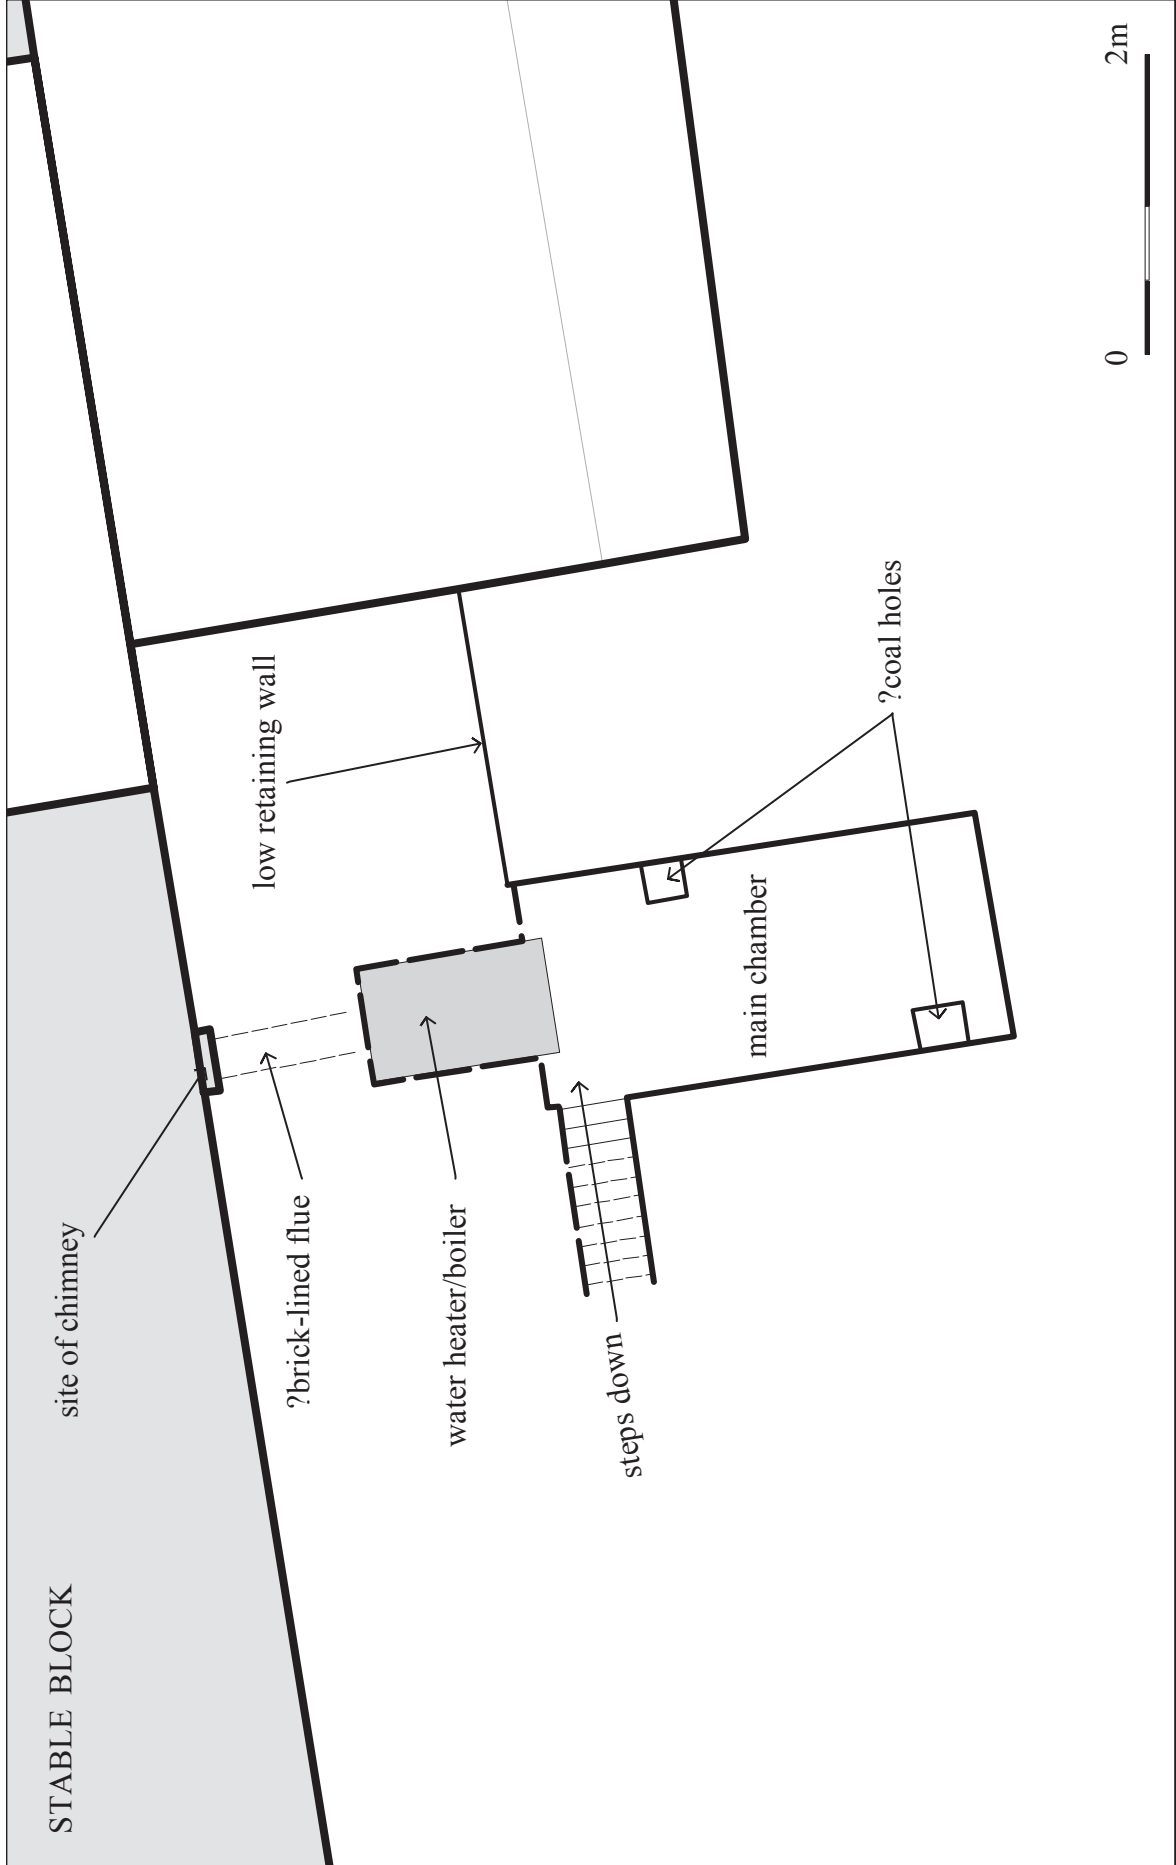
Figure 4. Plan of boiler house (2) on south side of stable block

Ground level reduction to the south of the stable block, in advance of the construction of an extension, revealed a second subterranean boiler house (Fig. 4). It comprised a brick built chamber, measuring approximately 1.5m by 3m, with an estimated internal height of 1.7m, and roofed over with a brick built vault. At the time of the monitoring visit the northern end of the chamber had been broken open and some of the brickwork removed (plate 11). A cylindrical boiler, c.0.7m in diameter and c.1.2m in length appeared to have been set into a space in the northern wall of the chamber so that only a small section protruded into the chamber. The boiler was surrounded by brickwork and even appeared to be mortared into the structure (plates 12 and 13). The top of mountings of the boiler were broken and any connecting pipework had already been removed. The boiler flue had been removed but it clearly connected with a short remaining length of brick-lined flue leading into a protruding chimney breast against the southern wall of the stable block. The top of this chimney would have passed through the edge of the stable block's slate roof but had been previously blocked and roof continued over (plate 14).

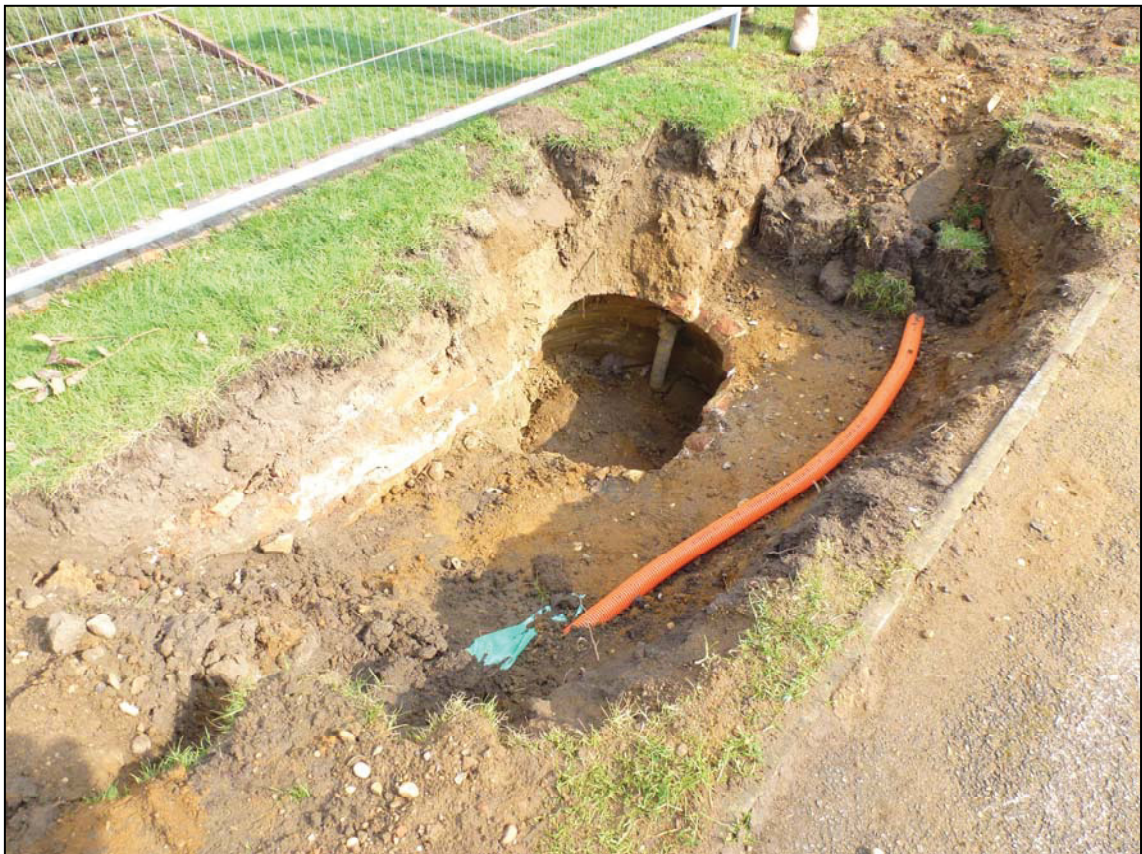
The broken remains of a covered vertical shaft were observed in a service trench running east-west on a line roughly coincidental with the back wall of the former house. It was constructed of brick and covered with a brick dome (plate 4). The dome was partly broken and the shaft filled with soil. This feature is likely to be a well to feed a hand cranked pump. Comparison with early Ordnance Survey maps suggest it was located within a small yard at the back of the house (see Fig. 5) in an area that was presumably close to the kitchens. No pump or well is marked suggesting it was located within the house.

Plate 4. Well shaft and brick dome revealed in service trench, camera facing NE

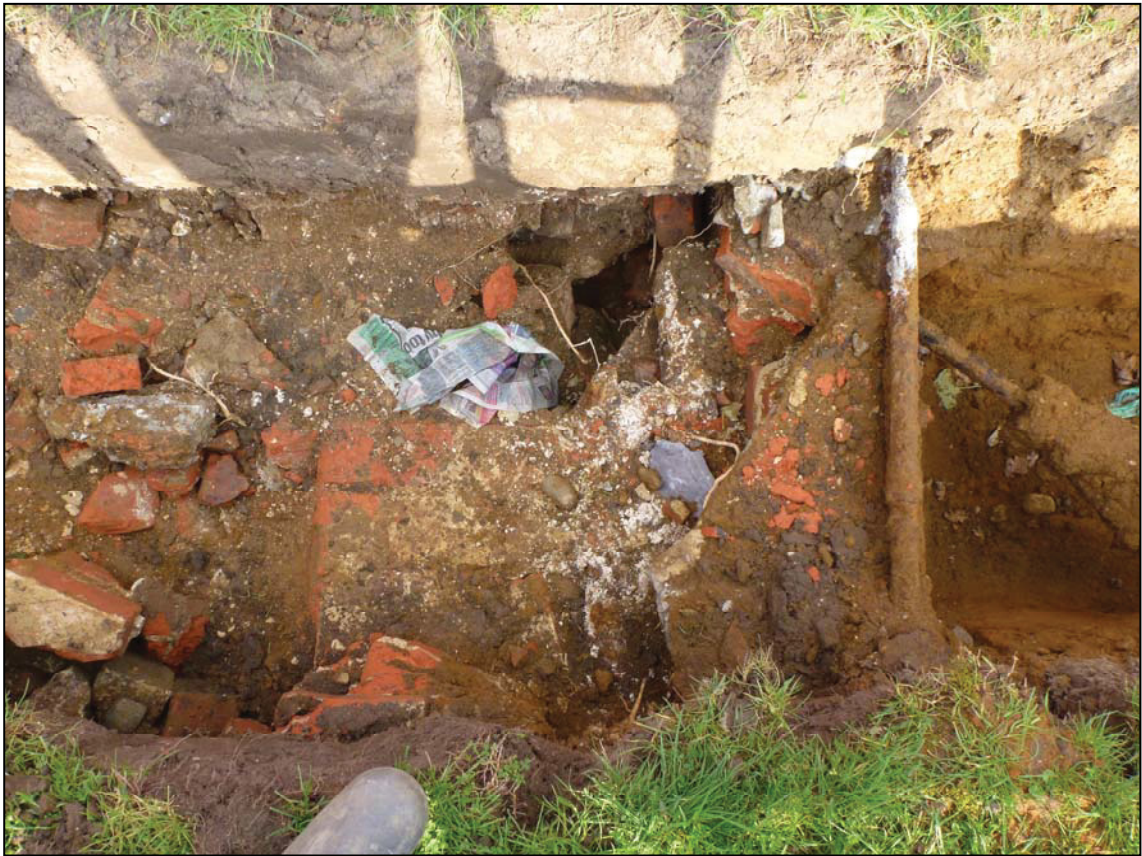
Elsewhere in the trench a wall base of soft red brick with lime mortar was noted (plate 5). It was fairly substantial and appeared to be forming an angled or rounded corner. Although there is no clear indication on early Ordnance Survey maps it is likely to be the site of buttress, a bay window or, more likely, a chimney breast that protruded from the southern wall of the house (see Fig. 5).

Plate 5. Brickwork, probable wall base, revealed in service trench, camera facing N

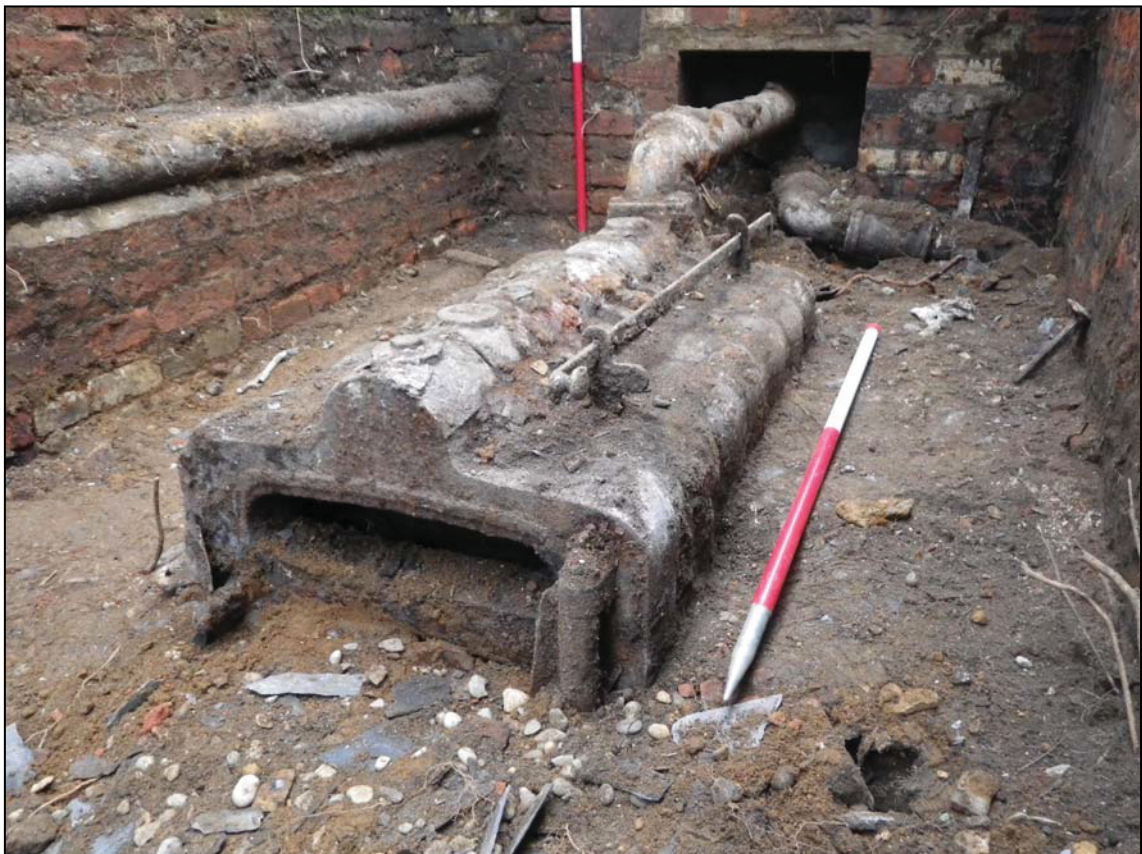
Located close to the southern end of the chamber the top 0.2m to 0.3m of an extant cast-iron water boiler or heater was exposed (plate 8). The southern end of the boiler was connected to c.10cm diameter cast iron pipe which exited out of the chamber through a square hole on the southern wall. A second pipe was visible which ran through the hole and then ran down in the southwest corner of the chamber where it would have presumably connected to the bottom of the boiler. A concrete lintel ran across the top of this access hole and the adjacent brickwork had been clearly rebuilt suggesting a repair or alteration (plate 9). The boiler flue comprised a brick-lined channel capped with stone slabs that ran from the southern end of the chamber and, after an initial slope up, continued roughly horizontally, just below ground level, before turning and entering the west wall of the stable block (plate 10). From there it presumably ran under the floor or within a void in the wall before exiting through an extant chimney visible at the apex of the roof.

Plate 8. Boiler/water heater within boiler house 1, camera facing S

Upon completion of the ground reduction the boiler was left *in-situ* and the chamber was sealed under a concrete slab supported by brackets mounted on the side walls.

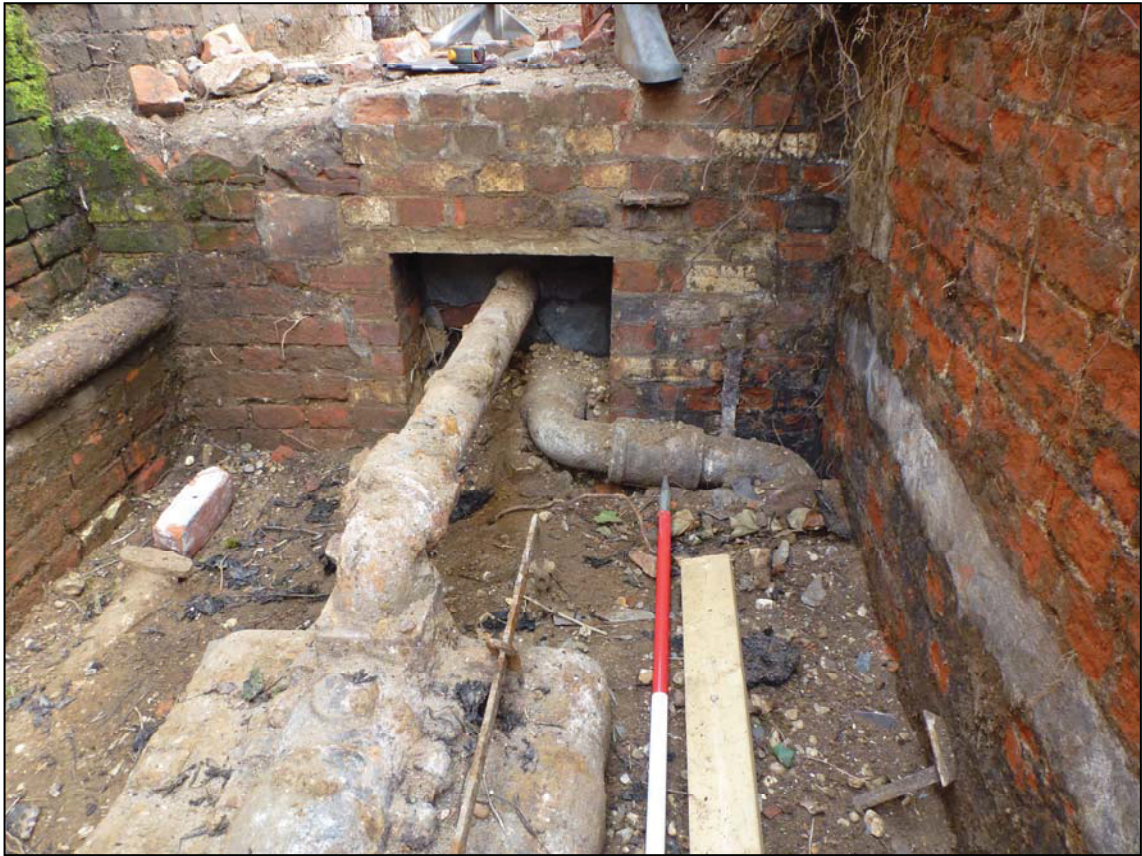
edition map (1927) all glasshouses, other than the still extant Orangery, have been removed from the area to the south side of the house. The site of boiler house 1 is marked as a solid roofed structure suggesting the boiler may still be in use, possible to provide heating and hot water for the stable block itself. This possible change of use could account for the repair/alteration noted in southern wall of the main chamber.

Plate 9. Southern wall of boiler house 1 showing repair/alteration, camera facing S

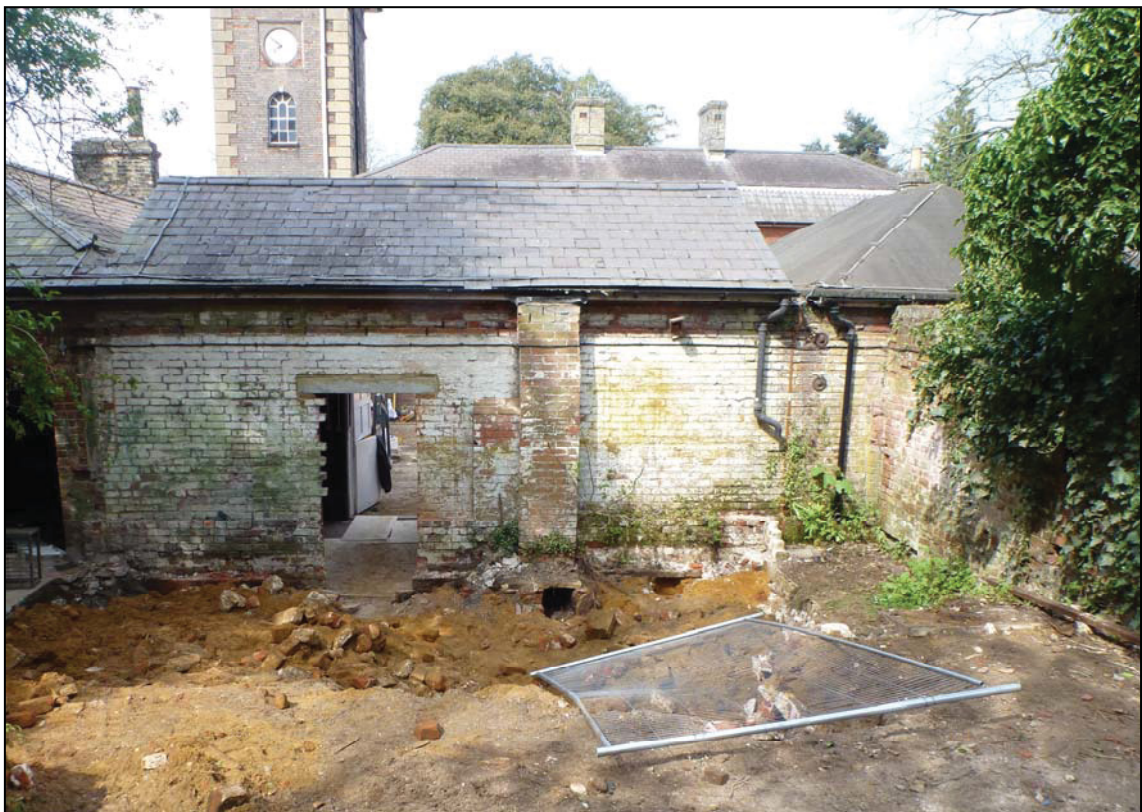
Plate 14. General view of area of boiler house 2, camera facing N.
The flue and chimney breast can be seen in the centre of the photograph

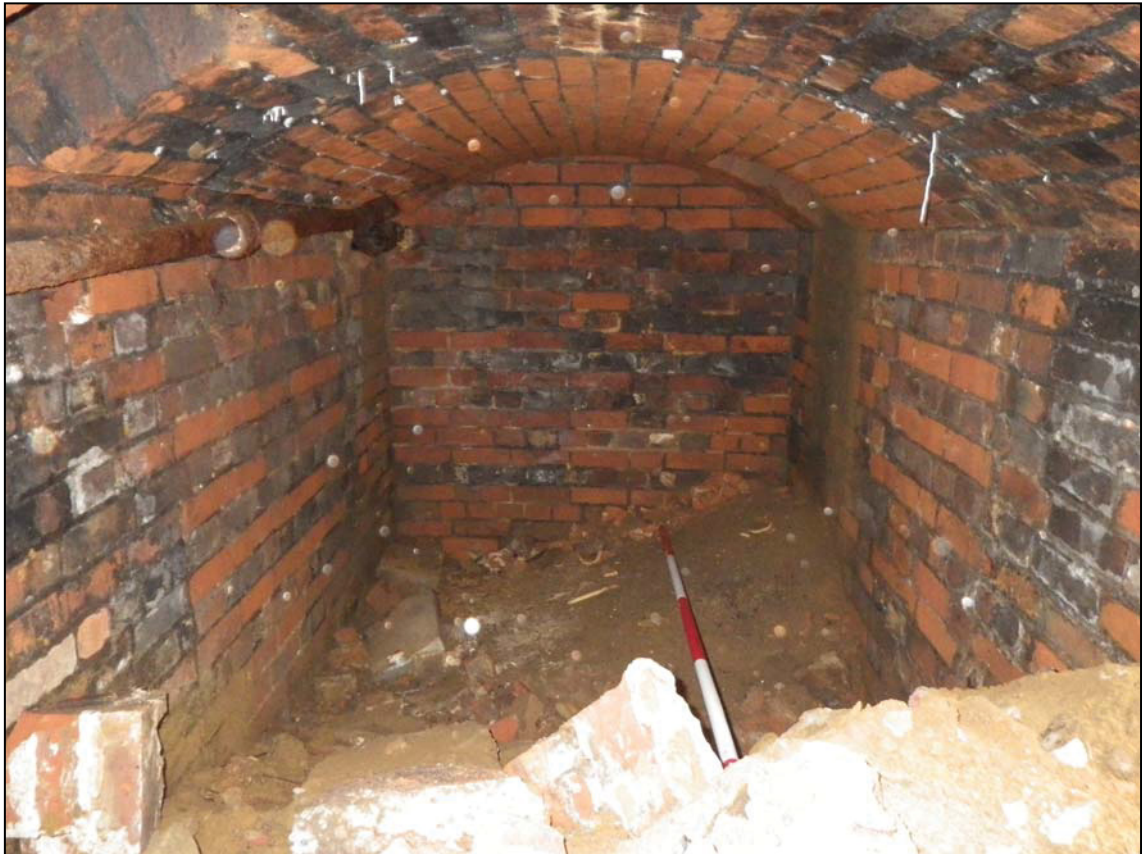
Access to the chamber was via a set of narrow stairs close to the northwest corner. This boiler was also presumably coal fired by an operative standing in the main chamber (plate 15). Two square holes through the brick vault were presumably for tipping fuel into the chamber. A cast iron pipe was mounted along the top edge of the eastern wall. It presumably connected with the top of the boiler and appeared to exit the chamber in the southeast corner. It was noted that the brickwork forming the southern half of the vault and the top section of the southern wall was clean suggesting a possible rebuild, although this was not conclusive.

Plate 15. main chamber in boiler house 2, camera facing S

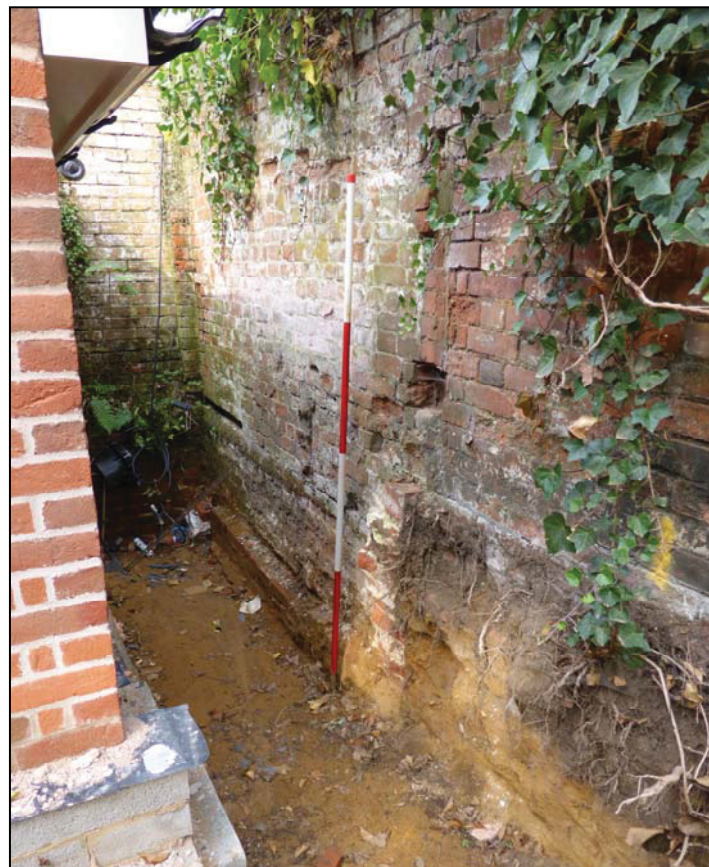
It was noted that the north wall of the main chamber coincided with a low retaining wall running approximately east – west. Evidence on an extant wall to the east suggested this may have been the base for a glasshouse that formerly stood on this site (plate 16). It was also noted that the south wall of the stable block and the west face of the eastern wall had been previously whitewashed. On the south wall of the stable block the roof line of the former glasshouse was marked by the clear horizontal boundary to the whitewashed section (visible in plates 14 and 16).

Plate 16. The north-south wall to the east of boiler house 2 (post construction) showing remnants of the retaining wall and other marks where a former glasshouse was attached, a clear vertical boundary to the whitewash is also visible

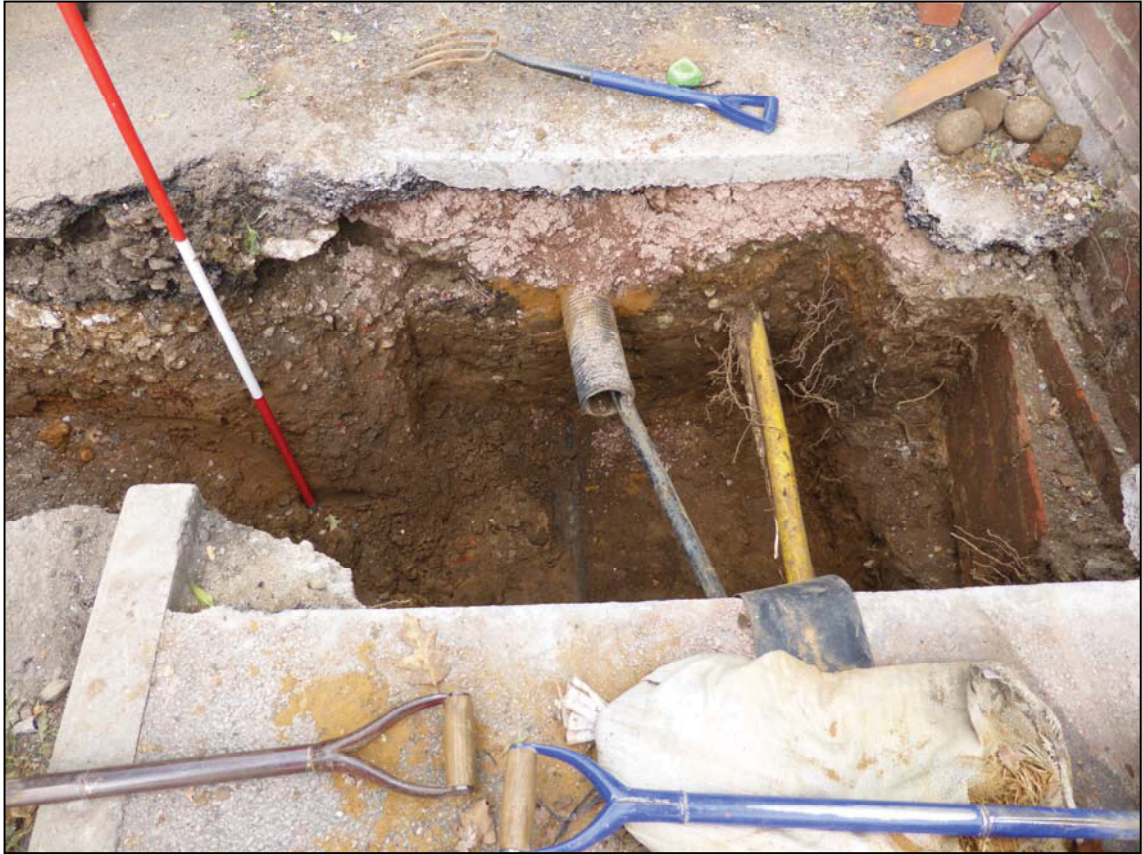
A pair of large brick gate piers were to be construed at the park's Cliff Lane entrance. The foundations for these were inspected but this revealed only a truncated natural subsoil, of yellow-brown sandy silt, below the make-up of the existing roadway, and a large number of modern services (plate 17). This aspect of the monitoring was allocated the HER event no. ESF22938.

Plate 17. Cliff Lane entrance, foundation for eastern gate pier, camera facing N

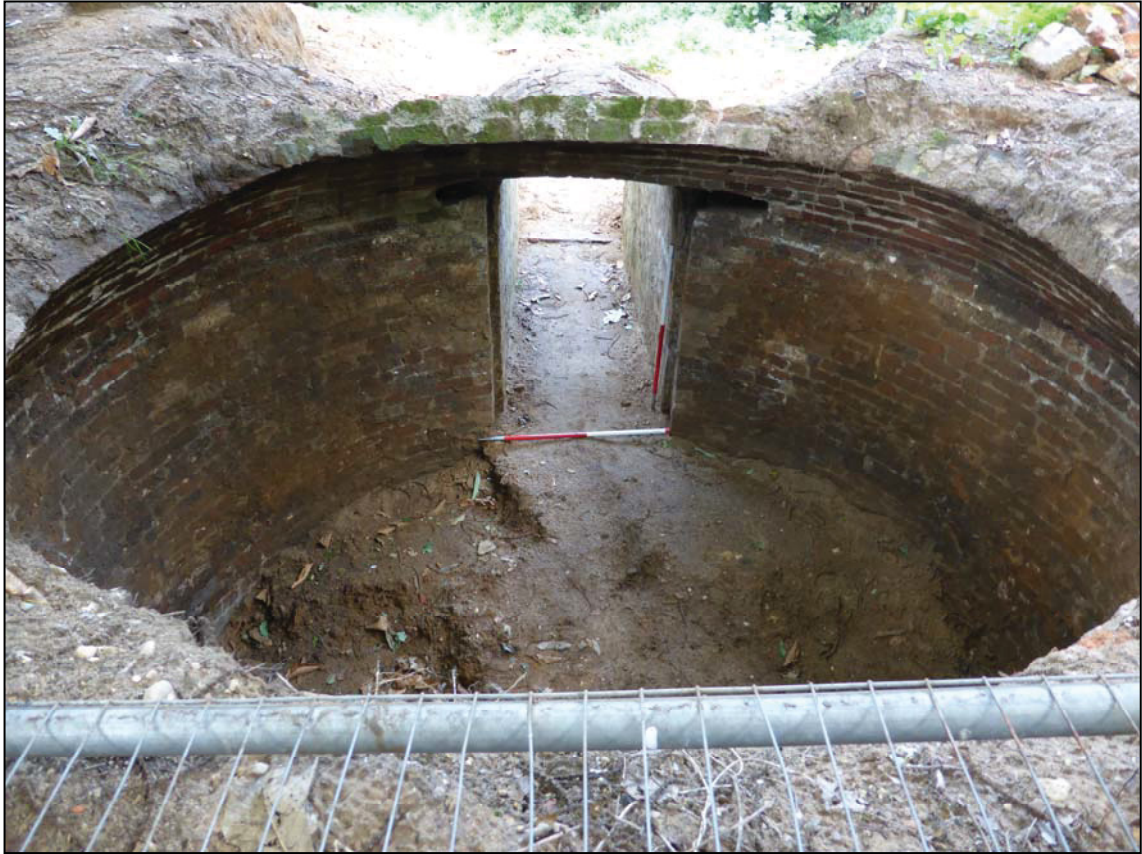
The presence of a 19th century icehouse within the park was confirmed during earlier exploratory works undertaken as part of the 'Parks For People' project (HER ref. IPS 749). The top of the brick dome over the ice chamber was found to be broken and the chamber itself was entirely filled with soil. The entrance portal and tunnel had also been damaged and the area landscaped hiding the icehouse completely. The fill material is being removed by hand by volunteers from the Friends of Holywells Park group. The aim of this phase of the project is to restore the structure's damaged brickwork and to then present it to the general public.

Plate 19. General view through the broken dome of the icehouse, camera facing N

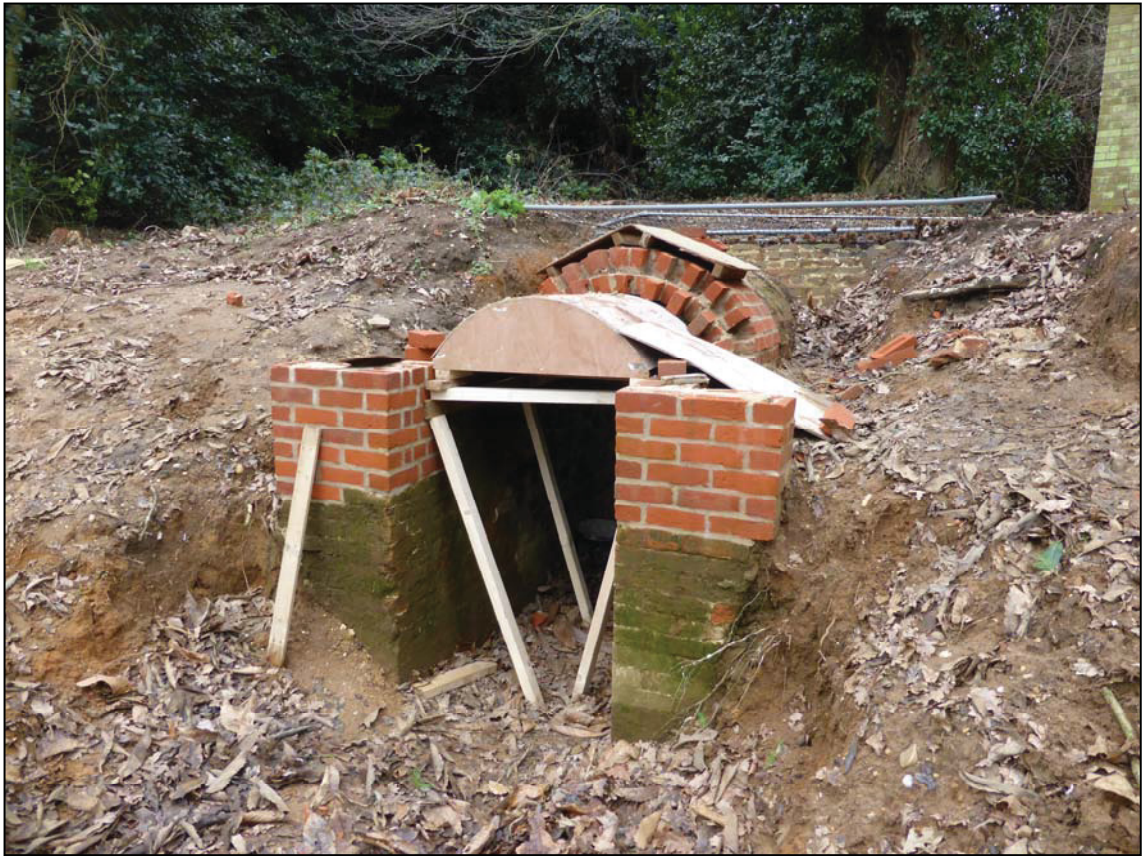
It was noted during the January 2015 visit that some of the brickwork had been repaired. Part of the brick vault covering the access tunnel had been replaced and the flanking walls either side of the entrance had been rebuilt (plate 21).

Plate 21. Restored brickwork around the entrance to the icehouse (Jan 15), camera facing SE
