**West Villa,  
Woodbridge Road, Ipswich  
IPS 771**

**Historic Building Record**

# **West Villa (Formerly Ipswich Workhouse), Woodbridge Road East, Ipswich, Suffolk**

## **Historic Building Record**

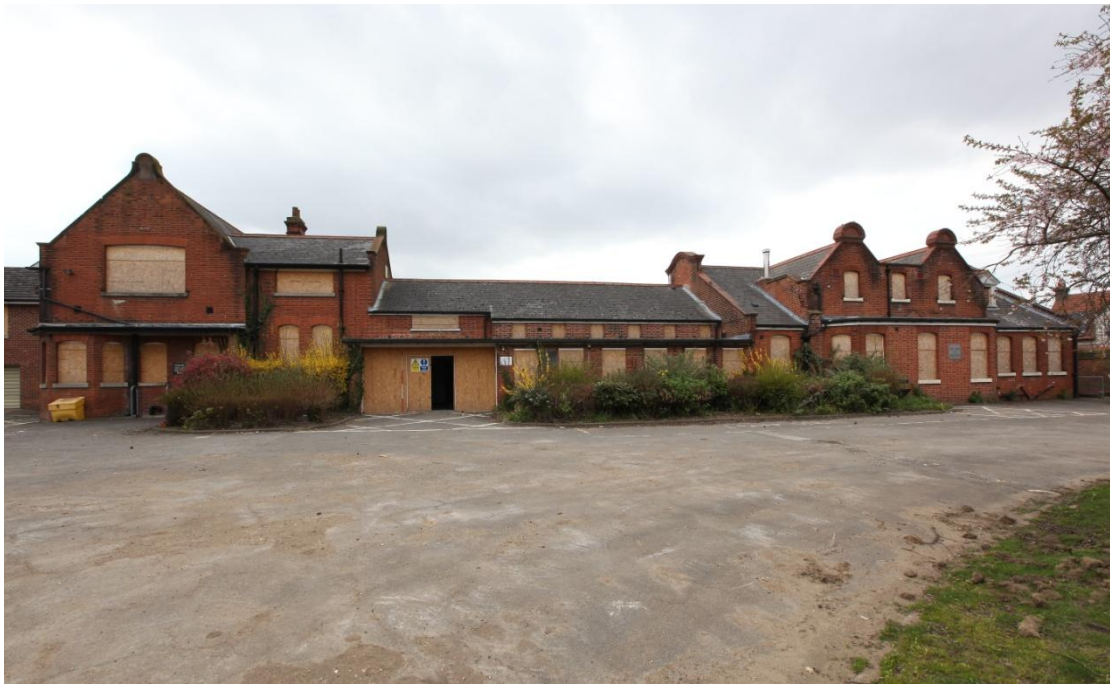
**Illus. 1. The eastern facade of the former workhouse showing the original structure of the 1890s as illustrated in figure 2 on the right (A) and the early-20<sup>th</sup> century extension (B) to the left. The original three-tiered central range has lost its upper tier of windows and the roof of the southernmost block has been remodelled and now lies behind the boarded modern entrance. The extension consists of the left-hand gable and the adjoining tall section containing the staircase shown in illus. A2.14 below.**

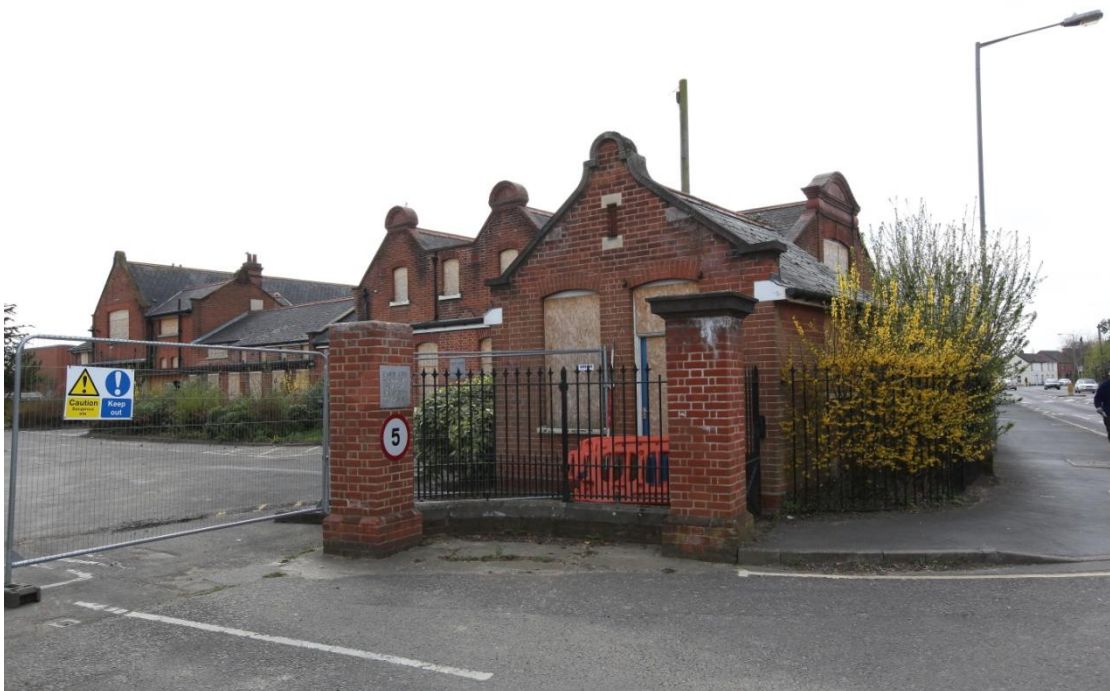
**Illus. 2. The entrance to the site from Woodbridge Road on the north (viewed from the east) showing the small porter's lodge of the early-20<sup>th</sup> century. The shape of the latter's gable matches those of the contemporary extension to the extreme left (B).**

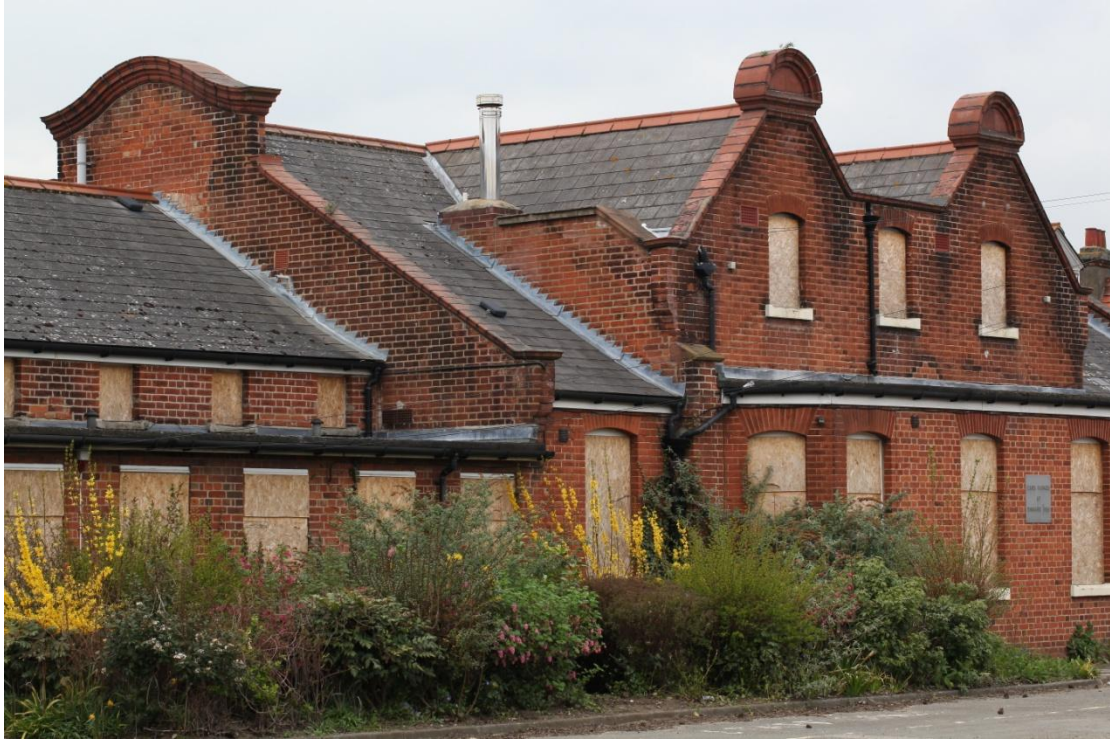
**Illus. 3. The distinctive original gables of the eastern facade (A) from the south-east. The southern gable to the left clearly reveals the outline of the narrow upper tier of windows shown in figure 2 that formerly capped the contemporary roof to the extreme left. The large bay window on the right is a 20<sup>th</sup> century addition but the roof scars of two smaller gabled projections can be seen on the wall immediately above its flat roof.**

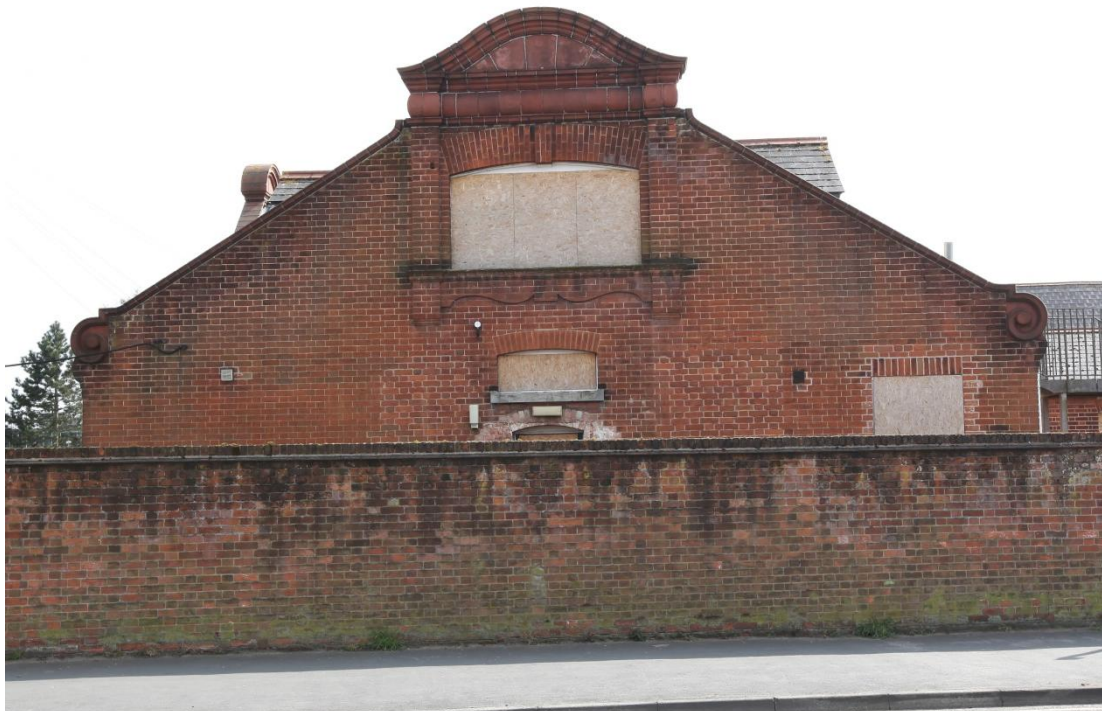
**Illus. 4. The impressive Art Nouveau northern gable seen from Woodbridge Road. Note the terracotta volutes of the two corners to left and right, and the evidence of two blocked ground-floor windows flanking the later central door. The blocked first-floor windows are shown in illus. A2.12, but the high window beneath is hidden internally. The full photographic record includes several details of this gable.**

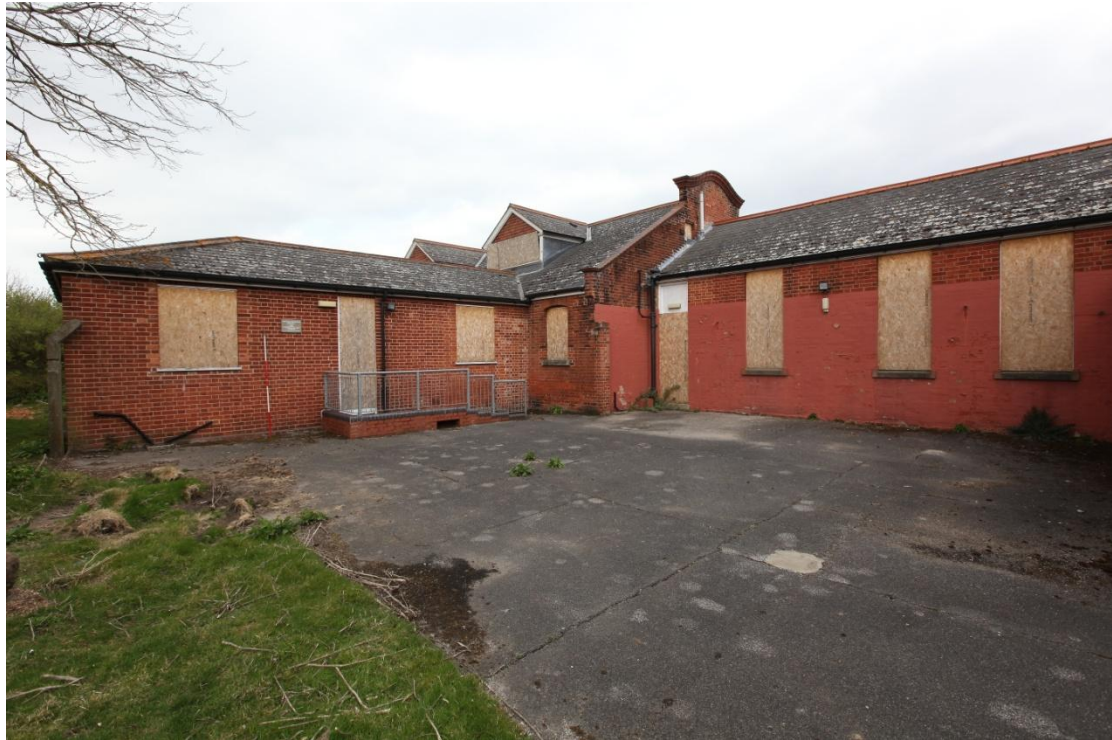
**Illus. 5. The original structure (A) from the south-west with the mid-20<sup>th</sup> century extension on the left (C3). The wall of the single-storied range on the right has been rebuilt and it was formerly of the same width as the two-storied range, as indicated by the scar of the original roof on the latter's gable. Note the loss of the chimney depicted in figure 2 which belonged to the fireplace in illus. A2.11.**

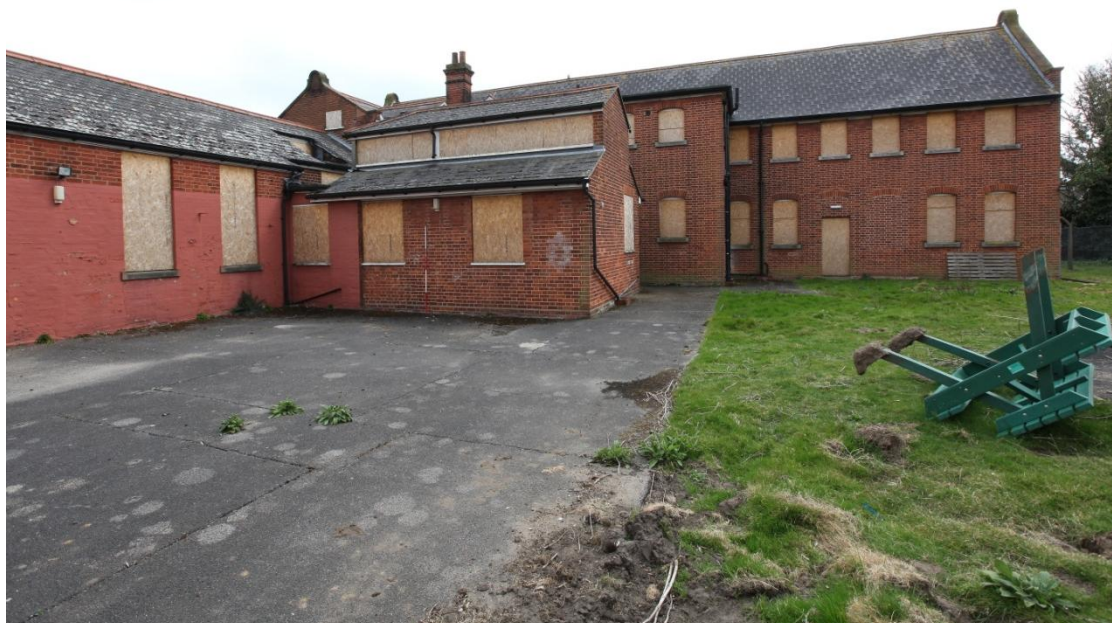
**Illus. 6. The mid-20th century central extension (C2) from the north showing its roof profile with an upper tier of blocked windows reflecting the identical tier which has since been removed from the single-storied southern range of the original structure to the left (A). The large southern extension of the mid-20<sup>th</sup> century (C1) is shown to the rear.**

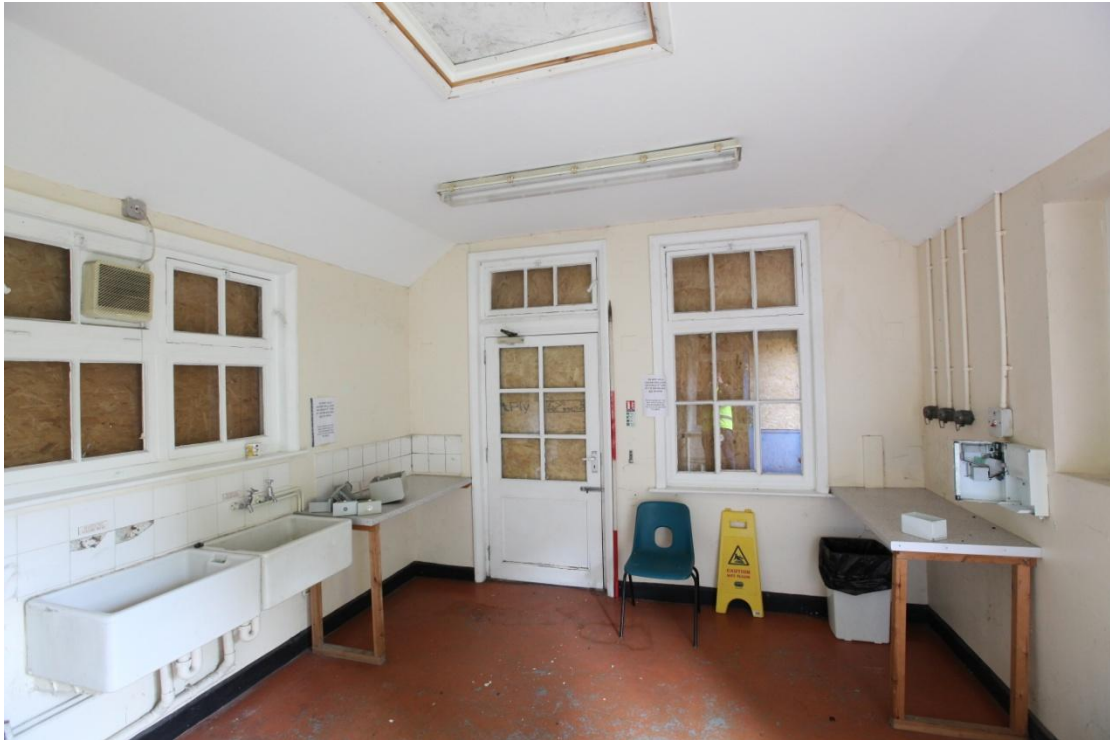
**Illus. 7. The interior from the west of the early-20th century porter's lodge showing its original eastern entrance door and the ceramic sinks reflecting its most recent purpose as a communal laundry.**

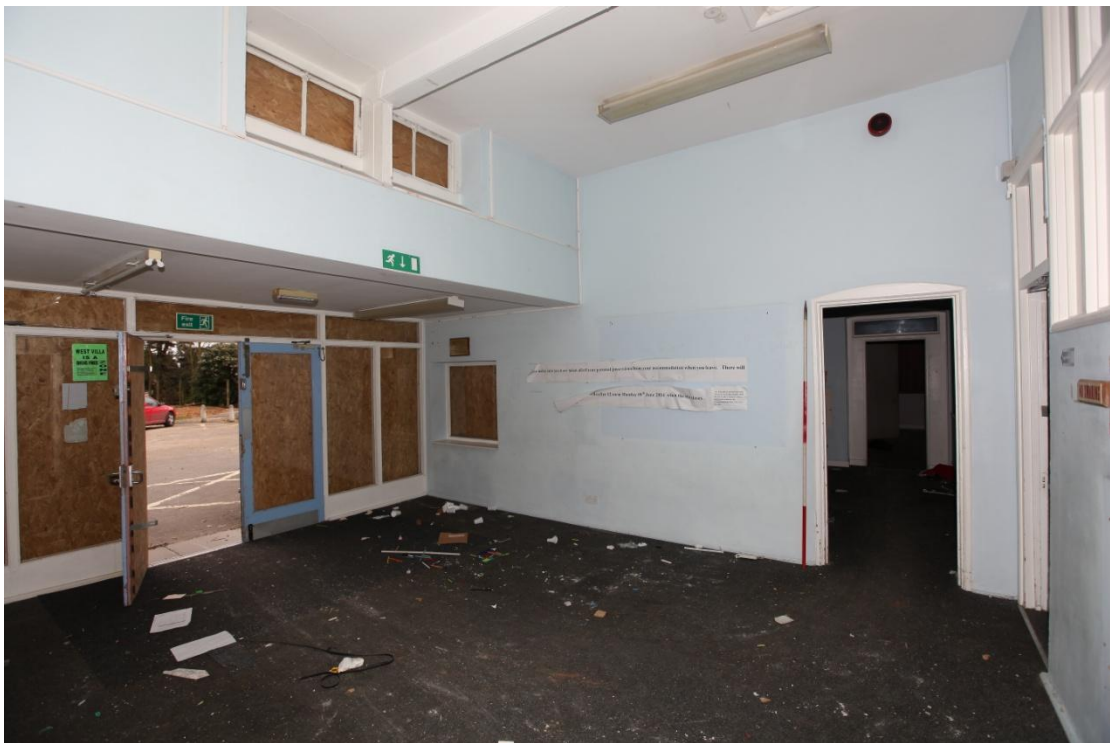
**Illus. 8. The interior from the north of the modern entrance lobby at the southern end of the original structure (A). The lower section of its eastern wall to the left has been removed where it adjoins the flat-roofed late-20<sup>th</sup> century 'porch', which retains a brass plaque commemorating the 'reopening' of West Villa in 1995 (above the hatch in the centre of this image). The door to the right opens into the early-20th century extension (B) and marks the southern gable of the late-19<sup>th</sup> century building.**

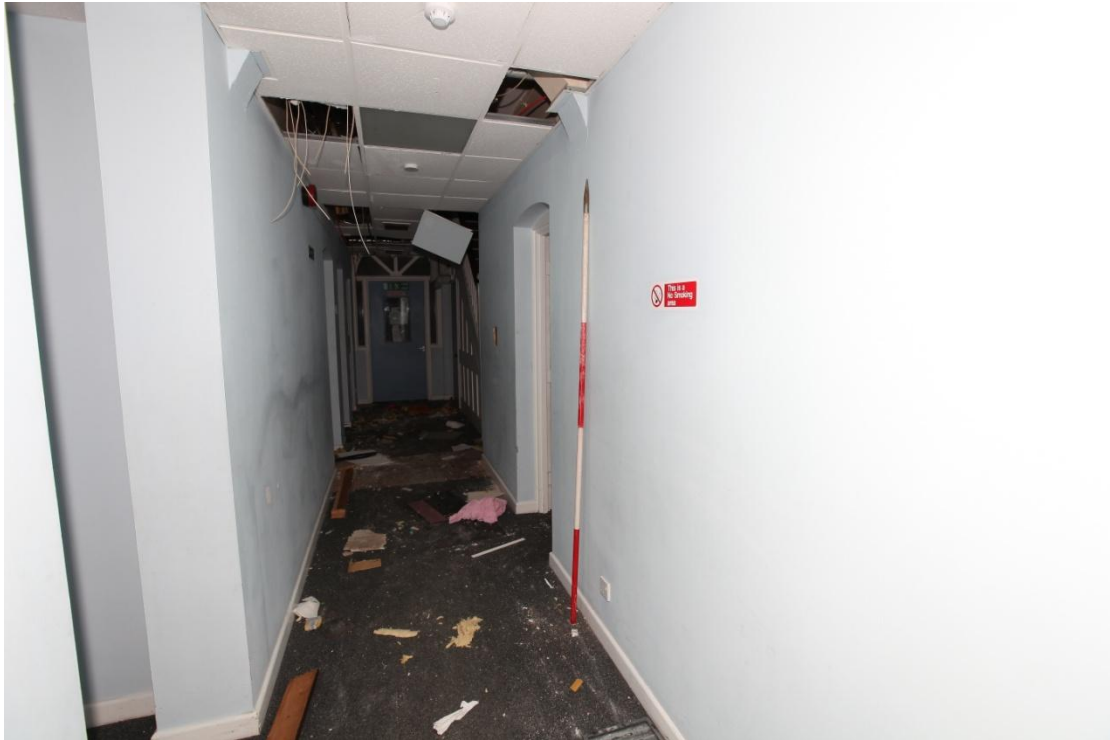
**Illus. 9. The southern section of the axial ground-floor corridor in the original structure (A) viewed from the south and showing the late-20<sup>th</sup> century cladding which dominates the interior. This corridor links the entrance lobby shown in illus. A2.8 above to the staircase in A2.10 . Note the lower section of a tall original brick arch immediately above the scale rod which indicates the original height of the corridor before the insertion of the present ceiling.**

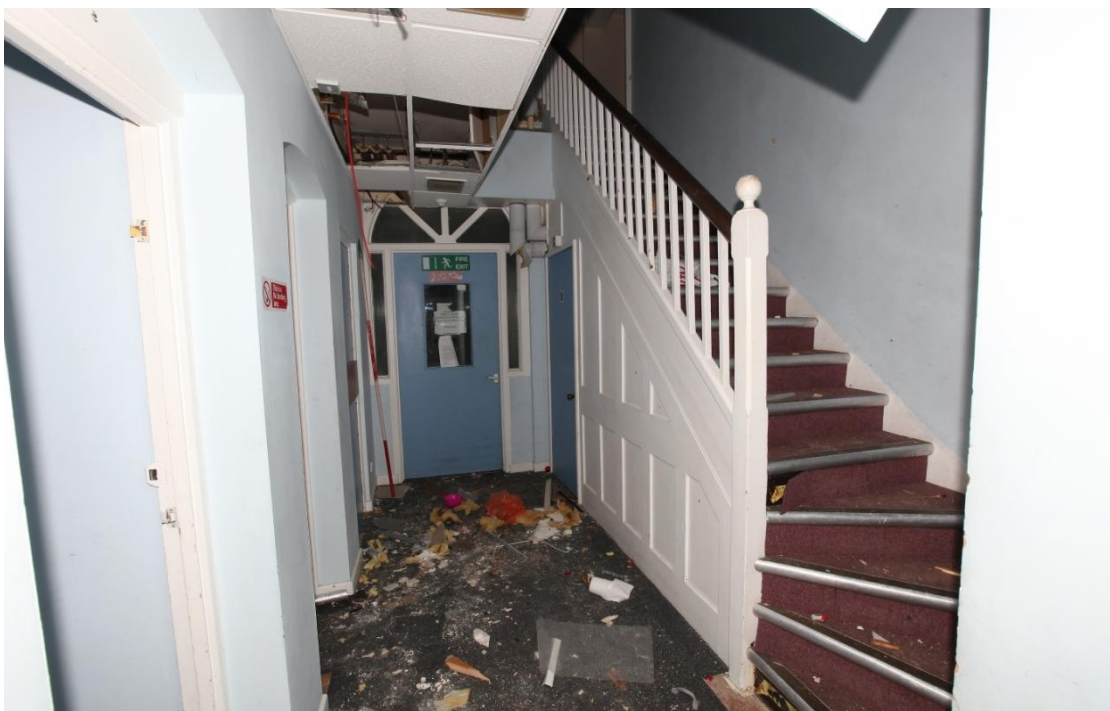
**Illus. 10. The possibly original staircase at the northern end of the southern section of corridor in structure A, seen from the south. This rises to the southern end of the two-storied section of the building, and the door beneath its balustrade opens onto the cellar steps. The arched fire door leads to the northern section of the axial corridor.**

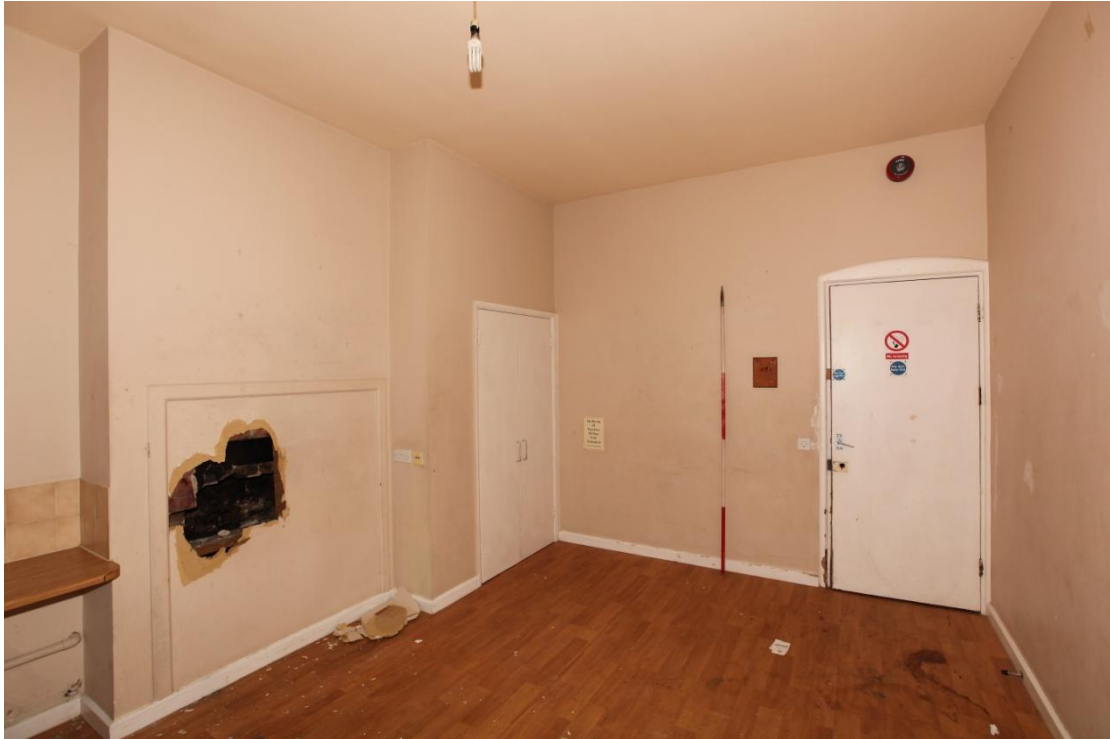
**Illus. 11.** The central ground-floor room to the rear (west) of the axial corridor in the two-storied northern half of the original structure (A). The door to the right opens into the corridor and a blocked fireplace is visible to the left. The latter was served by the missing chimney depicted in figure 2a. The late-20<sup>th</sup> century cladding to the floor, wall and ceiling of this room is replicated throughout the building, effectively concealing its original fabric.

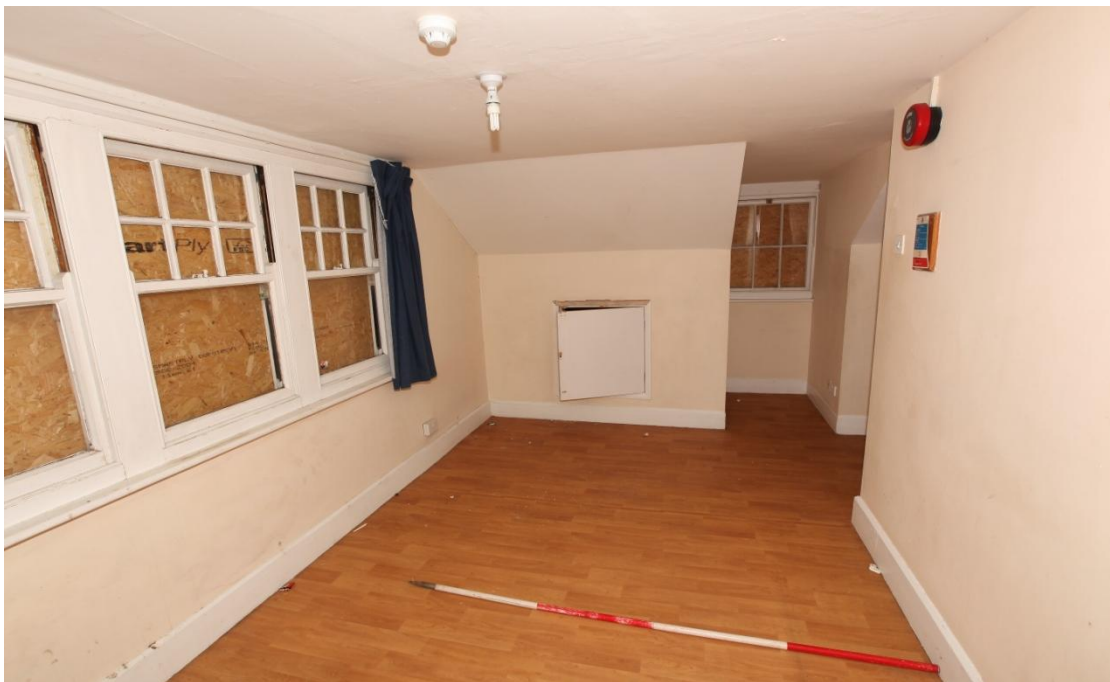
**Illus. 12.** The northernmost first-floor chamber of the original structure (A), seen from the west and showing the blocked windows in the Art Nouveau gable on the left with the secondary dormer window (not depicted in figure 2) on the right. All the partitions on the upper storey appear to represent 20<sup>th</sup> century insertions.

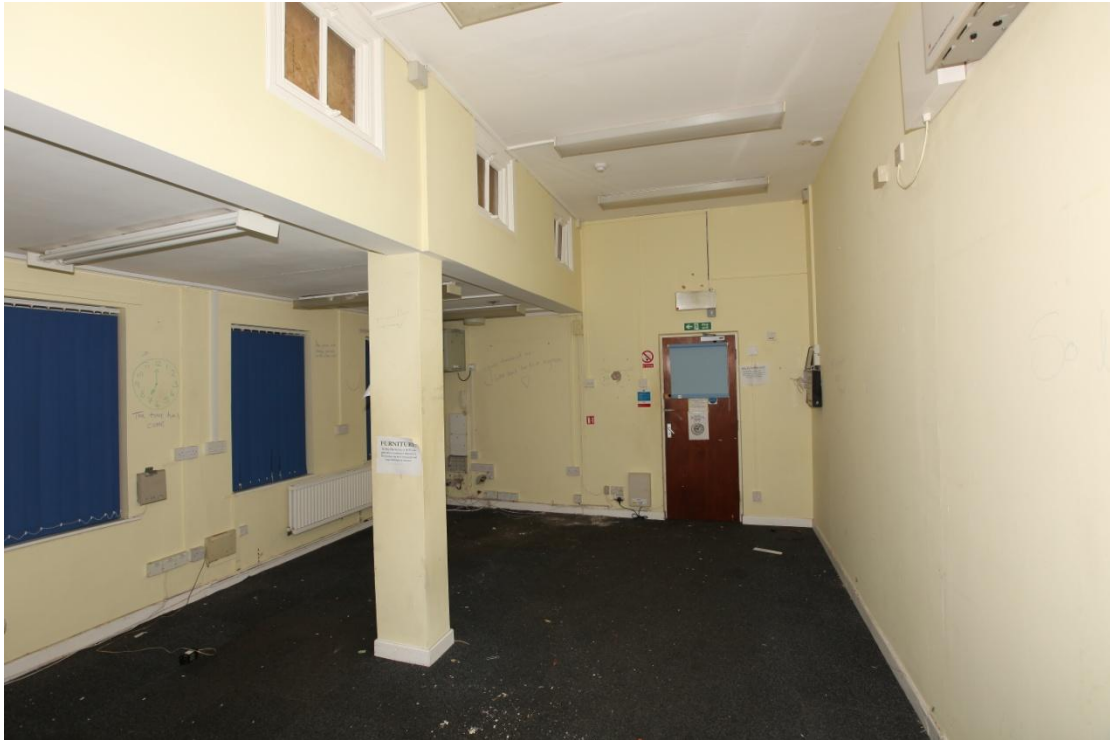
**Illus. 13. The high-ceilinged room to the east of the axial corridor in the single-storied section of the original structure (A), viewed from the north and showing the eastern facade on the left and the door to the entrance lobby on the right.**

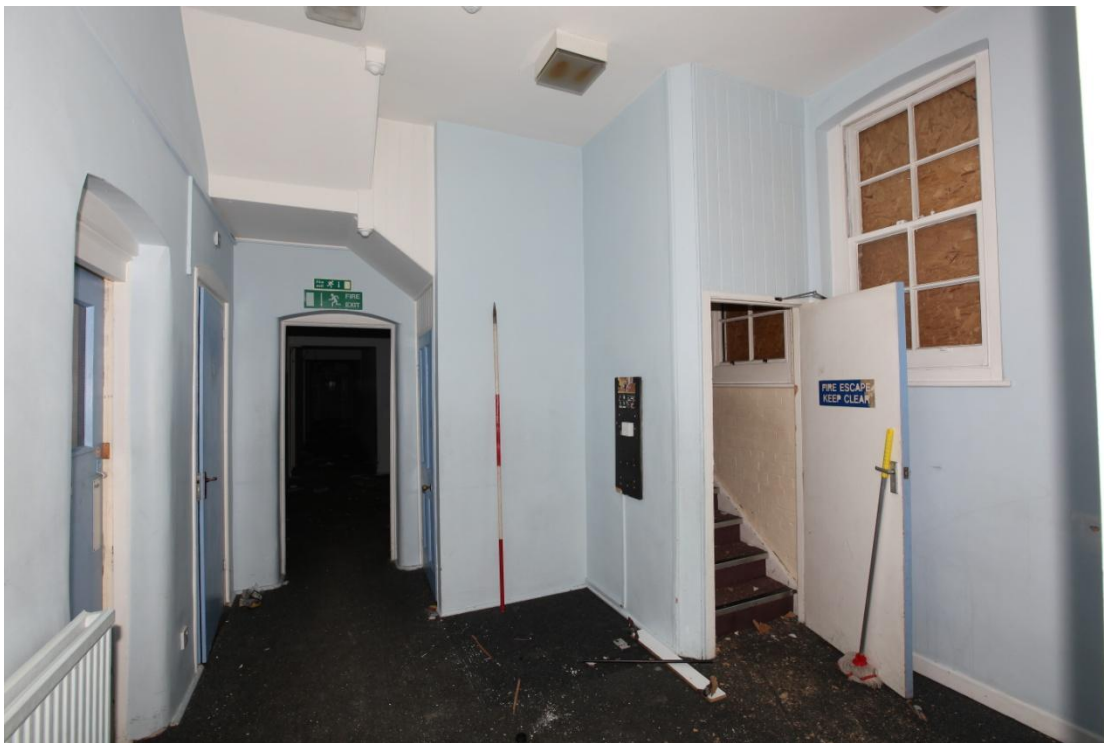
**Illus. 14. The probably original staircase in the northern room of the early-20th century extension (B), viewed from the south and showing the door to the entrance lobby in the centre (see illus. A2.8). The stair has been enclosed and its treads renewed but the turned finials of its posts project from the ceiling. The curved jambs of the left-hand doorway are an original feature found elsewhere in structure B.**

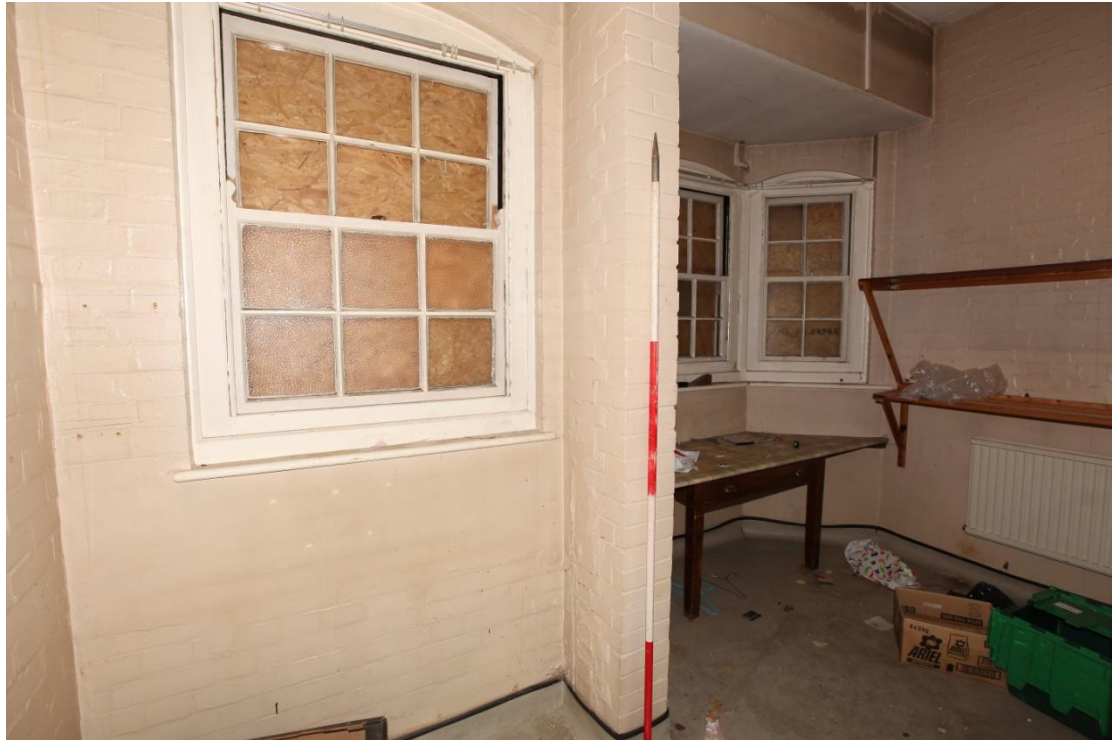
**Illus. 15. The interior of the bay window at the eastern end of the early-20th century extension (B) as seen from the north-west (visible to the extreme left in illus. A2.2). This narrow room of painted brickwork is one of very few spaces where the original fabric and historic character of the building is exposed internally. Note the counter table in the window recess.**

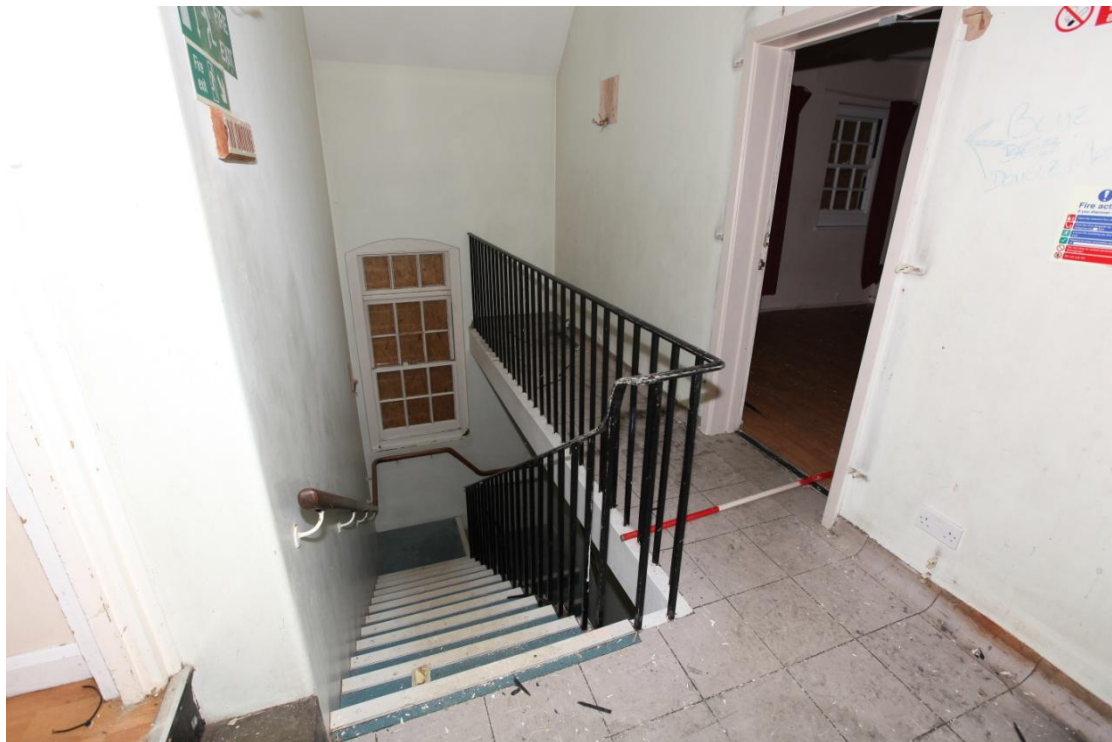
**Illus. 16. The first floor landing of the iron staircase at the western end of the early-20th century extension (B) as viewed from the north. This stair was probably added when the building was extended in the mid-20<sup>th</sup> century. The internal division between structures B on the left and C1 on the right is heavily disguised.**

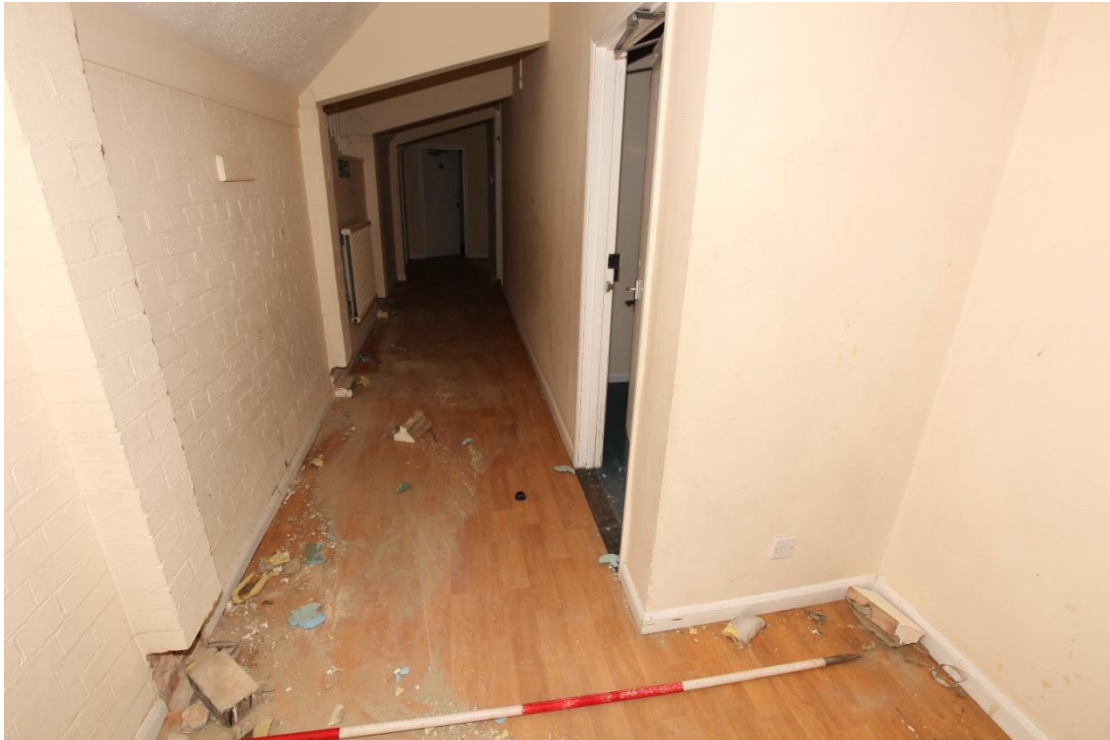
**Illus. 17.** The rear (northern) first-floor corridor of the early-20th century extension (B) viewed from the landing of the iron staircase to the west. Original painted brickwork is exposed on the left but the partitions of the rooms and kitchens on the right all appear to be later insertions.

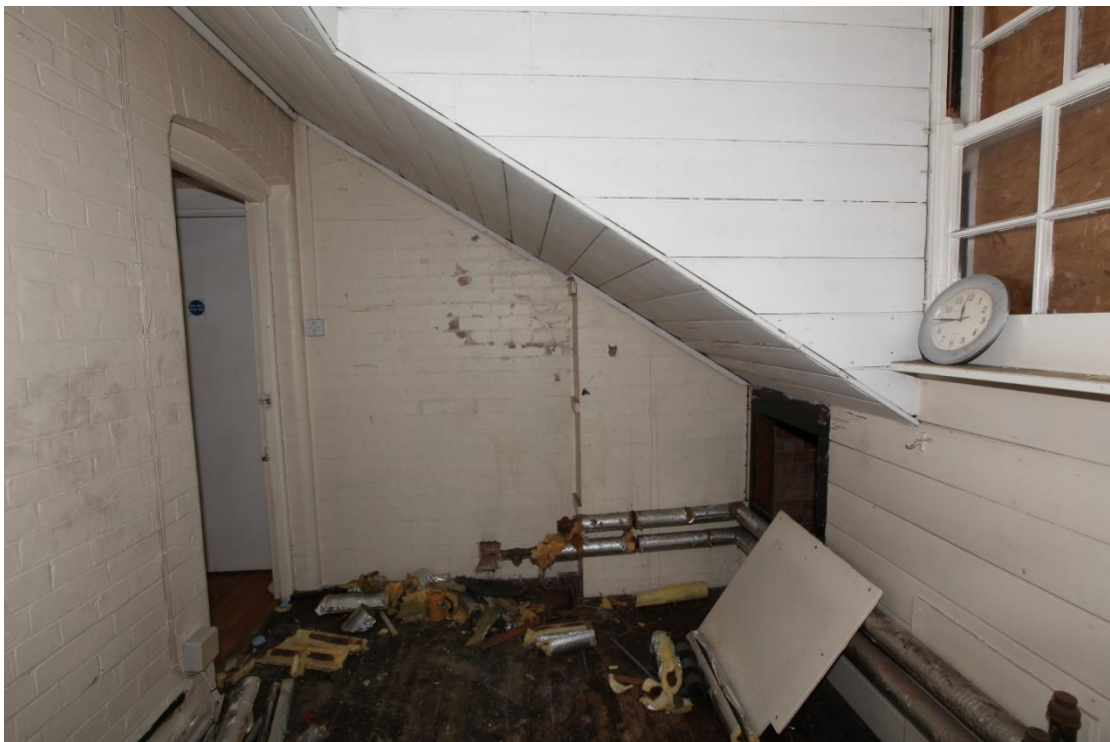
**Illus. 18.** The first-floor north-western chamber of the early-20th century extension (B) viewed from the north and showing the door to the staircase shown in A2.14 on the left. The painted brickwork and horizontal boarding of this space appears to be largely original as it served as a storage cupboard and escaped modernisation in 1995.
