**Outbuilding at Guildhall Farm,
Long Melford, Suffolk
LMD 244**

Historic Building Record

August 2015

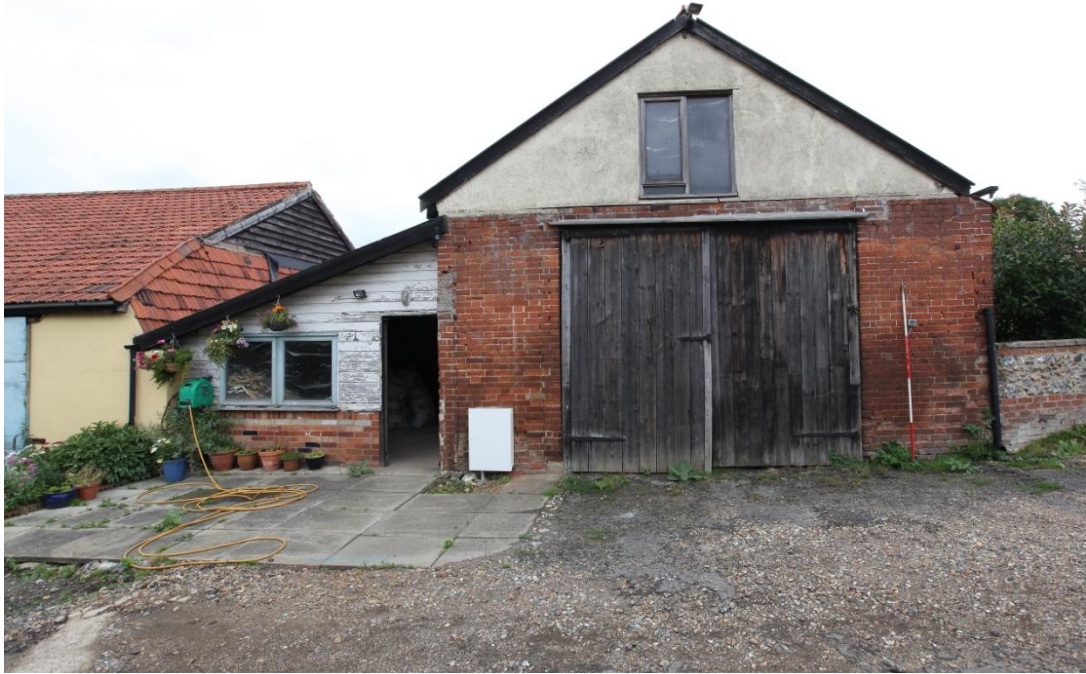
The shed’s red-brick southern gable (illus. 3) is laid in regular Flemish Bond and contains an original central entrance of 3.7 m in width by 3.4 m in height (12 ft by 11 ft) which is

Illus. 3. The southern exterior of Barn 1 showing the original double doors of the mid-19th century vehicle shed (1) respected by closers (quarter bricks) in both brick jambs. These doors are interrupted internally by the secondary ceiling, and the gable window dates from the alterations of *circa* 1980. The lean-to shed adjoining on the left (1a) and the yellow-painted workshop beyond (1b) were built on the site of the 19th century sheds depicted on the Ordnance Survey of 1958 (figure 6).

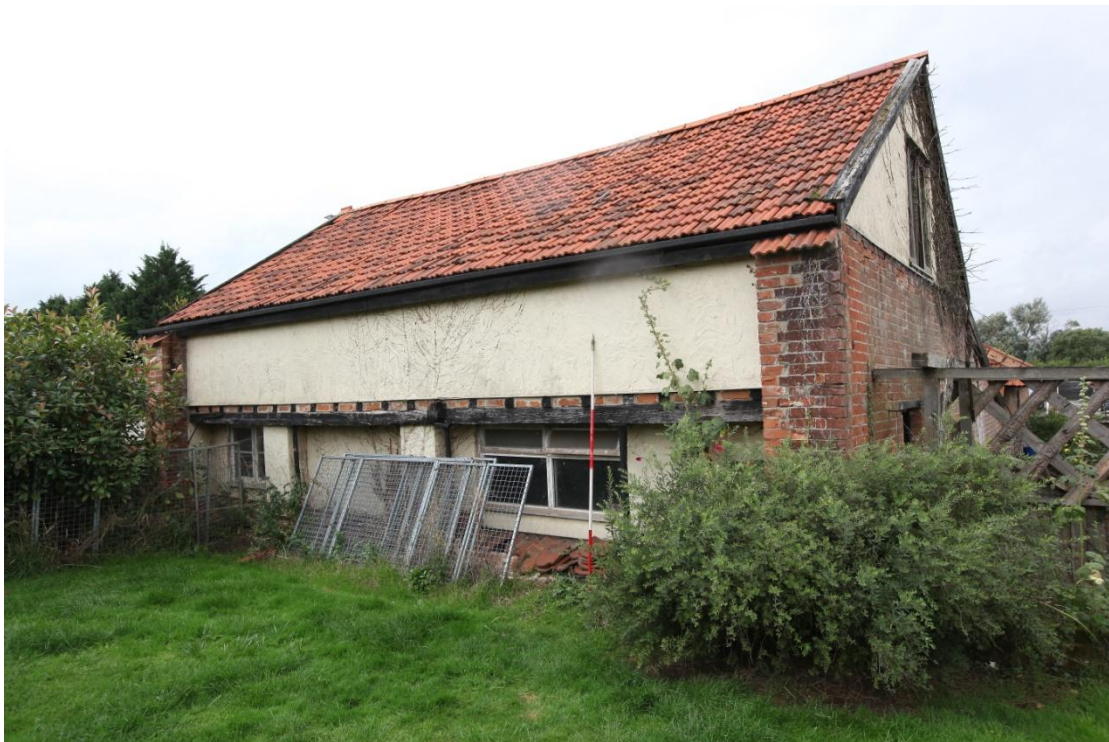
The fabric of the eastern wall is recessed behind the brick piers of its corners and was rebuilt as part of the *circa* 1980 refurbishment (A2.4). The foundation of the thicker original wall, which is reported to have consisted entirely of flint rubble, is now covered at ground level by a series of pantiles. The lower storey of the new wall consists of cement blocks and the upper of vertical studs infilled with brickwork. The roof structure including its gables was rebuilt in softwood at the same time. The internal ceiling at a height of 2 m (6.5 ft) consists of tall-sectioned machine-sawn softwood joists notched into a pair of principal joists and supported by iron posts. A blocked trap in its south-eastern corner indicates the position of a former stair, and the present stair in the opposite north-western corner is a modern insertion. The north-eastern quarter of the ceiling consists of lateral common joists but appears to have been rebuilt as there is evidence of earlier axial joists in the adjoining principals. The character of the timber in this ceiling identifies it as an early-20th century insertion, probably of the 1920s or 30s, as does the fact that it interrupts the original southern entrance (A2.9 & 10).

Illus. 4. The cement-rendered eastern wall of the vehicle shed (1) rebuilt in *circa* 1980 and recessed behind its original brick corners to left and right. The original wall is understood to have consisted of flint-rubble, and the pantiles at ground level protect the remains of its foundation. The treble-tiled roof also dates only from *circa* 1980.

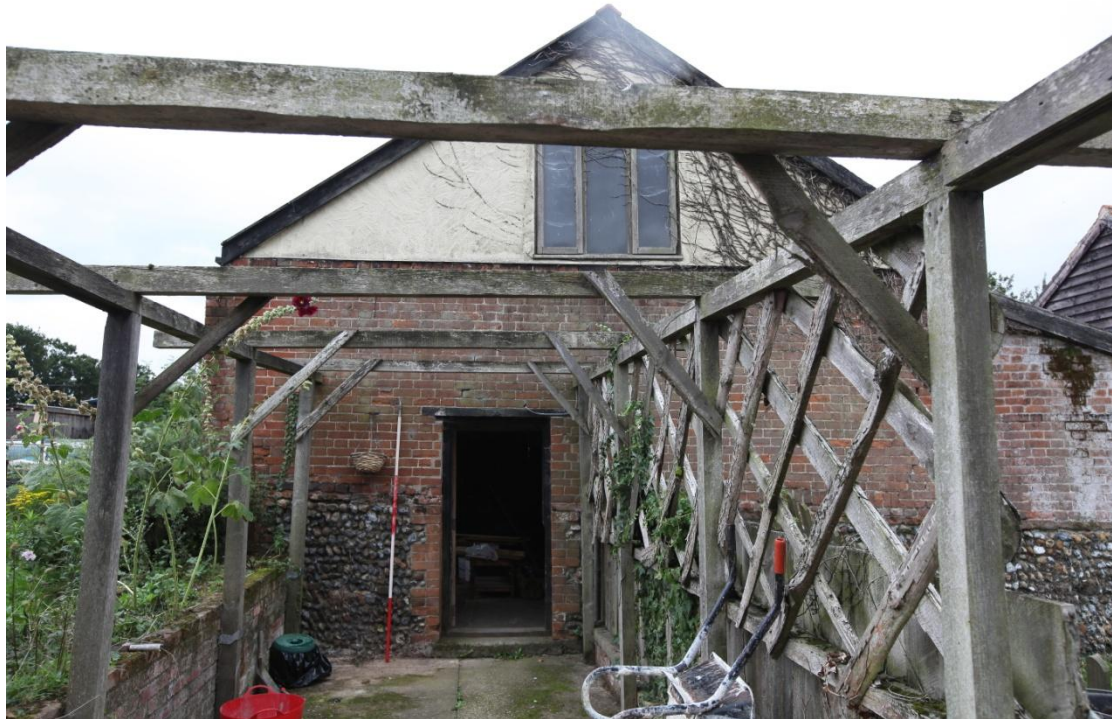
Illus. 5. The northern external gable of the vehicle shed (1), showing its 20th century window and an ostensibly secondary door with cement-mortared brick jambs interrupting the flint-rubble plinth.

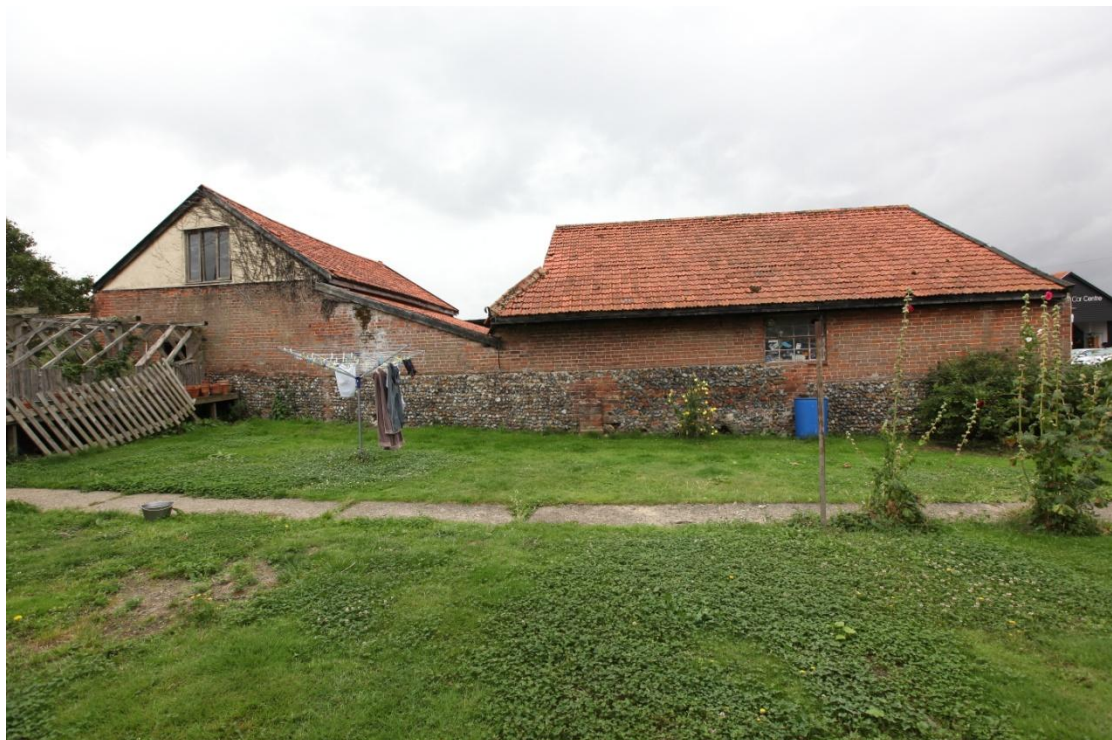
Illus. 6. The northern exterior of Barn 1 showing the vehicle shed (1) to the left and the surviving red-brick and flint-rubble wall of the contemporary buildings on the site of the lean-shed (1a) and storage shed (1b). The rest of these two structures dates only from the second half of the 20th century. The flint-rubble plinth may have been retained from an earlier yard wall, although there is no obvious sign of this on the tithe map.

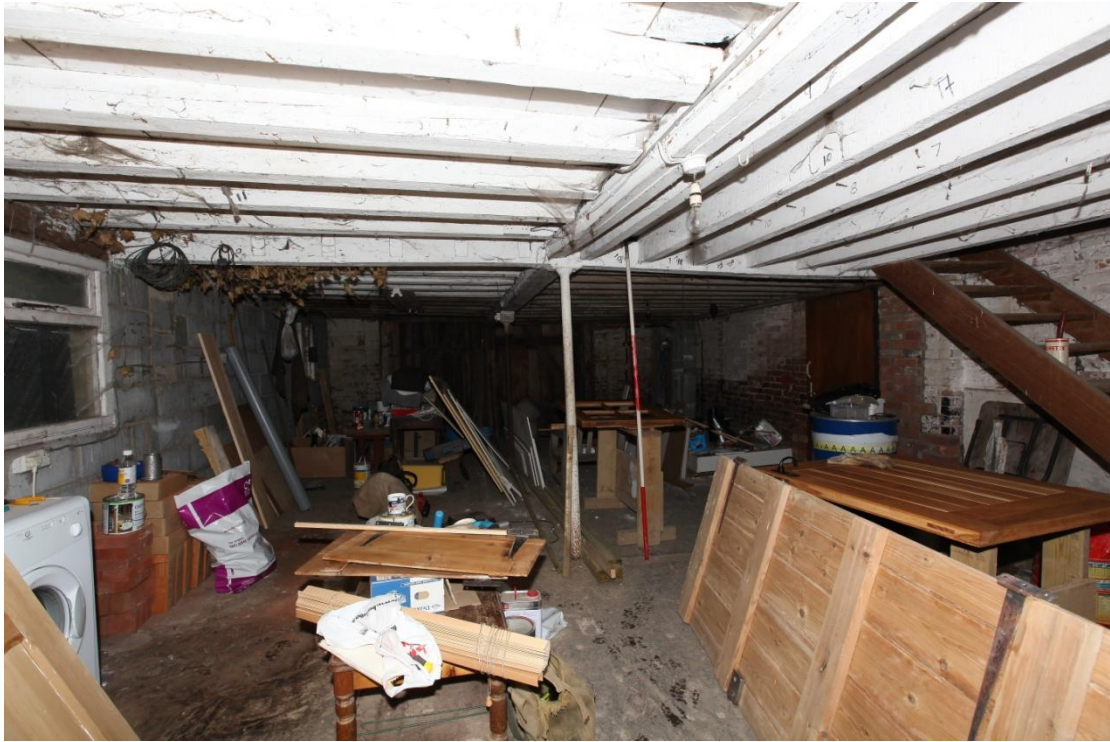
Illus. 7. The interior of the vehicle shed (1) from the north showing its early-20th century secondary ceiling of painted deal joists supported by two axial iron posts. The lateral joists to the left have been altered as the principal joist is rebated for earlier axial joists. The stair to the right is a late-20th century insertion.

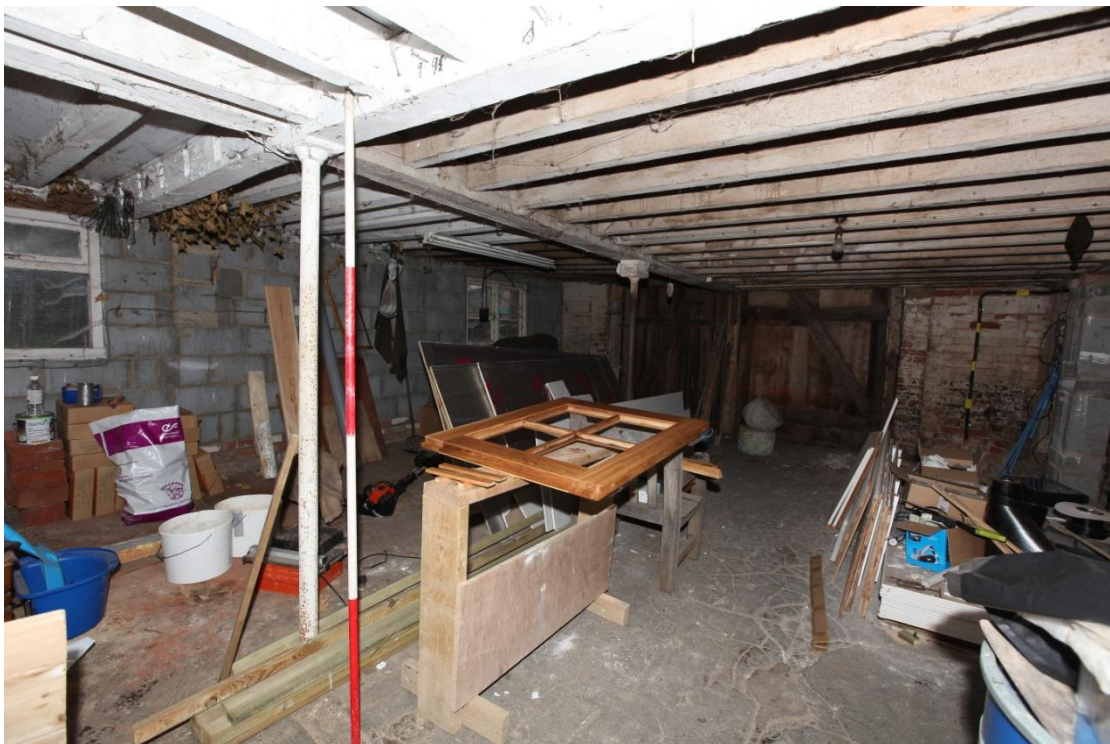
Illus. 8. The interior of the vehicle shed (1) from the north-west showing its two axial iron posts with the southern gable doors in the rear and the cement-block fabric of the eastern wall on the left. The floor consists entirely of 20th century concrete.

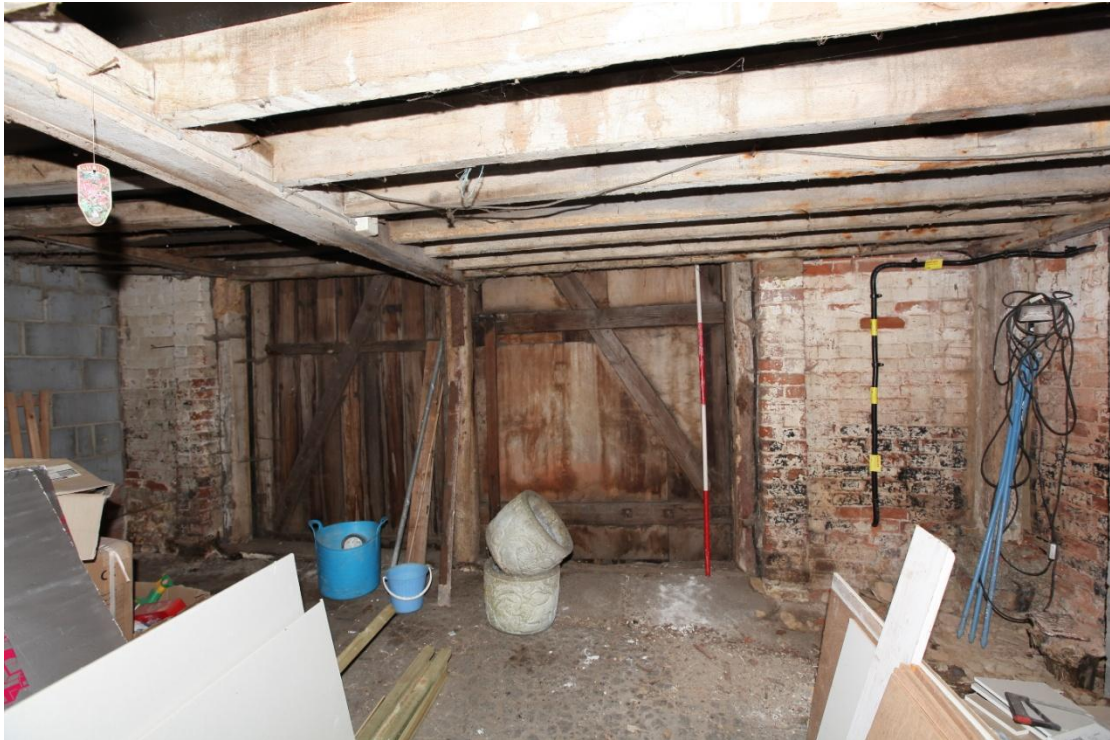
Illus. 9. The original entrance doors in the southern gable of the vehicle shed (1) now partly blocked by the later ceiling and its central supporting post.

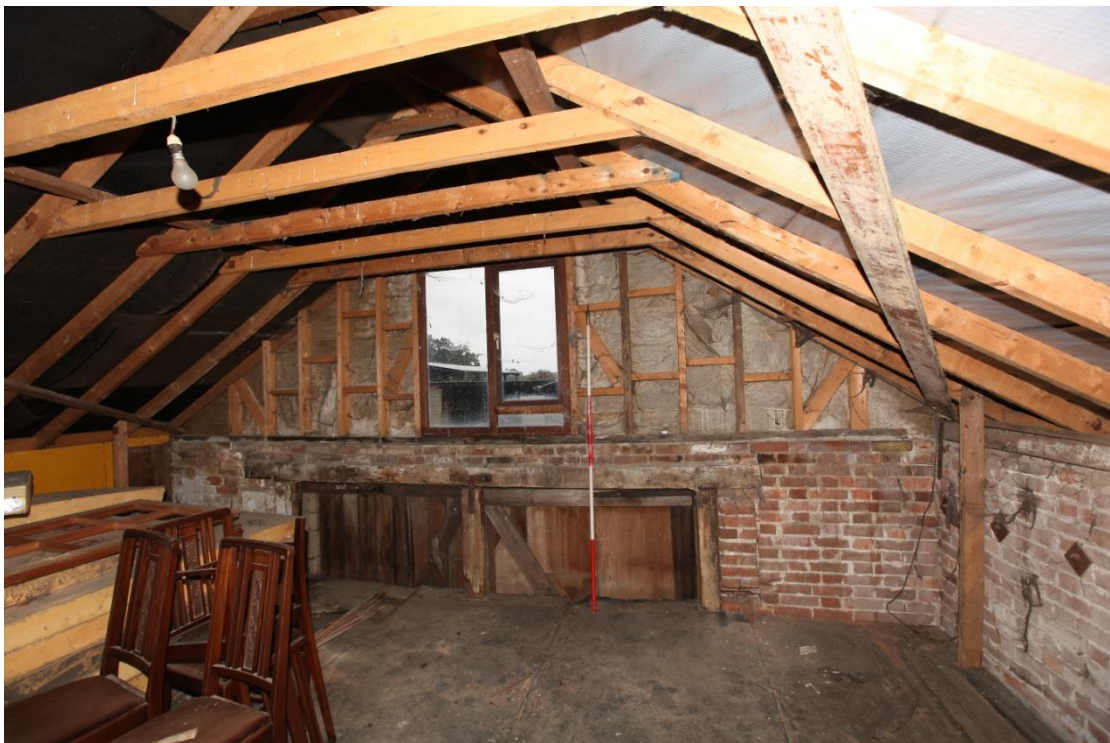
Illus. 10. The top of the original entrance doors in the southern gable of the vehicle shed (1) as seen from the loft. The window and studwork above the original brickwork are part of the alterations of *circa* 1980, as is the entire roof structure.

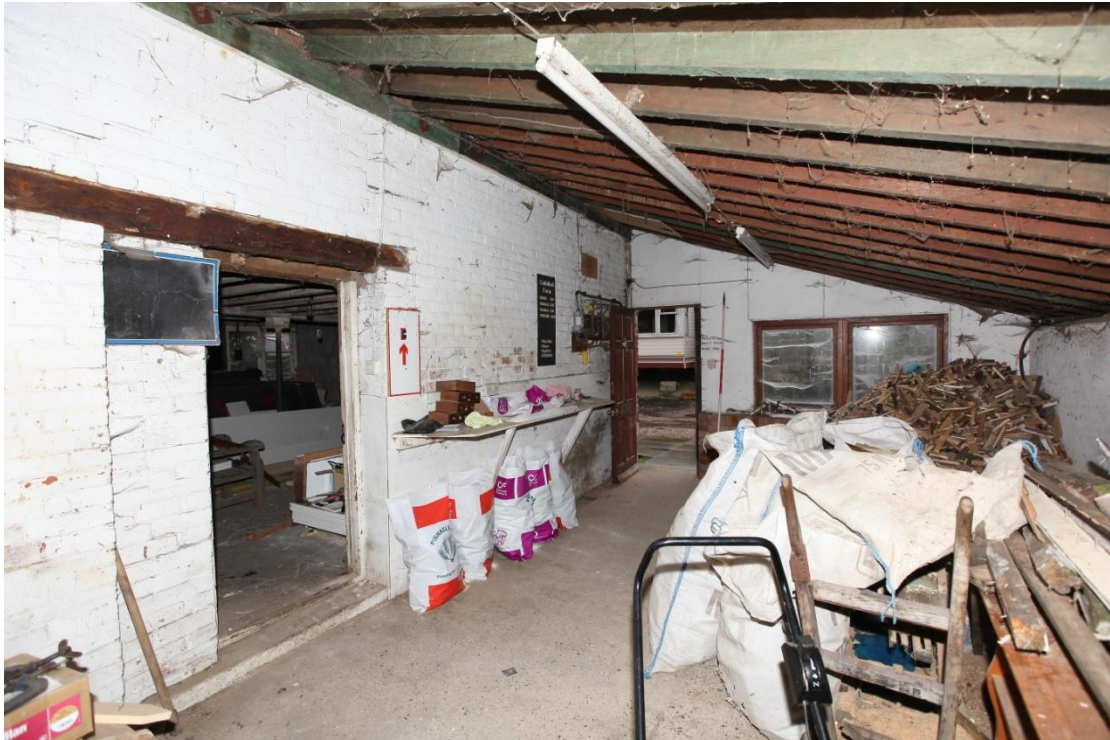
respected by closers (quarter bricks) in both jambs and retains a pair of ostensibly original double doors. The western wall also consists of red brick and contains a second original door of 1.3 m in width by 2 m in height beneath a timber lintel (illus. A2.11). This door was reduced in width during the late-20th century by inserting a pier of Fletton brick on the north. A third door in the brick and flint-rubble northern gable appears to be a later insertion as its red-brick jambs interrupt the plinth and are laid in cement mortar (illus. A2.5).

Illus. 11. The interior from the north of the 20th century lean-to shed (1a) showing the original side door of the vehicle shed (1) on the left. This doorway is respected by closers in the brickwork but has been reduced in width by inserting a new brick pier to its left. The right-hand (western) wall of this shed consists of cement block-work.

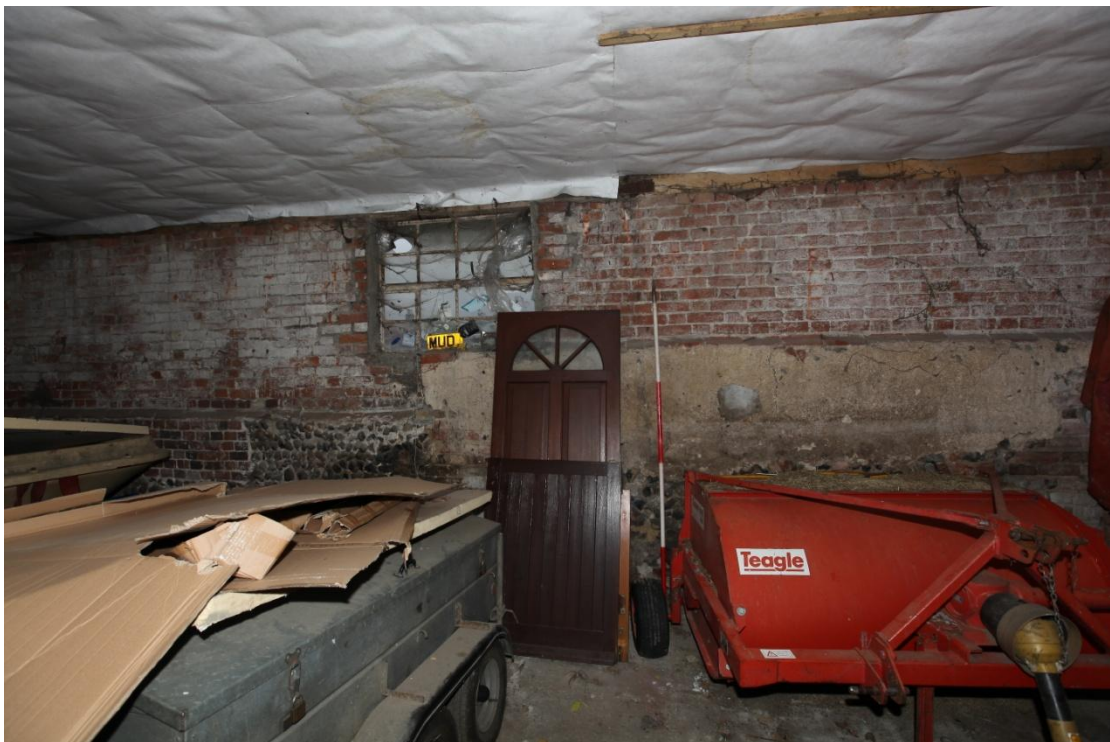
Illus. 12. A detail of the original 19th century northern internal wall of the workshop (1b) showing its secondary window. The rest of the shed consists of cement block-work and represents a 20th century reconstruction on the site of the 19th century sheds to which this wall belonged.

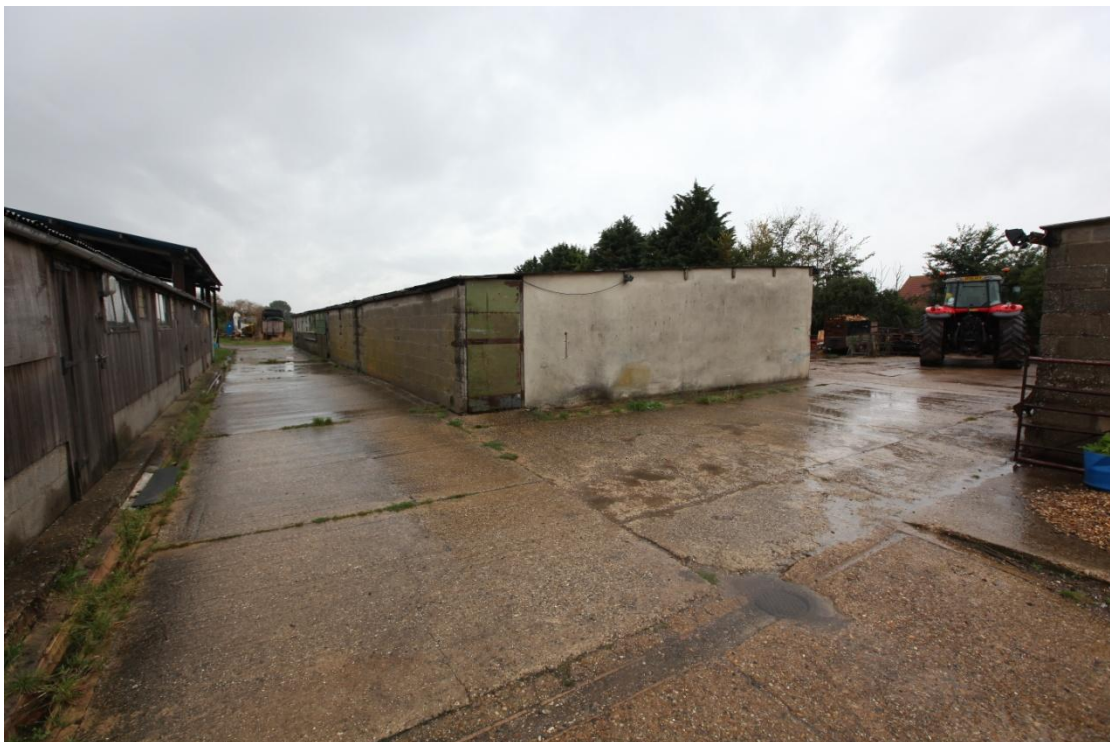
Illus. 14. The mid-20th century farm buildings to the south of the site entrance, viewed from the north. Barn 5 is shown in the centre with Barn 3 on the left and Barn 2 on the right. These cement-block structures were built to house pigs in the 1960s and are not of historic significance. Included for site context.
