## **St. Andrews Church, Aldringham Cum Thorpe**

**Client:**  
Aldringham PCC

Archaeological Evaluation Report

SACIC Report No. 2015/073

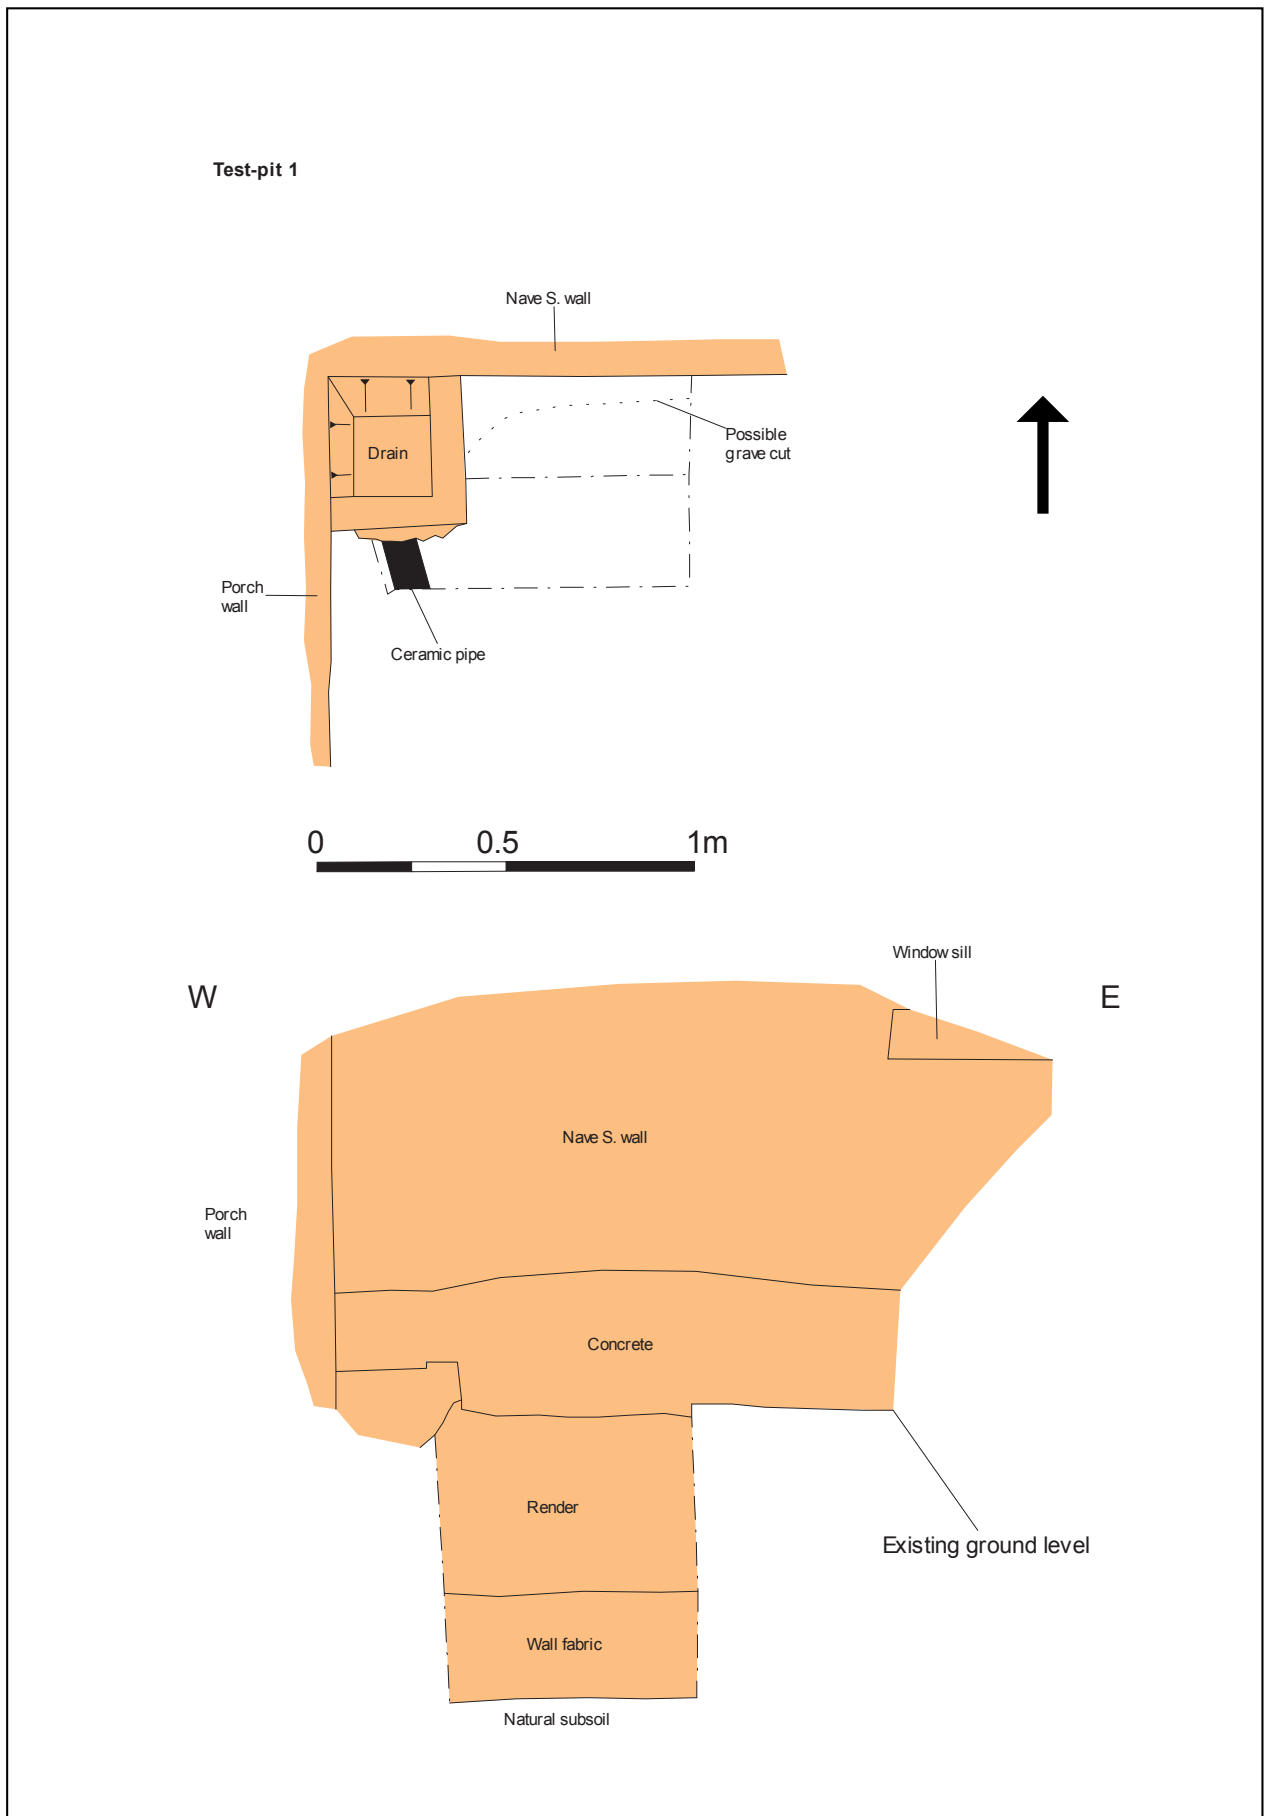
Figure 3. Test-pit 1; plan and section

**Test-pit 1:** was excavated in the angle formed by the junction between the east wall of the south porch and the south wall of the nave. This pit was positioned to investigate the integrity of the below ground component of the extant drain in the angled corner formed by the two walls (Figs 2 and 3; Plates 1 and 2). At this juncture, the c.0.3m wide band of hard cementitious mortar, which runs the entire length of the wall base, extended to a depth of only 4cm below the existing ground level.

Below this, the face of the wall was covered with a gravel rich lime render for c.0.46m, giving way to a further c.0.28m of bonded fabric down to the wall base at a depth of 0.8m below the existing ground surface. The gravel rich render exhibited a smooth vertical face and was in a perfect unweathered condition. This almost certainly was the same layer as seen above ground at this juncture where weathering had removed the outer surface to leave an uneven face with the gravel inclusions more pronounced.

The base of the wall appeared to be horizontal at this juncture, but within the confines of such a limited intervention this could not be ascertained for certain. While it was unclear if there was an excavated footing below the base of the bonded wall, it was clear that the level of the wall base was also that of the surface of the naturally occurring subsoil which comprised orange sand with frequent gravel inclusions. A possible grave cut was seen in the base of the trench cutting into the natural sand and gravel. The wall fabric comprised predominantly of poorly coursed flint pebbles and cobbles, mostly rounded, set in a cream-coloured lime mortar.

The excavated overburden comprised greyish silty loam grading down to an orange/brown silty sand with a few inclusions of flints, roof tile, mortar, limestone fragments and very occasional small pieces of human skeletal material. There was no evidence to suggest that the drain base or its associated ceramic pipe was leaking.

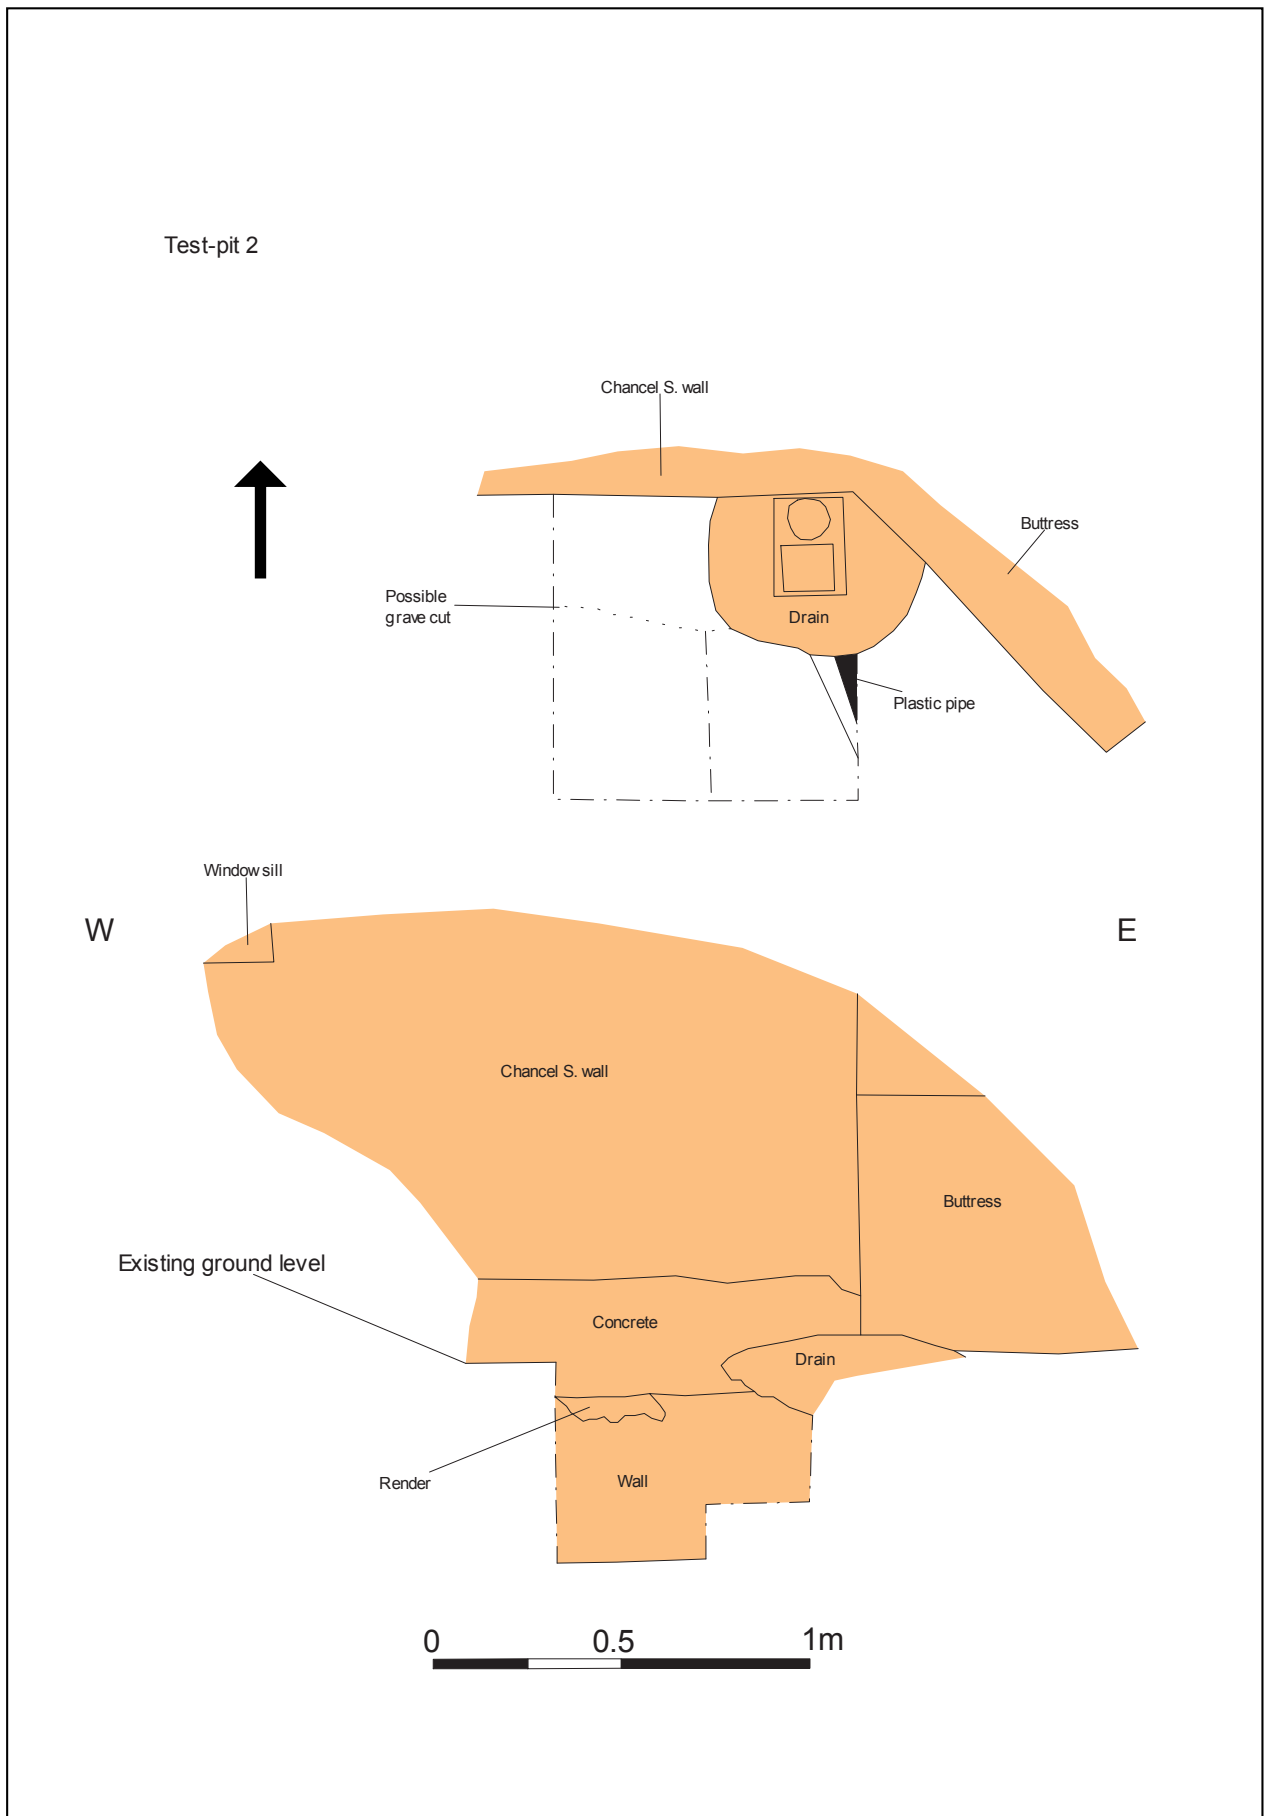
Figure 4. Test-pit 2; plan and section

**Test-pit 2:** was excavated in the shallow angle formed between the eastern end of the chancel south wall and the adjacent south-east corner diagonal buttress. Similarly to Test-pit 1, this pit was positioned to investigate the integrity of the below ground component of the extant drain in the angled corner formed by the two walls (Figs 2 and 4; Plates 3 and 4). At this juncture, the c.0.3m wide band of hard cementitious mortar, which runs the entire length of the wall base, extended to a depth of 10cm below the existing ground level.

Below this, there was a small remnant of gravel rich lime mortar render on the face of the wall which, itself, continued down for a further 0.46m to its base which again equated to the level of the naturally occurring subsoil, here, comprising orange sand.

Again, the base of the wall appeared to be horizontal within the confines of the limited excavation and the presence or absence of an underlying footing below the base of the bonded wall was not ascertained. Another possible grave cut was seen in the base of the trench cutting into the natural sand.

Again, there was no evidence to suggest that the drain base or its associated plastic pipe was leaking.

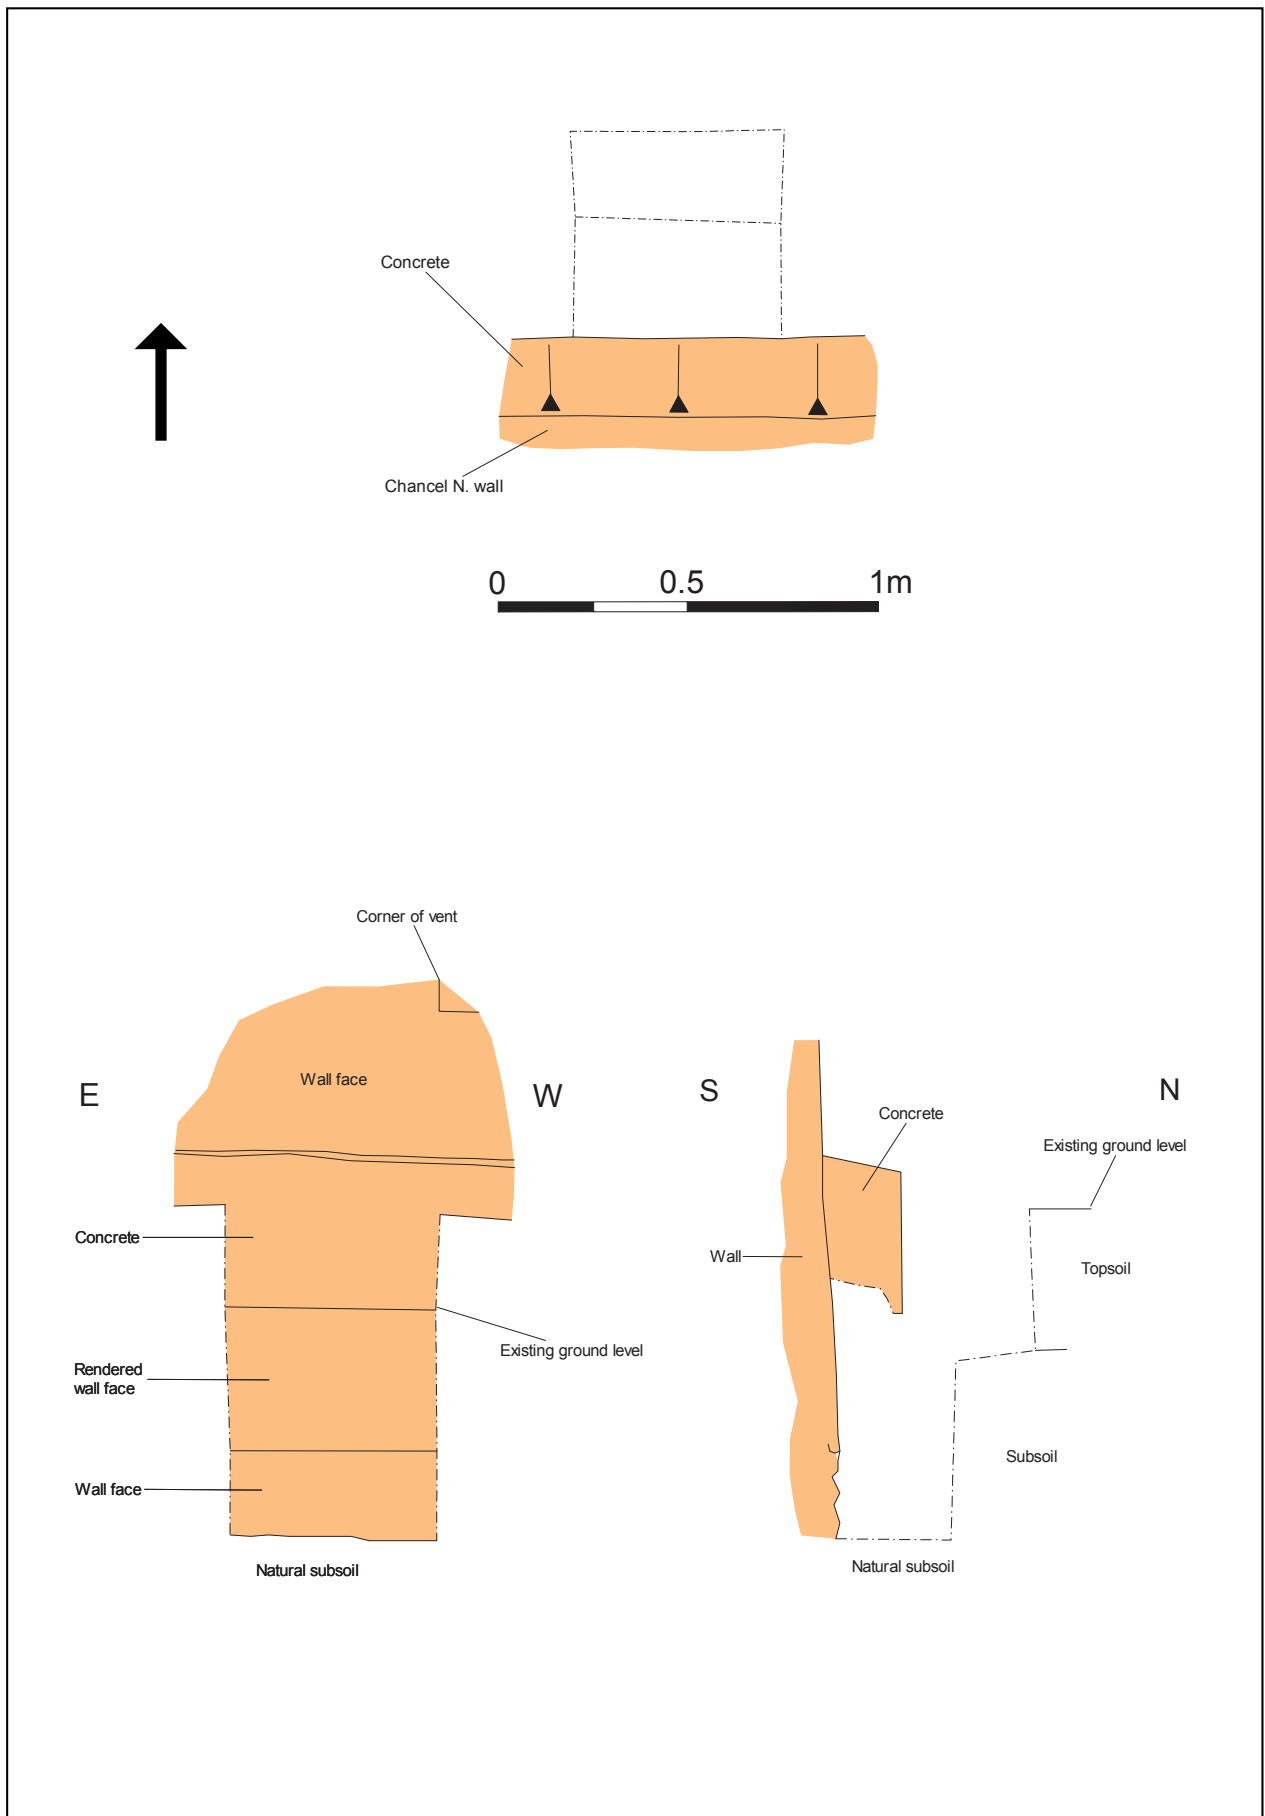
Figure 5. Test-pit 3; plan and sections

**Test-pit 3:** was excavated against the northern wall of the chancel approximately 2.5m from its eastern end (Figs 2 and 5; Plates 5 and 6). The north wall did not have the same strip of hard cementitious render at its base, but did have a stepped feature running for its entire length, the surface of which appeared to be similar in character to the render strip on the south side of the church.

Excavation revealed that the vertical face of the feature continued down for approximately 0.3m below the present ground surface and was found to be sitting directly on subsoil. Removal of the subsoil directly below the feature revealed the face of the chancel wall c.0.2m back. The wall face was again covered in a well preserved gravel rich render layer which continued down to 0.64m below existing ground level with the, apparently horizontal, base of the wall a further 0.26m down, again equating to the level of the naturally occurring orange sand subsoil. The presence of a lower footing was not ascertained.

The wall fabric here comprised predominantly of closely packed flints with a hint of coursing.

The excavated overburden comprised 0.36m of dark brown loam over 0.55m of orange/brown silty sand; both layers contained frequent flint cobbles.

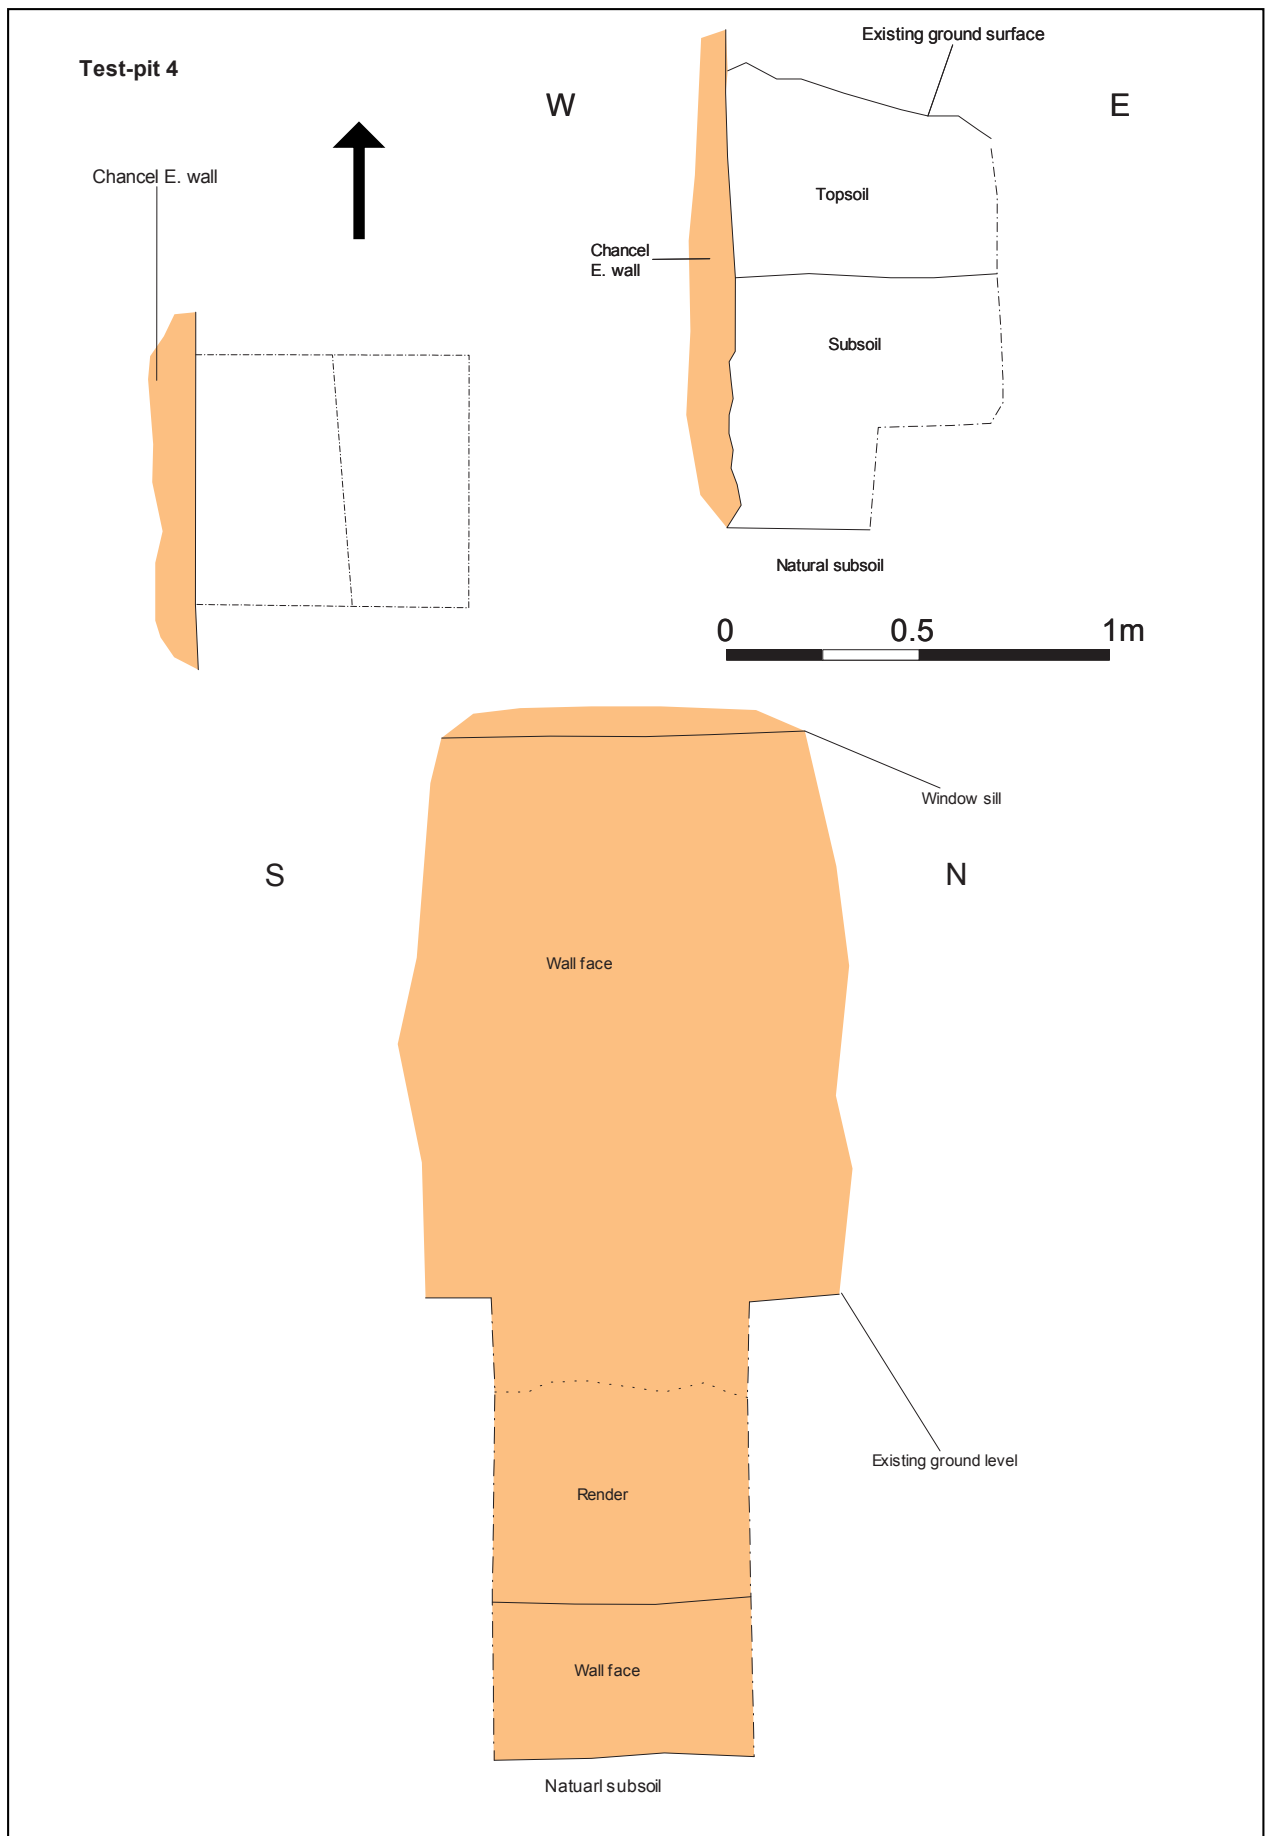
Figure 6. Test-pit 4; plan and sections

**Test-pit 4:** was excavated central to the face of the east wall of the chancel end within a flowerbed (Figs 2 and 6; Plates 7 and 8).

At approximately 0.2m below the existing ground level the wall face exhibited a similar layer of gravelly render to that seen in the other trenches, continuing down to a depth of 0.80m. The bonded wall fabric continued on down for a further 0.40m, to a total depth of 1.20m below the present ground surface. The fabric here comprised relatively uniformly sized large rounded flint pebbles/small cobbles set in a rather loosely aggregated dark cream-coloured lime mortar. The presence or absence of a lower footing was not ascertained.

The excavated overburden at this juncture comprised a dark grey/brown loam in the flowerbed, which graded into a less organic loam (all shown as one layer on Fig. 6), the whole with a combined maximum depth of 0.5 against the wall face itself. Below the topsoil was a c.0.60m thick brown silty sand layer which exhibited some stratification and included fragments of tile/brick, mortar and a few sherds of medieval coarseware pottery.

Again, the level of the naturally occurring orange sand subsoil also marked the base of the solid bonded wall.
