**Guildhall Feoffment Primary School
(HORSA Huts),
Bury St Edmunds, Suffolk BSE 494
ESF23314**

Historic Building Record

Guildhall Feoffment Primary School (HORSA Huts), Bridewell Street, Bury St Edmunds, Suffolk

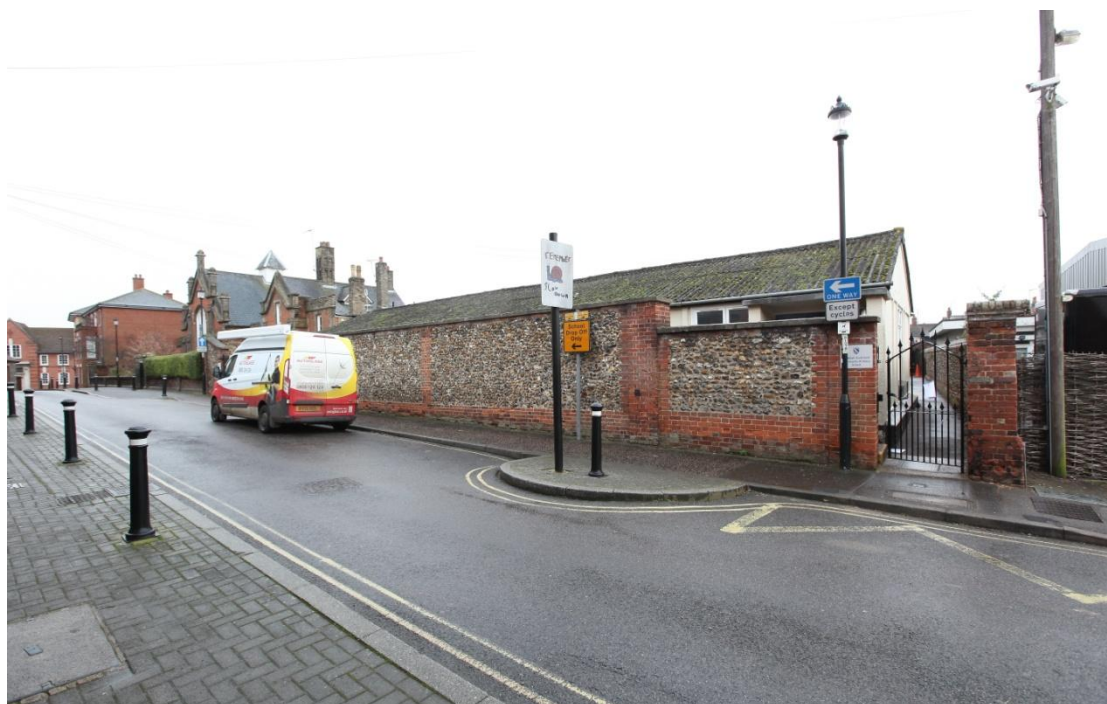
Illus. 1. A general view of the site from Bridewell Lane to the north-east showing the corrugated asbestos roof of the eastern range (1) behind the flint-rubble perimeter wall. The original Mock Gothic school buildings designed by Henry Kendall in 1842 are visible in the rear to the left.

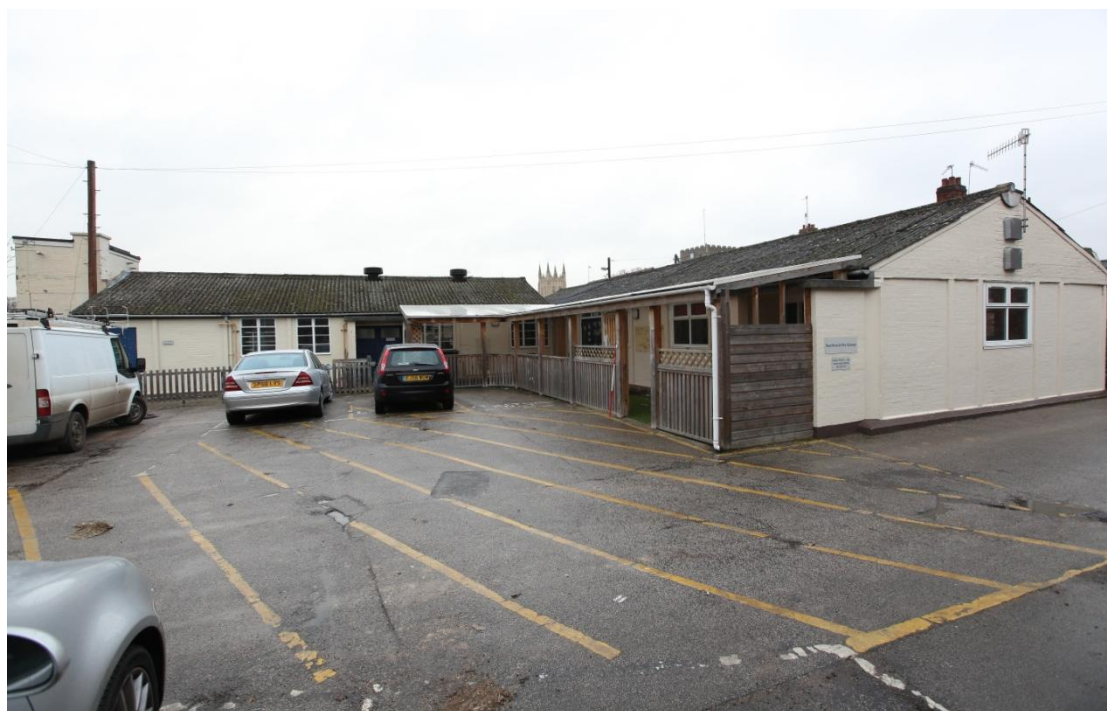
Illus. 2. The two adjoining huts from the south showing the modern veranda adjoining the eastern range (1) on the right and the water tower against the gable of the western range (2) on the left. The outline of a blocked original window is visible in the southern roof gable on the extreme right. The windows of the eastern range are modern PVC replacements but the original Crittall windows survive in the western hut.

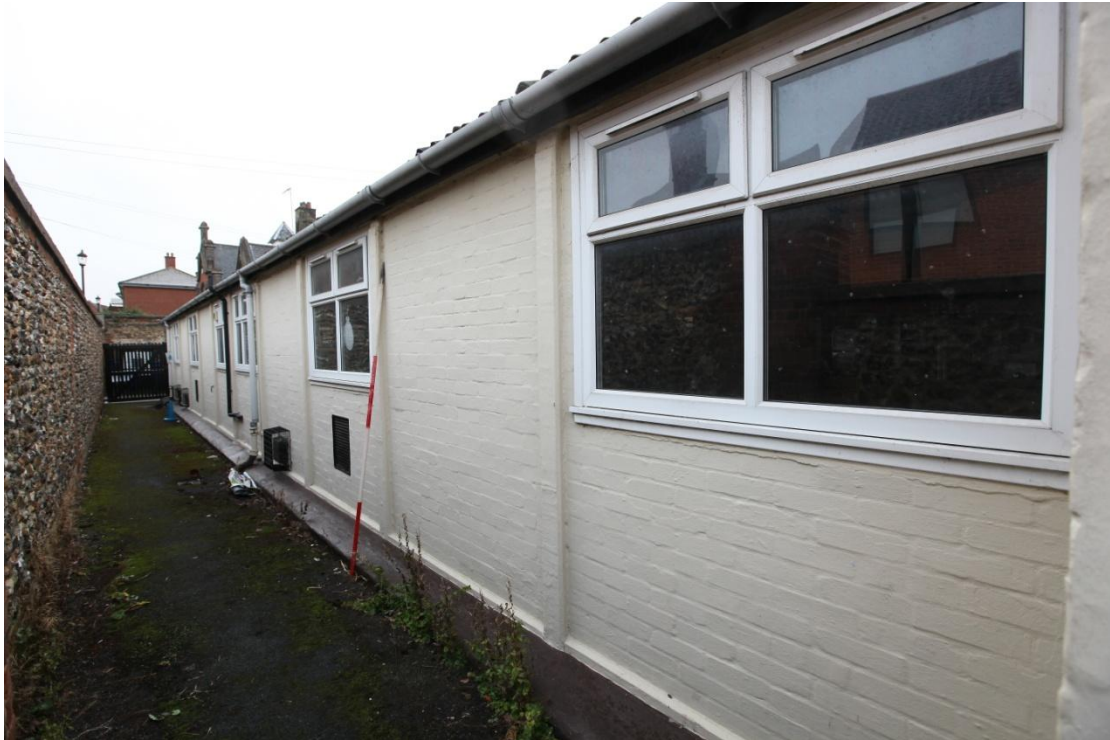
Illus. 3. The eastern exterior of the eastern hut (1) seen from the north with the perimeter wall adjoining Bridewell Lane on the left. The wall fabric of pre-cast concrete piers infilled with brick is original but the PVC windows are recent replacements.

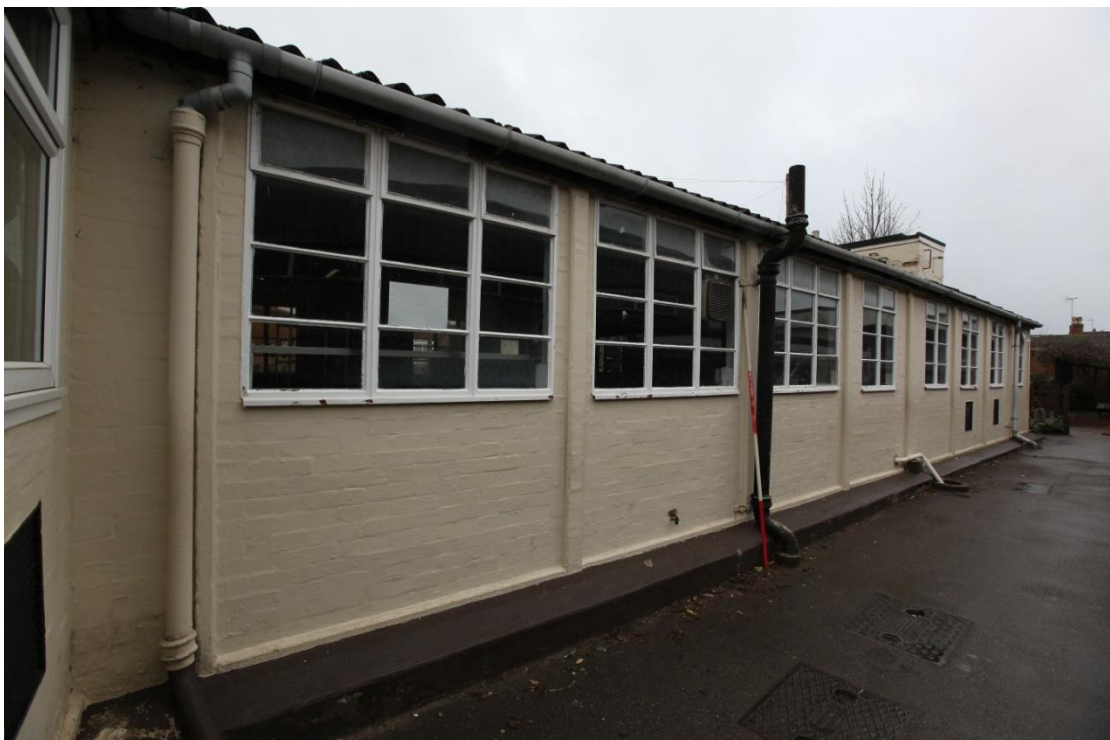
Illus. 4. The northern exterior of the western range (2) showing its largely unaltered appearance with a full complement of original Crittall windows. Its junction with the eastern range is visible on the left.

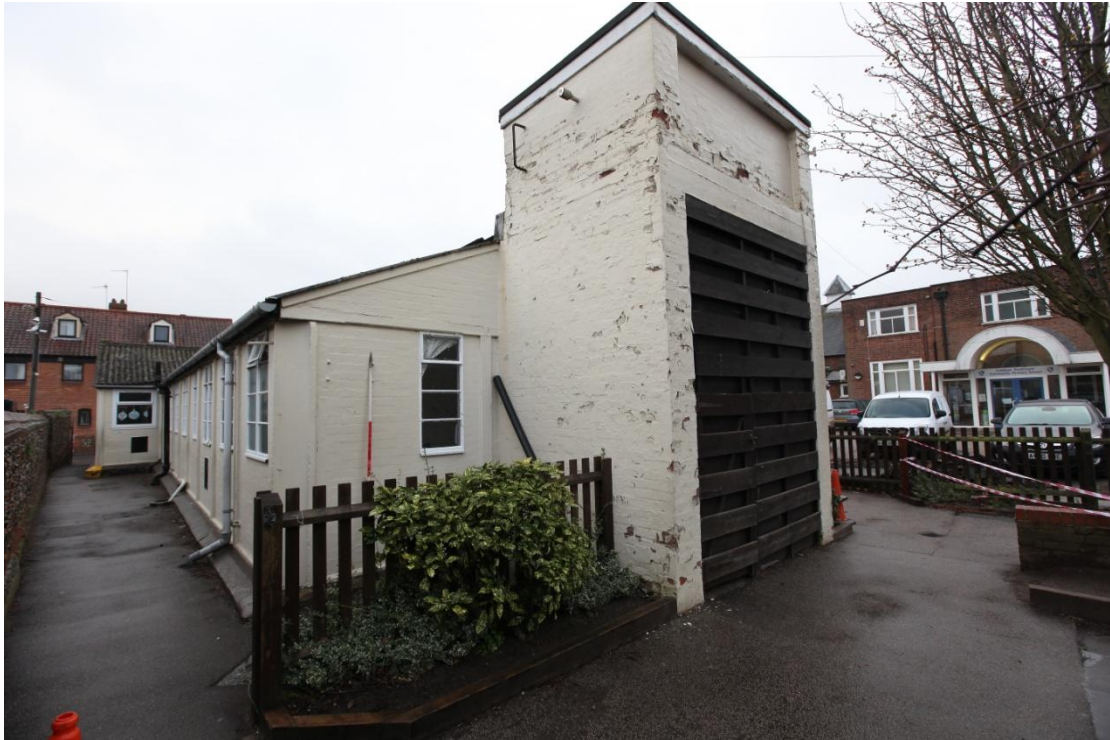
Illus. 5. The brick piers supporting a water tank adjoining the western gable (2e) with the main school building visible to the right. The wooden doors are recent insertions and the piers were formerly open to the yard.

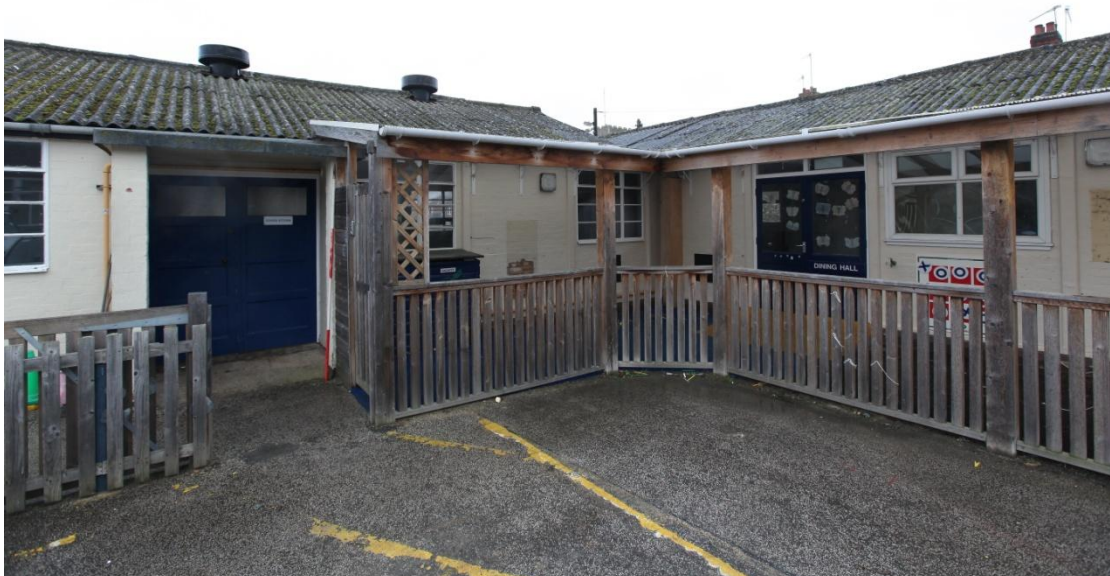
Illus. 6. The southern junction of the two ranges showing the later doors to the dining hall (1a) on the right and the original doors to the kitchen (2a) on the left.

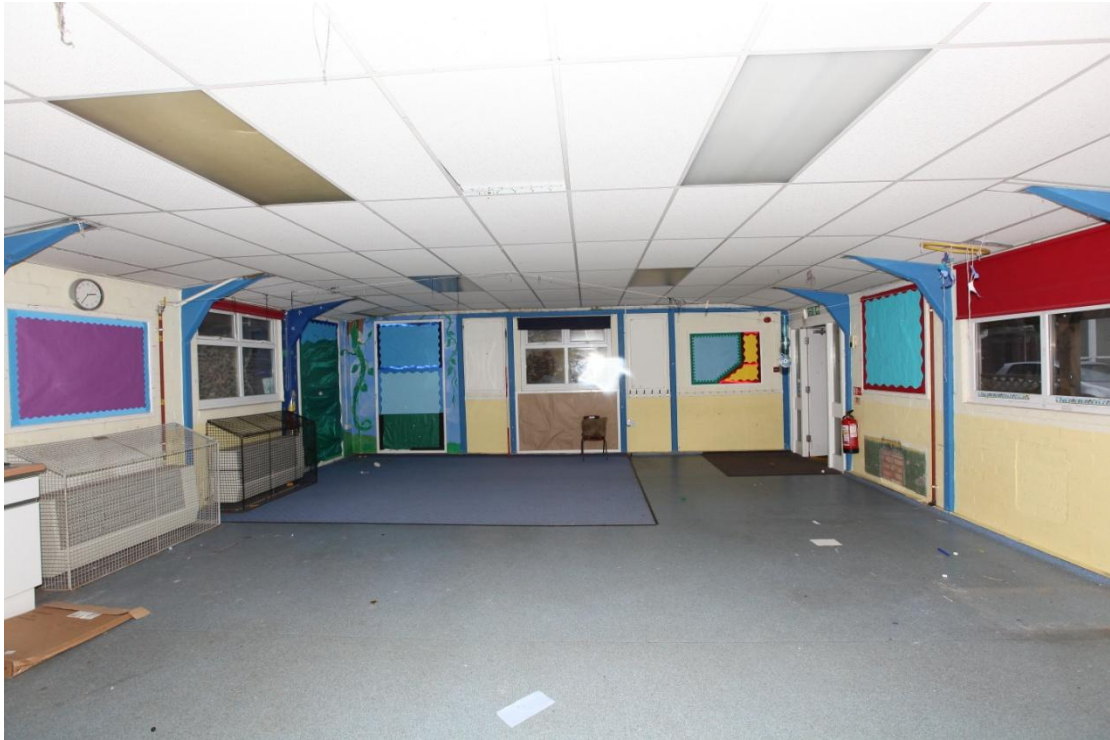
Illus. 7. The southern classroom (1d) from the north showing the original bolted pre-cast concrete knee-braces beneath the later ceiling.

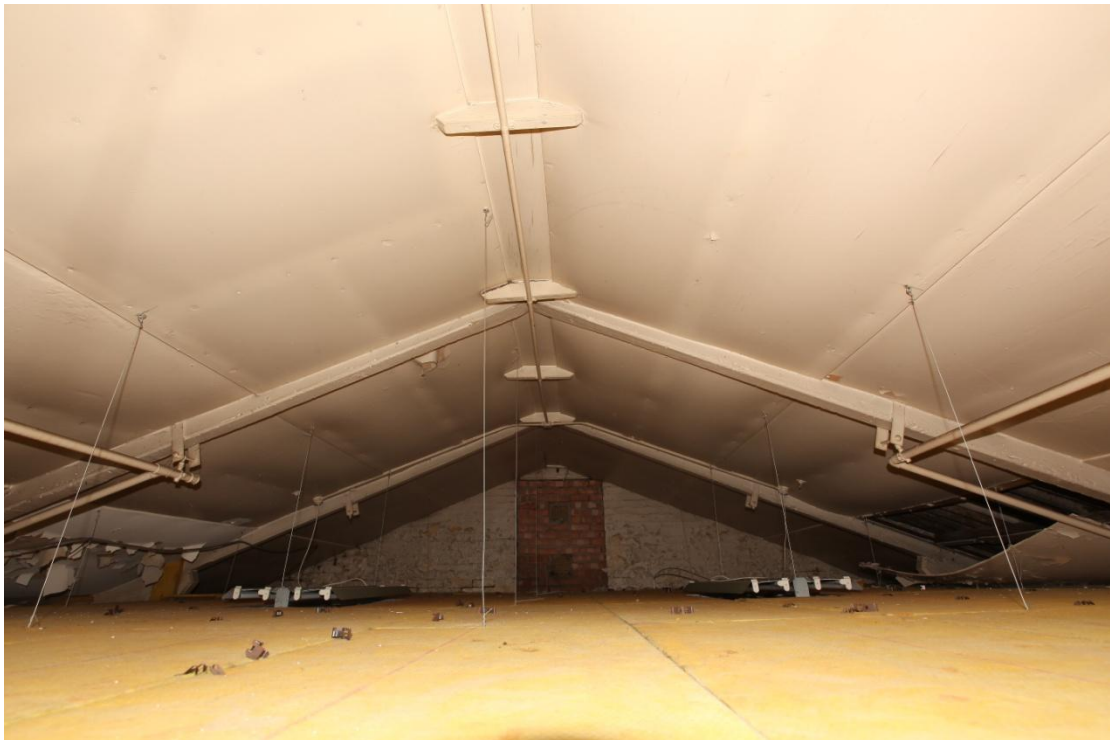
Illus. 8. The original ceiling of the southern classroom (1d) above the present suspended ceiling seen from the north, showing the blocked window in the southern gable. The chamfered principal rafters are of pre-cast concrete and the corrugated asbestos is hidden above nailed boarding.

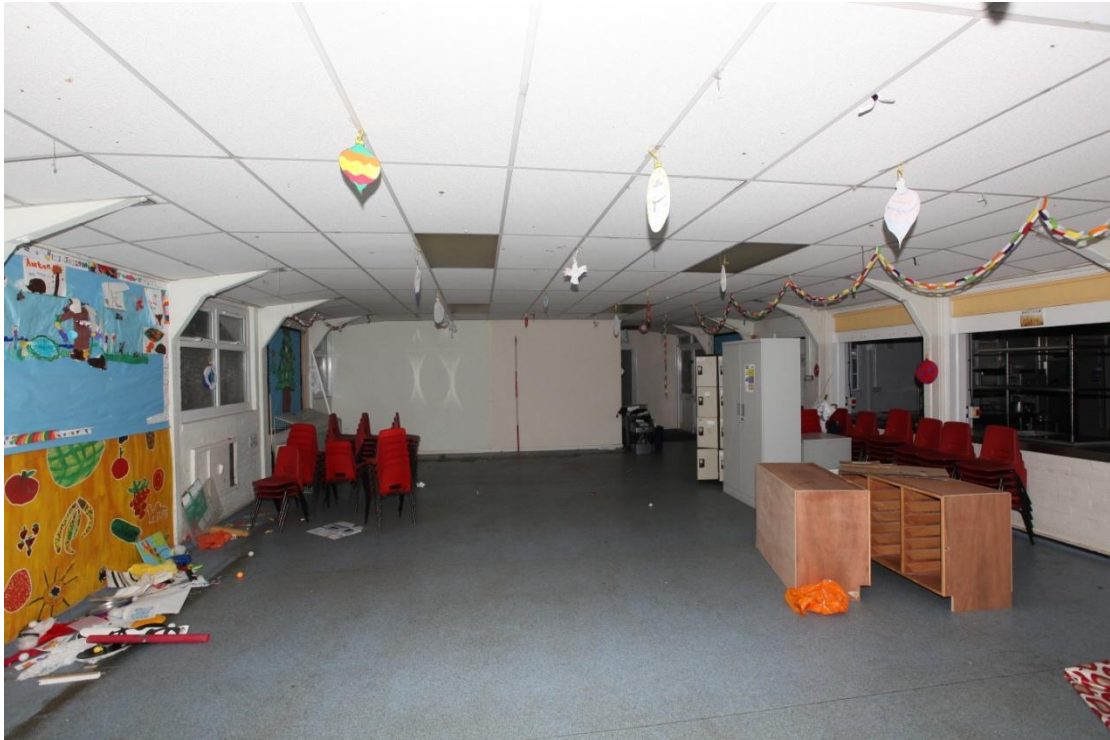
Illus. 9. The dining hall (1a) from the north showing the later ceiling and original concrete bolted knee-braces. The serving hatches adjoining the kitchen (2a) on the right are divided by the original concrete piers.

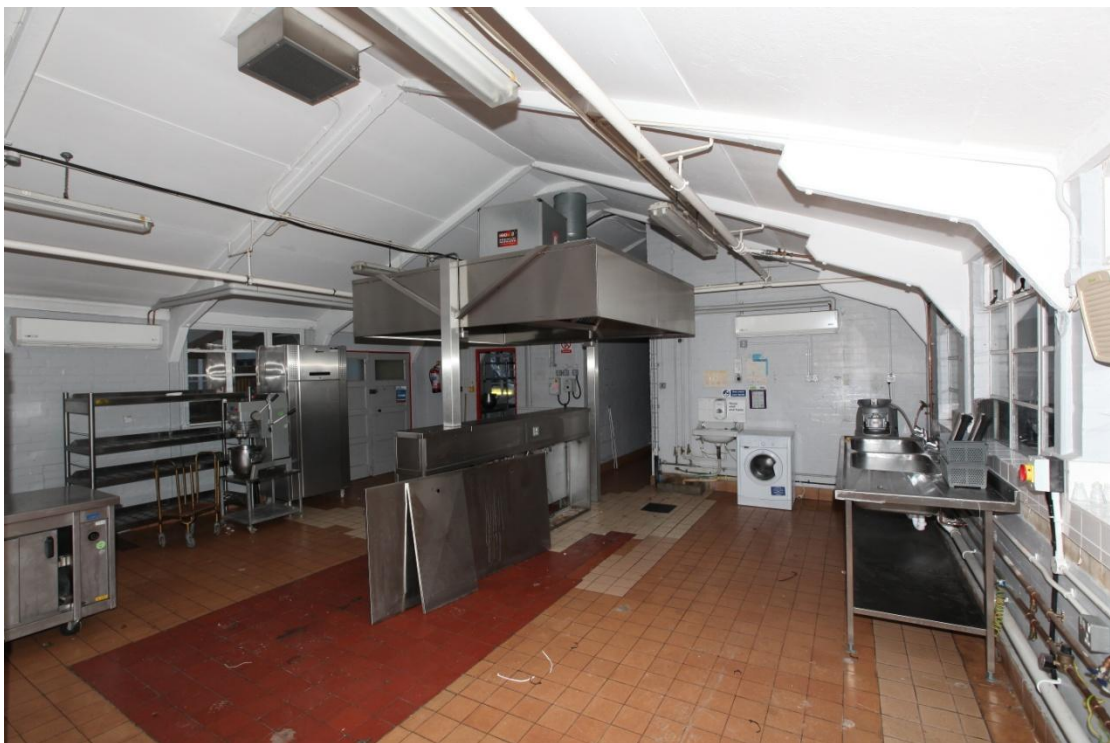
Illus. 10. The kitchen (2a) from the east, showing the original height of the ceiling with concrete principal rafters and bolted knee-braces. The axial passage (2f) is visible in the rear.

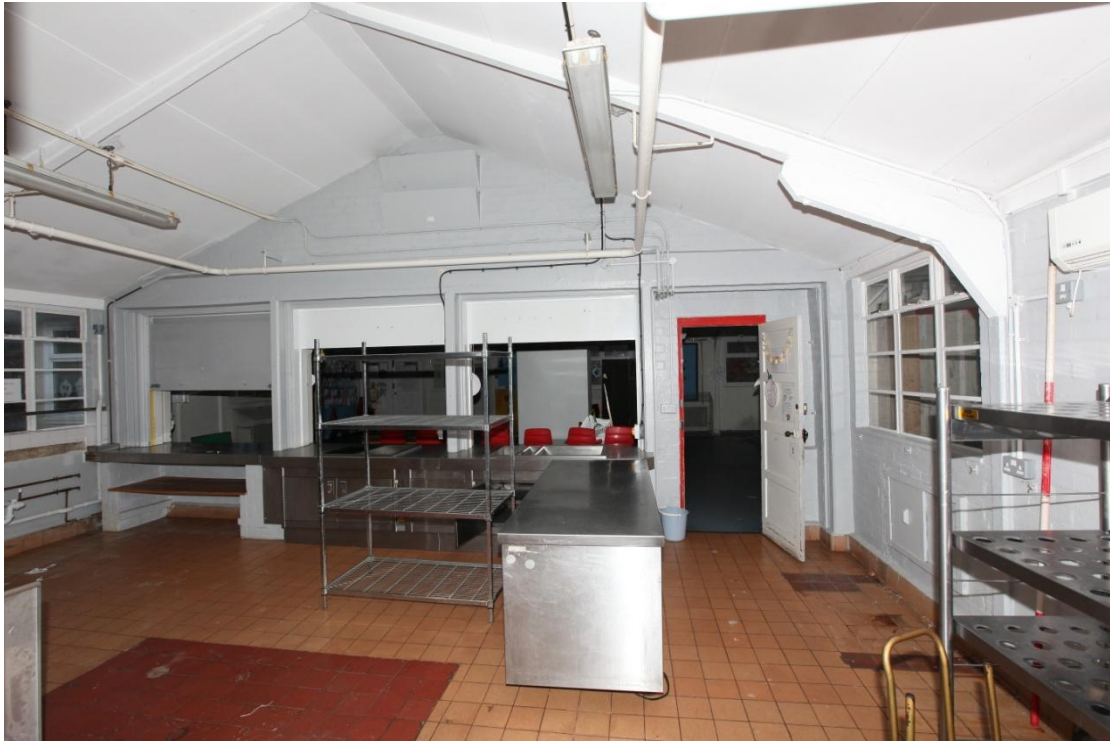
Illus. 11. The kitchen (2a) from the west showing the serving hatches and the original door adjoining the dining room (1a).

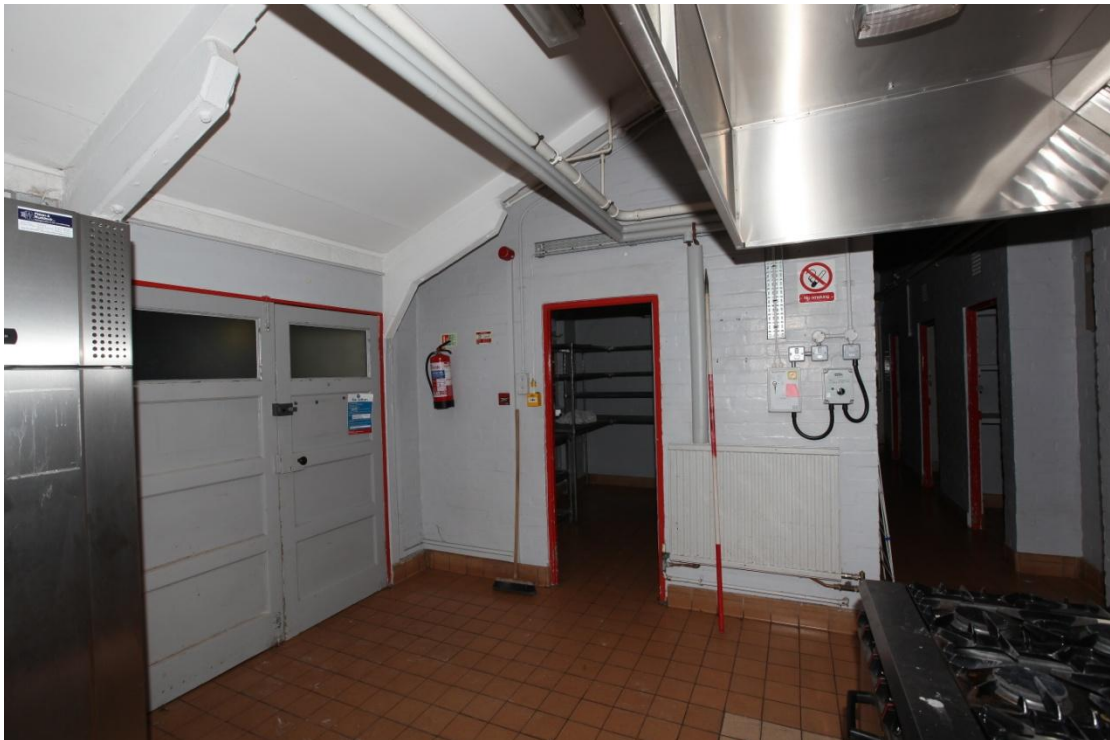
Illus. 12. The south-western corner of the kitchen (2a) showing the axial passage (2f) on the right, the door to the store room (2h) in the centre and the original entrance doors on the left.

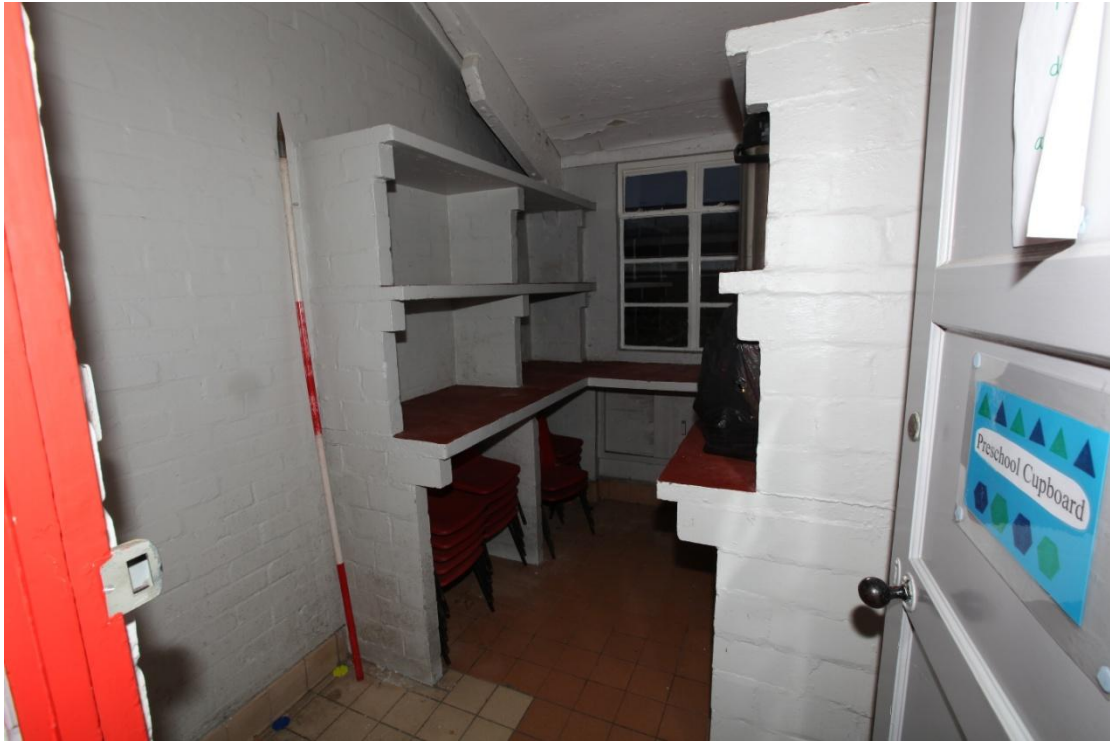
Illus. 13. The interior from the axial passage to the south of the narrow central store room (2c) showing its original door and brick shelving.

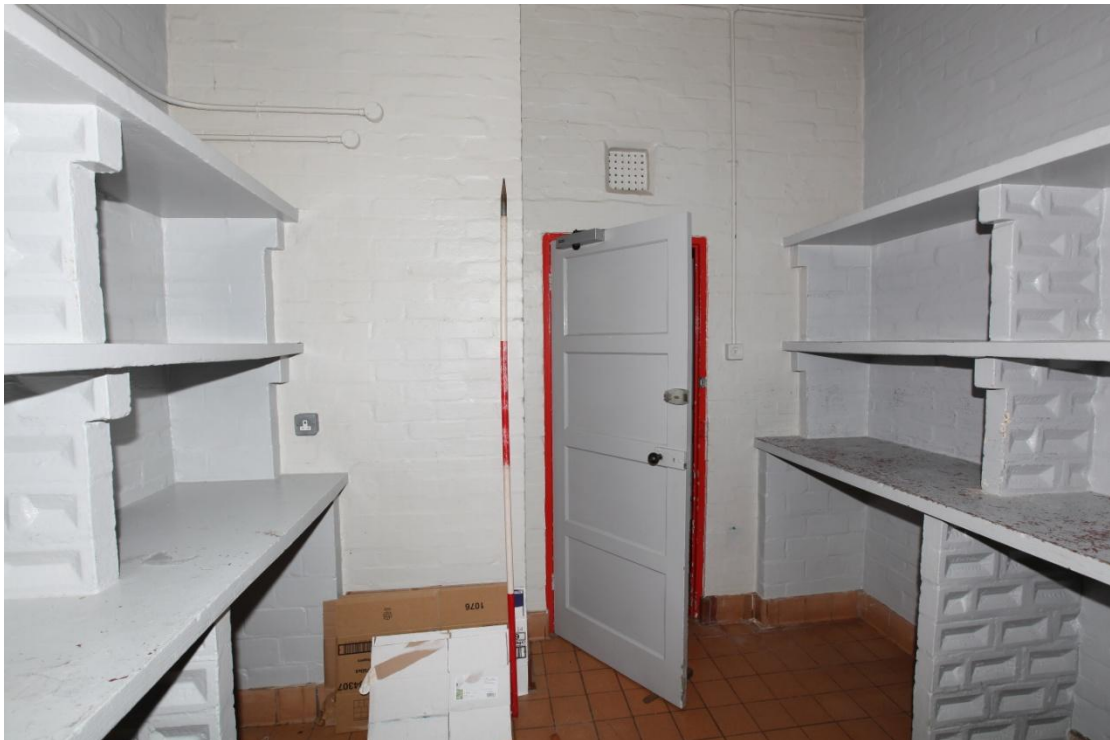
Illus. 14. The eastern store room (2d) from the north showing its original brick shelving and the door to the axial passage (2f).

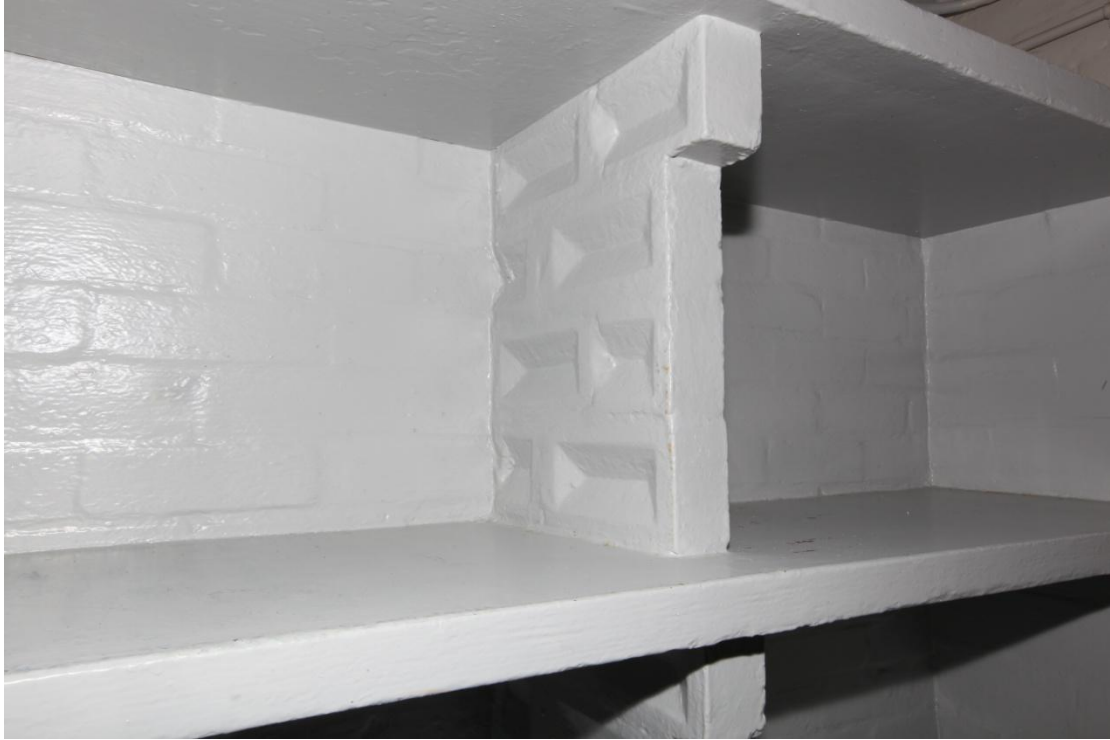
Illus. 15. A detail of the exposed frogs in the brick piers supporting the original shelves of concrete slabs against the western wall of the eastern store room (2d).

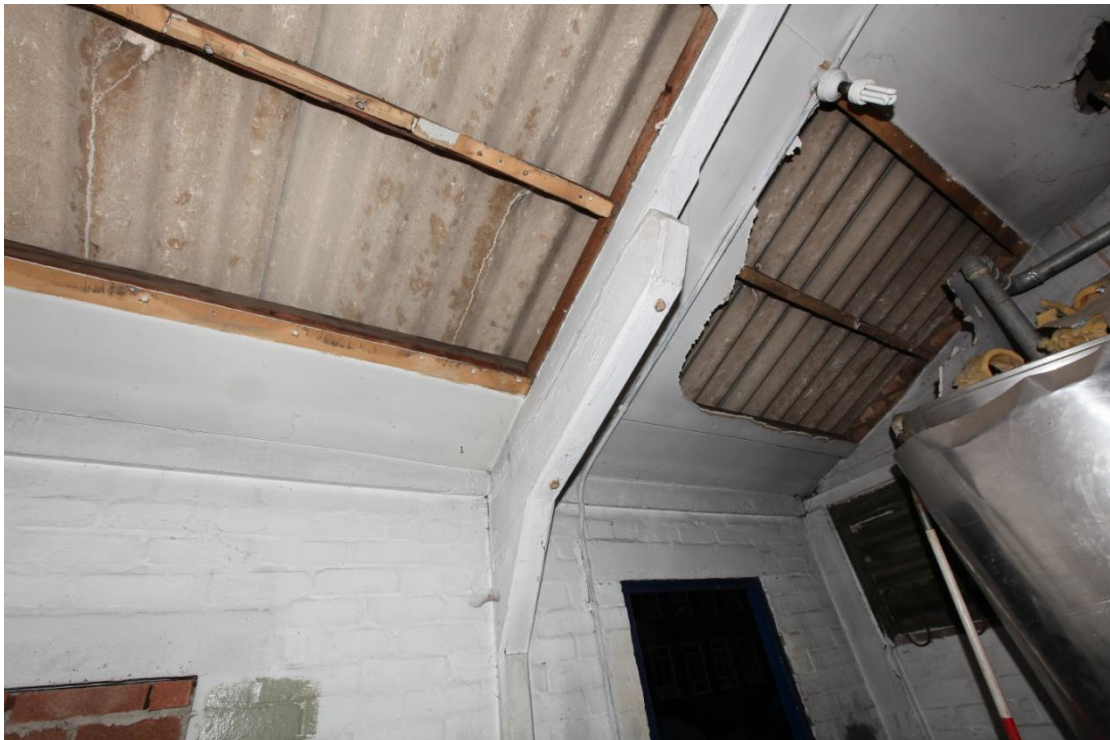
Illus. 16. The southern internal wall of the boiler room (2g) showing its external entrance door and exposed roof structure. The softwood battens supporting the corrugated asbestos are attached to concrete rafters which are linked to the wall piers by bolted knee-braces of pre-cast concrete.
