**Barn at Green Farm,
Finningham,
Suffolk
FNN 024**

HER Event No: ESF 24221

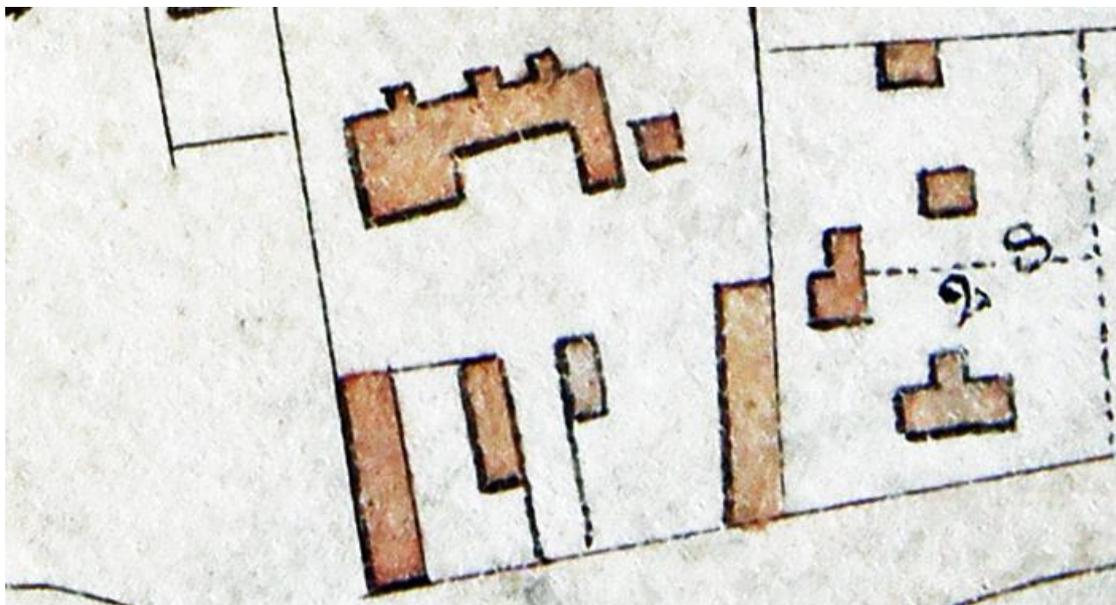
Figure 2a. A detail of the 1839 map. The rectangular barn and stable (structures 1 & 2 in figure 6) occupy the south-western corner of the enclosure with the shelter-shed (3) on the right. The latter adjoins a narrow avenue through which the house was approached, with a second large outbuilding in the site's south-eastern corner. The avenue and boundary walls survive as rare earthen structures in the shelter-shed & loose boxes (3 & 4). The barn did not possess a porch at this time.

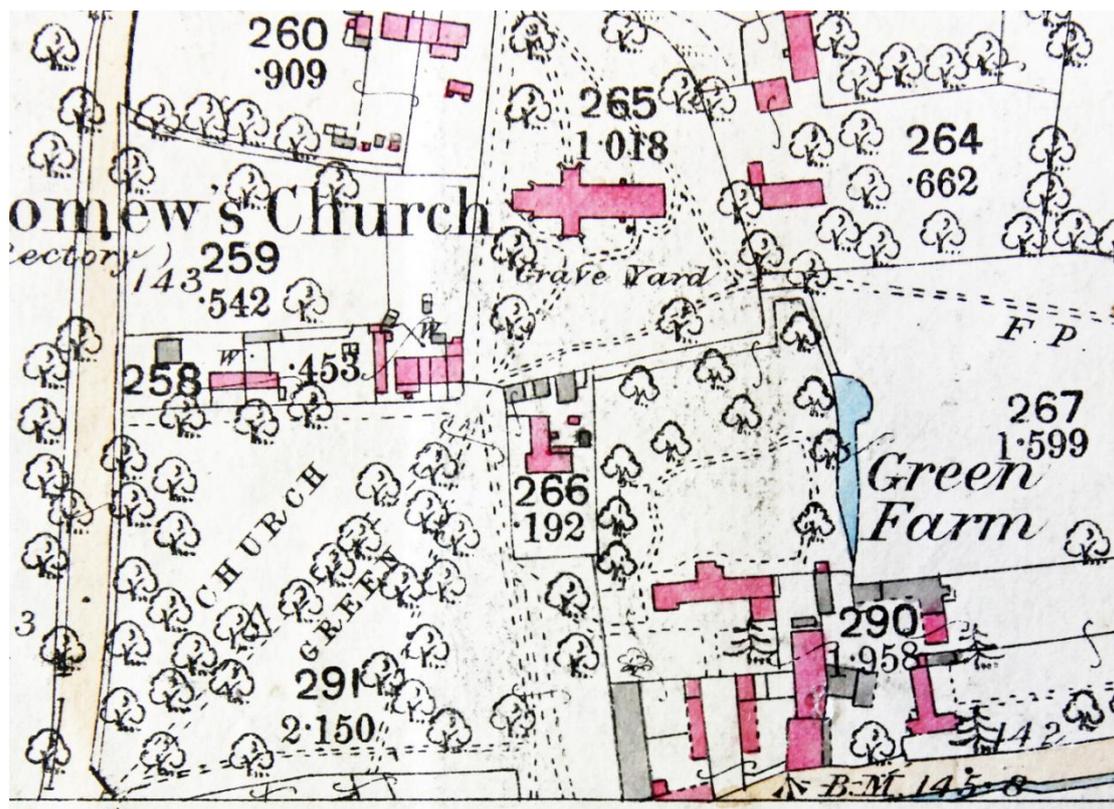
Figure 3. The First Edition 25 inch Ordnance Survey of 1884, with detail below. Red is used to distinguish domestic buildings from outbuildings, and tiled or brick outbuildings from timber-framed structures.

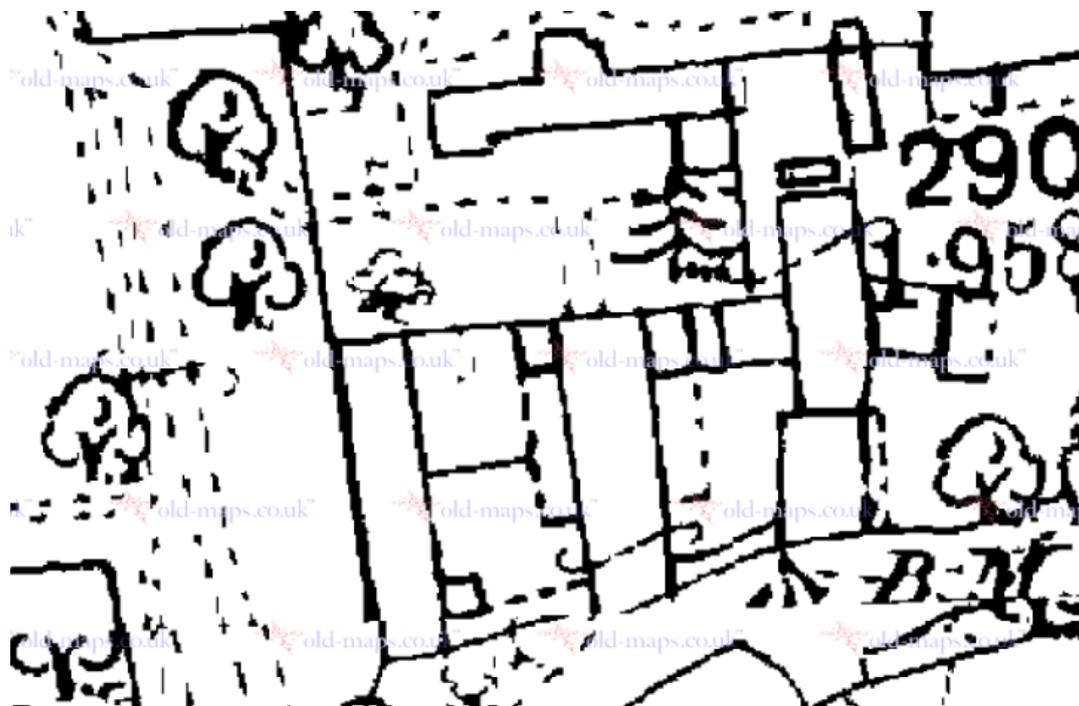
Figure 3a. A combined version of the 1884 Ordnance Survey. (The site is bisected by a sheet boundary and the Suffolk Record Office does not hold coloured copies of both.) Broken lines are used to indicate the open-sided western elevation of the shelter-shed (3a) with its enclosed shed (3b) to the north, and a new porch (1b) and open-sided shelter-shed (4) are shown to the south.

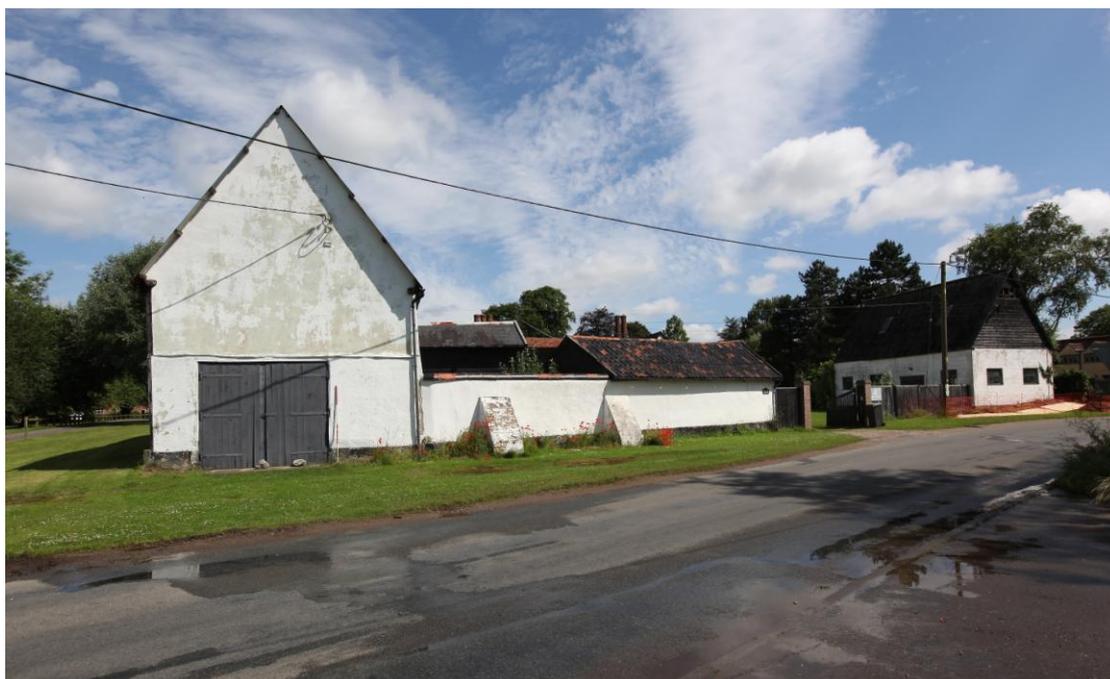
Illus. 1. The site from Wickham Road to the south-west showing the imposing scale and conspicuous location of the early-17th century threshing barn (1) on the corner of Church Green to the left. The former stable range (2) projects to the rear with the single-storied pantiled loose boxes (4) adjoining a rare buttressed earthen boundary wall on the right (which consists of shuttered or rammed clay on a flint plinth).

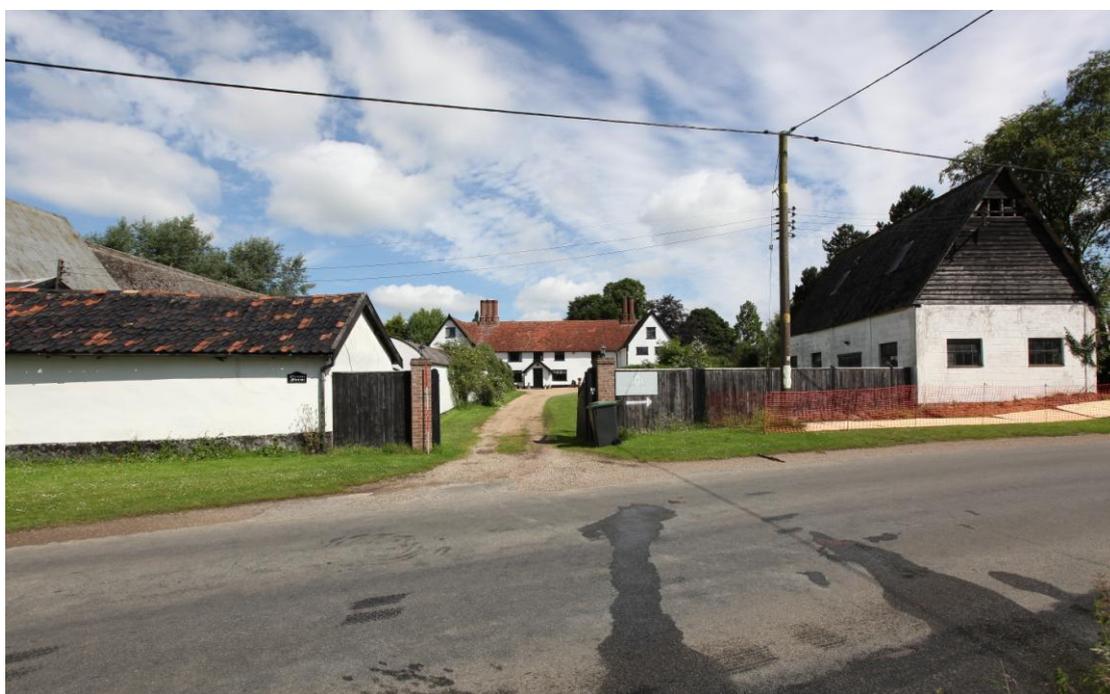
Illus. 2. The site from the south showing the walled base court formed by the two 'barns' in front of Green Farmhouse to the rear. The right-hand barn appears to be a much rebuilt stable range or granary of the late-19th or early-20th century with an internal loft.

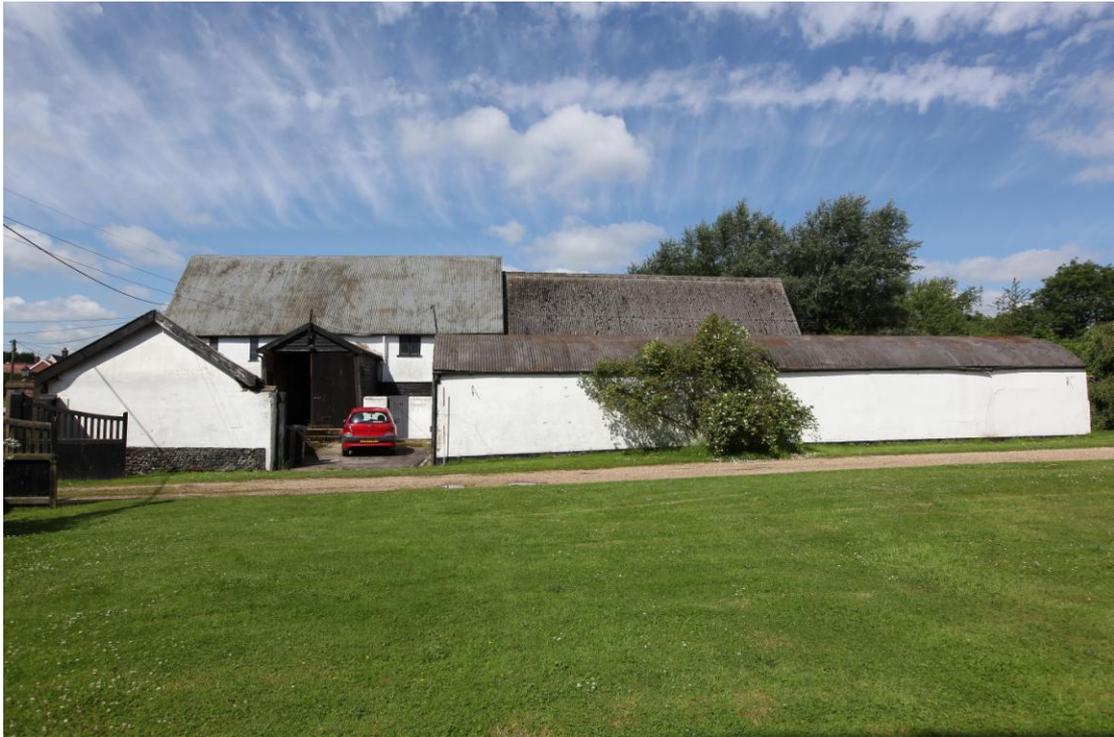
Illus. 3. The site from the base court to the east showing the former shelter-shed (3) on the right and the pantiled loose-boxes on the left, with the barn (1) and former stable (2) in the rear. The long cement-rendered wall of the shelter-shed incorporates an earthen wall which formed part of an avenue approaching the house.

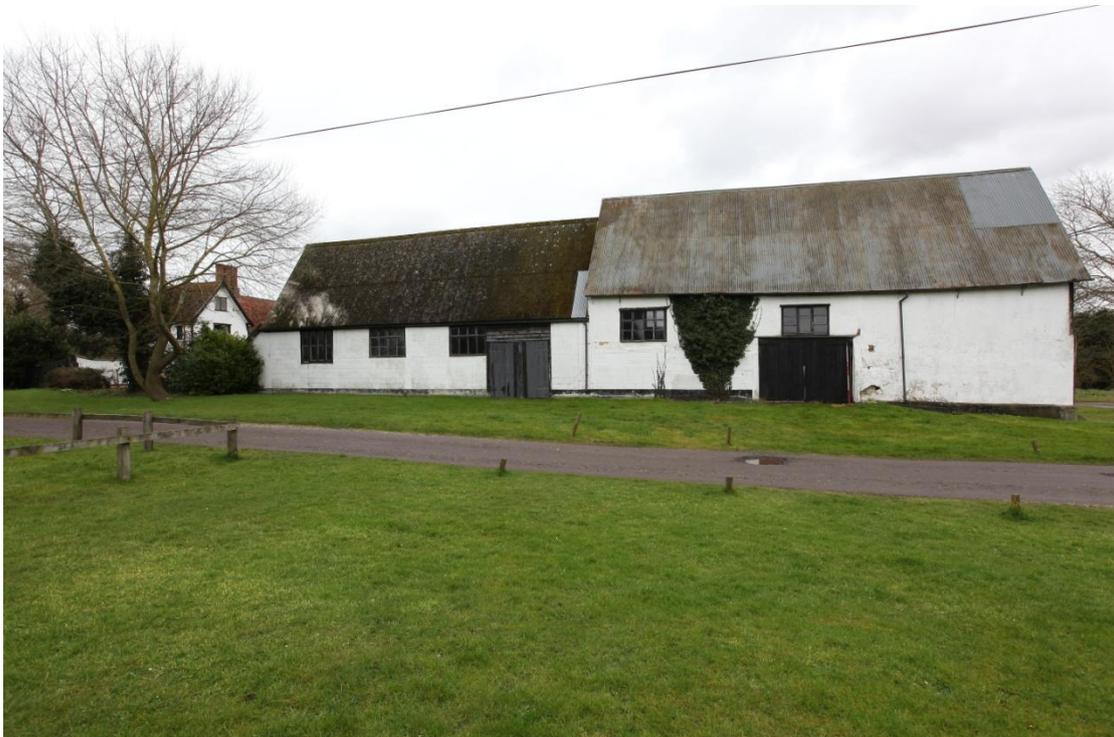
Illus. 4. The threshing barn (1) and former stable (2) from Church Green on the west. Both original roofs are steeply pitched for thatch but are now covered with corrugated asbestos and iron respectively. The stable walls consist of painted 20th century cement block-work between the original storey posts, and the barn has been rendered in cement. The windows and both sets of double doors are insertions of the 20th century.

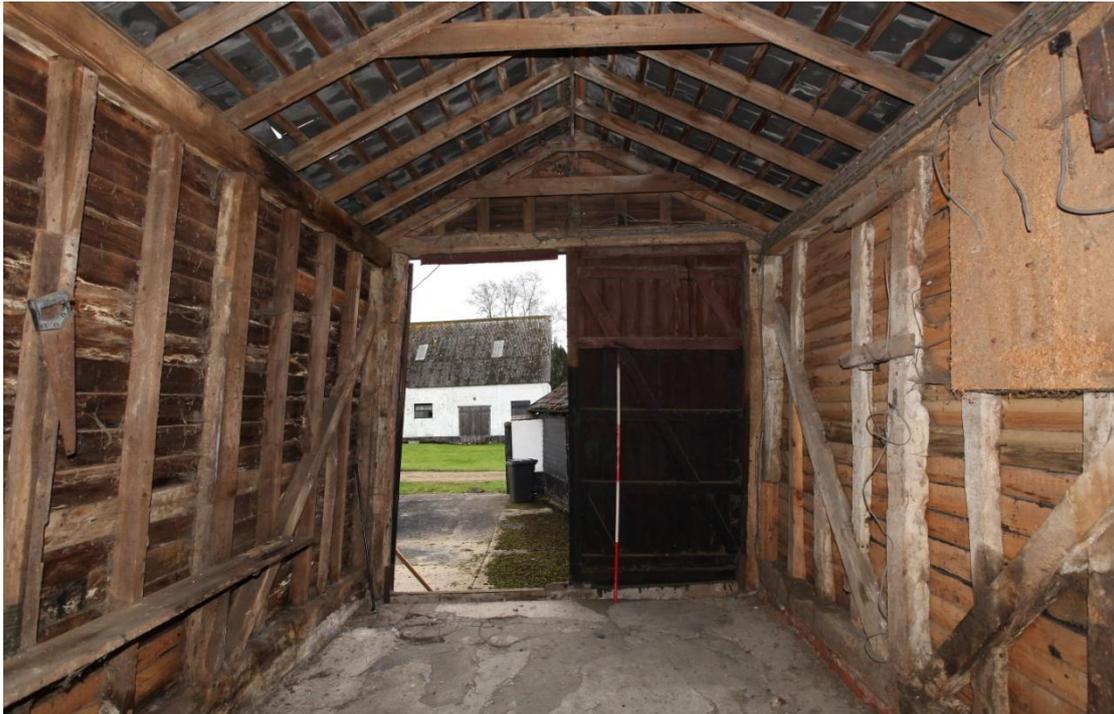
Illus. 9. The interior from the main barn to the west of the eastern porch (1b), showing fragments of mid-19th century framing in the right-hand wall with nailed primary braces interrupting the studs. The roof and much of the left-hand wall have been rebuilt in softwood, probably when the doors were replaced early in the 20th century - as dated by an incised inscription to the latter's right-hand jamb: EP AGE 16 JAN 11 1913.

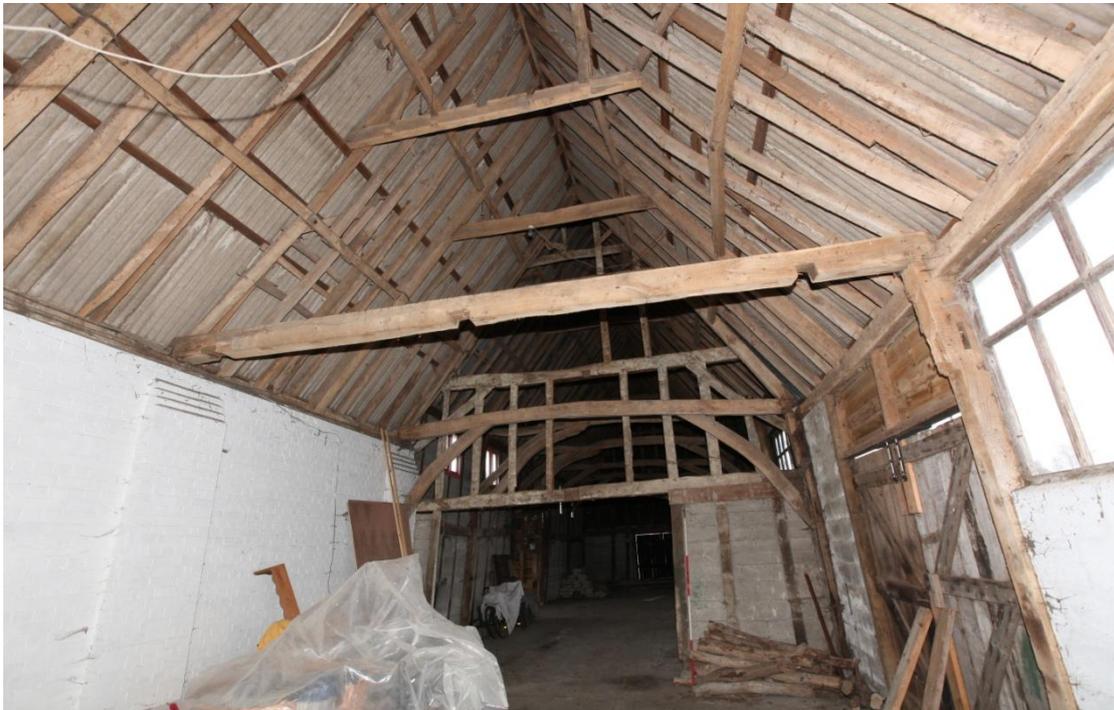
Illus. 10. The interior from the north of the southern section of the former stable (2a) showing the arch-braced open truss adjoining the barn (1a) in the rear. The barn's studs show traces of the clay and lime daub with which they were originally rendered. The central tie-beam and collar contain mortises for the studs of a missing partition which divided the stable's southern bay from an original three-bay section to the north.

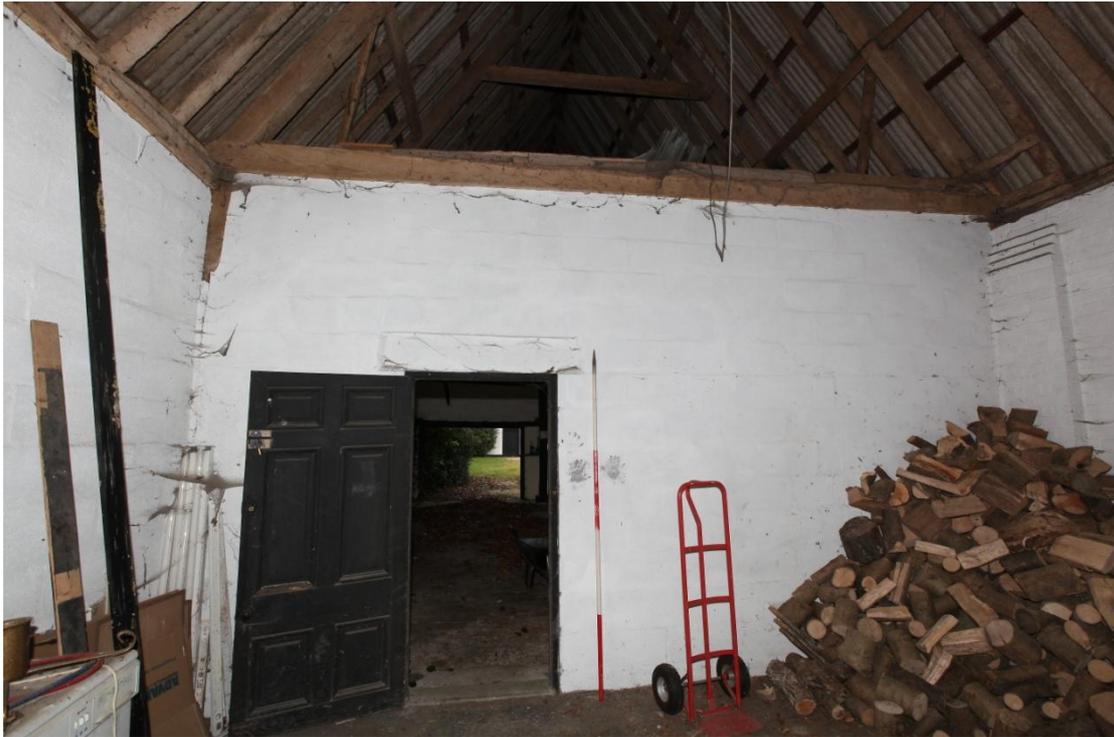
Illus. 11. The 20th century cement-block northern wall of the former stable's southern section (2a), with a connecting door to the two northern bays (2b). The arch-braces of the original open truss survive within the block-work as their profiles are clearly visible to left and right. The framing of the external walls has been replaced with block-work to the west (left) and 20th century brickwork to the right.

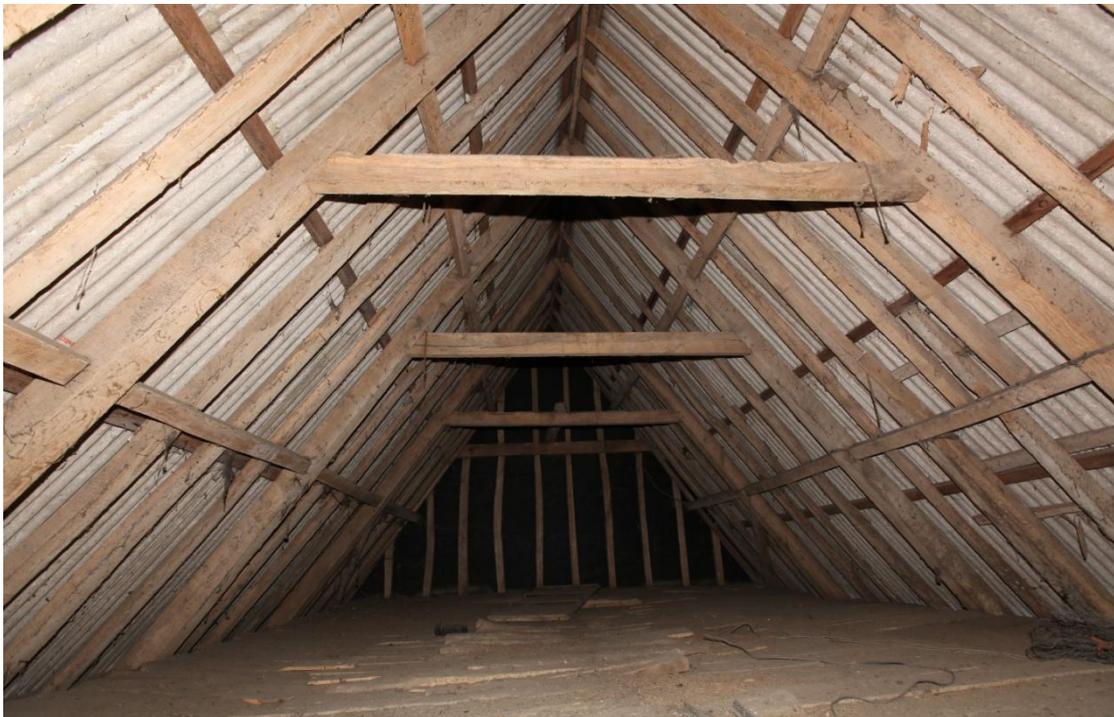
Illus. 12. The intact butt-purlin roof and northern gable of the northern section of the former stable (2b), as seen from the southern section (2a), i.e. above the block-work wall shown in illus. 11 above and the ceiling shown in illus. 13 & 14. Now covered in corrugated asbestos the steep pitch of this roof indicates it was designed for thatch.

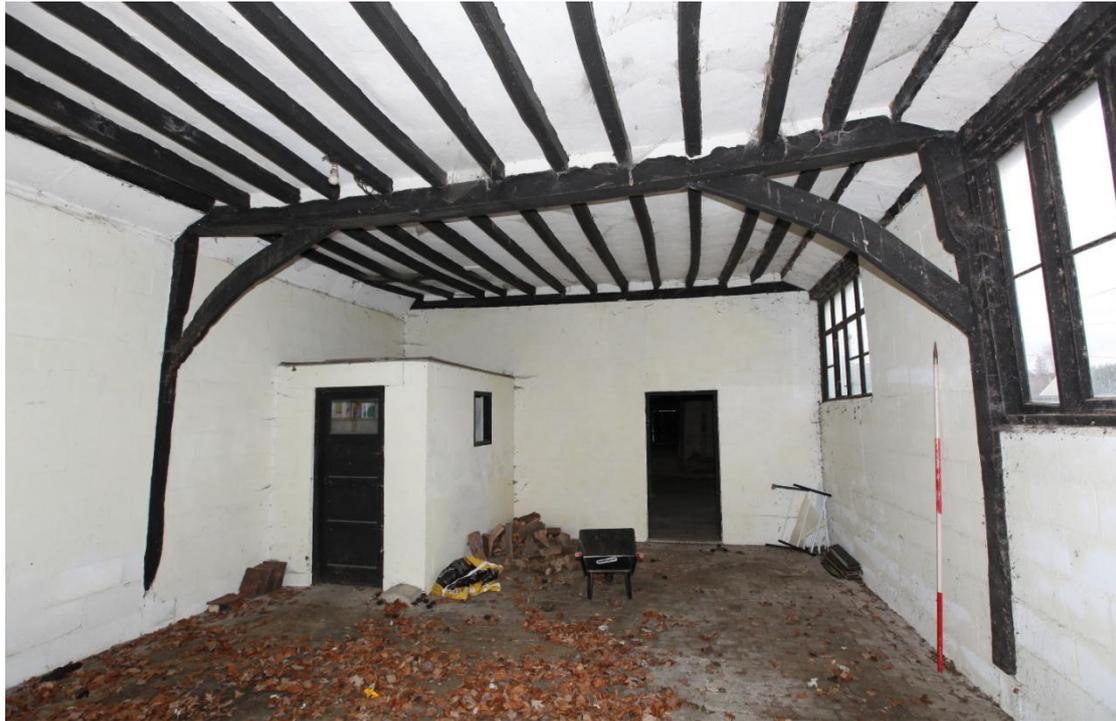
Illus. 13. The interior of the northern section of the former stable (2b), seen from the north, with the block-work partition to the southern section (2a) in the rear. The arch-braced tie-beam is original, but both storey posts contain pegged mortises for the binding joist of a missing original ceiling just below the braces – so the present ceiling is a later insertion that may relate to the building’s alleged conversion into a schoolroom. This compartment originally extended to the central tie of the southern section (2a).

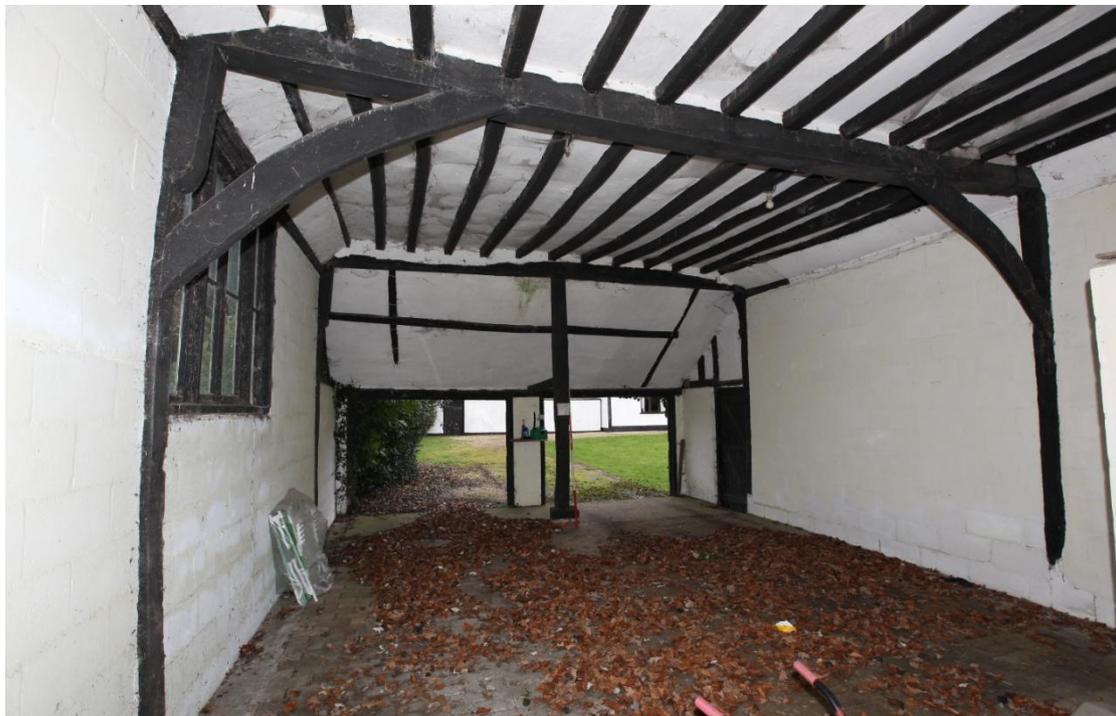
Illus. 14. The northern section of the former stable seen from the south, showing the later lean-to shed adjoining the northern gable with an incised date to its original central post. The gable tie-beam and corner posts contains mortises for missing studs and primary braces that were tenoned and pegged to the posts.

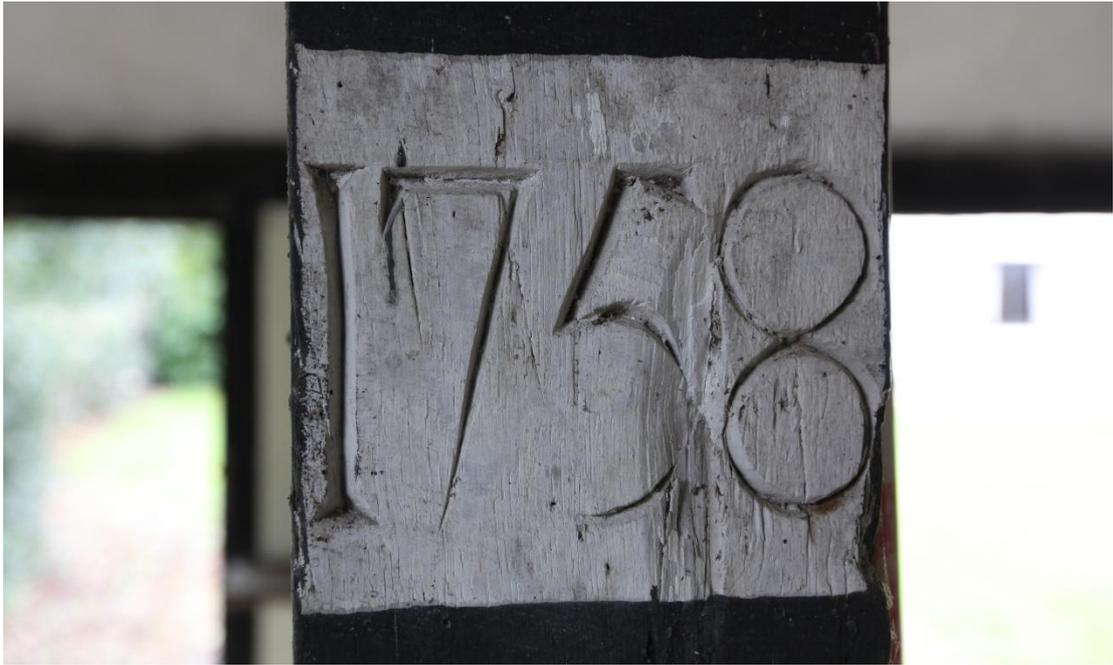
Illus. 15. A detail of the carved date 1758 to the interior of the central post of the former stable's northern section (2b). The carving appears authentic and is consistent with the likely date of construction.

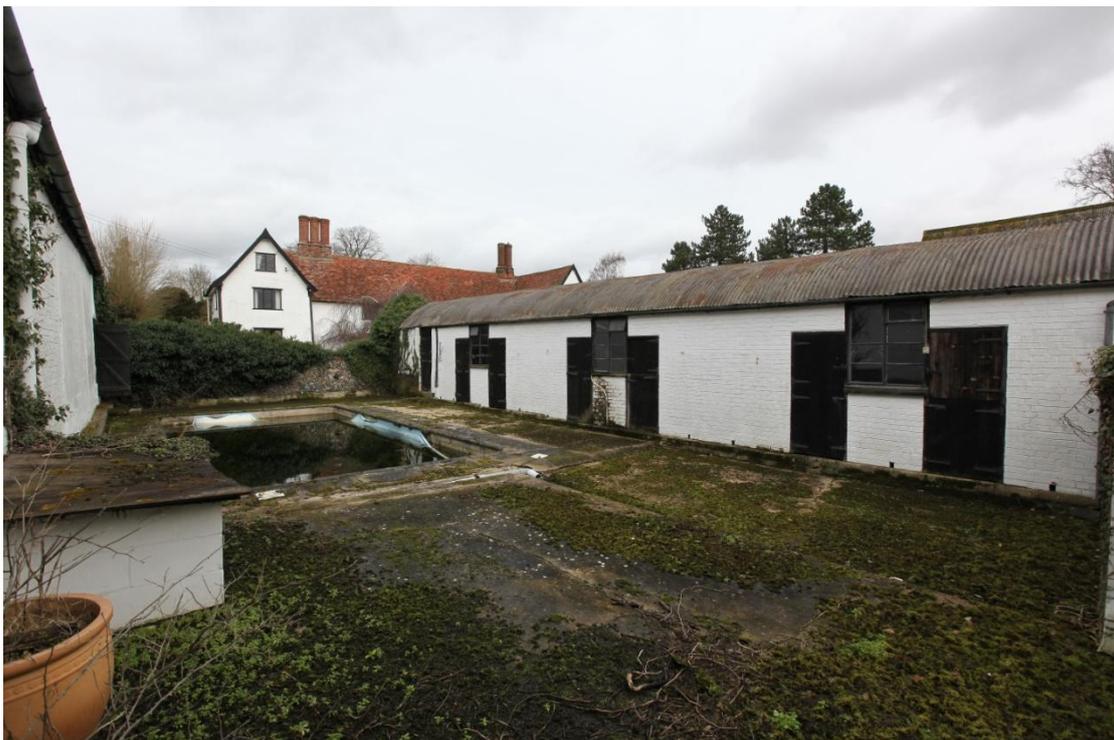
Illus. 16. The yard to the east of the barn (1) seen from the south, with the grade II-listed former farmhouse of the 16th and 17th centuries in the rear and the stable (2) on the left. The building to the right (3) was originally an open-sided shelter-shed serving a horse or cattle yard, but its open elevation was obstructed with brickwork in the 20th century to convert it into a series of loose boxes with half-hung doors.

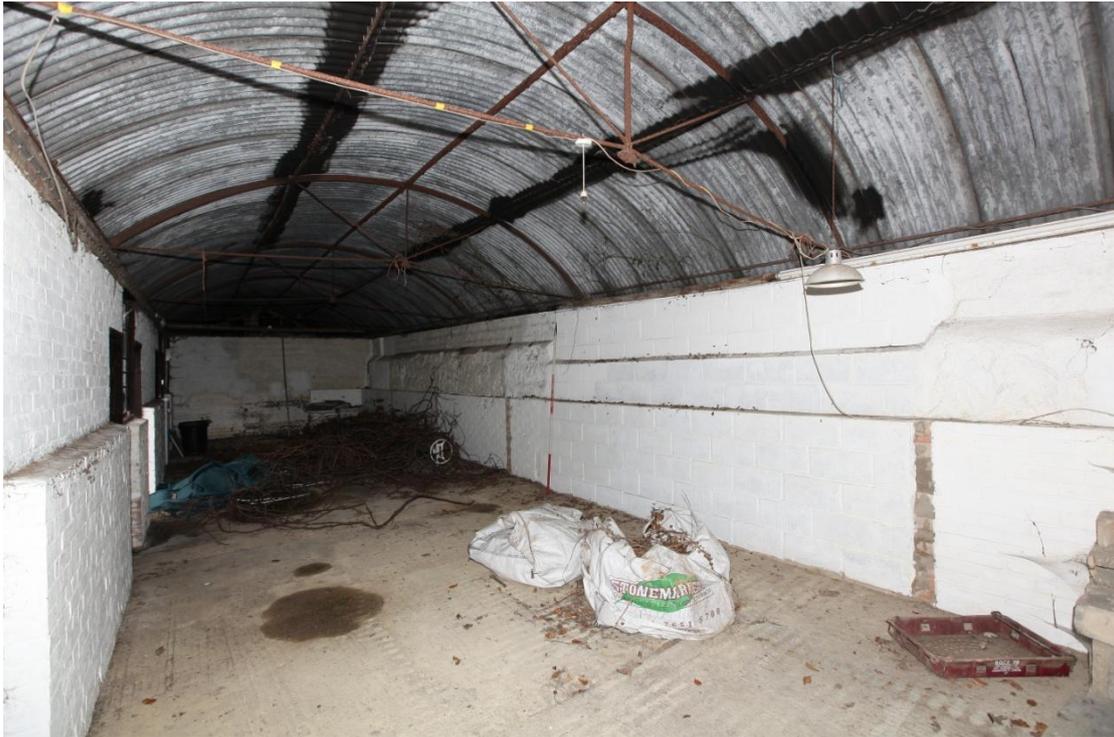
Illus. 17. The interior from the south of the former shelter-shed (3a) showing its early-20th century steel-framed segmental roof of corrugated iron. Part of the eastern wall on the right consists of shuttered or rammed clay, but has been raised in height with clay-lump (i.e. pre-fabricated blocks of clay). The internal partition in the rear also consists of clay-lump.

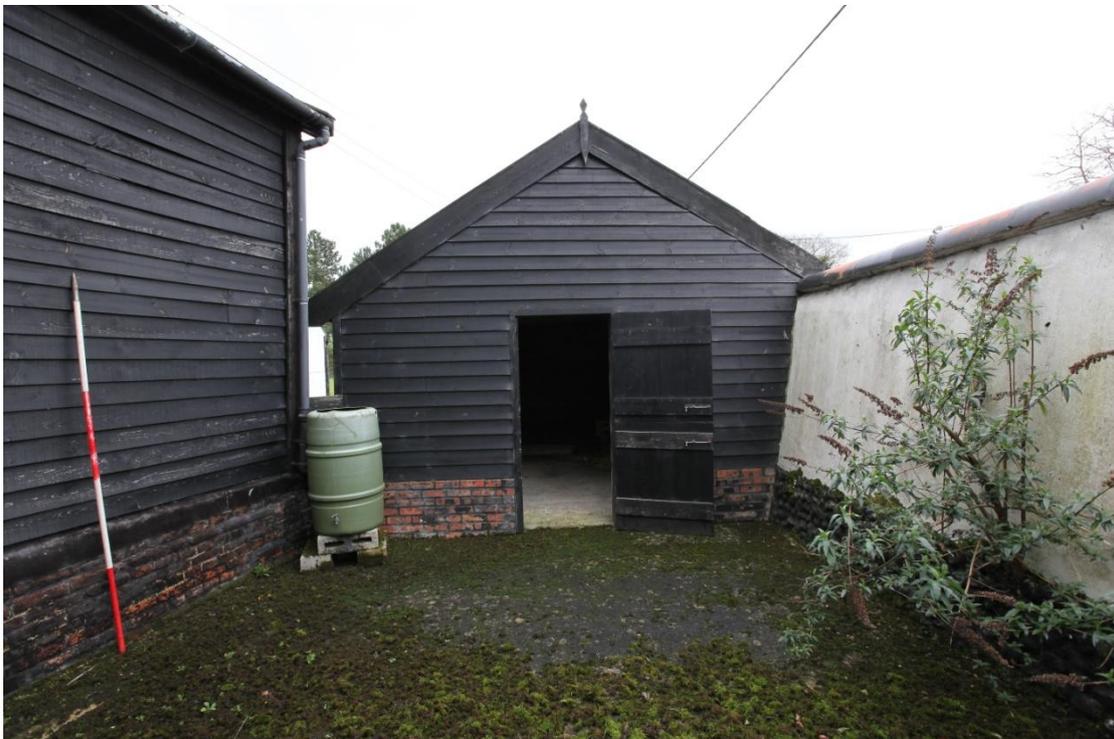
Illus. 18. The western external gable of the pantiled loose boxes (4) showing its 20th century weatherboarding with the rare buttressed boundary wall of rammed or shuttered clay on the right. The 20th century weatherboarding of the barn's porch (1b) is shown on the left.

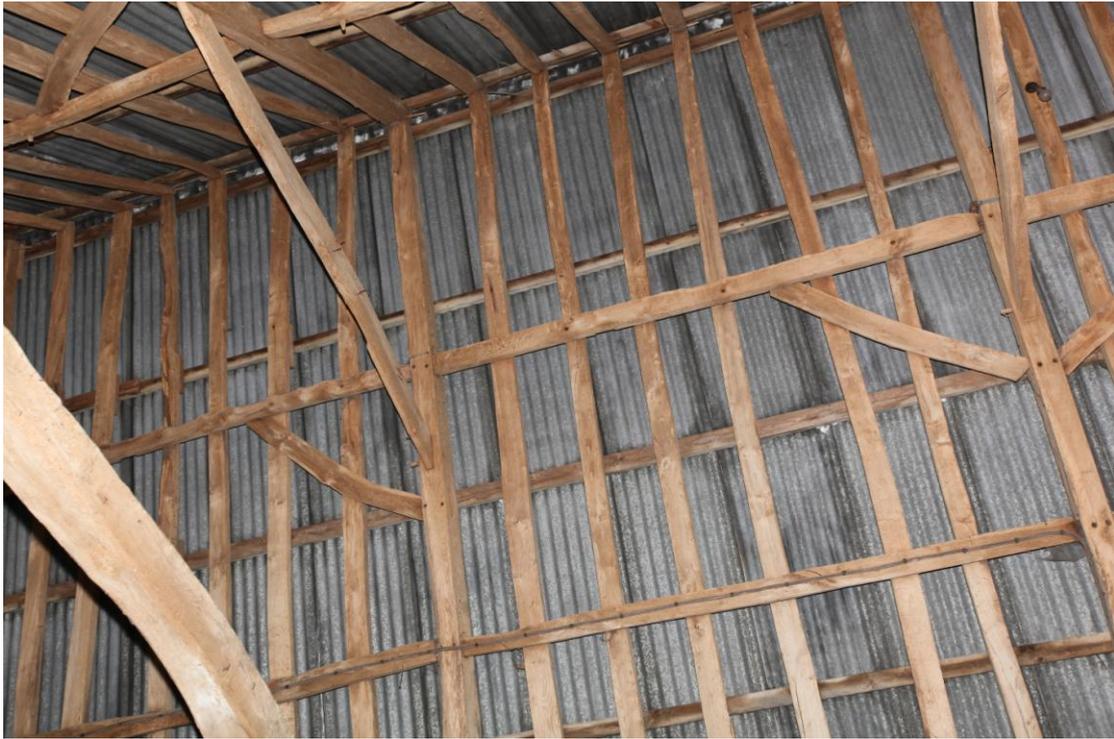
Illus. 19. A detail from the west of the intact two-tier butt-purlin roof structure of the barn (1a) showing a pegged mortise for a missing wind-brace in the principal rafter to the left.

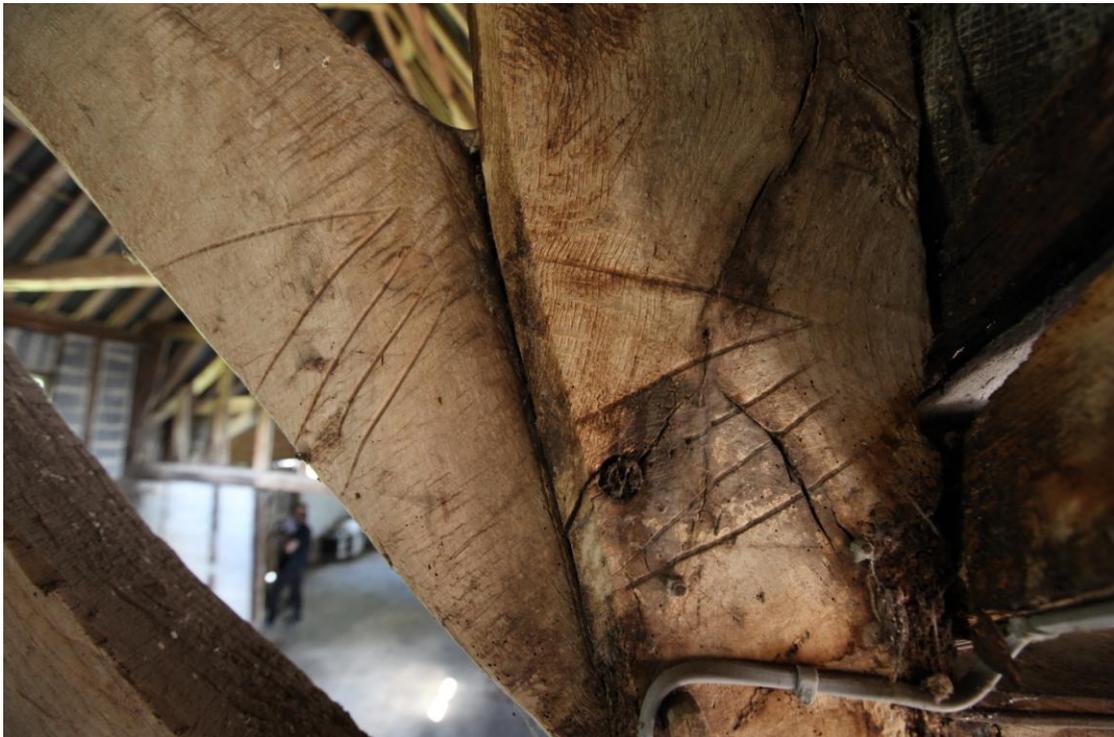
Illus. 20. A detail of the incised carpenter's Roman numeral VIII to the southern face of the brace and jowled storey post in the north-eastern corner of the entrance bay (i.e. to right in illus. 7 above).
