**Farm Buildings at  
Pitcher's Green Farm,  
Bradfield St Clare, Suffolk  
BSC 034**

**Heritage Asset Assessment**

# **Farm Buildings at Pitcher's Green Farm, Pitcher's Green, Bradfield St Clare, Suffolk**

## **Historic Building Record**

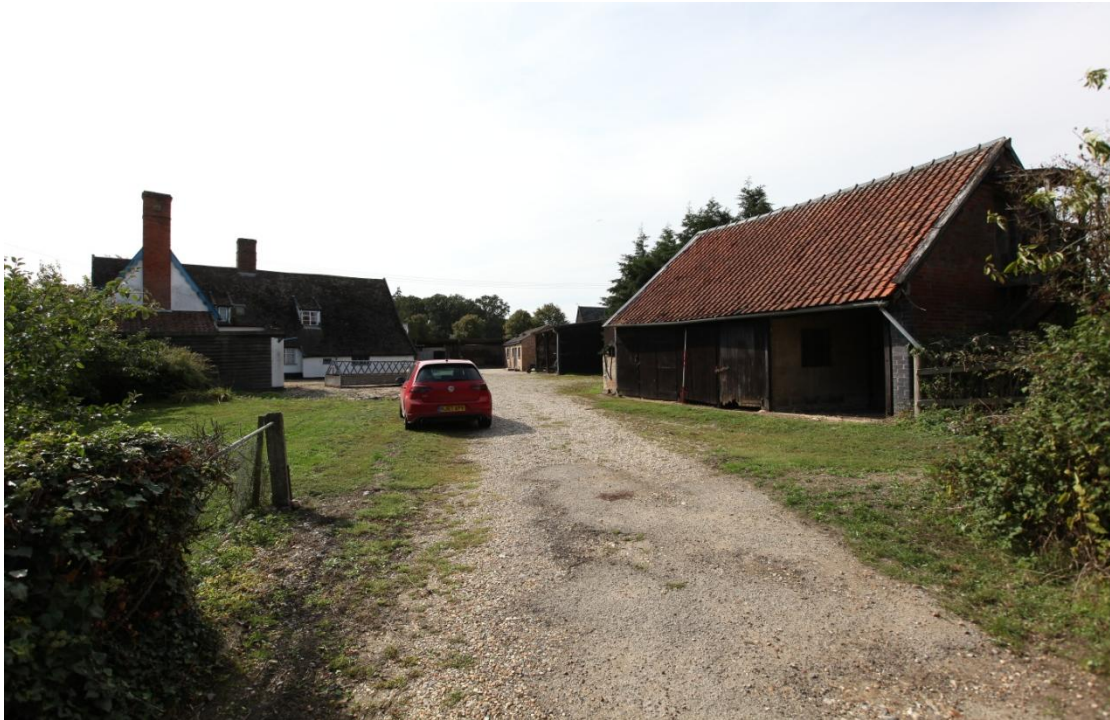
**Illus. 1. The site from the entrance track to the north showing the cart lodge probably built in 1899 (5) to the right and the grade II-listed early-17<sup>th</sup> century house on the left.**

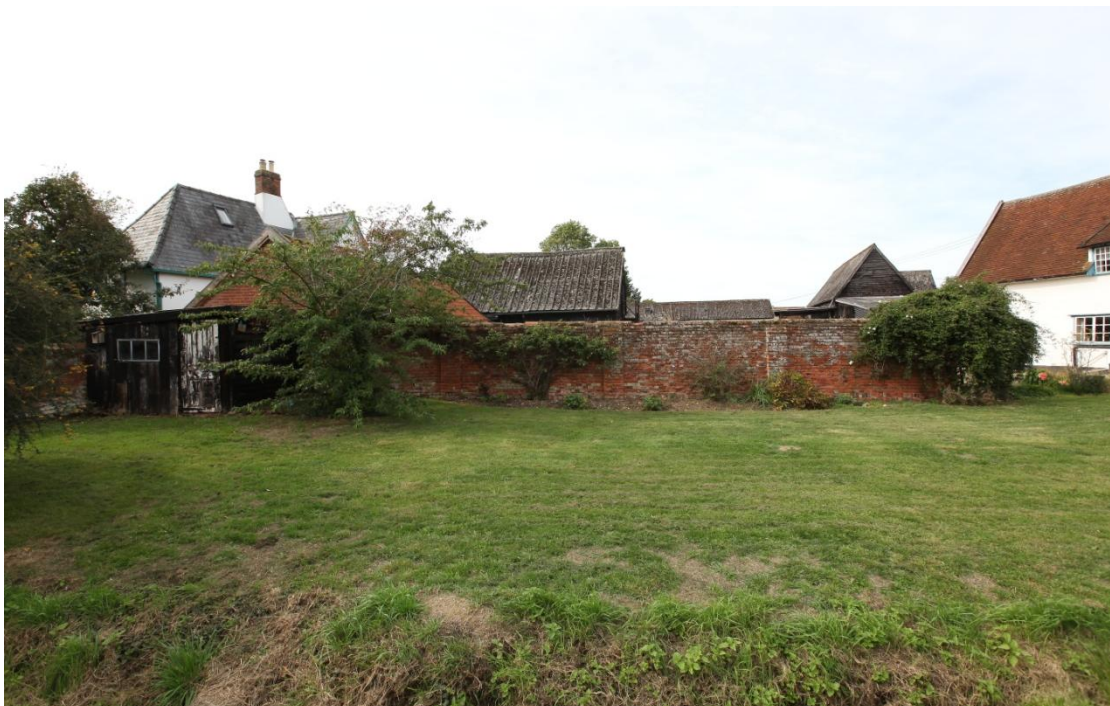
**Illus. 2. The site from the east showing the lawn in the foreground occupied in 1843 by a large building that may have formed a second barn. The ditch in the foreground marked the western edge of the medieval green. The house of neighbouring Bishop's Farm lies on the left in unusually close proximity to Pitcher's Green Farmhouse on the right with the roofs of the 19<sup>th</sup> century barn (1), stable (3) and shelter-shed (4) visible from right to left in the rear.**

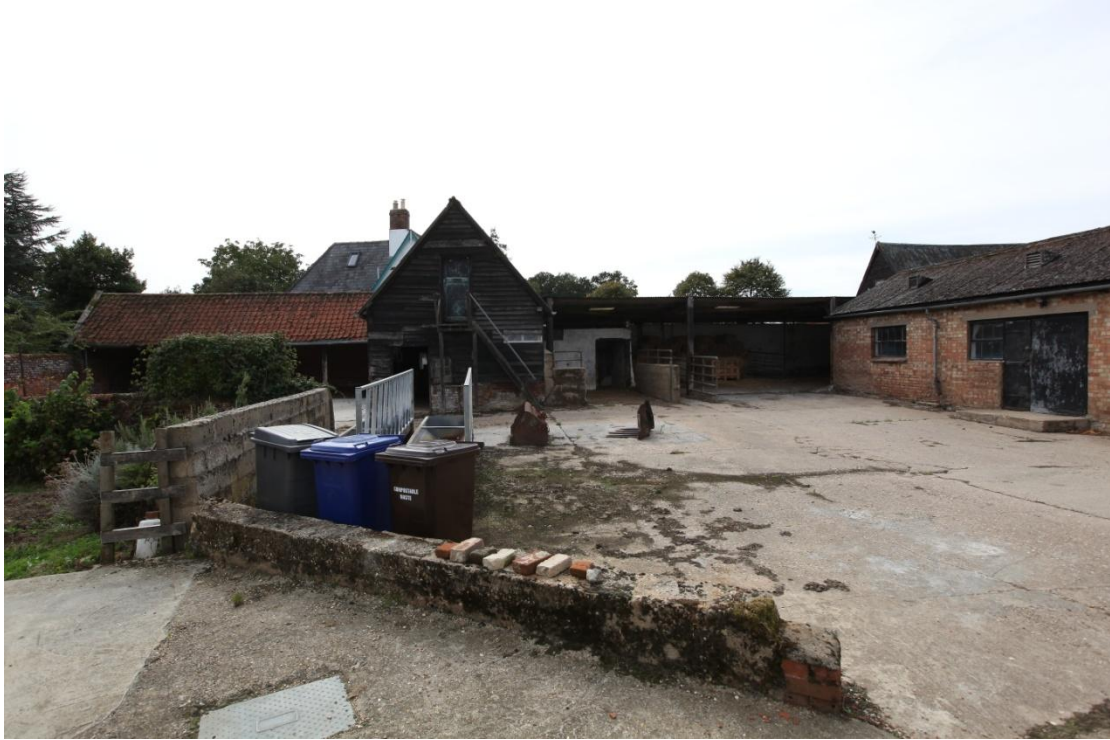
**Illus. 3. The southern range of farm buildings seen from the house to the north showing the 1950s Fletton-brick milking parlour (6) on the right and the stable (3) in the centre with the shelter-shed of a horse yard adjoining on the left (4). The external stair to the granary above the stable is an early-20<sup>th</sup> century replacement but retains the traditional narrow steps intended to help labourers carrying heavy sacks.**

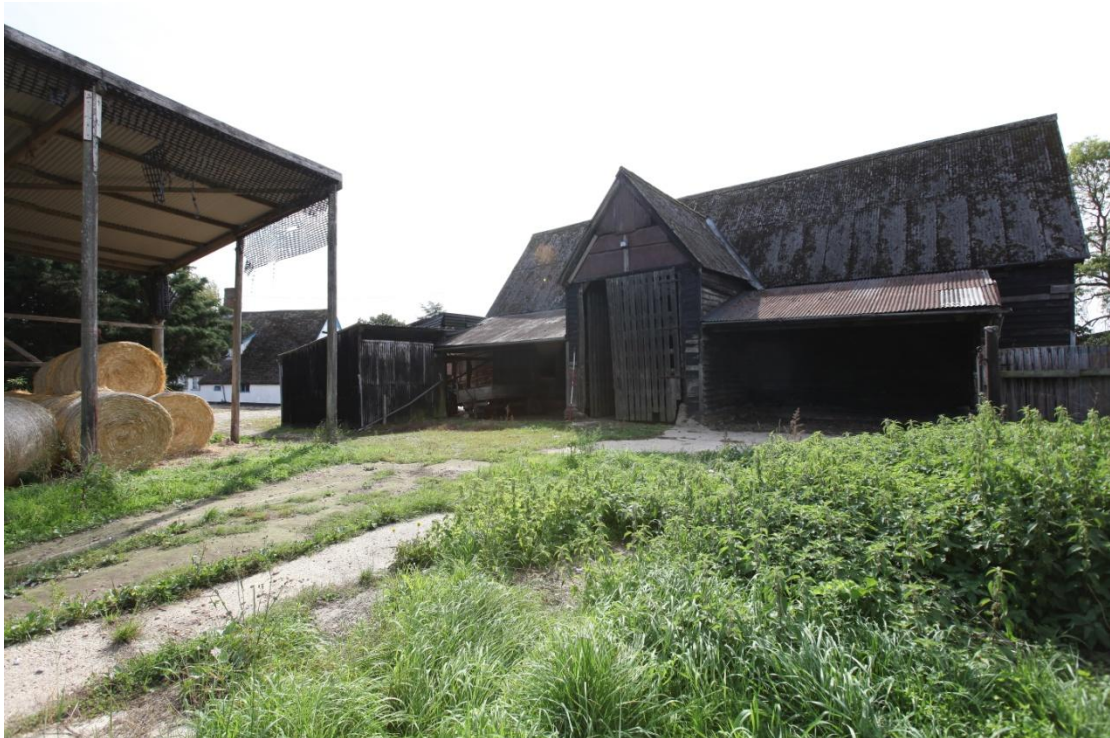
**Illus. 4. The early-19th century threshing barn (1) from the north showing its corrugated asbestos roof and central entrance porch. The corrugated iron lean-to implement sheds on each side are 20<sup>th</sup> century additions.**

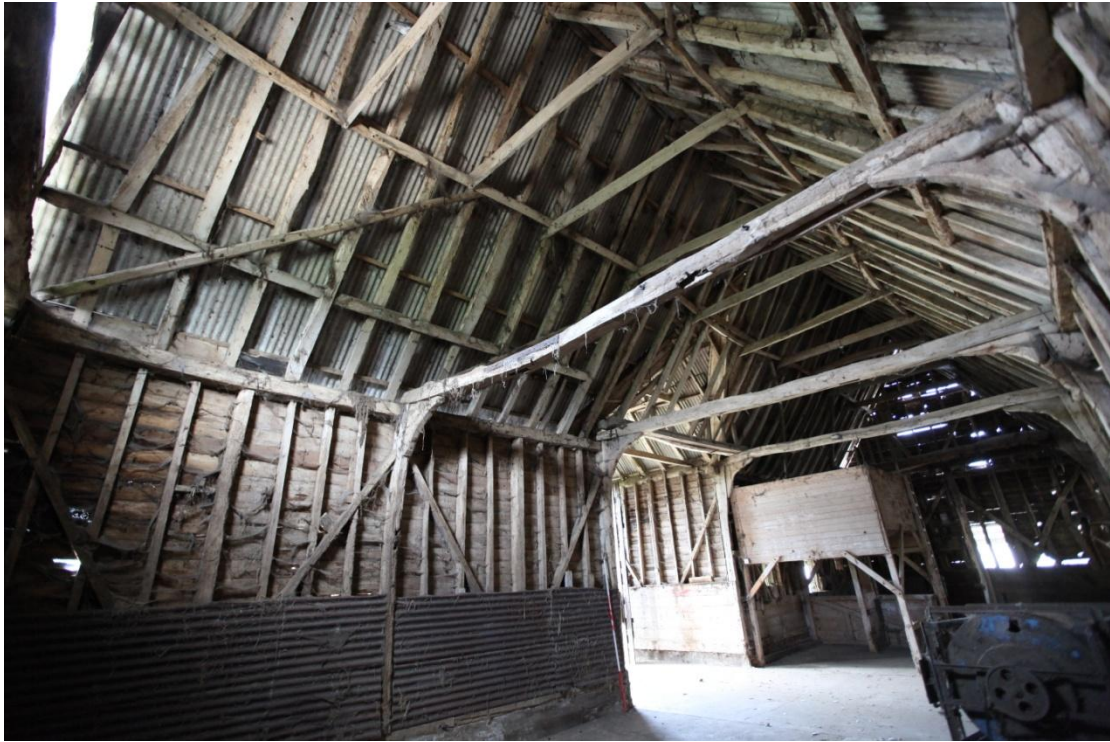
**Illus. 5. The interior of the five-bay early-19<sup>th</sup> century threshing barn (1) from the west showing the clasped-purlin roof structure with a lower tier of butt-purlins that unusually extends only over the western bays. The posts and tie-beams contain mortises for arch-braces that were replaced with knee-braces later in the 19<sup>th</sup> century.**

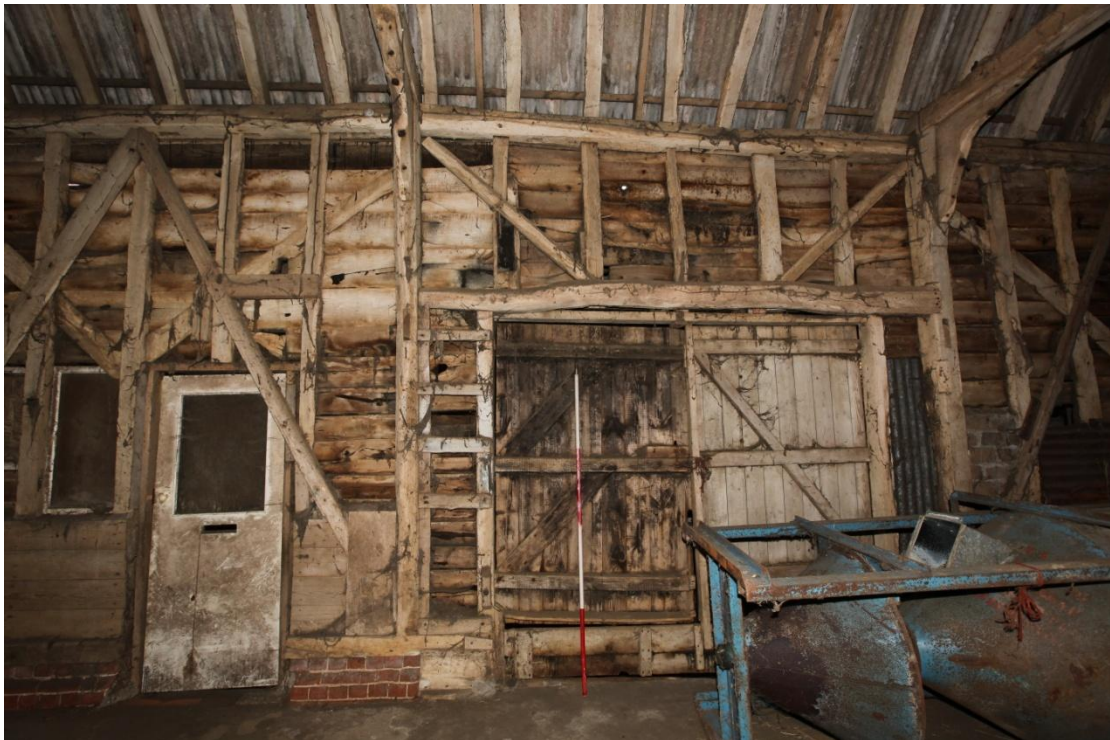
The building is arranged as a traditional threshing barn with a central threshing floor entered by a front porch with low rear doors immediately opposite (A2. 6). The floor is now of concrete throughout and there is no trace of the brick or boarded threshing floor in the central bay, but the rear doors survive from the 19<sup>th</sup> century complete with a rare retaining board secured by vertical grooves in the jambs. A notch in the right-hand jamb suggests the lintel of these doors has been raised in height, perhaps in conjunction with a rise in the internal floor which now lies half a metre about the cattle yard to the south. The roof-plate adjoining the porch was also removed to increase headroom but otherwise the roof and wall framing is substantially intact with 19<sup>th</sup> century tarred weatherboarded protected in part by 20<sup>th</sup> century lean-to implement shelters on the north-east and the covered yard to the south-west. Additional inverted V braces were nailed to the internal walls in the late-19<sup>th</sup> or early-20<sup>th</sup> century and there is evidence of a missing inserted loft in the eastern half of the barn and possibly the western. Rails for joists are visible on the walls and the rungs of a wooden loft ladder are shown to the left in A2. 6 along with a loft hatch in the eastern bay. Lofts of this kind were often inserted in the late-19<sup>th</sup> century to facilitate feed storage and preparation, but this example was replaced in the late-20<sup>th</sup> century by the surviving milling platform alongside the entrance as shown in A2. 5.

**Illus. 6. The 19<sup>th</sup> century rear doors in the southern interior of the barn's central bay (1), complete with a rare retaining board secured by vertical grooves. A number of horizontal rails indicate the presence of a former loft hence the nailed rungs of a wall ladder to the left. A notch in the storey post to the right suggests the door lintel has been raised by approximately 12 inches. The floor is now of concrete throughout.**

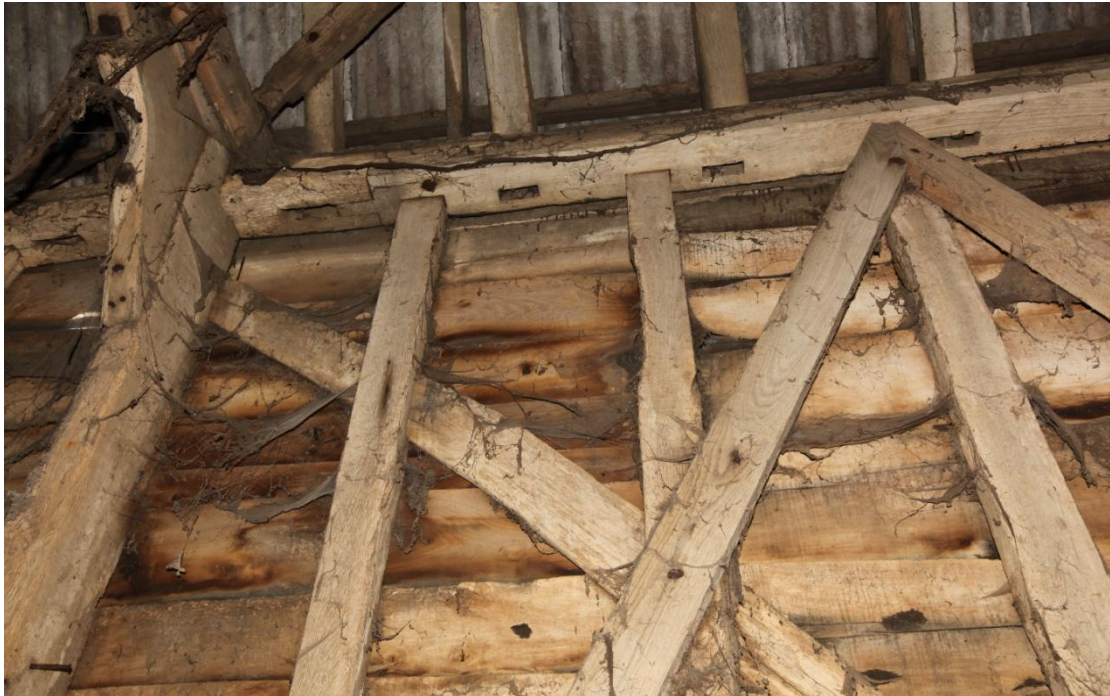
**Illus. 7.** A detail of the barn's southern wall (in the penultimate eastern bay to the left in A2. 6) showing the empty mortises and 16<sup>th</sup> century style edge-halved and bridled scarf joint in the roof plate above. The inverted V braces on the right are 20<sup>th</sup> century additions but the trenched external braces are original to the fabric. These are highly unusual in a 19<sup>th</sup> century barn and have also been re-used; they are now lapped and nailed to the studs but terminate in pegged tenons from their former lives.

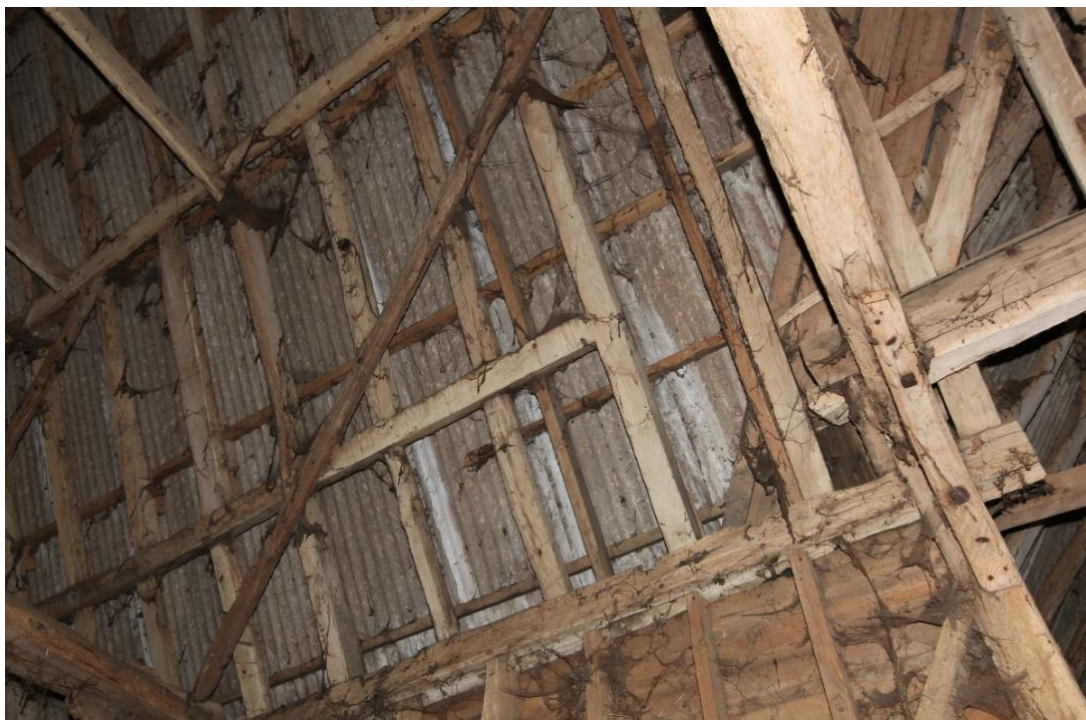
and contains clasped-purlins with pegged collars and a lower tier of butt-purlins that unusually extends only from the north-western gable to the central threshing bay (A2. 8). Pegged mortises in the final rafters suggest these purlins once continued further but there is no evidence for them in the south-eastern half of the barn which in all other respects is fully integral. There is ample evidence of re-used timber in the walls and the additional purlins may relate either to the partial re-use of an earlier structure or to a change of heart during the construction process. The roof-plates contain numerous irrelevant mortises and edge-halved and bridled scarf joints of a kind not found later than the 16<sup>th</sup> century but are clearly not *in situ* (A2. 7). Most unusually too is the re-use of plank-sectioned external braces in the rear walls on each side of the threshing bay in combination with primary braces elsewhere. These trenched braces are lapped and nailed to the exteriors of the frame but contain pegs for the mortises of their former lives. They may have been incorporated for decorative effect or simply because they were available with the rest of the second-hand timber, but they are confined to the back wall where they would have been best appreciated by anyone entering the barn. The studs of the front wall are narrower than elsewhere but are more typical of the barn's period than the substantial re-used oak of the gables and back wall and probably simply reflect the fact that insufficient old material was available for the entire barn.

**Illus. 8.** The northern roof showing the lower butt-purlin terminating short of the central porch on the right. A pegged mortice in the right-hand edge of the rafter suggests it continued further but it is unclear whether this results from the use of second-hand timber or the reconstruction of the eastern section of roof in the mid-19<sup>th</sup> century – although the former is more likely.

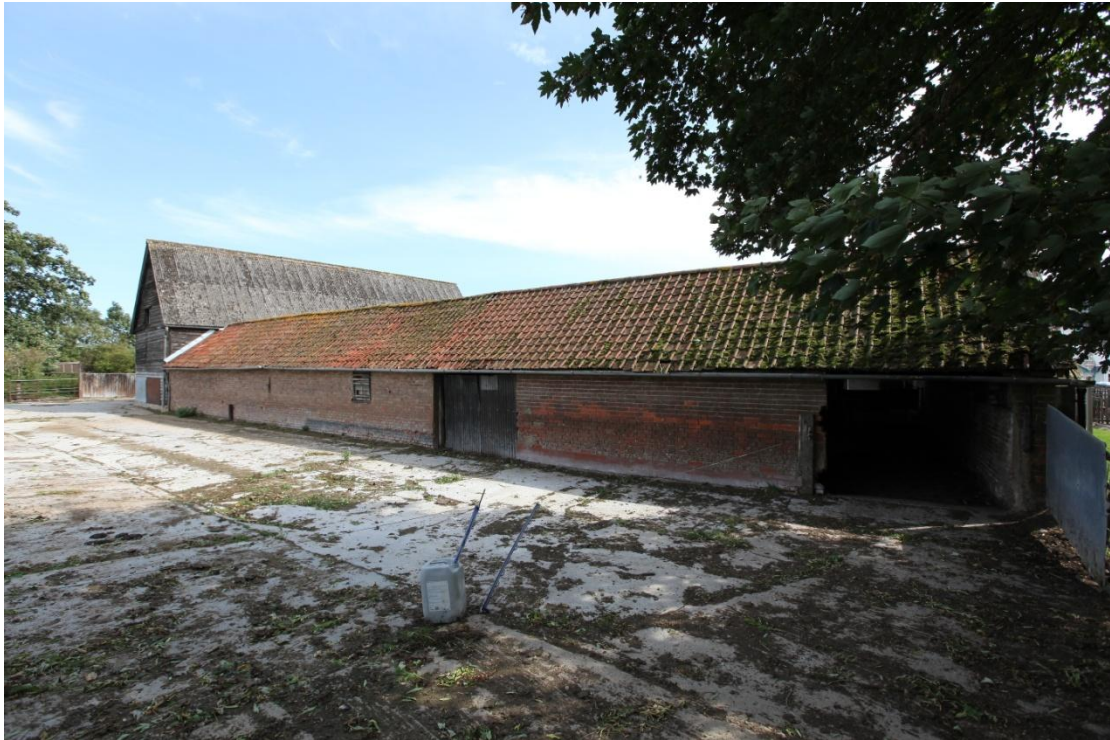
**Illus. 9.** The barn and the mid-19<sup>th</sup> century shelter-shed (2) from the cattle assembly yard showing the latter's two inserted doorways. The central doorway divides original 19<sup>th</sup> century red brick on the right from the wall of the central loose box (2b) and northern shelter-shed (2a) that was rebuilt in Fletton brick in the 20<sup>th</sup> century.

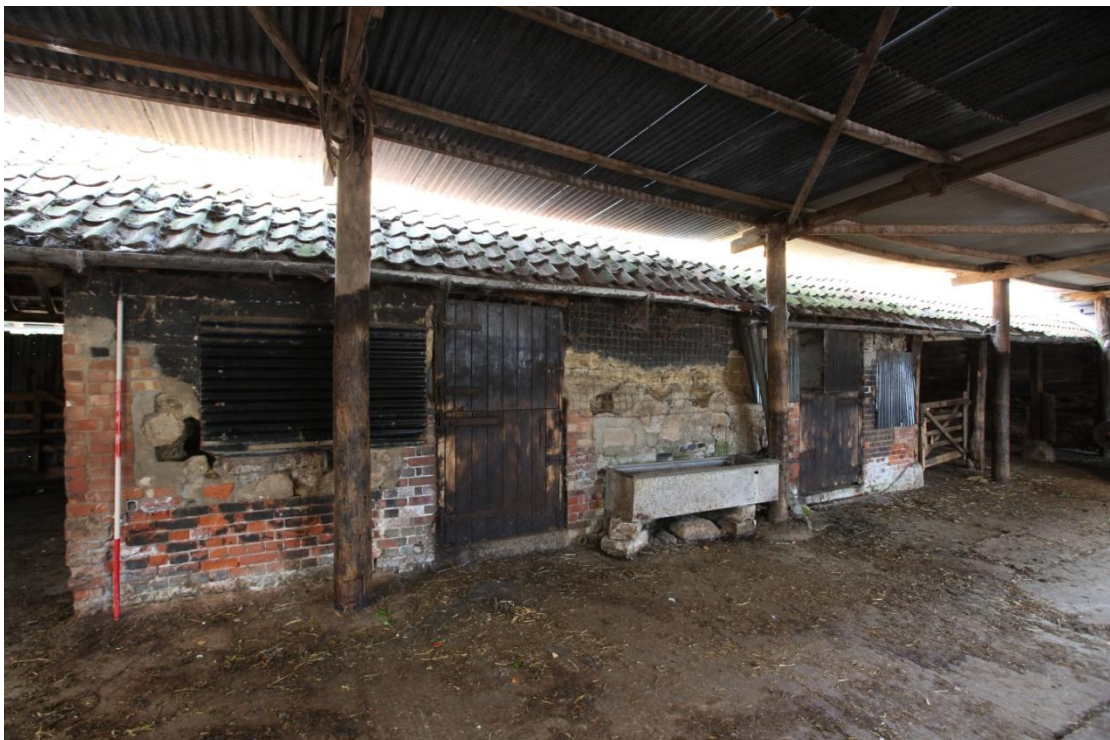
**Illus. 10.** The facade of the clay-lump shelter-shed (2b) from the 1970s covered cattle yard supported by telegraph poles to the east. Open-sided shelter-sheds (2a & 2c) are visible on both sides. This shed has been much altered but its original clay-lump fabric is still visible above its red-brick plinth. The interior was probably divided into two cattle boxes initially, although the present door surrounds have been largely rebuilt.

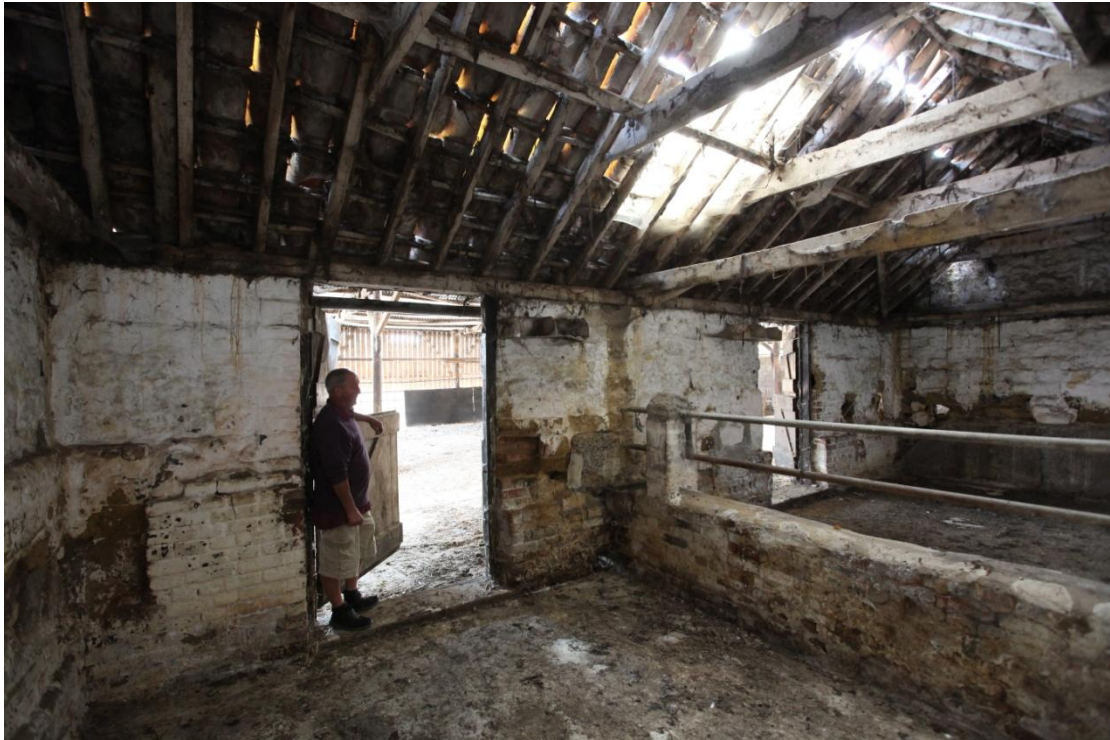
**Illus. 11. The eastern internal wall of the loose box (2b) showing its whitewashed clay-lump with the scar of its probably original clay-lump internal partition in the centre. Only the brick plinth of this partition now survives. Mr Glyn Thomas and his father have operated a dairy farm here since the 1960s.**

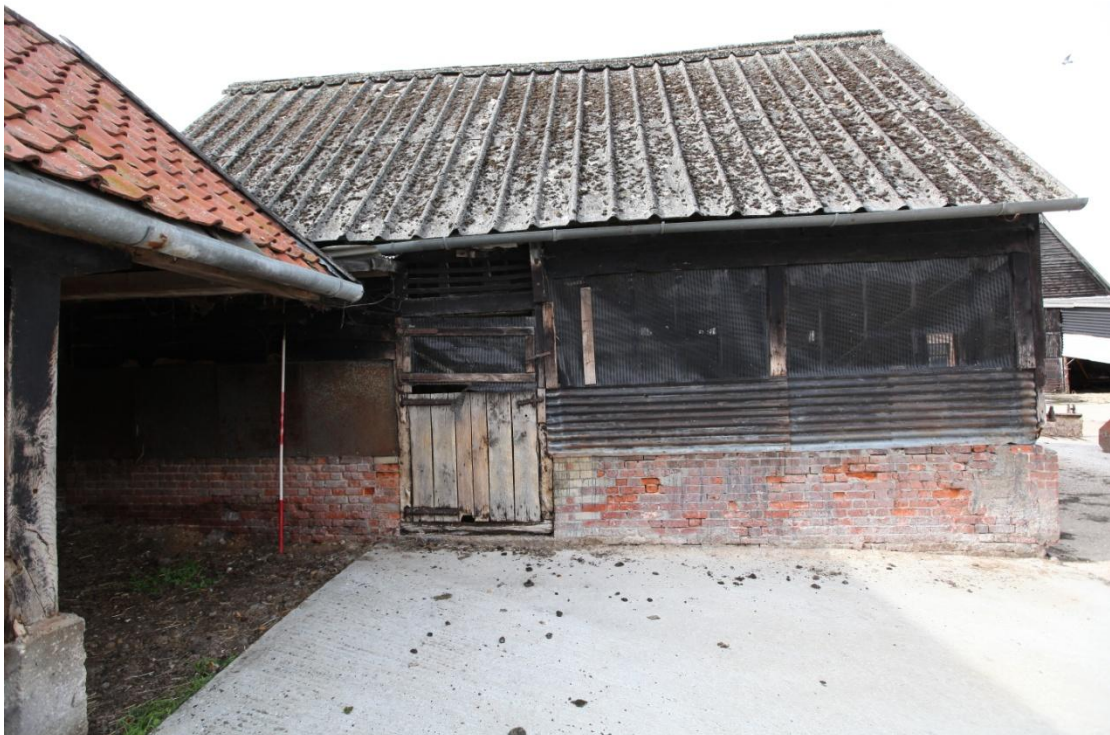
**Illus. 12. The eastern facade of the stable (3) from the horse yard showing its corrugated asbestos roof and original central entrance respected by closers in the brick plinth. A tarred louver is visible above the half-hung door but the weatherboarding to the right was replaced with mesh to increase ventilation and combat pneumonia when the interior was used as a calf shed.**

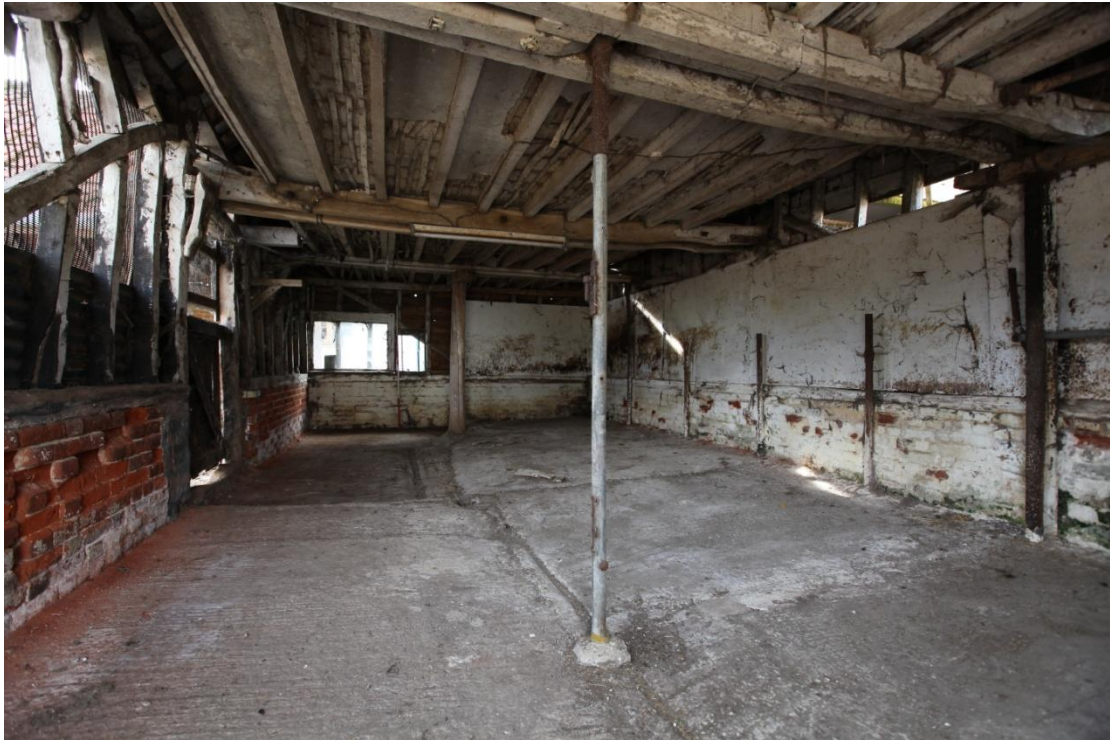
**Illus. 13. The interior of the stable (3) from the north. This space has been used for cattle in recent years but a section of original brick floor with an axial drain survives in the rear to the left with the remains of a chaff box on the right. The ceiling joists retain original plaster secured by laths nailed to the loft boards and are tenoned to the principal joists – but the latter are sandwiched between later bolted reinforcing rails.**

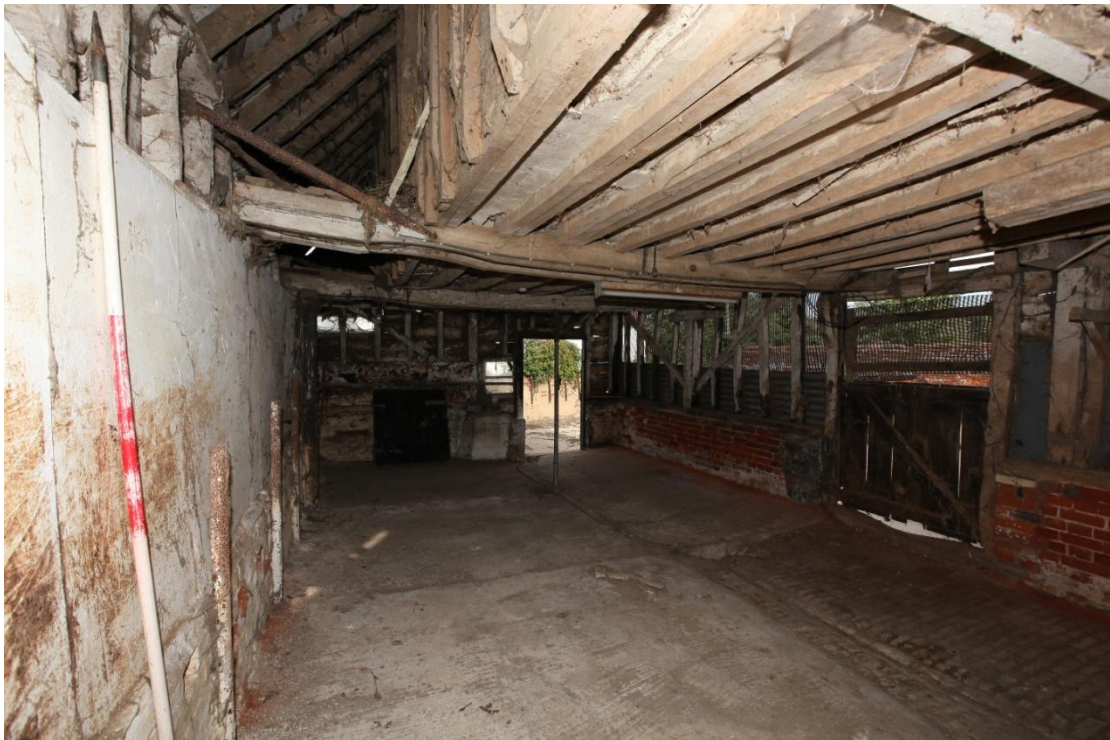
**Illus. 14. The stable (3) from the south showing the western wall of the original boarded granary above. The reinforcing rails are deeper than the original principal joists they sandwich and have been neatly chamfered and curved to increase headroom above the hay rack and manger that would have adjoined the western wall on the left.**

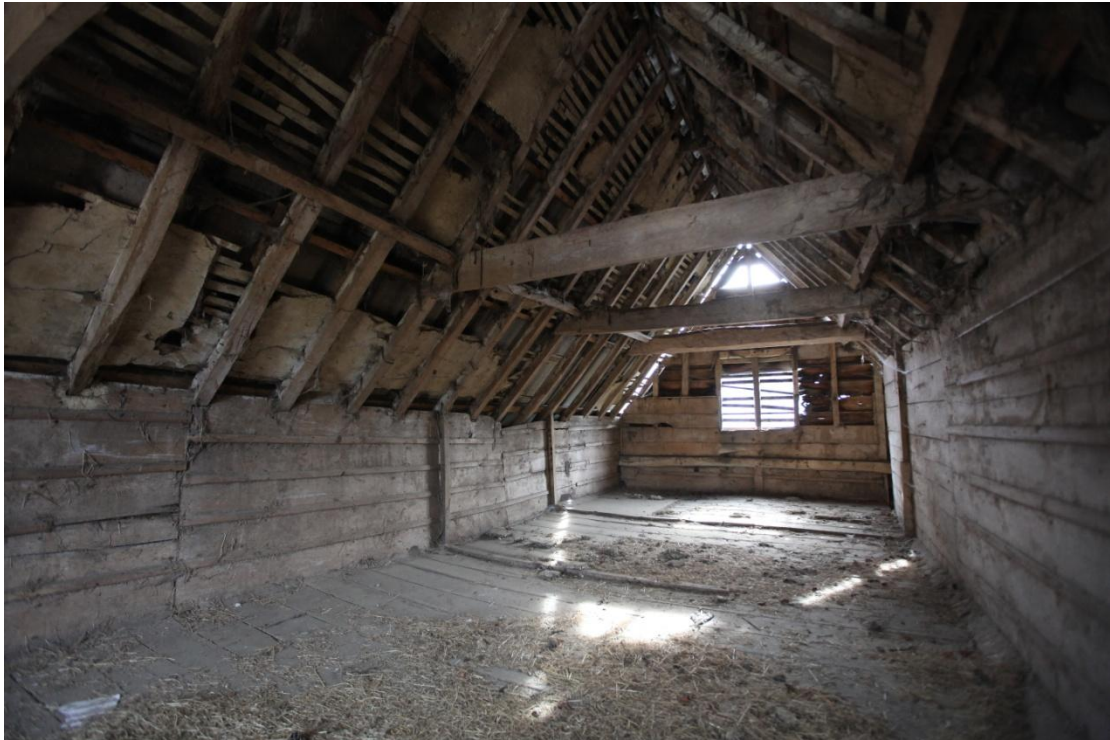
**Illus. 15.** The well preserved granary above the stable (3) from its northern entrance showing the original clasped-purlin roof with nailed collars and a ridge board. The roof retains a quantity of original clay plaster secured by laths to the outsides of the rafters. The original boards are sealed by fillets of wood covering their joints and there are mortises for missing grain bins in the floor. A board has been removed above the chaff box at the southern end of the right-hand wall.

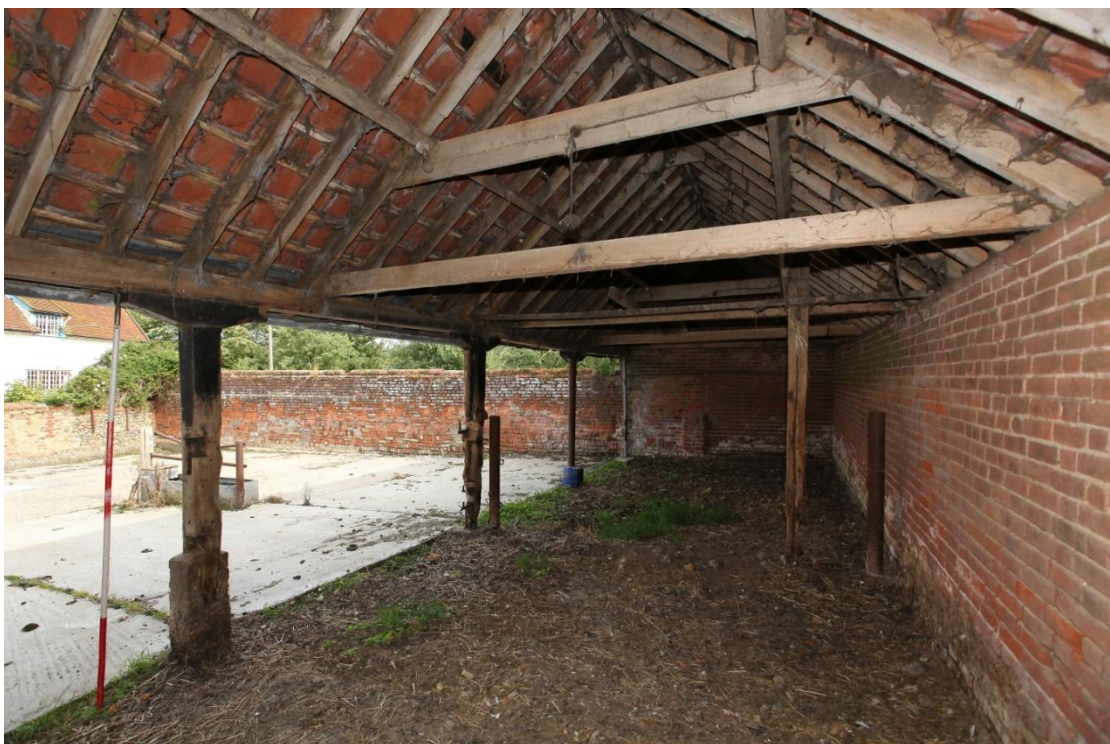
**Illus. 16.** The interior from the west of the stable's shelter-shed (4) showing its original arcade posts and softwood clasped-purlin roof with nailed collars. The eastern gable in the rear was built against the earlier brick wall of the horse yard on the left.

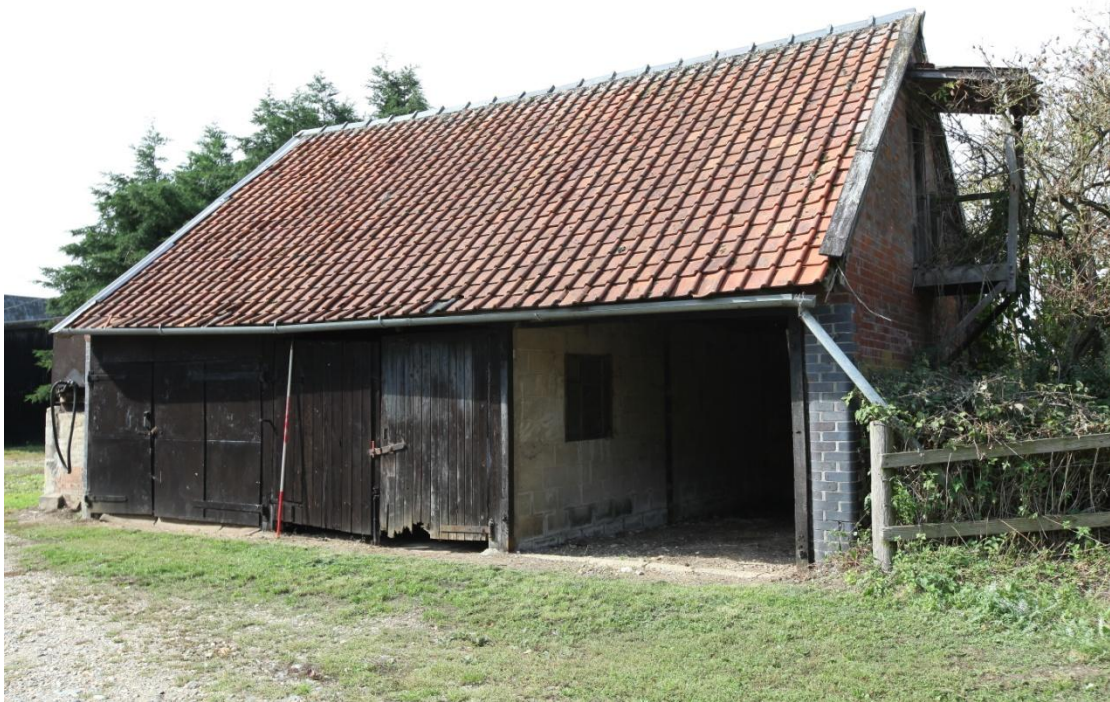
**Illus. 17.** The eastern facade of the pantiled late-19th century cart lodge adjoining the site entrance (5). This three-bay building was formerly open-fronted with a grain loft in its northern bay reached by an external stair against the gable to the right. The present internal partition dates only from the 20<sup>th</sup> century with original boarding above. Note the glazed and curved bricks to both piers in typical late-19<sup>th</sup> century fashion. This structure may well date from 1899 as suggested by a boldly cut internal inscription.

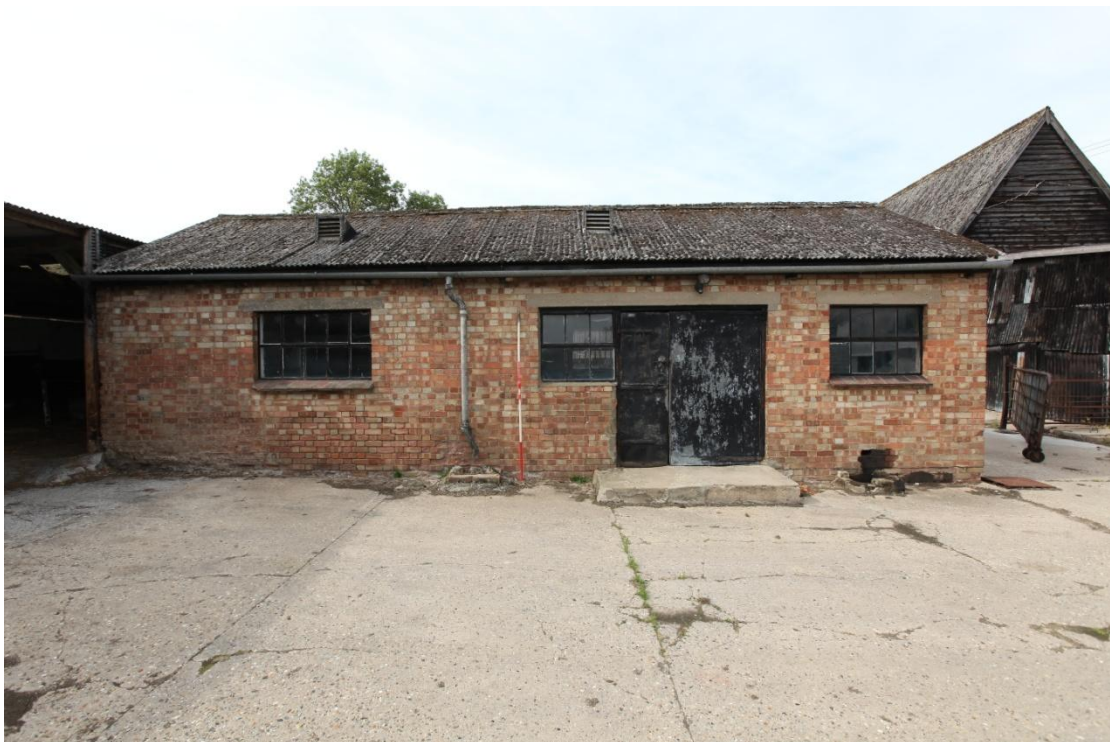
**Illus. 18.** The eastern facade of the 1950s Fletton-brick milking parlour (6) showing the steel entrance doors to its central compartment with the threshing barn on the right. The milking equipment from this building is now at the Museum of East Anglian Life.
