HISTORIC BUILDING PHOTOGRAPHIC SURVEY
AT THE BARN,
UPPINGHAM ROAD,
MEDBOURNE, LEICESTERSHIRE.

National Grid Reference: SP 8012 9364
Leicestershire Museums Service Accession No.: X.A130.2014
Planning Reference: 14/00965/FUL (Revised Scheme of
13/01295/FUL)

PREPARED FOR MR. BILL JONES

September 2015

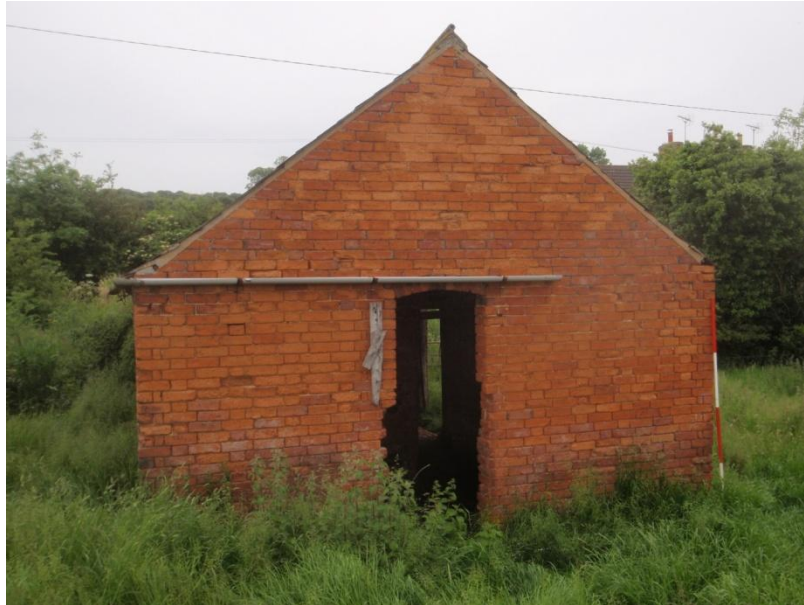
Plate 1: View of the West Elevation, from the west

The wall fabric of this West Elevation was of brick with the uppermost levels in courses of stretchers in Stretcher Bond. Below these levels and down to ground level, the brickwork was composed of courses of alternate brick headers and stretchers in Flemish Bond [Plate 1].

The central door opening, minus a door, had no distinctive side surrounds. The door head was composed of a simple arch in brick headers along with a threshold in brick stretchers [Plate 1].

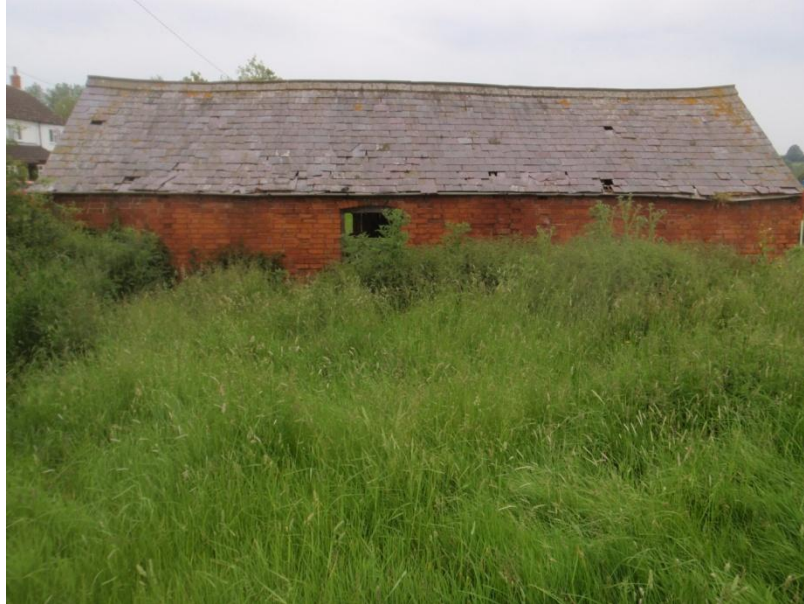
The wall fabric of this North Elevation was mostly composed of courses of alternate headers and stretchers in Flemish Bond [Plates 2 and 3].

Slightly to the left of the central portion of this North Elevation was a window opening, which was unglazed and open to the elements. The window head was arched in brick headers. There was no surround. The window cill was composed of a single course of bull-nosed brick stretchers. The window opening itself contained a simple timber frame with a rounded head, surround and cill timbers [Plates 2 and 4].

Plate 2: The North Elevation, from the north

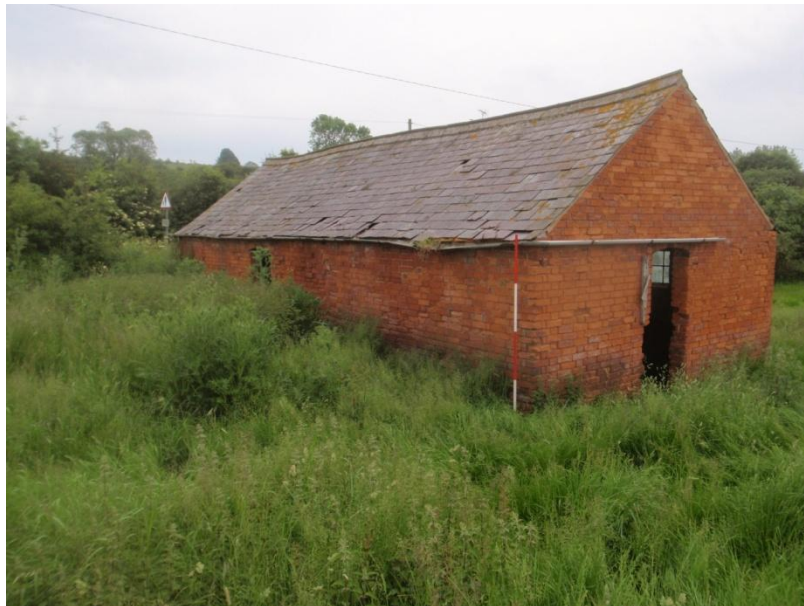
Plate 3: The North and West Elevations, from the north-west

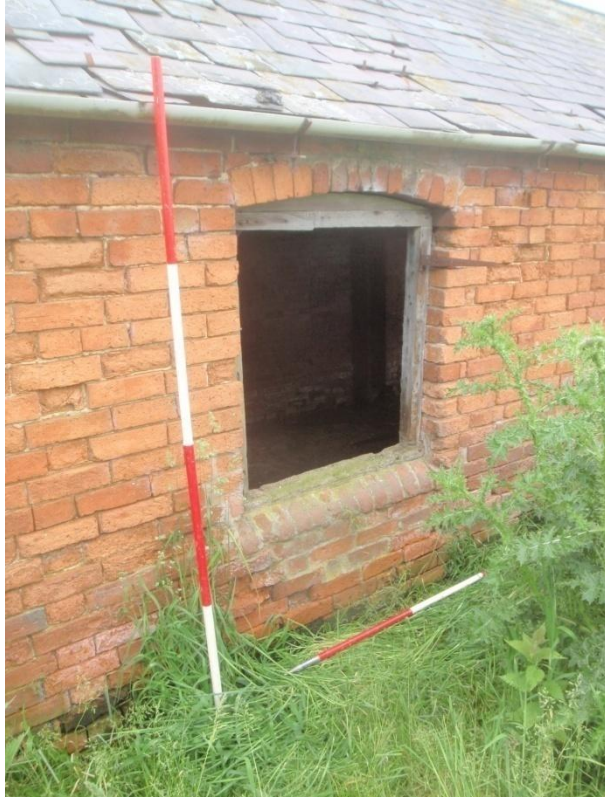
Plate 4: Detail: the window opening in the North Elevation, from the north-east

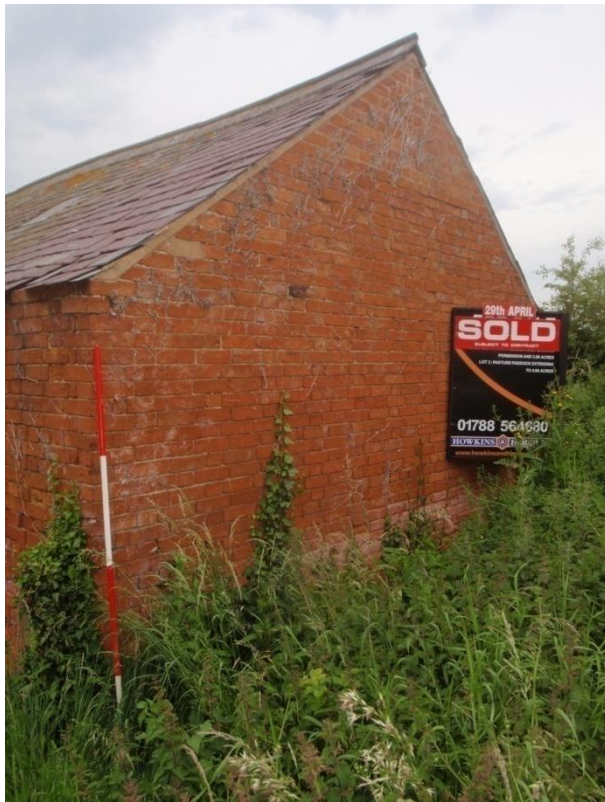
The wall fabric of this East Elevation was composed of courses of alternate headers and stretchers in Flemish Bond. There were no apparent openings within this wall fabric [Plate 5].

Plate 5: The East Elevation, from the south-east

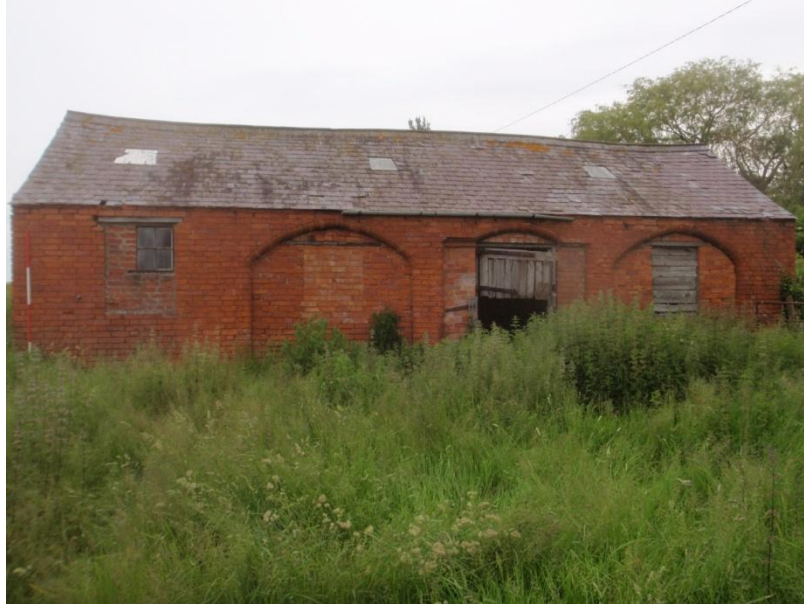
Plate 6: View of the South Elevation, from the south

Within the slate roof on this South Elevation were inserted three modern skylights which were glazed with modern glass. At roof level was modern Upvc guttering [**Plate 6**].

The brickwork in the wall fabric of this South Elevation was composed of courses of alternate brick headers and stretchers in Flemish Bond [**Plate 6**].

To the left (west), was one infilled and former window opening. At the window head was an original horizontal timber lintel. The infilling was composed of modern 20th century brickwork of mostly stretchers with the lowest courses of the infilling composed of brick headers. Within the infilled opening also was a modern 20th century steel framed four light casement window that had been inserted into the brickwork infilling [**Plate 6**].

To the right (east), was a second infilled archway. The arch and the surrounds to either side were composed of bull nose brick stretchers. This archway would also originally have been open to the south and was similarly an original feature of this building. This had been infilled with brick which was made to match that of the surrounding and original brickwork. This infilling brickwork was mostly composed of brick stretchers with occasional headers. Inserted in turn into this brick infilling was a second window opening. This had a horizontal timber lintel at its head with the opening occupied by a series of vertical timber planks [**Plate 6**].

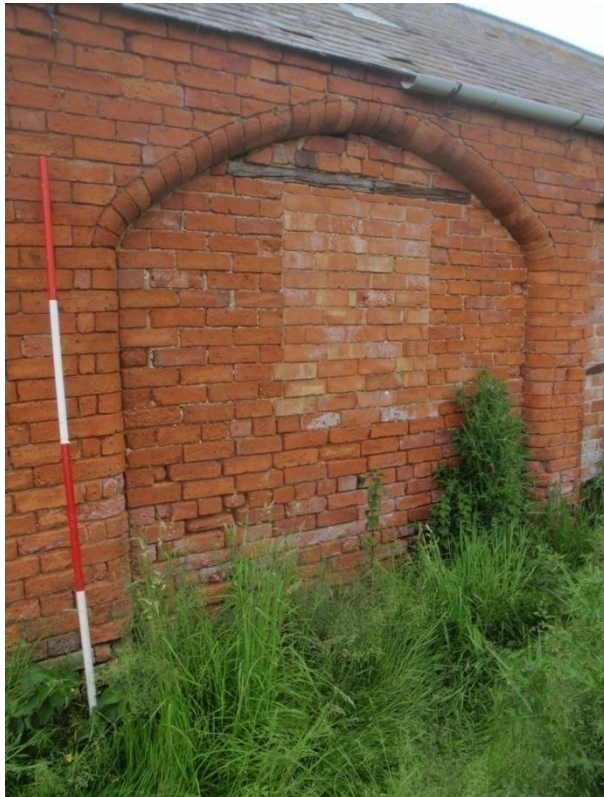
Plate 7: Detail: Infilled brick arch with infilled former window opening, from the south-west.

To the right (east), was an infilled archway. The edging of the archway itself including the arch and surrounds were composed of bull nose brick stretchers. This archway would originally have been open to the south and was thus an original feature of this building. There appeared to be two phases of later brick infilling. The first phase of brick infilling was composed of mostly brick stretchers with occasional brick headers which was made to match that of the surrounding original brickwork. The second phase of this infilling comprised the insertion of a window into this infilled opening. This window was indicated by the presence of a horizontal timber lintel at the window head and two vertical edges to either side. The window opening was in then in turn infilled by modern 20th century brickwork composed mostly of brick stretchers, the timber lintel, edges and brick infilling thus marking the position of this former window opening [**Plate 7**].

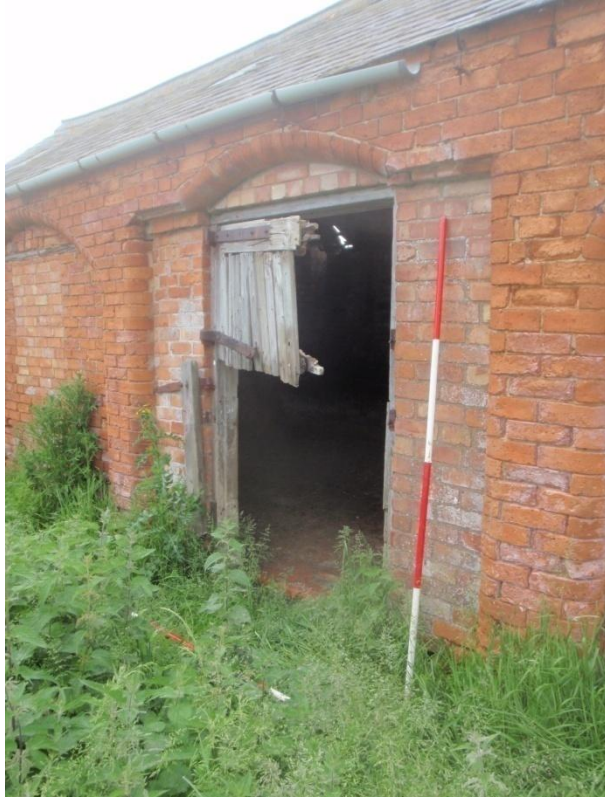
Plate 8: Detail: original arched entrance opening, infilled with modern brickwork and modern door opening, from the south-east

To the right (east), was a door opening. The original opening here would have been much larger than at present. This original opening was partially arched at its head with the archway composed of bull nosed brick stretchers. The original surrounds to either side were also composed of bull nose brick stretchers. This entrance was infilled with modern 20th century brickwork which was composed of a mixture of brick headers and stretchers. Into this modern brick infilling had been inserted a simple timber door frame which in turn

consisted of a horizontal timber at the door head with vertical timber surrounds to either side. No threshold here was apparent. Attached to this timber door frame had been two half doors, of which only the upper door had survived. This was composed of a series of horizontal timbers on a vertical internal timber frame. Two cast iron butt hinges were *in situ* to the left, which attached this door to the frame [**Plate 8**].

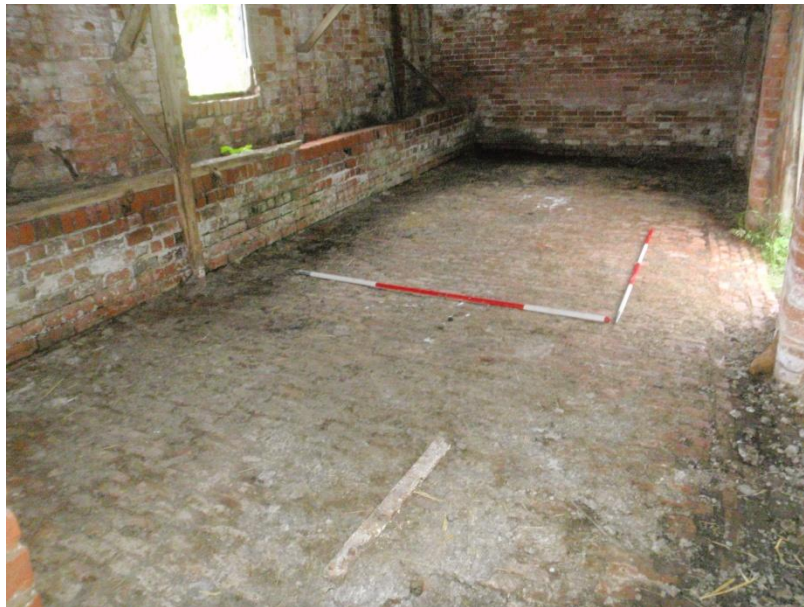
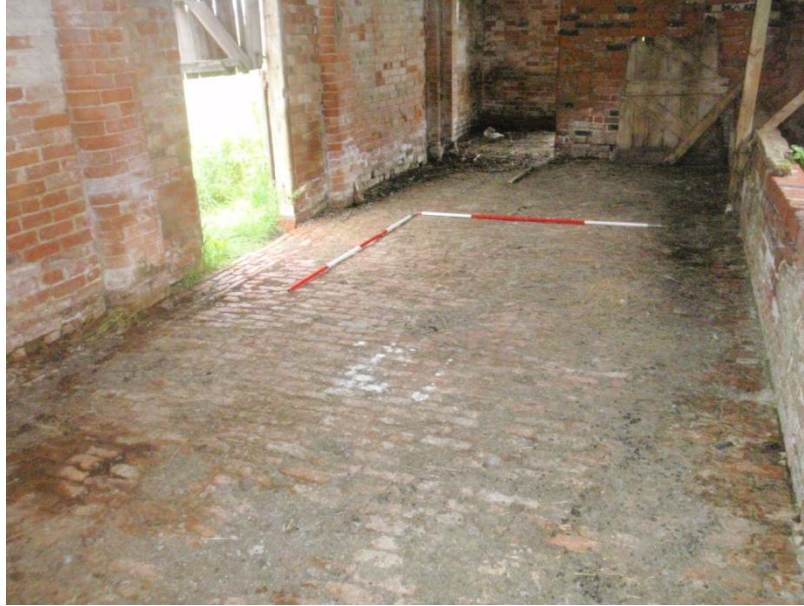
Plate 9: View of the floor of Cell 1, from the west

This floor was an original feature of the building of late 19th century date. The floor was composed of mostly handmade brick stretchers which had been laid on bed with the courses orientated from north-south. There was no apparent bonding material. By the entrance on the South Elevation, the floor here was composed of five courses of handmade brick stretchers laid on bed that were orientated from east-west [**Plates 9-10**].

Plate 10: View of the floor of Cell 1, from the east

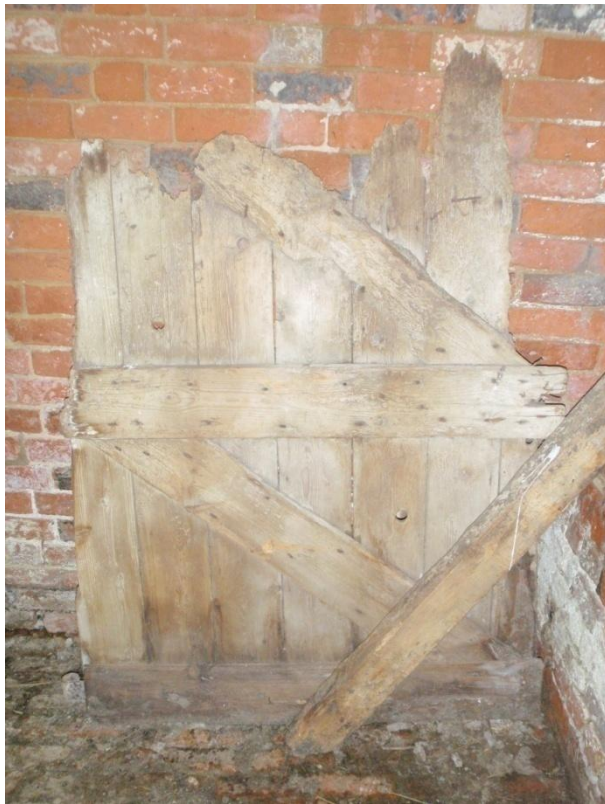
Plate 11: Detail: Removed half door

Plate 11 shows a removed timber half door from the later south facing entrance. This was composed of vertical timber planks that were attached to an internal frame of vertical and angled timber battens.

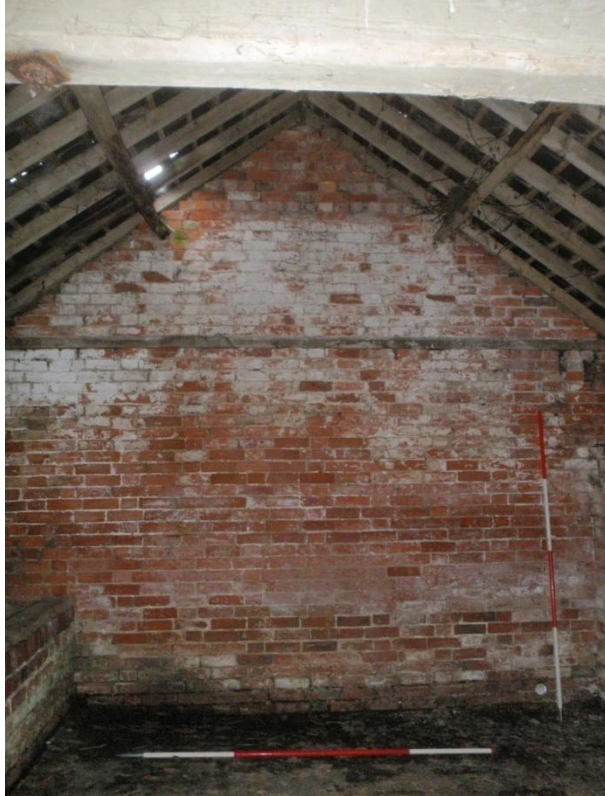
Plate 12: View of the East Wall, from the west

The brickwork fabric of this East Wall was composed of courses of alternate brick headers and stretchers in Flemish bond matching that of the brickwork on the external face of this wall. At roof level was a horizontal timber wall plate [Plate 12].

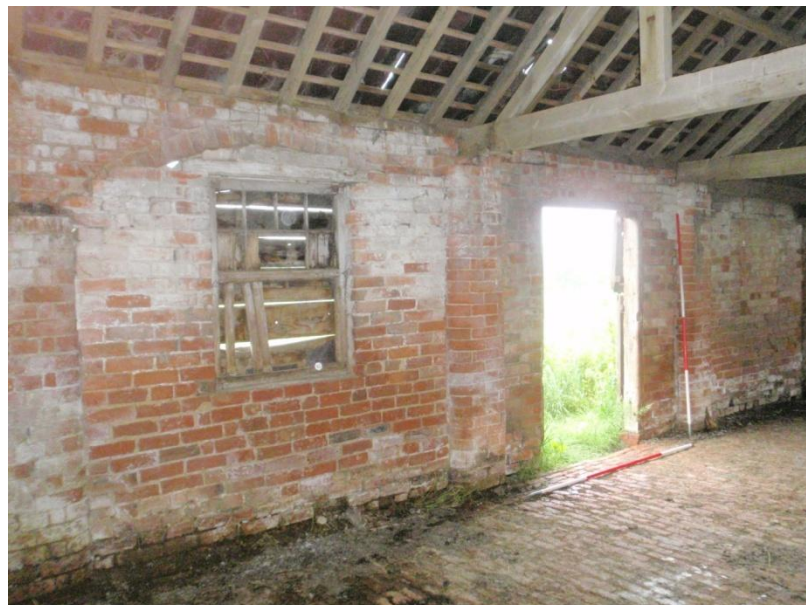
Plate 13: View of the South Wall, from the north-east

The brickwork fabric of this south wall was of two courses in thickness. A horizontal timber wallplate was recorded at roof level and extended along the whole length of this wall. The internal brickwork fabric matched that of the external composed of courses of brick headers and stretchers in Flemish Bond [Plates 13-14].

To the left (east), was the internal reverse of the infilled brick archway recorded on the external South Elevation, which was an original feature. The arch at just below roof level was composed of a course of brick headers. To either side, were two vertical columns or pilasters of brick. The brickwork of the column to the left (east) matched that of the original Flemish Bond wall fabric. The brickwork of the column to the right (west) was composed of brick stretchers and was also an original internal feature as this column was edged with bull nosed bricks. The internal brickwork infilling of this archway was a modern 20th century addition and was composed of courses of alternate headers and stretchers in Flemish Bond to match that of the surrounding original wall fabric. However, this brick infilling was incomplete as there were small gaps in the fabric just below the top of the arch which were open to the elements [Plate 13].

Inserted into this later brick infilling was the internal face of the window that was recorded in the external South Elevation. This comprised a two light timber sash window, which was unglazed. The transom and the upper window bars had survived. This sash window was contained within a simple timber frame of surrounds, head and cill, which was surmounted by an internal horizontal timber lintel. Above this a gap in the brickwork had been infilled with a further horizontal timber which was set into modern concrete [Plate 13].

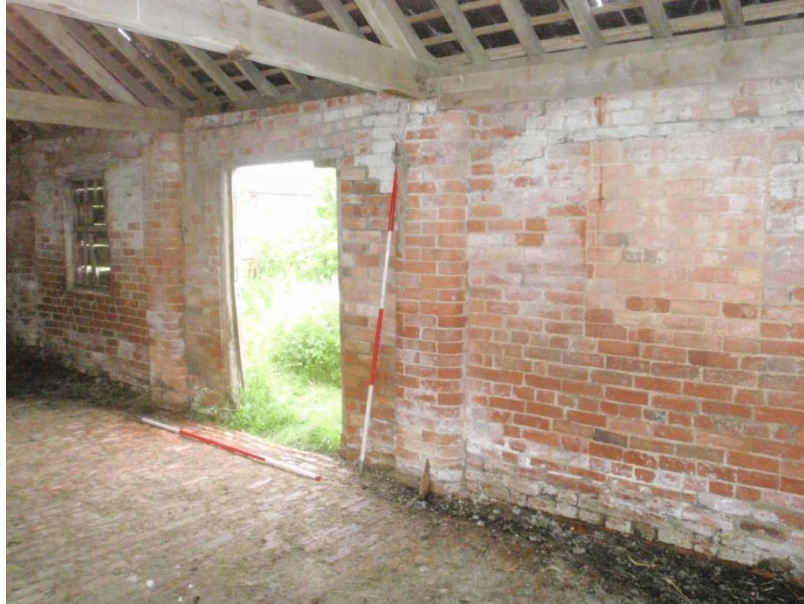
Plate 14: View of the South Wall, from the north-west

To the right (west) of this, the entrance opening contained within a simple timber frame described earlier was encompassed within the interior modern 20th century brick infilling of this entrance. This brickwork infilling was composed a mixture of late 20th century brick headers and stretchers [Plate 14].

To the right (west), of the infilled entrance opening was a third vertical internal column or pilaster of brick. This was similarly composed of brick stretchers matching that of the

second column and similarly edged with bull nosed brick stretchers. This also appeared to be an original feature with the second and third brick columns forming part of the original south facing opening, thus framing and defining it [**Plate 14**].

To the right (west), was the infilled window opening, which was previously recorded on the external South Elevation. The internal face of this former window opening, (which was a later feature), comprised a horizontal timber lintel at the window head, with the former window opening infilled with mostly modern 20th century brick stretchers with two courses of brick headers visible at the lower levels. The vertical edges of the window opening to either side were also clearly visible in the wall fabric [**Plate 14**].

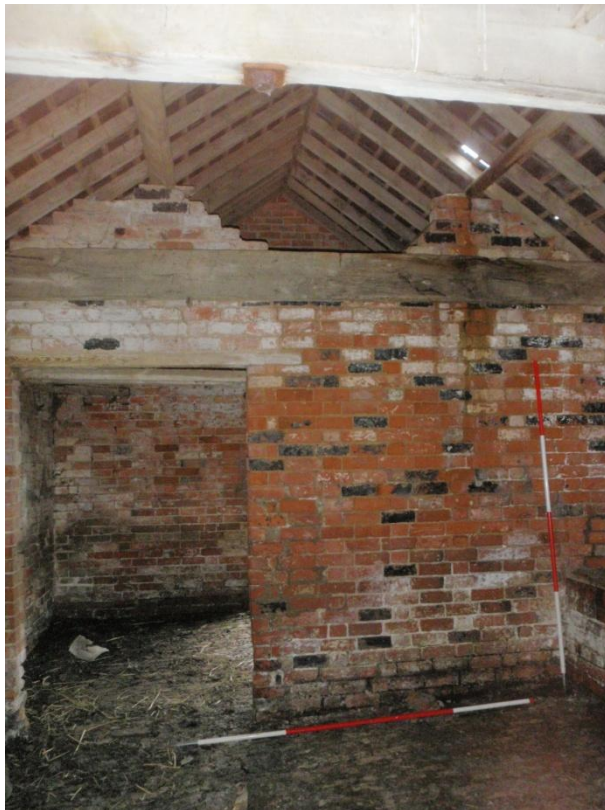
Plate 15: View of the West Wall (Internal Partition Wall), from the east

This internal partition wall was undoubtedly a later addition to the internal arrangement of this building. It is thus clear that this outbuilding was originally of one cell, and had been divided into two cells at a later stage by the construction of this additional wall, probably in the later 19th century. The wall brickwork fabric was composed of courses of alternate brick headers and stretchers in Flemish Bond to match the original brickwork fabric of the outbuilding. Some of the brick stretchers were distinctive and appeared to have been fired with a dark grey black glaze. Some of this brickwork fabric was absent at the upper levels [**Plate 15**].

Above this brickwork and at roof level was a substantial horizontal timber wallplate. To the left (south) was an internal entrance opening, contemporary with the addition of this internal wall with a horizontal timber lintel at the entrance head. [**Plate 15**].

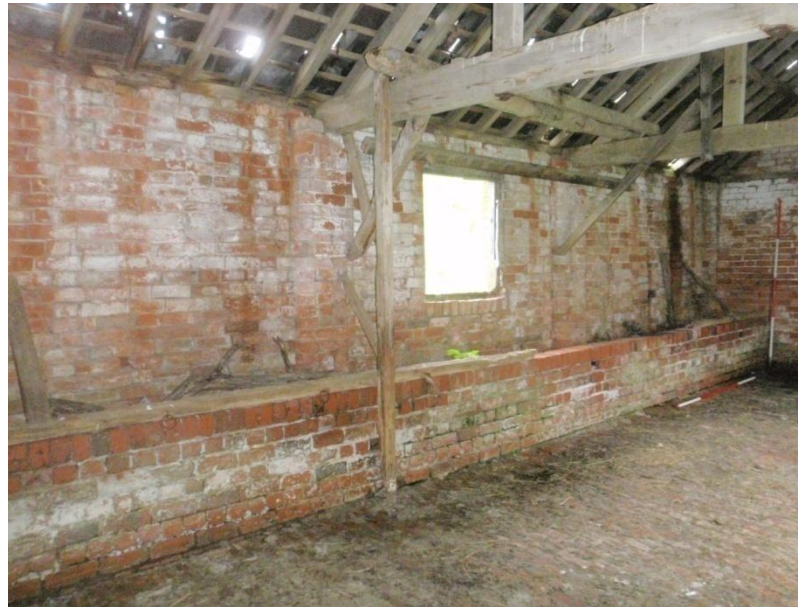
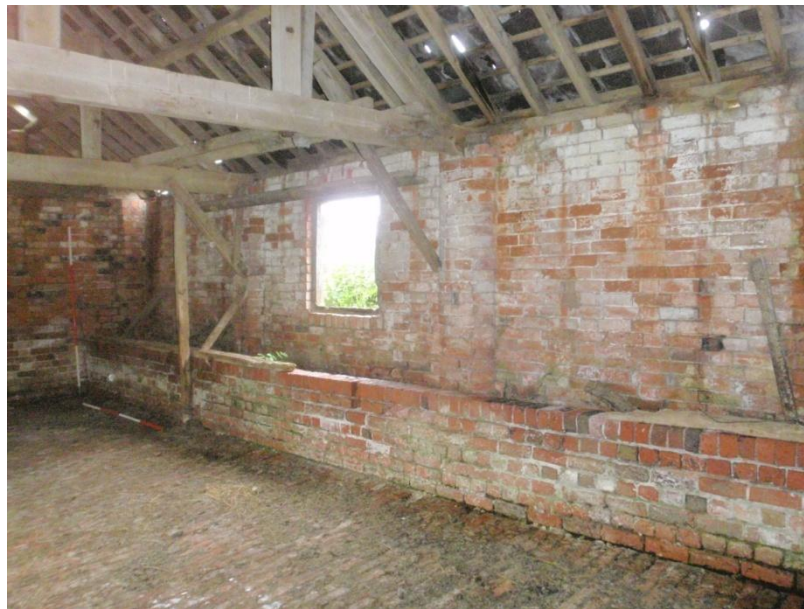
Plate 16: View of the South Wall, from the south-west

Plate 17: View of the South Wall, from the south-east

At the lower levels was a stud wall of brick, which had housed a former feed trough. This feature extended along the whole length of this south wall. This stud wall was seven courses in height and was composed of an uppermost course of brick stretchers laid on bed and below this six courses of alternate headers and stretchers. From this and to the left (west), a vertical timber and several angled timber braces extended upwards from this trough to support a roof truss. Three of the angled timber braces had been inserted into the wall fabric and were also attached to the roof timbers. Two of these angled brace timbers in turn supported a further horizontal timber which would have originally housed a hay cradle [Plates 16-17].

The brickwork wall fabric of this south wall was the same as that recorded elsewhere as original brickwork of courses of alternate brick headers and stretchers in Flemish Bond. To either side of the central window opening were two vertical columns or pilasters composed of brick stretchers and bull nosed brick stretchers. Both no doubt were further original build features [Plates 16-17].

The internal feature of this window opening comprised a cill in brick of headers. Two horizontal timber wallplates were also situated above the brickwork and at roof level [Plate 17].

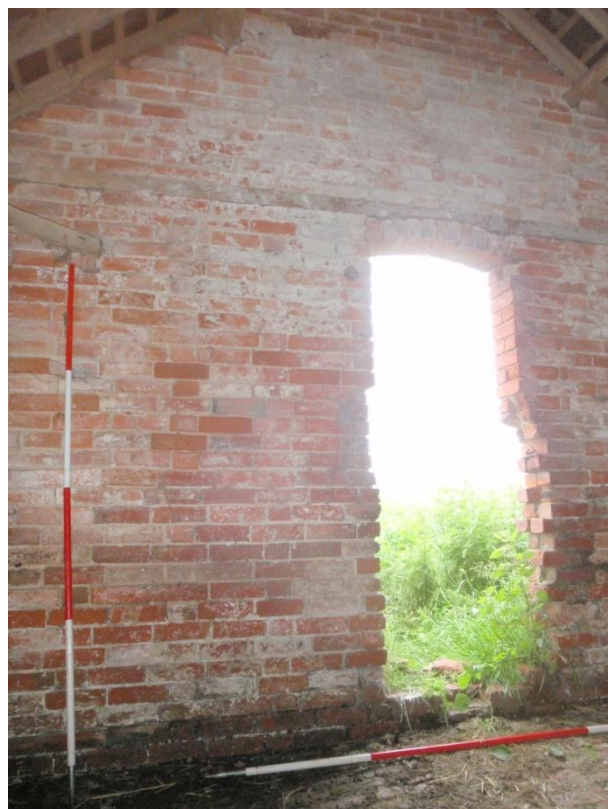
Plate 18: View of the West Wall, from the east

The internal wall fabric of this west wall matched that of the exterior (West Elevation) with the uppermost levels in courses of headers in Header Bond. Below this level and down to ground level, the brickwork was composed of courses of alternate brick headers and stretchers in Flemish Bond [Plate 18].

At ceiling level was a horizontal timber wallplate which had been incorporated into the brickwork. The internal details of the west facing entrance opening here was an arch at the entrance head composed of one course of brick headers. Parts of the internal surround brickwork had been removed. This revealed in turn a cavity wall here [Plate 18].

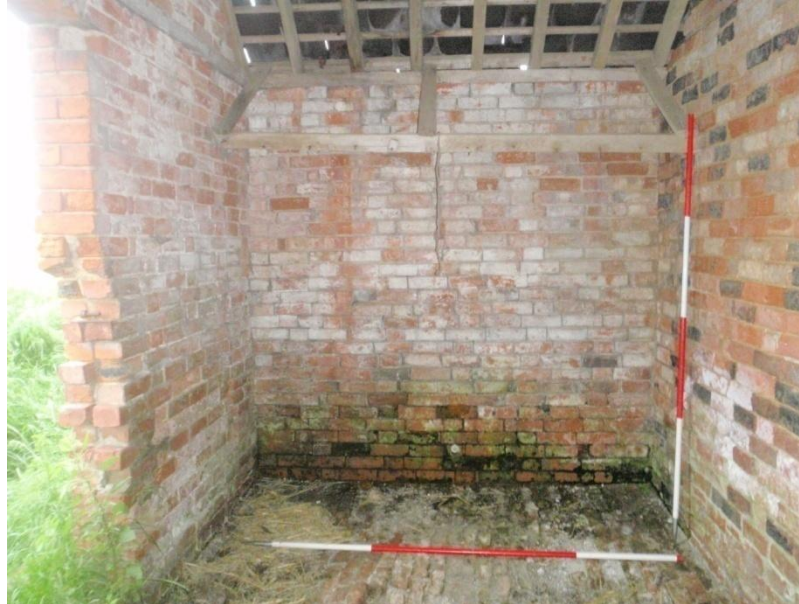
Plate 19: View of the floor and North Wall, from the south

As with the larger first cell, the floor within this second cell was identical composed of mostly brick stretchers laid on bed and mainly aligned from east-west with other brick stretchers laid out on a north-south alignment adjacent to the north wall [Plates 19-20].

The internal wall fabric of this North Wall mirrored that of the external North Elevation composed of courses of alternate headers and stretchers in Flemish Bond. This wall appeared to be of one course in thickness. A second hay cradle was also evident at roof level here composed of four timbers (one horizontal and three angled timbers) that were arranged as a frame. This frame had been inserted into the fabric of both the East and West Wall. There was also a horizontal timber wallplate at roof level [Plate 19].

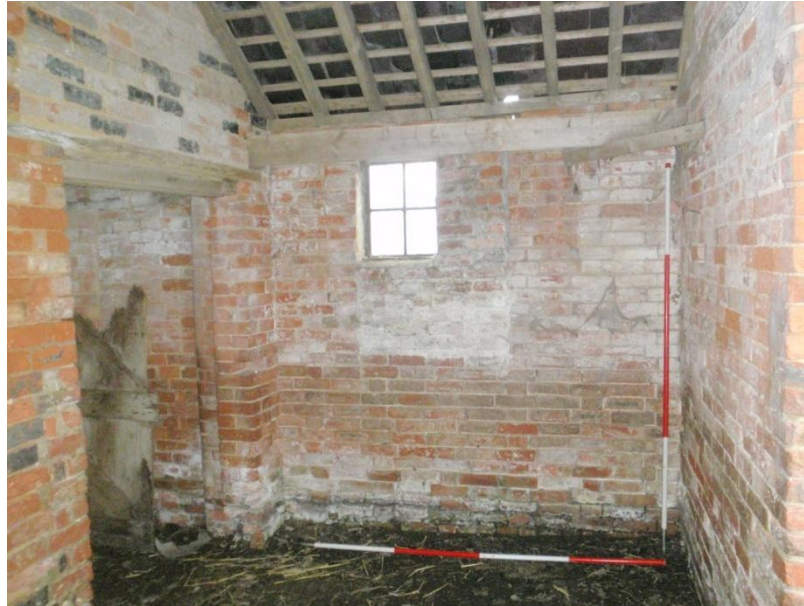
The internal wall fabric of this South Wall matched that of the external South Elevation composed of courses of alternate headers and stretchers in Flemish Bond. This wall appeared to be of one course in thickness. A horizontal timber wallplate was evident at roof level. A second and more substantial horizontal timber was also noted here at roof level. This appeared to provide extra support to the above roof structure at this western end of the outbuilding and had been inserted into the wall fabric of both the East and West Walls of this cell [Plate 20].

Inserted into this wall fabric and also previously recorded on the external South Elevation was an infilled former window opening; the extent of which was clearly defined by two vertical edges to either side. The infilling of this former window opening was composed of modern 20th century brickwork mostly of brick stretchers with the lowest courses of the infilling composed of brick headers. Within the infilled opening also was a modern 20th century steel framed four light casement window that had been inserted into the brickwork infilling [Plate 20].

Plate 20: View of the floor and South Wall, from the north

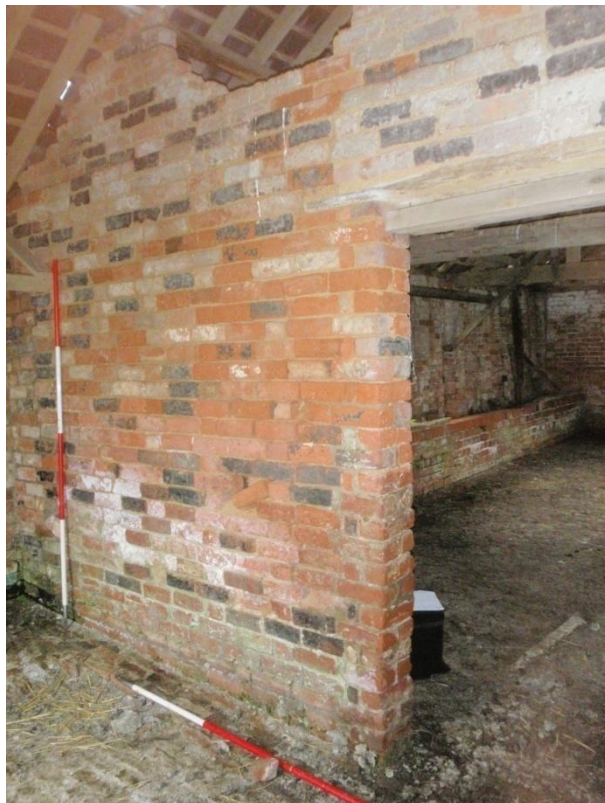
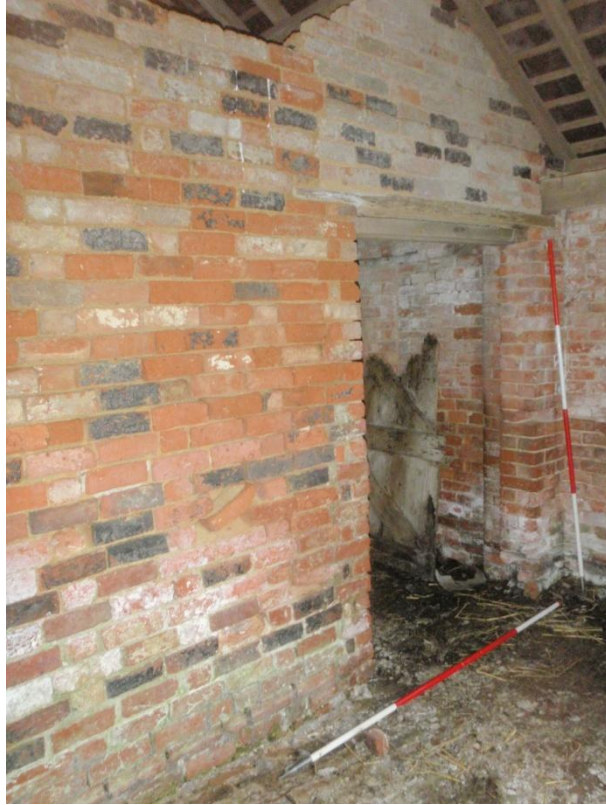
Plate 21: View of the East Wall (Internal Partition Wall), from the south-west

Plate 22: View of the East Wall (Internal Partition Wall), from the north-west

This wall appeared to be of at least two courses in thickness. The wall brickwork fabric was the same as that previously recorded for the opposing east face of other side of this wall, comprising courses of alternate brick headers and stretchers in Flemish Bond. As with the opposing face, some of the brick stretchers had been fired with a dark grey black glaze. The entrance opening to the right (south) had a second horizontal timber lintel at the entrance head [Plates 21-22].

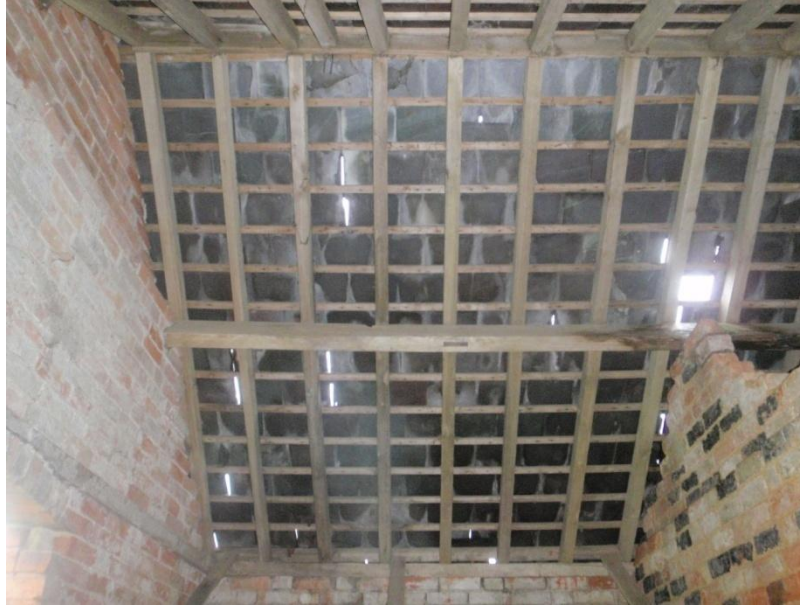
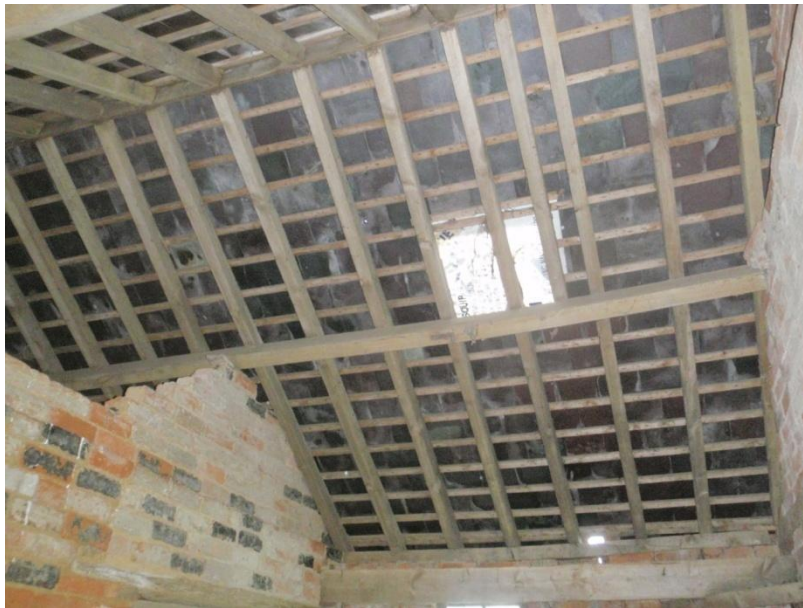
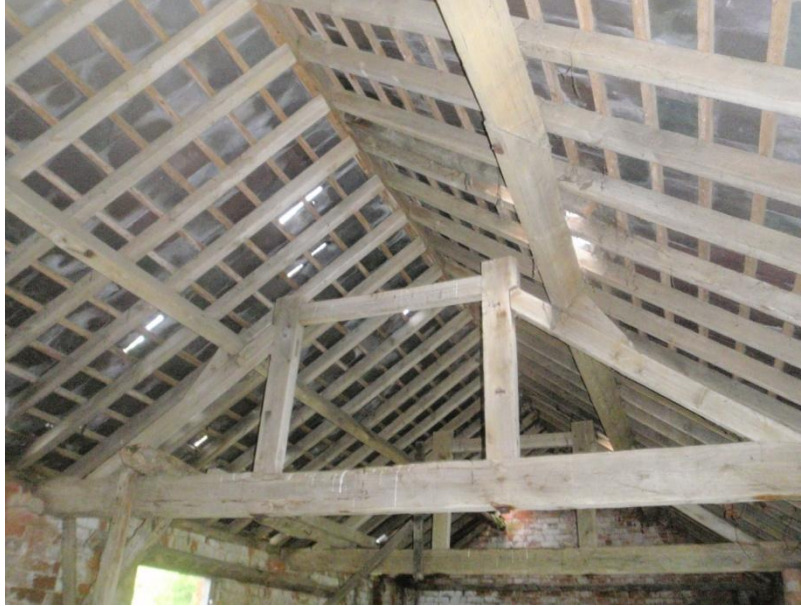
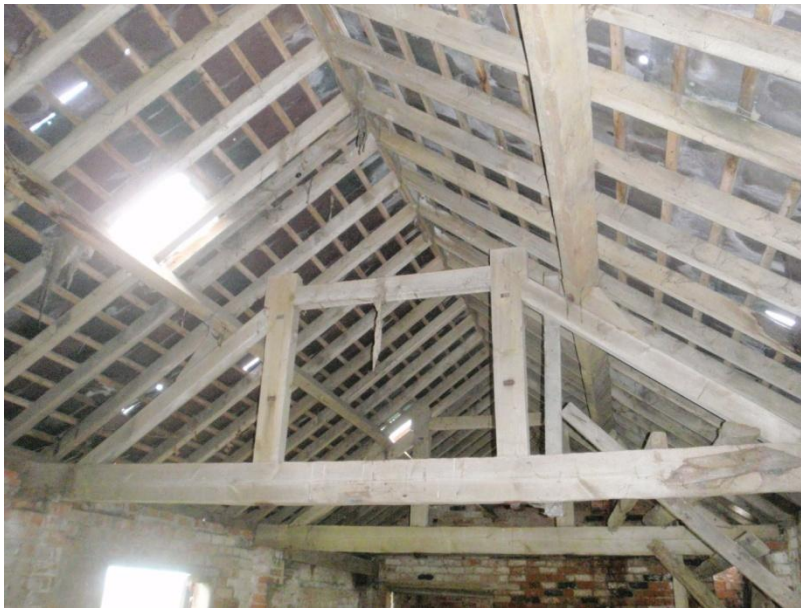
The supporting roof structure of this former outbuilding comprised two queen post roof trusses with a horizontal tie beam at the base, two angled braces to either side and a horizontal collar beam towards the roof apex. The roof trusses were attached to the various aforementioned wallplates and to the principal roof purlins. These timbers supported a roof structure which consisted of two sectioned principal purlins to either side and various rafters. The rafters were in turn attached to two further horizontal timbers at the roof apex [Plates 23-26].
