HISTORIC BUILDING RECORDING AT
PRIORY FARM,
HOWSHAM ROAD, KETTLEBY,
LINCOLNSHIRE

National Grid Reference: TA 0368 0712
Planning Reference: 133407
Site Code: PFKE15
Accession Number: LCNCC: 2015.248

January 2016

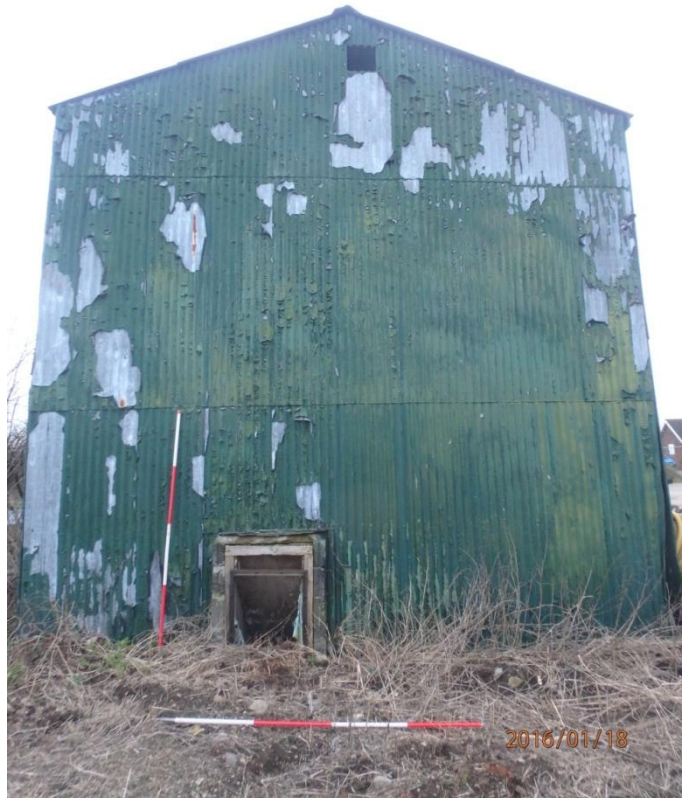
Plate 6: View of the South Elevation of the Hay Barn, from the south

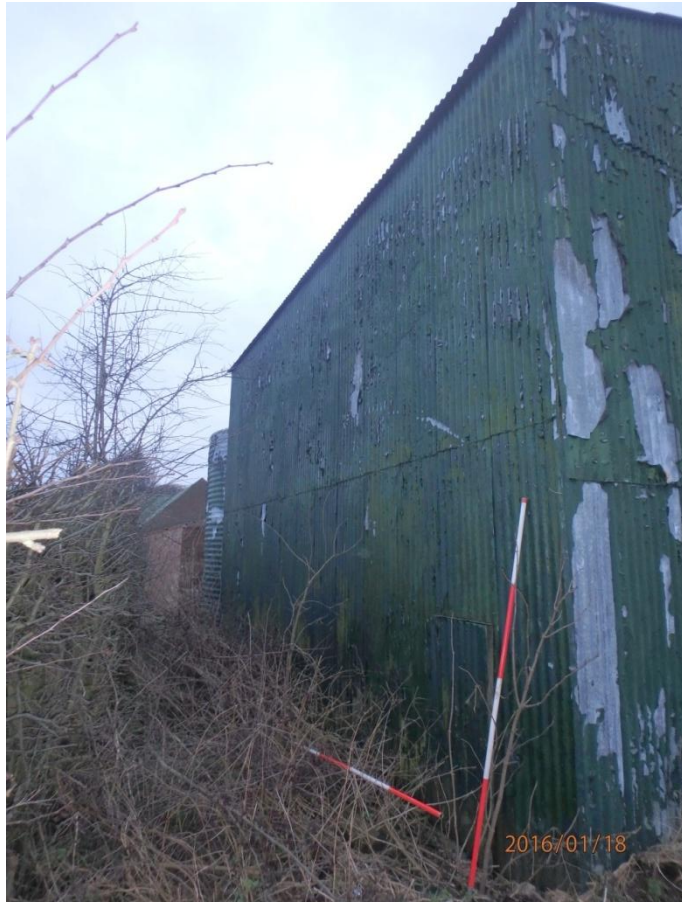
Plate 7: View of the West Elevation of the Hay Barn, from the south-west

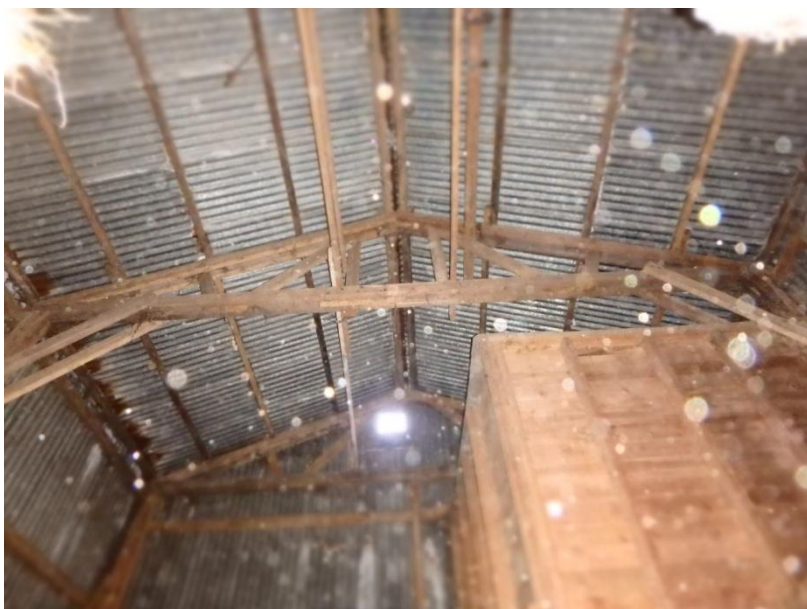
Plate 14: View of the supporting roof structure at the northern end of the Hay Barn, from the south

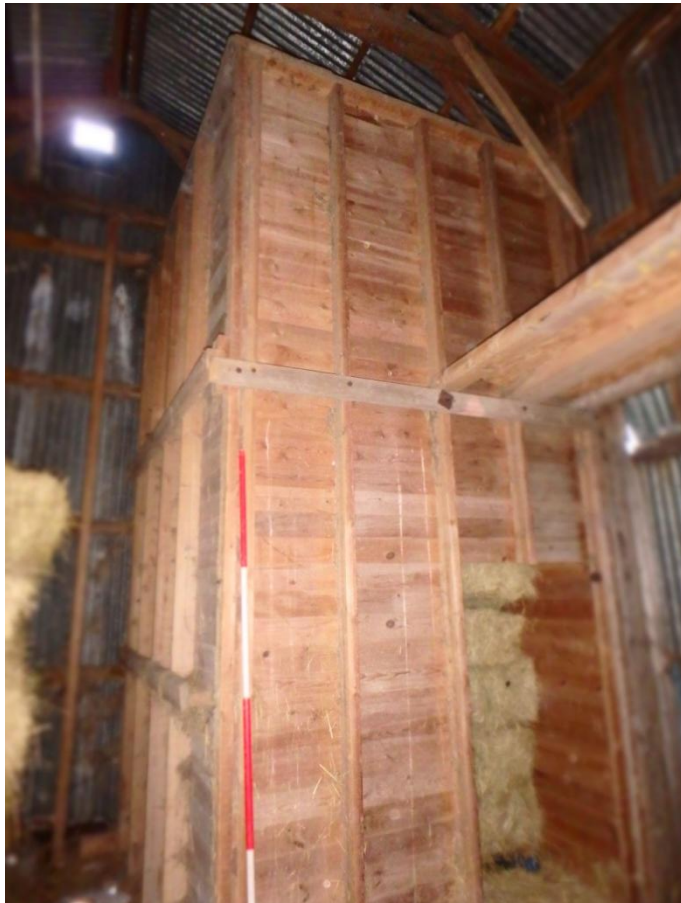
truss at the northern end of the building. This second truss has an additional two internal vertical timbers within its construction. These roof trusses are in turn attached to a series of horizontal timber purlins which lead onto horizontal timbers at the roof apex.

Plate 16: View of the upper levels of the northern internal partition, from the south

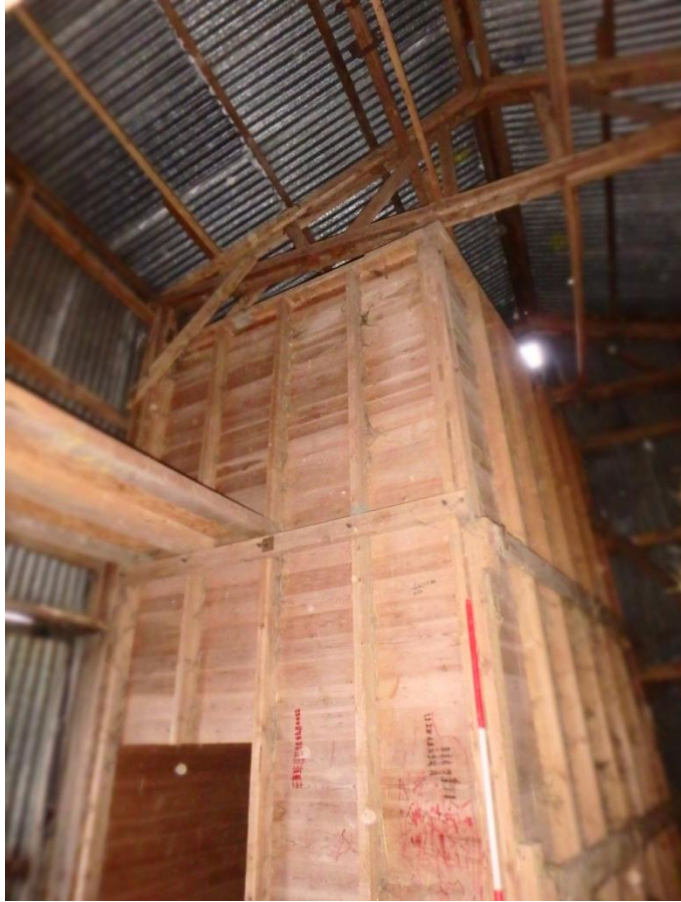
Plates 20 and 21 feature the corresponding southern internal timber partition which is situated on the eastern side of the building. This partition is composed of an external timber framework of horizontal and vertical timbers to which is attached an internal wall covering of horizontal timber planks.

Plate 21: View of the upper levels of the southern internal partition, from the north

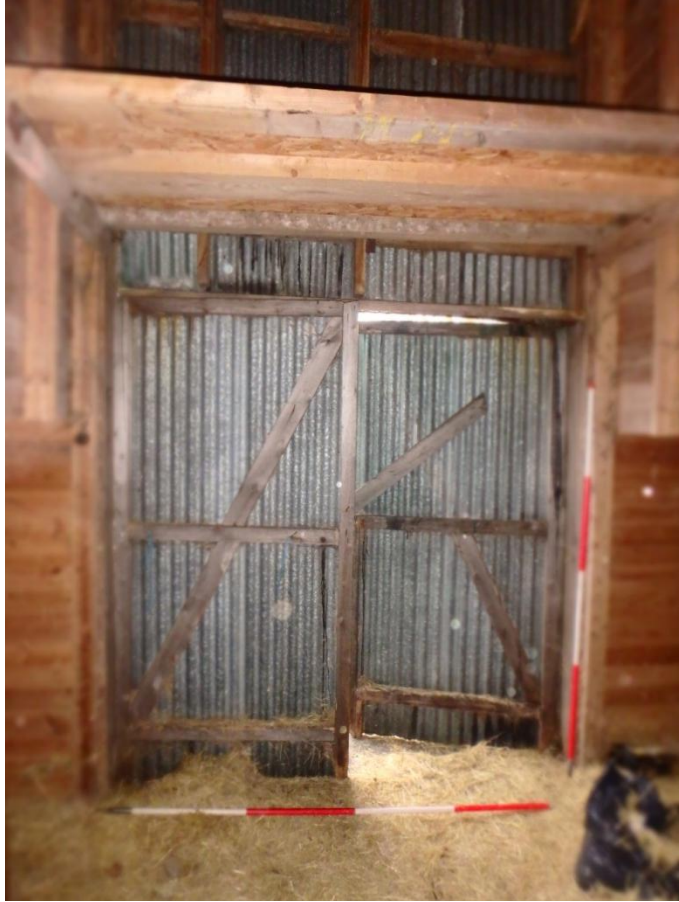
Plate 22 features the internal face of the east facing ground floor doubled doored entrance to this building. This entrance is located between the aforementioned two internal timber partitions. The external metal cladding is shown attached to an internal timber framework composed of a series of angled, vertical and horizontal timbers.

Plate 22: View of the doubled doored ground floor entrance, from the west

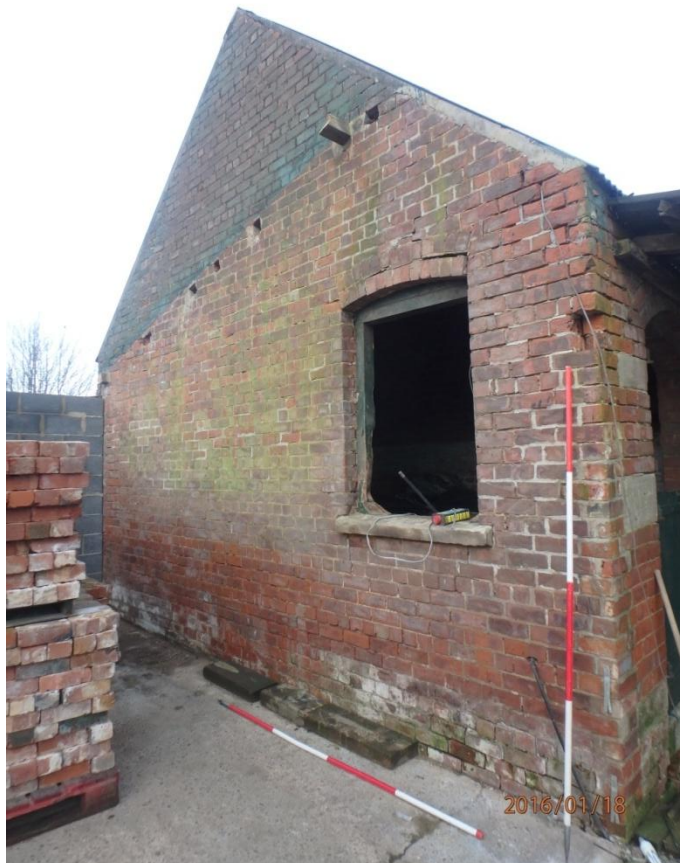
To the east of the South Elevation is a lean-to supported by a vertical column in brick which is attached to the adjoining West Elevation, which will be discussed in more detail later. To the right (east) is an unglazed original window opening with a curved head composed of two courses of brick headers and a stone cill at the base. Within the opening are the remains of a timber window frame of surrounds and head. Also visible within the brickwork fabric of this Elevation is the roof line of the former adjoining and partially demolished 20th century outbuilding. This line is also denoted by a line of eight holes for the timber roof purlins of this building.

Plate 42: View of the South Elevation of the West Range, from the south-east

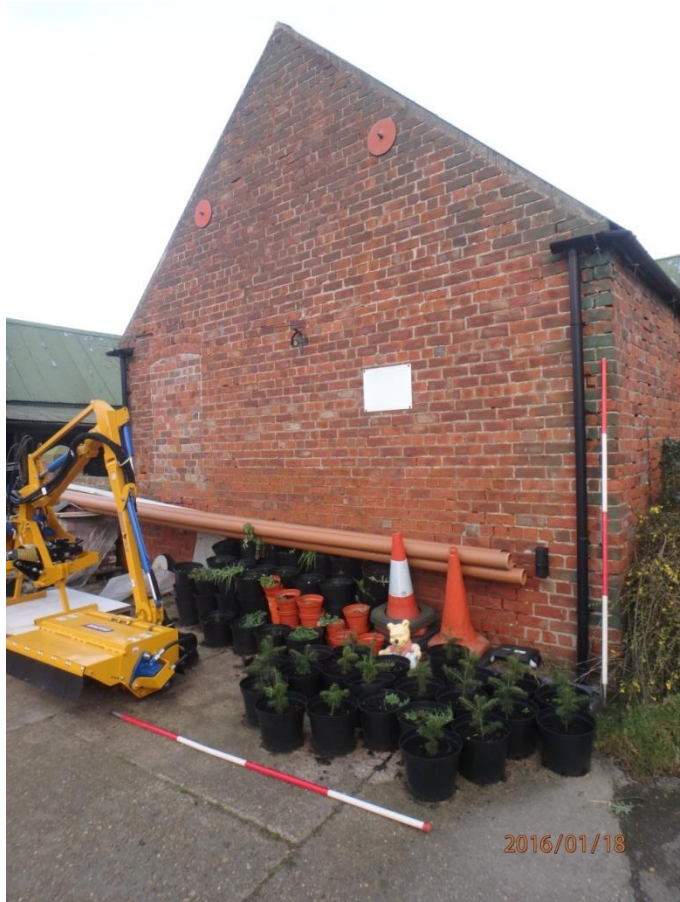
To the left (west), is an original and infilled former window opening with a curved head composed of two courses of brick headers. The infill is also of brick, though later brickwork in date, but which matches the surrounding brickwork wall fabric in English Garden Wall Bond. At just below roof levels are two circular shaped modern metal wall braces. There are also two vertical modern Upvc downpipes at each end of this Elevation.

Plate 43: View of the South Elevation of the East Range, from the south

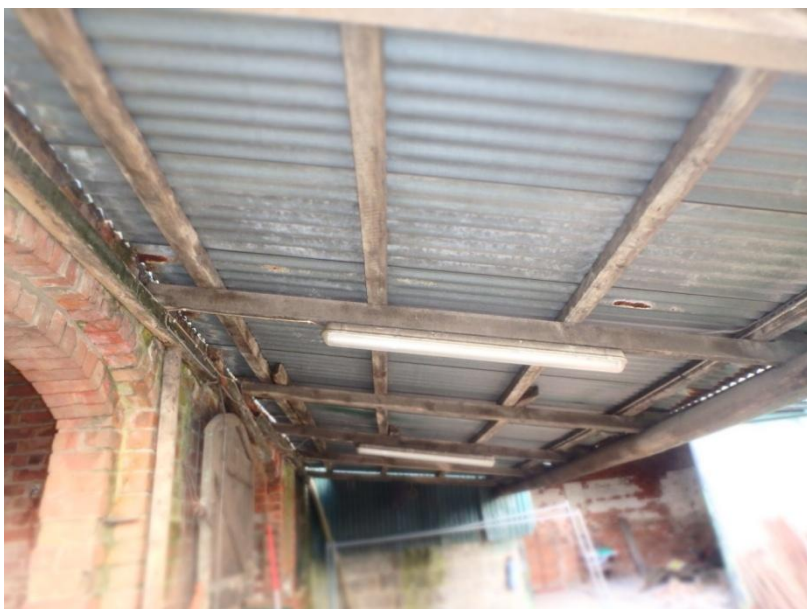
Plate 55 features the East Elevation of the West Range and in particular the east facing lean-to structure which is attached to this Elevation. The main support for this structure is a vertical column in brick stretchers at its southern end, whilst the corresponding northern end is attached to the South Elevation of the North Range. There is modern Upvc guttering at roof level which is in turn attached to a horizontal timber wallplate also at roof level. The roof supporting structure is attached on one side to this wallplate. This supporting roof structure is composed of a series of horizontal timber battens to which the roof covering of corrugated iron sheets is attached to. This whole structure is in turn affixed to a further horizontal timber wallplate attached to the brickwork fabric along the whole length of the East Elevation [**Plate 58**].

Plate 58: View of the roof supporting structure of the lean-to, from the south

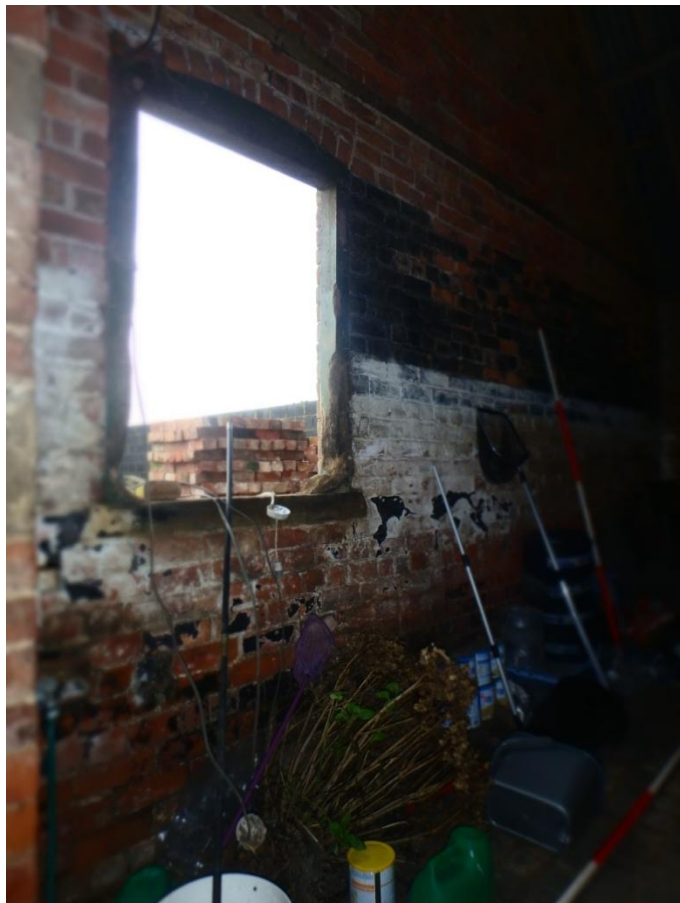
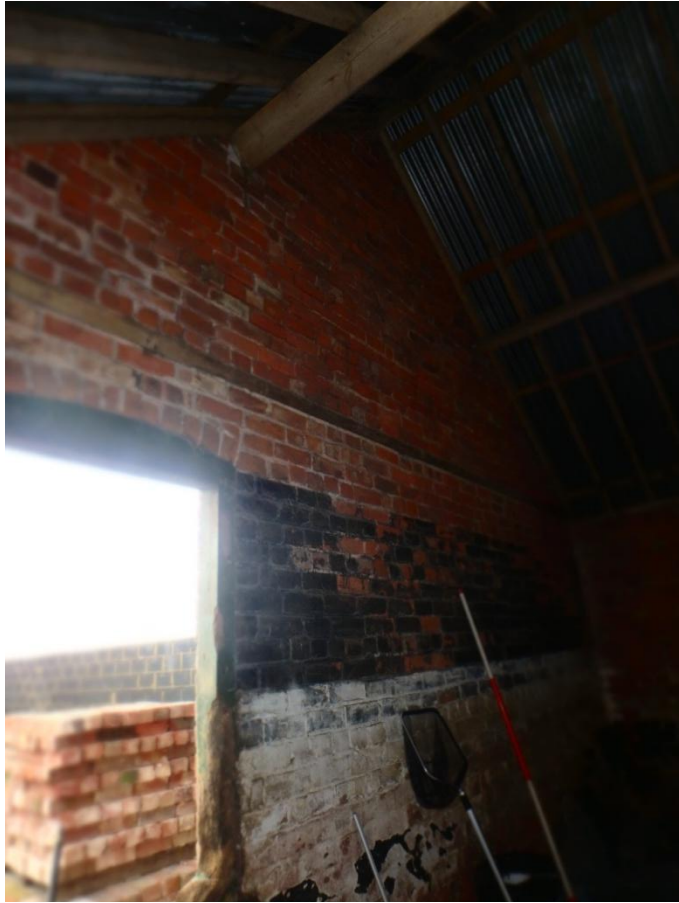
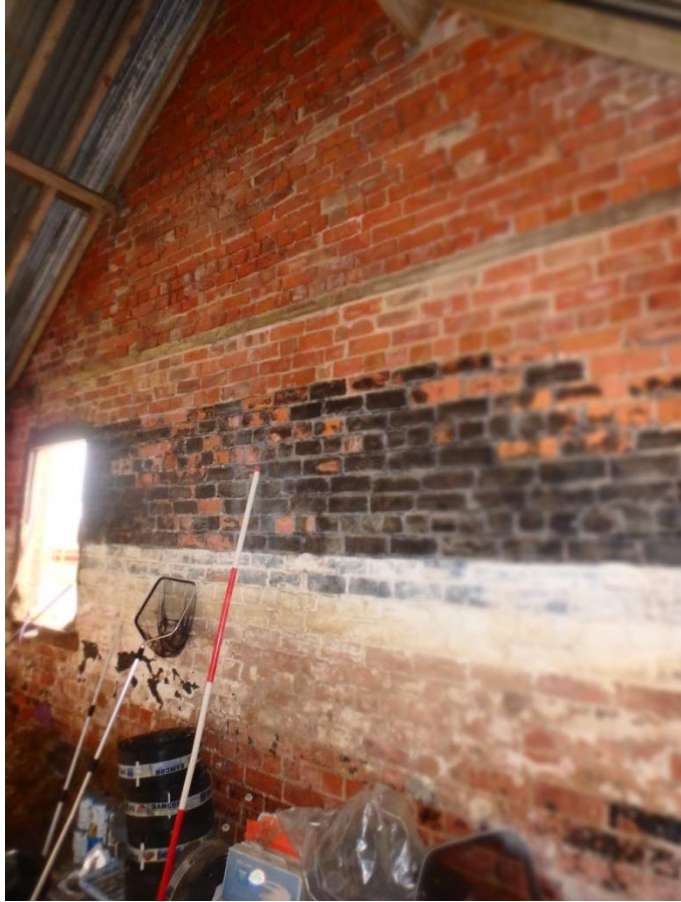
Plate 60: View of the south wall of Cell 1, from the east

Plate 61: View of the south wall of Cell 1, from the east

Plates 60-62 feature the south wall of **Cell 1**. The internal brickwork wall fabric of this wall in English Garden Bond matches that of the external brick wall fabric of the South Elevation. There is in addition a horizontal timber wallplate at ground floor ceiling level.

Plate 62: View of the south wall of Cell 1, from the west

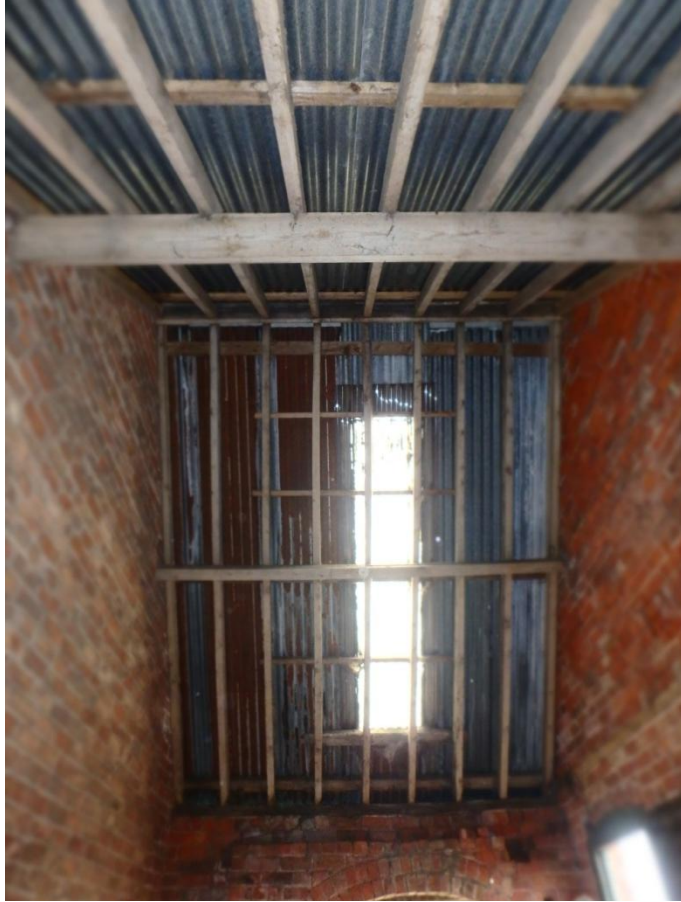
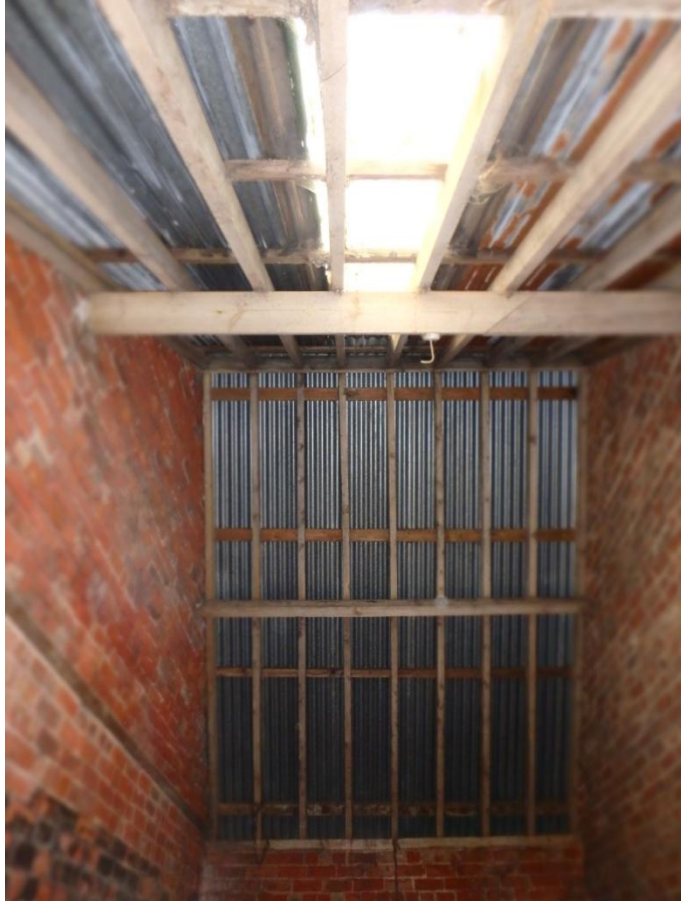
Plate 63: View of the roof supporting structure of Cell 1, from the west

Plates 63 and 64 provide images of the roof supporting structure in **Cell 1**. Two horizontal timber wallplates occur at the upper levels of the east and west walls of **Cell 1**. To these are attached a series of common timber rafters, which extend to horizontal timbers at the roof apex. Providing additional support to this roof structure are two principal horizontal purlins and a series of horizontal secondary purlins which extend the length of this West Range and to which are attached the roof rafters. This framework in turn supports the roof covering of corrugated metal sheeting.

Plate 64: View of the roof supporting structure of Cell 1, from the east

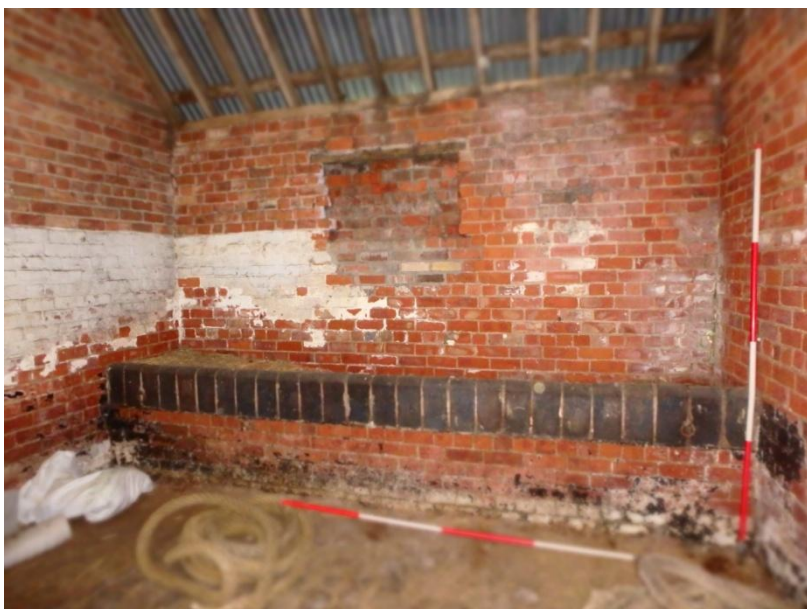
Plate 69: View of the west wall of Cell 2, from the east

Plate 69 features the west wall of **Cell 2**. The brickwork wall fabric here comprises three courses of brick stretchers which alternate with one course of brick headers in English Garden Wall Bond .

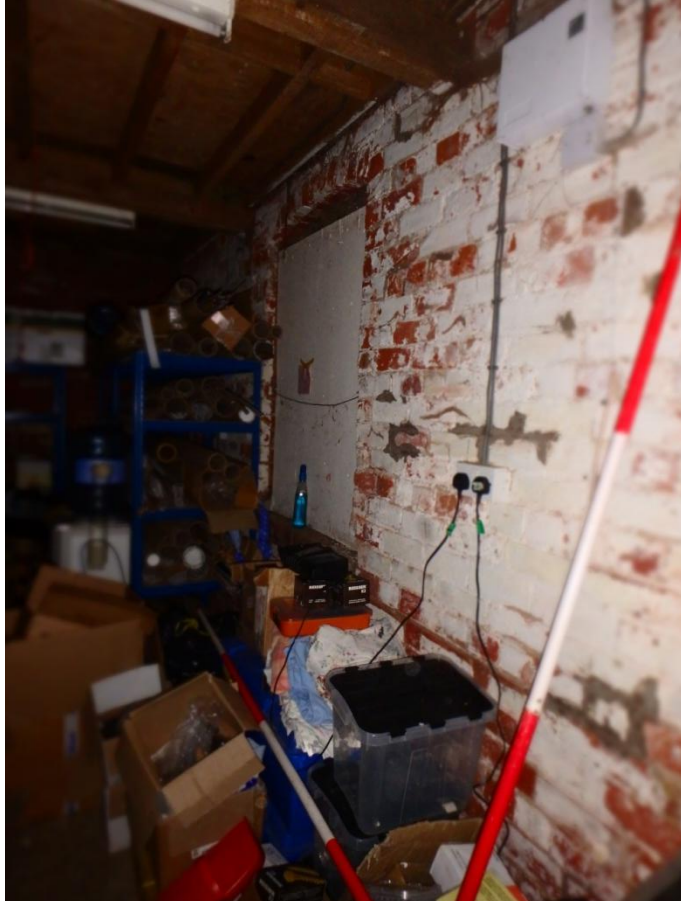
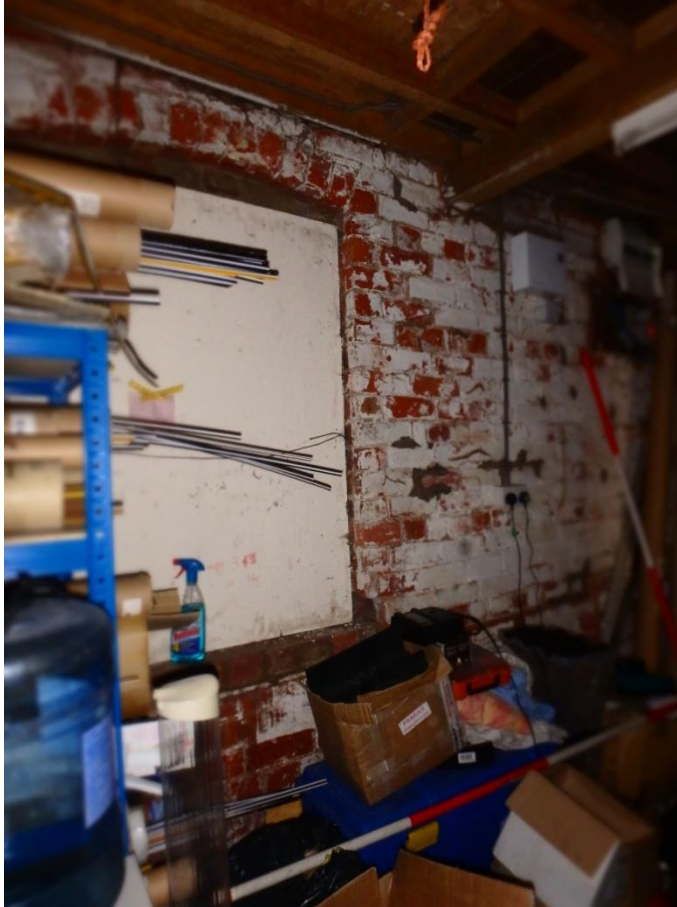
Plates 133 and 134 provide images of a portion of the east wall of **Cell 6** which is within this internal timber partition. The brickwork wall fabric here is of the same English Garden Wall Bond as noted elsewhere with the same bonding materials. To the left (north) is the inner face of an east facing entrance which was previously recorded on the external opposing East Elevation of the East Range. Much of the inner face of this entrance has been covered over with hardboard, though the inner face of the curved door head composed of two courses of brick headers along with a horizontal timber wallplate above this is visible.

Plate 133: View of the east wall of Cell 6, from the south

Plate 134: View of the east wall of Cell 6, from the north
