**NEVILLE HALL
FREELANCE ARCHAEOLOGIST & CONSULTANT**

HISTORIC BUILDING RECORDING AT
WOODHOUSE FARM, HURN ROAD,
HOLBEACH, LINCOLNSHIRE

March 2018

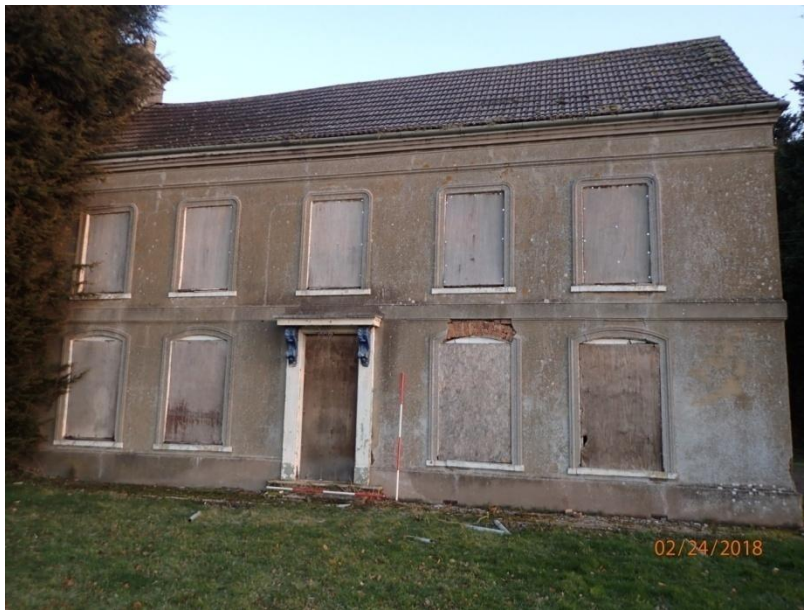
Plate 5: View of the South Elevation of the Farmhouse, from the south

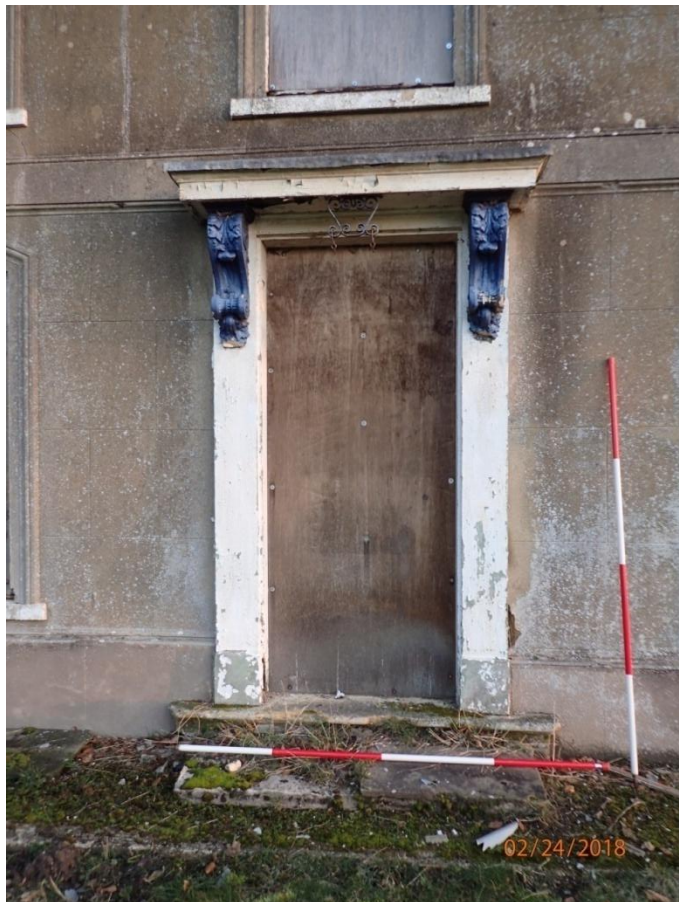
Plate 6: Detail: View of the south facing entrance to the Farmhouse, from the south

opening also in stone. Above the opening is a flat pediment, which is supported by moulded stonework on the opening surrounds to either side of the opening. Also featured is some decorative wrought iron work, which is attached to the underside of the pediment. **Plate 6** provides a detailed view of this south facing entrance.

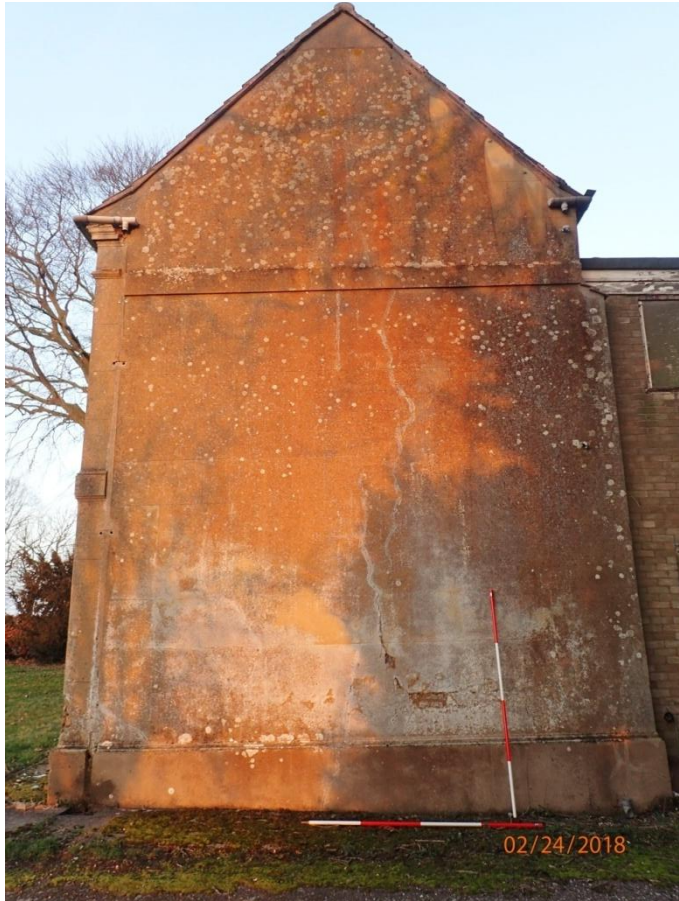
Plate 10: View of the East Elevation of the Farmhouse, from the east

Plate 10 provides a detailed view of the East Elevation of the Farmhouse. This is similarly entirely covered over with modern cement rendering, which obscures the underlying detail of its construction. Further modern horizontal Upvc guttering may be seen at just below roof levels as well as the tracing of a modern Upvc vertical downpipe to the left (south). The eastern end of moulded cement rendering may also be observed at the mid and uppermost levels of this Elevation to the left (south).

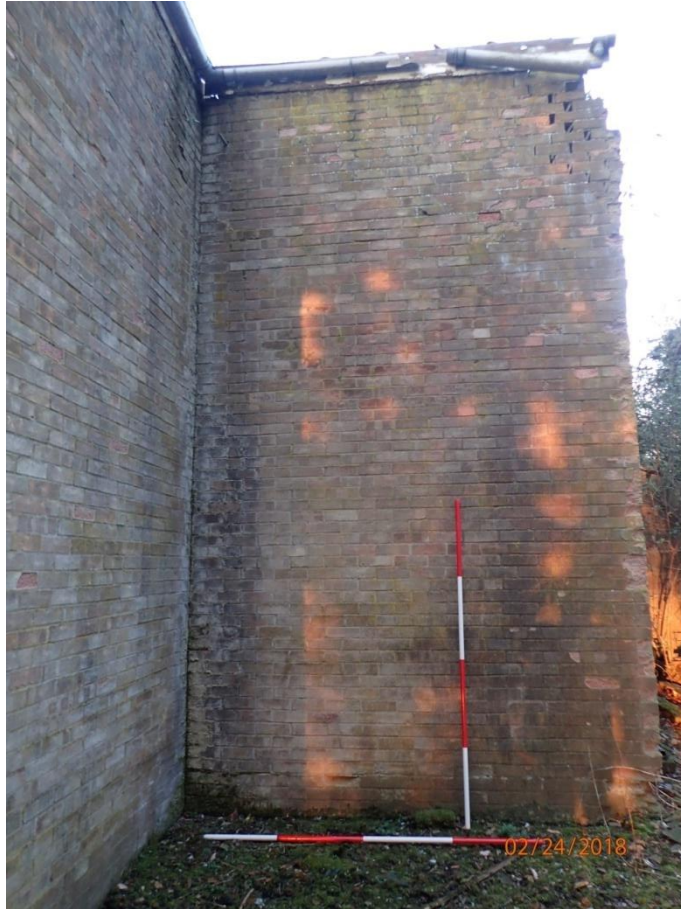
Plate 15: View of the Second East Elevation of the Modern Rear Extension of the Farmhouse, from the east

Plate 15 provides an image of the second East Elevation of the modern rear extension. The brickwork wall fabric of this second East Elevation is composed of courses of brick stretchers in Stretcher Bond. At just below roof levels are the timber fascia boards to which are attached the horizontal modern Upvc guttering.

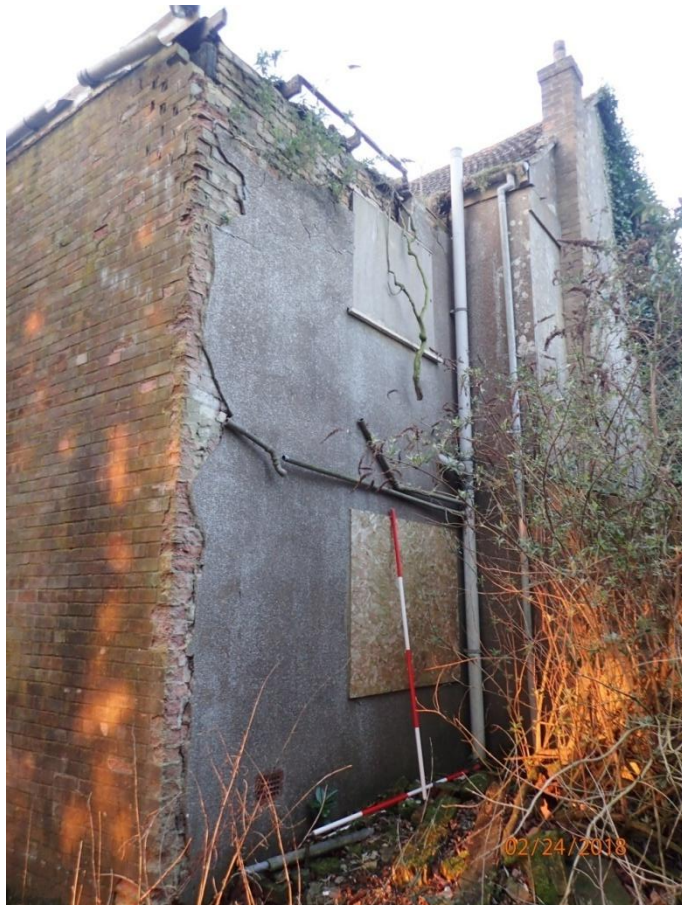
Plate 16: View of the Second North Elevation of the Modern Rear Extension of the Farmhouse, from the east

At ground floor level is a north facing window opening, which has been entirely boarded over. Above this, and at first floor level is a second north facing window opening. This has almost been entirely boarded over, though the timber frame head and sill may be observed.

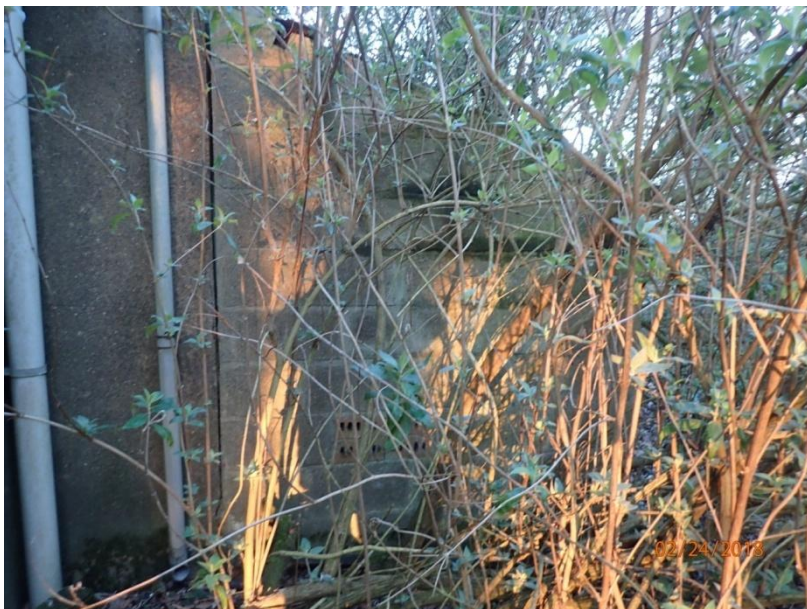
Plate 18 provides a detailed view of the modern single storey rear outbuilding that is attached to the North Elevation of the Rear Wing of the Farmhouse and of its modern breezeblock work construction.

Plate 18: View of the East Elevation of a single storey rear outbuilding to the North Elevation of the Rear Wing of the Farmhouse, from the east

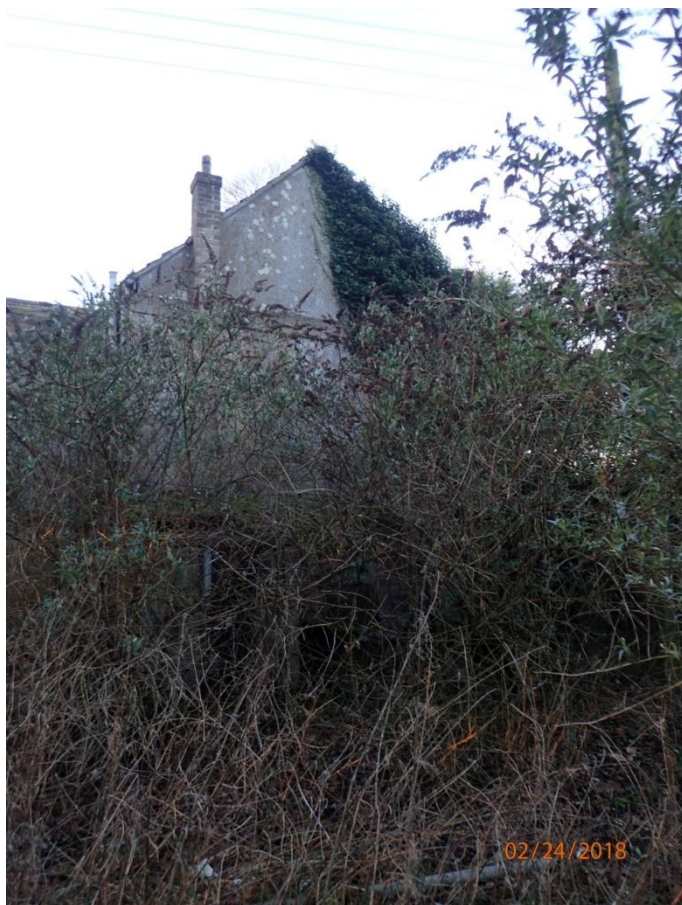
Plate 19 provides a general view of the North Elevation of the Rear Wing of the Farmhouse. This Rear Wing is also of two storeys in height and is bonded to the main body of the Farmhouse. The Rear Wing has a gabled roof with a covering of modern cement roof tiles. This image only shows the upper levels of this North Elevation owing to dense tree and vegetation cover in the foreground. These upper levels also appear to be entirely covered over with cement rendering which obscures the underlying wall fabric. The upper levels of the bonded vertical brick chimney stack may also be seen. This is composed of courses of mixed brick headers and brick stretchers.

Plate 19: General view of the North Elevation of the Rear Wing of the Farmhouse, from the north

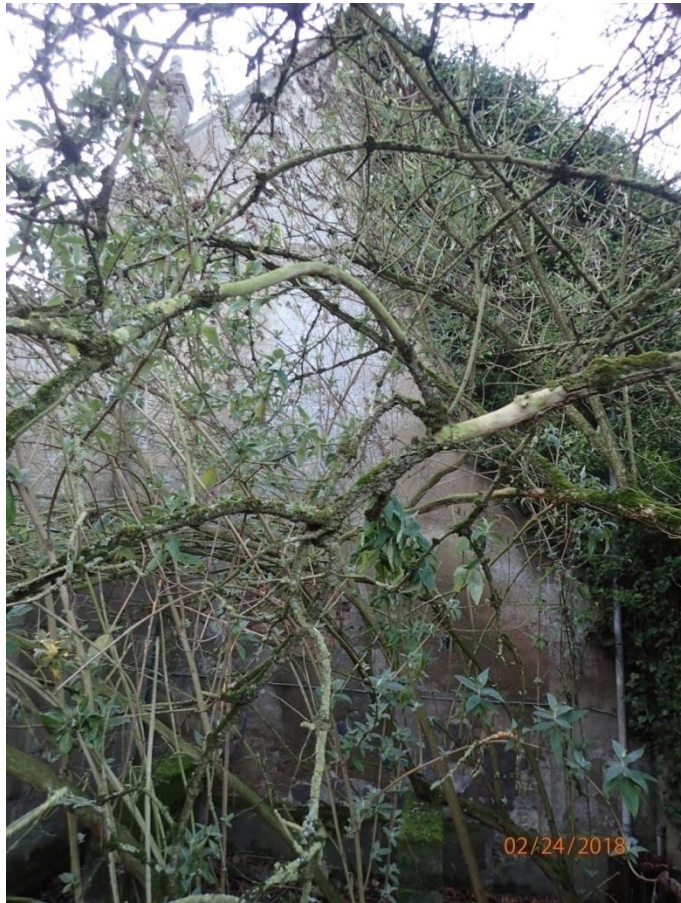
Plate 22 features both the upper and lower levels of this North Elevation, showing that it is entirely covered over with cement rendering. A further vertical modern Upvc downpipe may also be observed to the right (west).

Plate 22: View of the North Elevation of the Farmhouse, from the north

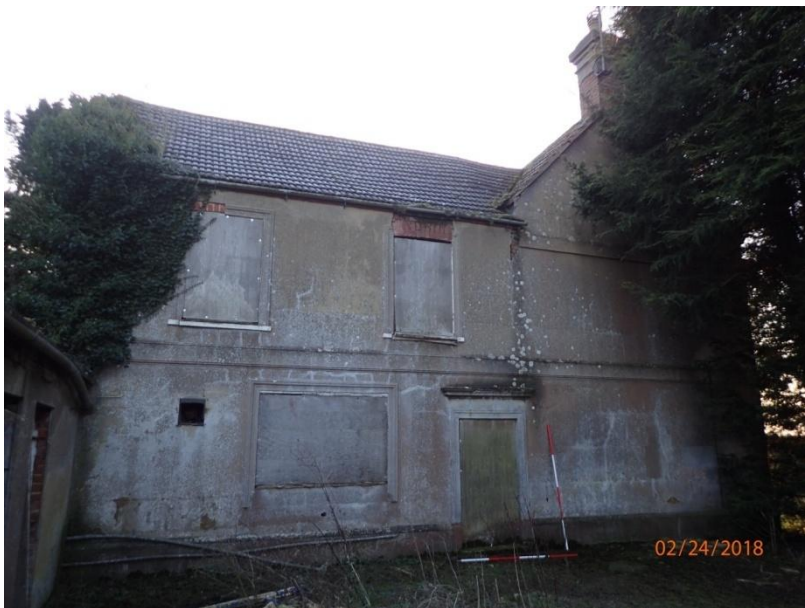
Plate 27: View of the West Elevation of the Farmhouse, from the west

Plates 25-27 provide detailed views from various perspectives of the West Elevation of the Rear Wing and also of the West Elevation of the main body of the Farmhouse. The gabled roof of the Rear Wing with its covering of modern cement roof tiles may be observed. The West Elevation of this Rear Wing is similarly almost entirely covered over with cement rendering. At just below roof level, is a single exposed course of brickwork composed of brick stretchers, to which is affixed modern horizontal Upvc guttering. Below this and at first floor levels are two west facing window openings. Both openings have been boarded over such that only the timber sills at the base of each opening are exposed. Both openings contain moulded cement heads and surrounds. However, the heads of both openings are also partially exposed by the removal of the overlying cement rendering. This has exposed portions of rounded window heads that are composed of courses of alternate brick headers and brick stretchers laid on end.

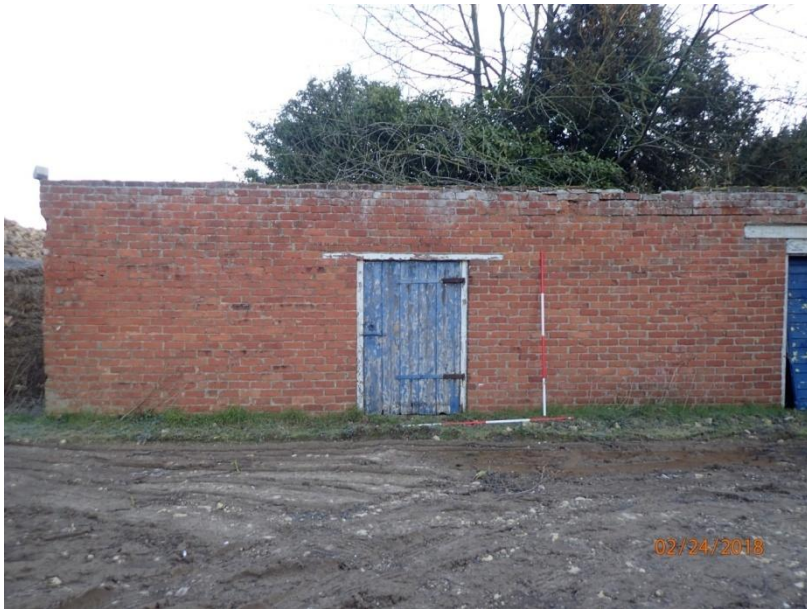
Plates 31 and 32 both provide further detailed views of the South Elevation of **Outbuilding 1**, featuring the brickwork wall fabric in Stretcher Bond, the south facing door opening and the two south facing modern garage door openings.

Plate 32: View of the South Elevation of Outbuilding 1, from the south

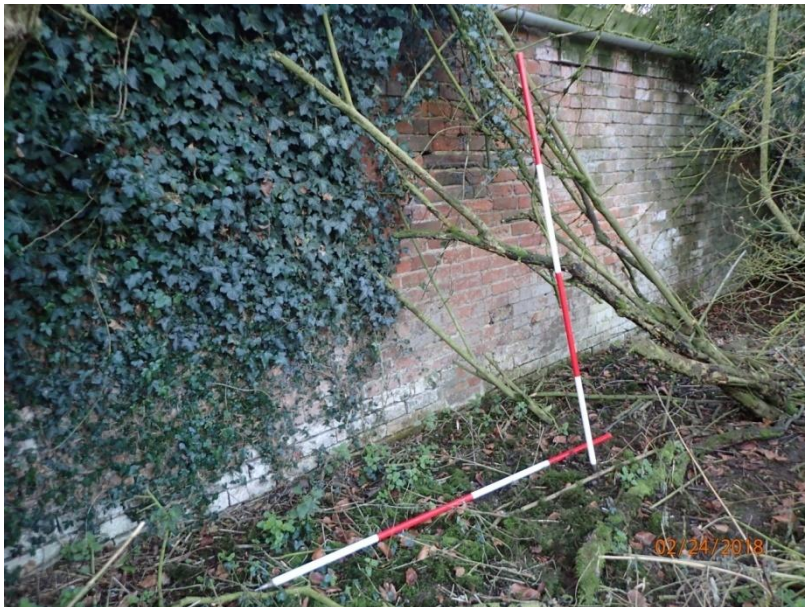
Plate 35 provides a view of the rear North Elevation of **Outbuilding 1**. The brickwork wall fabric of this North Elevation is mostly composed of courses of brick stretchers along with occasional courses of brick headers. A small infilled north facing window opening may also be observed. The window frame and lintel are both absent. The opening infilling is composed of a mix of courses of brick headers and of brick stretchers. At just below roof levels and attached to this brickwork is modern horizontal Upvc guttering.

Plate 35: View of the North Elevation of Outbuilding 1, from the north-east

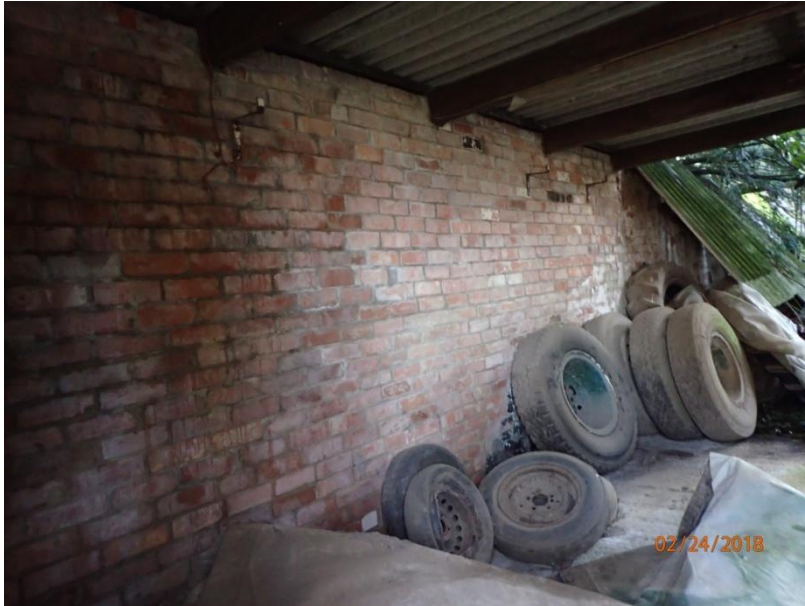
Plate 52: View of the north wall of Cell 2, from the west

Plate 52 provides a view of the corresponding north wall of **Cell 2**. The brickwork wall fabric of this south wall is composed of courses of brick stretches in Stretcher Bond. The northern ends of the horizontal timber floor joists above may be observed to be inserted into the upper levels of this south wall.

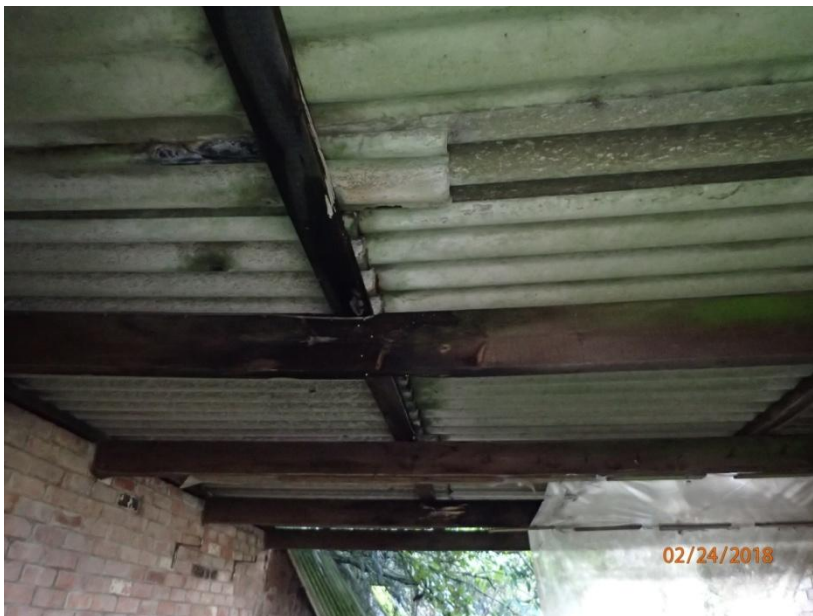
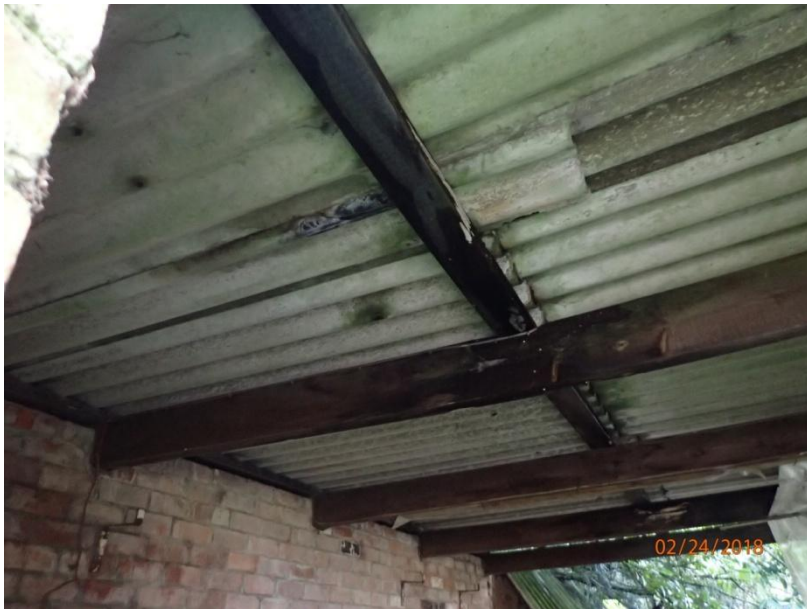
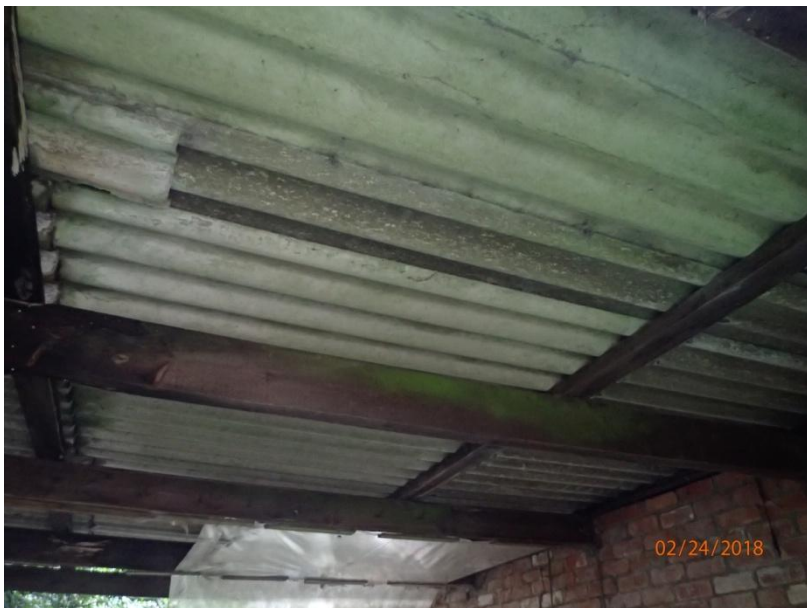
Plates 53-55 provide images of the ceiling of **Cell 2**. This structure is composed of a series of north-south orientated horizontal timber floor joists along with further east-west orientated timbers which create in turn a simple framework of timbers that support the roof covering of sheets of modern corrugated iron. The presence of the floor joists as within the adjoining **Cell 1** testifies to this whole building once having had an upper first floor, which at some point has been demolished.

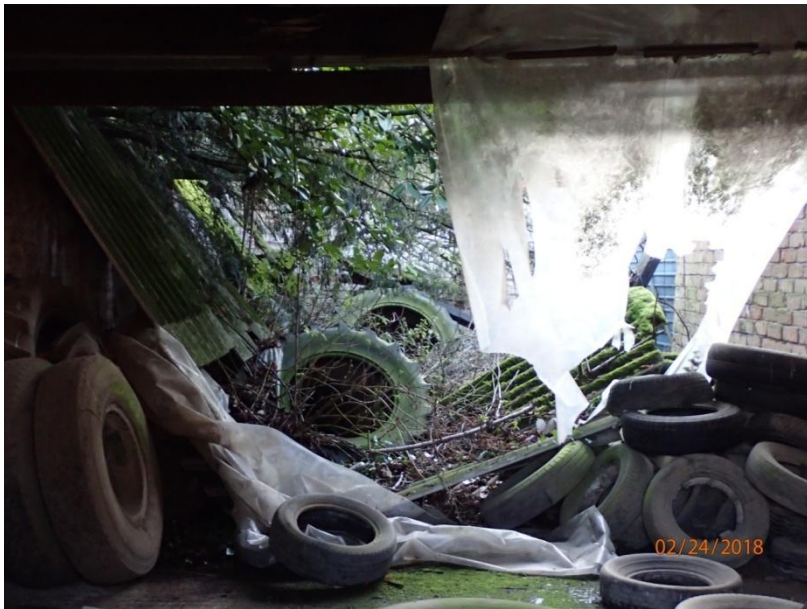
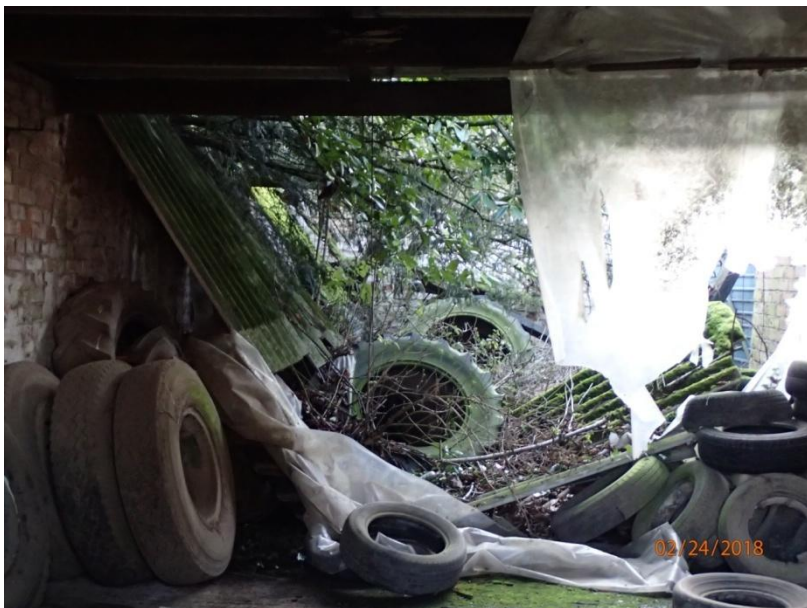
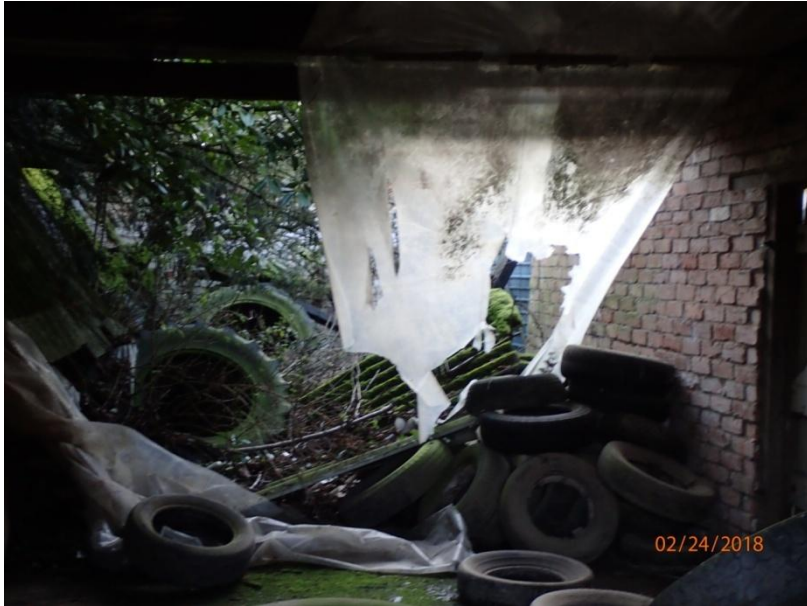
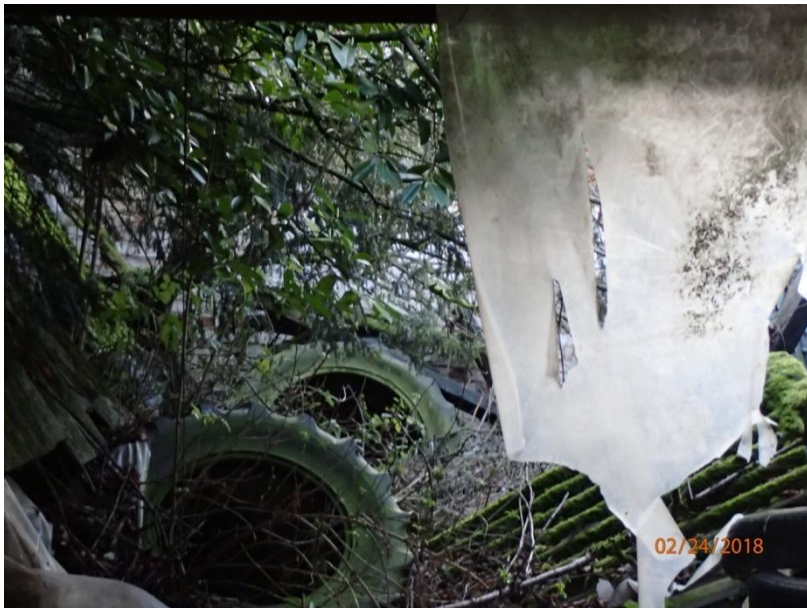
Plates 56-60 provides images of the eastern end of **Cell 2**, not much detail of which could be discerned, as this portion of the building was inaccessible. This portion of the building was roofless. Though modern sheets of displaced corrugated iron may be observed, which may have provided the roof covering here.

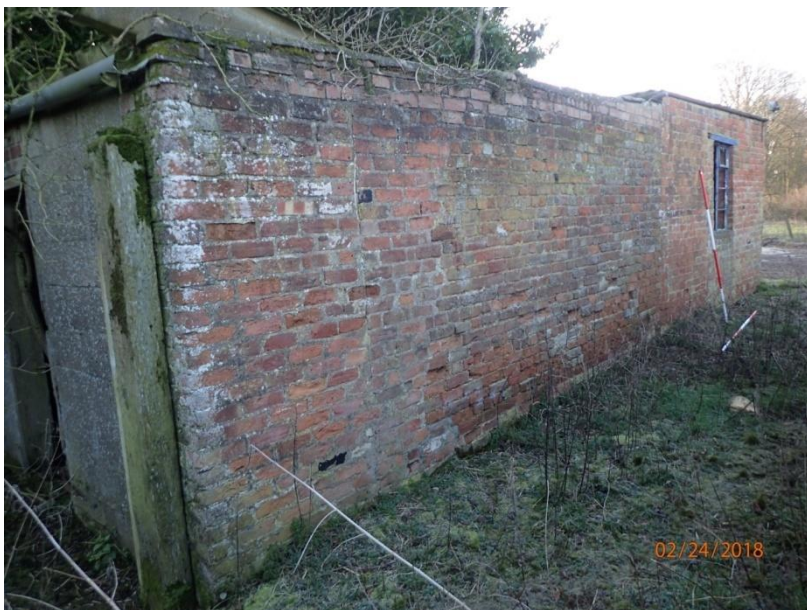
Plate 61: View of the West Elevation of Outbuilding 2, from the north

Plate 61 features a detailed view of the West Elevation of **Outbuilding 2**. This Elevation is thought originally to have been a boundary wall. The brickwork wall fabric appears to be a mixture. The southern portion is composed of three courses of brick stretchers that alternate with one course of brick headers in English Garden Wall Bond. The brickwork wall fabric of the northern portion of this West Elevation is mostly of courses of brick stretchers with occasional courses of mixed brick headers and stretchers. There is also some evidence of limited modern repair in brick such as at the uppermost levels.

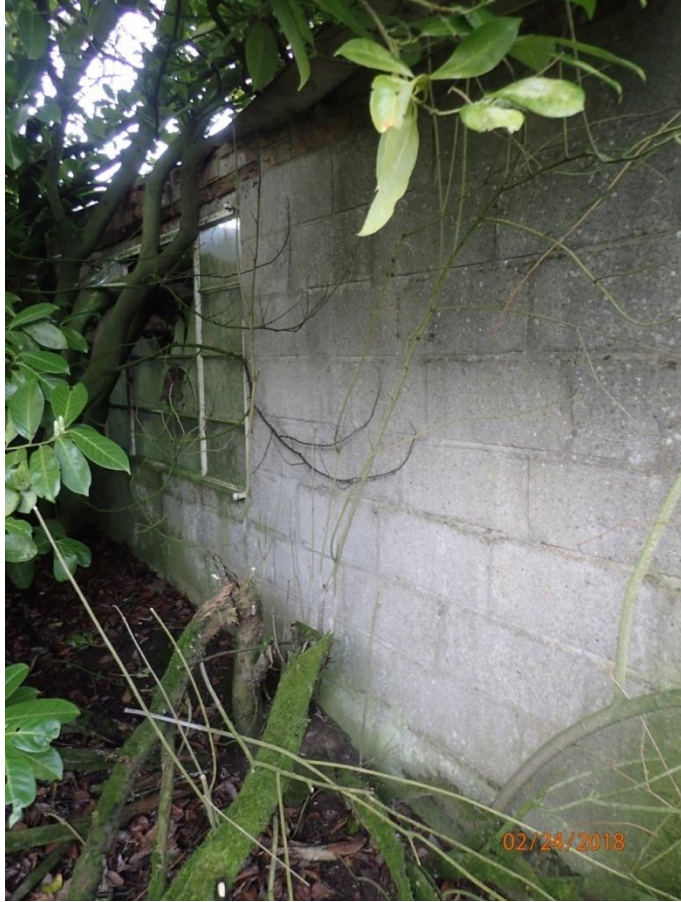
Plates 63 and 64 feature detailed images of the East Elevation of **Outbuilding 2**. The wall fabric of this East Elevation is also of modern breezeblock work. This Elevation also contains an east-facing widow opening. This is a modern twelve light glazed casement window with a metal frame. An horizontal timber lintel is located above the window opening and is incorporated into brickwork wall fabric, which is at the uppermost levels of this East Elevation just below the roof line. This brickwork is composed of two courses of mixed brick headers and brick stretchers.

Plate 63: View of the East Elevation of Outbuilding 2, from the north

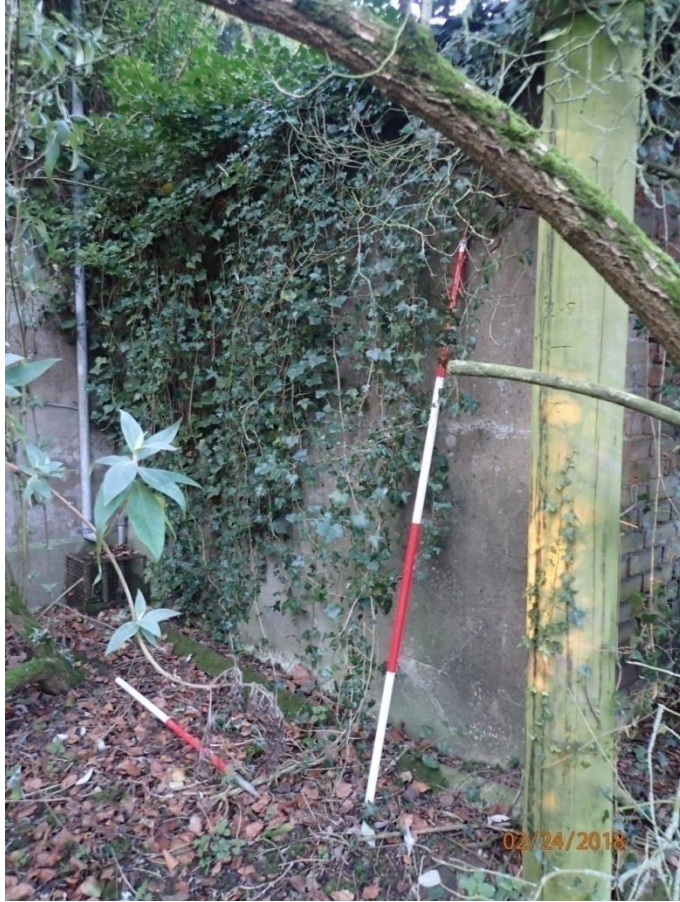
Plate 71: View of the East Elevation of Outbuilding 3, from the north

Plate 71 gives a specific and detailed view of the East Elevation of **Outbuilding 3**, which is covered over with cement rendering.

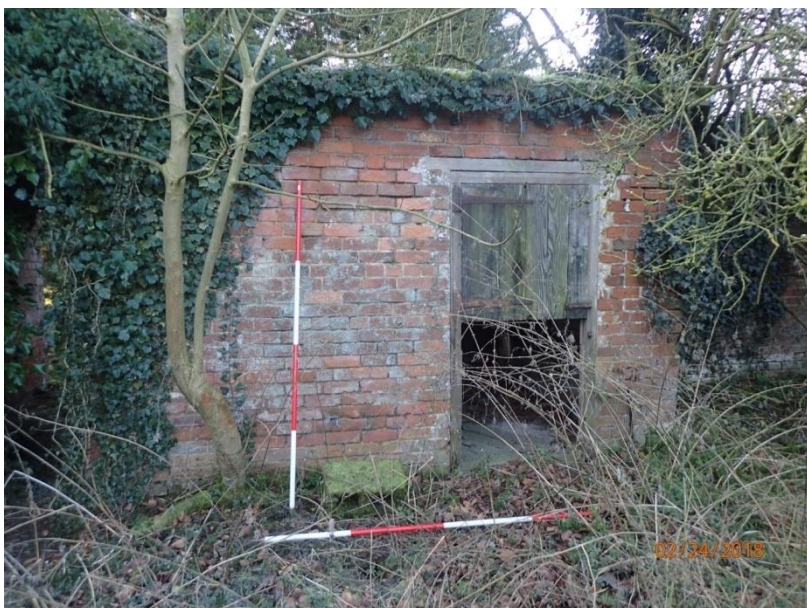
Plate 78: View of part of the North Elevation of Outbuilding 3, from the north

Plates 77 and 78 provide views of the western portion of the North Elevation of **Outbuilding 3**. The brickwork wall fabric of this portion of the North Elevation is composed of three courses of brick stretchers that alternate with one course of brick headers in English Garden Wall Bond. Also featured is a north facing window opening. The opening contains a simple timber frame of head and surrounds. There is an horizontal timber lintel above the opening which is incorporated into the brickwork wall fabric. The opening originally contained two timber half doors, of which only the upper half door survives. This is composed of a series of vertical tongued and grooved timber planks with two cast metal strap hinges to the left (east). The half door suggests that this portion of **Outbuilding 3** once functioned as a stables.

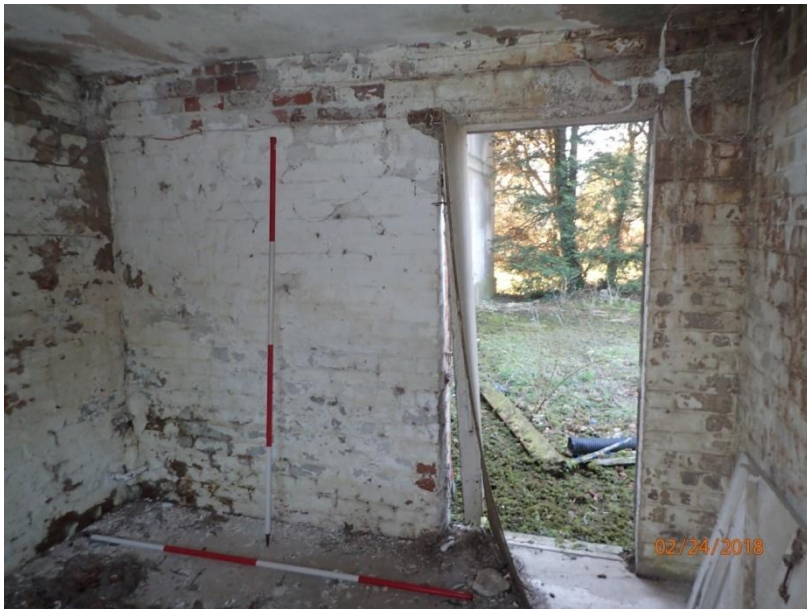
Plate 86 features the south wall of **Cell 4**. The brickwork wall fabric of this south wall has been covered over by layers of whitewash, which has obscured to some extent, the detail of the underlying brickwork wall fabric. Where discernible, this fabric appears to be mostly composed of courses of brick stretchers with occasional courses of brick headers. The inner face of the south facing door opening, that was recorded externally on the opposing South Elevation is also featured. The opening contains a simple timber frame of head and surrounds. The door itself is absent.

Plate 86: View of the south wall of Cell 4, from the north
