AN ARCHAEOLOGICAL WATCHING BRIEF AT
THE CHURCH OF THE HOLY CROSS,
CHURCH LANE,
KIRKBY GREEN, LINCOLNSHIRE.

National Grid Reference: TF 0850 5778
Site Code: HCKG19
Accession No: LCNCC: 2019.201
Faculty Reference: 2019-043314

PREPARED FOR MR. PAUL MENDHAM OF PAUL MENDHAM STONEMASONS LTD.

November 2019

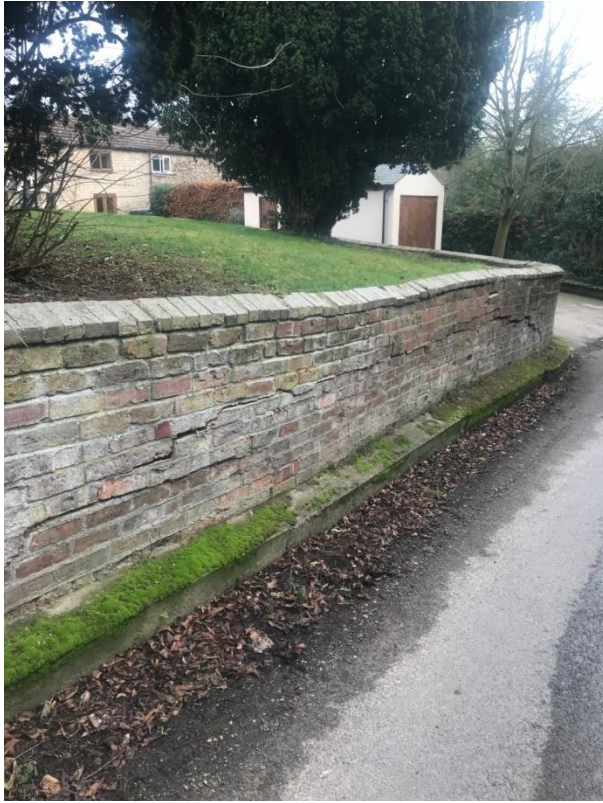
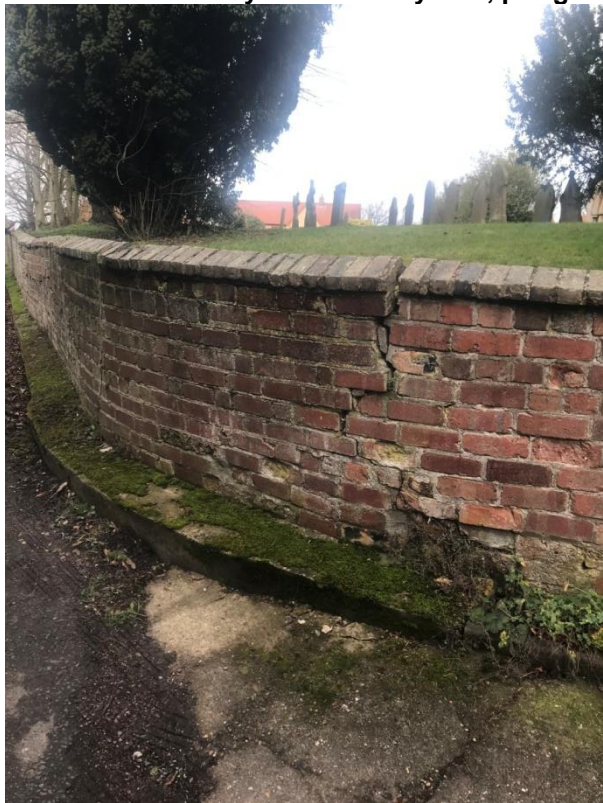
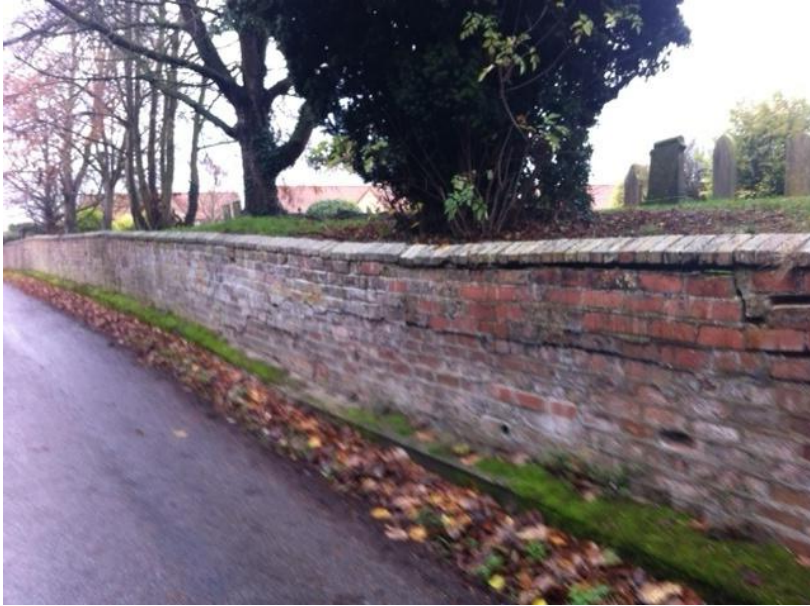
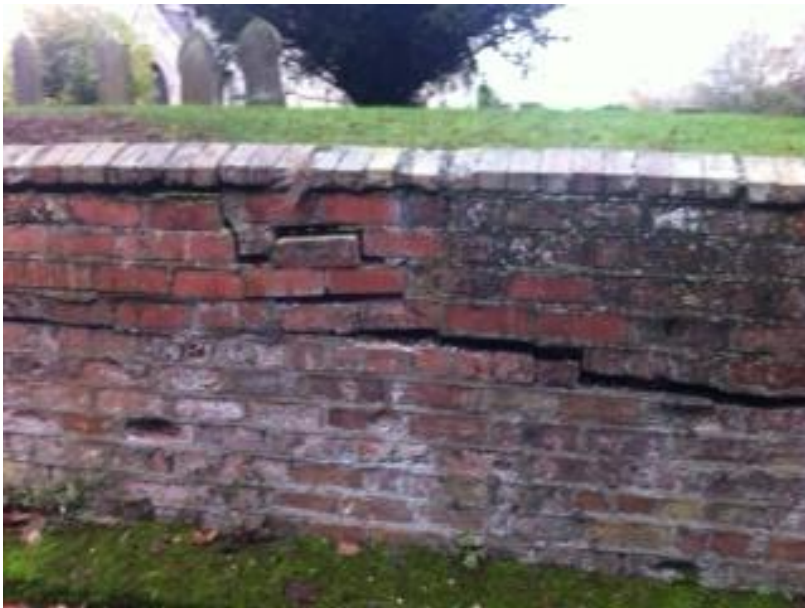
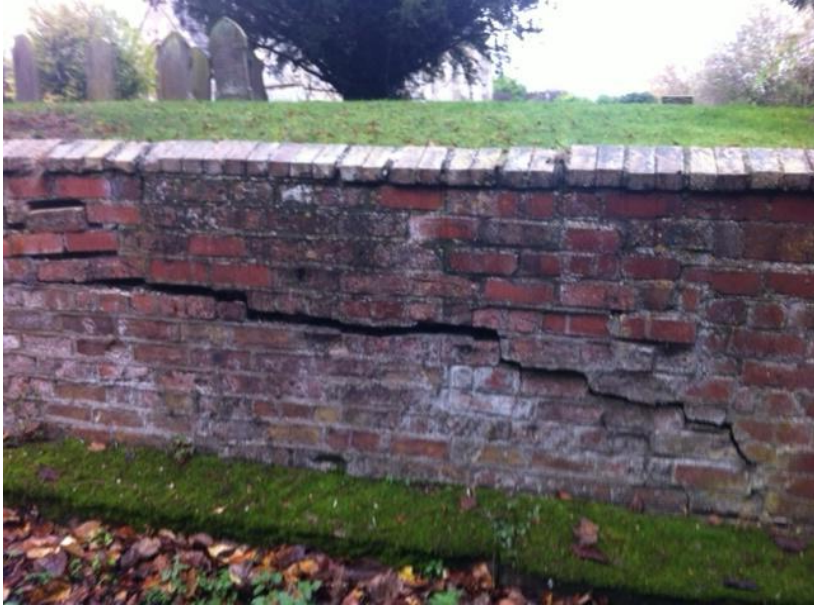
- 7.1 **Plates 1-5** provide detailed views of the pre-groundworks state of the south-western portion of the existing churchyard boundary wall prior to the proposed repairs. Large cracks and gaps may be observed within the existing brickwork wall fabric of this south-western portion of the churchyard boundary wall, which is of probable early-mid 20th century origin. **Plates 1-5** also show that the brickwork wall fabric of this south-western portion of the churchyard boundary wall is composed of a mix of mostly courses of brick stretchers with occasional courses of brick headers and of courses of mixed brick headers and brick stretchers. The wall is topped with a single course of plinth bricks.

Plate 1: View of the churchyard boundary wall, pre-groundworks, from the north

Plate 2: View of the churchyard boundary wall, pre-groundworks, from the south

Plate 3: View of the churchyard boundary wall, pre-groundworks, from the south-west

Plate 4: View of the churchyard boundary wall, pre-groundworks, from the west

Plate 5: View of the churchyard boundary wall, pre-groundworks, from the west

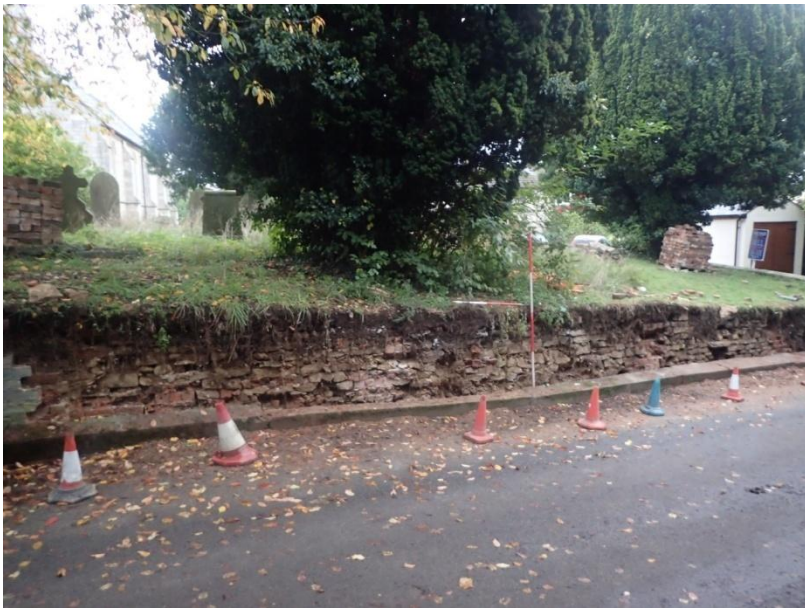
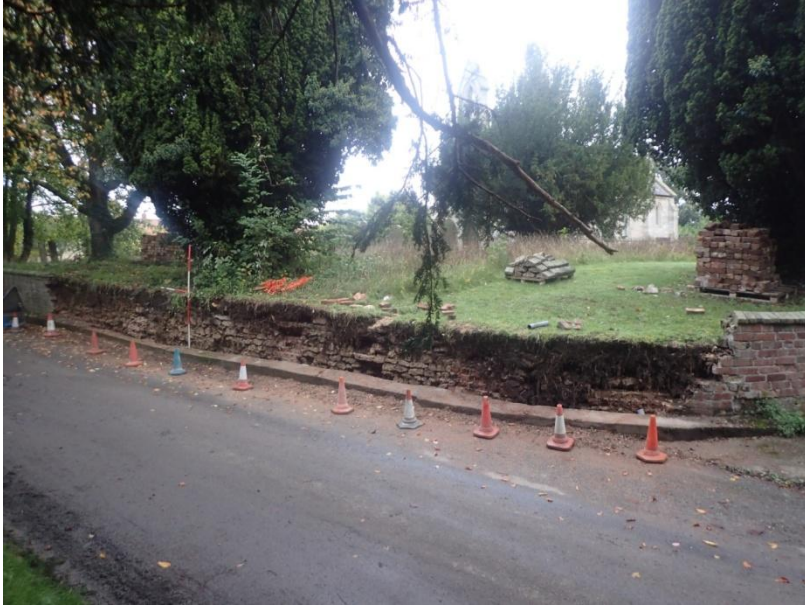
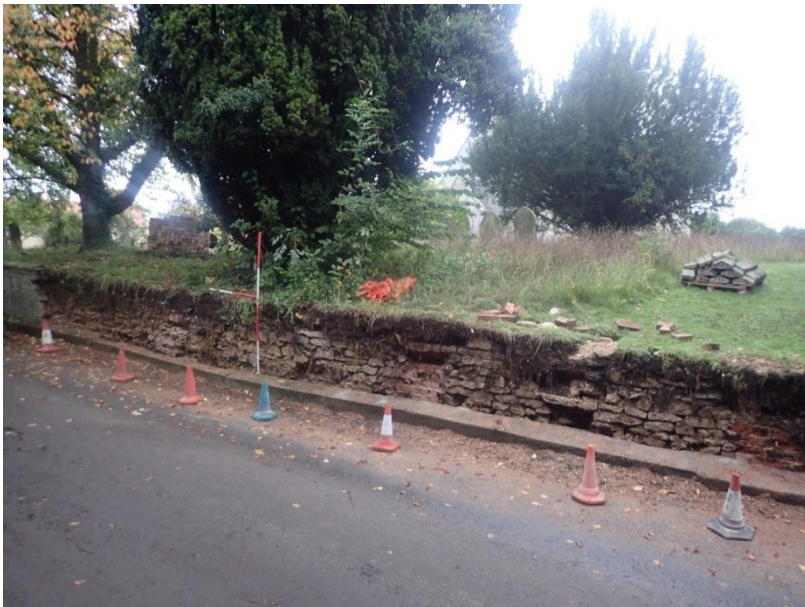
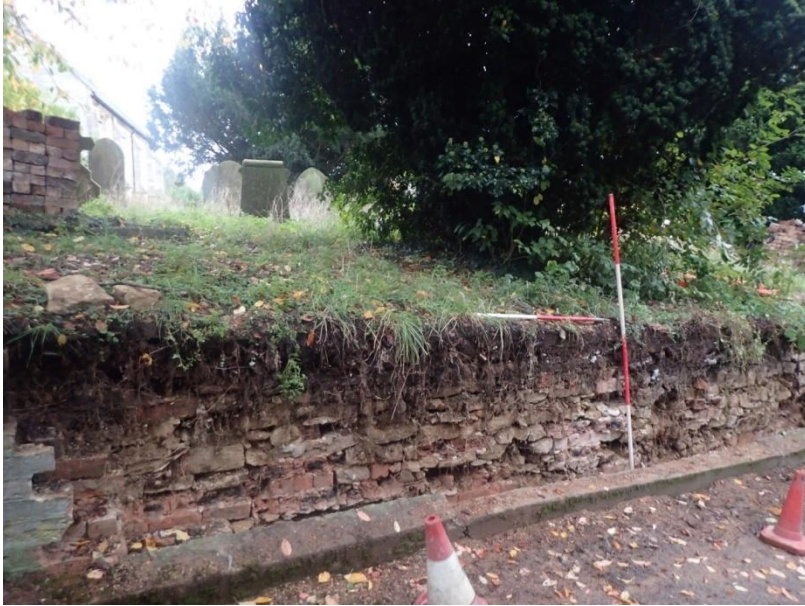
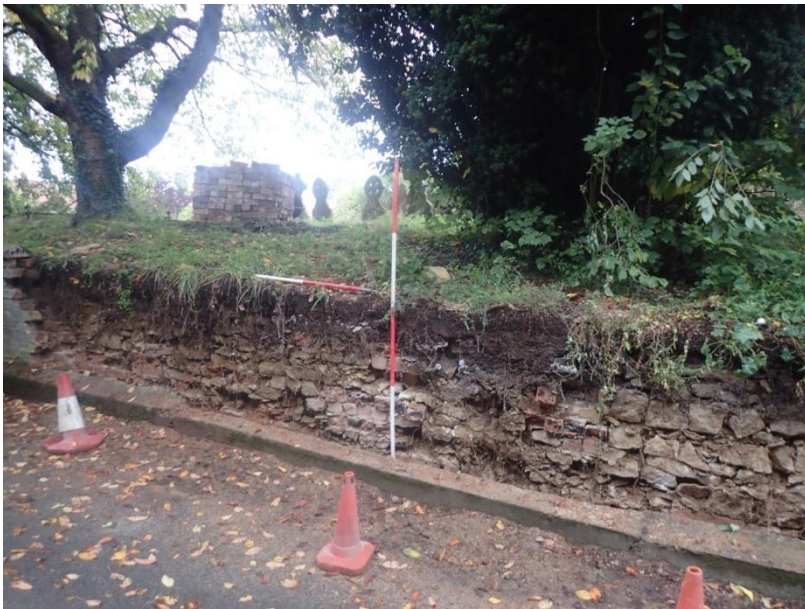
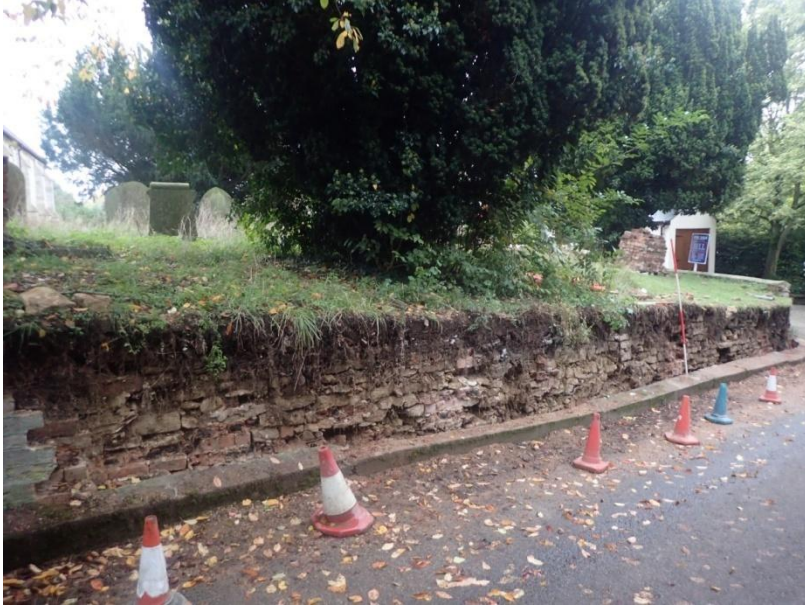
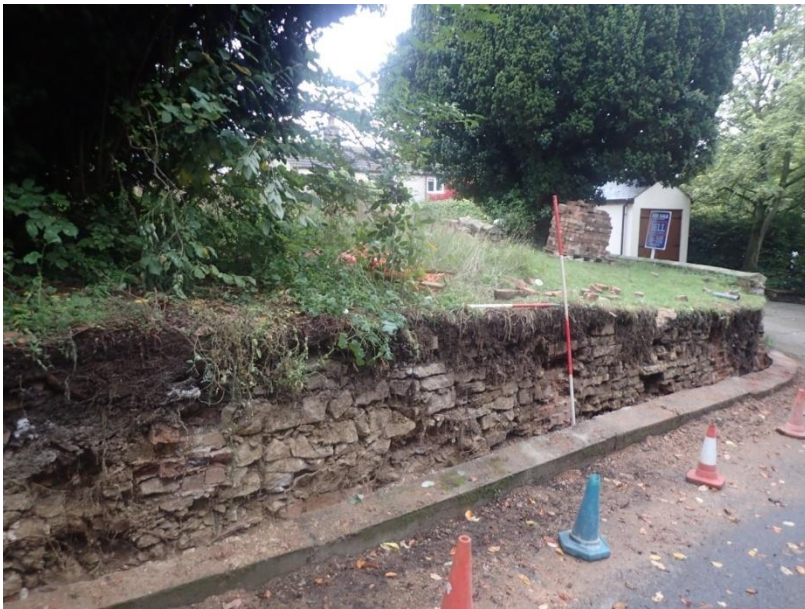
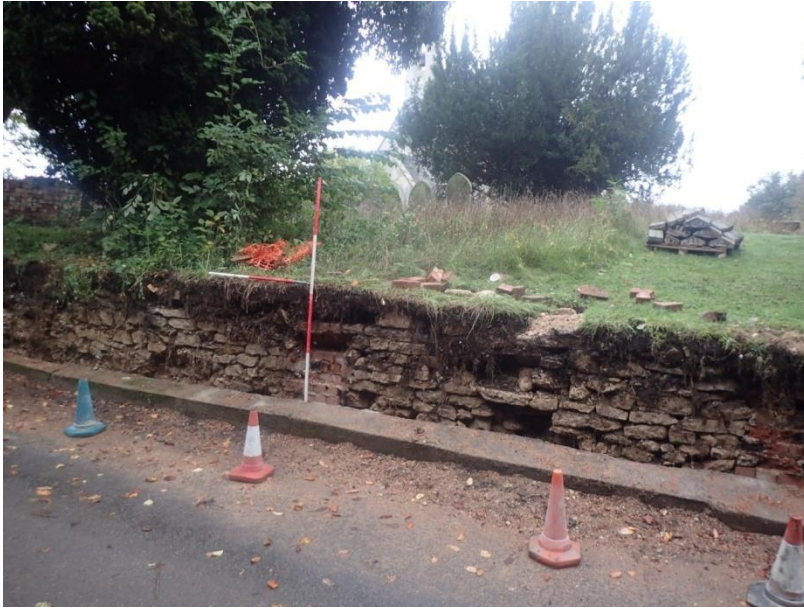
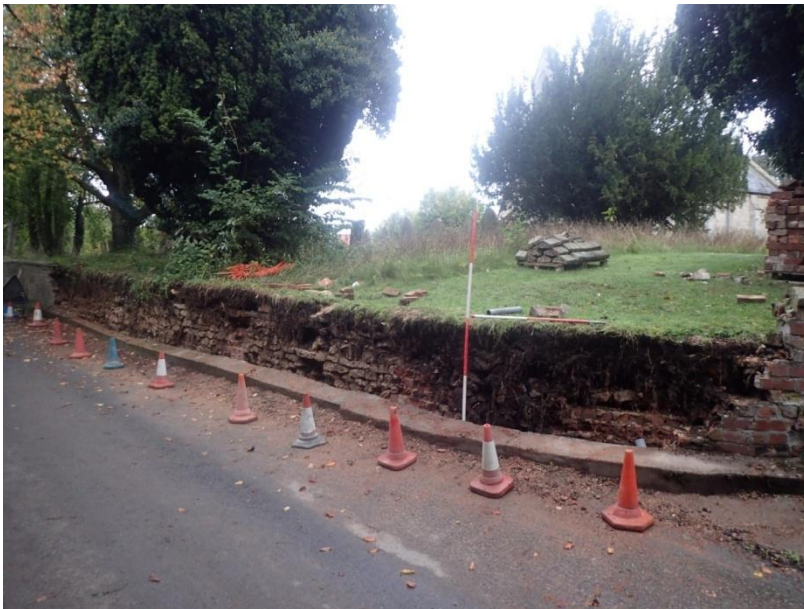
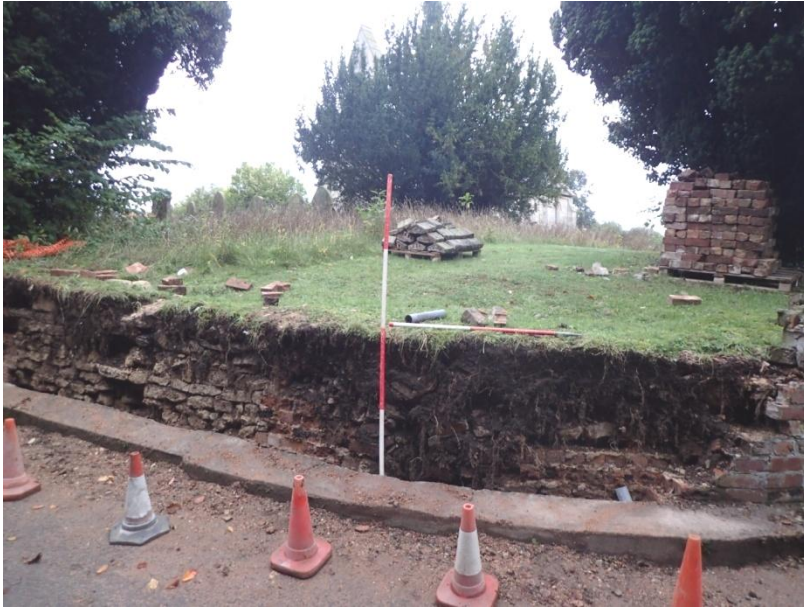
- 7.2 **Plates 6-15** present general views from different perspectives of the demolished section of the churchyard boundary wall. This has exposed an earlier churchyard wall of rougher construction behind the current 20th century walling. It is likely that this earlier churchyard boundary wall is of mid 19th century origin and was thus probably contemporaneous with the rebuilding of the church in the mid 19th century. Of note are the series and line of modern concrete kerb stones at the foot of the current walling. The length of the exposed section of mid 19th century boundary wall was 14.60m. The width of the demolished section of early-mid 20th century modern churchyard boundary wall was of the same length with a width of 0.25m.

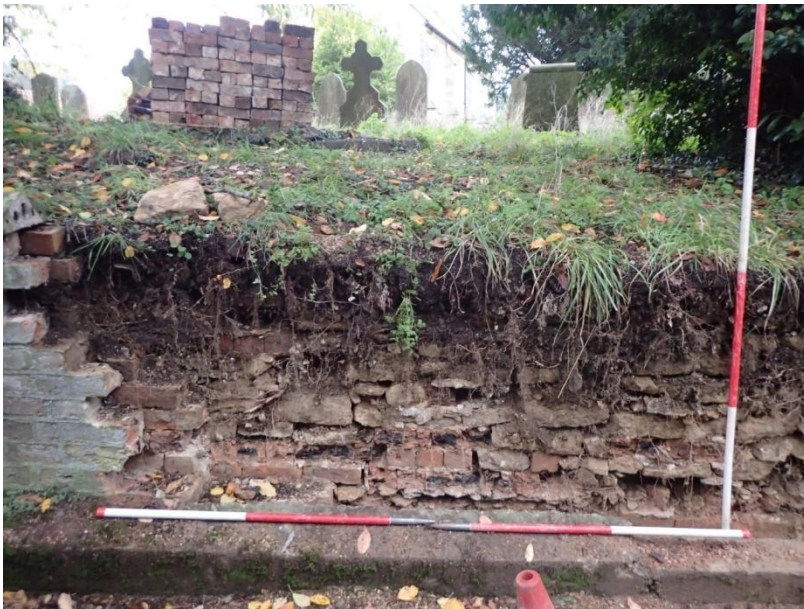
- 7.3 **Plates 16-18** provide detailed views of the northern demolished section of the current churchyard boundary wall from various western viewpoints. **Plate 16** features the northernmost section of the newly exposed mid 19th century former churchyard boundary wall. This portion of the wall is composed of random and uncoursed, roughly worked, shaped and faced limestone blocks. There is also some evidence of later brick infilling and/or repair composed of short courses of brick stretchers and of brick headers. **Plate 17** provides a further view of the northern section of the newly exposed mid 19th century former churchyard boundary wall. The central feature here are the remains of a former west facing brick buttress, which is composed of courses of brick headers along with some rough stone infilling. To the either side of this buttress, there is the same random and uncoursed, roughly worked, shaped and faced limestone blocks with the same brick infilling and/or repair of brick headers and brick stretchers. **Plate 18** features a further detailed view of the northern section of the newly exposed mid 19th century former churchyard boundary wall. This portion of the wall is composed of both coursed and random and uncoursed, roughly worked, shaped and faced limestone blocks with limited evidence for late brick infilling and/or repair, that is composed of brick stretchers.

Plate 16: Detailed view of the northern demolished section of current churchyard boundary wall, from the west

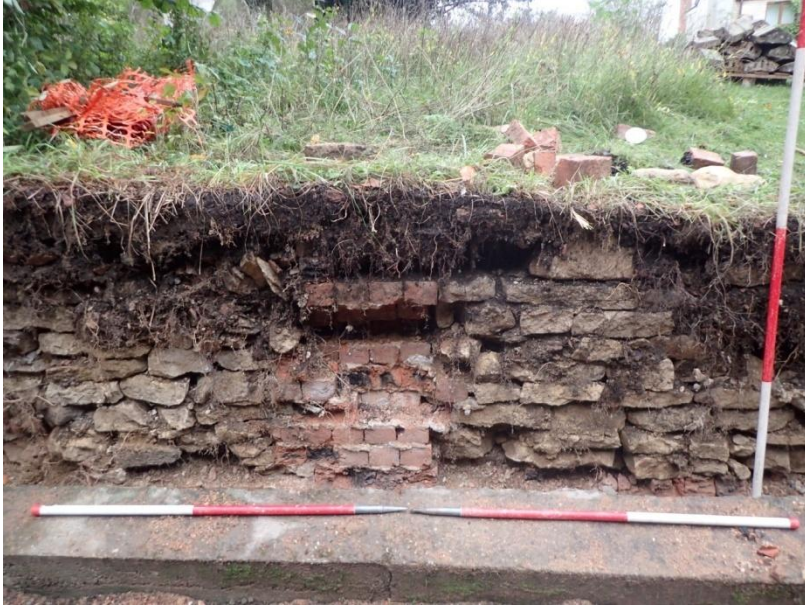
- 7.4 **Plates 19 and 20** provide detailed views of the central demolished section of the current churchyard boundary wall from various western viewpoints. **Plate 19** features a portion of the newly exposed mid 19th century former churchyard boundary wall. This portion of the wall is by contrast composed of coursed, roughly worked, shaped and faced limestone blocks. The central feature in this image are the remains of the second west facing brick buttress, which is composed of courses of brick headers. **Plate 20** presents a further view of this central demolished section of the current churchyard boundary wall. This image shows further wall fabric composed of coursed, roughly worked, shaped and faced limestone blocks. To the right (south), is a third former west facing buttress composed of courses of brick headers. To the left and at the lower levels of this portion of the exposed 19th century churchyard wall, is a rectangular shaped gap, which may have been a former churchyard outlet drainage feature.

Plate 19: Detailed view of the central demolished section of current churchyard boundary wall, from the west

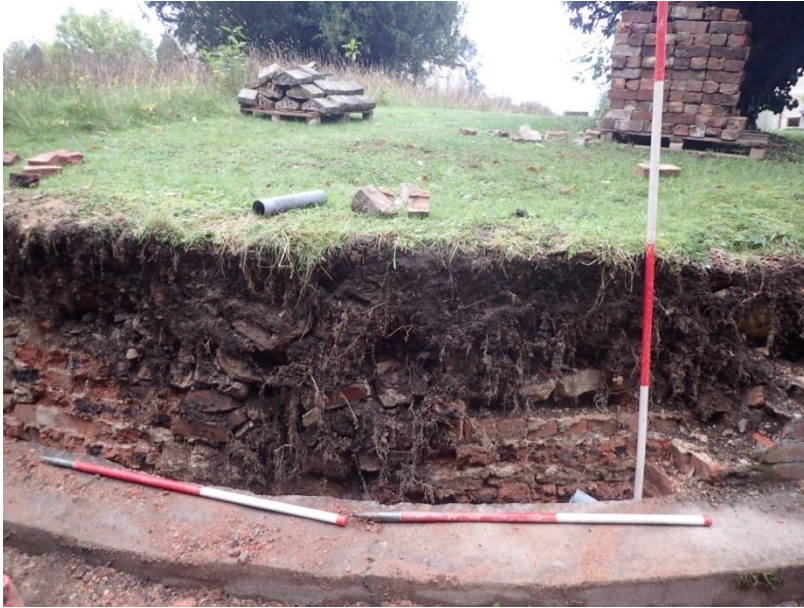
- 7.4 **Plate 21** provides a detailed view of the southern demolished section of the current churchyard boundary wall. This shows little detail of the newly exposed former mid 19th century churchyard boundary wall here, but does feature a fourth and final former south-west facing brick buttress that is composed of courses of brick headers.

Plate 21: Detailed view of the southern demolished section of current churchyard boundary wall, from the south-west

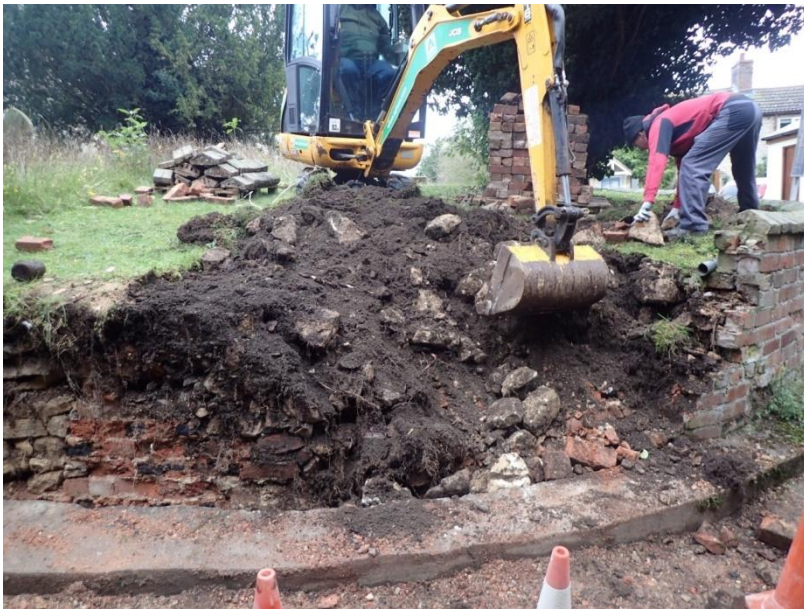
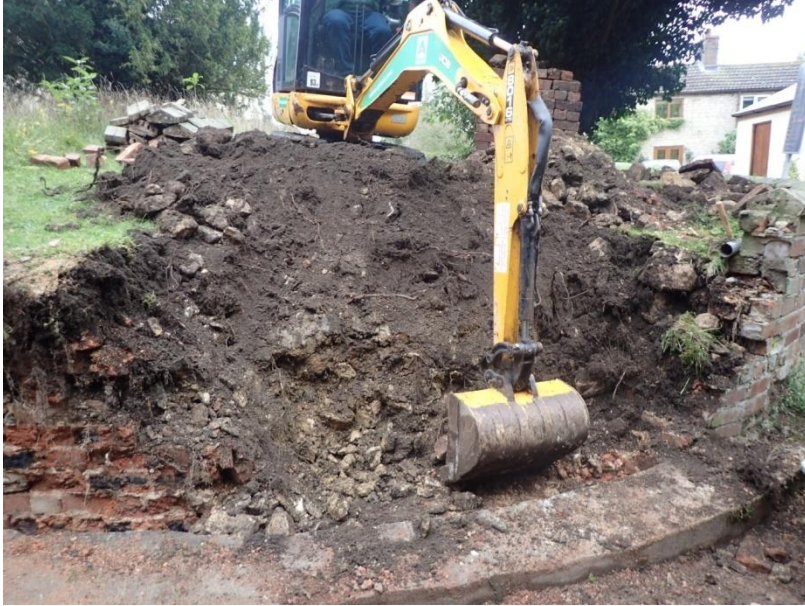
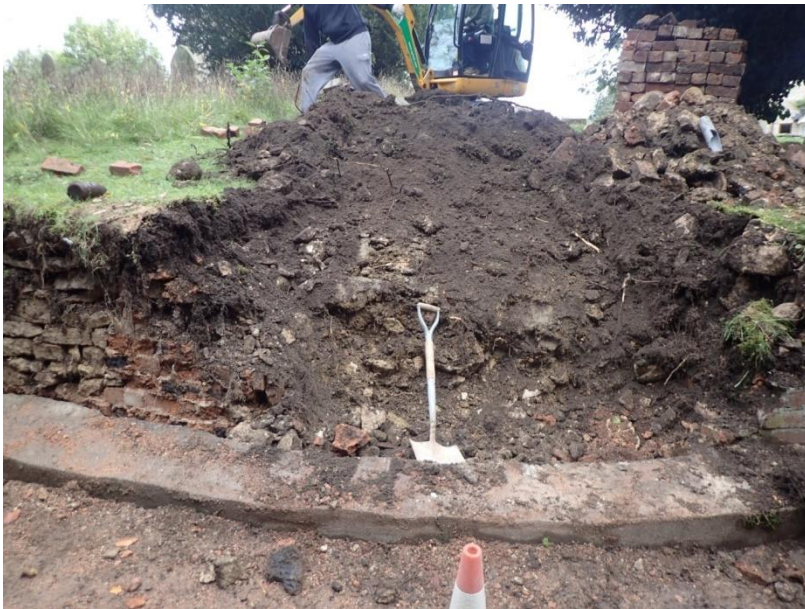
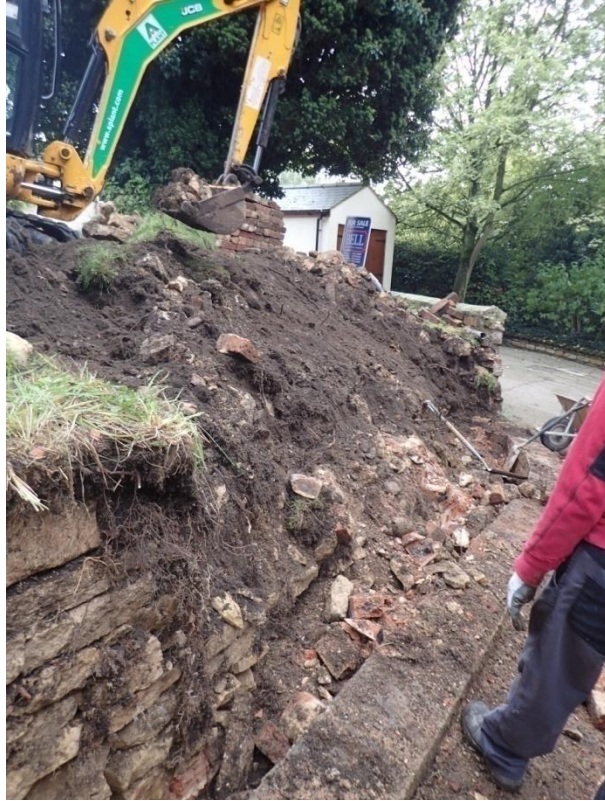
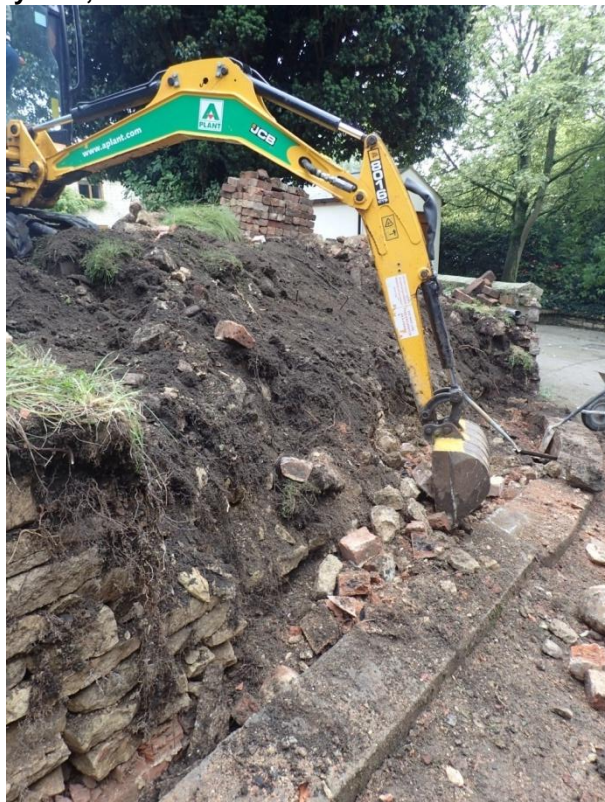
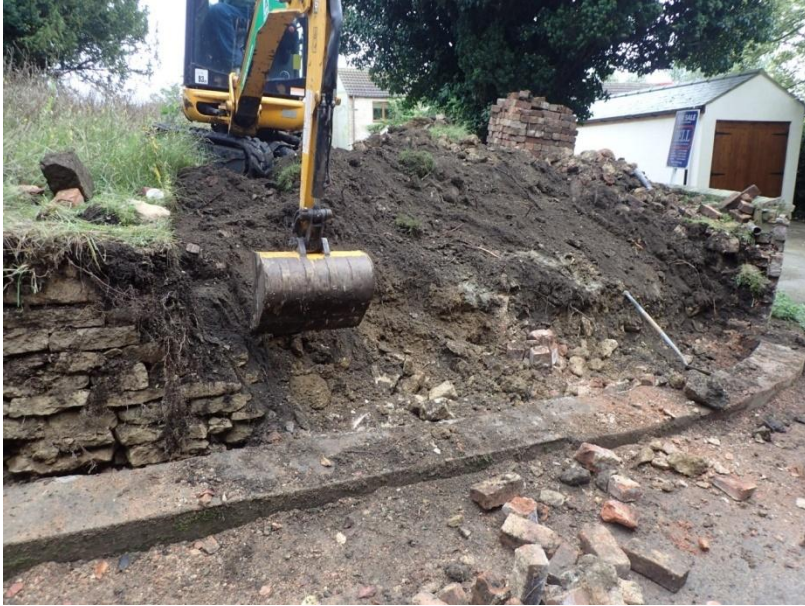
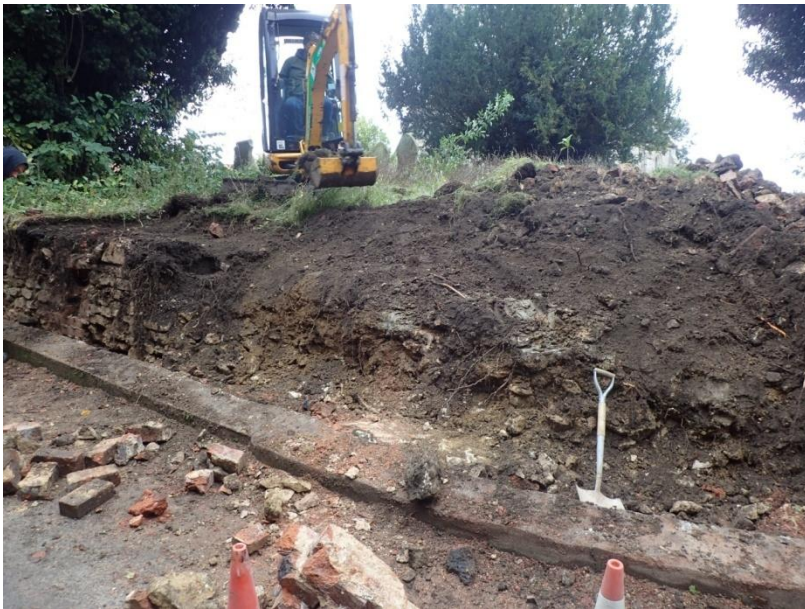
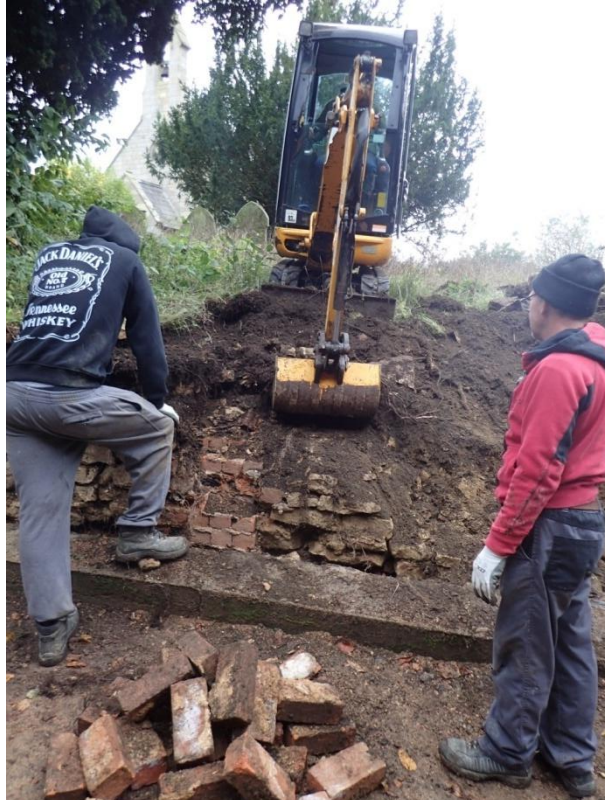
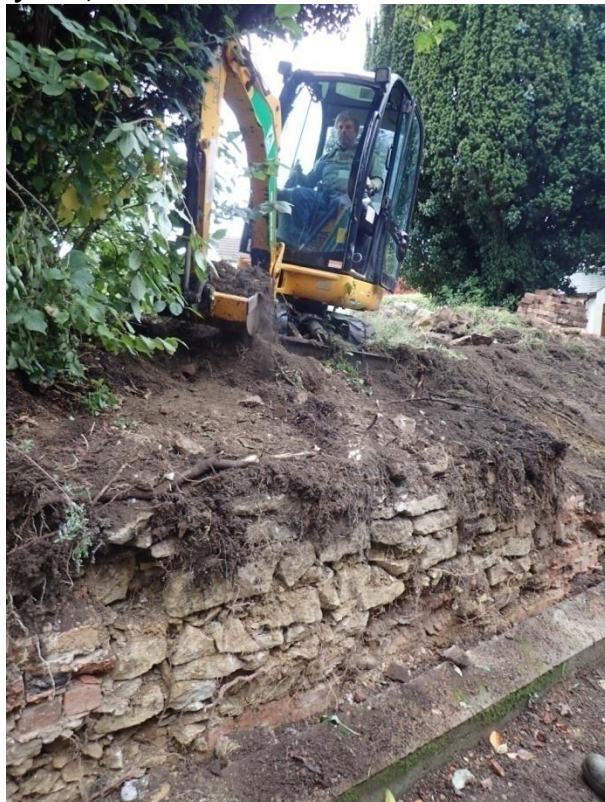
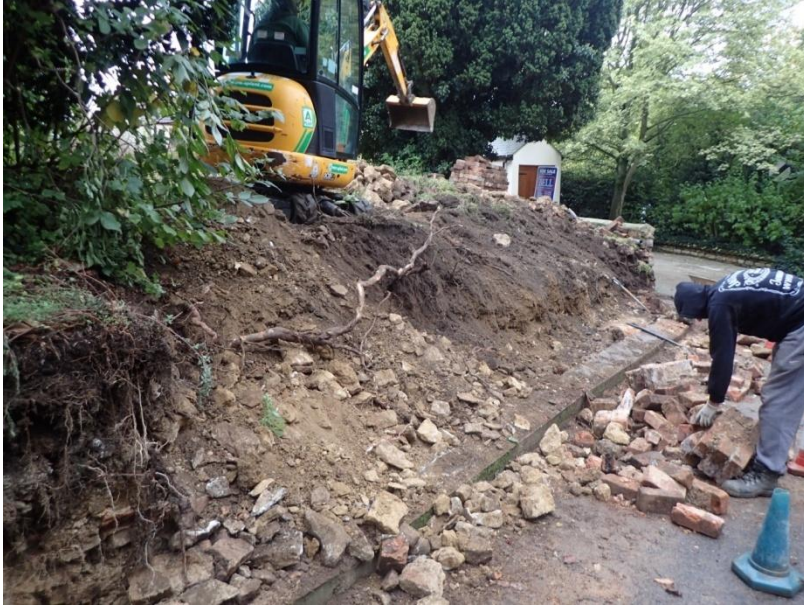
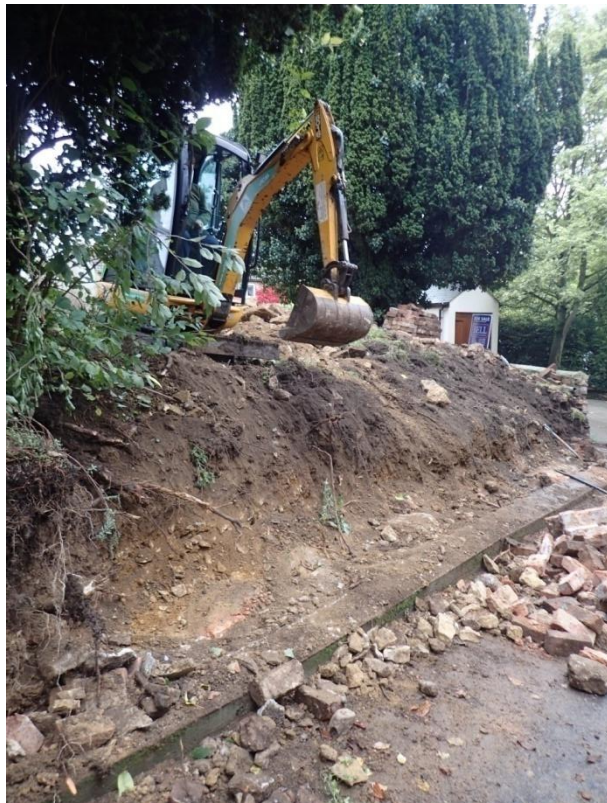
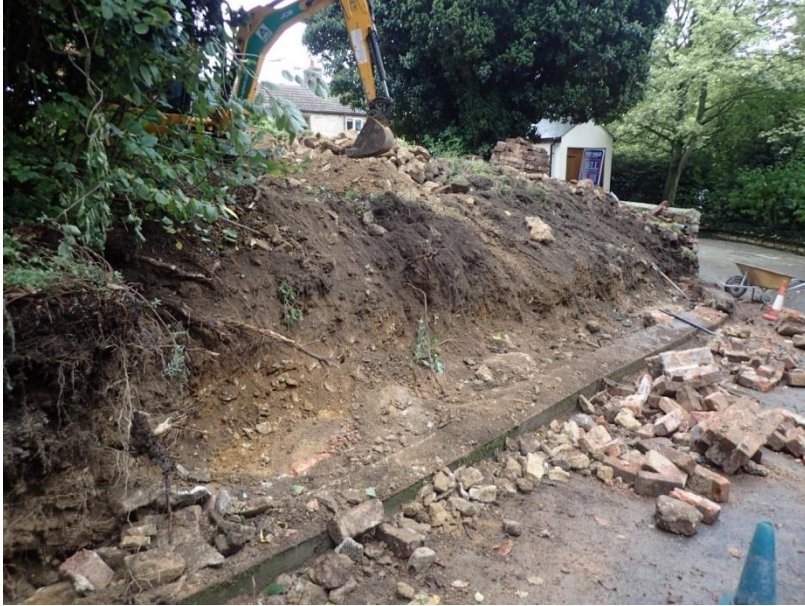
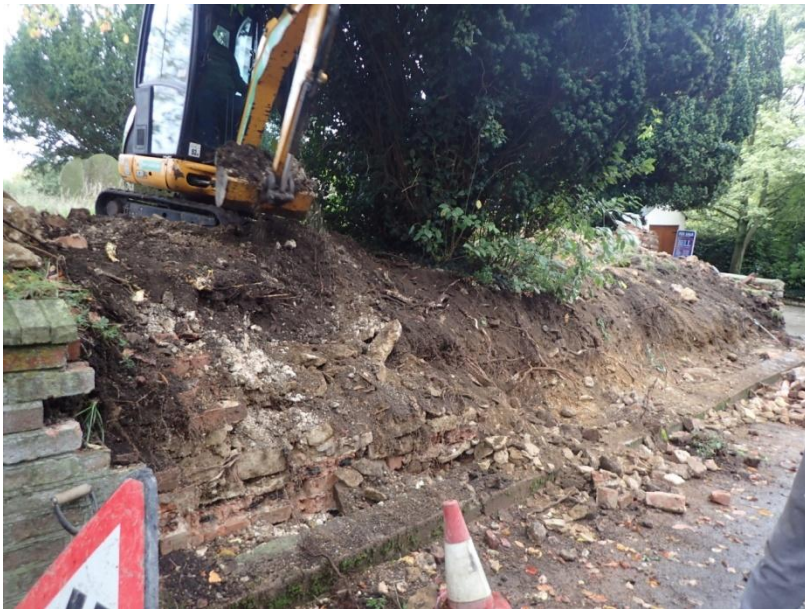
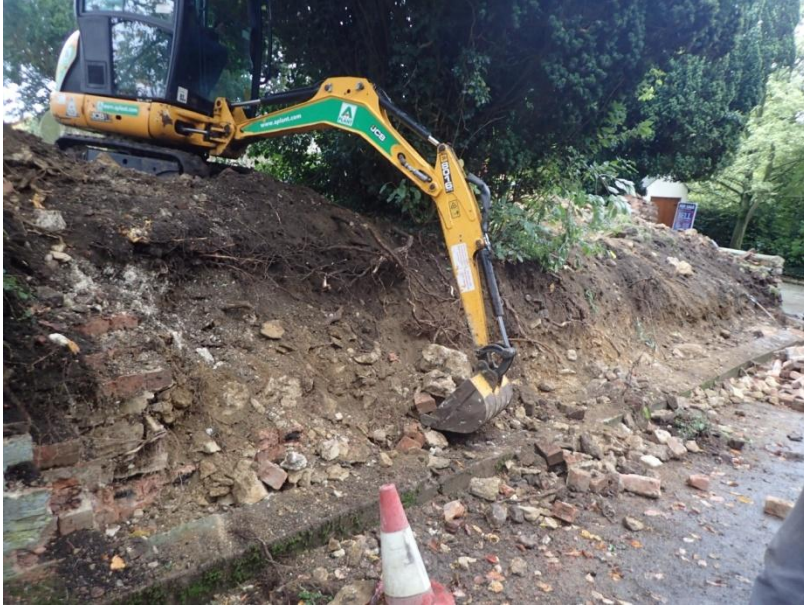
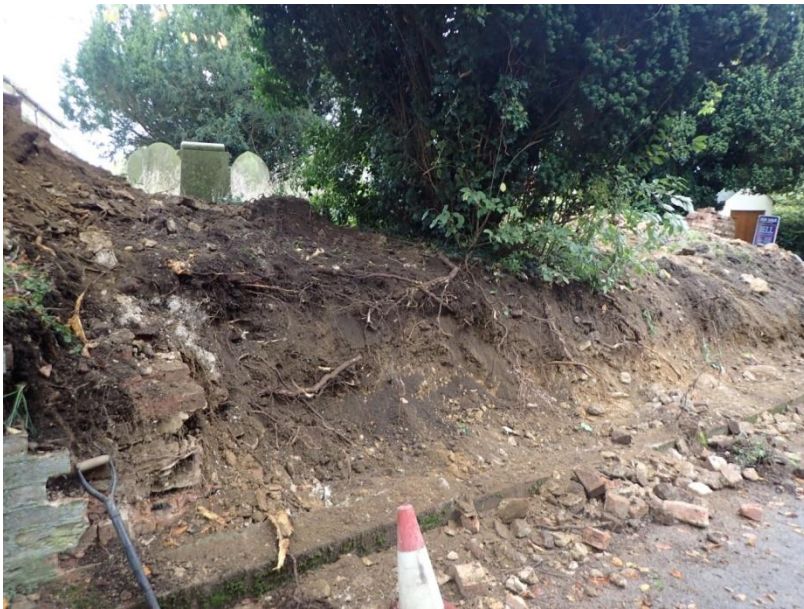
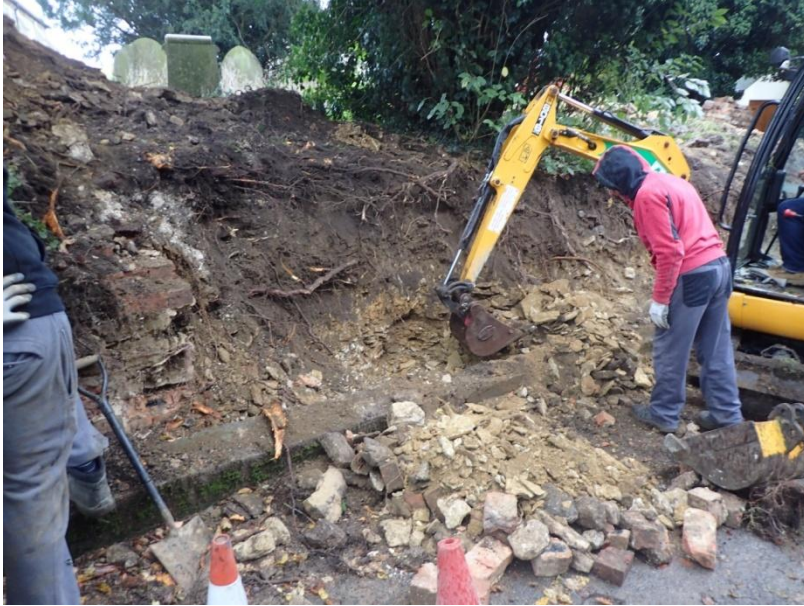
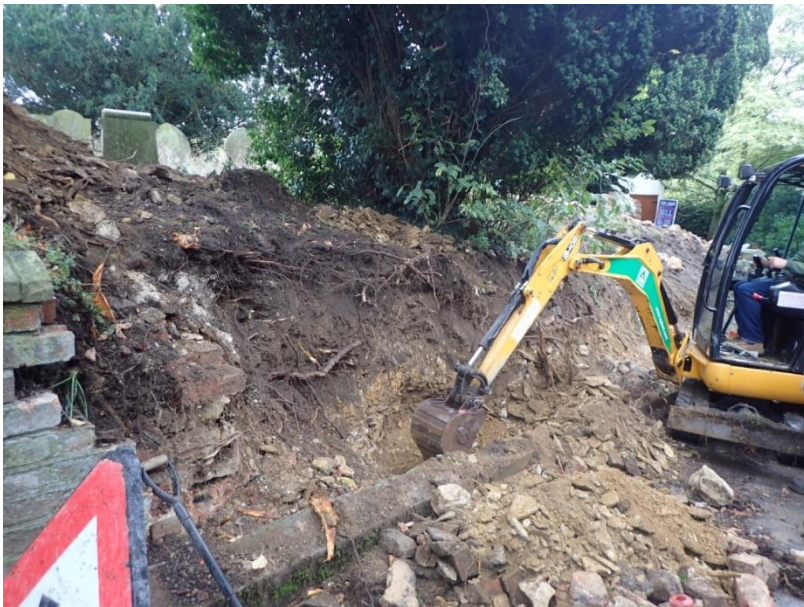
- 7.5 **Plates 22-38** detail the mechanical removal and demolition of the exposed section of the mid 19th century churchyard boundary wall, along with associated ground reduction. It may be observed from these images that this earlier boundary wall extended in height of between 1.10m-1.20m up to the ground levels of the present churchyard. The mechanical removal of this earlier wall revealed a thin topsoil horizon (**001**), a graveyard soil horizon (**002**) and toward the base of the demolition and ground reduction works, a natural horizon (**003**) and a final horizon of angular limestone bedrock (**004**) at the base of these works. The mechanical demolition and ground reduction works extended to a width of 0.80m beyond the edge of the line of the modern concrete kerb stones and up to the full recorded height of the former mid 19th century churchyard boundary wall.
