# **Mount Pleasant Farm, Wheldrake**

# Historic Building Record

March 2019

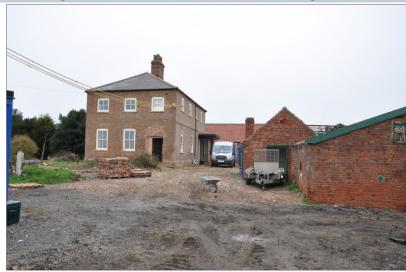
1.Farmhouse and farmstead looking NW

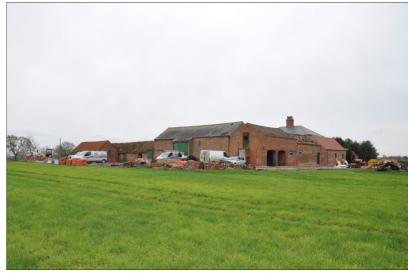
3. Farmstead looking S

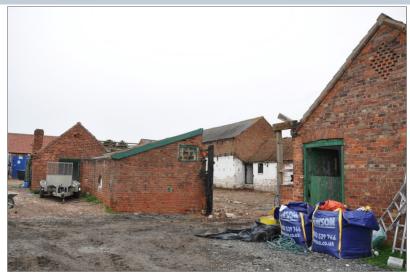
2. Farmstead looking N

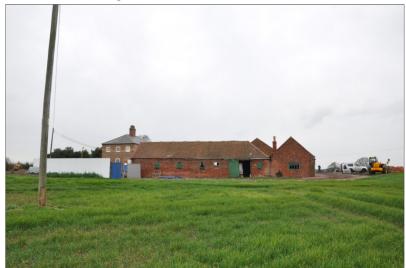
4. Farmstead looking NW

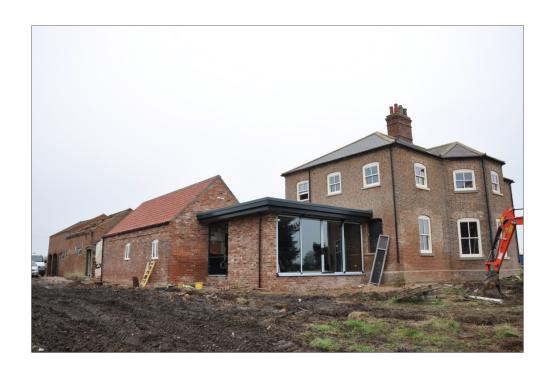
5. Farmstead and farmhouse looking E. Newly extended farmhouse and rebuilt outbuilding in foreground (not included within survey)

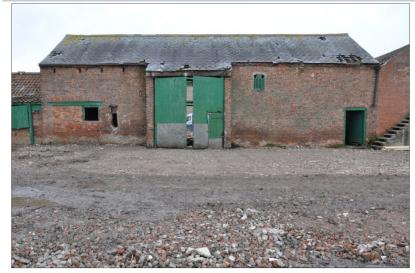
6. Northeast elevation of Building A, looking SW

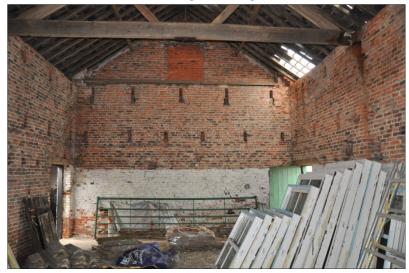
8. Building A, looking NW, showing the internal northwest elevation

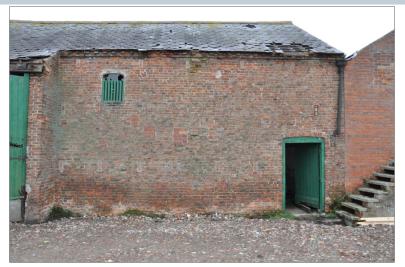
- simple wooden lintel. At ground floor level there is a simple pedestrian door with a brick, arched lintel.
- 7.06 Also visible in the northeast elevation, to the right of the main doorway, a number of blocked sockets can be seen and the ghost of the roofline of a former building that stood perpendicular to the barn. Its roof ridge was slightly lower than the eaves of the barn. These are the remains of a building shown in this position in 1850/51 and subsequently removed before 1890.

7. Detail of Building A looking SW, showing traces of former perpendicular building at this location

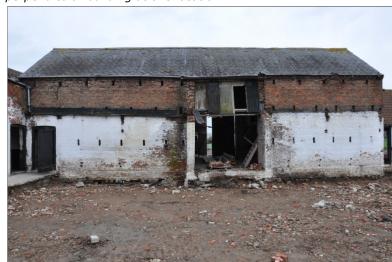
- 7.08 The southwest elevation of the barn faces the courtyard and contains two openings, described from left to right. A pedestrian door is found at the left hand side of the elevation, matching the equivalent door in the northeast elevation. The main doorway originally matched the fabric of the northeast elevation doorway, but this example has been crudely modified in the recent past to create a single-storey door with the upper storey blocked with corrugated sheets. This elevation bears the traces of the covered yard that was constructed in the courtyard space between 1908 and 1950 (demolished prior to the survey).

9. Southwest elevation of Building A, looking NE

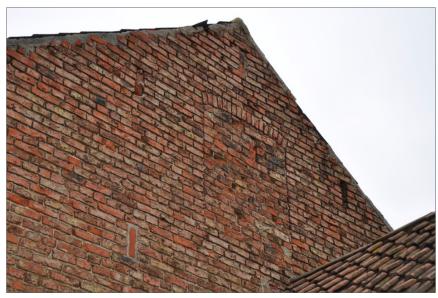
- 7.09 The southeast elevation of the barn now forms a wall of Building C, which also dates to pre-1850/51 but which was clearly a later addition to the barn. As with the opposed northwest gable, there was originally an attic level opening that was later blocked. There was also a pedestrian door at ground level, subsequently blocked.

10. Blocked opening in southeast gable of Building A, looking N

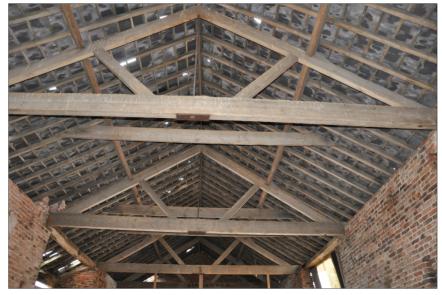
- 7.10 Internally the barn has an upper floor in the southeast half, made of sawn timber that is probably a twentieth century insertion. The floor of the barn is of brick in places and modern concrete elsewhere. The roof is a later replacement and the simple trusses are of sawn timber.

11. Upper floor in Building A, looking SE

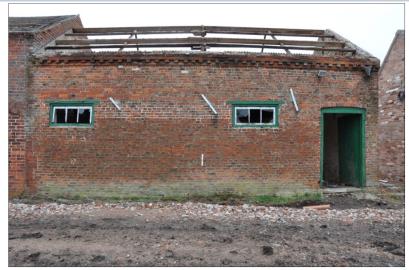
- 7.12 The northwest elevation faces away from the yard. There are two small windows that may originally functioned as ventilators to two internal loose boxes. There is also a pedestrian door. Some of the brickwork in this elevation has been reconstructed or replaced.

13. Northwest elevation of Building B, looking SE

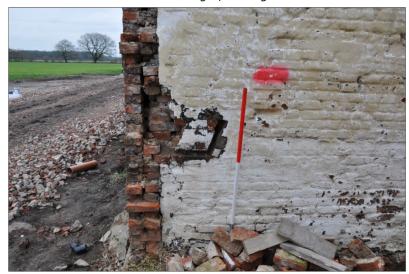
- 7.13 The southwest elevation is now exposed, although there would once have been an attached building with a slightly lower roof ridge (demolished before the time of the survey). The demolished building was probably a later addition as it incorporated a small ventilator, high in the gable of Building B, that would have served to ventilate the first floor granary. Traces in the gable of Building B show that the demolished building included a built-in feeder for livestock. A door, later made through the gable wall of B, would have joined it to the demolished building.

15. Detail of southwest elevation of Building B showing socket of built-in feeder in demolished building, looking NE

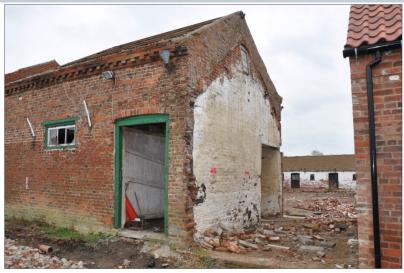
14. Southwest elevation of Builing B, looking E

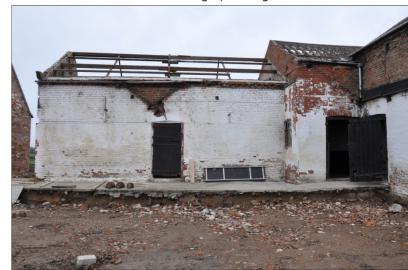
- 7.14 The southeast elevation faced the courtyard and had a single, simple pedestrian doorway. On the southwest corner of the elevation is a single sandstone kneeler. This trace of architectural elaboration is not seen elsewhere in the building or anywhere else in the farmstead.

16. Southeast elevation of Building B, looking NW

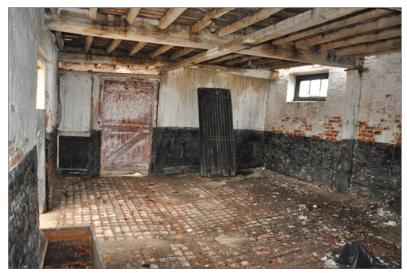
17. Building B interior, showing internal subdivision with timber panel, looking W Building C

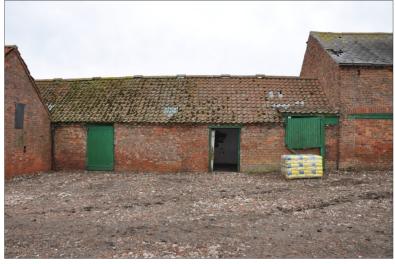
19. Northeast elevation of Building C (right centre) with break in fabric where it was later extended by Building E (left centre), looking SW

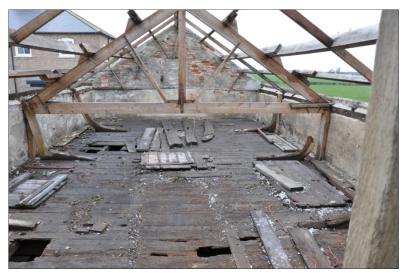
18. Granary above Building B showing unusual timbers, looking SW

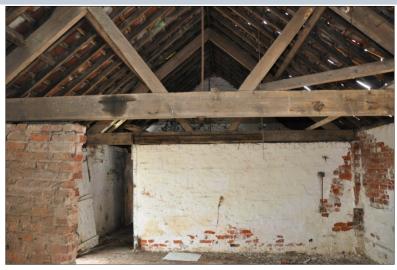
20. Former southeast gable of Building C, later adapted as an intyernal wall following extension by Building E, looking SE

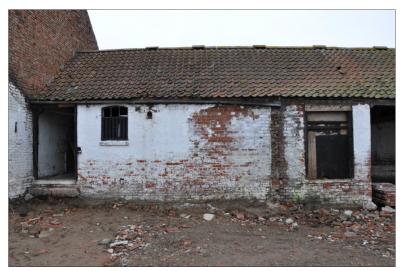
21. Southwest elevation of Building C (left and centre) with building break to Building E (right), looking NE

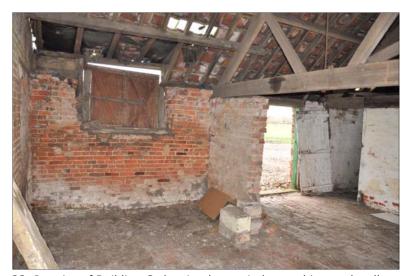
22. Interior of Building C showing later window and internal wall, looking E

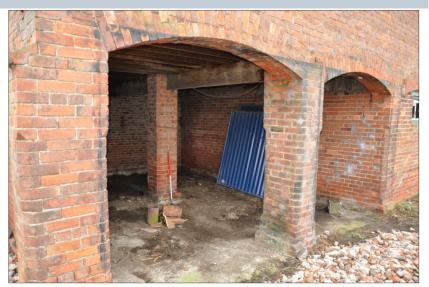
24. Interior of Building D showing original internal wall, looking S

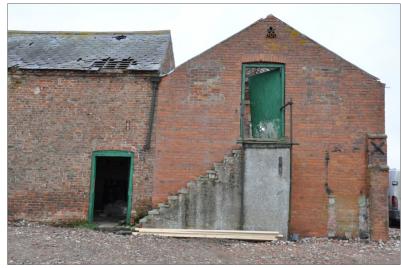
26. Northeast elevation of Building D, looking SW

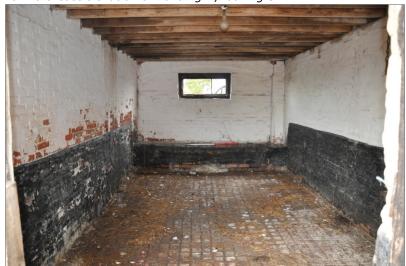
28. Interior of southwest bay of Building D, repurposed as a loose box, looking NW

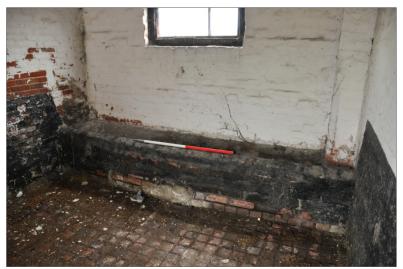
29. Built-in feeder in southwest bay of Building D (1m scale)

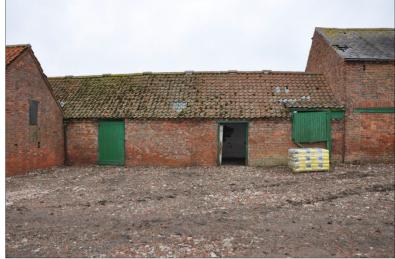
31. Northeast elevation of Building E (centre left) showing building break where it extends Building C (right centre), looking SW

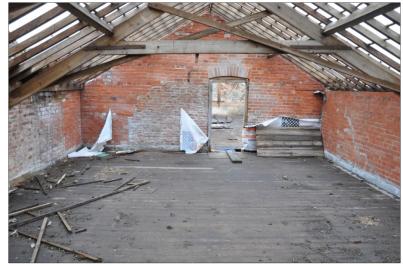
30. Granary floor of Building D, looking SW

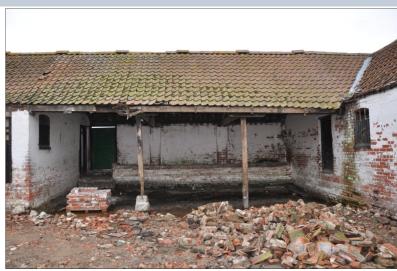
32. Covered stockyard of Building E, looking NE

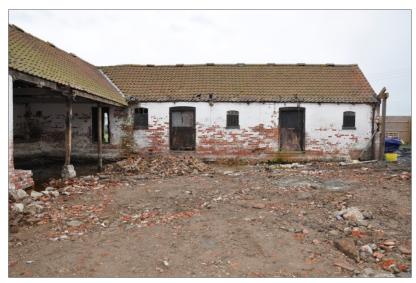
33. Northwest elevation of Building E, looking SE

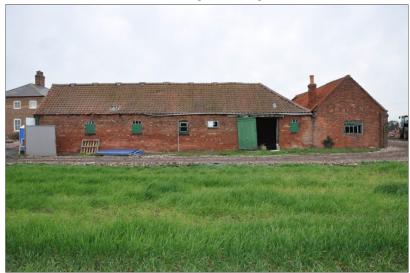
35. Southeast elevation of Building E, looking NW

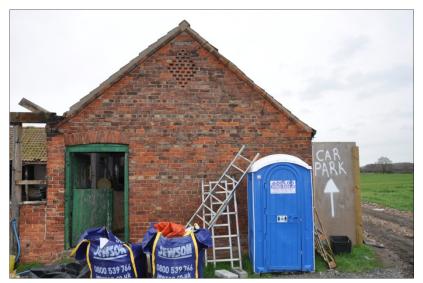
34. Southwest elevation of Building E, looking NE

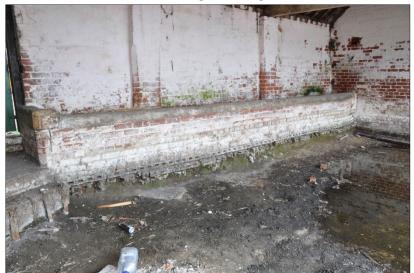
36. Built-in feeder in covered stockyard, looking N

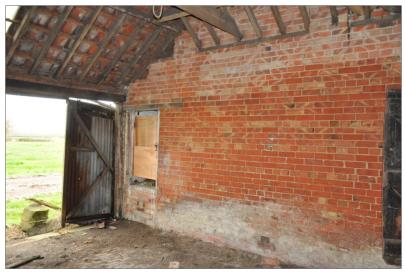
37. Interior of northeastern bay of Building E (possible cake store?), looking S Building F - Pigsty

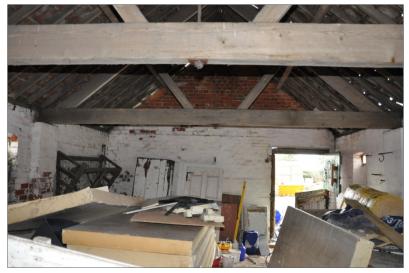
38. Interior of Building E, looking SW

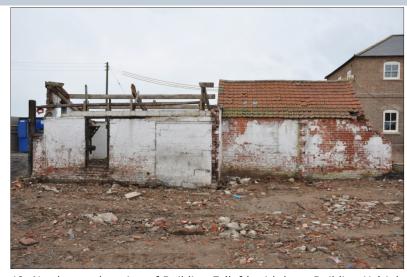
40. Northeast elevation of Building F (left) with later Building H (right and centre), looking SW

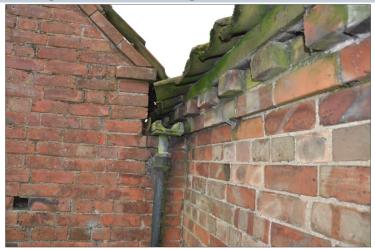
41. Inelegant junction of Building G and Building E, requiring use of a V-gutter, looking S

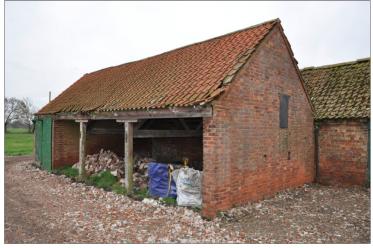
43. Northwest and northeast elevation of Building G, looking S

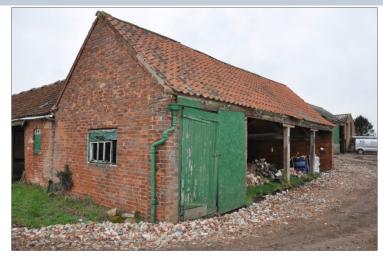
42. Northeast and southeast elevations of Building G, looking W

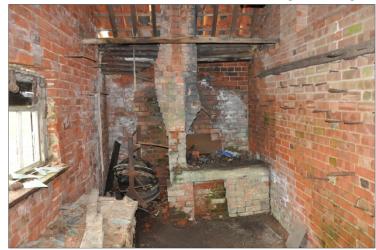
44. Interior of forge in Building G showing forge, hand bellows, tool hooks on wall (right) and work bench (left), looking SW

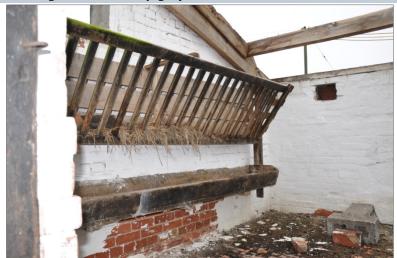
46. Detail of original pigsty (building F), later extended (Building H) and converted to a loose box, looking S

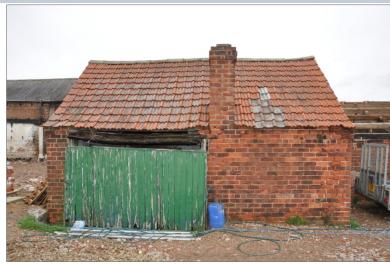
47. Southwest elevation of Building H showing sty (left) and boiler house with small chimney (right) for boiling pigswill, looking NE

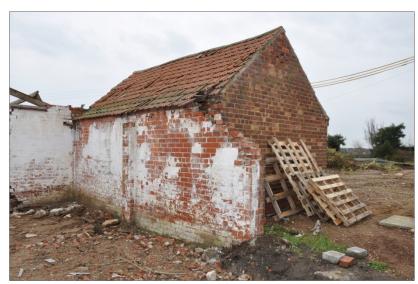
48. Northeast and northwest elevations of Building H showing yard wall with gateway (right), looking S

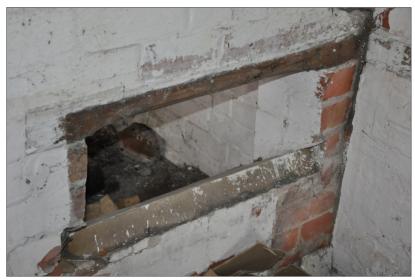
50. Detail of feeding chute from boiler house, looking N

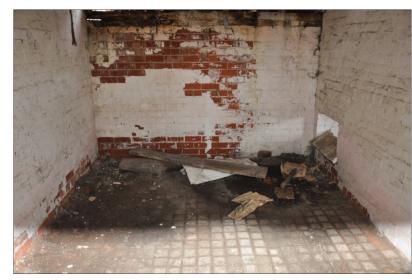
49. Interior of northwest bay of Building H showing pigsty with feeding chute (right), looking NE

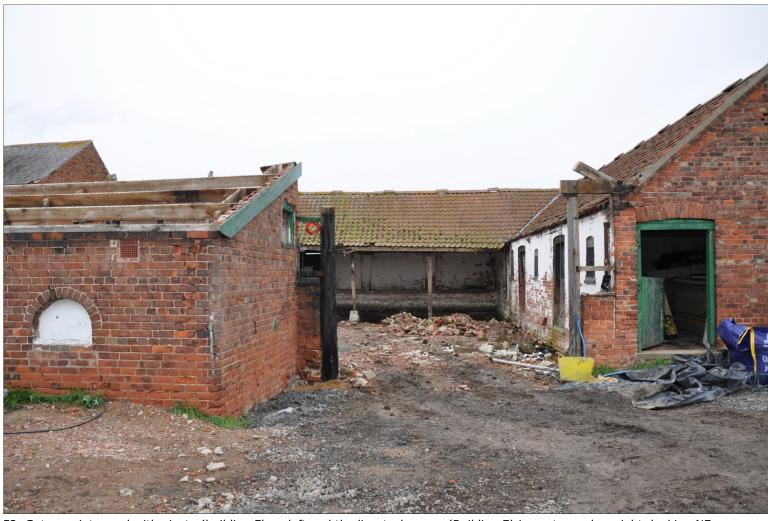
52. Gateway into yard with pigsty (building F) on left and the livestock range (Building E) in centre and on right, looking NE
