**Thornton Beam Engine House,  
Thornton,  
Fife,  
Standing Building Record,  
Data Structure Report**

**March 2016**

Client: Mr Mark Bruce  
Project: Thornton Beam Engine House  
Document Title: Standing Building Recording  
Job No: 224

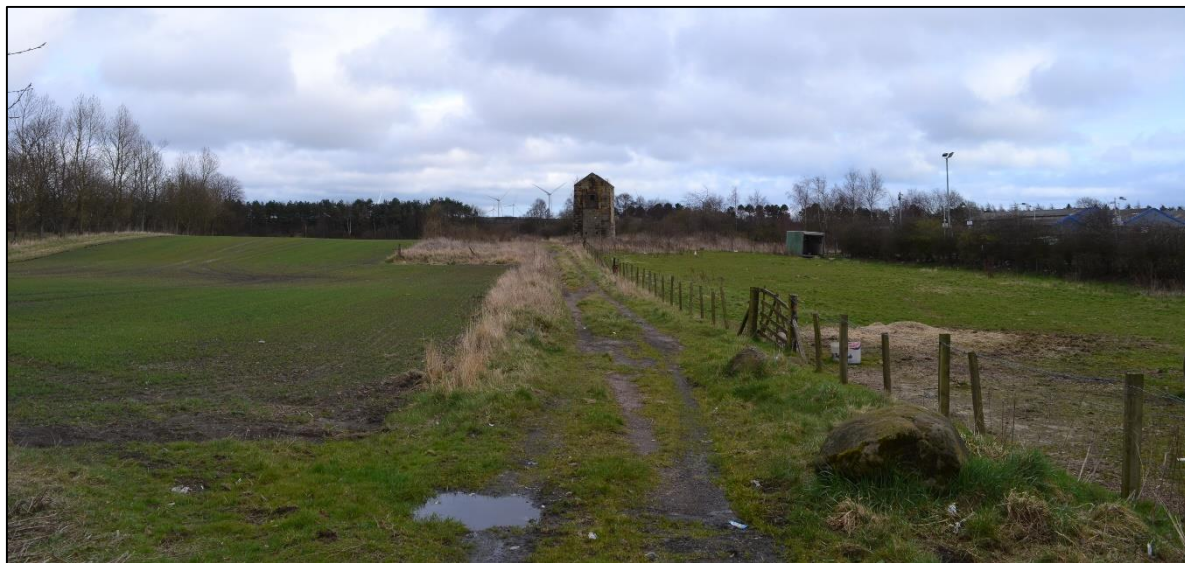
- 1.2.3 Thornton Beam Engine House is the last surviving part of what would once have been a more extensive industrial complex. Almost wholly intact, the building survives to three courses, with only the roof in an obvious case of disrepair.

**Plate 1:** View of Thornton Beam Engine House within its wider setting from the east (Photograph 044)

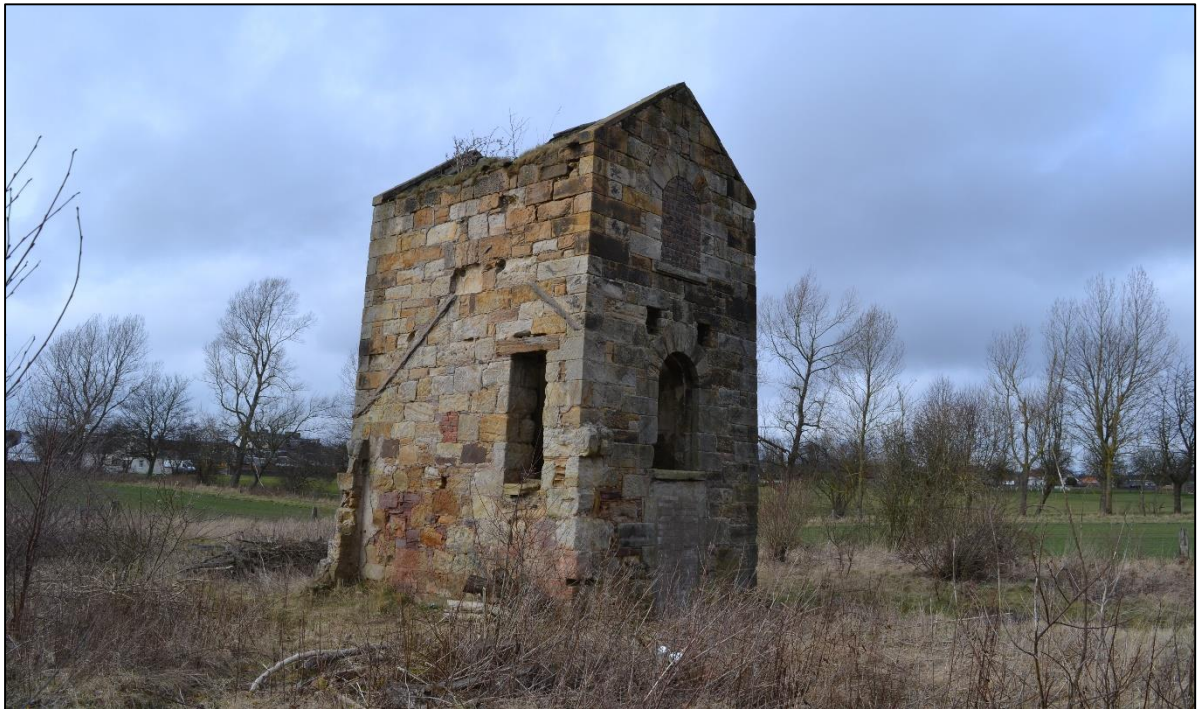
- 4.1.2 The building (Plate 2) was visited by John R Hume in 1976 during his collation of 'Industrial' sites in his important series, "The Industrial Archaeology of Scotland". Hume briefly discusses the complex, dating it to the late 18<sup>th</sup> or early 19<sup>th</sup> centuries and describing the surviving buildings as "a unique example of the buildings of an 'engine pit' of the period".<sup>6</sup> Many of the buildings Hume viewed were in use as a farm complex attached to the Beam Engine House. These are now demolished leaving the Beam Engine House standing alone (Plate 2).

**Plate 2: The Beam Engine House from the north west. Note the indications on the fabric of the building showing the presence of now demolished structures (Photograph 007)**

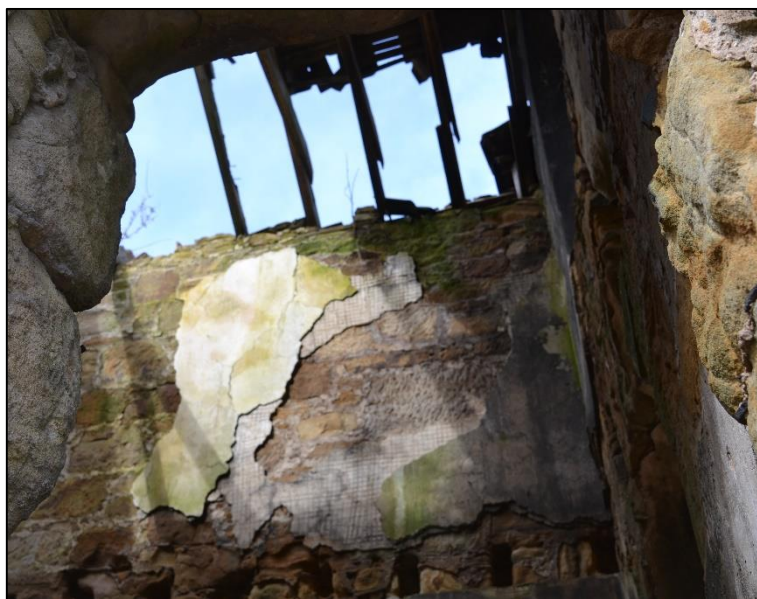
- 5.1.5 The only real access to the interior of the Beam Engine House survives on the southern elevation where an entranceway is located at first floor height. Although this and other safety concerns preclude access to the building, inspection through this opening show the interior to be much denuded (Plate 3 and Plate 4), with only a number of floor beams surviving between ground and first floor level – none survive between the first and second floors. Much of the interior walls have sections where lime plaster survives *in situ*.

**Plate 3:** View of the interior showing the poor condition of the roof  
(Photograph 024)

- 7.1.5 ARCHAS Ltd recommend that a further short phase of building recording is completed when access to the interior of the structure can be safely secured. This is unlikely to be an onerous exercise. In addition, consideration should be given to the archaeological implications of any excavations associated with the construction of the development and any impact that may have on buried deposits or structural remains. This is particularly true on the south and east sides of the Beam Engine House.

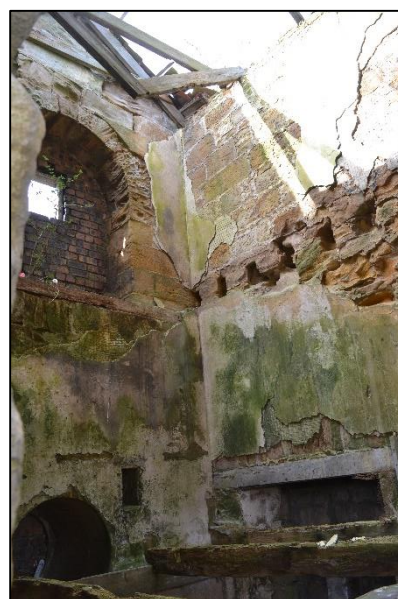
**Plate 4:** View of the interior showing internal plasterwork & features  
(Photograph 026)

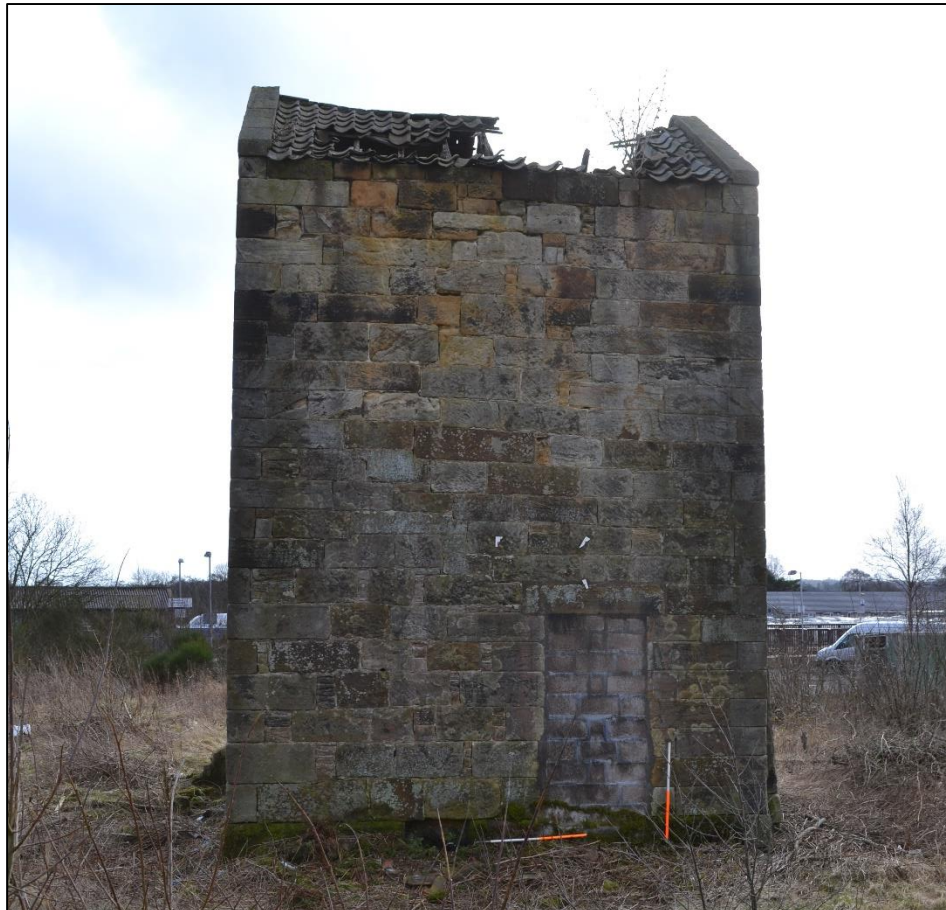
5.2.1 The north elevation of Thornton Beam Engine House is the most unremarkable and unaltered elevation of the building (Plate 5). It has an entrance built as a primary feature in the western half of the wall, although this is now blocked with modern nine inch concrete blocks. The jambs and lintel of this opening are well dressed sandstone blocks, although not as high quality as those in the western elevation. The coursing of the stonework is reasonably consistent, specifically at the lower level, although this loses its consistency above door level, particularly on the western side.

**Plate 5: North elevation of the Beam Engine House (Photograph 012)**

5.2.2 On the eastern side of the wall, a small hole has been punched into one of the sandstone blocks while a short Fe bar also protrudes. These are likely to be secondary additions.

5.2.4 A stone has been robbed from the dressed foundation course which runs around the base of the Beam Engine House, creating a gap c.0.70m wide. This opening does not continue all the way through the wall of the building.

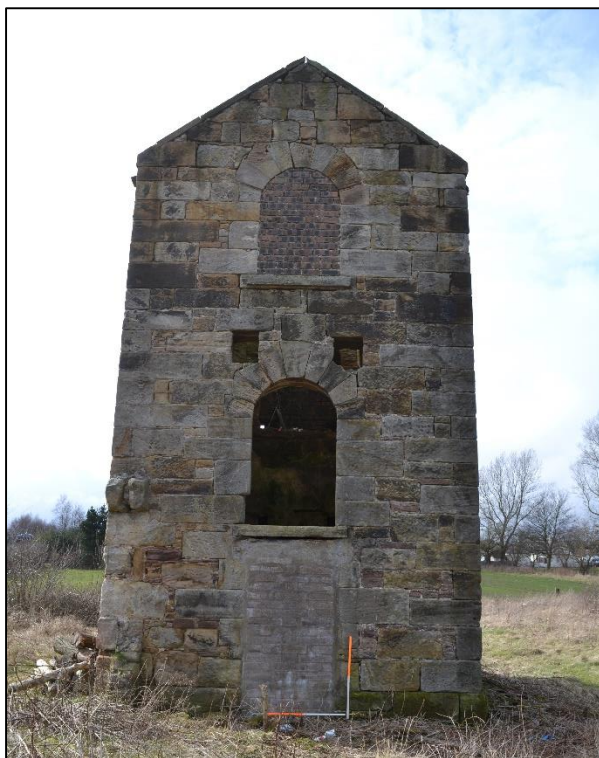
5.3.1 The East elevation contains a number of openings (Plate 6). An entrance at ground level is now blocked by modern breeze blocks, while of the two arched openings above, located at first and second floor levels, the uppermost is blocked by what appear to be 19<sup>th</sup> century bricks. The function of these openings is not clear. The opening on first floor level has the height and location at floor level to have acted as a doorway. The upper, now blocked opening appears too small for this and may have been a window or associated with the use of machinery.

**Plate 6: East Elevation of Thornton Beam Engine House (Photograph 016)**

5.3.2 There are also two large, square slots running through the wall above the first floor opening. On casual inspection, the northernmost of the two is more roughly constructed and has the appearance of being cut through an existing wall. However, closer inspection of the specifically cut and placed stonework around these openings shows them to be an integral part of the primary build of the structure. Their function is unclear, but the size of the slots and their location may indicate a function related to the stabilisation of the steam engine located directly on the other side of the wall.

5.3.4 Like the north elevation, a number of small punched holes and an Fe bar were noted in the wall, here at southern side. A possible faint raggle could also be discerned running towards the brick blocked upper opening, although like that on the northern side, this is likely to just be scarring of the stone.

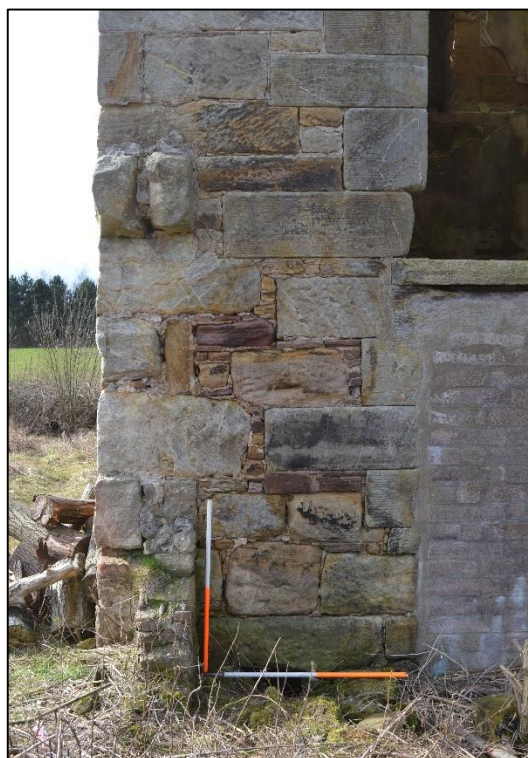
**Plate 7: Detail of the wall stub on south side of the East Elevation (Photograph 022)**

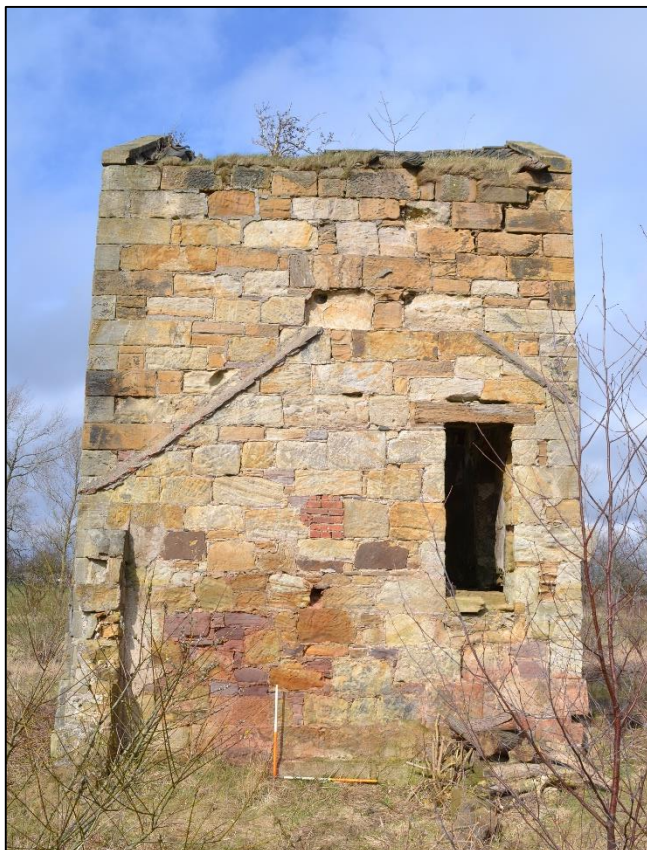
- 5.4.1 The South elevation is that which has the most features to interpret (Plate 8). The stonework here is clearly the roughest and poorest quality of all elevations, with only semi-regular coursing and poorer quality stone, particularly in the south west corner.
- 5.4.2 As discussed, it retains an open entrance into the interior of the building at first floor level. This entrance is a primary feature, but without the well-dressed ashlar quoins found to varying degrees elsewhere around the building.

**Plate 8:** South Elevation of Thornton Beam Engine House (Photograph 029)

- 5.4.3 There is a small area of 19<sup>th</sup> century bricks in the middle of the wall, adjacent to the doorway. Presumably these block an opening in the wall rather than a repair to the otherwise sound fabric in this area. It is not possible to tell from the external inspection whether this is a primary opening or is cut into the wall.

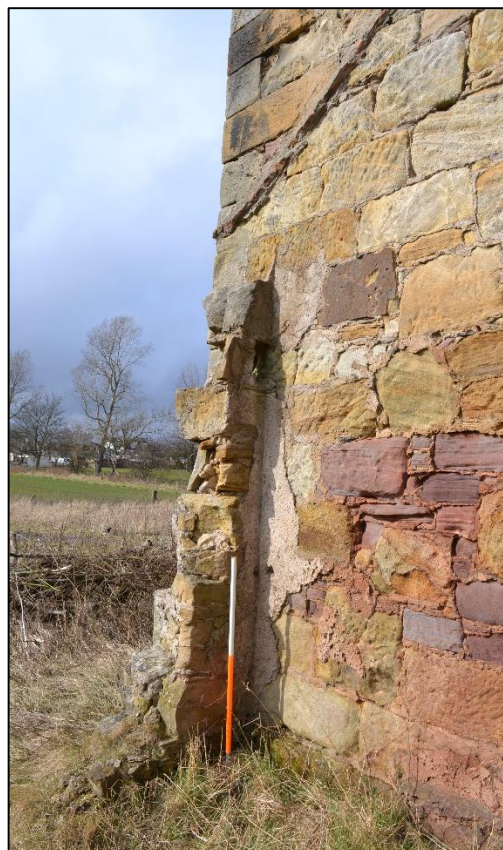
**Plate 9:** Detail of wall stub retaining plaster from the south east. Note the line of the raggle (top) and scorched stonework (right) (Photograph 034)

- 5.4.4 A clear raggle indicates the former presence of a substantial building with a red pan tiled roof which once extended southwards from the main edifice. The raggle is uneven and offset from the centre of the elevation, extending lower on the west side to meet the teeth of a broken wall stub running southwards (Plate 9). The eastern side of this now demolished building extended beyond the eastern end of the south façade. This is indicated by the higher placement of the raggle against the eastern side of the south elevation, and the eastwards running wall running from the south east corner (described under Section 5.3.3 above) which would have formed part of the same building. This now demolished building was part of the primary build of the Beam Engine House structure as the remaining stub is closely tied into the main Beam Engine House structure.

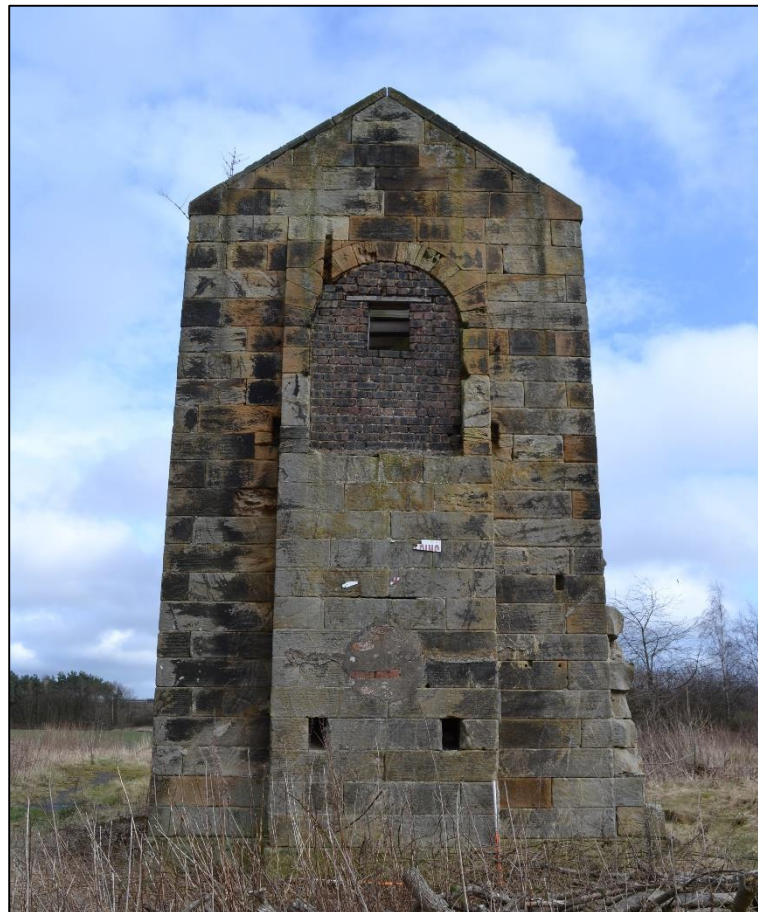
- 5.5.1 The ashlar stone work on the West Elevation is of very high quality (Plate 10). This facade was clearly the most important side of the Beam Engine House, facing the main access track to the site, accentuating and enhancing the quality and importance of the structure, while providing a stable building to withstand the rigours of a functioning beam.

**Plate 10: West Elevation of Thornton Beam Engine House (Photograph 038)**

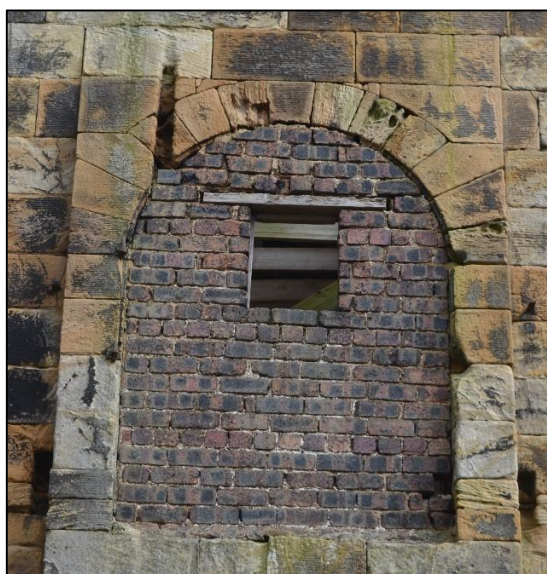
- 5.5.2 As with elsewhere around the building, the main openings through the wall have been blocked. The main beam of the engine would have protruded from the uppermost of these openings, blocked now with what appear to be 19<sup>th</sup> century bricks (Plate 11). A small square opening with a timber lintel left in the centre of this blocking, is a window relating to the re-

use of the building. Although it was not possible to access this opening for closer inspection, protruding Fe rods and pintles on either jamb indicate the opening could be closed off by two large doors. This is curious as they appear from distance to be primary to the main build and it is difficult to see why, or how the opening would be closed with the beam in place.

- 5.5.3 Twin slots either side at the base of the opening would have acted as supports for the pivot of the beam.
- 5.5.4 A large vertical gouge running upwards from the north side of the opening is more difficult to explain, but is a secondary insertion and must relate to the use of and complexities of the machinery fitted in this tight space.
- 5.5.5 Lower down the wall a circular opening is also blocked with bricks, these likely to be later in date than those blocking the beam opening (Plate 12). This hole would have been for the steam pipe, but is now also smeared with cement, likely in an attempt to disguise the blocking.

**Plate 11:** Detailed view of opening for the Beam in West Elevation (Photograph 037)

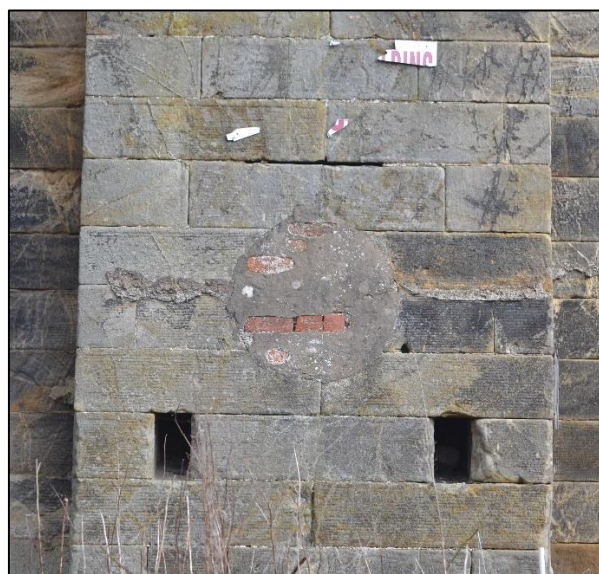
**Plate 12:** Detailed view of the blocked steam hole. Note the raggle running across the opening (Photograph 038)

- 5.5.6 Two sockets below the blocked steam hole are bearing bolt access holes. These have been left unaltered.
- 5.5.7 A raggle running from a high point on the southern side of the West elevation, slopes down at a c.45° angle before cutting horizontally along the face of the blocked steam pipe hole, before once again sloping downwards to terminate c.1.20m above ground level. Blocking or obscuring important parts and areas of the Bean Engine House's primary function, this raggle relates to a now demolished secondary building, likely from the use of the site as a farm complex. The low level at which it reaches on the north side, indicates that this area in particular would have been some sort of storage area.
