Channel Tunnel Rail Link  
**Kvaerner Construction Ltd.**  
for Union Railways (South) Ltd.

**BROCKTON FARM, CHARING HEATH, KENT**  
ARCHAEOLOGICAL RECORD IN ADVANCE OF AND DURING DISMANTLING

NGR: TQ 9220 4890

**Oxford Archaeological Unit**  
April 2001

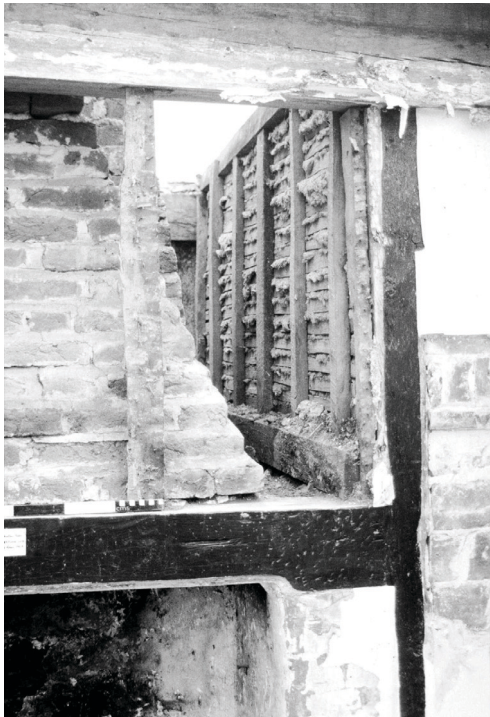
*Above: Void adjacent to brick stack where the 'spiritual midden' was discovered, as seen from room FF05.*

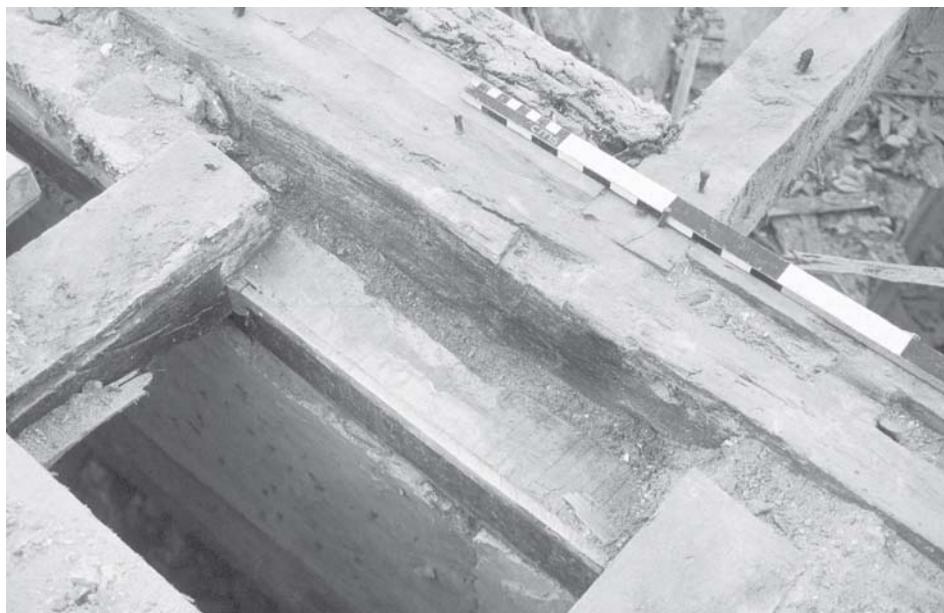
(a) Surviving section of Phase I western tie to north of stack

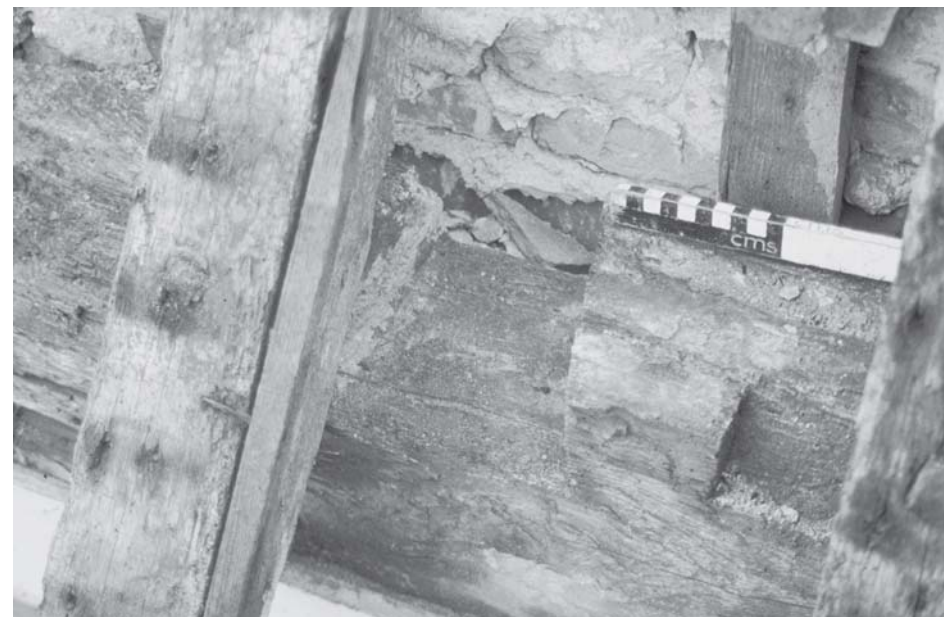
(b) Redundant, former tie dovetail in eastern wall plate

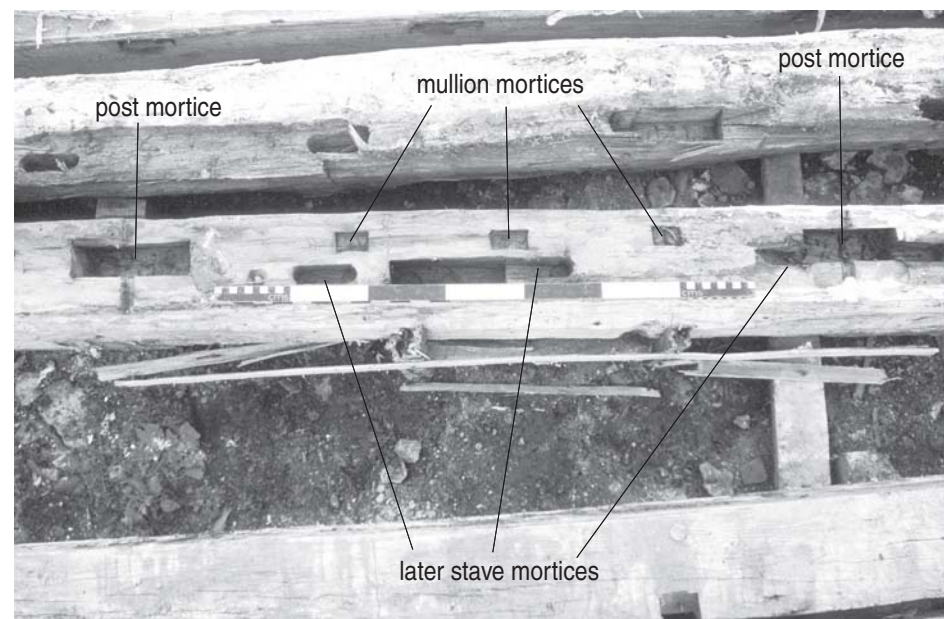
(c) Evidence for Phase I window in soffit of western wall plate

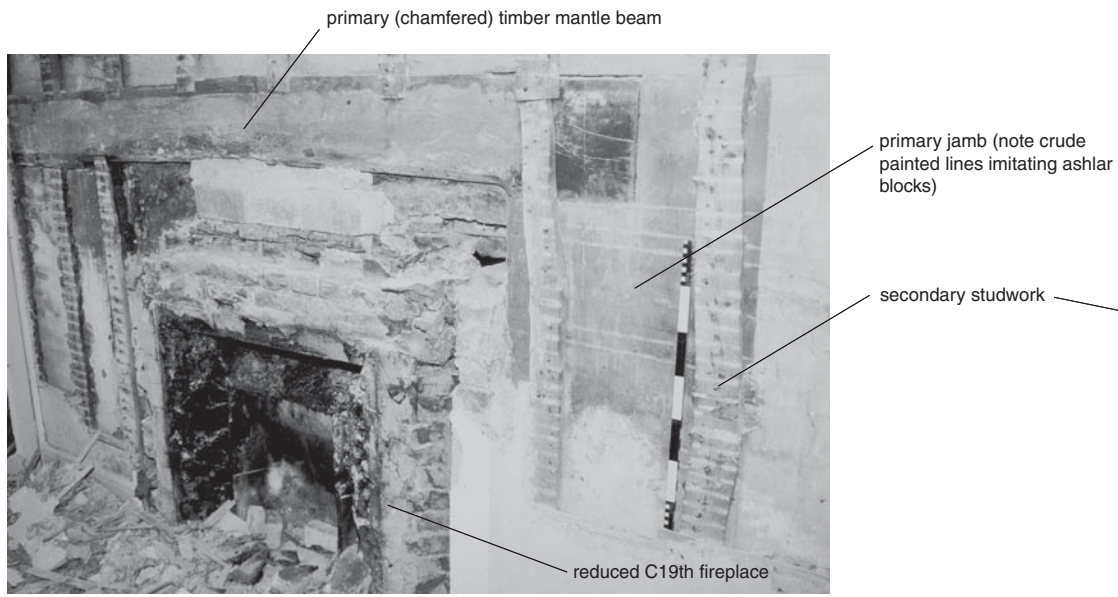
(a) Primary fireplace within nRoom GF05 after initial opening up

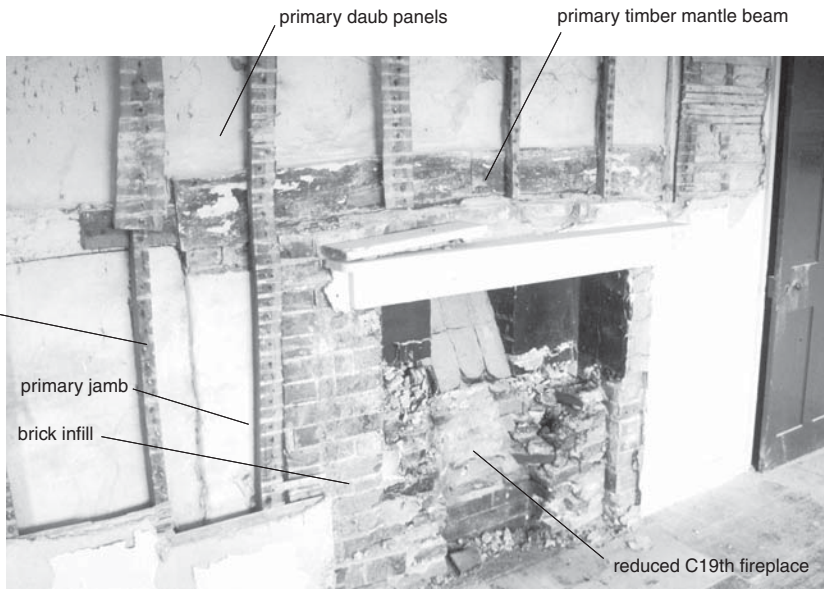
(b) Primary fireplace within Room FF01 after initial opening up

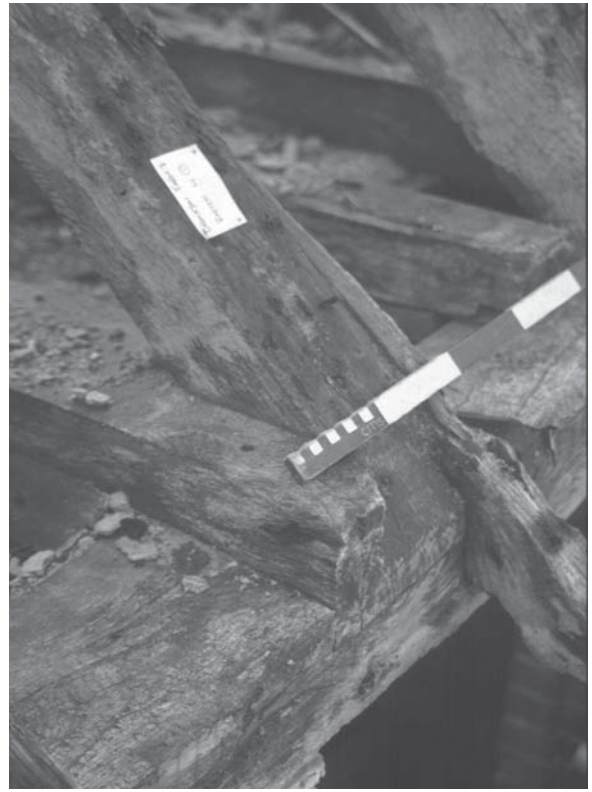
(b) tie beam sawn off flush with outer face of wall plate

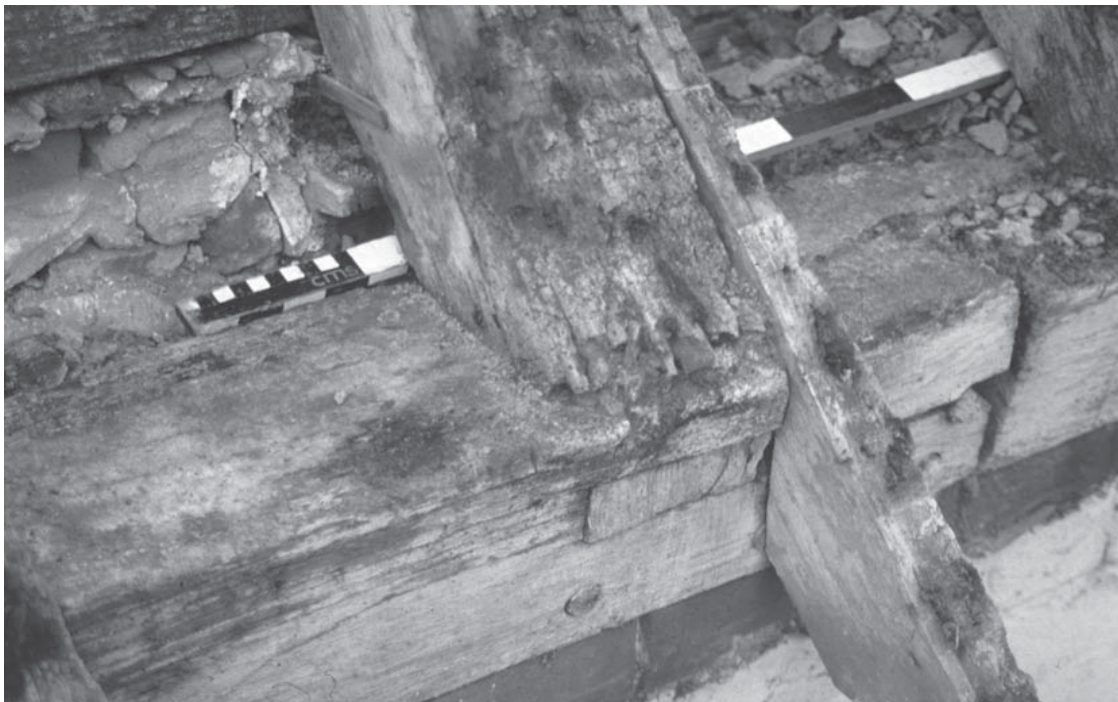
(c) sawn off tenon in outer face of north plate

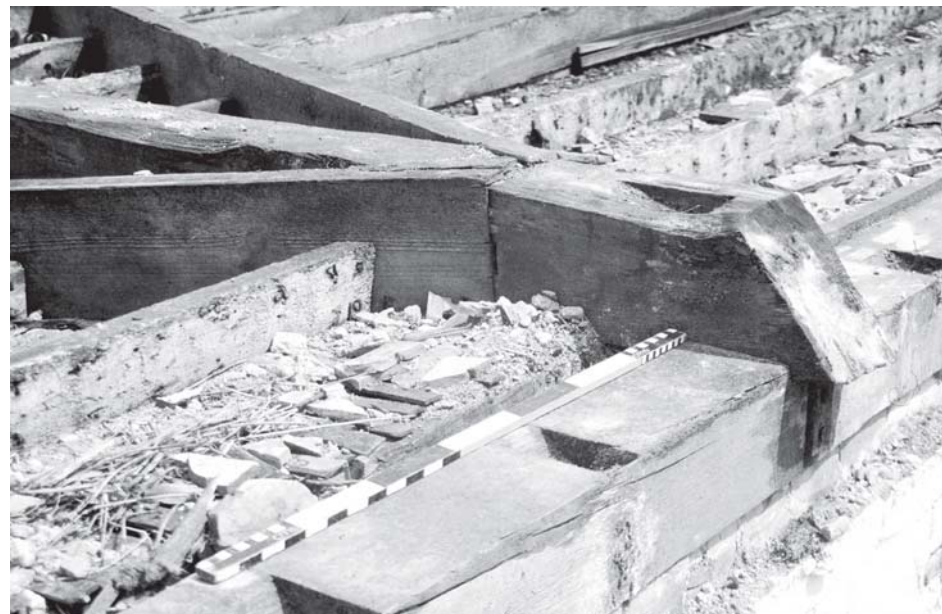
(b) Detail of jointing of tie at south plate; note iron strapping reinforcement

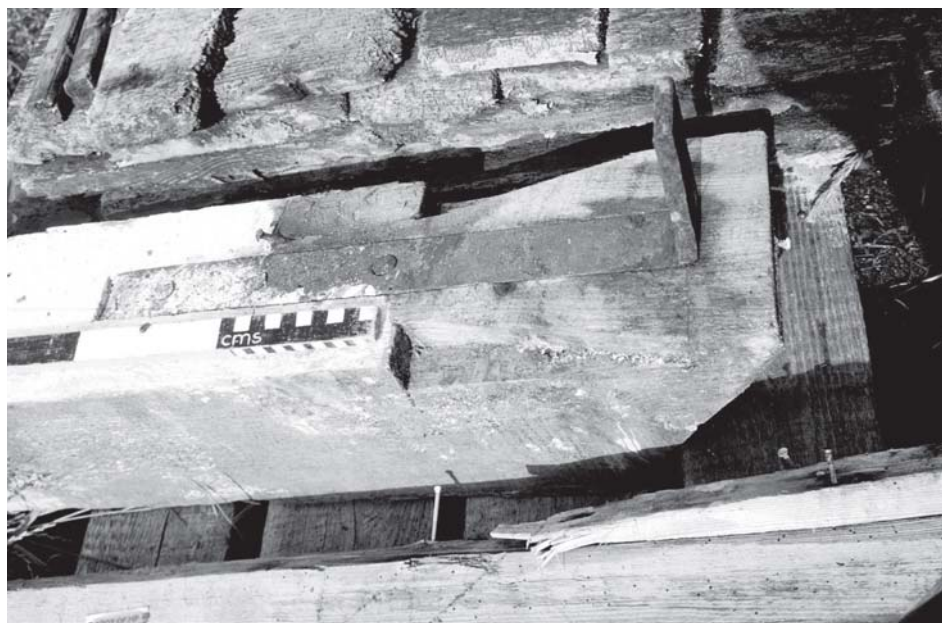
(c) Ex-situ detail of iron strapwork reinforcement let into soffit of tie
