Channel Tunnel Rail Link
Balfour Beatty Major Projects
for Union Railways (South) Ltd.

TALBOT HOUSE, SELLINDGE, KENT
ARCHAEOLOGICAL RECORD IN ADVANCE OF AND DURING DISMANTLING

Environmental Statement Route Window: 36

October 2002

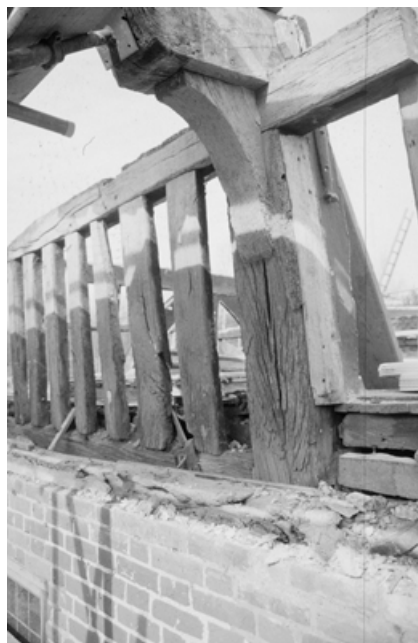
Plate 1: Phase I close studwork of upper hall wall, bay III (note transverse bracket. CF2).

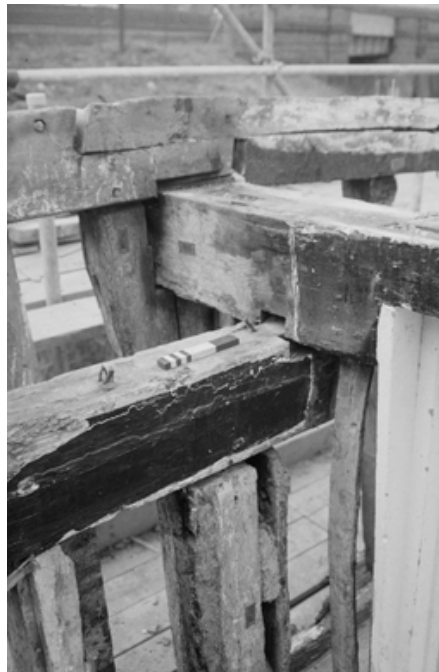
Plate 2: Reversed assembly at CF3 (S).

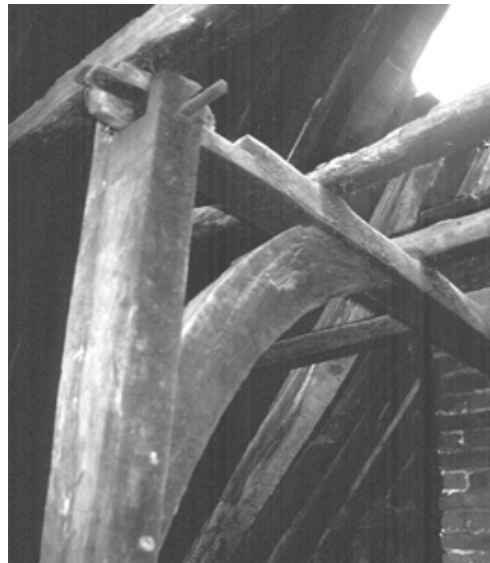
Plate 3: Surviving crown-post, arch brace and collar purlin at CF3.

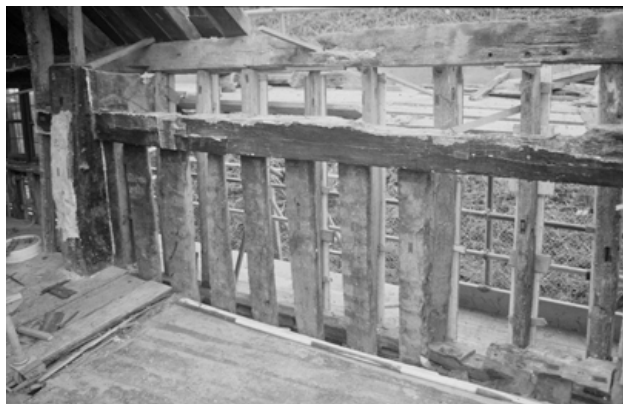
Plate 4: Bay 3(S); Phase I studwork with inserted studwork beyond (below bressummer) for support of tile hanging.

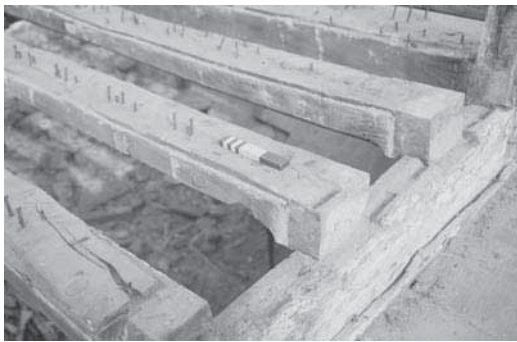
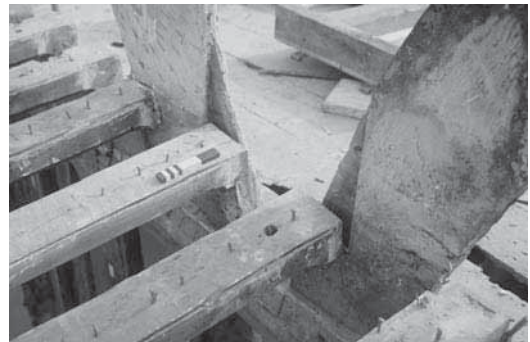
(b) At the high end of the hall, the common joists of the inserted floor are supported by packing pieces atop the pre-existing dias beam (left) or, in certain cases, are cut into the arch bracing of the end elevation (right).
