Ward Block 10

Heartlands Hospital Bordesley Green east Birmingham West Midlands

Historic Building Record

March 2010

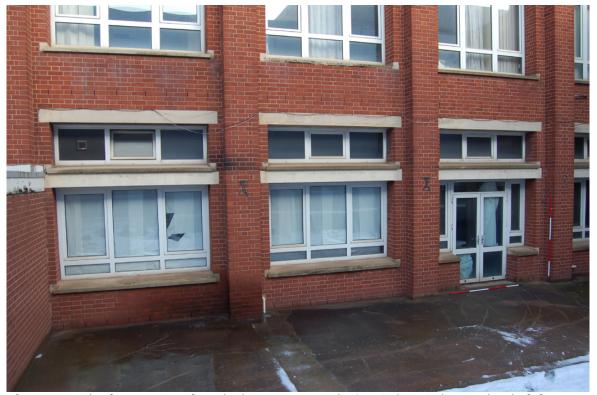
Plate 14: Wider fenestration of south elevation, **NB**: split GF windows indicating level of former canopy, originally supported by projecting RSJs within brickwork piers.

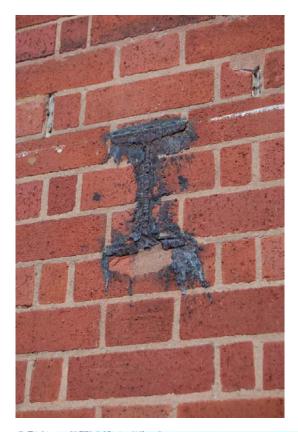
Plate 15: Detail of sawn off RSJ in brickwork pier of south elevation, formerly supporting canopy.

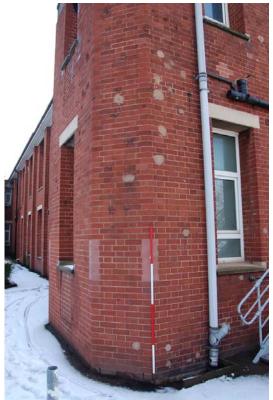
stairs.⁸ The western elevation is of note in that the fabric shows clear signs of damage, particularly around the north-west corner, attributed to shrapnel resultant from bombing raids of the Second World War (R Davey, *pers. comm.*).⁹

During WW2, about 30 bombs dropped on the Heartlands and Yardley Green hospital sites (Ayres, Ellis and Portsmouth 1995, 12), mainly during 1940; minor damage is recorded at the Heartlands site during a raid on December 12th 1940 (*ibid*. 69).

Plate 18: Shrapnel damage at NW corner.

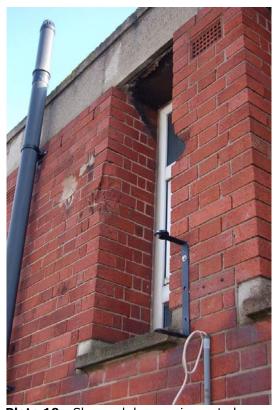
Plate 19: Shrapnel damage in west elev.

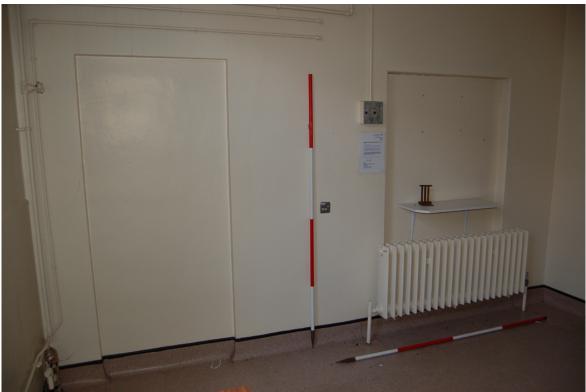
Plate 38: Blocked door and window openings within west wall of [1F06;] (former duty room).

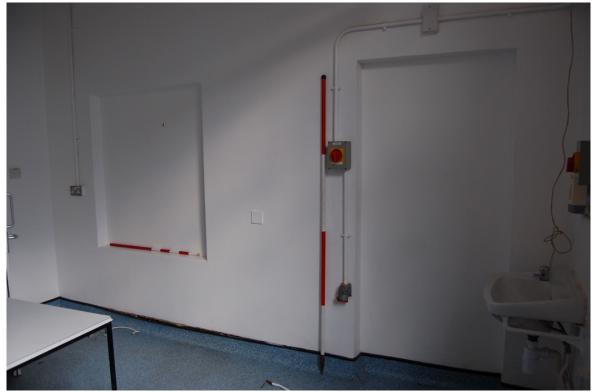
Plate 39: Corresponding blocked window and door openings within east wall of [1F05].

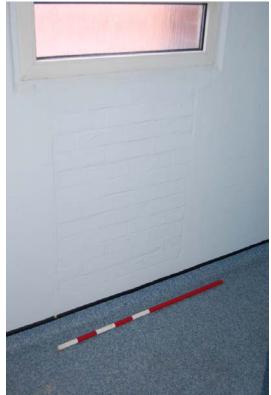
Plate 49: Blocking beneath window [1F15] (north wall).

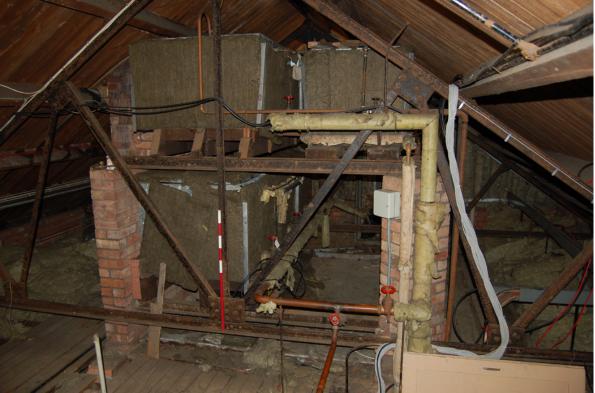
Plate 51: Lowered ceiling level and water storage tanks over central 'core' area of block.

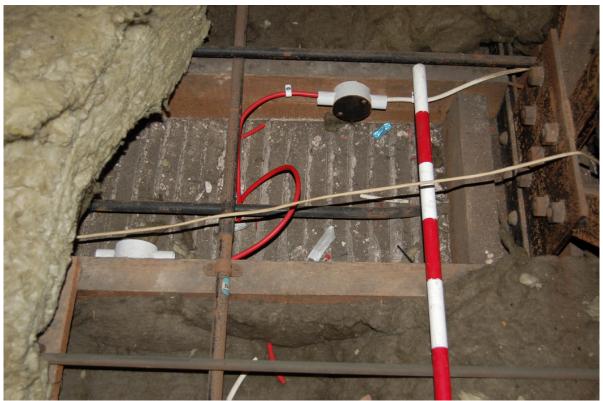
Plate 52: Original lath and plaster ceiling of first floor level visible within roofspace.
