THE WHITWELL TITHE BARN

By M. J. DOLBY

THE WHITWELL TITHE BARN PLAN OF THE SITE

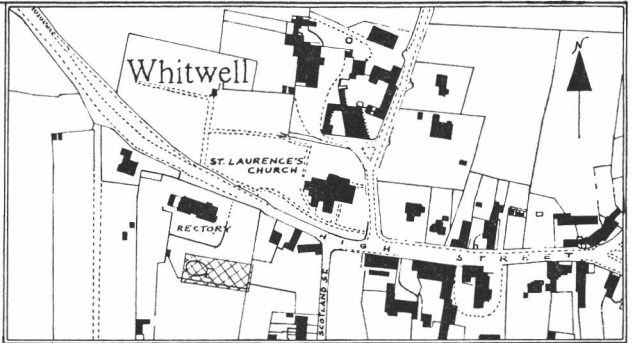
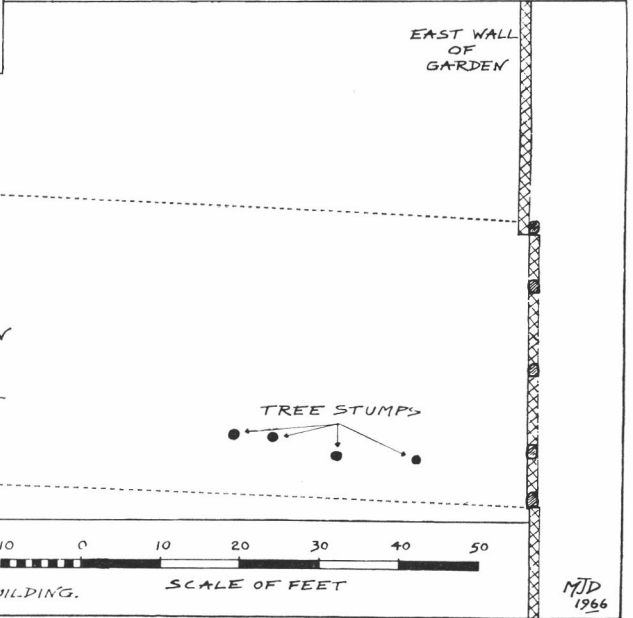
FIG. 22.

During August 1966 the upright was measured, and the mortices were plotted as accurately as the present state of the timber would allow.¹ The measured drawing shows the probable layout of the timber framework of the original barn adjacent to the upright (fig. 22). Grooves for horizontal weatherboarding were found on the north side of the upright between the top of the lower tie-beam and the base of the mortice for the raking strut to the main tie-beam, and three further grooves were found in the same face, directly above the raking strut mortice. Above these three grooves were six circular

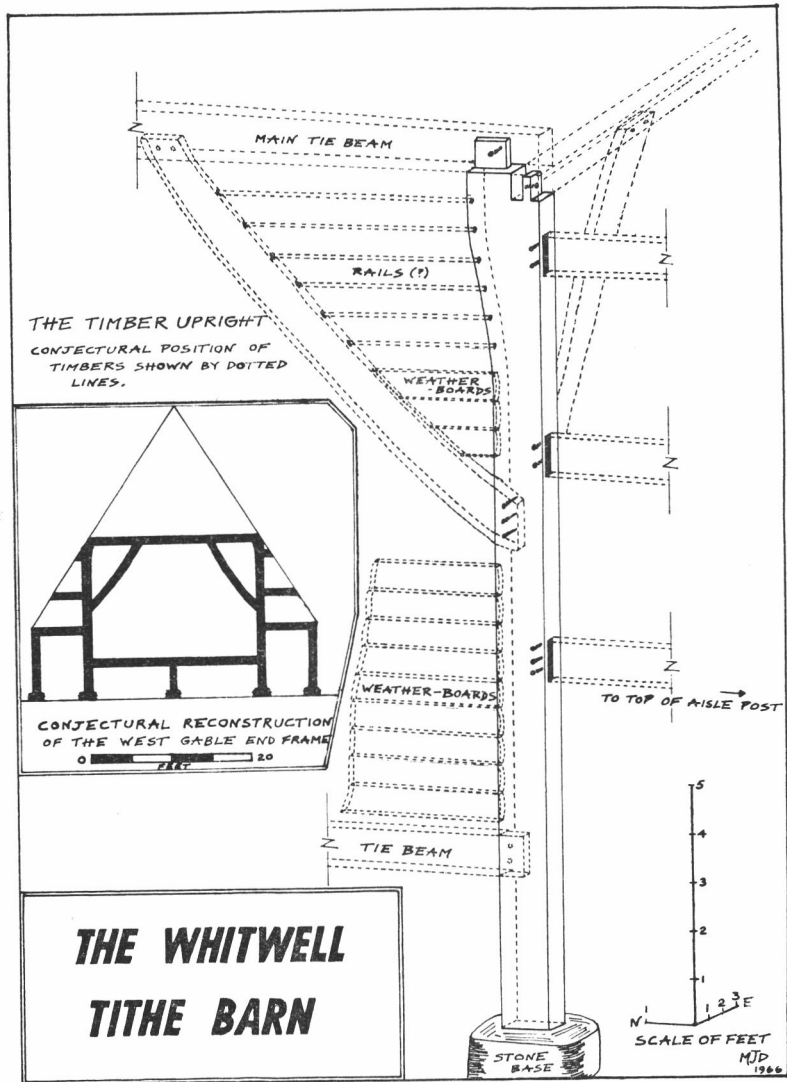
FIG. 23.

hollows, spaced at regular intervals, which could be locating holes for wooden rails or louvres. The end of the eastern raking strut, i.e. the one supporting the wall-plate, was found in position in its mortice, but its outer end had been sawn off (fig. 23).

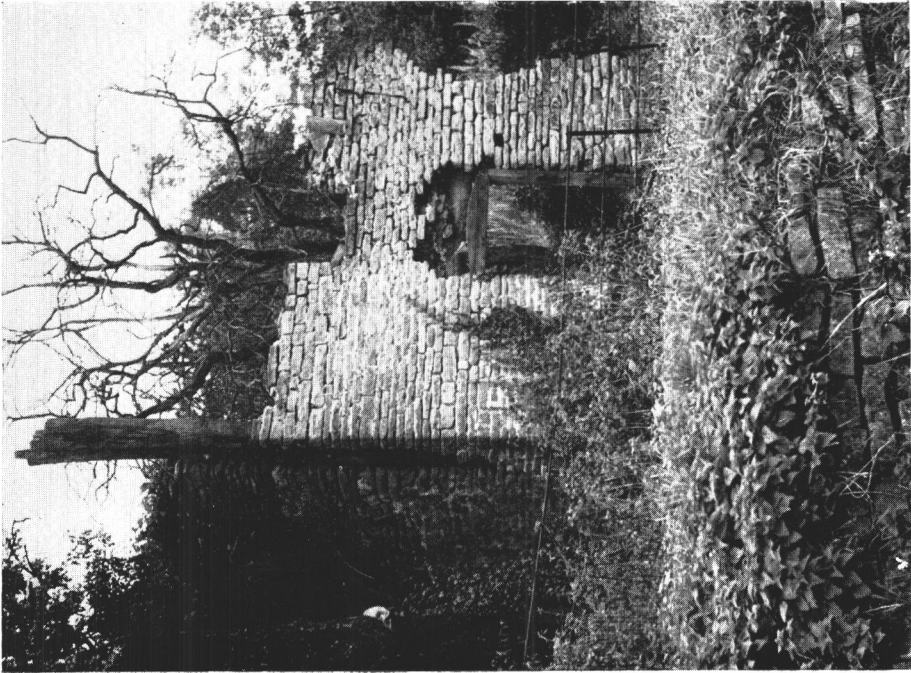
a. General view of the S.W. corner showing the timber upright.

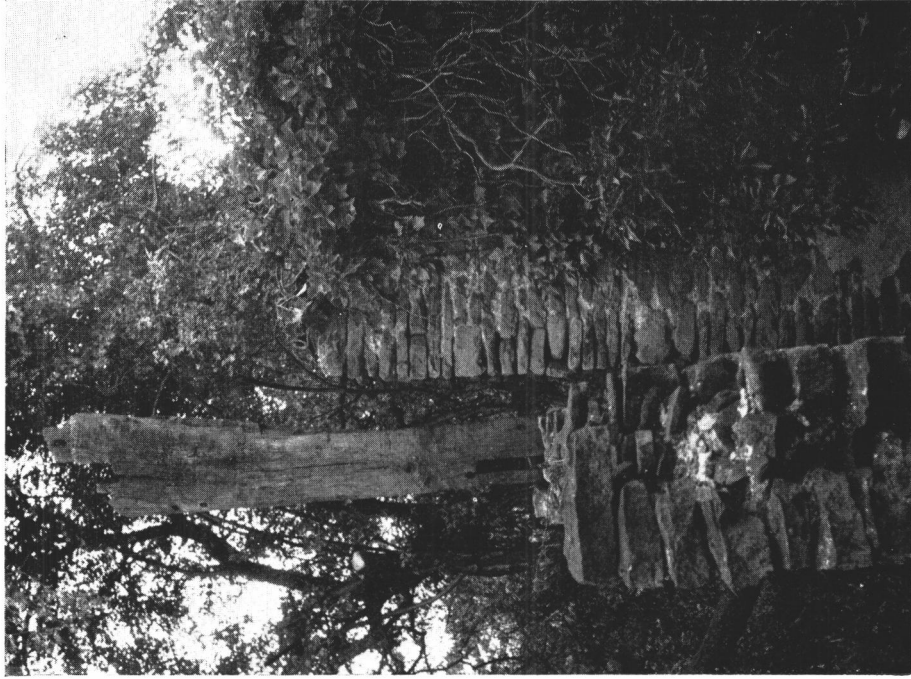
b. View to the W. along the line of the S. wall showing the upper portion of the timber upright.
