Historic Building Record & Analysis

68 St Peters Street, St Albans, Hertfordshire. AL1 3HG.

INSTALLATION OF ROOFLIGHT & TILE VENT

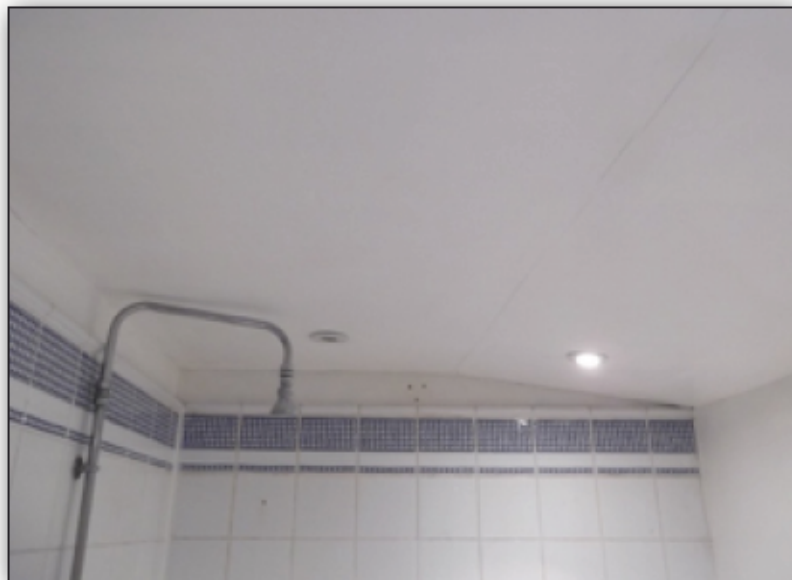
Plate 1 - Modern ceiling prior to works (towards party wall)

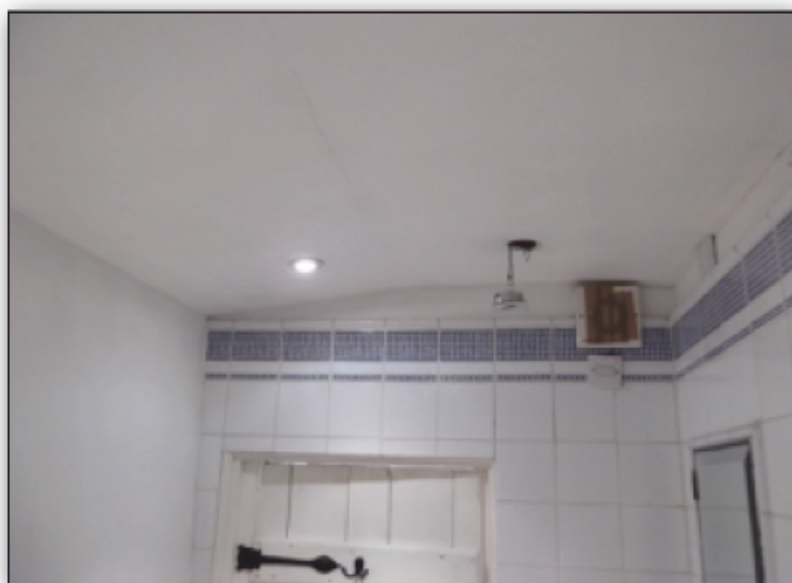
Plate 2 - Modern ceiling prior to works (towards bathroom door)

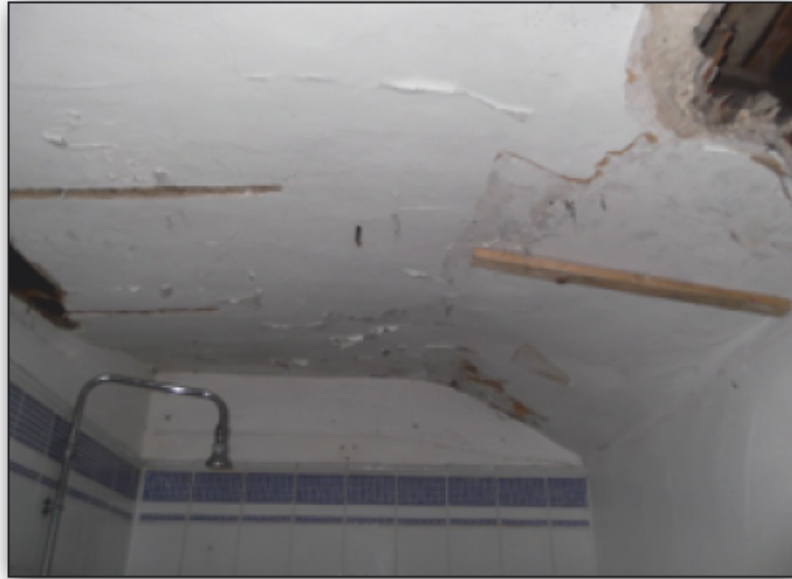
- 5.1.2. Following removal of the modern plasterboard ceiling, 2No areas of the lath and plaster ceiling were found to be missing and 3No rafter feet had rotted away from the wall plate. By agreement with the LPA the lath and plaster ceiling above the bathroom was removed to enable a wider assessment of the condition of the roof timbers.

Plate 3 - Lath and plaster ceiling following removal of plasterboard ceiling (towards party wall)

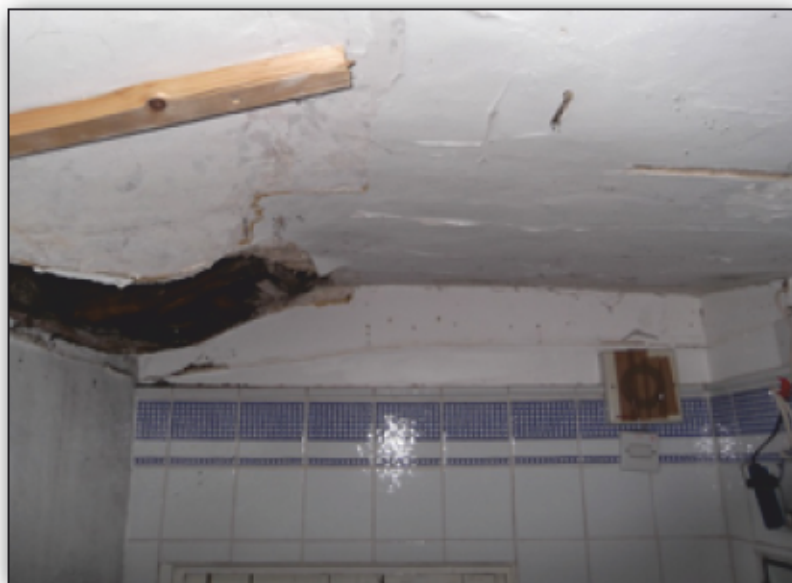
Plate 4 - Lath and plaster ceiling following removal of plasterboard ceiling (towards door)

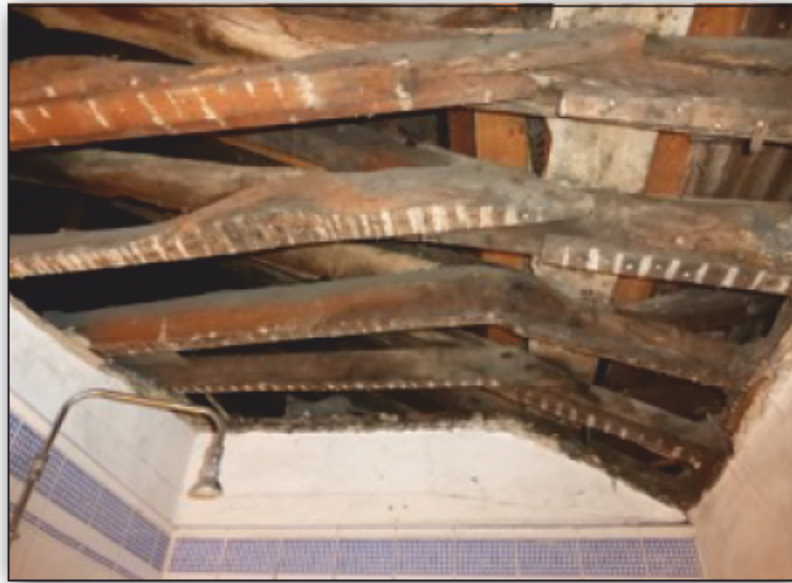
- 5.1.3. The roof was found to be formed of a variety of hardwood structural timbers, from a older building, that have been modified for re-use. The timbers used as rafters had been birds-mouthed and nailed over the rear face of the main wall plate of the front timber frame.

Plate 5 - Roof structure following removal of lath and plaster ceiling (towards party wall)

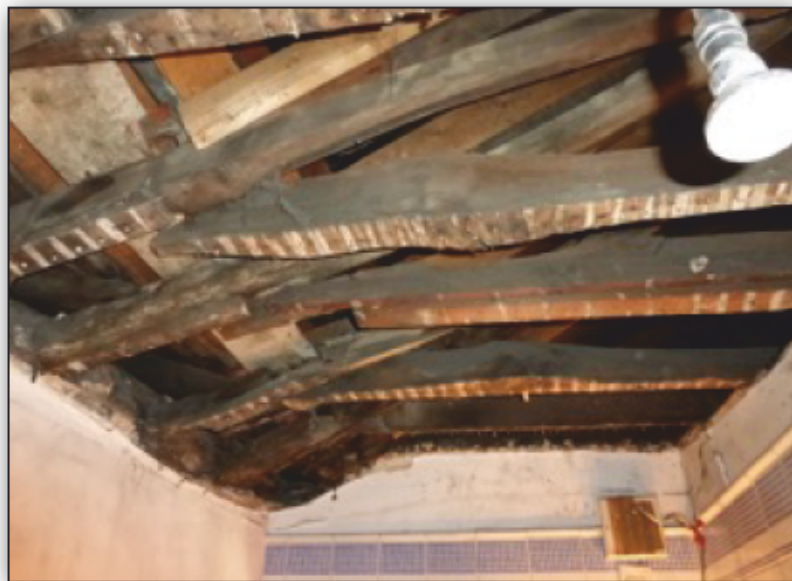
Plate 6 - Roof structure following removal of lath and plaster ceiling (towards door)

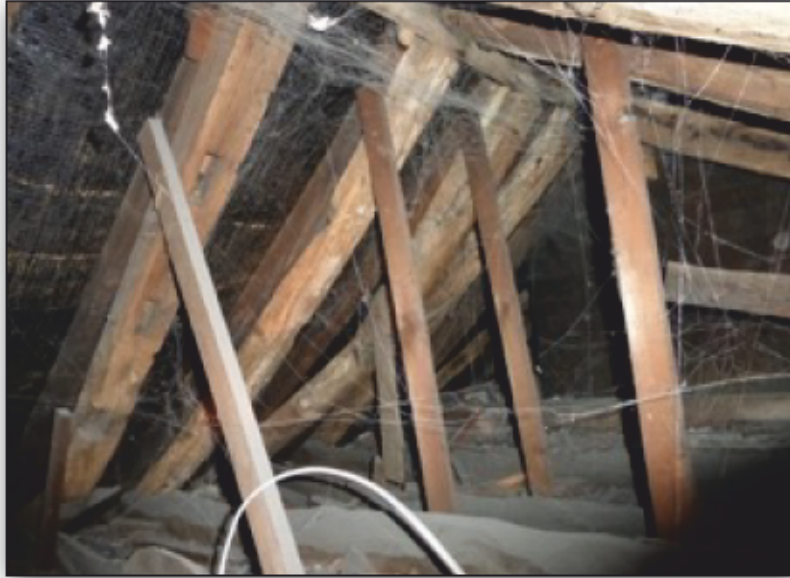
- 5.1.4. Between the front and rear roof rafters are curved timber bearers, which support the central valley gutter valley boards.
- 5.1.5. The older roof structure had been subsequently overlaid with more modern softwood rafters and packing timbers, and covered with a bituminous sarking membrane. This indicates that the property was re-roofed, probably in the mid to late 20th century.

Plate 7 - Example of other timbers with roof void

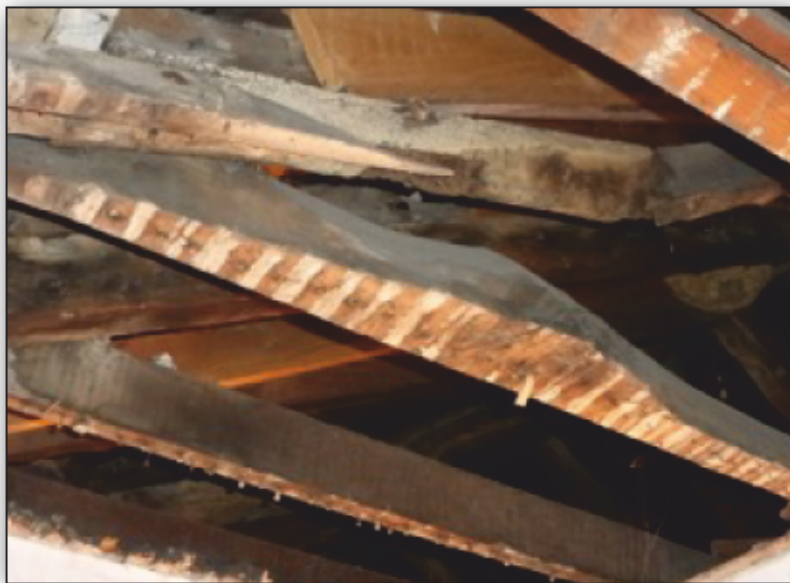
5.3.2. Rafter 3 was fractured mid-span and by agreement with the LPA, was removed, along with a section of ceiling joist, to allow the rooflight to be inserted. The removed rafter was recorded and analysed in more detail.

Plate 8 - Rafter and ceiling joist (No 3) prior to removal

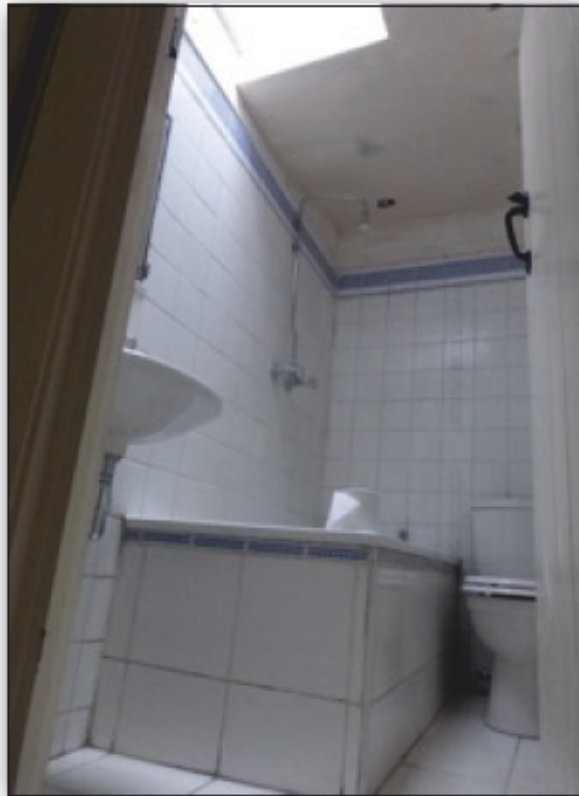
Plate 9 - Reinstated lath and lime plaster ceiling

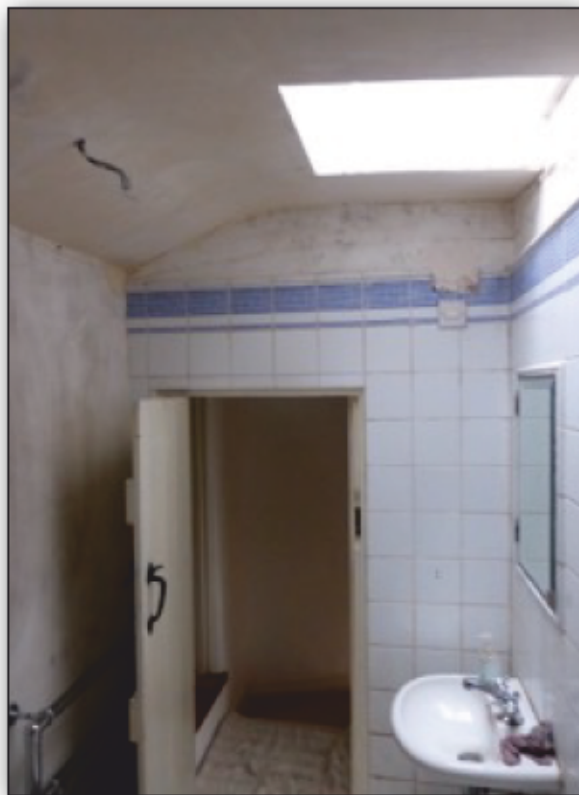
Plate 10 - Reinstated lath and lime plaster ceiling

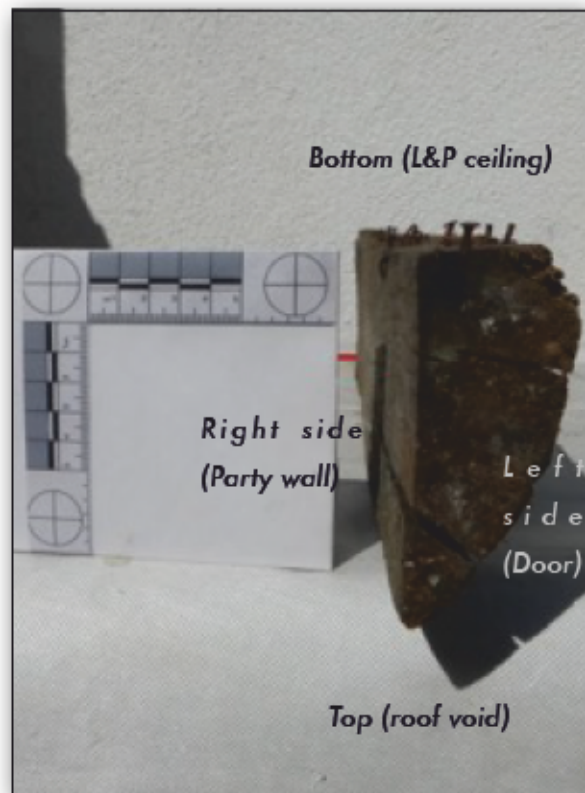
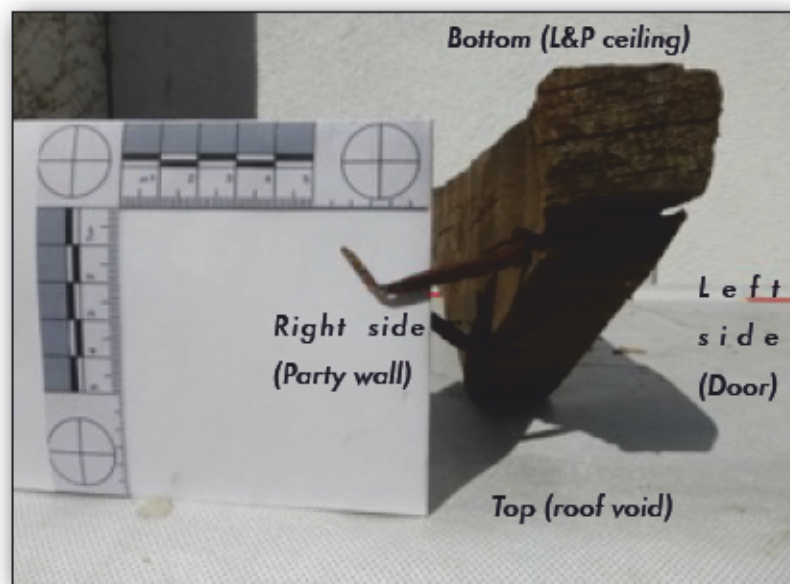
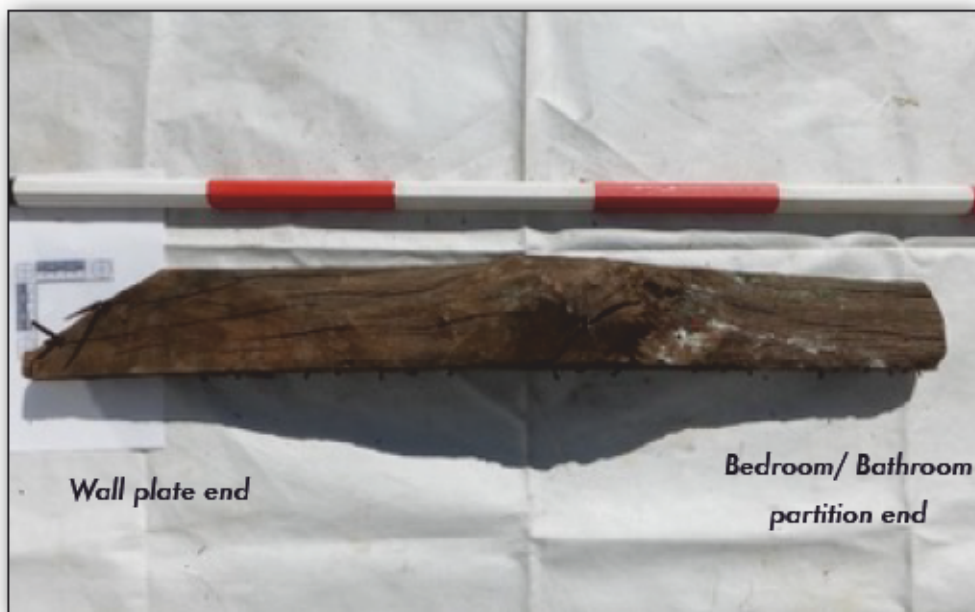
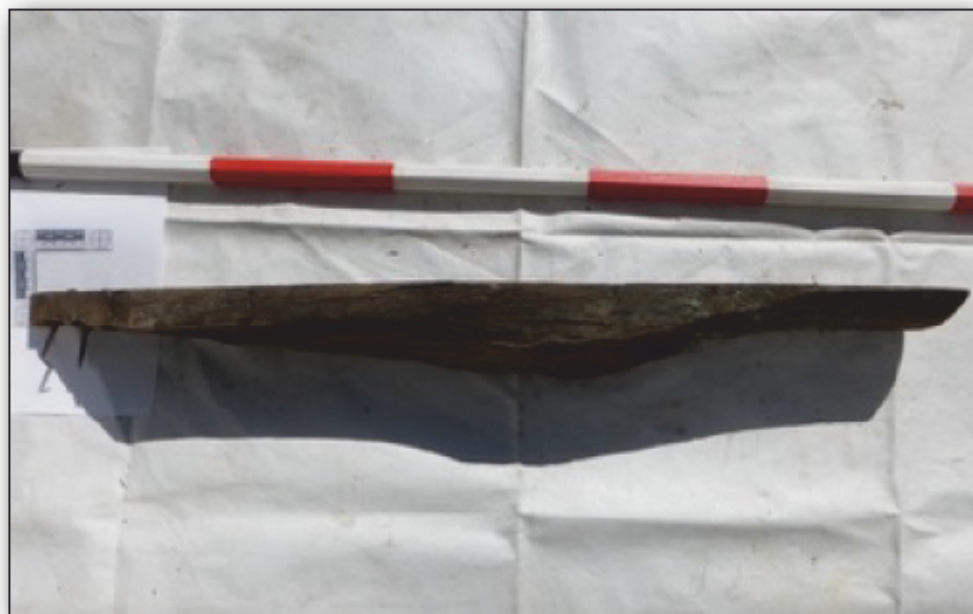
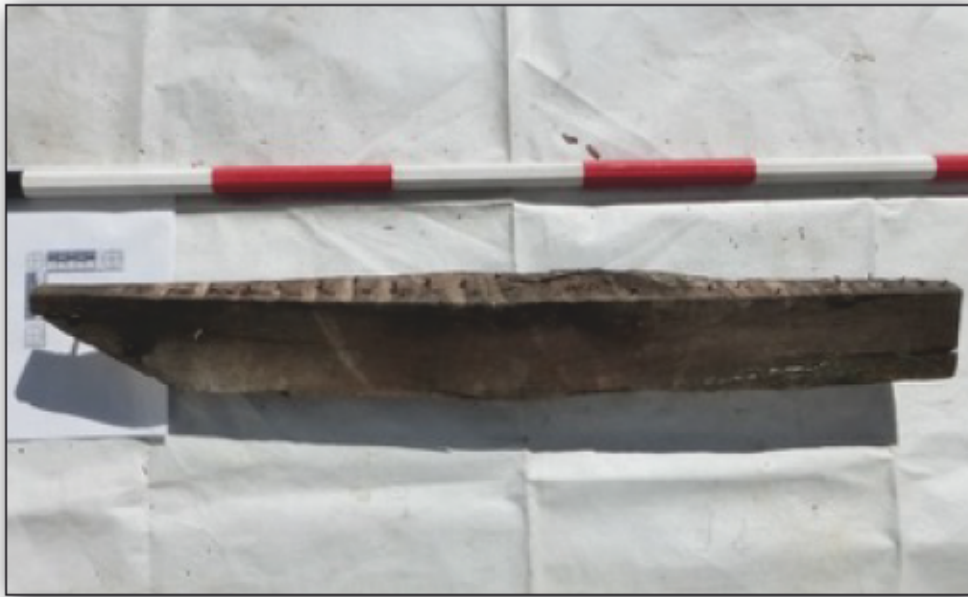
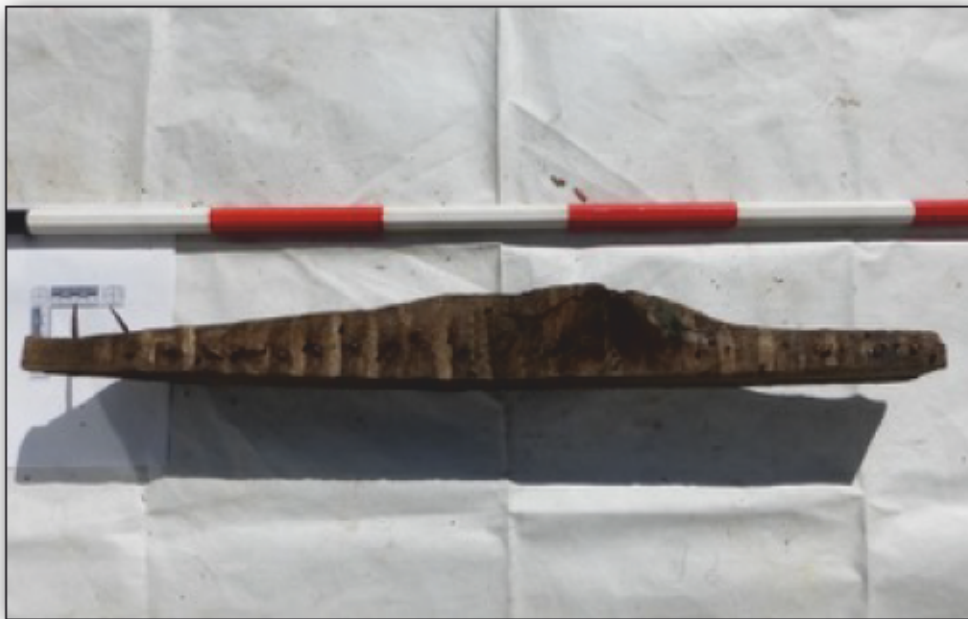
- 5.2.1. The removed section of ceiling joist was a quartered section, with flat faces.
- 5.2.2. The timber was irregular in section shape along its length and, by inspection, it would appear that only heartwood timber remains.
- 5.2.3. The joist was fixed into the rafter with 2No. hand forged iron nails. There were no other features or markings on it.

Plate 11 - Removed ceiling joist timber (bedroom/bathroom partition end)

Plate 12 - Removed ceiling joist timber (wall plate end)

Plate 13 - Removed ceiling joist timber: Right side view (party wall)

Plate 14 - Removed ceiling joist timber: Top view (roof void)

Plate 15 - Removed ceiling joist timber: Left side view (door)

Plate 16 - Removed ceiling joist timber: Bottom view (lath and plaster ceiling)

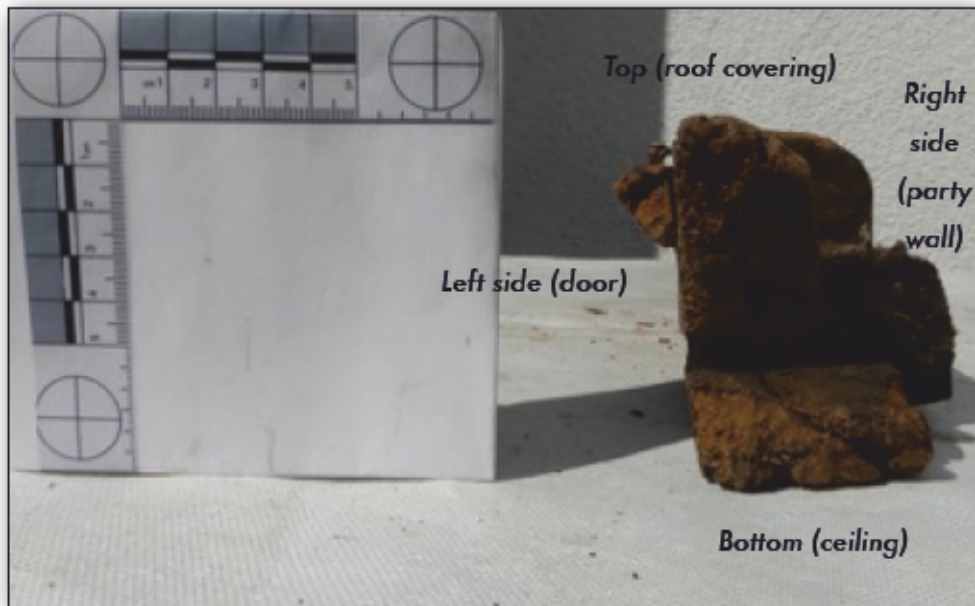
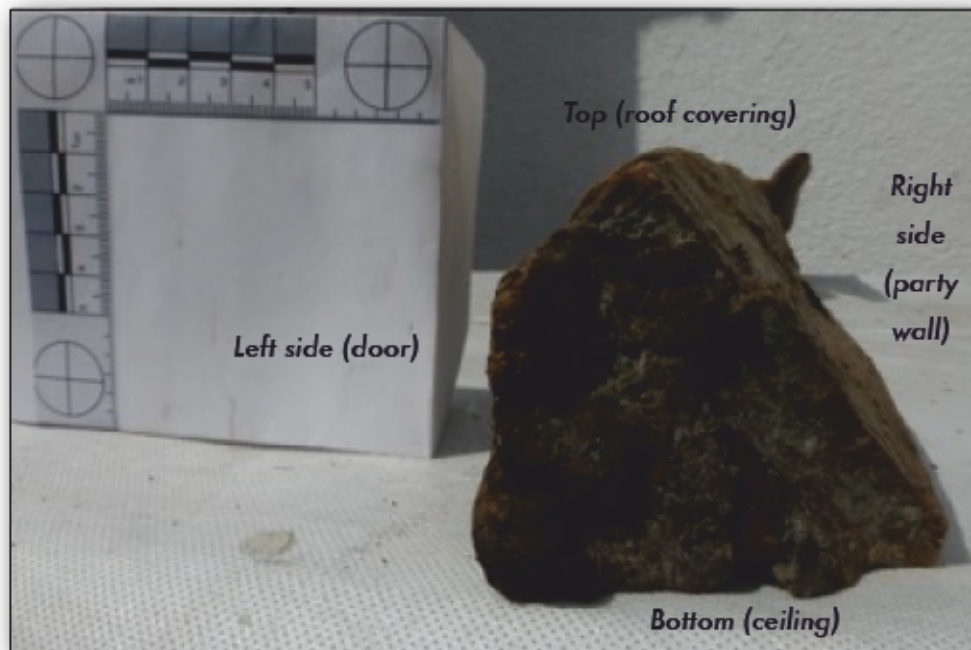
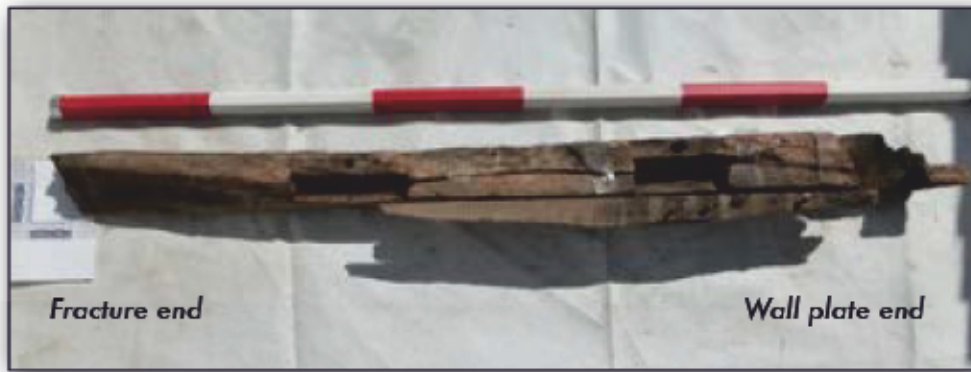
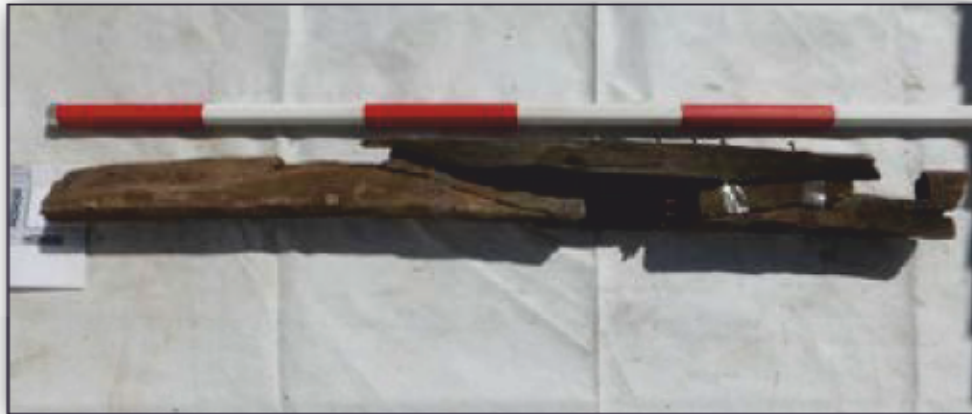
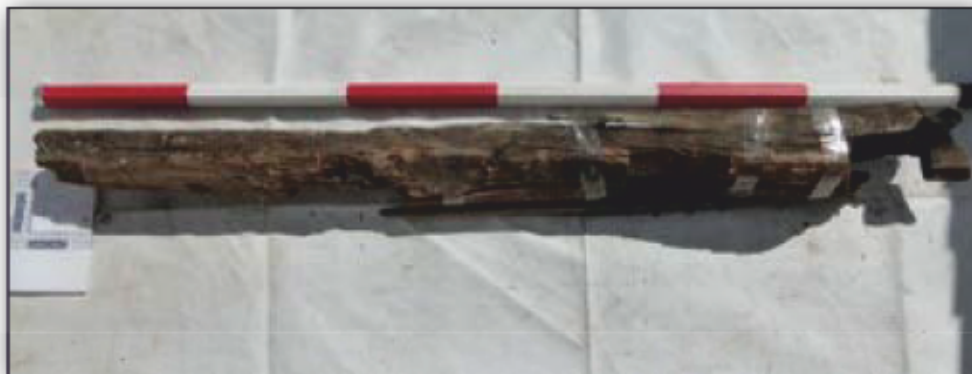
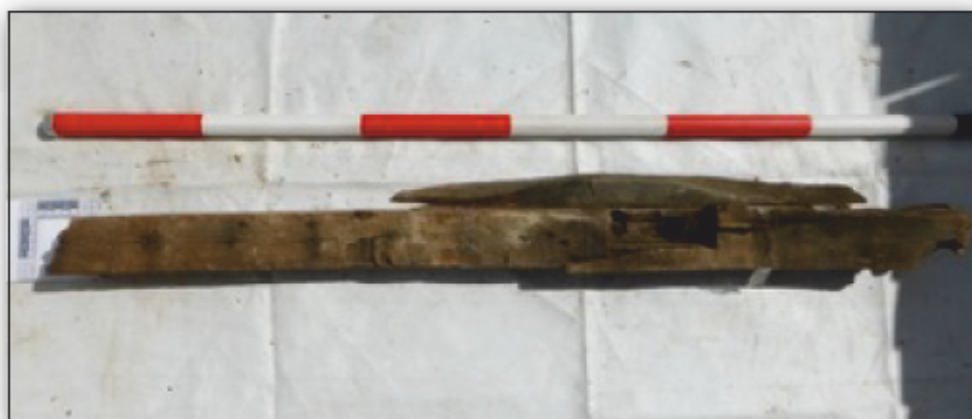
5.3.3. The timber was irregular in section shape along its length and had localised areas of fungal decay and beetle infestation.

Plate 17 - Removed rafter timber: Wall plate end

Plate 18 - Removed rafter timber: Fracture end

Plate 19 - Removed rafter timber: Bottom view (ceiling)

Plate 20 - Removed rafter timber: Right side view (party wall)

Plate 21 - Removed rafter timber: Left side view (door)

Plate 22 - Removed rafter timber: Top view (roof covering)

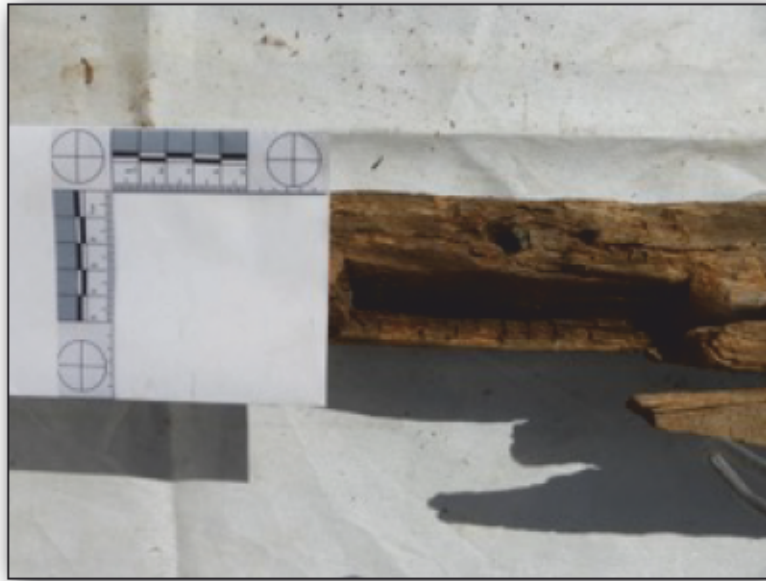
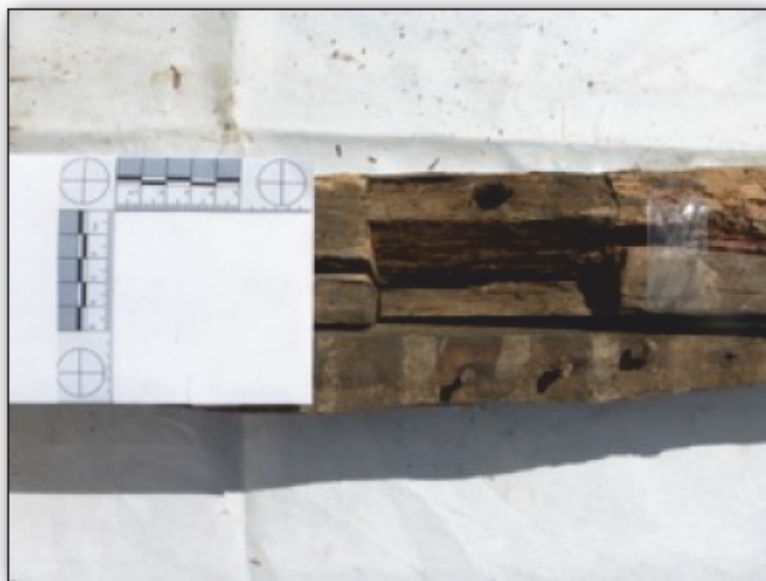
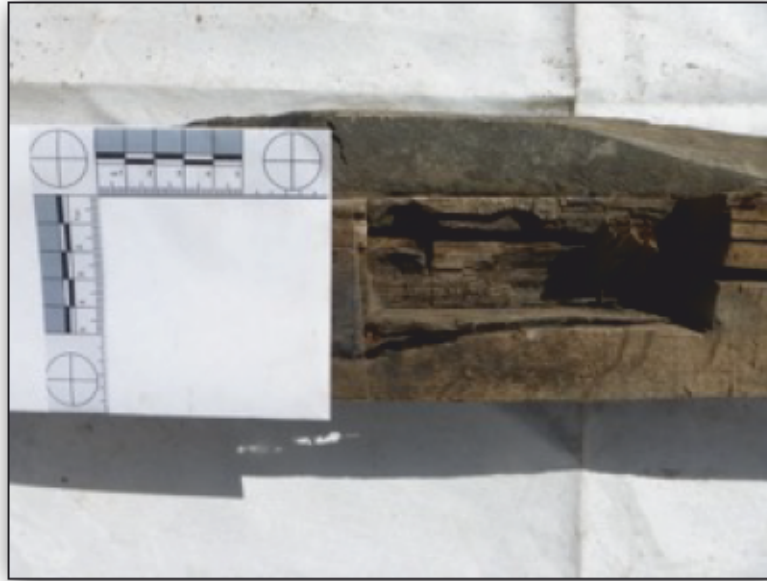
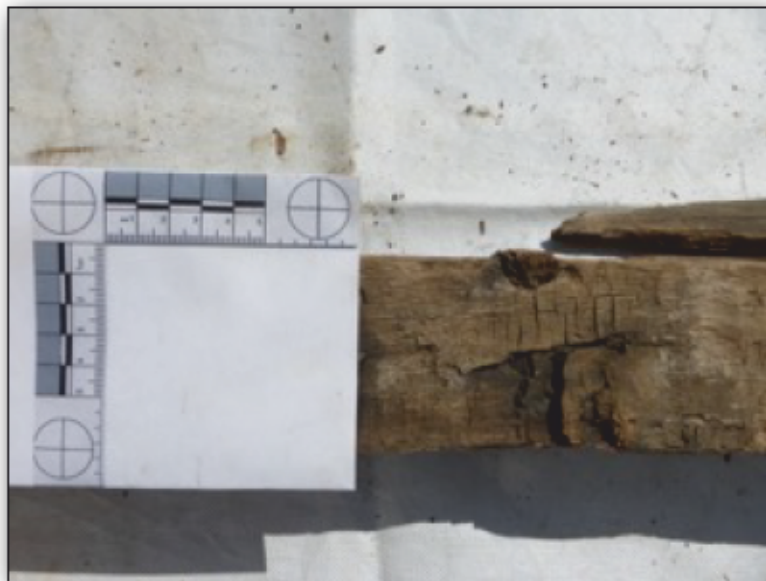
5.3.4. It had 3No. notches spaced along its length at the corner. These each had a peg or peg-hole (18mm square/dia.) running diagonally across its section to a corresponding chamfer.

5.3.5. It is most likely that the notches would have received separate perpendicular timbers, with the diagonal pegs providing a stronger fixing.

Plate 23 - Removed rafter timber: Fracture end, bottom notch

Plate 24 - Removed rafter timber: Wall plate end, bottom notch

Plate 25 - Removed rafter timber: Wall plate end, top, notch & peg

Plate 26 - Removed rafter timber: Fracture end, top, peg hole

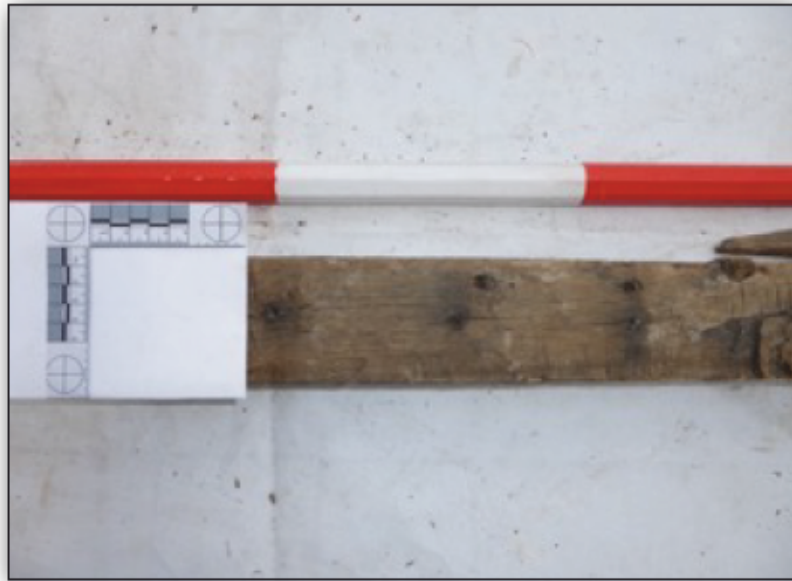
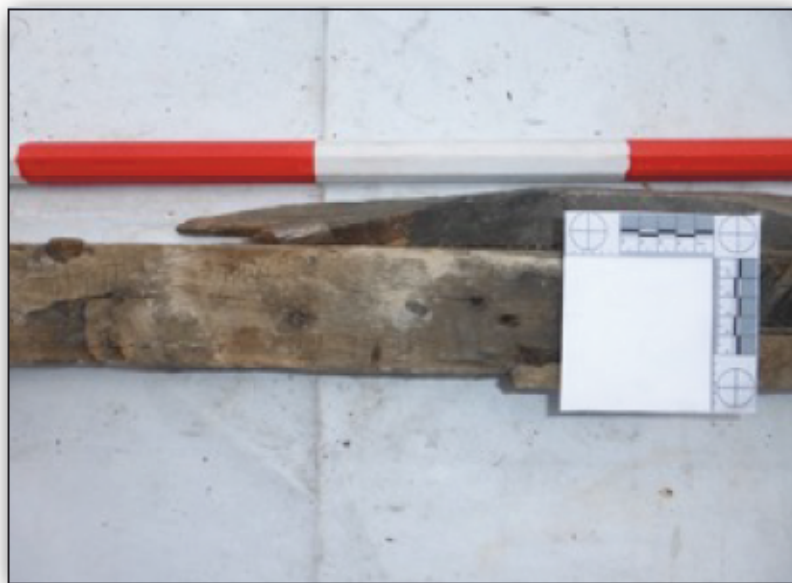
5.3.6. There were also a series of 6No. nail holes to top face of the timber. Their spacing ranged 100-125mm, most likely to be from the tile battens.

Plate 27 - Removed rafter timber: Fracture end, top, nail holes

Plate 28 - Removed rafter timber: Wall plate end, top, nail holes
