Historic Building Record

**Boyton Mill
Northcott
Boyton
Devon**

January 2016

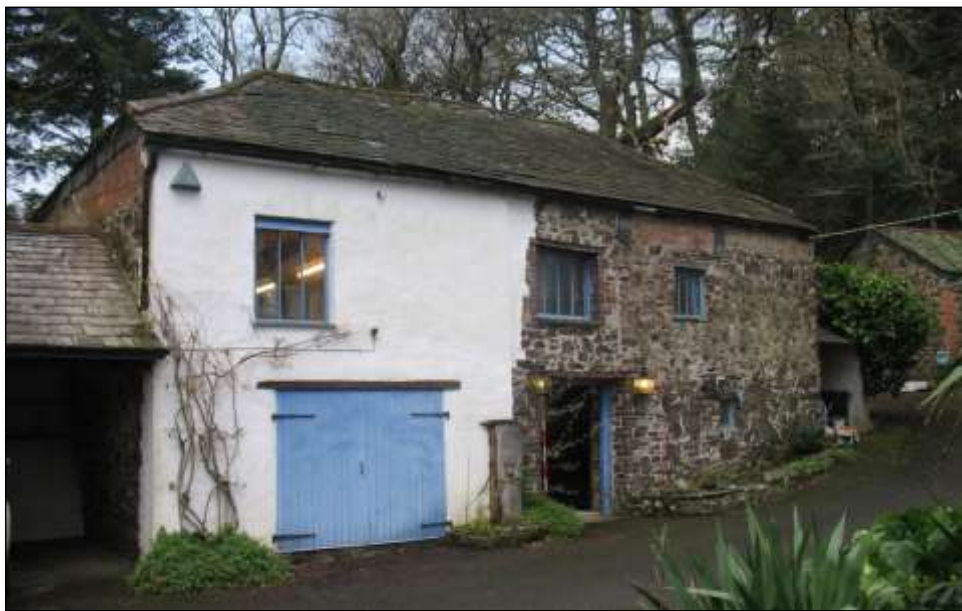
Figure 5: The south elevation of the mill building, viewed from the south-west.

The western end of the south elevation has been rebuilt in the late 20th century in concrete block, rendered and painted to the exterior (Fig. 5). To the interior the ground floor at this end is infilled with rubble, capped with cement forming the floor at first floor level. There is a former door opening at ground floor level, roughly central in the exterior west elevation, formerly giving access to this end of the building, blocked with stone rubble set in modern cement (Fig.7 & see Appendix 4, Fig. 36). The masonry of the southern end of this wall is disturbed and has been repaired in hard grey cement with the date 1947 etched into it. Below ground level toward the north end of the west wall is a small square opening, blocked to the interior (Fig. 6 & see Appendix 4 Fig. 33)

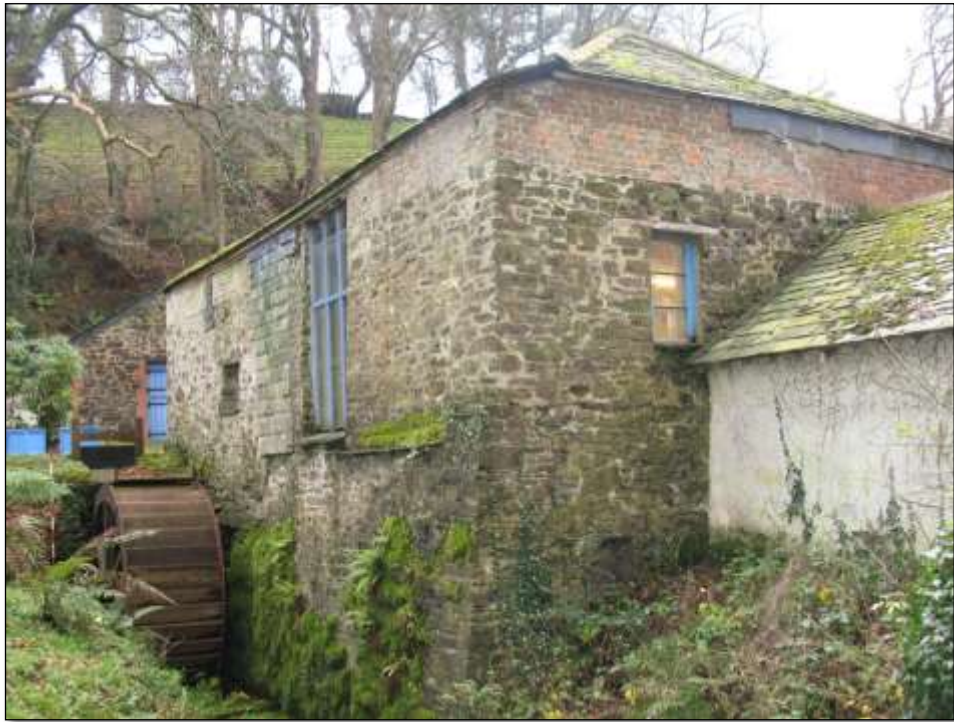
Figure 6: The north and west elevations of the mill, views from the north-west.

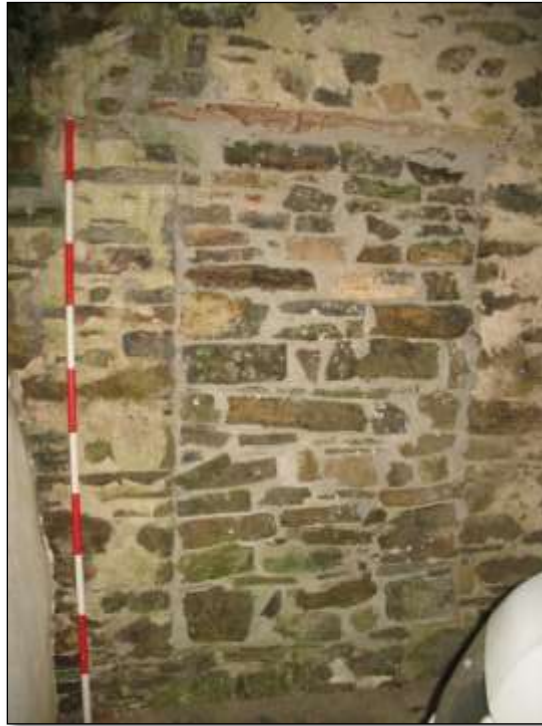
Figure 7: Blocked door opening in the west elevation of the mill, viewed from the west (2m scale).

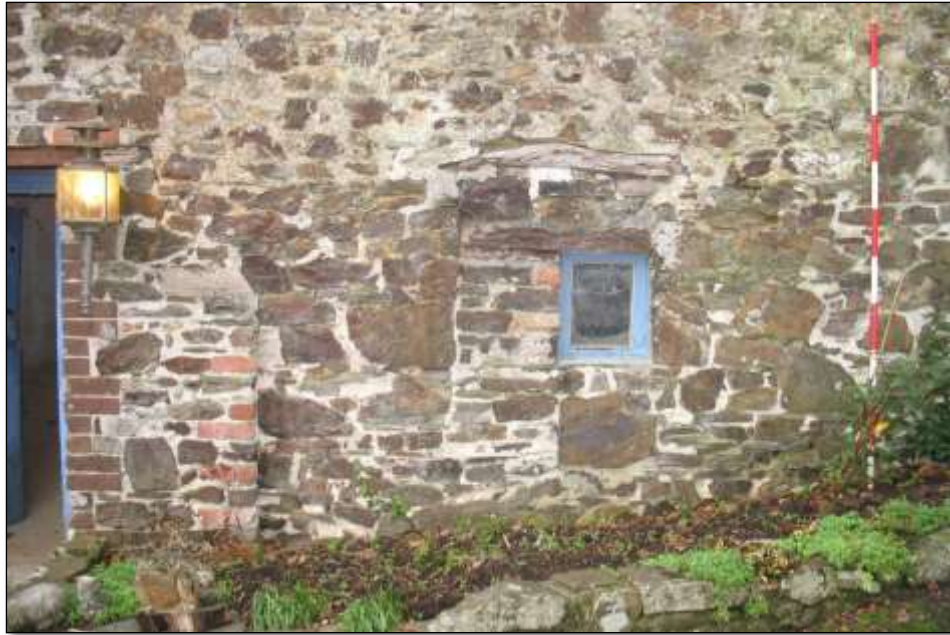
The central door opening and window opening above in the south elevation have been rebuilt and reset in the 20th century, with modern machine-made brick to the door jambs and window reveals, set in reused rubble stone and orange brick bonded with modern cement (Figs. 5 & 8 & Appendix 4, Figs. 18 & 38). The wall to the east of the door is disturbed and the extant late 19th century ground floor window opening is set within an earlier, larger opening with the earlier timber lintel visible to the exterior and internally (Fig. 8 & see Appendix 4, Figs. 18, 20, 46 & 48).

Figure 8: The eastern portion of the southern ground floor elevation, with repaired door opening and blocked former larger window opening, viewed from the south (2m scale).

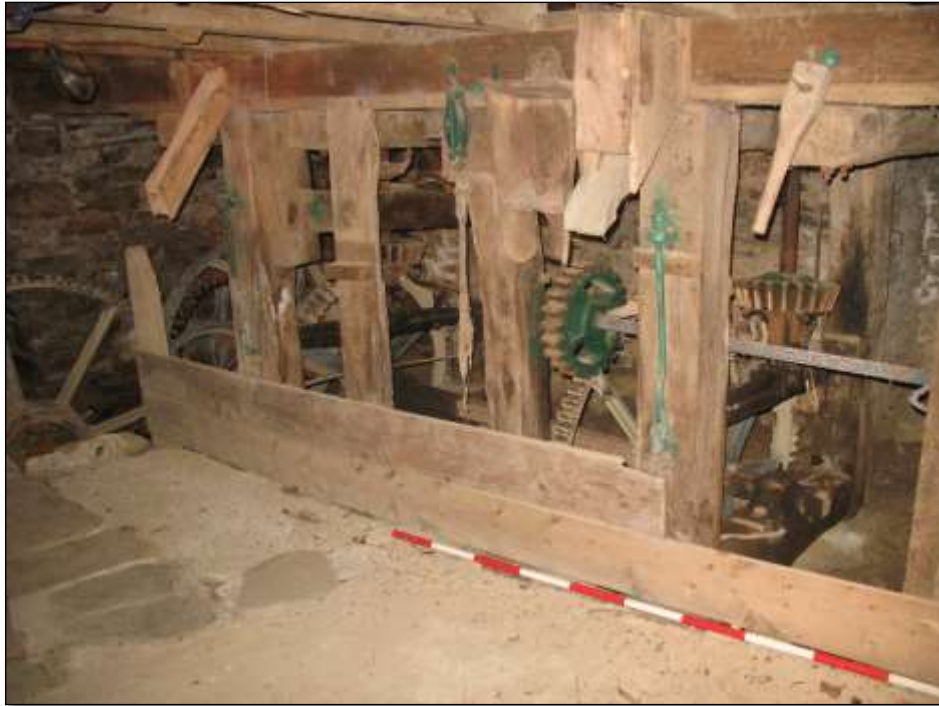
The interior eastern lower ground floor retains the late 19th century layshaft drive mill gearing and hurst (see 3.2 below), now set on cement plinths resting on an earth floor (Fig. 9 & see Appendix 4, Figs. 39, 40, 41 & 42). The walls to east and south are earth bonded and there is a recess toward the south end of the east wall, probably a former fireplace (Fig. 10 & see Appendix 4, Fig.39).

Figure 9: The hurst and gearing, viewed from the south-west (2m scale).

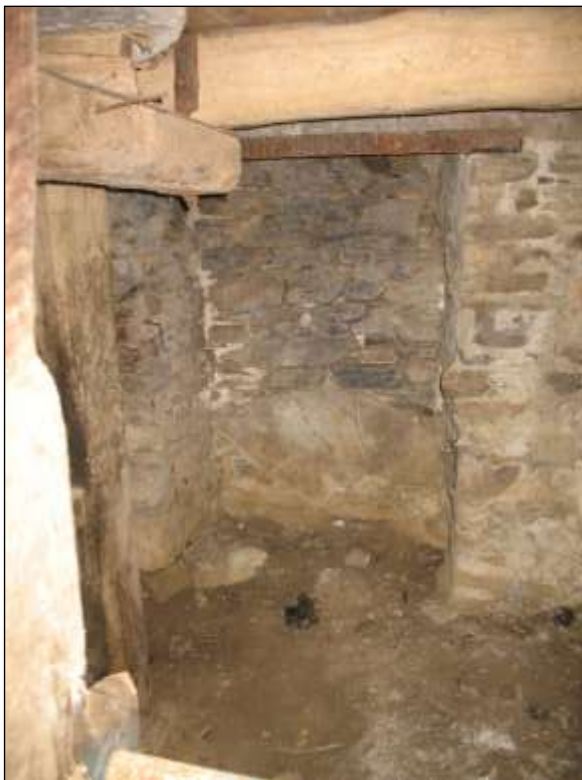
Figure 10: Left - Former fireplace in the ground floor east wall, viewed from the west.

The recess in the upstream corner can be reasonably confidently identified as a former fireplace. It was again not uncommon for west country watermills to have fireplaces at ground floor level. The risk of fire in damp draughty mills is somewhat over-estimated, particularly when compared with the miller's comfort! The ground floor was where the miller spent most of his working day when the mill was running. (Watts, M. 18.01.2016)

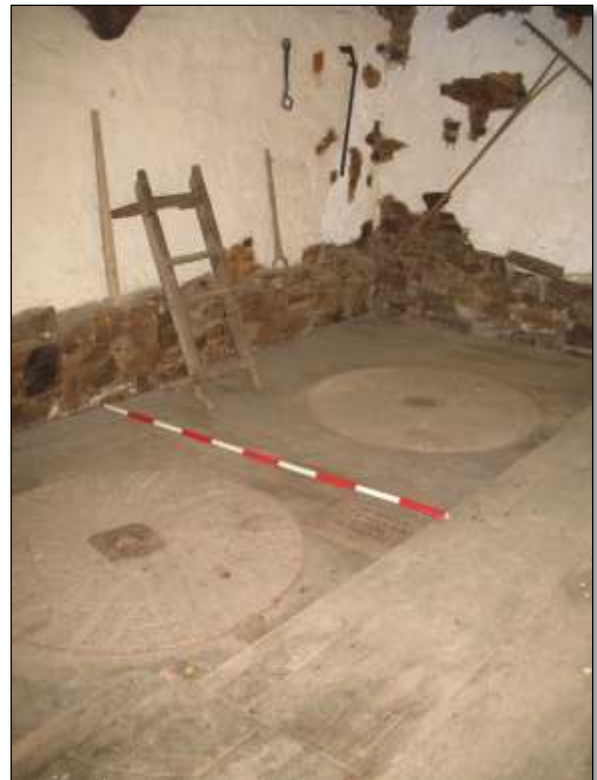
The first floor above (the stone floor) has the bedstones set into the floor boards (Fig. 11), and is open to the west, with most of the timber framework dating to the late 19th and 20th centuries (Fig. 12 & see Appendix 4, Figs. 37, 38, 46 & 50). The south and east walls have a ragged step to the base with thinner, later masonry walls above probably dating to the early 19th century 'rebuilding' (Figs. 11-12 & Appendix 4, Figs. 46 & 47). The lintel of the former opening in the south wall is visible in the earlier masonry (Appendix 4, Fig. 48). To the east a heavy timber is set into the earlier masonry just above floor level (Appendix 4, Fig. 49), which probably relates to an earlier arrangement of the mill machinery (see 3.2 below). Likewise, notches in the ceiling beams to the west suggest a former arrangement (see Appendix 4, Fig.50).

Figure 11: Right - Bedstones set into the floor at first floor level above the gearing, viewed from the north-west.

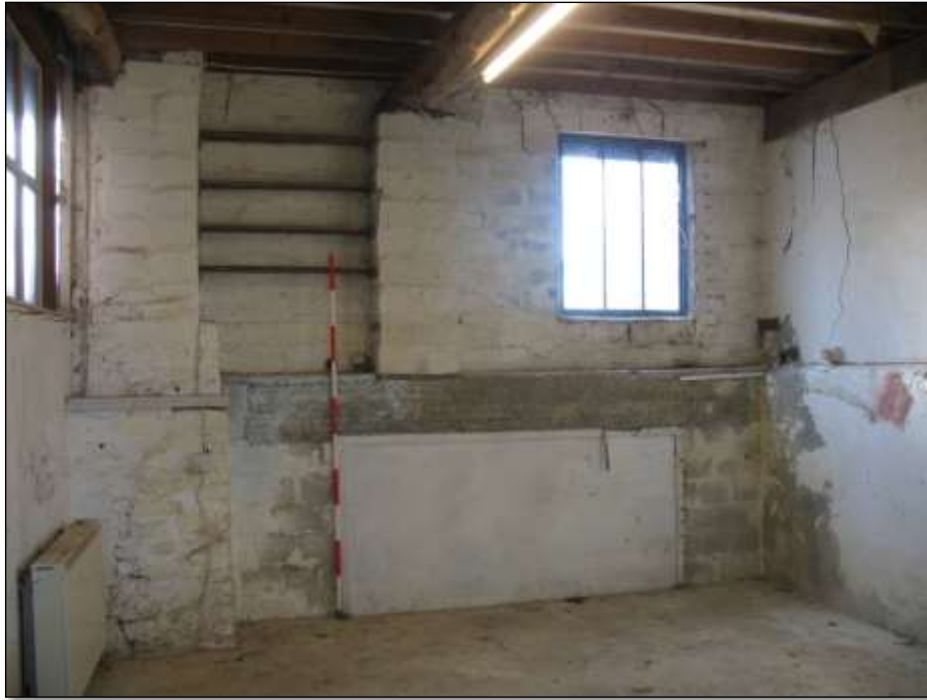
The first floor room to the west is modern, with all structural elements, with the exceptions of the west and parts of the north walls, dating to the 20th century (Fig.13 & see Appendix 4, Figs. 44 & 45).

Figure 13: The modern western first floor room, viewed from the north (2m scale).

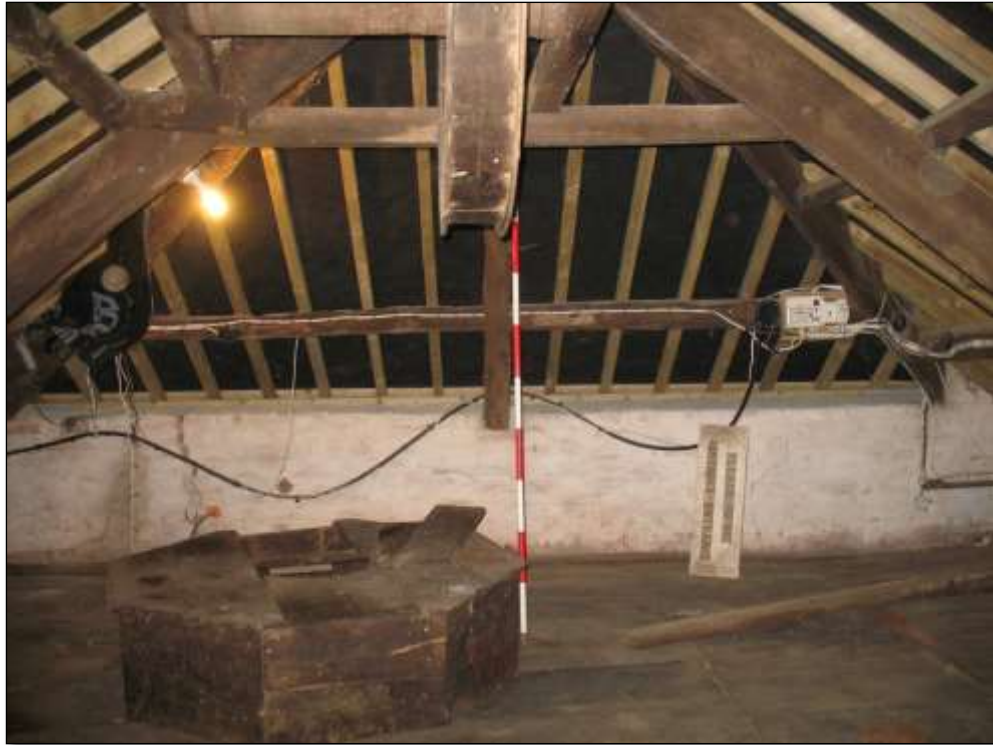
The four bolted roof trusses of the five bay second floor loft date to the late 19th century, although some timbers have been reused and the collars and purlins reinforced or replaced with later timbers (Fig. 14 & Appendix 4, Figs. 52, 53, 54 & 55). The building has been reroofed in the late 20th century; all rafters are modern, with modern felting above. The walls have been raised in brick probably in the late 19th century, with the feet of the truss blades of the three roof trusses to west set into the brickwork, or modern concrete block to the south west, with the timbers of the eastern truss resting on timber pads set into the wall at the height of the former wall head (Appendix 4 Figs. as above). The floor to west is modern chipboard, with that to east timber planks set at a lower level, probably contemporary with the brick wall tops. At this end a timber sack hoist, fixed to the roof timbers, and a freestanding stone cover remain (Fig. 14 & Appendix 4, Figs. 54 & 56) .

Figure 14: The hipped end of the roof structure, with remaining hoist in foreground and stone case, viewed from the west (2m scale).

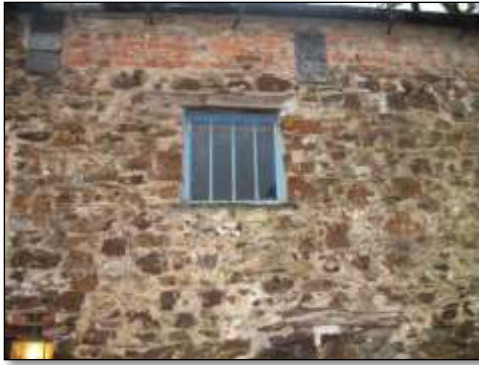
Figure 20: Left – First floor (ff) south elevation, east end, showing ff window & lintel of former ground floor (gf) opening, from the south.

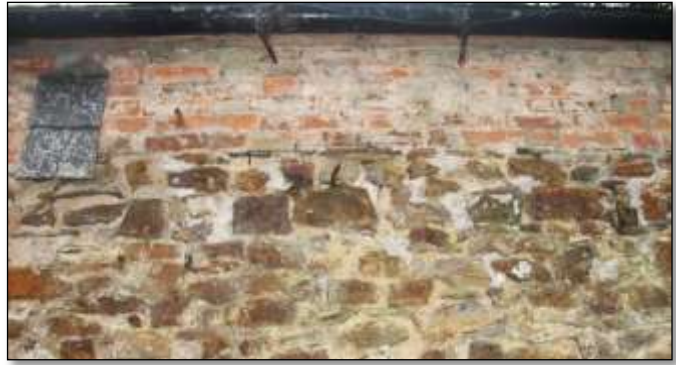
Figure 21: Right – South elevation, east end, second floor (sf) brickwork with slate hanging nails remaining, from the south.

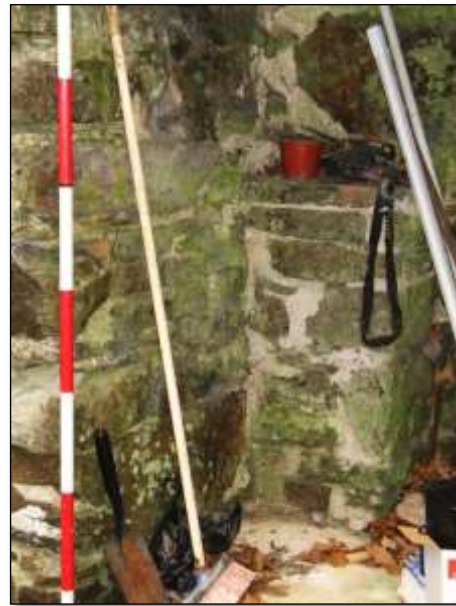
Figure 23: Right – Former flue in north-west corner of log store, from the south-east.

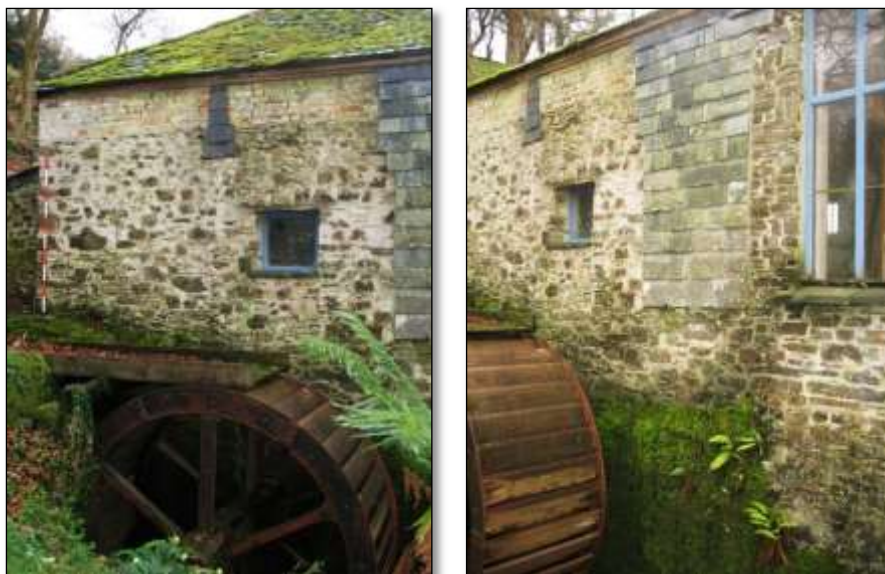
Figure 29: Left – North elevation, east end, with waterwheel and launder, from the north.

Figure 30: Right – As above, showing blocked opening and modern window, from the north-west.

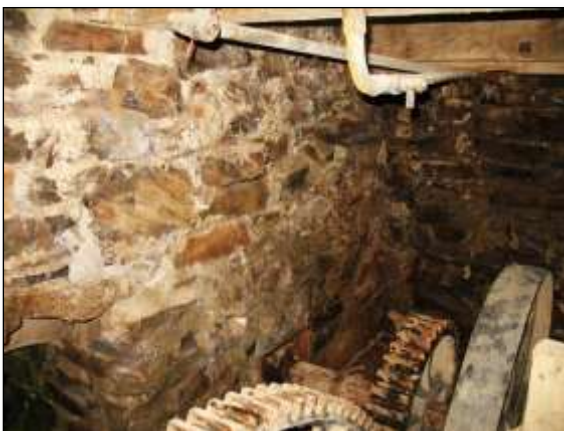
Figure 41: Left – view into the north-east corner of the eastern ground floor area, showing stones projecting from the north wall, from the west.

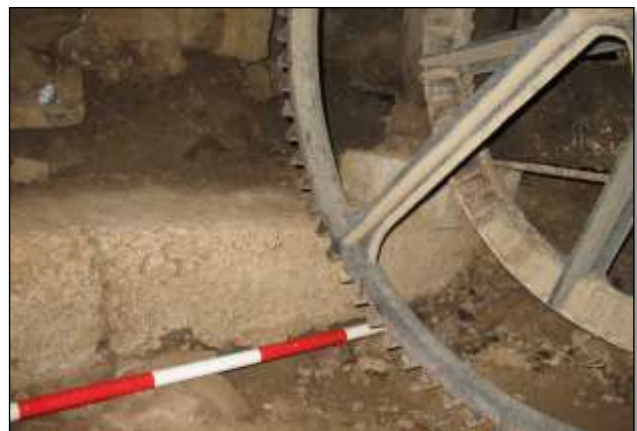
Figure 42: Right – Cement plinth under the hurst from the west.

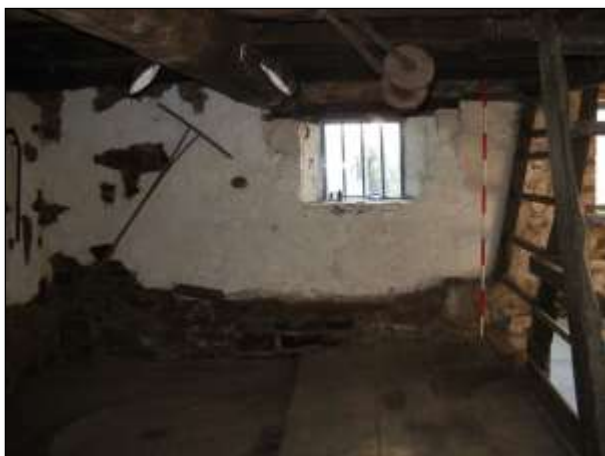
Figure 46: Left – Eastern first floor stone floor, with earlier masonry projecting from the base of the south wall, from the north.

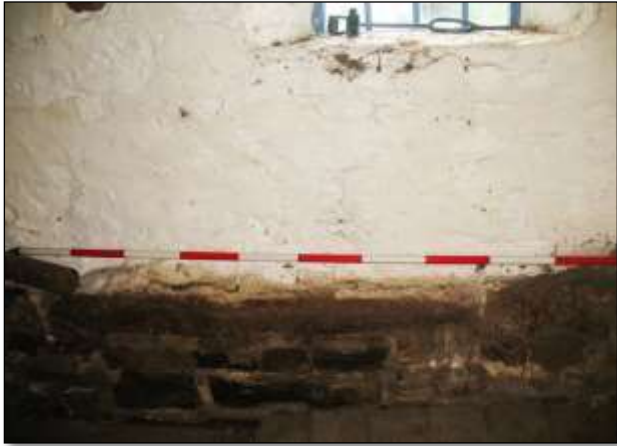
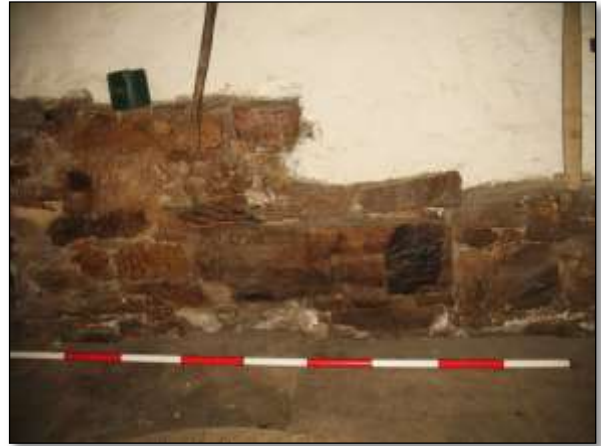
Figure 48: Left – Detail of Fig. 46 above, timber lintel with blocking below of former opening at first floor level, from the north.
Figure 49: Right – Timber set into east wall of the stone floor, from the west.

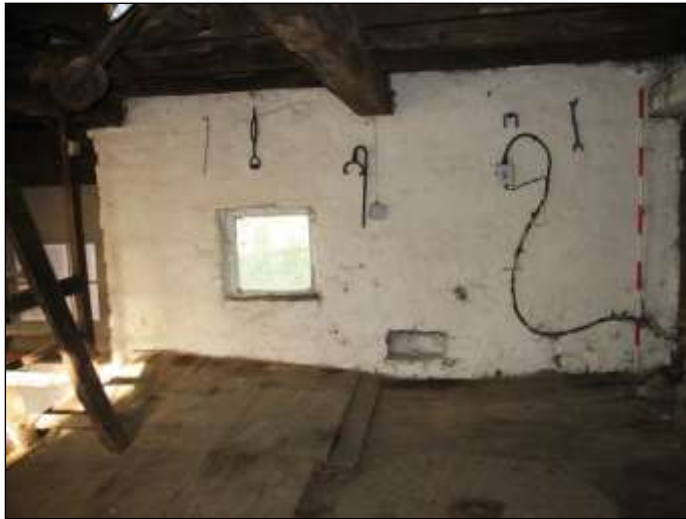
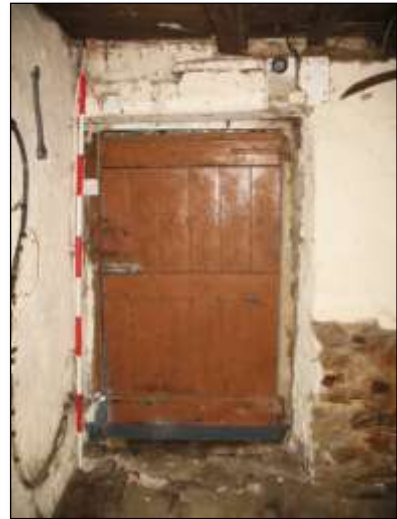
Figure 50: Left – North wall of stone floor, notches in the ceiling timbers just visible top left, from the south.
Figure 51: Right – Door at the north end of the first floor stone floor, from the west.

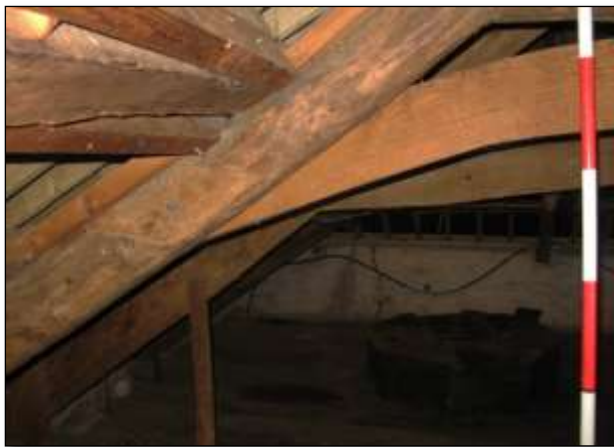
Figure 55: Left – Detail of face of third roof truss from the east, with rebate for former collar reused in later 19th century, from the west.
