Hedrick Rigg Level 2 Assessment

Hedrick Rigg Level 2 Building Assessment

The work is in response to an Application for Planning Permission Planning permission (DM/21/01835/FPA): Conversion of Farm Buildings to create three residential units. A building survey Level 2 is required as a condition of the planning permission.

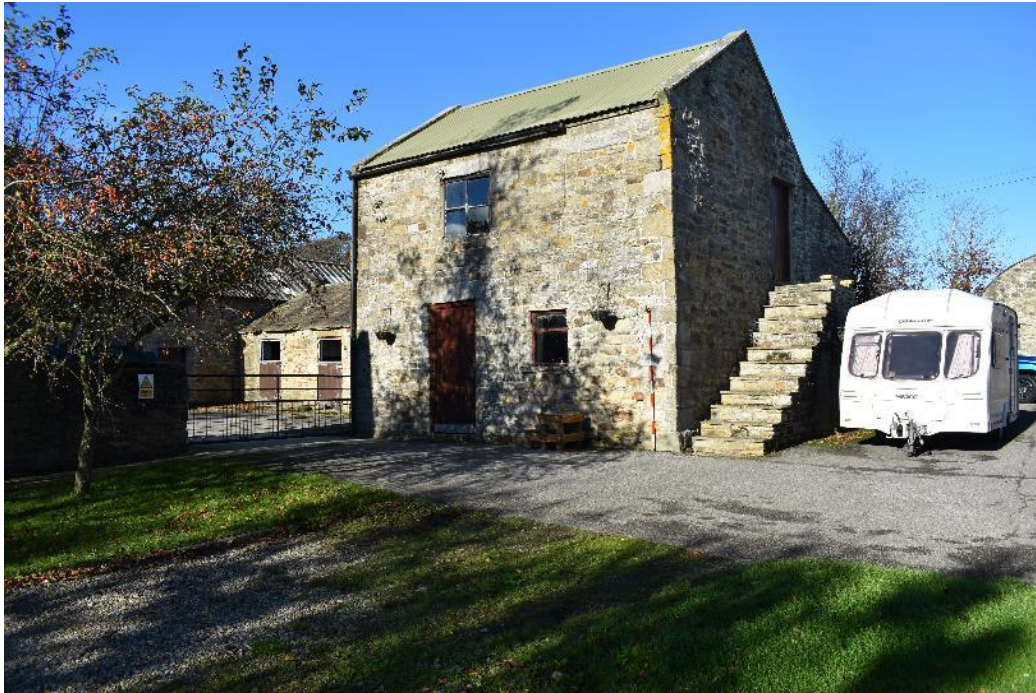
Plate 3: Granary

- 4.1.2 Granary – Two storey square building of random coursed stone with stone quoins, corbel eaves stones stone kneelers to the gables with a corrugated roof supported by timber trusses, purlins and rafters (Plates 3, 4, 32, 33, 34 and 35). The first floor is accessed by external steps and an internal ladder. Timber floor in reasonable condition and it is used for storage. Timber windows in poor condition and a first-floor window to the south side has been blocked up.

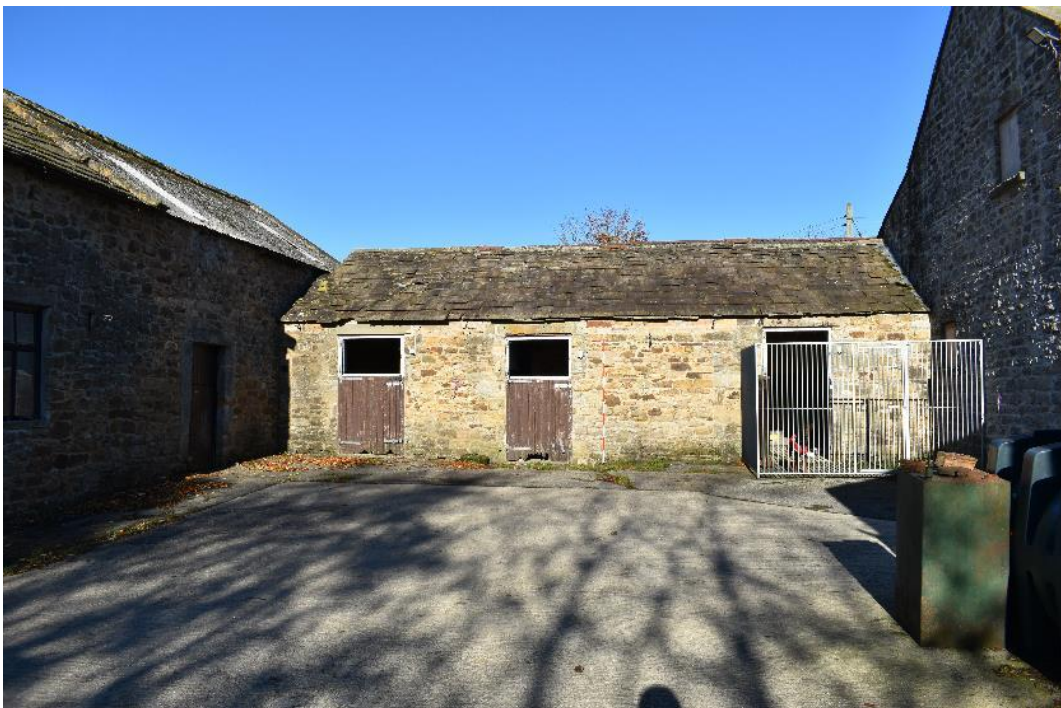
Plate 24: Courtyard looking North to Stables

- 4.1.3 Stables – Link building to the north of the courtyard of random coursed stone, Teesdale slate roof and three stable doors with stone heads. The roof is in poor condition and supported by rough-hewn trusses (with added cross ties), purlins and rafters. Limewash plaster to is left to some walls and the three stables are divided by modern block walls (Plates 24, 41 and 42).

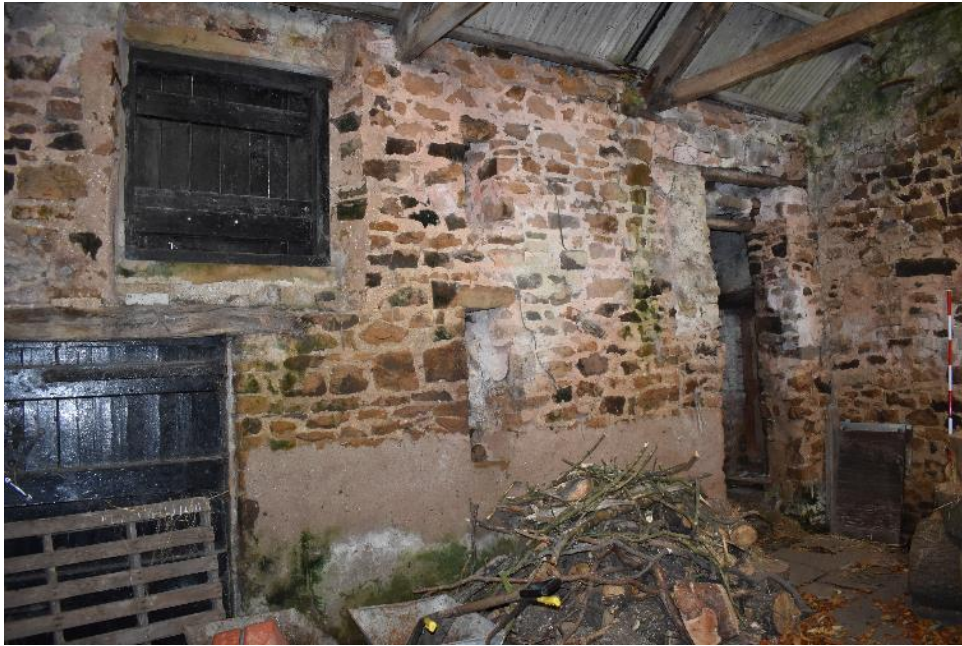
Plate 45: Straw Barn West Wall.

- 4.1.5 Straw Barn and Store 2 – Random coursed bare stone walls inside and out with a triangular timber roof truss and purlin structure directly supporting corrugated roofing sheets. Some cracking is evident to the gable end walls. Timber stable doors and shuttered windows, high level to the store (Plates 26, 43-48).

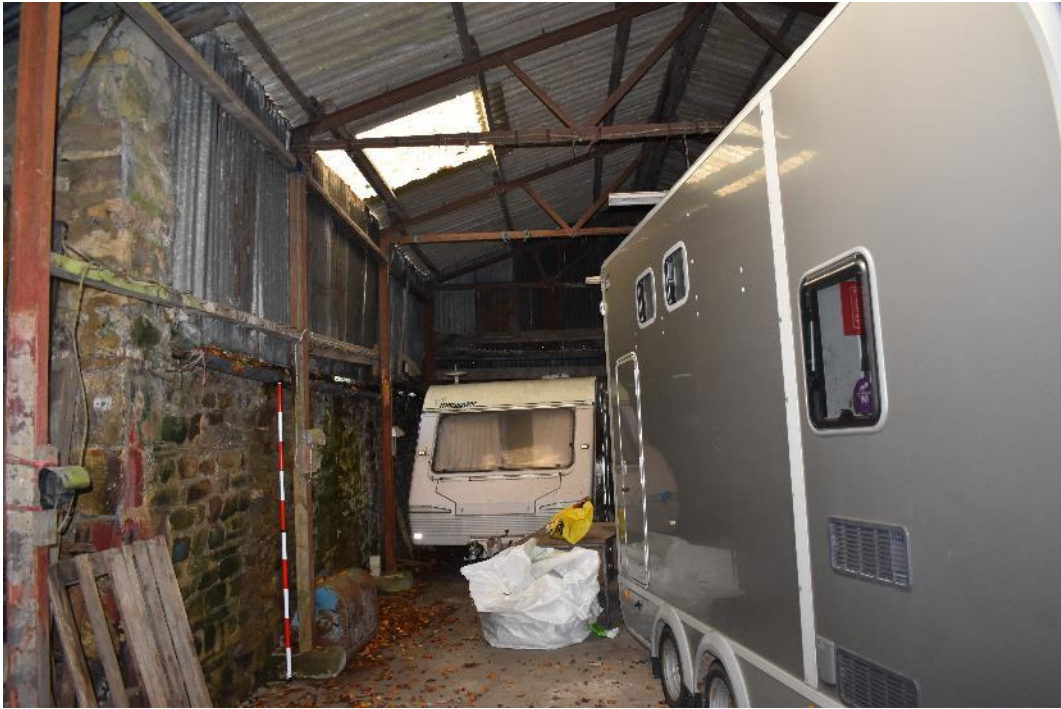
Plate 51: Garage

- 4.1.4 Garage, Workshop and Wood Store – Set behind the stables to the north, the garage is an extension to the original wood store ad workshop which are of the same materials as the other outbuildings. The garage is a lightweight steel post and truss frame clad with corrugated sheeting and block wall to the front (east). It abuts the stables to the south side. The workshop and wood store have the same timber truss, purlin and rafter construction as the buildings running to the west side of the courtyard but have a corrugated sheet roof covering. Condition is generally poor with bare stone walls, wood decay and damaged roof sheets (Plates 51 to 56).

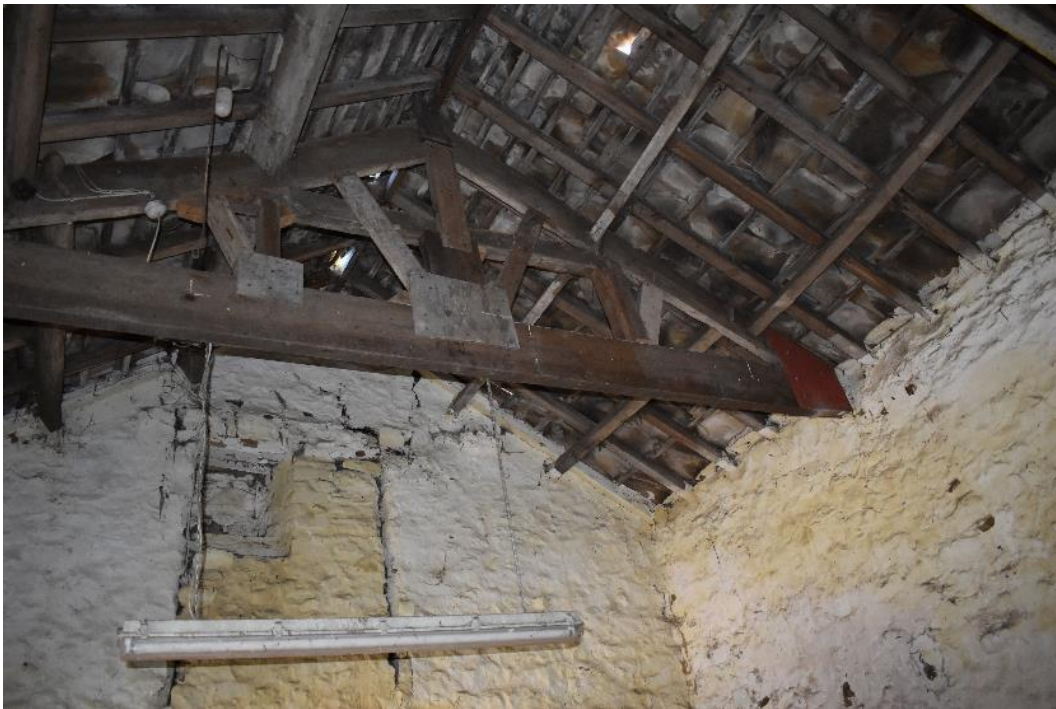
Plate 64: Loose Box Roof Detail

- 4.1.6 Loose Box – This section of building forms the end of the higher of the courtyard buildings to the west and is the same random coursed stone walls. The roof trusses have square and diagonal ties that have been reinforced with timber plates, timber purlins and rafters but with the original stone slates set between stone kneelers to the dividing and end gable walls. A gable window to the south wall has been blocked up with stone. This wall has stone quoins and eaves corbel stone (Plates 21, 22, 26, 63 and 64).

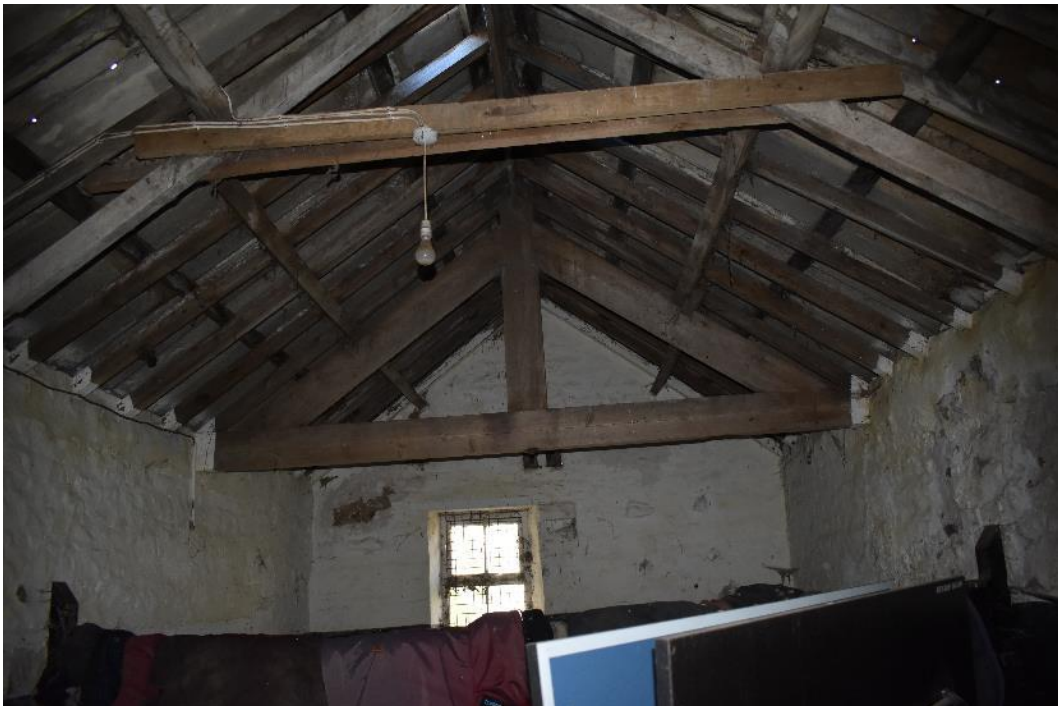
Plate 66: Plate Milking Shed Roof Detail

- 4.1.7 Milking Shed – This section of building is set lower than the previously discussed buildings forming the west side of the courtyard. It is the same random coursed stone with a king post truss with timber purlins and rafters supporting a corrugated sheet roof. There is a later additional timber double tie repair. The walls are white limewashed. There is a timber window to the south gable and three owl holes with protruding perch stones (Plates 12, 13, 20, and 65 to 67).

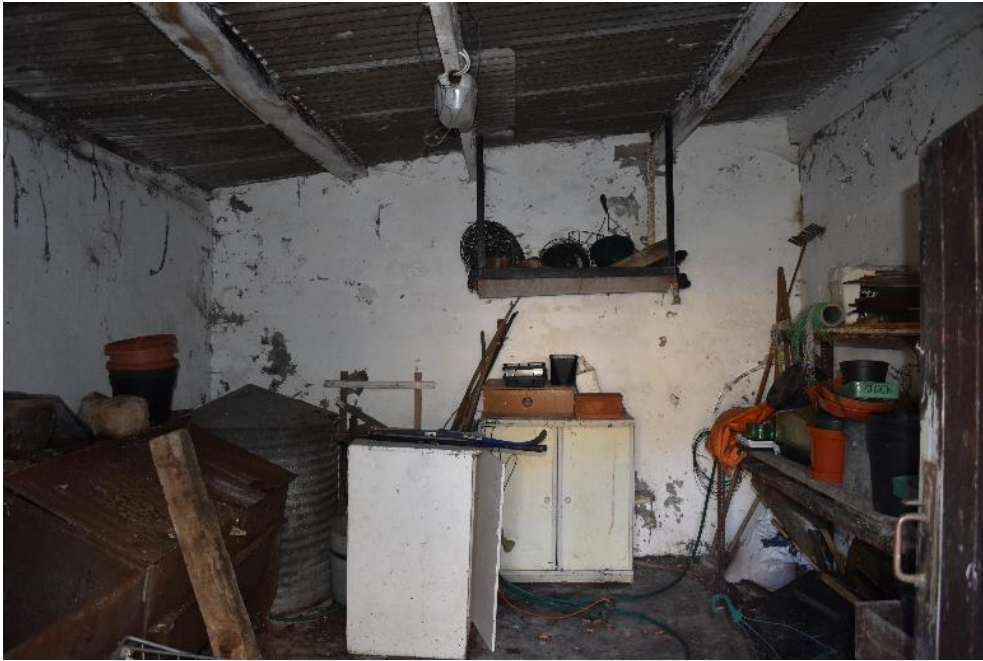
Plate 68: Dairy

- 4.1.8 Dairy – Small lean-to roofed building joining the Milking shed. The timber entrance double door is to the north side along with a small window. The south wall is random coursed stone, but the remaining walls have been rebuilt in blockwork and painted. The roof is a shallow mono-pitch with two timber purlins supporting corrugated sheeting (Plates 9, 12 and 68).
